# NATIONAL TRANSPORTATION SAFETY BOARD

## MATERIALS LABORATORY FACTUAL REPORT

Report No. 12-148

Place : Homer, Alaska  
Date : July 29, 2012  
Vehicle : Bellanca 8KCAB Decathalon  
NTSB No. : ANC12IA085  
Investigator : Chris Shaver, AS-ANC

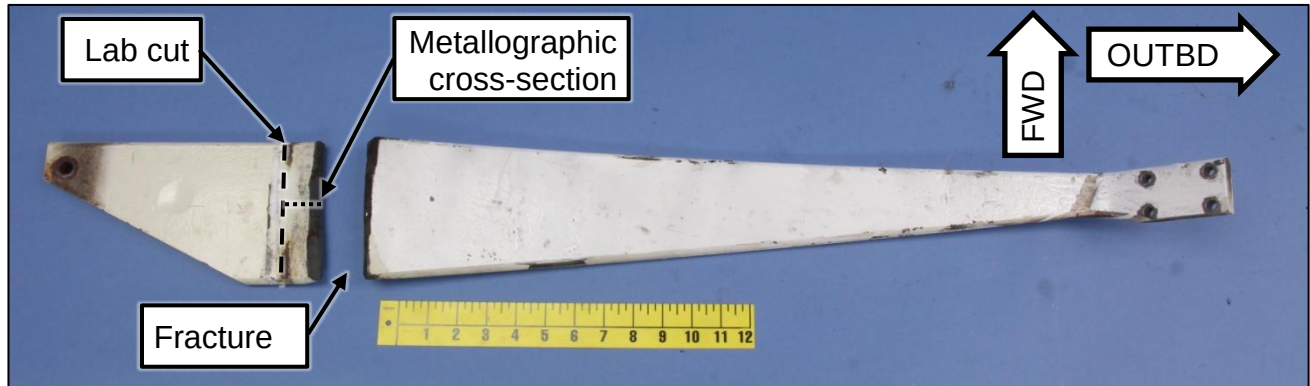
An overall view of the submitted left main landing gear leg is shown in figure 1. The leg is displayed as viewed looking at the lower surface. The leg was fractured near the middle of the bend between the horizontal and angled portions of the leg near the inboard end as shown in figure 1.

Figure 1. Overall view of the fractured left main landing gear leg showing the lower surface of the leg.

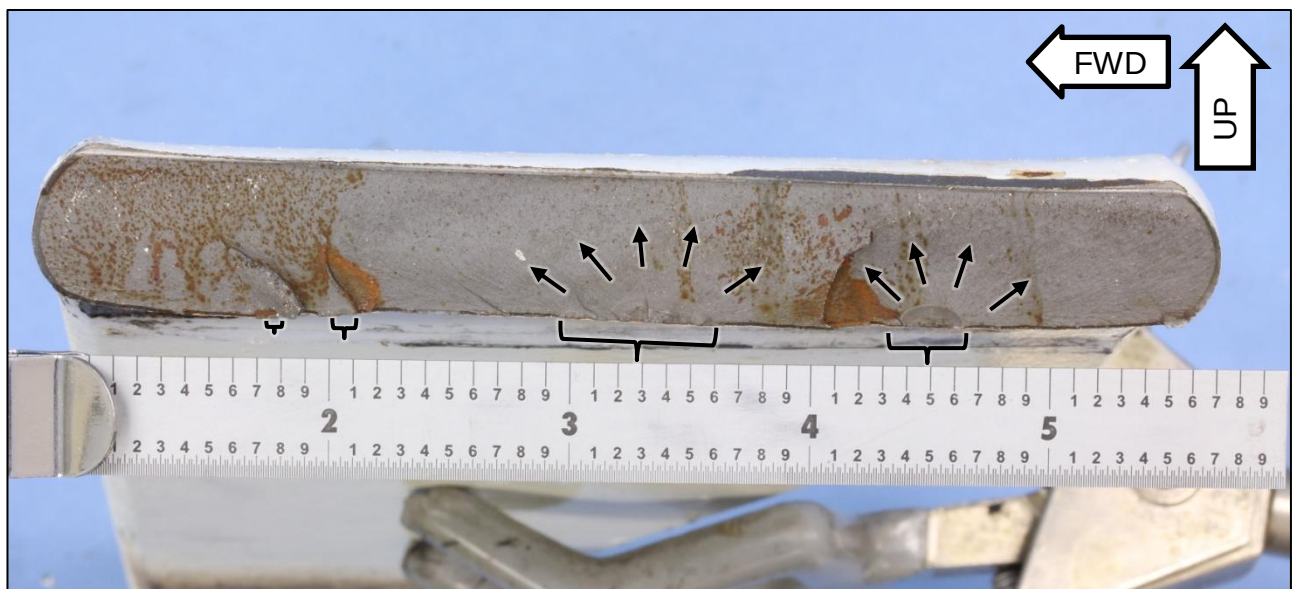
An overall view of the fracture surface on the inboard side of the fracture is shown in figure 2. Portions of the fracture surface had relatively smooth and flat fracture features with a curving boundary and no shear lip at the edge of the fracture,<sup>1</sup> features consistent with fatigue. Four separate areas of fatigue were observed emanating from the lower surface, and these areas are indicated in figure 2 with brackets. The largest area of fatigue, located near the middle of the width of the leg, was 0.65 inch wide along the lower surface and extended upward to a maximum depth of 0.12 inch. The remainder of the fracture surface had a matte gray appearance with radial features indicating final fast fracture propagation emanating from the two largest fatigue regions as indicated with arrows in figure 2. Some of the fracture was covered with orange oxide, consistent with post-fracture oxidation of the surface.

Figure 2. View of the inboard side of the fracture. Brackets indicate multiple fatigue regions originating at the lower surface, and arrows indicate fracture propagation directions emanating from the two largest fatigue regions.

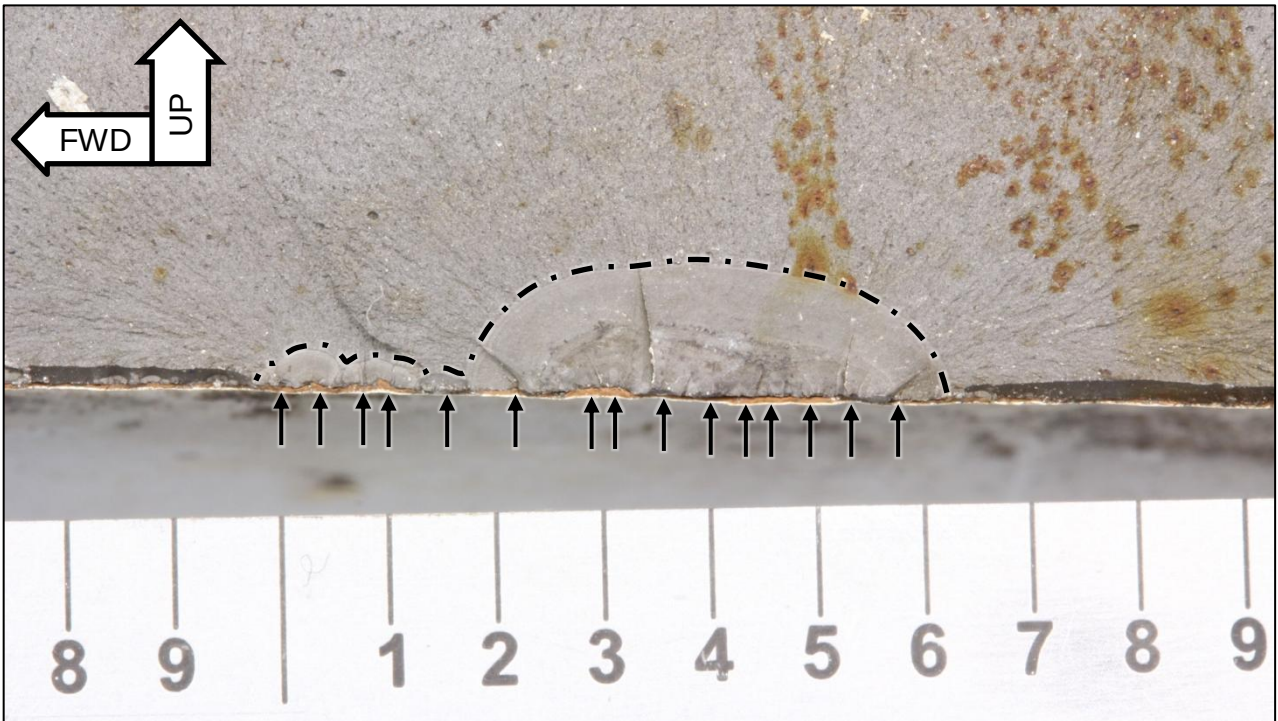
A closer view of the largest fatigue region is shown in figure 3. The fatigue features emanated from multiple origin sites. Arrows in figure 3 indicate origins located at the lower surface along the fatigue region. The origins were separated by ratchet marks of varying size.<sup>2</sup> A dashed line in figure 3 indicates the extent of fatigue propagation.

Figure 3. Close view of the largest fatigue region. Arrows indicate individual fatigue origin sites, and a dashed

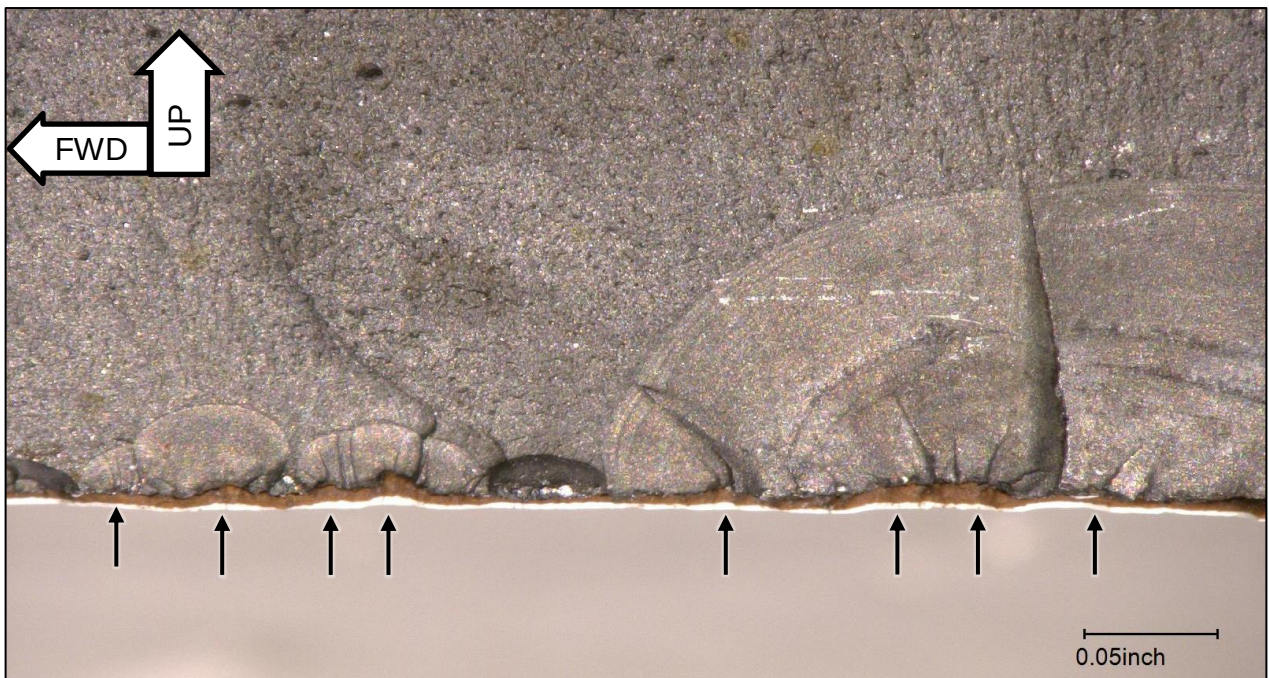
The forward portion of the largest fatigue region is shown at higher magnification in figure 4. The fatigue generally originated from pits in the lower surface. Arrows in figure 4 point to the pits observed at fatigue origins. The pits were filled with brown paint, and the brown paint was covered with white paint.

Figure 4. Close view of several of the fatigue origins. Arrows point to pits at the fatigue origins. The pits were filled with brown paint.

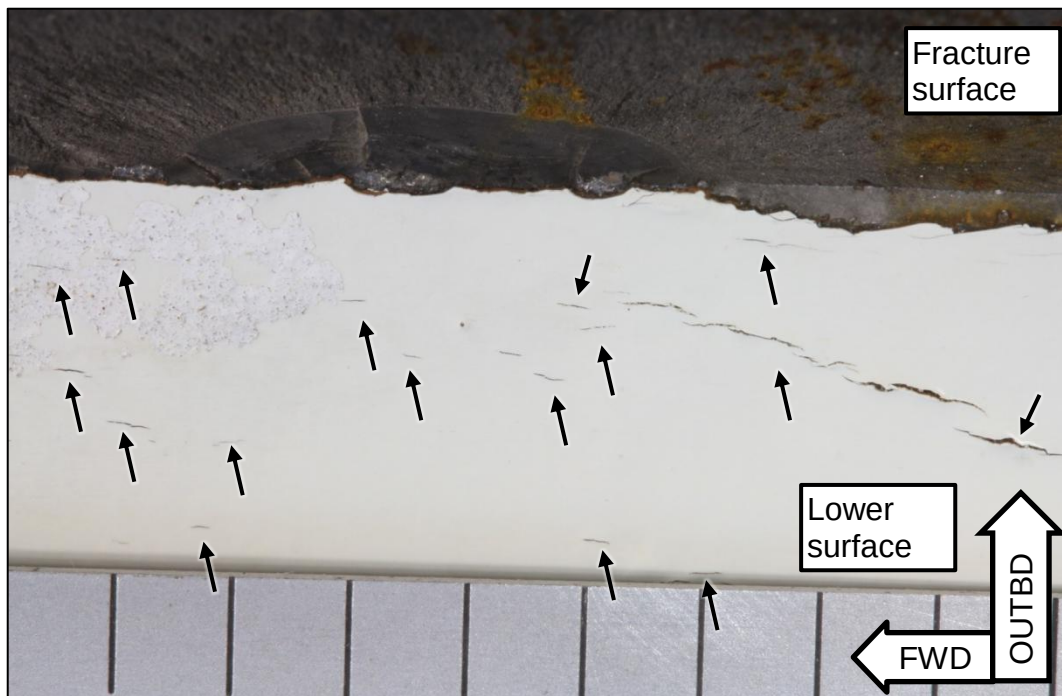
Multiple cracks were observed in the paint near on the lower surface near the fracture surface. The surface was partially covered with dirt and debris, so the surface was cleaned using soapy water and a soft-bristle brush. Paint cracks on the lower surface are shown in figure 5 after cleaning. The cracks were mostly aligned in the transverse direction.

Figure 5. View of the lower surface adjacent to the fracture surface after cleaning with soapy water. Arrows indicate multiple cracks observed in the paint.

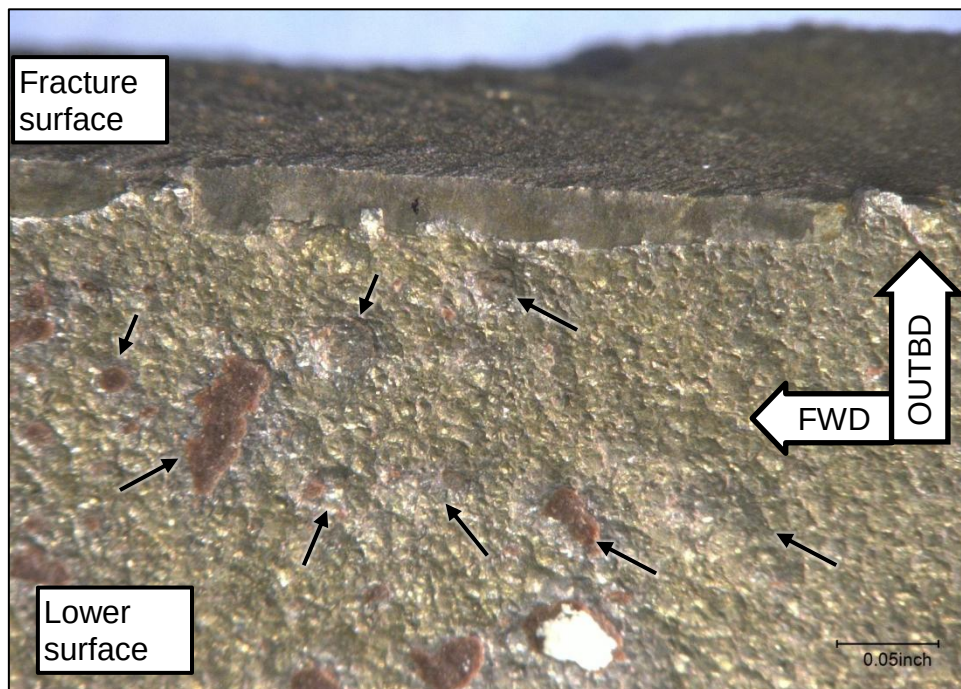
A view of the lower surface adjacent to the fracture surface after paint removal is shown in figure 6. The lower surface had a roughened surface consistent with a shot blast treatment with a 250-microinch surface finish. Most of the surface had a flat uniform appearance, but discrete pits were observed scattered around the surface. Arrows in figure 6 point to a cluster of pits observed in one area near the fracture surface. Some of the pits remained covered in paint. The exposed pits appeared to have a shot blast finish similar to that of the remainder of the surface.

Figure 6. View of the lower surface adjacent to the fracture after paint was mostly stripped away. Arrows indicate pits in the surface. Paint filled some of the pits.

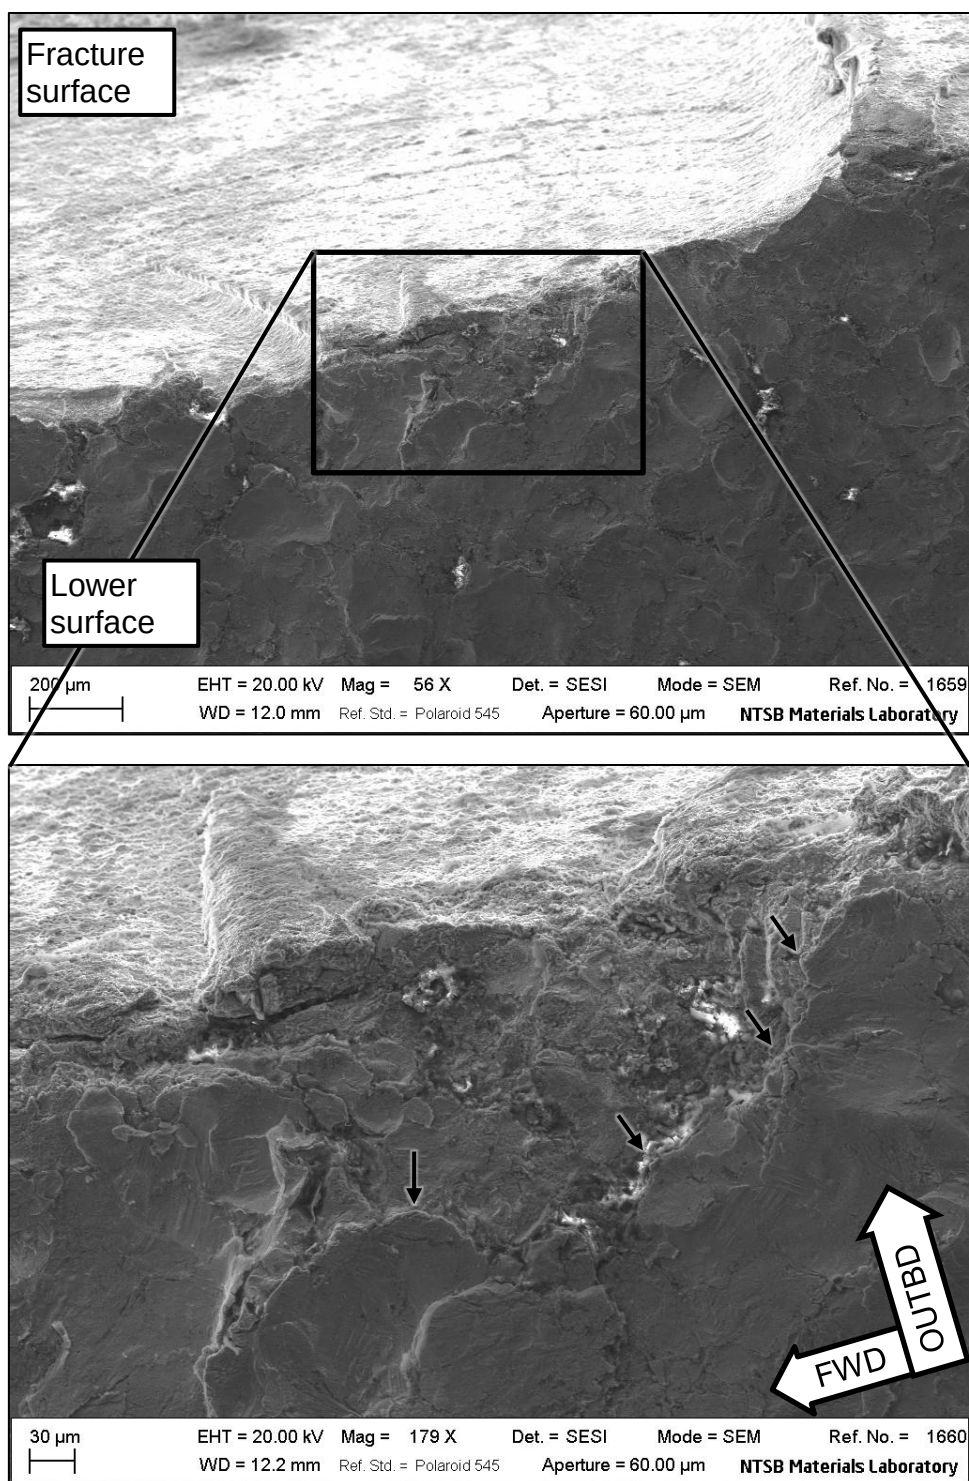
The sectioned piece of the landing gear leg was examined next using a scanning electron microscope (SEM). Oblique-angle SEM views of the fracture surface and adjacent lower surface at an origin area of the largest fatigue region are shown in figure 7. The box in the upper image of figure 7 highlights a pit feature on the lower surface at a fatigue origin, and the pit is shown at higher magnification in the lower image. Arrows in the lower image in figure 7 point to the edge of the pit. Deformed material appeared to lip over the edges of the pit at locations indicated by arrows.

Figure 7. SEM views of a pit at the primary origin area of the largest fatigue region. Deformed material appeared flowed over the edges of the pit.

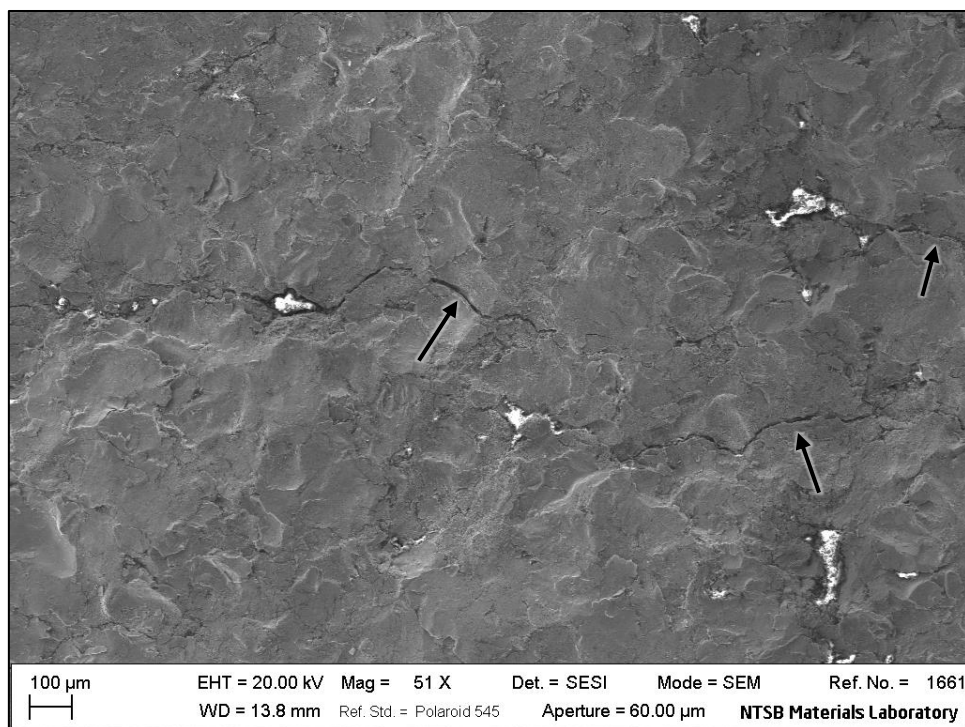
Secondary cracks were observed on the lower surface near the fracture surface. One area with secondary cracks on the lower surface just inboard of the largest fatigue region is shown in figure 8. Arrows in figure 8 point to several of the observed secondary cracks.

Figure 8. SEM view of the lower surface of the leg near the largest fatigue region. Arrows indicate secondary cracks on the surface.

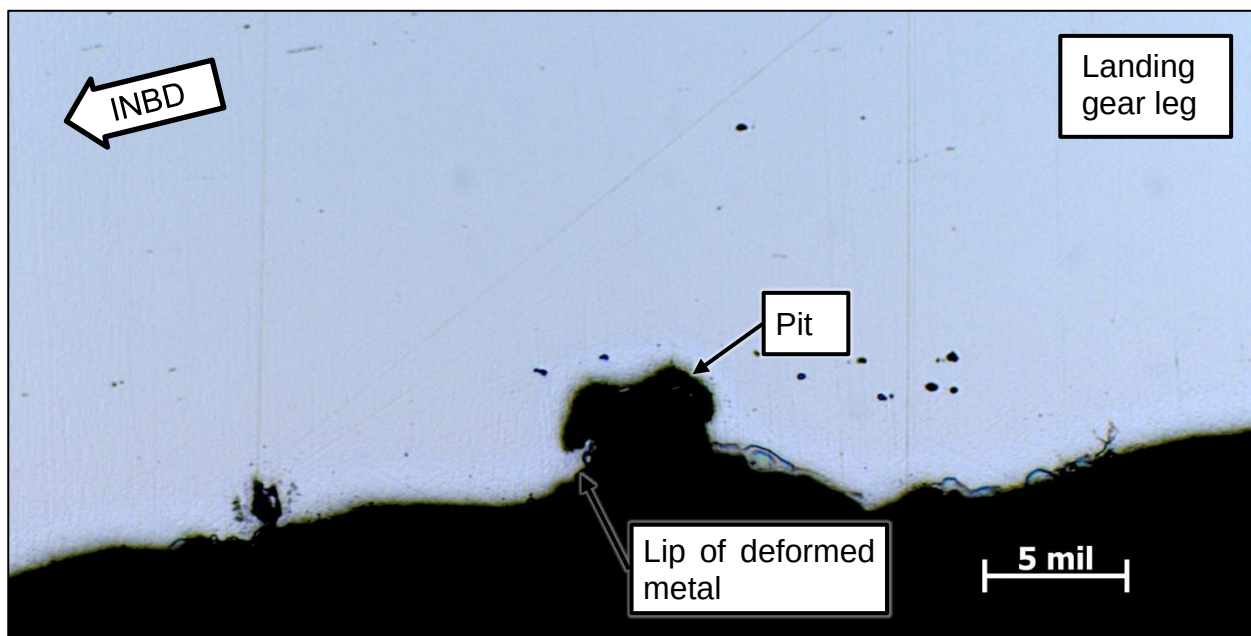
the lower surface. One of the deeper pits is shown in figure 9. An arrow in figure 9 indicates a lip of deformed material that is formed at the edge of the pit.

Figure 9. View of a pit on the lower surface of the main landing gear leg showing a lip of deformed metal at the edge of the pit.
