# M&P LAB COMPONENT ANALYSIS

| Component Part #: | <input type="text" value="649900"/> | Part Name: | <input type="text" value="Crankshaft"/> | |
| Component Serial #: | <input type="text" value="N01AA316"/> | Aircraft Registration #: | <input type="text" value="N35952"/> | |
| <div style="border: 1px solid black; padding: 5px; min-height: 40px;">The crankshaft of the engine listed above was presented for analysis under analytical exhibit 1478.</div> | | | | |

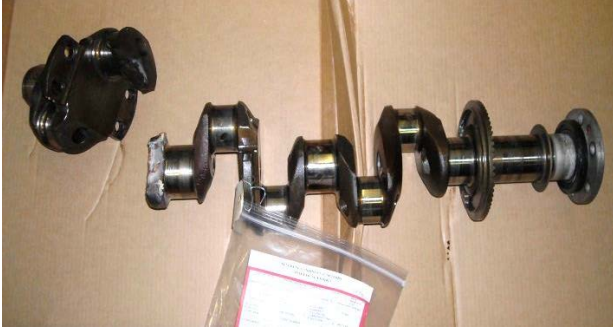
The crankshaft was in two pieces, fractured between the number 2 crankpin and the #2 main bearing, or on the third cheek, as shown in figure 1. The fracture surface on the aft section was severely damaged, as shown in figure 2. The fracture of the fore section was cut from the rest of the crankshaft for closer analysis. The number 2 main was cut as shown in figure 3. No ladder cracks or post separation cracks were identified using magnetic particle inspection, as shown in figure 4. Figure 5 shows the relatively undamaged fracture surface of the fore section. Beachmarks indicate propagation in fatigue. The ratchet lines indicate multiple initiation points. The fracture propagated in fatigue from the surface, given the lack of any subsurface indication of origin.

Figure 1. Crankshaft fractured at the third cheek

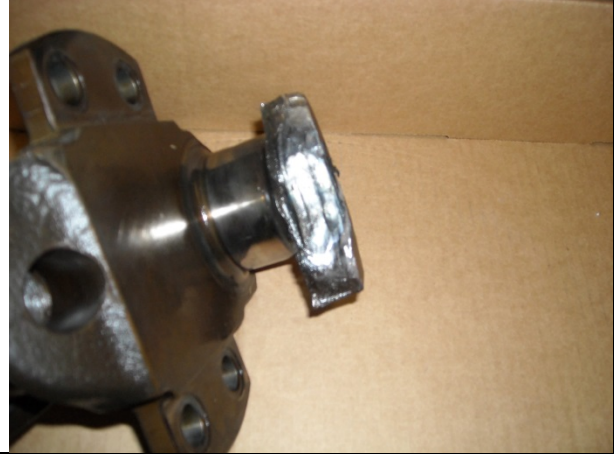
Figure 2. Aft section fracture surface is obliterated

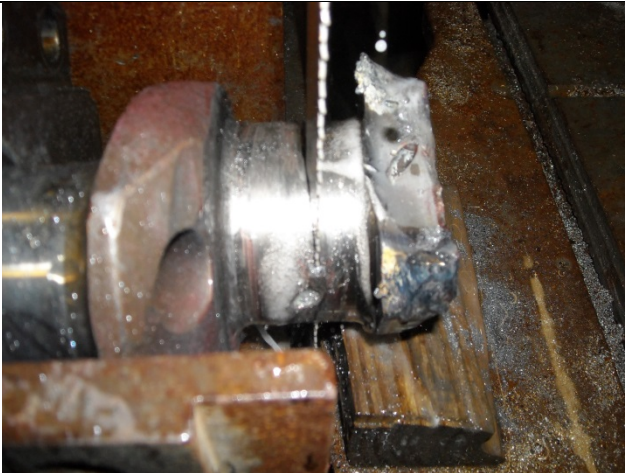
Figure 3. Sectioning #2 main of fore section

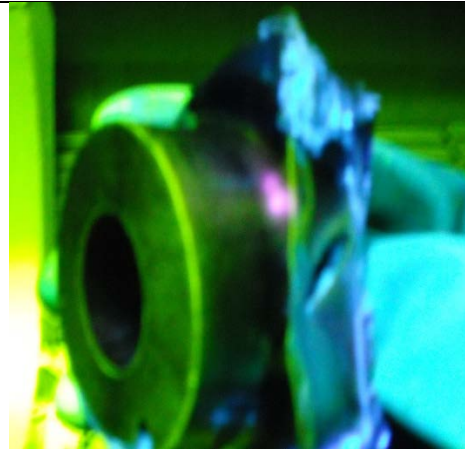
Figure 4. Magnetic particle inspection

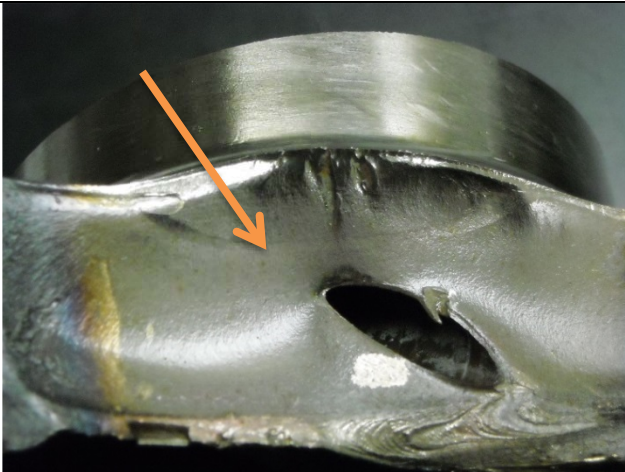
Figure 5. Fracture surface of fore section showing beachmarks

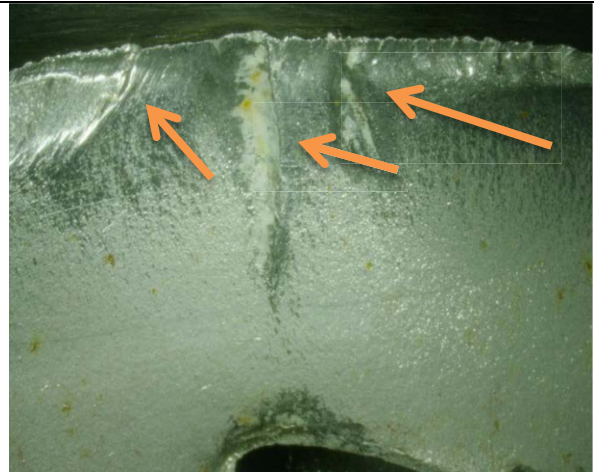
Figure 6. Fracture surface of fore section showing ratchet marks

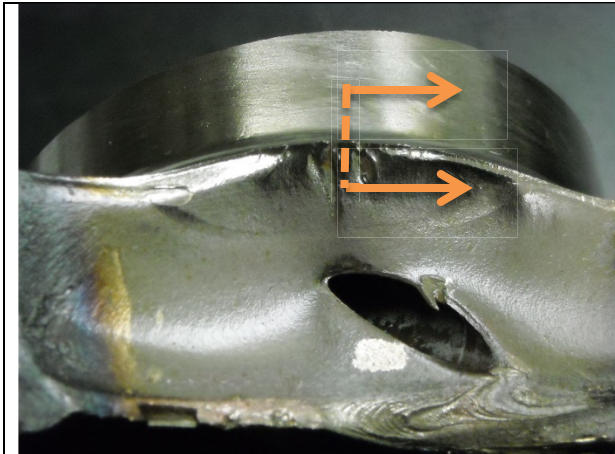
The part was sectioned perpendicular to the fracture surface at the initiation area as shown in figure 7. The cross section was mounted and polished for metallography. Figure 8 shows the cross section of the fracture surface. The darker nitride case on the left side is visible below the bearing surface. Figures 9 and 10 show the microstructure of tempered martensite, darkened nitride case, and white layer at the surface. There are small cracks in the white layer that terminate at the nitride case. No inclusions or microstructural anomalies have been identified.

Figure 7. Fracture surface sectioned

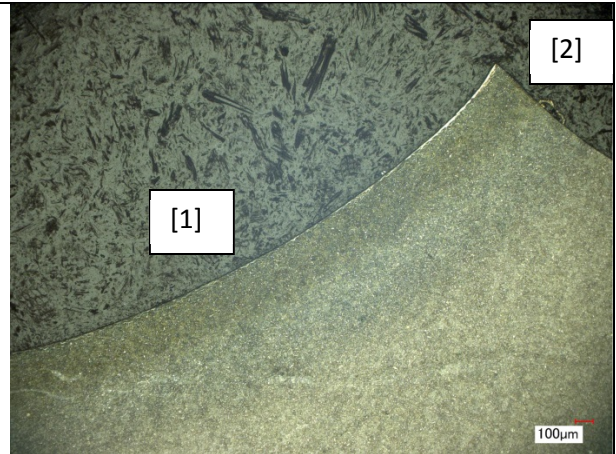
Figure 8. Bearing surface [1] and fracture surface [2] near initiation area.

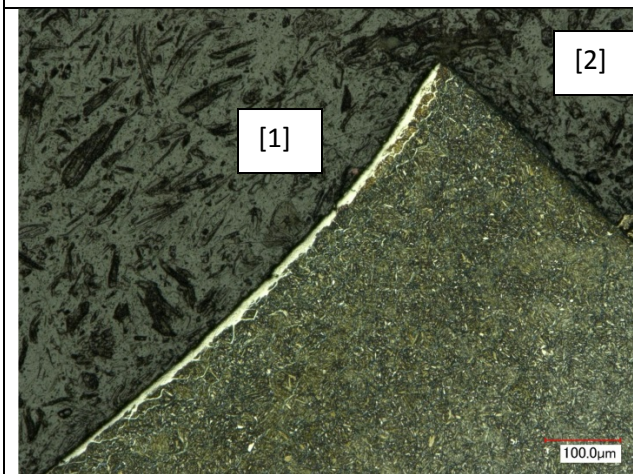
Figure 9. Bearing surface [1] showing nitride white layer and case. Fracture surface has no white layer [2]

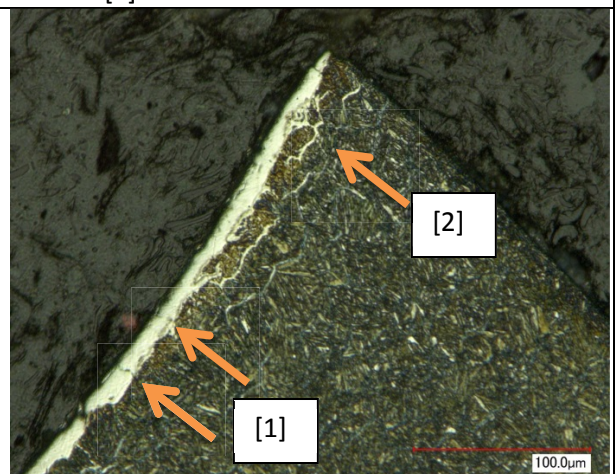
Figure 10. Bearing surface showing cracks [1] in the nitride white layer and white layer below the surface [2]
