# NATIONAL TRANSPORTATION SAFETY BOARD

MATERIALS LABORATORY FACTUAL REPORT

Report No. 15-088

Place : Seward, Alaska  
Date : July 14, 2014  
Vehicle : Cessna 180H, N9083M  
NTSB No. : ANC14LA054  
Investigator : Brice Banning, ASI-ANC

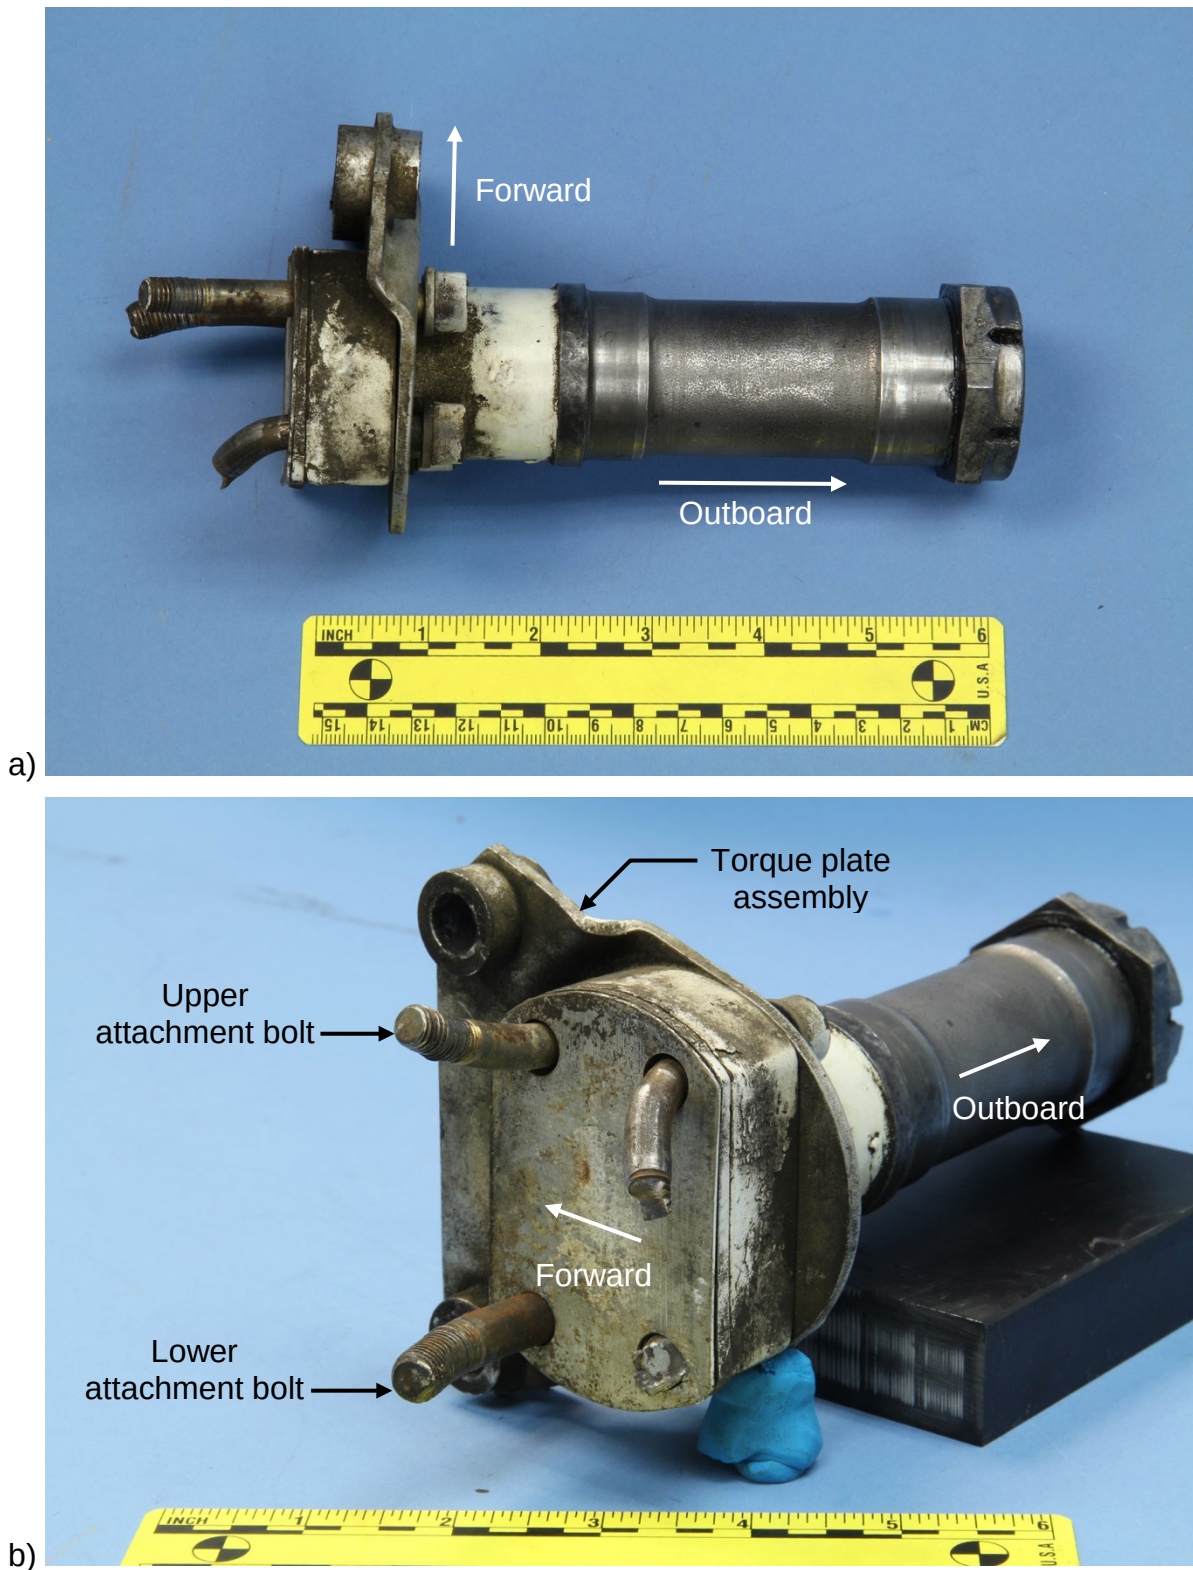
A right main landing gear axle was received by the NTSB Materials Laboratory as shown in figures 1a and 1b. The axle is attached to the main landing gear spring assembly using four attachment bolts. As shown in figures 1a and 1b, the two forward bolts were intact and exhibited a comparatively slight bend in the aft direction. The two aft bolts were fractured and bent in the aft direction. A closer examination of the forward attachment bolts indicated that the threaded ends of those bolts exhibited longitudinal wear marks near the end of the threaded region, as indicated in figure 2. Near the middle of the threaded sections, helical strips of metal were observed, as indicated in figure 2, consistent with material from a stripped nut. The fracture surfaces on the two aft bolts (not shown) were consistent with overstress fractures. Taken as a whole, the features were consistent with an overload on the main landing gear axle in the aft direction.

**Figure 1:** a) Image of the right main landing gear axle viewed from the top down and b) image of the axle viewed outboard and forward showing the deformed and fractured attachment bolts.

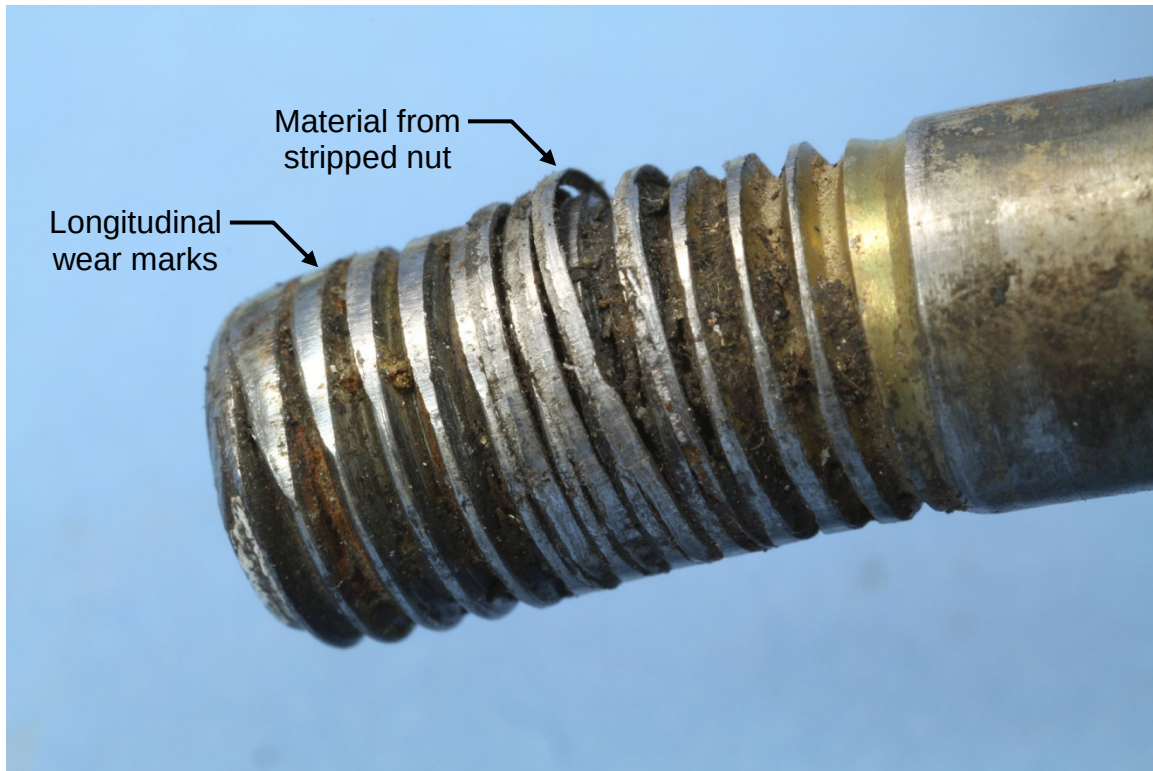
**Figure 2:** Image of the threaded end of the upper forward attachment bolt. Longitudinal wear marks were observed on the end of the bolt and a strip of metal was observed retained in four consecutive threads near the middle of the threaded section, consistent with material from a stripped nut.
