## **NATIONAL TRANSPORTATION SAFETY BOARD**

### **Group Chairman's Weather Study Report**

# **METEOROLOGY**

**ANC15FA049**

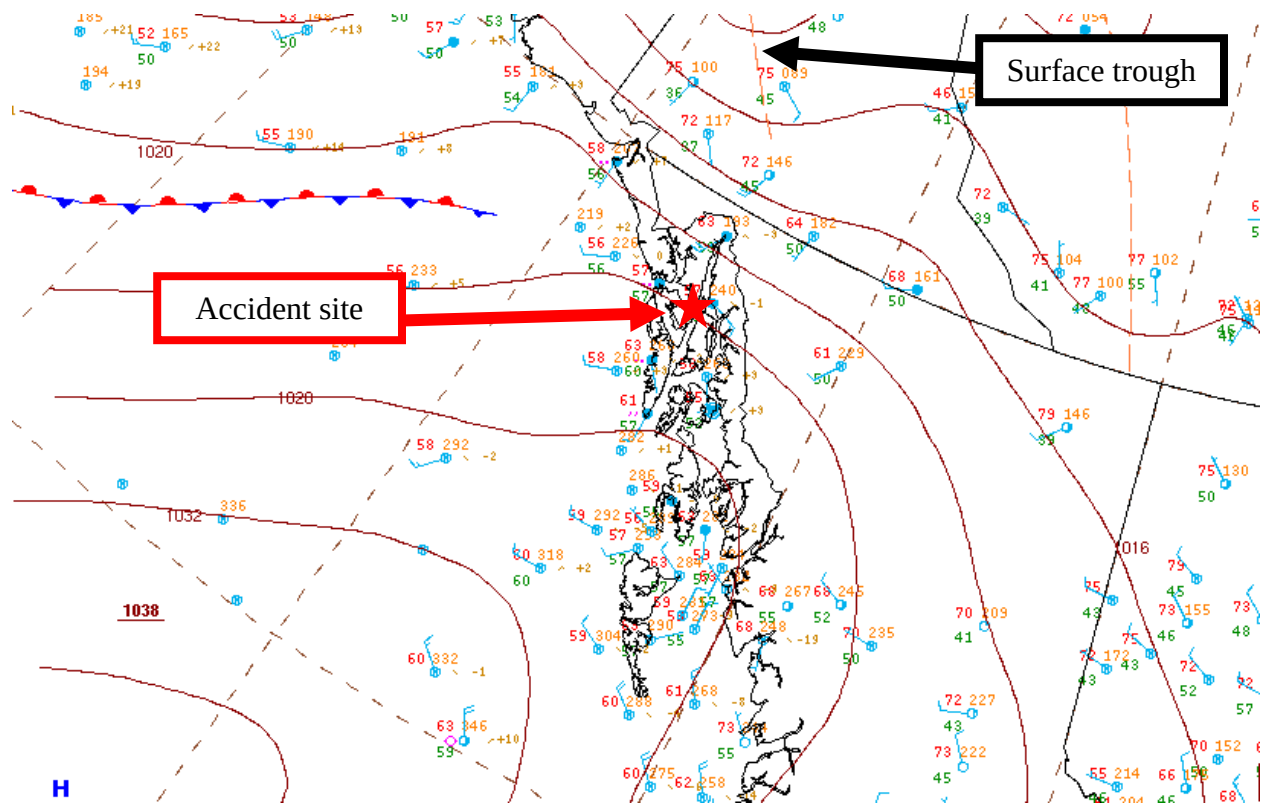
The NWS Surface Analysis Chart for 1300 AKDT is provided as figure 1 with the approximate location of the accident site marked. The chart depicted a surface trough<sup>2</sup> to the north of the accident site located in the Yukon stretching northward into eastern Alaska. A stationary front was located in the central Gulf of Alaska stretch westward south of the Aleutian Island chain. A surface high pressure center with a pressure of 1038-hectopascals (hPa) was located off the west coast of North America well southwest of southeastern Alaska in the northeastern Pacific Ocean. The station models around the accident site depicted air temperatures in the upper 50’s to low 60’s Fahrenheit (F), with temperature-dew point spreads of 4° F or less, a southwest to southeast wind between 5 and 15 knots, cloudy skies, and areas of light rain. With surface high pressure located off the coast of southeastern Alaska and lower pressure inland (in the Yukon near the surface trough), this would have promoted onshore flow conditions with the wind flowing towards the mountainous terrain of southeastern Alaska, favoring the development of continued widespread cloudy conditions and precipitation.

Figure 1 – NWS Surface Analysis Chart for 1300 AKDT

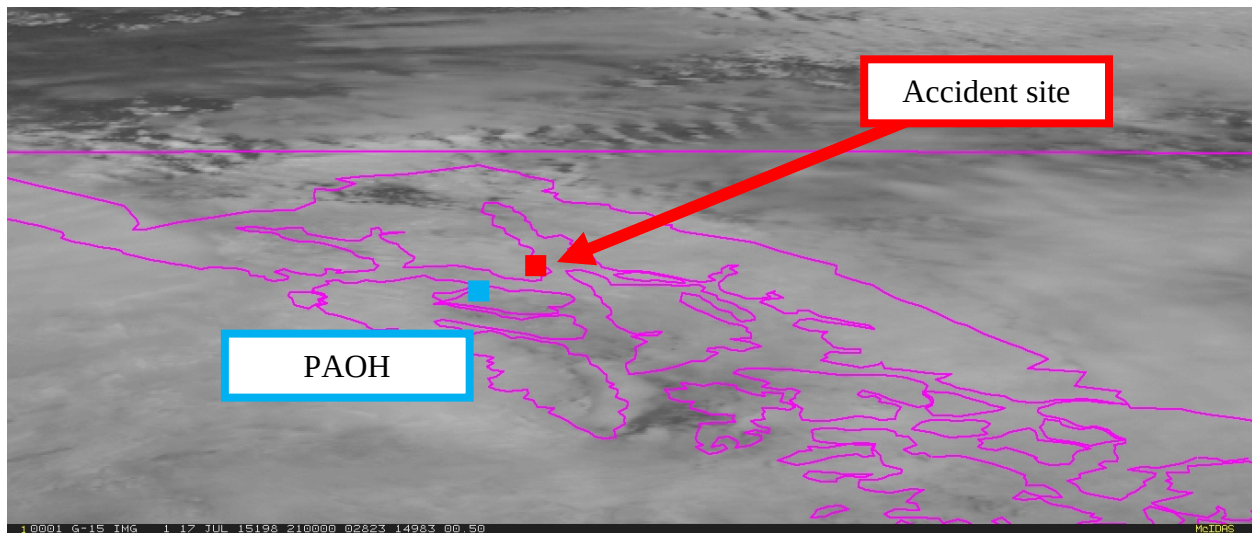
Figures 4 and 5 present the GOES-15 visible imagery from 1300 and 1330 AKDT at 2X magnification with the accident site marked by a red square. The visible imagery indicated abundant cloud cover over and around the accident site at the accident time with that cloud cover moving from west to east. Figure 6 presents the GOES-15 infrared imagery from 1330 AKDT at 6X magnification. Inspection of the infrared imagery indicated the more enhanced bands (yellows and greens, higher cloud tops) were located to the east of the accident site into northern British Columbia. Based on the brightness temperatures above the accident site and the vertical temperature profile provided by the 1300 AKDT GDAS sounding, the approximate cloud-top heights over the accident site were 16,500 feet at 1330 AKDT.

**Figure 4 – GOES-15 visible image at 1300 AKDT**

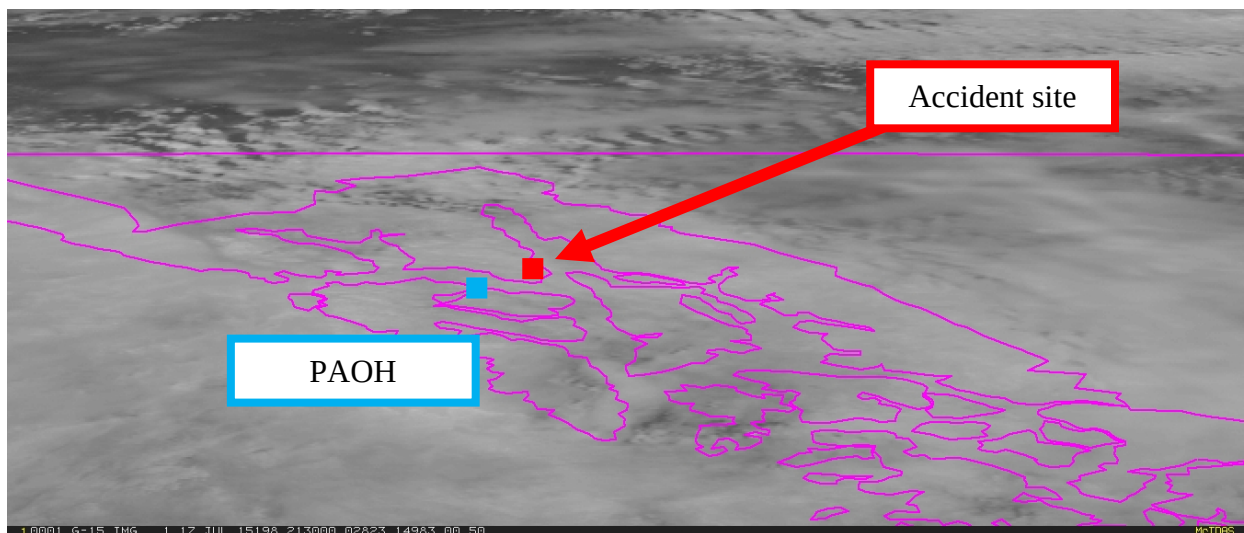
**Figure 5 – GOES-15 visible image at 1330 AKDT**

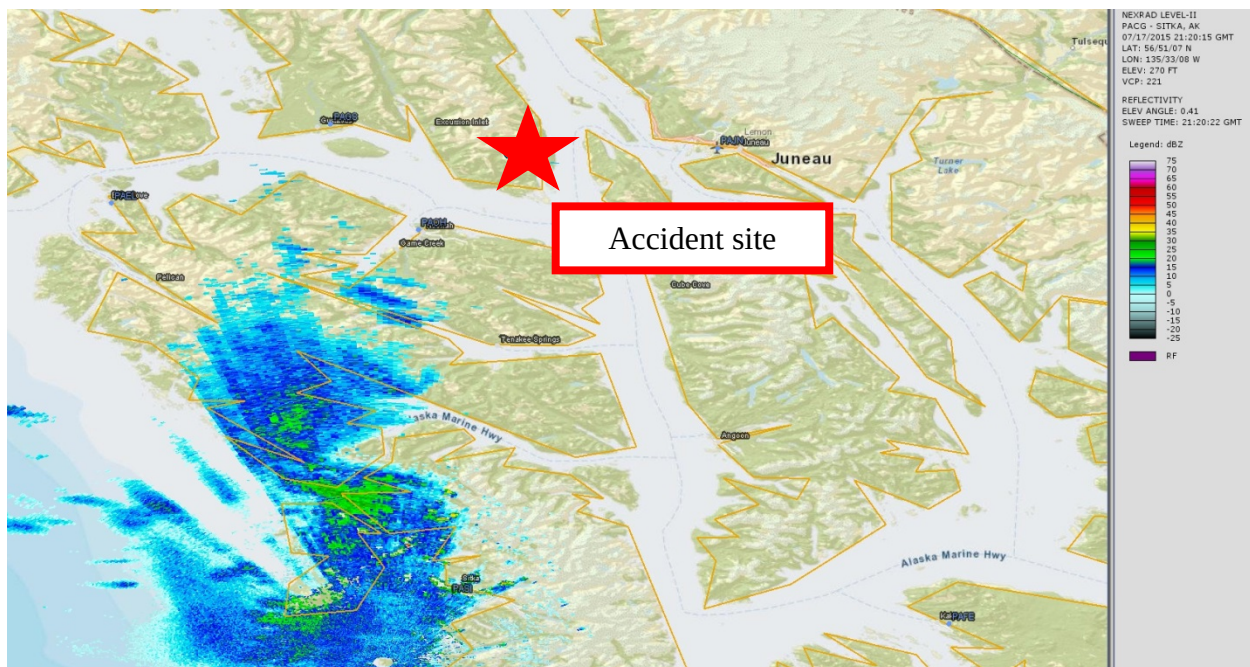
Figure 7 presents the PACG WSR-88D base reflectivity images for the 0.5° elevation scan initiated at 1320 AKDT with a resolution of 0.5° X 250 m. There were no reflectivity targets above the accident site at the accident time. Given that there was decreased moisture above 11,000 feet msl (freezing level), it was not surprising no reflectivity targets were observed above the accident site, as there was not enough moisture in the atmosphere to create large rain droplets. Given the observations from PAJN and the upper air sounding (section 4.0) light rain and drizzle were still likely at the accident site at the accident time. Attachment 1 is PACG base reflectivity imagery from 1203 through 1343 AKDT and there was an area of reflectivity values between 5 and 20 dBZ there were moving towards the accident site west of PAOH between 1226 and 1306 AKDT. These reflectivity values would have likely indicated precipitation at the surface with lower visibilities, mist, and light rain, which would have arrived at the accident site at the accident time. The FAA’s Aviation Web Camera imagery will further show the lower visibility conditions (section 13.0). There were no lightning strikes at or near the accident site at the accident time.

**Figure 7 – PACG WSR-88D reflectivity for the 0.5° elevation scan initiated at 1320 AKDT**

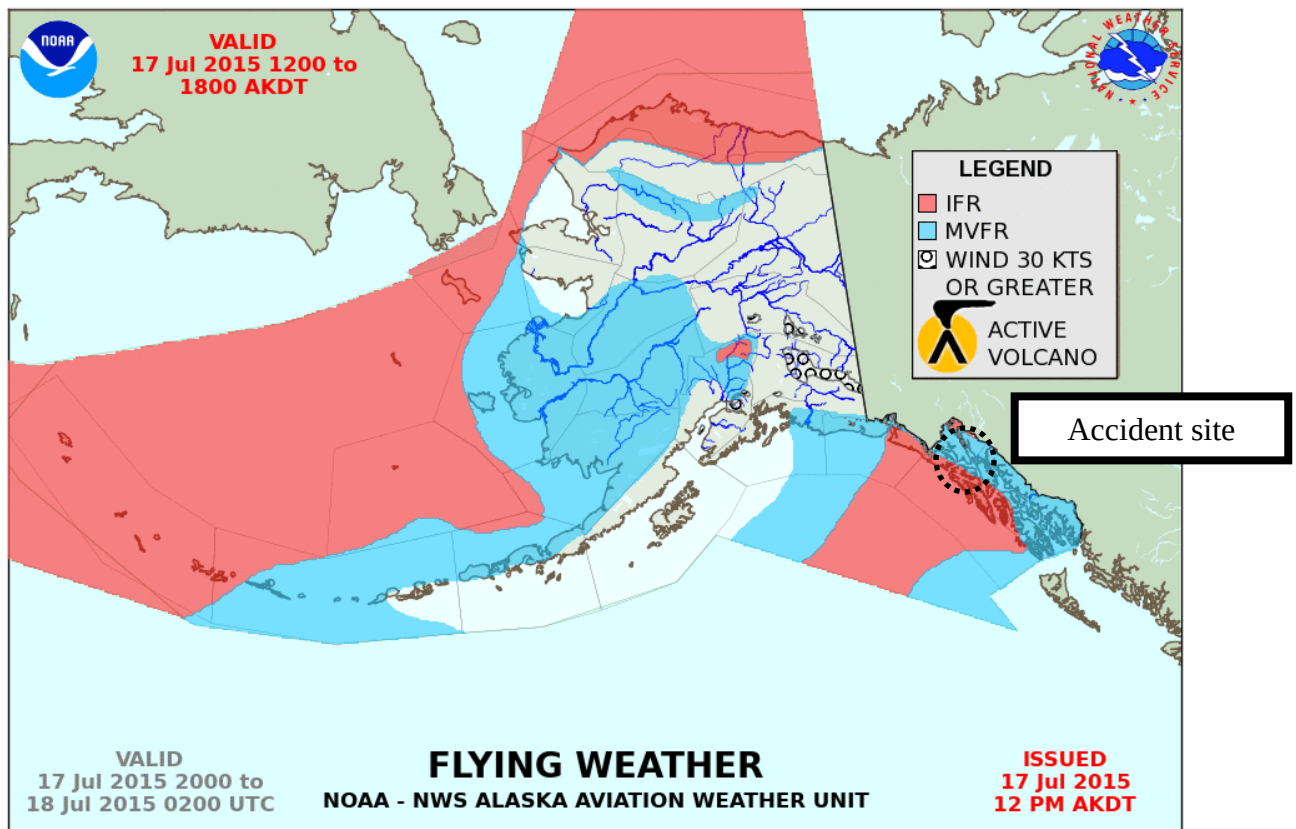
The Area Forecast issued by the NWS Alaska Aviation Weather Unit (AAWU) at 1210 AKDT included an AIRMET for mountain obscuration due to clouds and precipitation and the AIRMET was valid at the accident site at the accident time. The Area Forecast mentioned scattered clouds at 1,200 feet msl with broken to overcast ceiling at 2,000 feet msl with clouds top to FL250<sup>19</sup>, and an occasional broken ceiling at 1,200 feet msl with 5 miles visibility and light rain. Isolated IFR conditions were also forecast with rain and mist. The AAWU weather charts produced at 1200 AKDT indicated the accident site on the boundary of the MVFR to IFR conditions with isolated moderate low-level turbulence between the surface and 6,000 feet msl (figures 8, 9, and 10). Isolated moderate icing conditions were forecast above 16,000 feet msl:

Figure 8 – AAWU IFR and MVFR weather chart issued at 1200 AKDT valid through 1800 AKDT

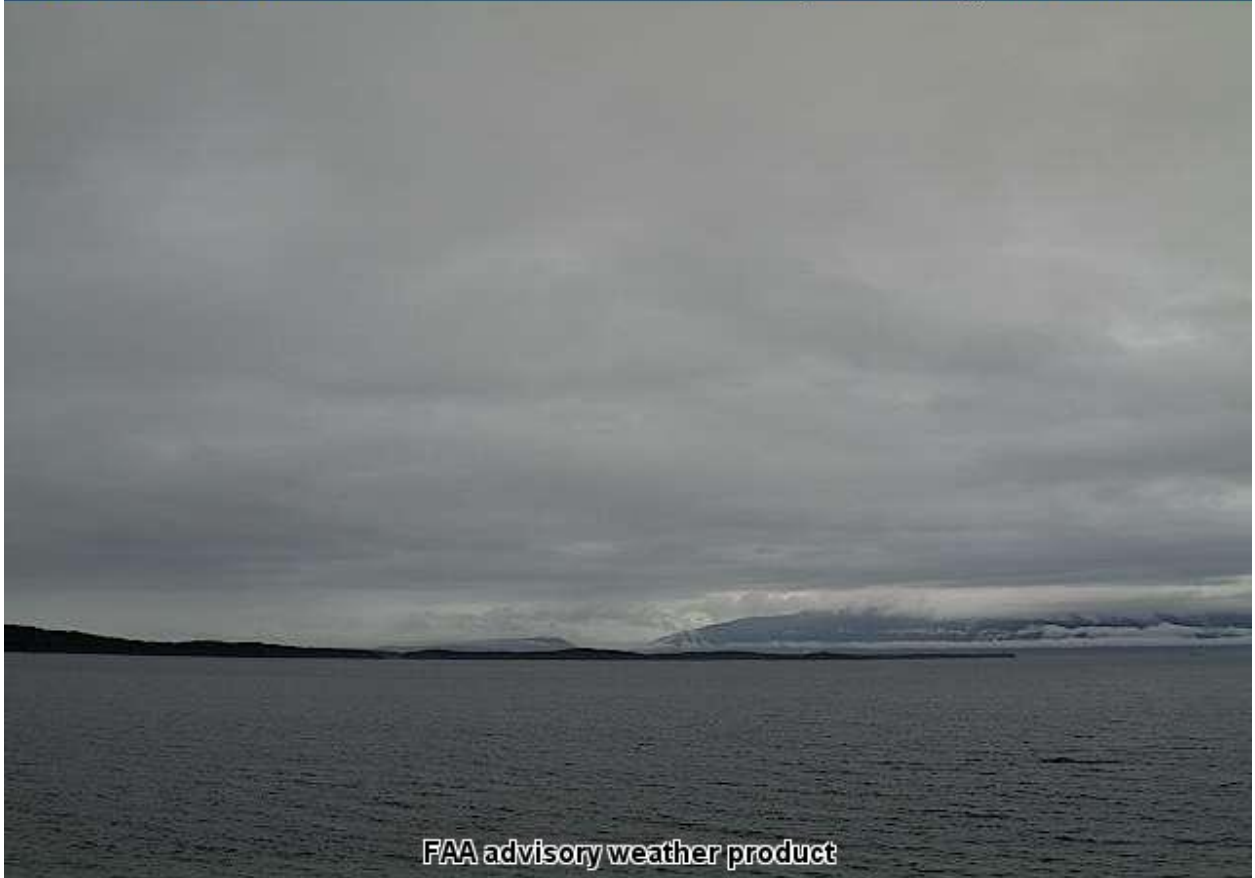
**Figure 13 – FAA weather camera from Sisters Island northeast looking view from 1235 AKDT**

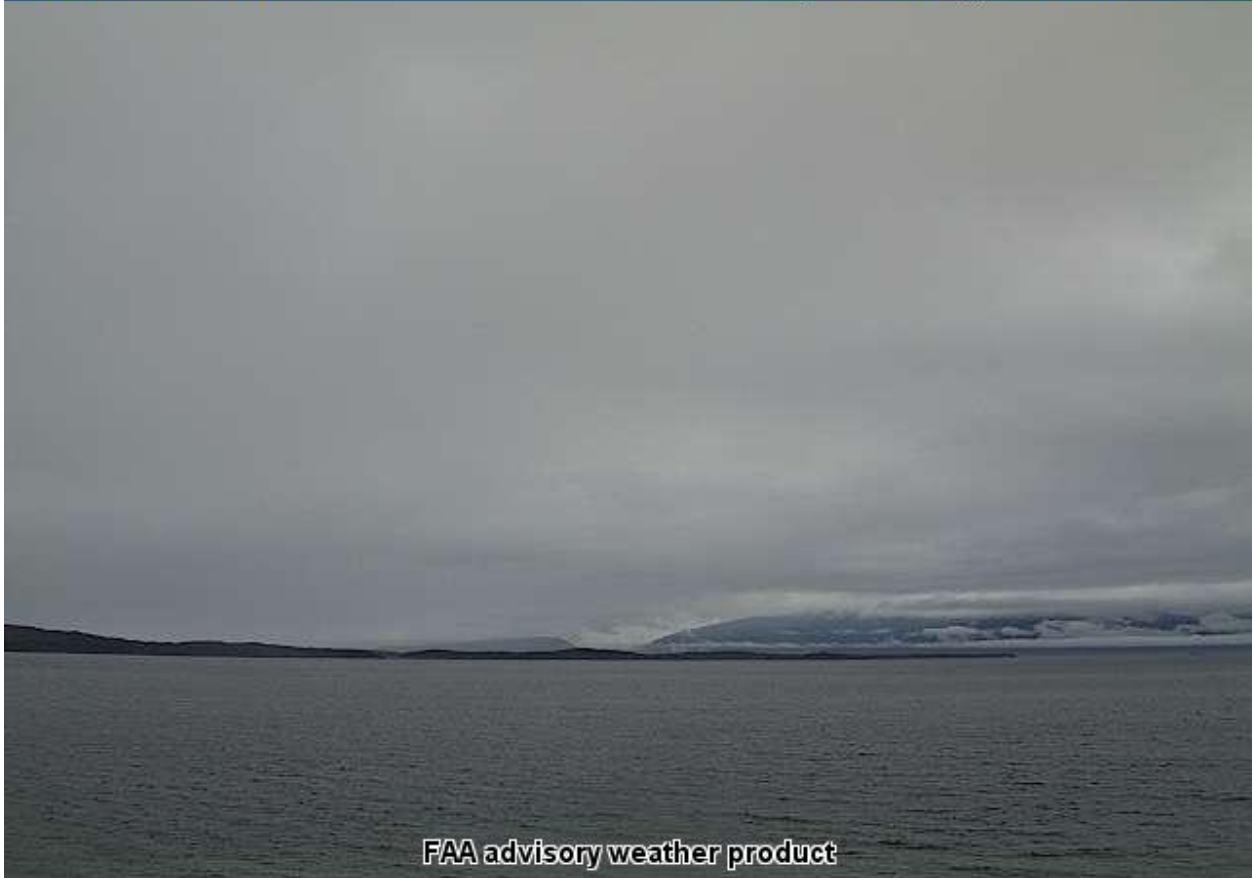
**Figure 14 – FAA weather camera from Sisters Island northeast looking view from 1255 AKDT**

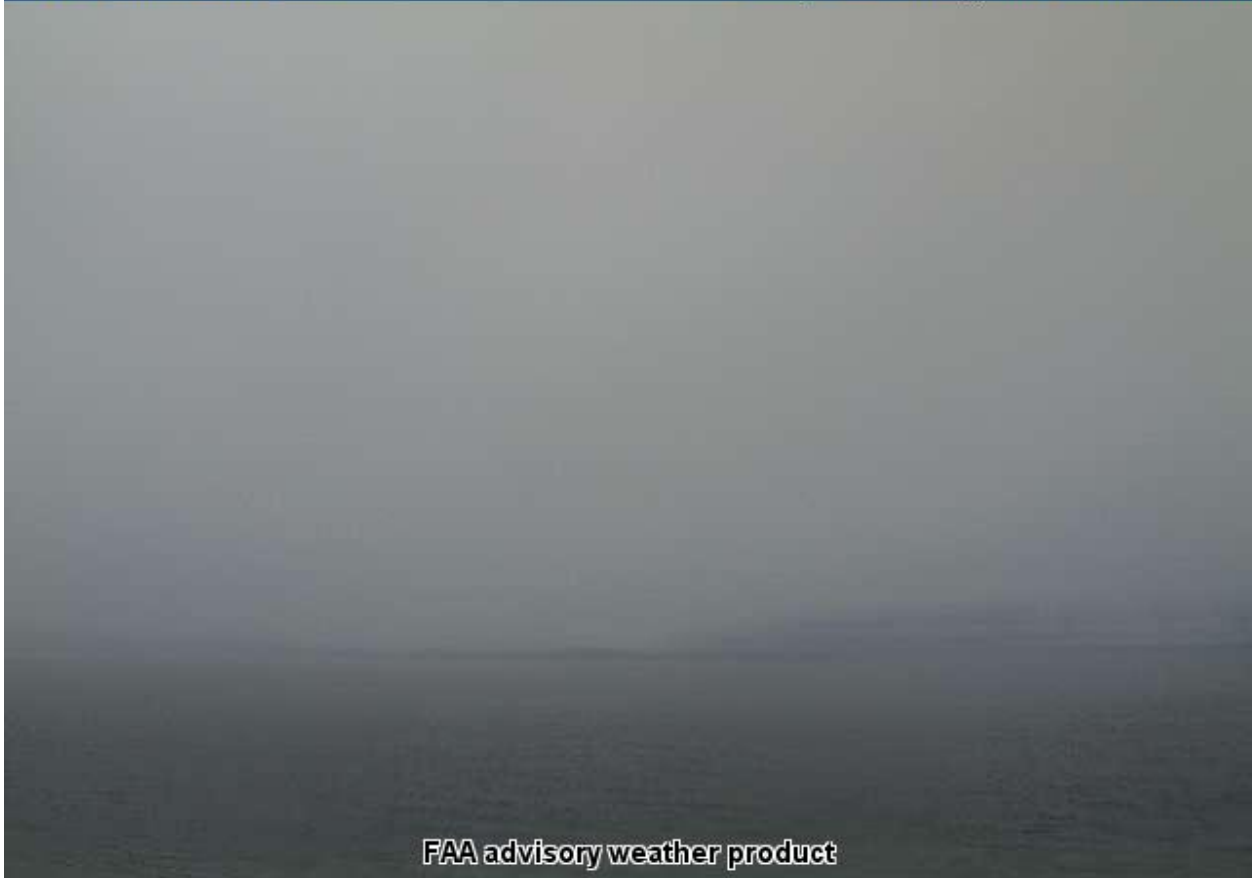
**Figure 15 – FAA weather camera from Sisters Island northeast looking view from 1305 AKDT**

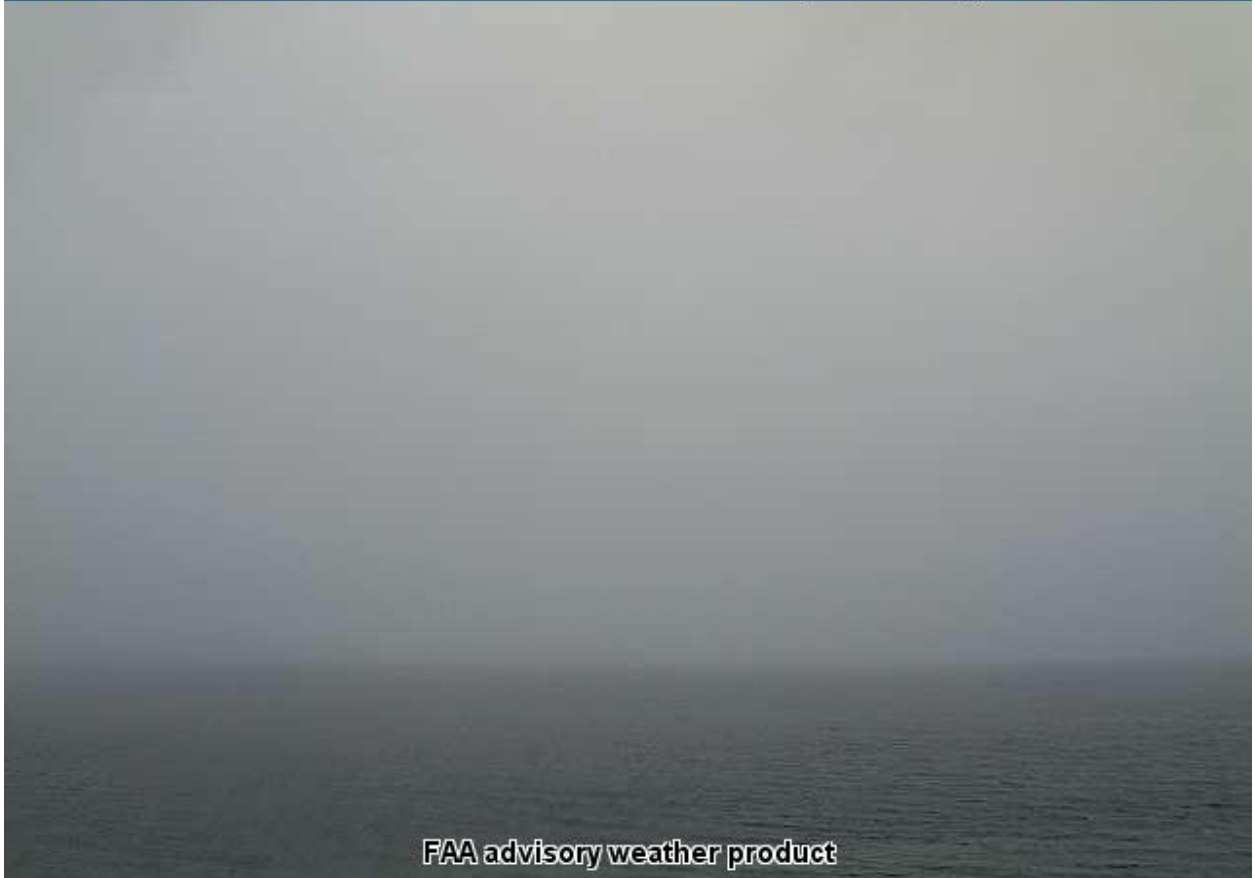
**Figure 16 – FAA weather camera from Sisters Island northeast looking view from 1315 AKDT**

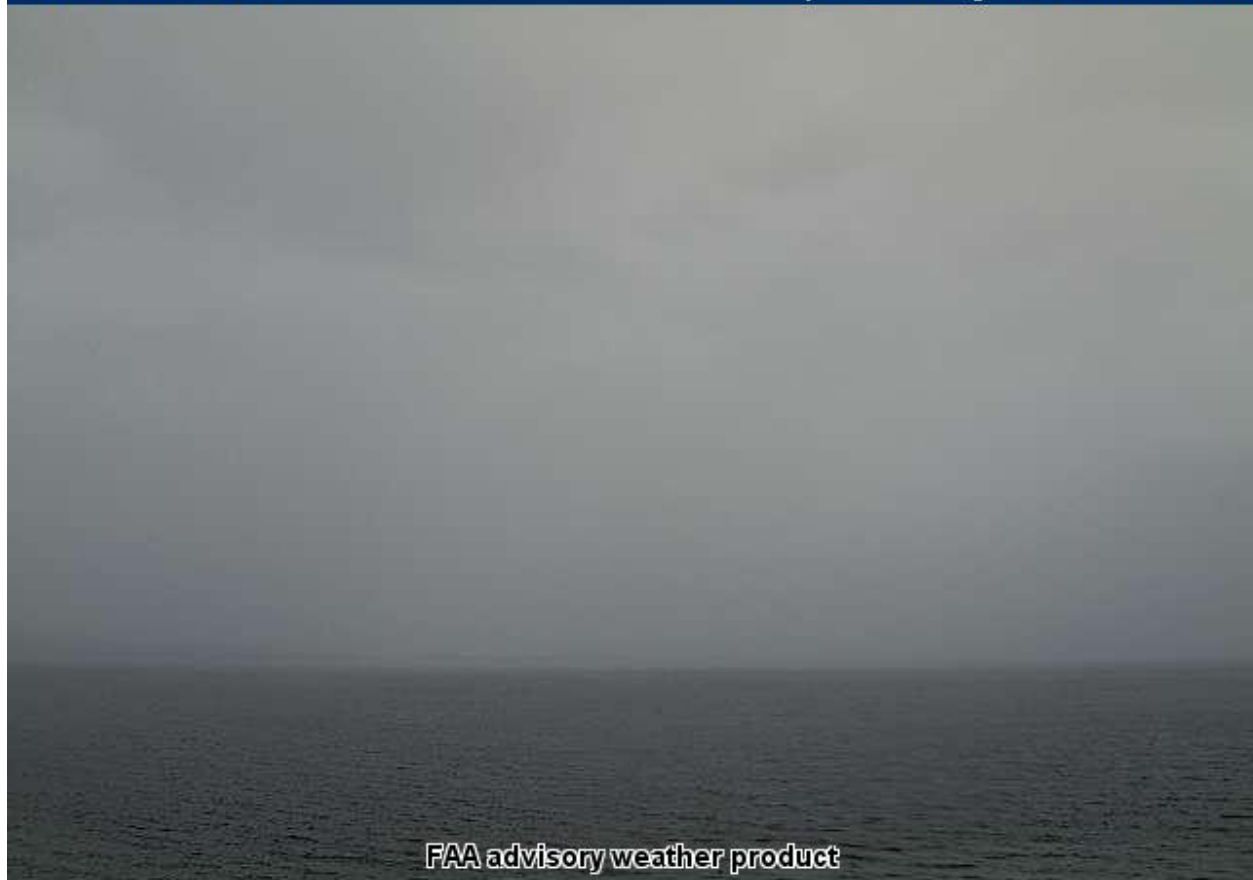
**Figure 17 – FAA weather camera from Sisters Island northeast looking view from 1325  
AKDT**

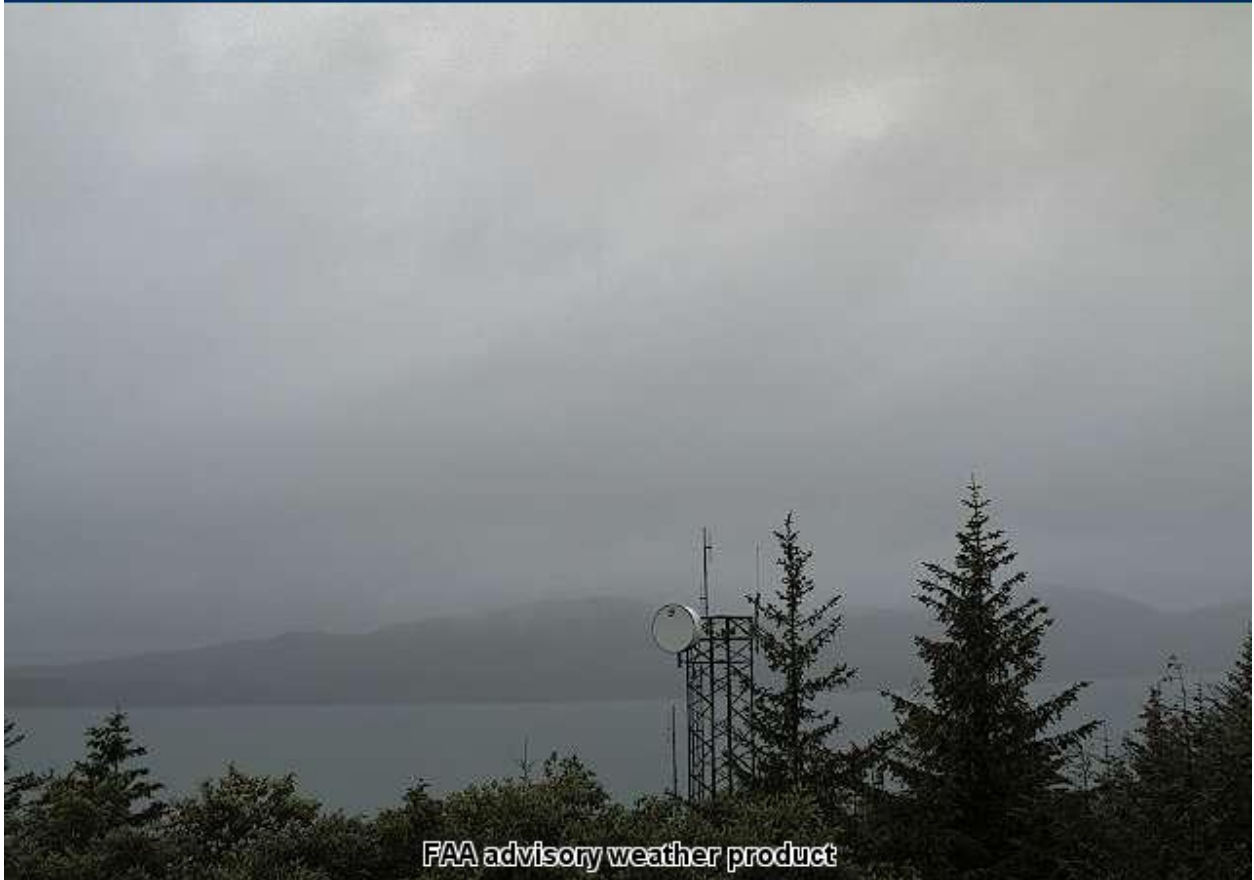
**Figure 20 – FAA weather camera from Lena Point west looking view from 1306 AKDT**

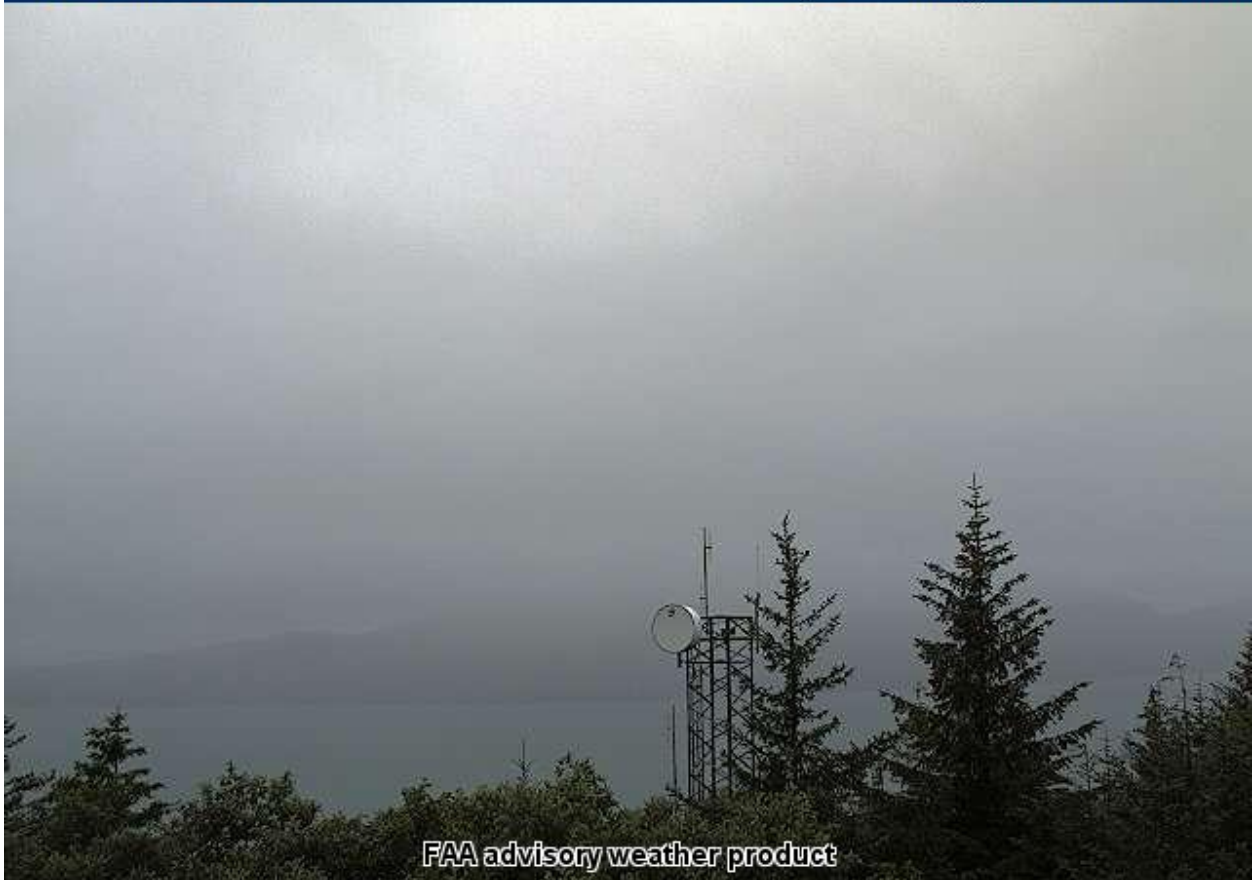
**Figure 21 – FAA weather camera from Lena Point west looking view from 1316 AKDT**

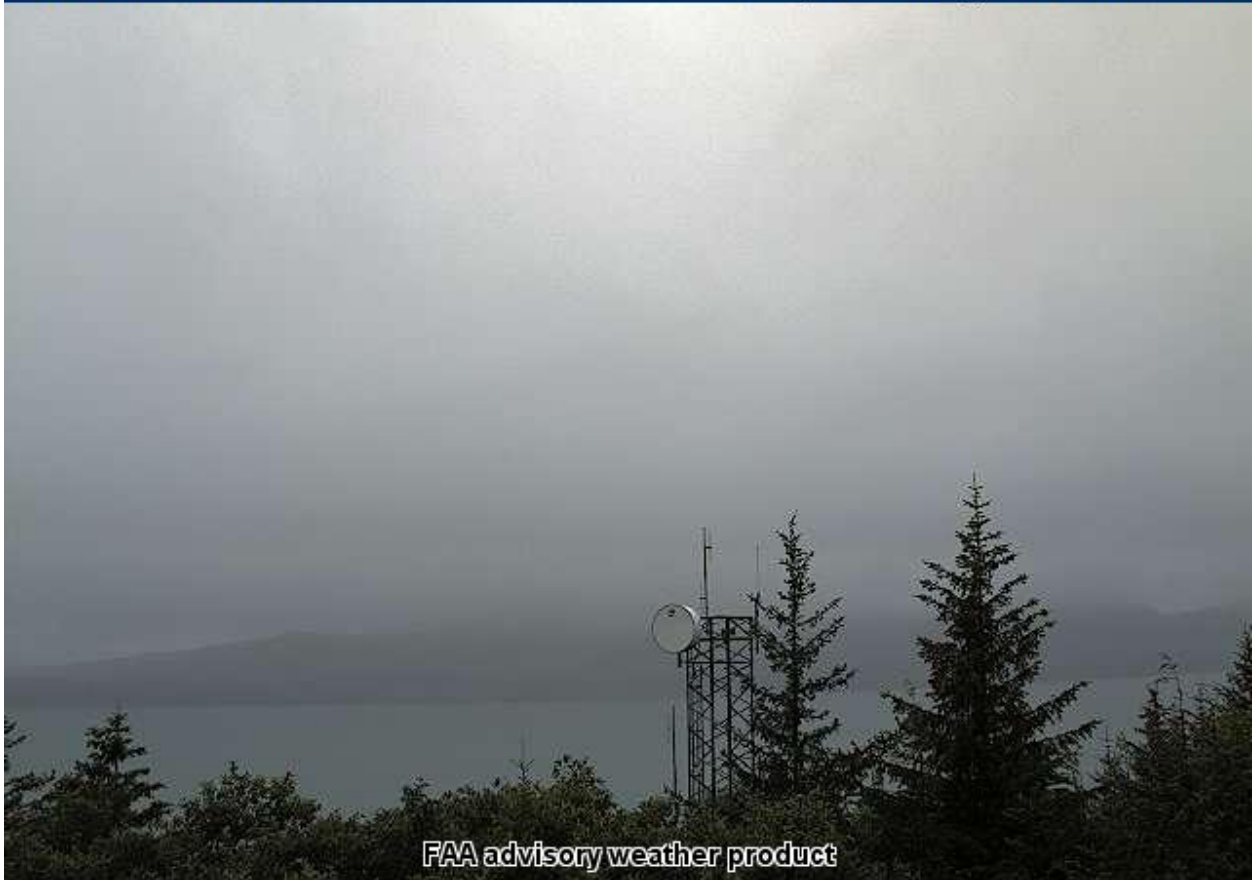
**Figure 22 – FAA weather camera from Lena Point west looking view from 1326 AKDT**

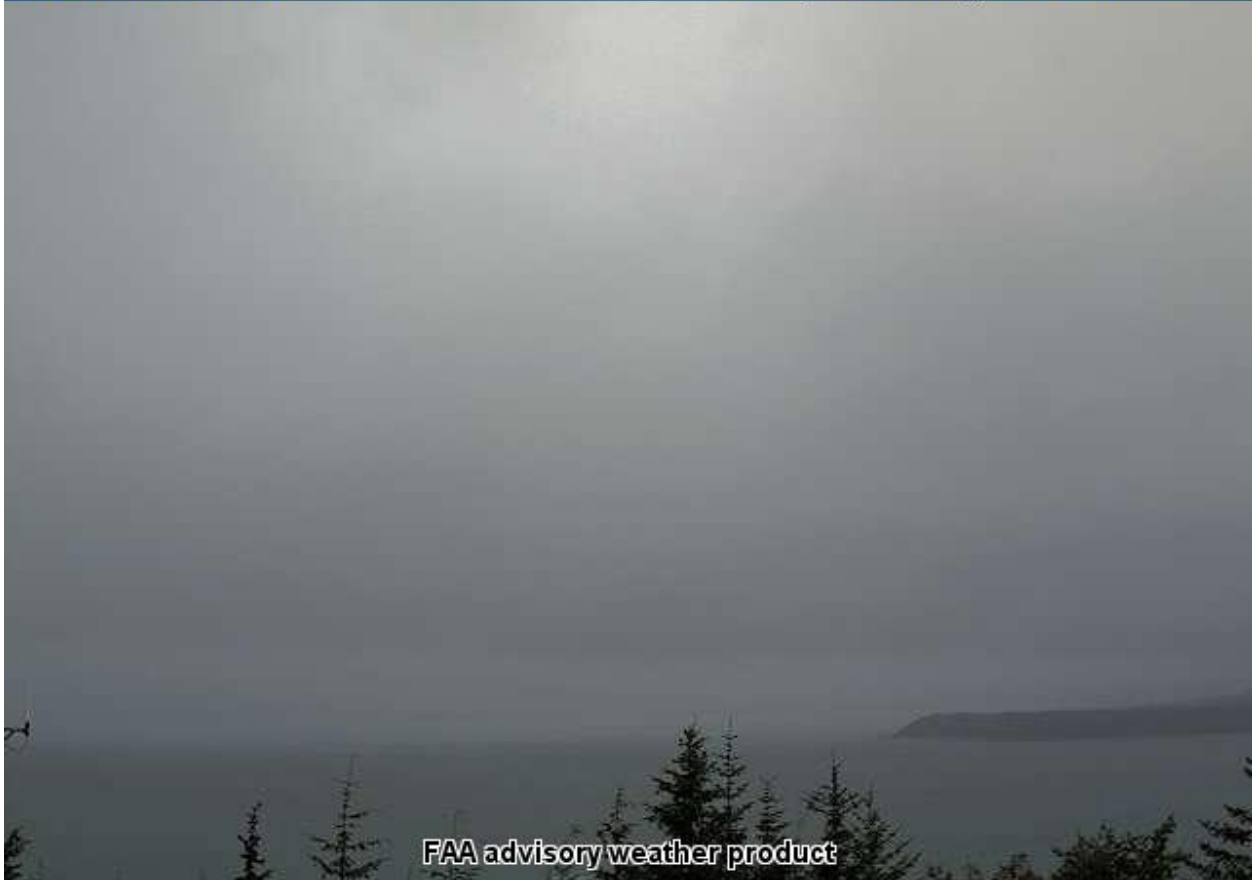
**Figure 24 – FAA weather camera from Lena Point southwest looking view from 1307 AKDT**

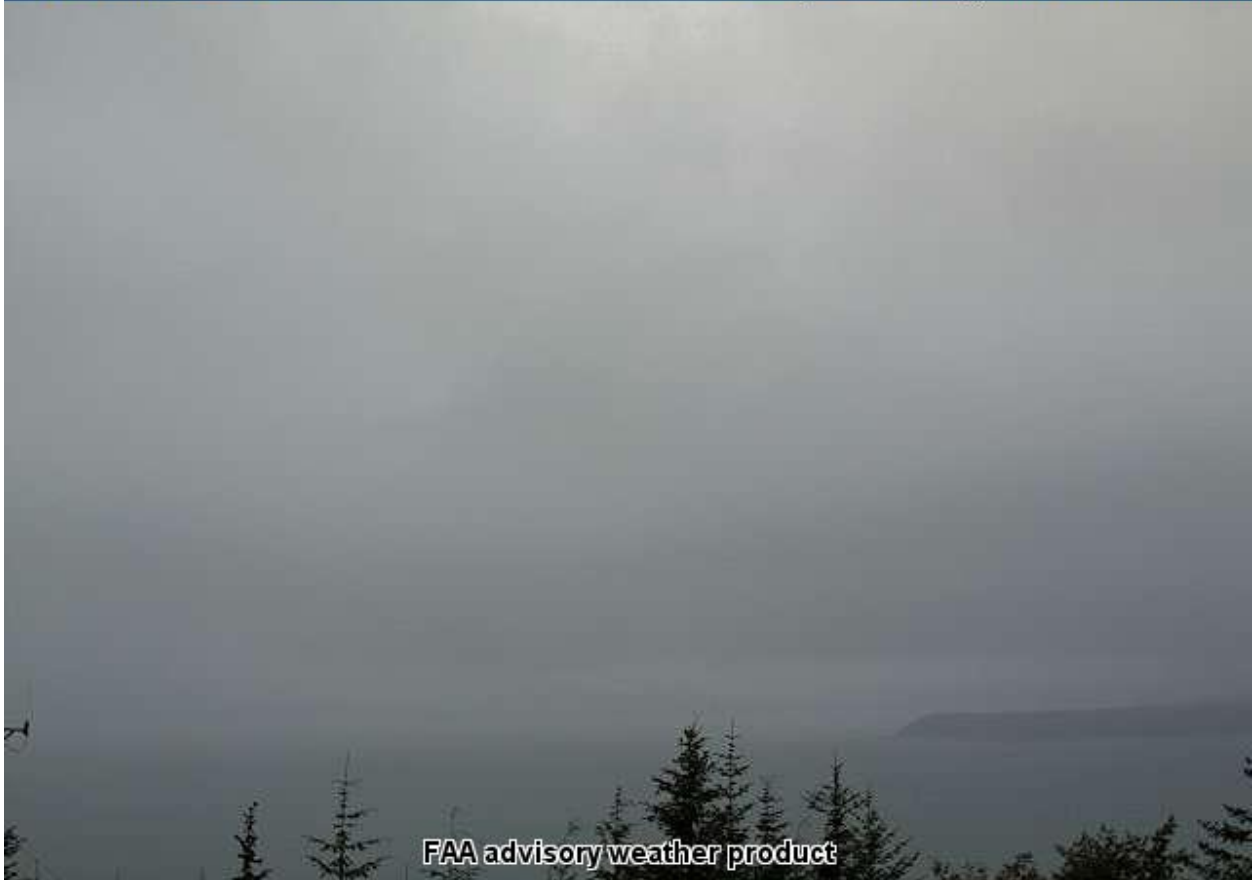
**Figure 25 – FAA weather camera from Lena Point southwest looking view from 1317 AKDT**

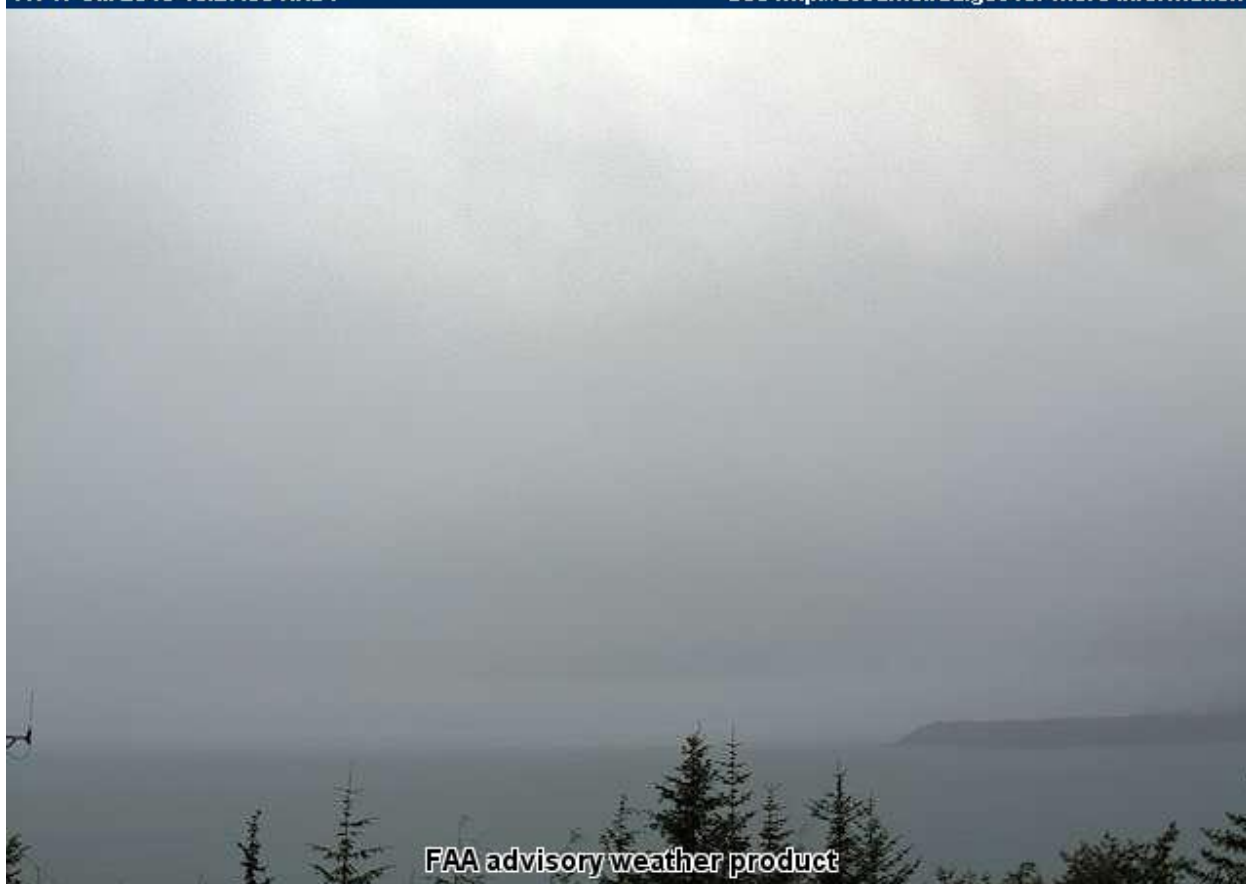
**Figure 26 – FAA weather camera from Lena Point southwest looking view from 1327 AKDT**
