# NATIONAL TRANSPORTATION SAFETY BOARD

## MATERIALS LABORATORY FACTUAL REPORT

Report No. 15-126

Place : Kasilof, Alaska  
Date : August 22, 2015  
Vehicle : Cessna 180 (N3043E)  
NTSB No. : ANC15FA066  
Investigator : Shaun Williams

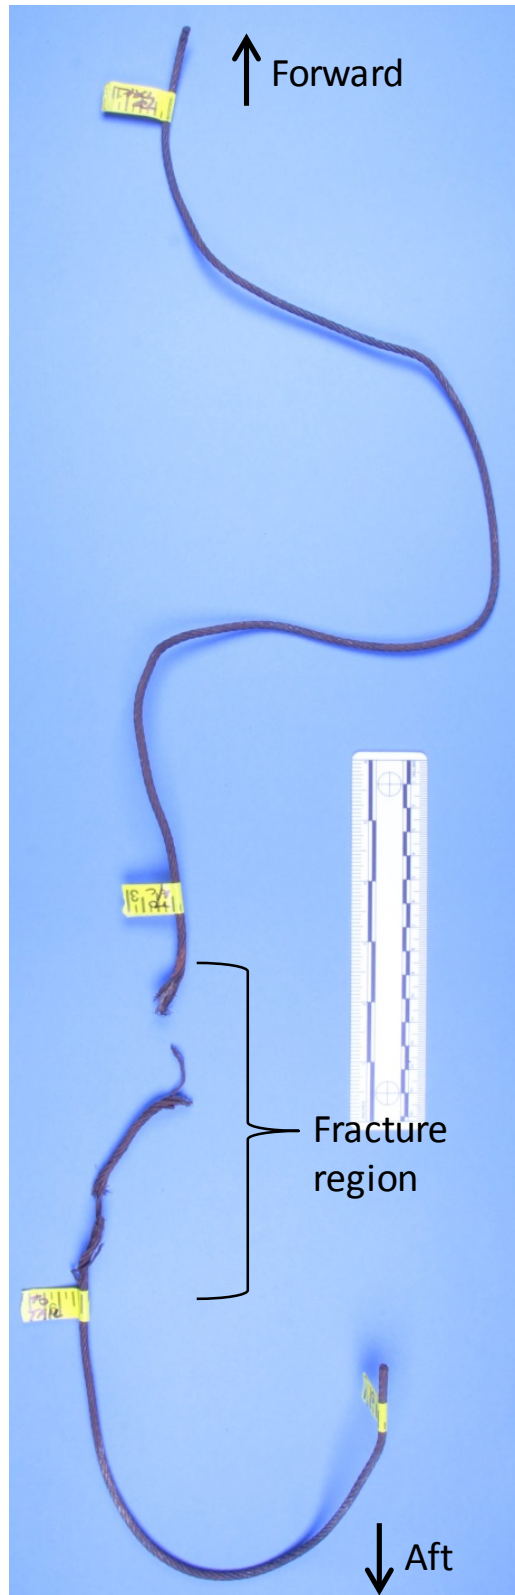
The submitted wire rope pieces are shown in Figures 1 and 2 with forward and aft orientations of the rope labelled. As-received, the surfaces of the wire rope wires exhibited corrosion product on all surfaces—including fracture surfaces.

Figure 1 As-received wire rope pieces, arranged according to the forward and aft directions of the airplane.

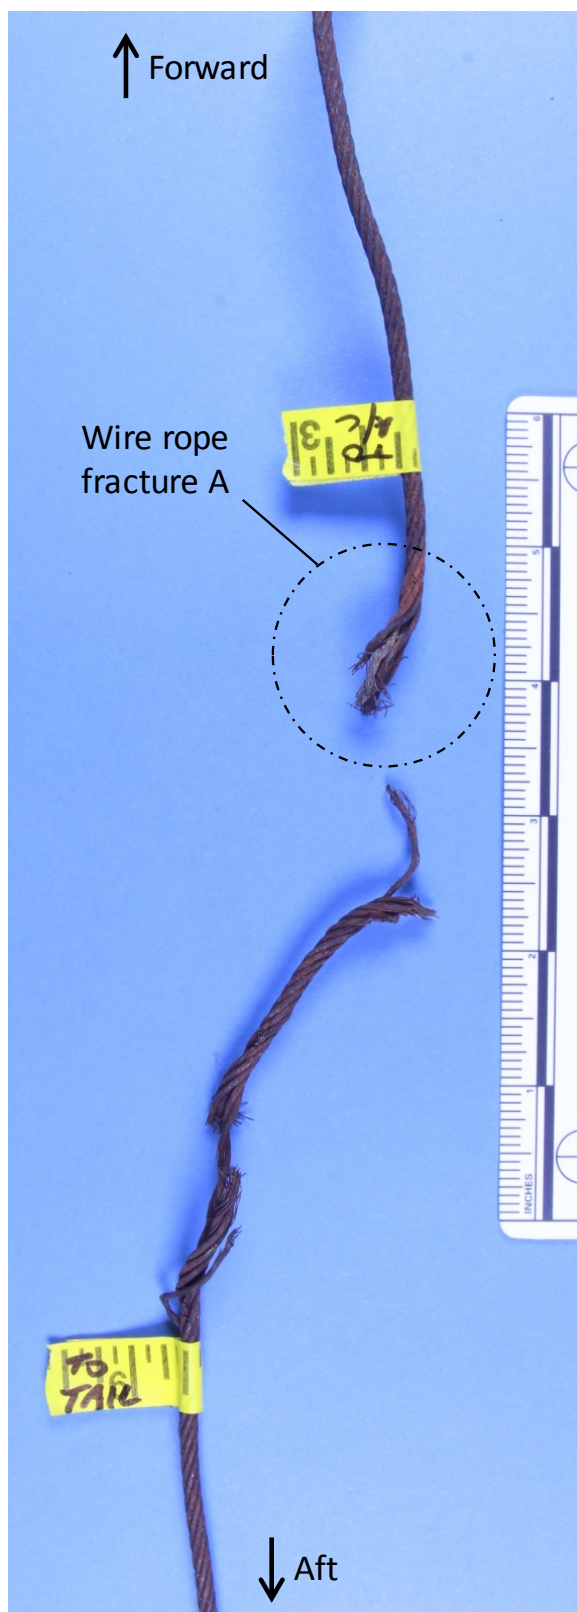
Figure 2 Closer view of the fractured ends on the wire rope pieces.

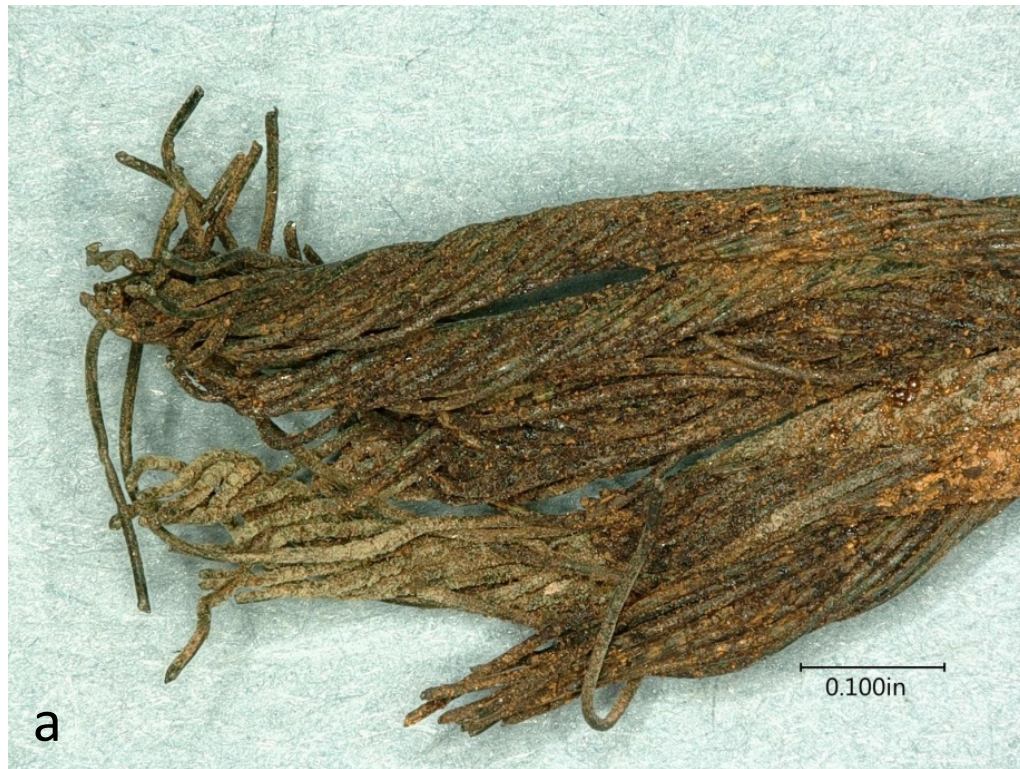
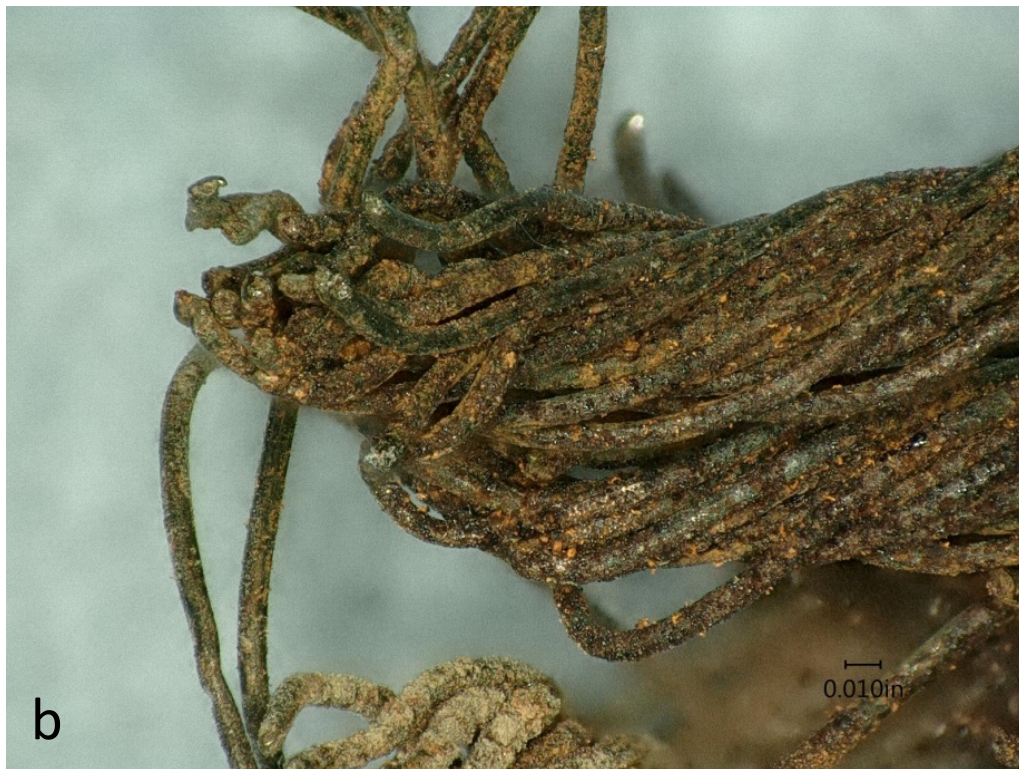
Using a 5X to 50X stereo-zoom microscope and a 5X to 200X digital microscope, the fractured ends of the wire rope pieces were examined. Representative images of the fractured end labelled "wire rope fracture A" in Figure 2 are shown in Figures 3-5. Corrosion product obscures the surfaces and the fractured ends of the wires.

Figure 3 Digital microscope images of the end labeled “wire rope fracture A” in Figure 2 (before cleaning). A higher magnification image is shown in view b.

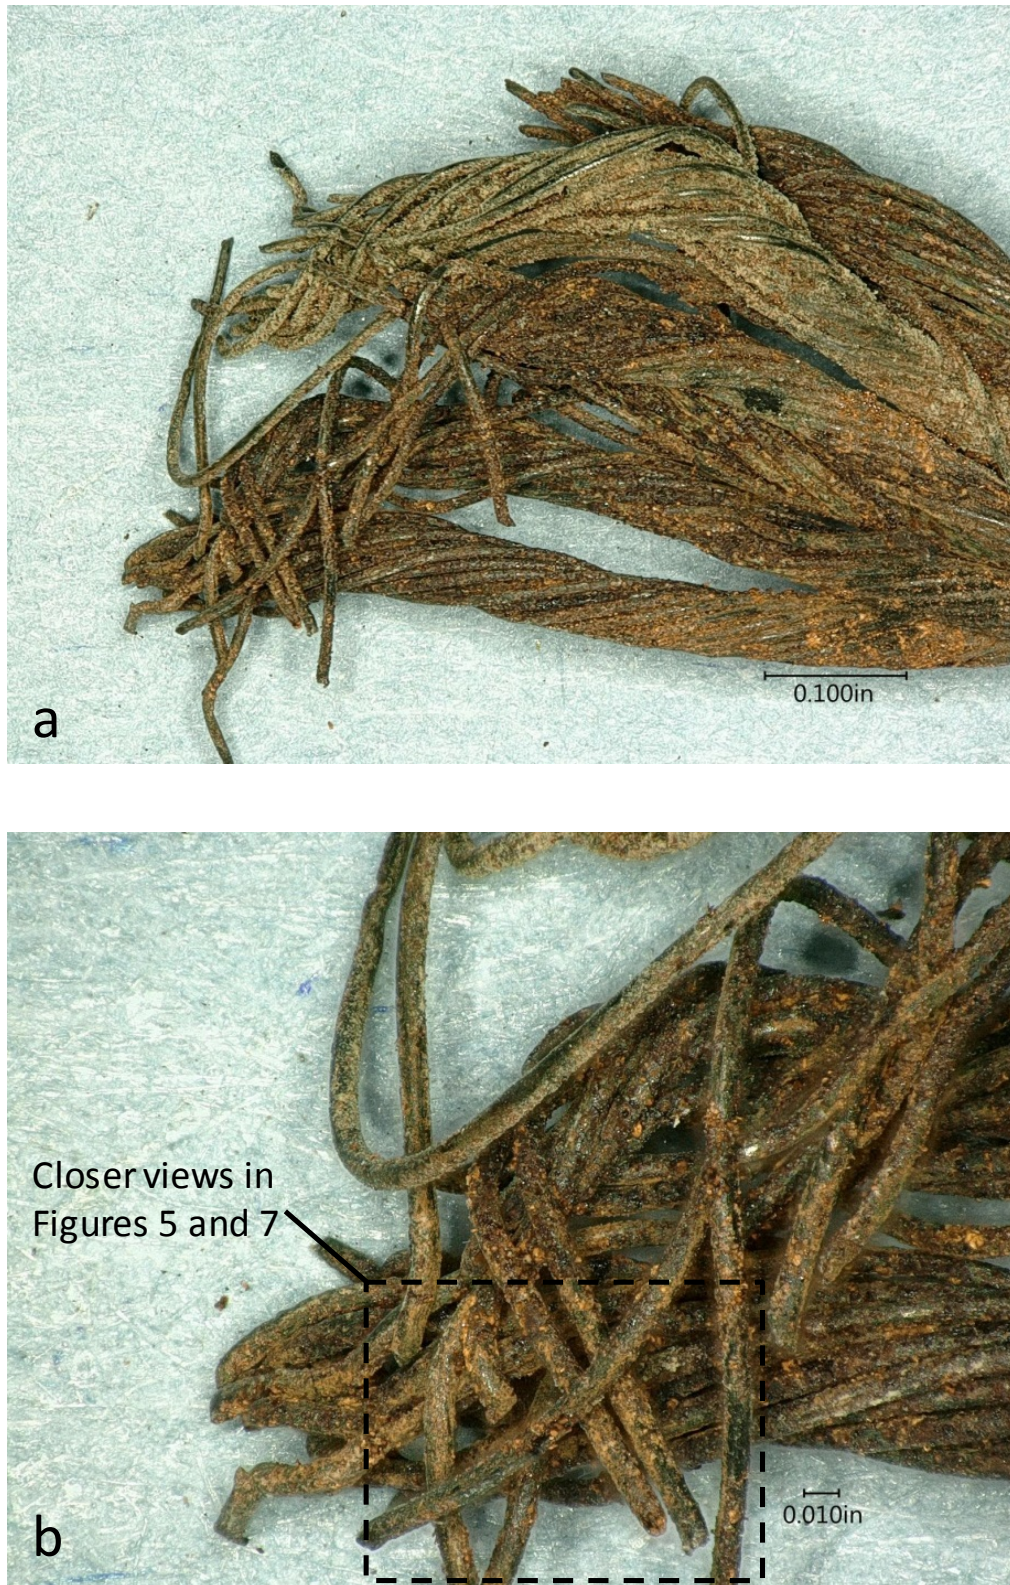
Figure 4 Digital microscope images of the end labeled “wire rope fracture A” in Figure 2 , the reverse side of Figure 3 (before cleaning). A higher magnification image is shown in view b.

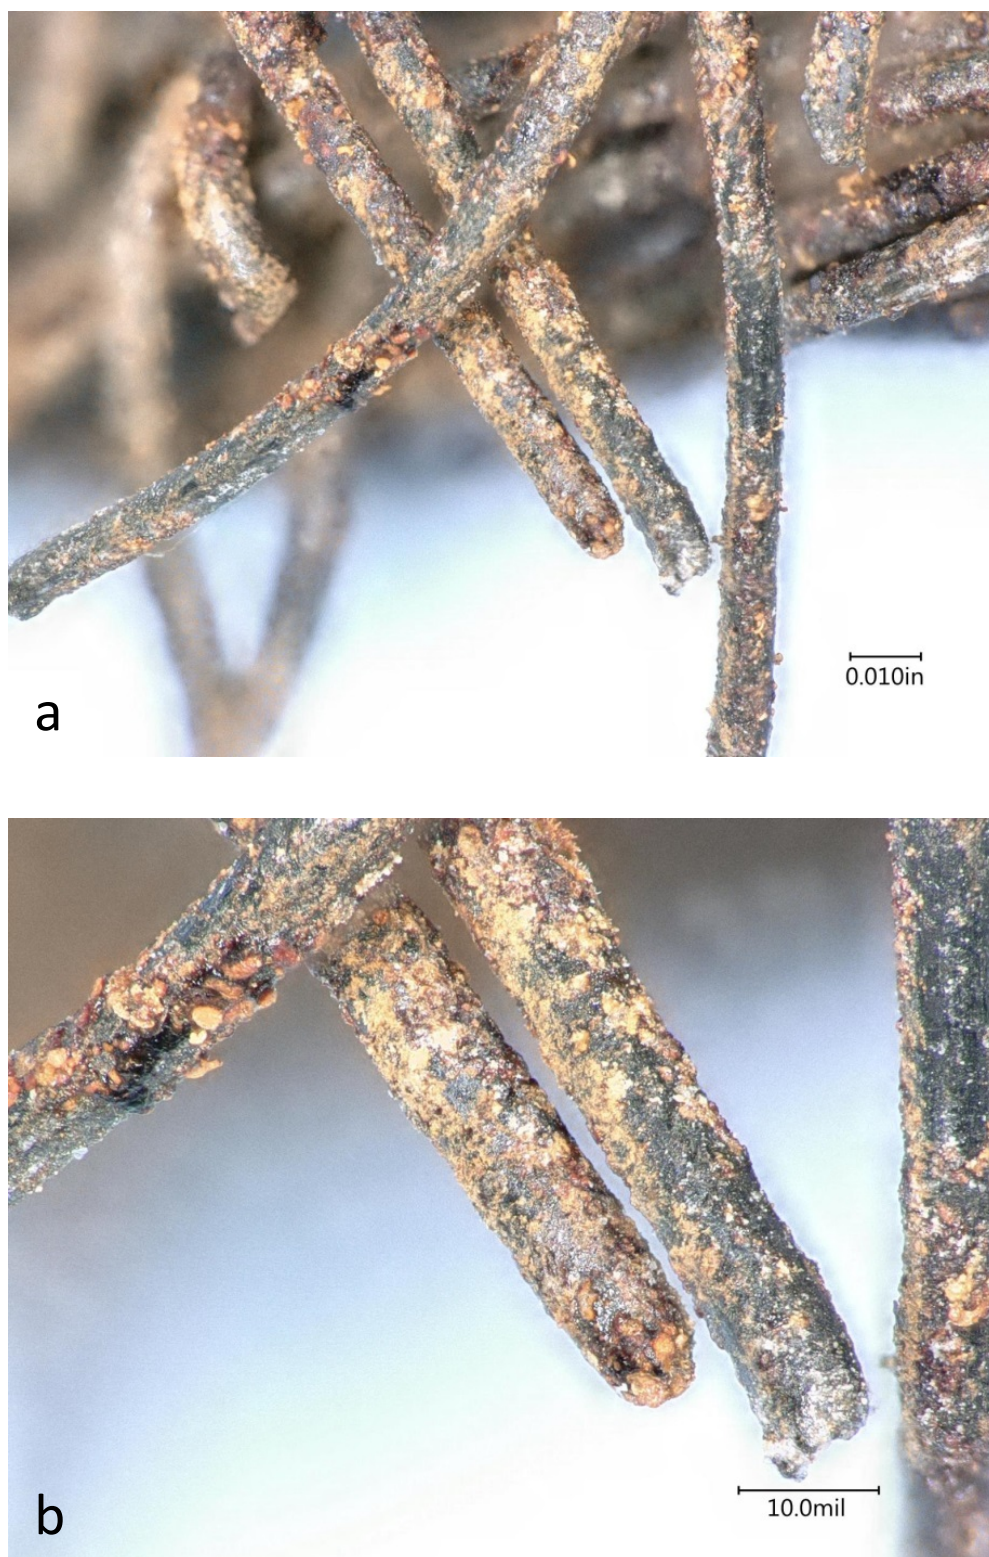
Figure 5 Digital microscope images of individual wires identified in Figure 4b (before cleaning).

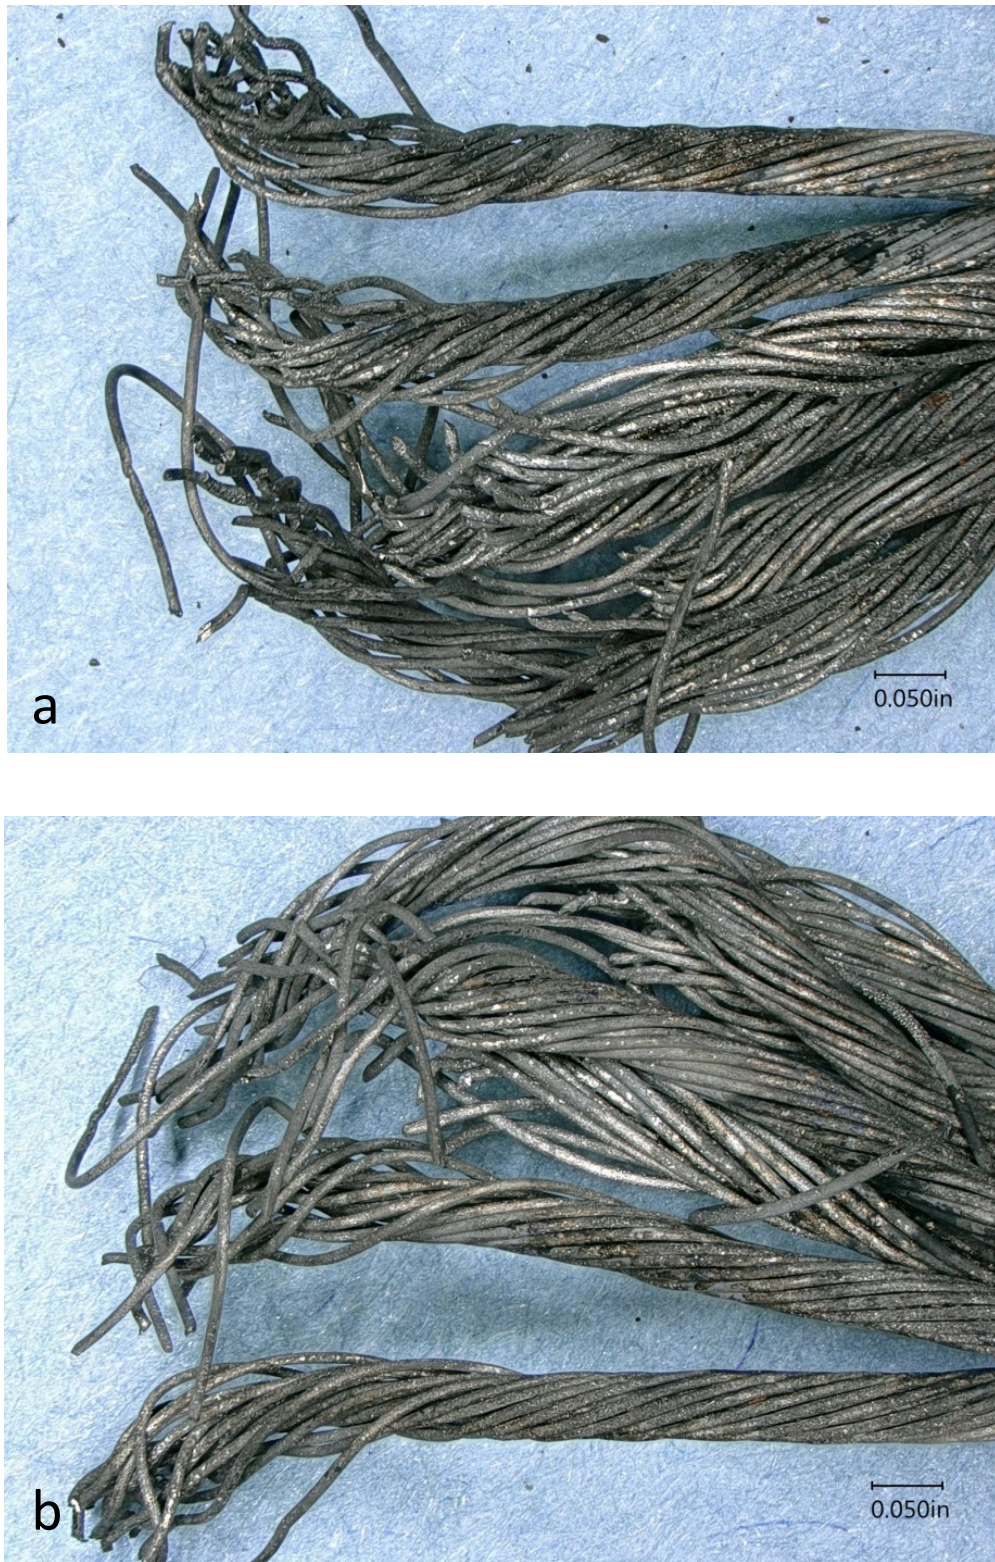
The fractured ends of the wire rope pieces were cut from the larger wire rope pieces and were cleaned to remove corrosion product<sup>1</sup>. After cleaning, the fractured wires were examined using a 5X to 50X stereo-zoom microscope and a 5X to 200X digital microscope. Representative digital microscope images are shown in Figures 6 and 7. In all instances, the wire fracture surfaces exhibited necking and shear lips consistent with overstress fracture.

Figure 6 Digital microscope images of the end labeled “wire rope fracture A” in Figure 2 (after cleaning to remove corrosion product). View a is the obverse side shown in Figure 3a. View b is the reverse side shown in Figure 4a.

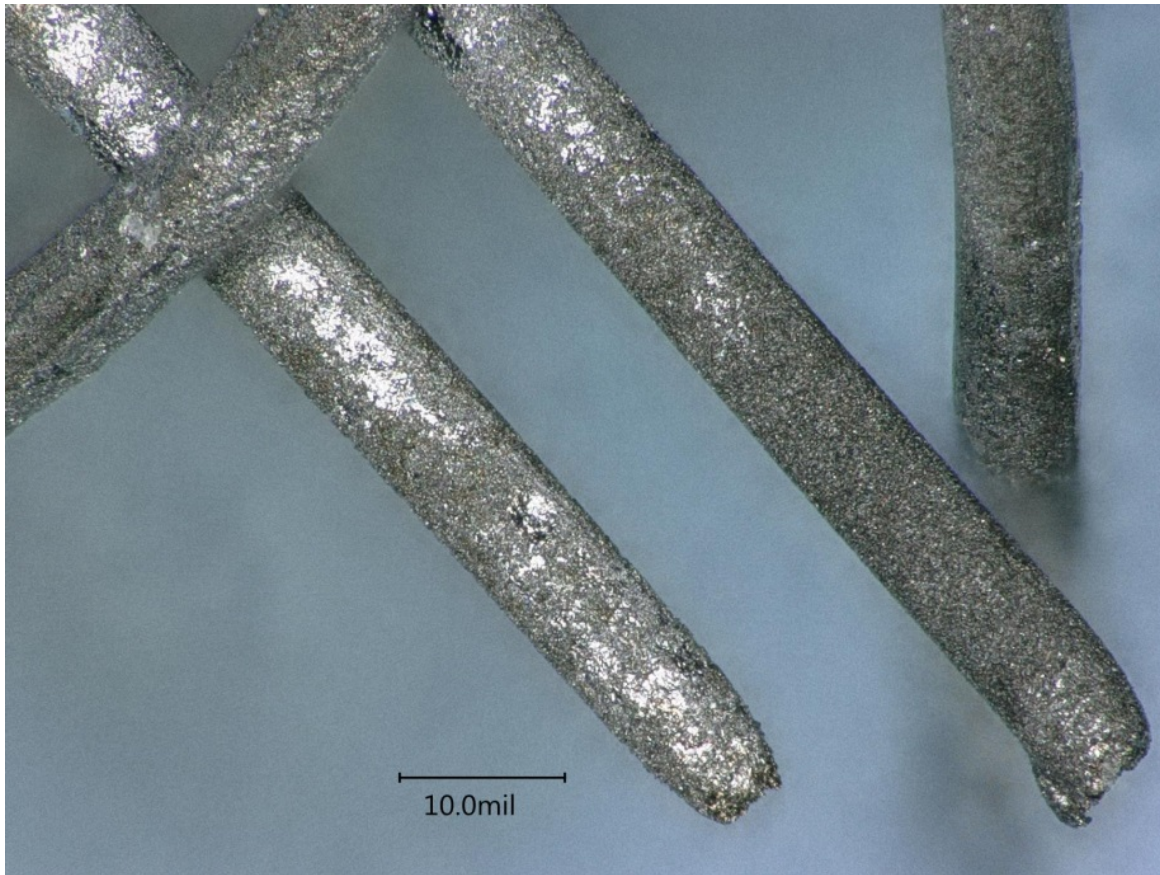
Figure 7 Digital microscope images of individual wires identified in Figure 4b (after cleaning to remove corrosion product).

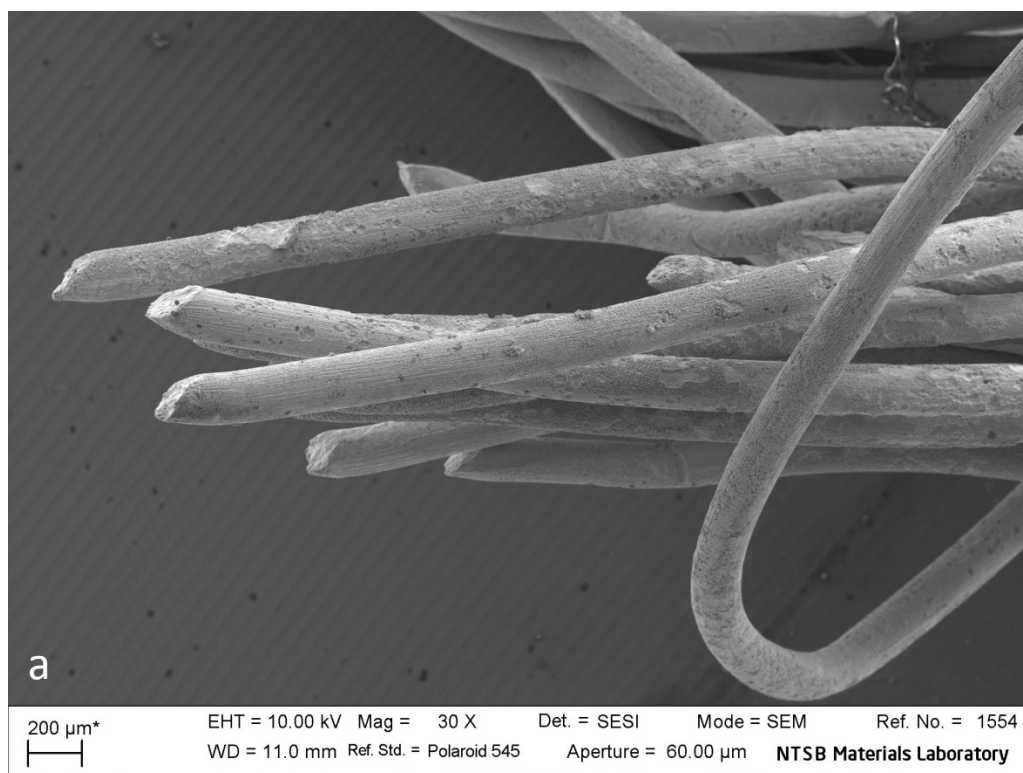
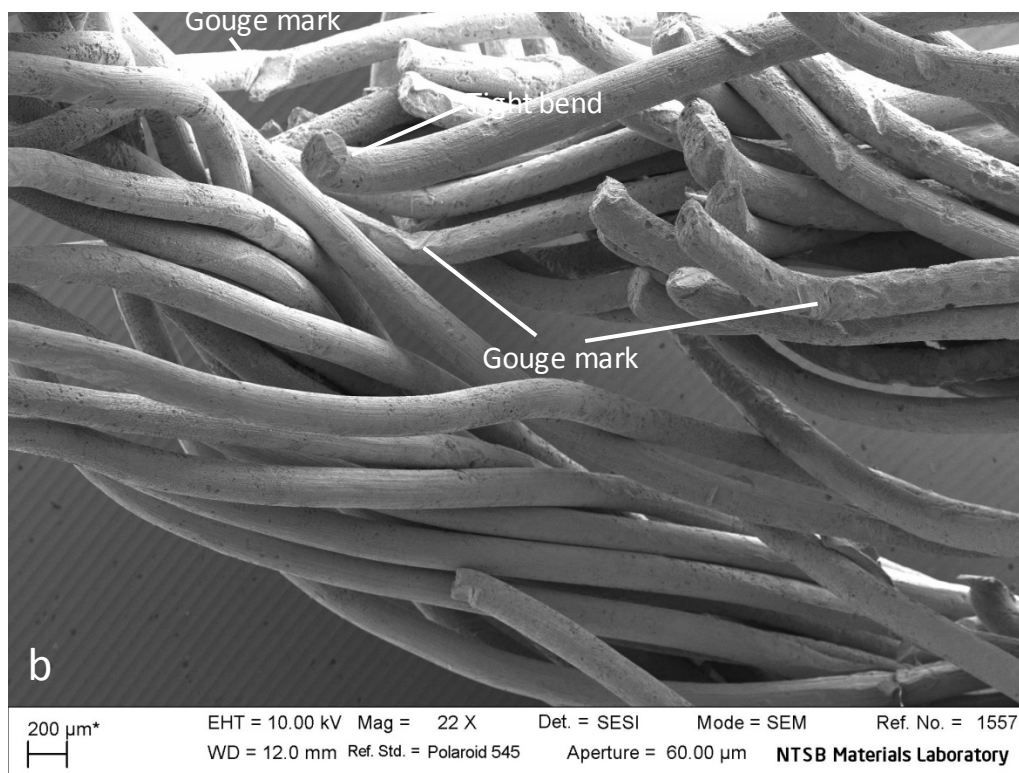
The fractured end labelled "wire rope fracture A" (Figure 2) was also examined by scanning electron microscope (SEM). Representative SEM images are shown in Figures 8-10. In addition to necking and shear lip features, the SEM images revealed gouging and skiving scars on the wire surfaces. In some instances, gouging scars are present at the wire fracture surface (see Figures 8b, 9a, and 10). Some of the fractured wires exhibited tight-radius bends at the fractured end as depicted in Figures 8b and 9a. Skiving scars were observed on the surfaces of some wires as indicated in Figure 9b.

Figure 8 SEM micrographs of “wire rope fracture A.” View a showing generalized necking at the fracture wire ends, with concomitant shear lips. View b shows gouging scars and tight bends at the ends of some fractured wires.

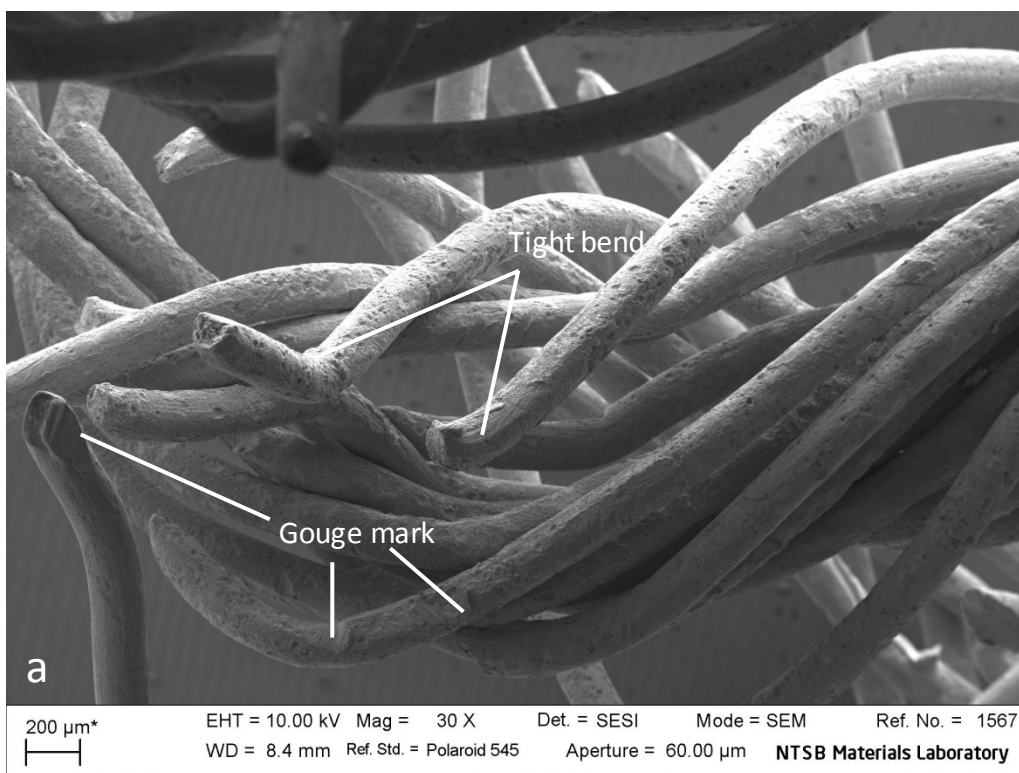
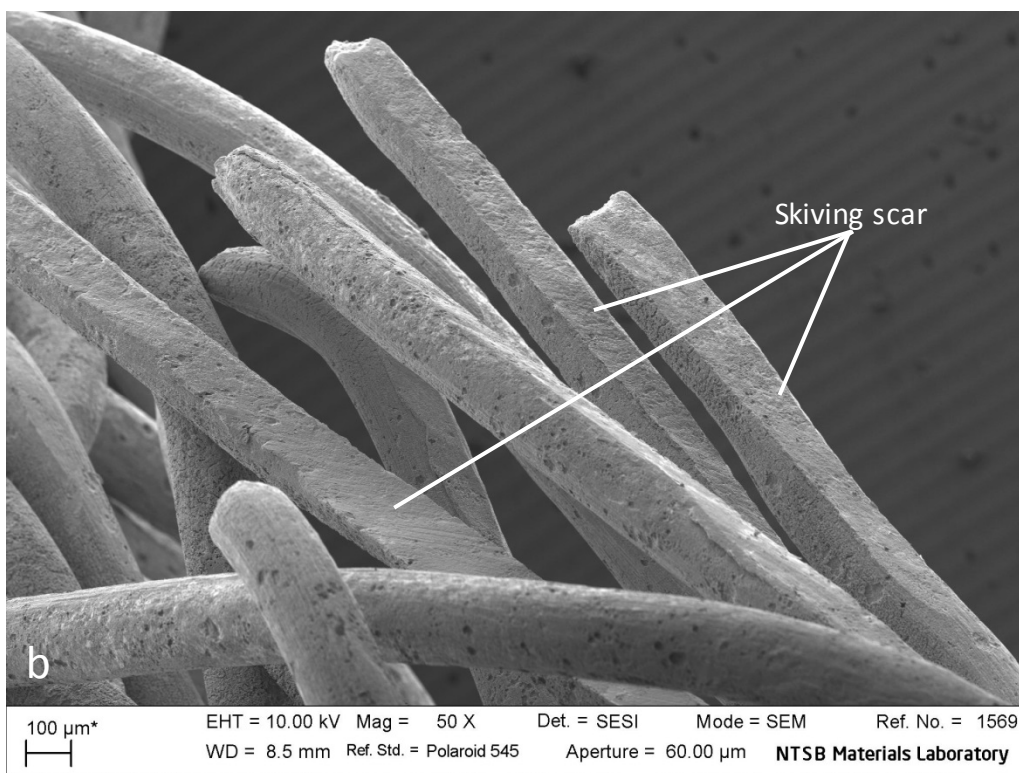
Figure 9 View a shows gouging scars and tight bends at the ends of some fractured wires. View b shows skiving scars on the wire surfaces.

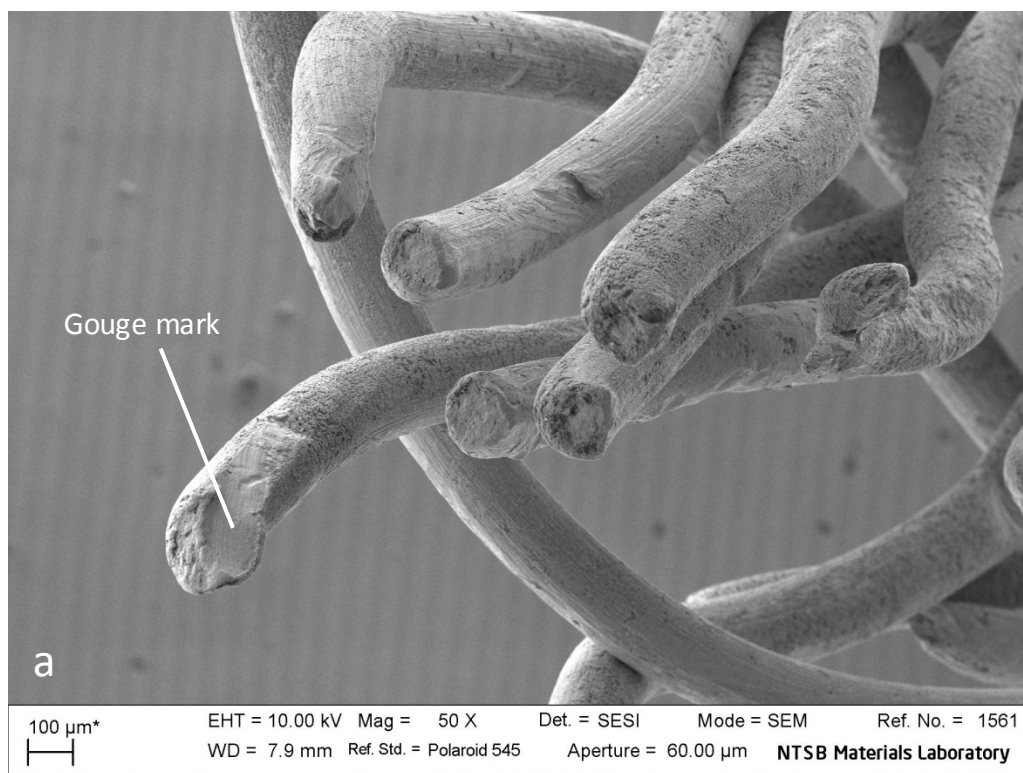
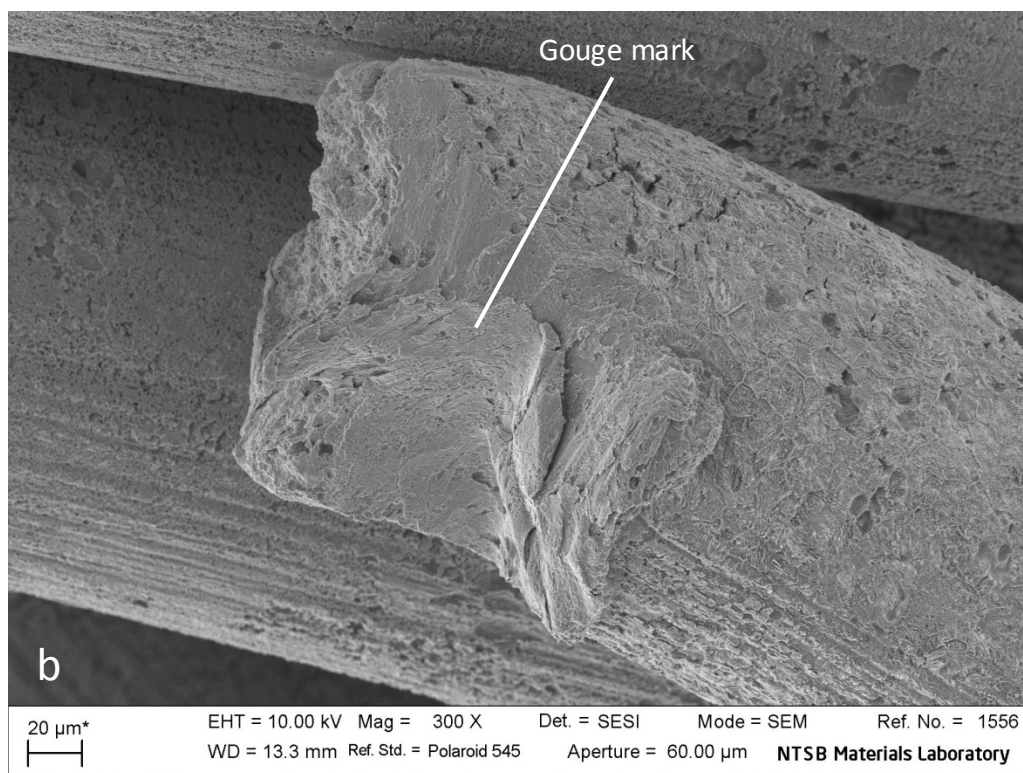
Figure 10 View a and b show gouging scars at the wire fracture surfaces.
