## **NATIONAL TRANSPORTATION SAFETY BOARD**

### **Group Chairman's Weather Study Report**

# **METEOROLOGY**

**ANC16LA012**

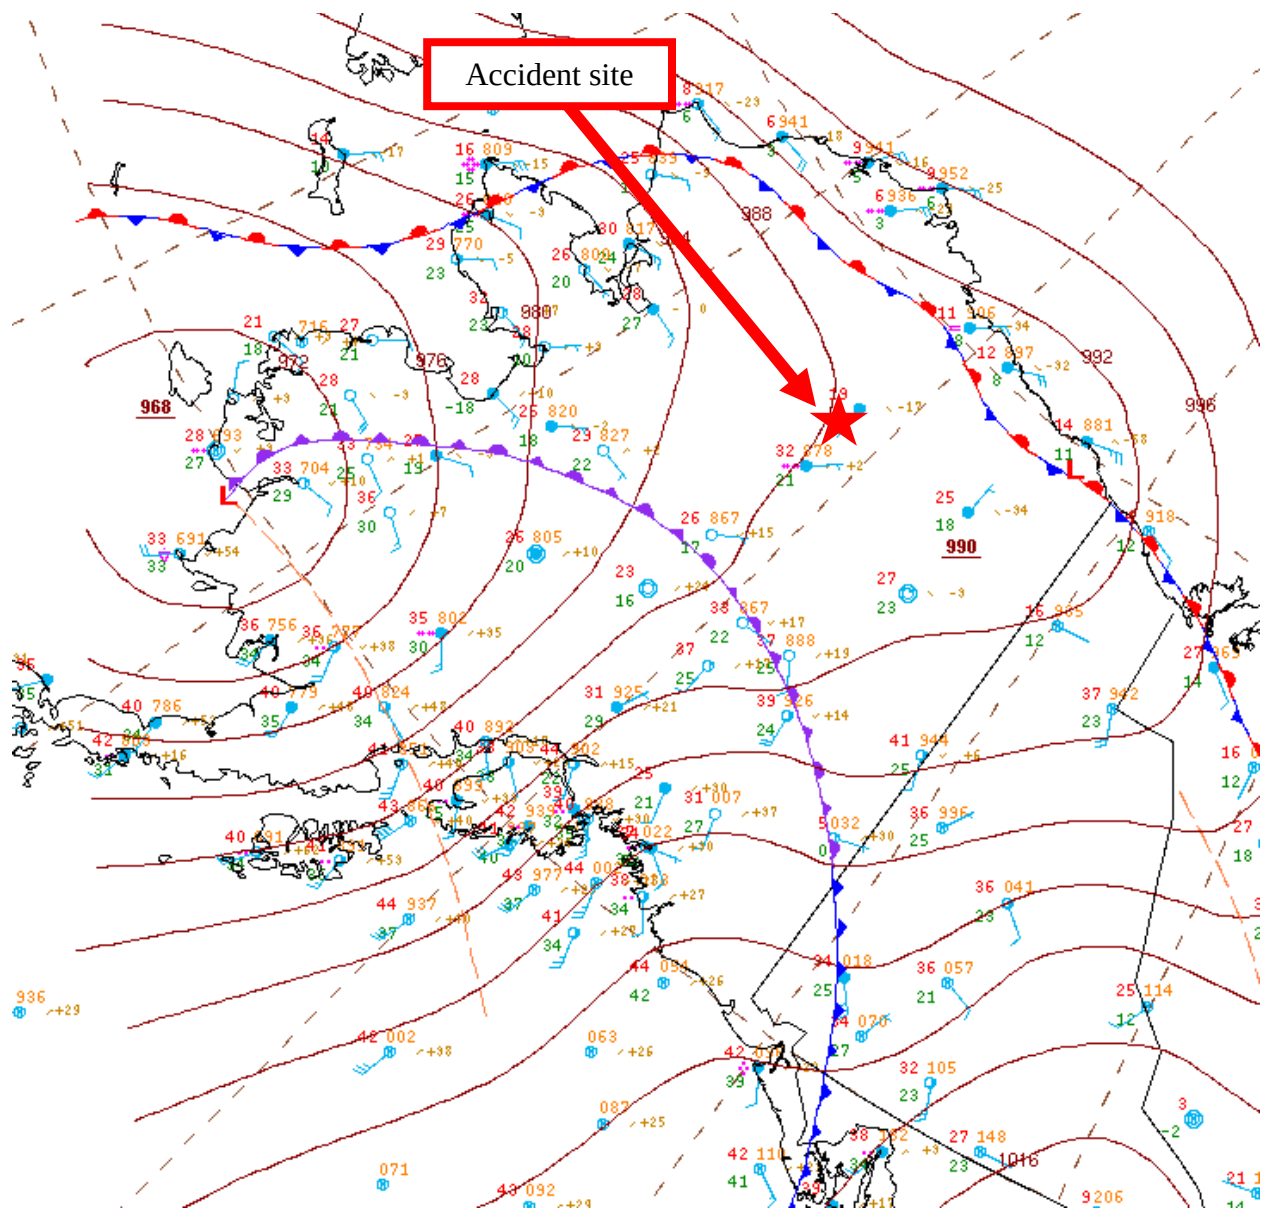
**Figure 1 – NWS Surface Analysis Chart for 1200 AKST**

The NWS Surface Analysis Chart for 1200 AKST is provided as figure 1 with the approximate location of the accident site marked. The chart depicted an occluded front to the south of the accident site stretching from west to east across the Alaska Range and then southeastward into western Yukon Territory. A stationary front was located across northern Alaska stretching from west to east from the Bering Sea eastward into northern Yukon Territory. The accident site was located about half way between these two frontal boundaries. A surface low pressure center with a pressure of 990-hectopascals (hPa) was located in northeastern Alaska and a surface low pressure center with a pressure of 968-hPa was located in southwestern Alaska. The station models around the accident site depicted air temperatures in the upper teens to low 30's Fahrenheit (F), with temperature-dew point spreads of 11° F or less, a variable wind around 5 knots, cloudy skies and light snow. With surface low pressure area located in southwestern Alaska, southerly wind flow from the surface up to the jet stream level would have been likely and any wind flow over the higher terrain would have promoted cloud cover. Areas of precipitation would have been favored in locations with enough surface to mid-level moisture. The accident site was in location of relatively higher surface moisture which would have promoted the development of continued widespread cloudy conditions and precipitation near the higher terrain.

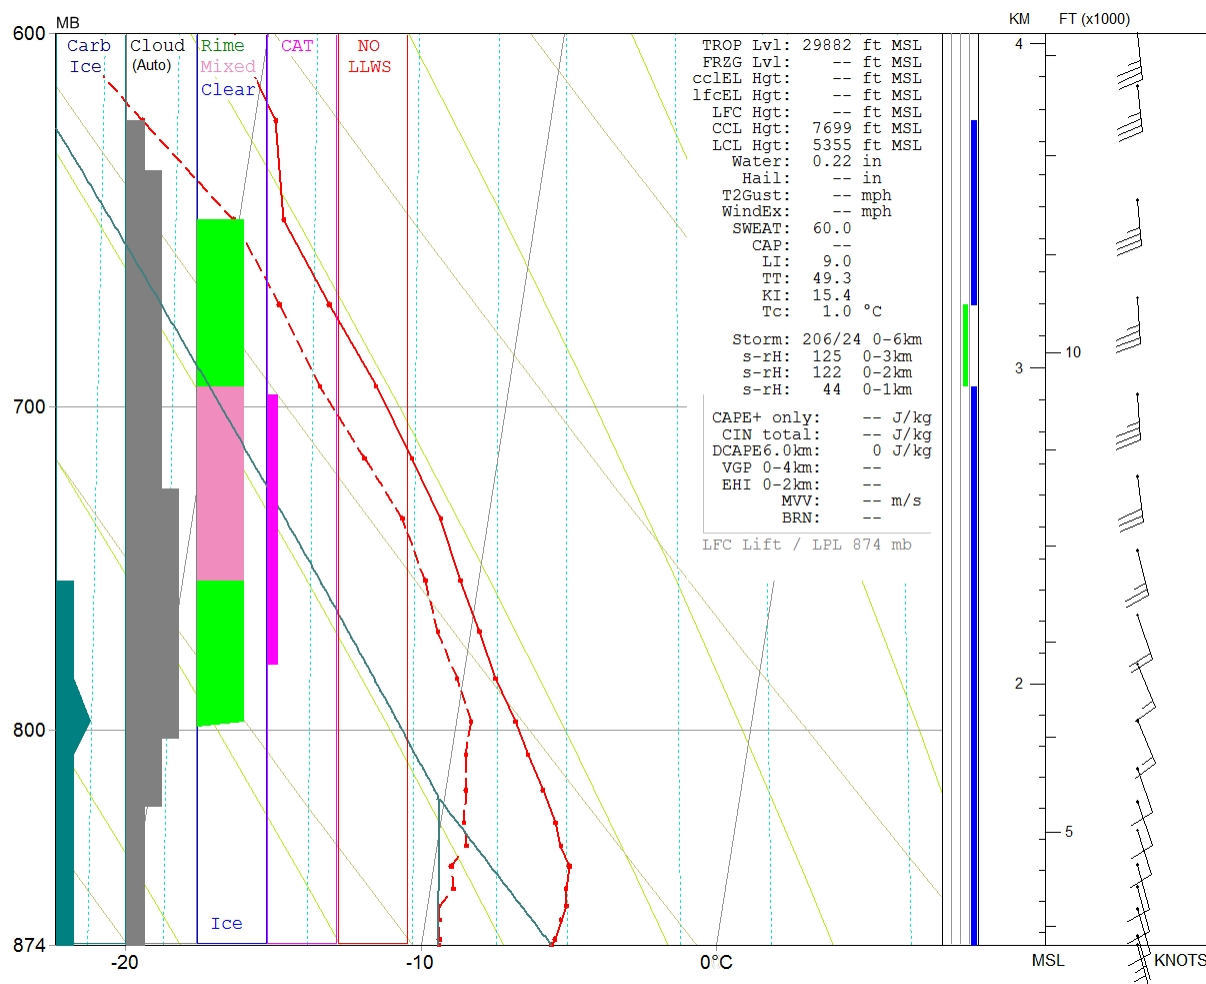
Figure 3 – 1200 AKST GDAS sounding for the accident site

A Global Data Assimilation System (GDAS) computer model upper air sounding for the accident site was generated for 1200 AKST. The 1200 AKST sounding was plotted on a standard Skew-T log P diagram<sup>8</sup> with the derived stability parameters included in figure 3 (with data from the surface to 600-hPa, or 13,000 feet msl.) This data was analyzed utilizing the RAOB<sup>9</sup> software package. The sounding depicted the Lifted Condensation Level (LCL)<sup>10</sup> at 5,355 feet msl and a Convective Condensation Level (CCL)<sup>11</sup> of 7,699 feet. The freezing level was located at the surface. The precipitable water value was 0.22 inches.

The 1200 AKST GDAS sounding indicated a relatively moist conditionally unstable environment from the surface through 13,000 feet msl. RAOB indicated that clouds were likely from the surface through 12,000 feet msl. Given the wind flowing over the terrain with the terrain acting as a lifting mechanism, clouds and light precipitation would be expected. Icing conditions were likely from 6,000 through 11,000 feet msl as indicated by RAOB.

The sounding wind profile indicated a surface wind from 166° at 6 knots with the wind increasing to 20 knots by 7,000 feet msl while remaining out of the south-southeast. The wind continued to increase in speed through 13,000 feet to near 35 knots with the wind remaining out of the south. No low-level wind shear (LLWS) was identified by RAOB between the surface and 13,000 feet msl, but there was a layer of clear air turbulence possible from 7,000 feet through 10,000 feet. Given the vertical environment of the lowest 2,000 feet msl, LLWS would not be expected near the surface, but some gusty wind conditions could be expected along and near the mountainous terrain at the accident time.

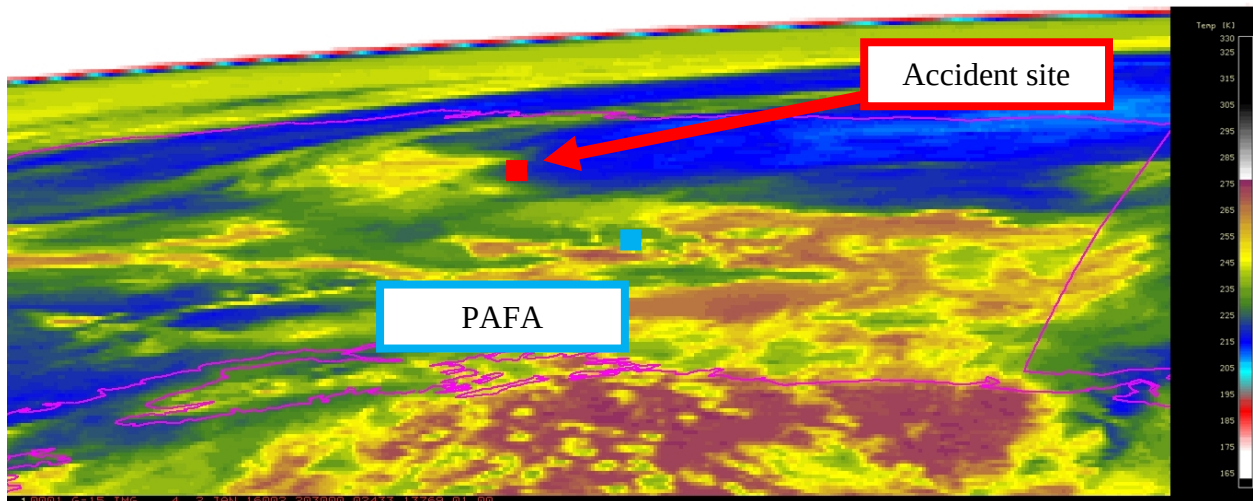
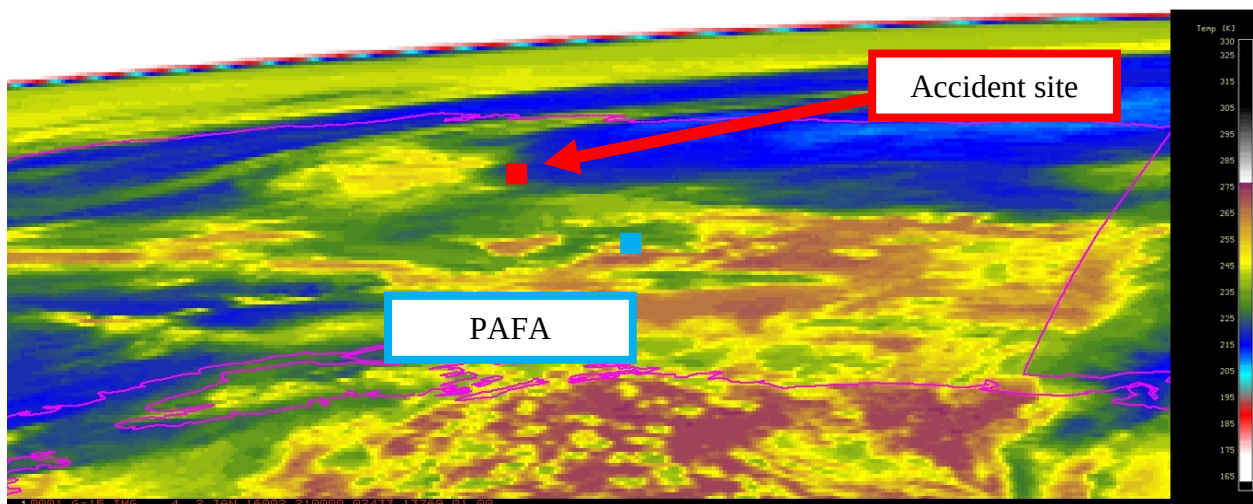
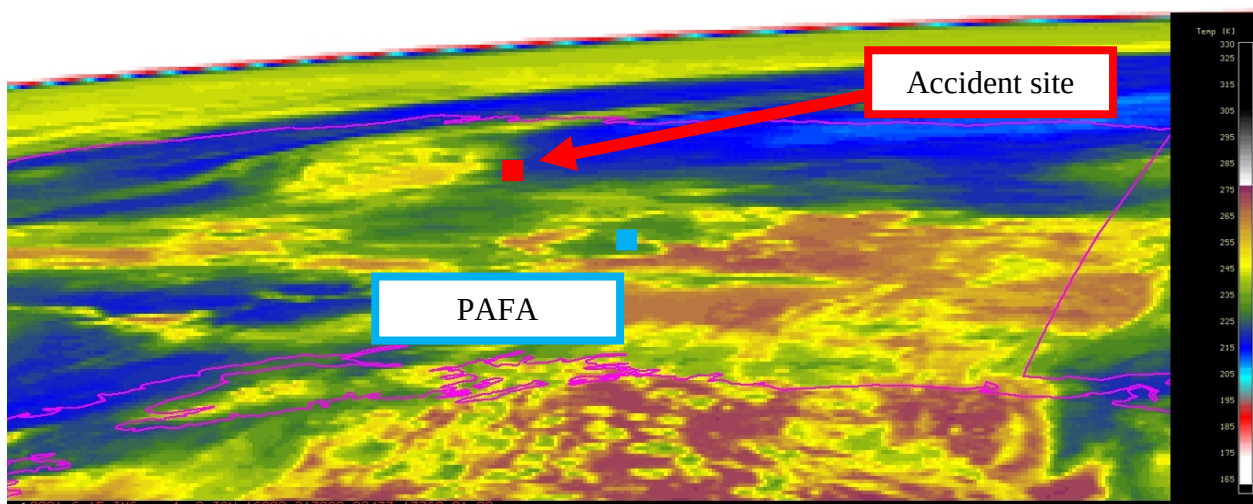
Figures 4, 5, and 6 present the GOES-15 infrared imagery from 1130, 1200, and 1230 AKST at 4X magnification. Inspection of the infrared imagery indicated an enhanced bands (greens and blues, higher cloud tops) were moving northward across the accident site at the accident time. Lower cloud tops were located over Fairbanks Airport (PAFA), Alaska. Based on the brightness temperatures above the accident site and the vertical temperature profile provided by the 1200 AKST GDAS sounding, the approximate cloud-top heights over the accident site were 25,000 feet at 1200 AKST.

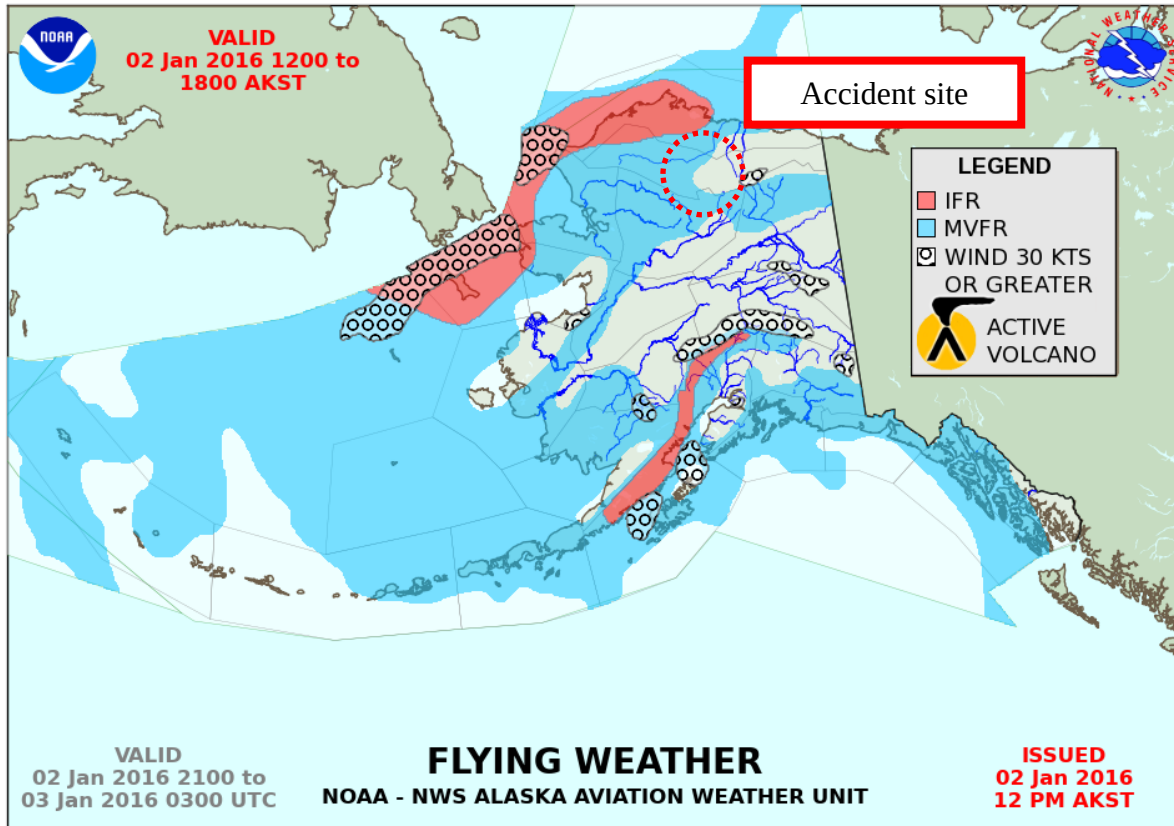
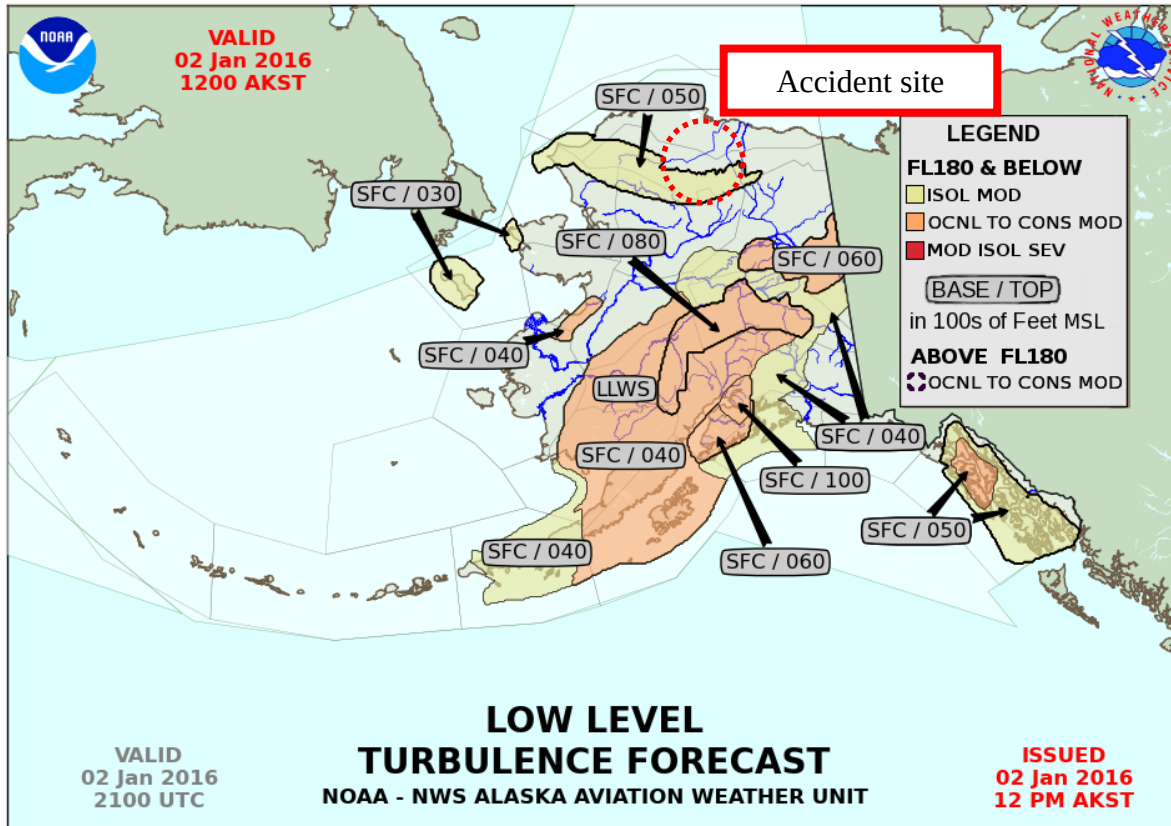
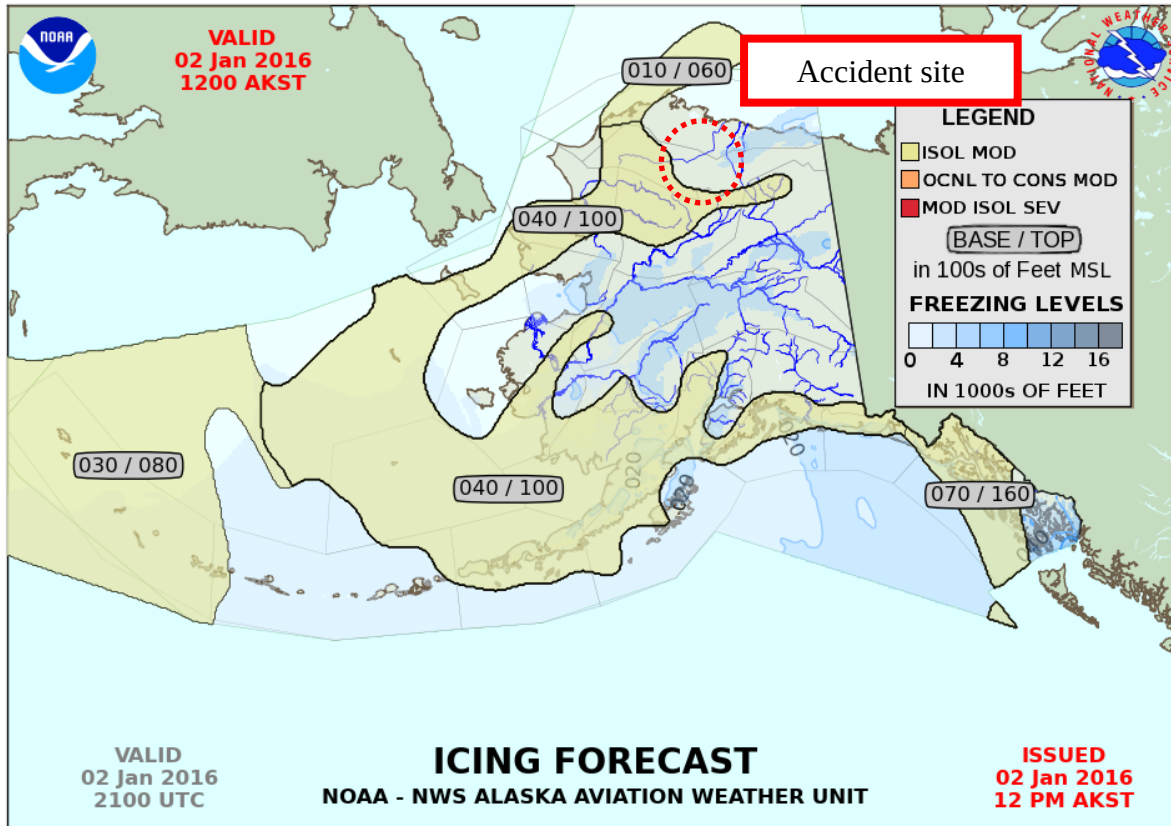
.  
The Area Forecast issued 3 minutes after the accident time, at 1208 AKST, included an AIRMET for mountain obscuration due to clouds and precipitation and the AIRMET was valid at the accident site (figures 8, 10, and 12). This later Area Forecast mentioned scattered clouds at 1,500 feet agl, a broken ceiling at 2,500 feet agl, and overcast skies at 3,500 feet agl with several clouds above through FL300, and an occasional visibility between 3 and 5 miles with light snow showers west of Anaktuvuk Pass. Isolated broken ceiling at 1,500 feet agl and visibility below 3 miles in light snow, blowing snow, and mist was also forecast west of Anaktuvuk Pass. VFR conditions were forecast for the rest of the north slopes of Brooks Range forecast area with channeled terrain surface winds from the south at 20 knots and gusts to 30 knots:

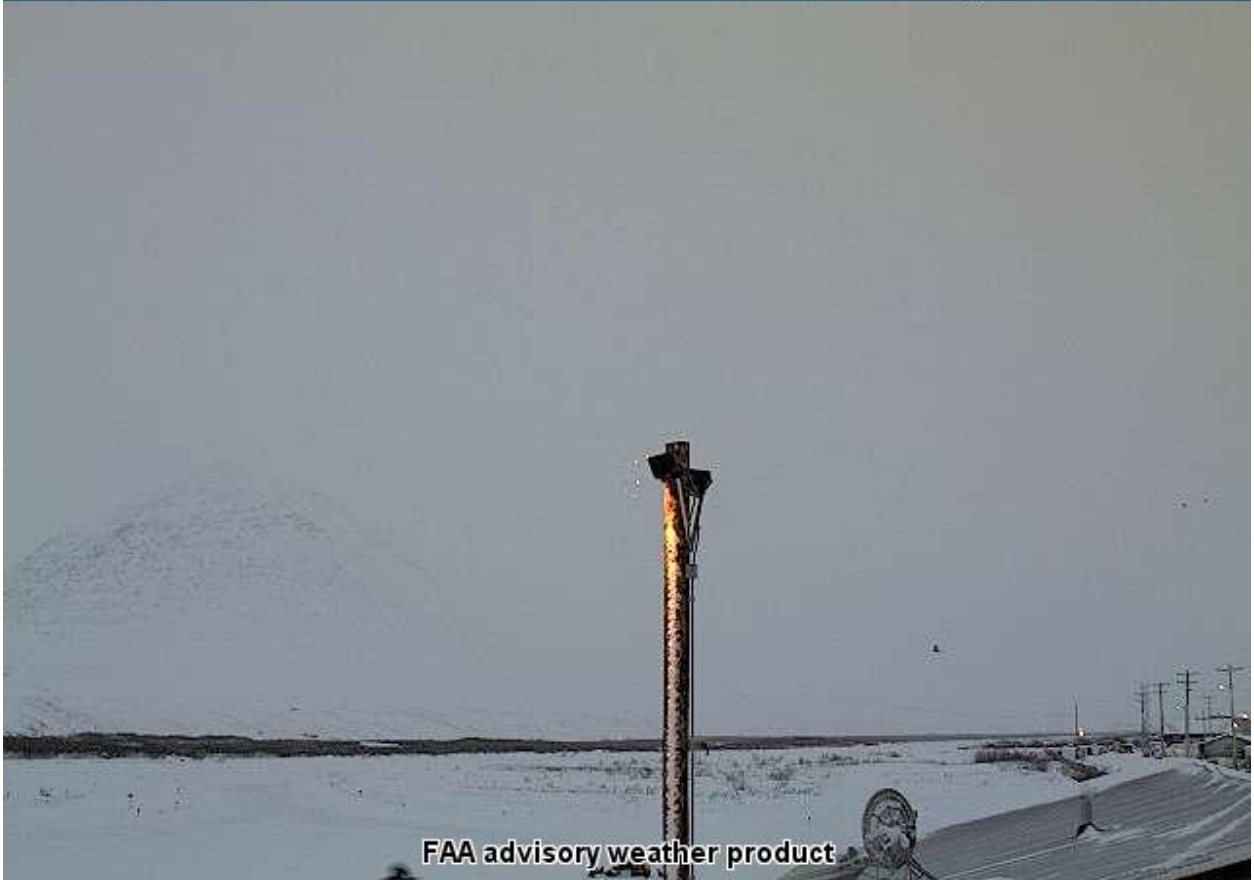
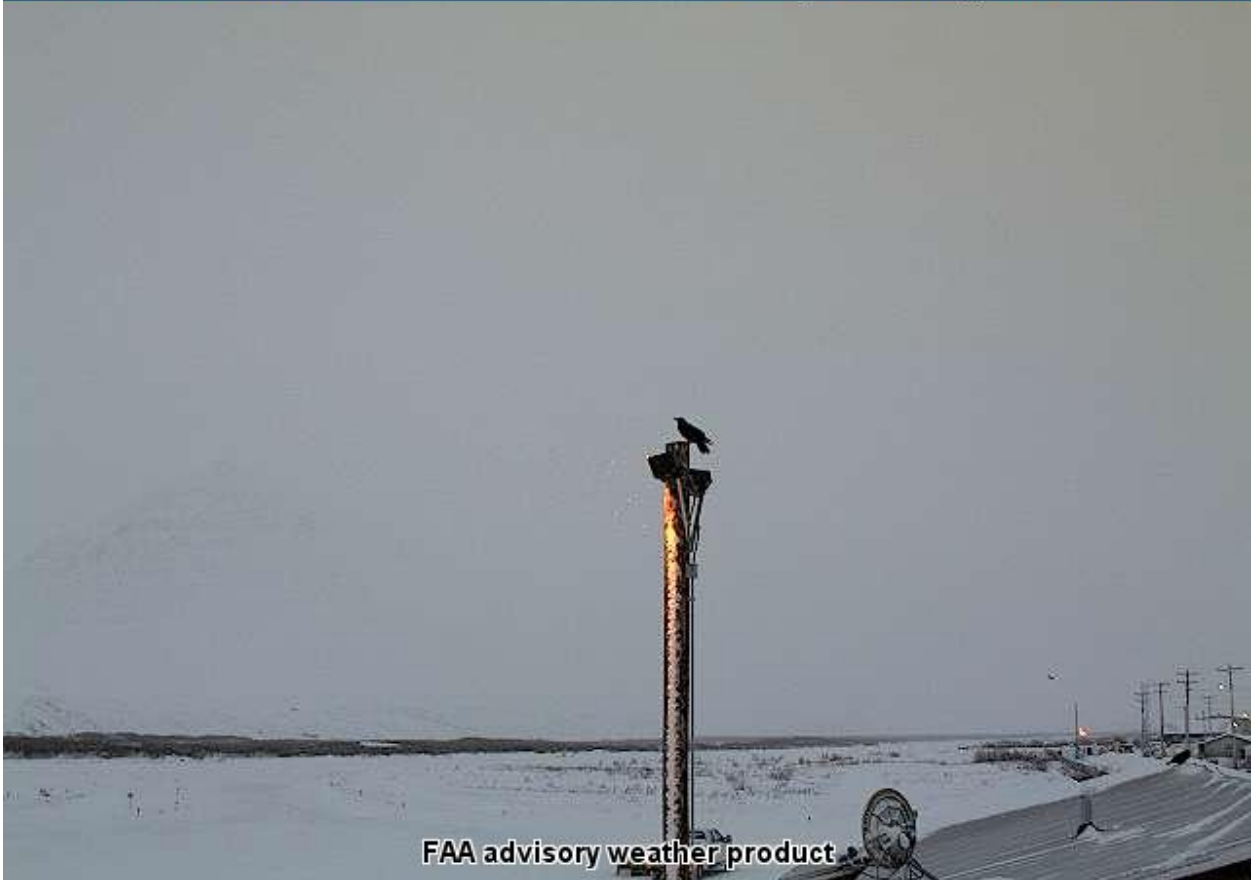
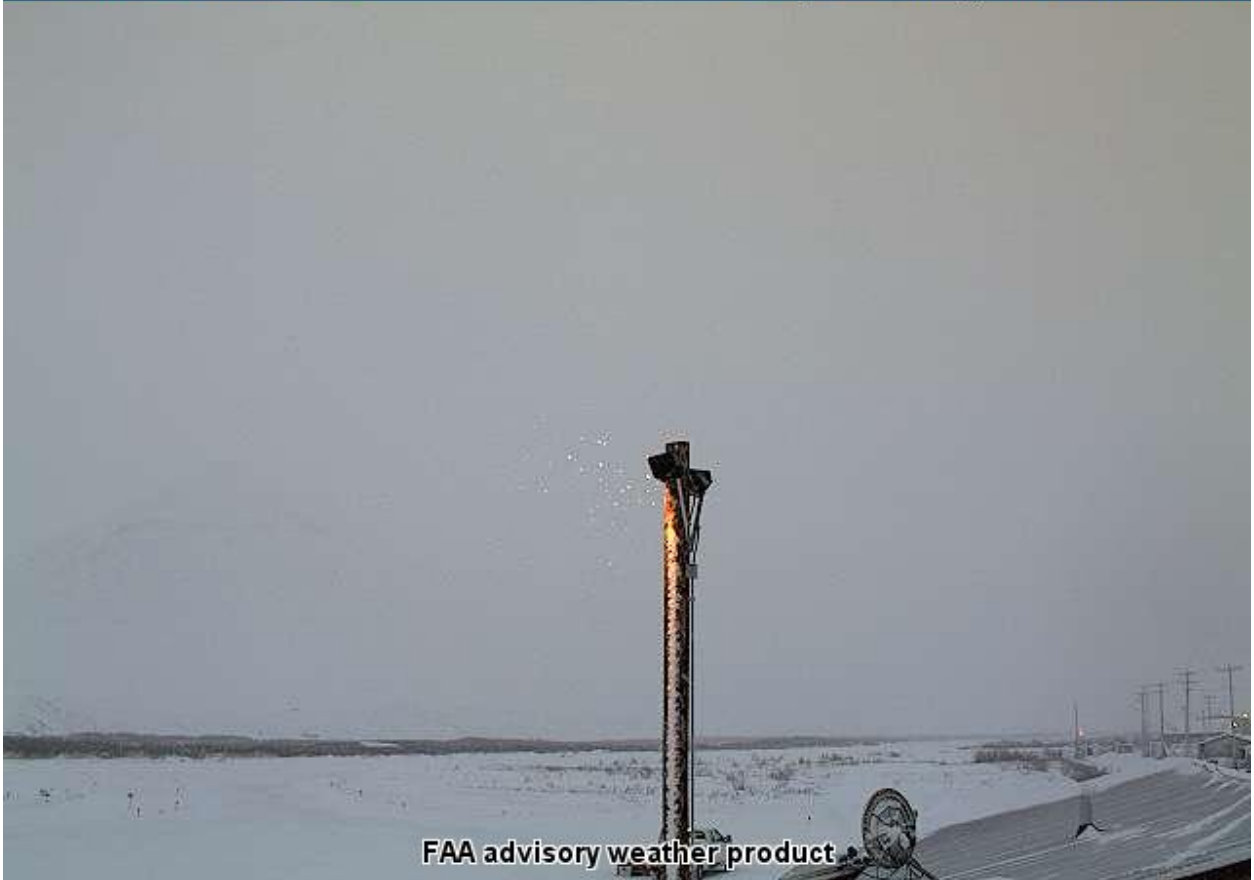
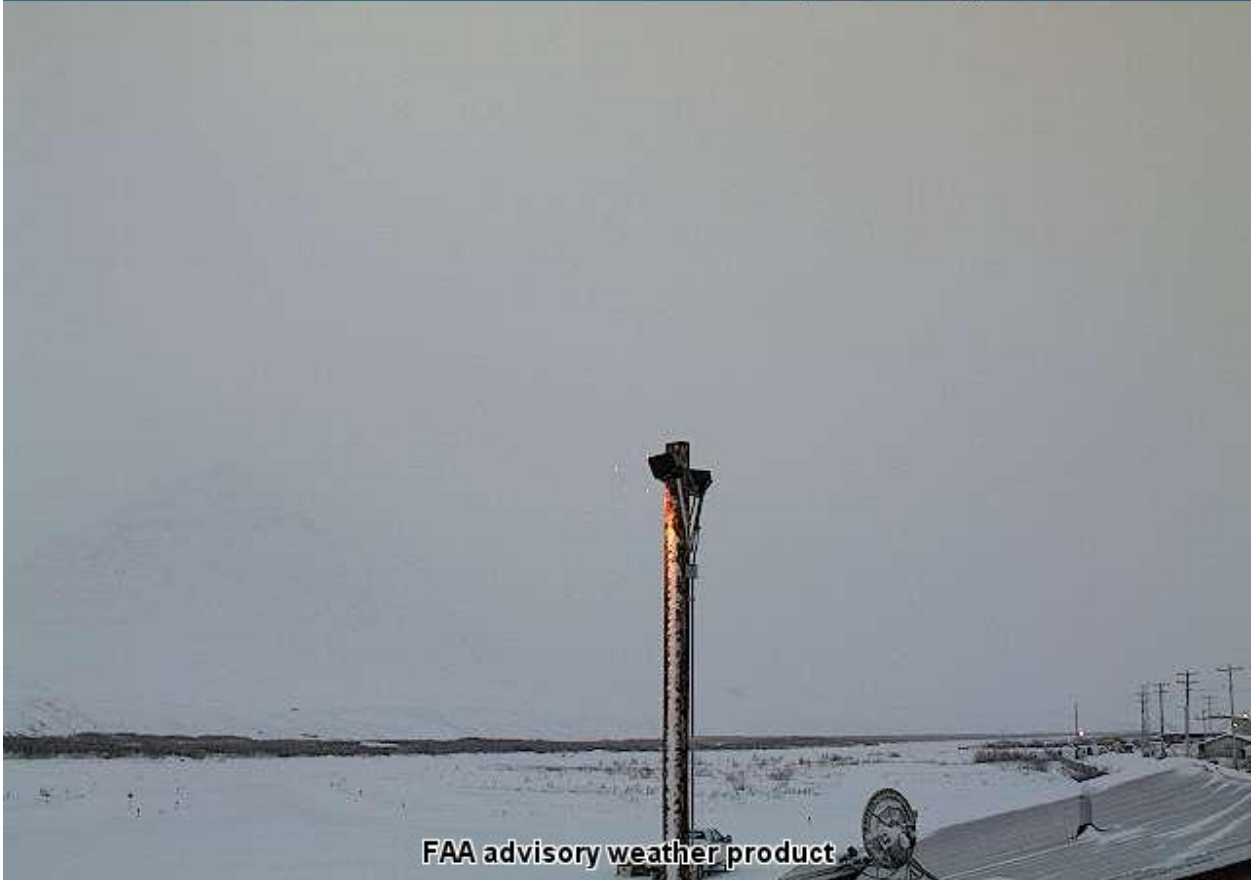
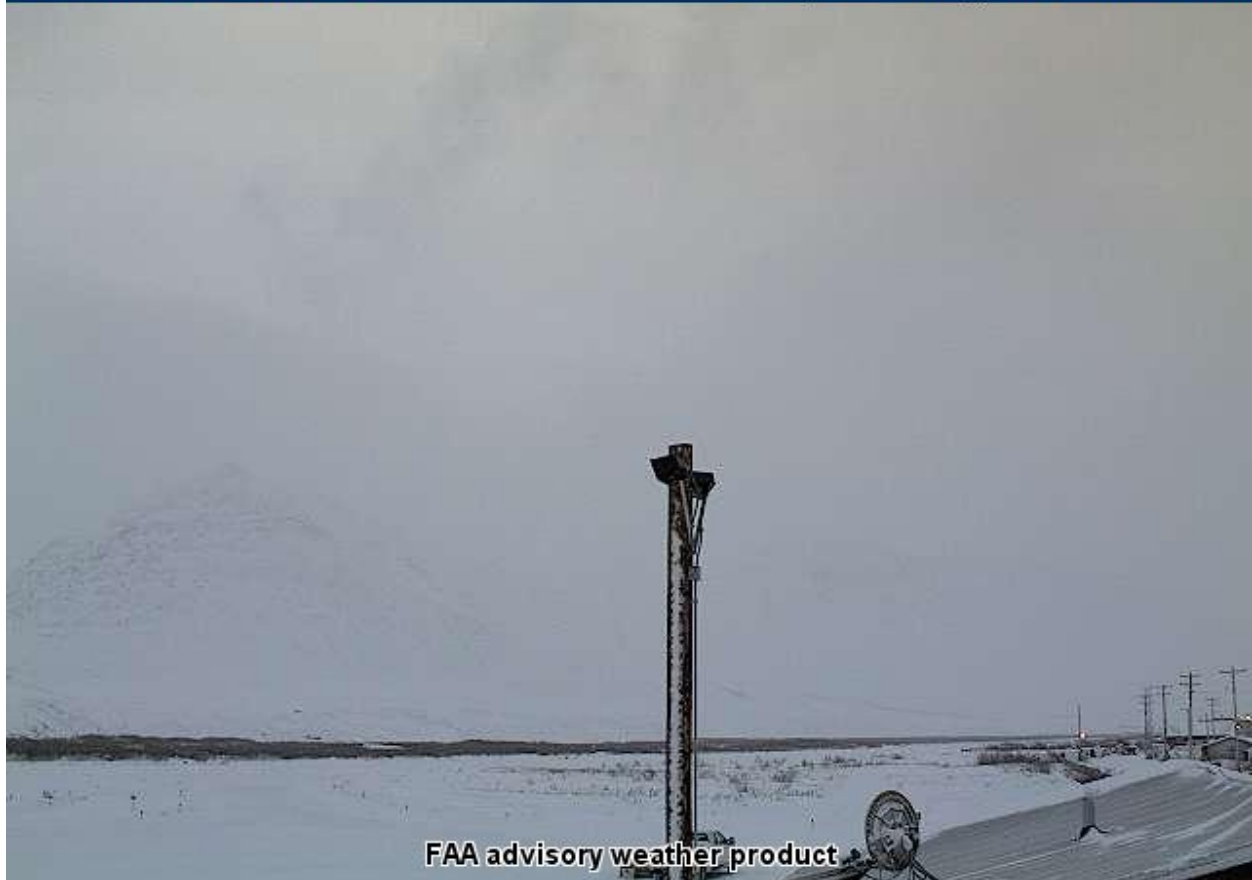
Images from the FAA's Aviation Weather Cameras are shown in figures 13 through 27 along with attachments 1 through 4 providing images of the weather conditions surrounding the accident site at the accident time. The weather camera from Anaktuvuk Pass, 5 miles northeast of the accident site, showed the weather conditions surrounding the accident time with the south facing camera images provided in figures 15 through 19 with times from 1142 AKST through 1222 AKST. The horizontal visibility conditions deteriorated between 1152 and 1212 AKST with less than 2 miles visibility and ceiling conditions below 4,100 feet msl (figures 16 through 18 compared to figure 13), and snow can be seen falling in the light beam shining down towards the ground from the airport flood lamp in the foreground. Weather conditions improve slightly by 1222 AKST with visibility greater than 2 miles but less 4 miles and a broken ceiling of clouds (figure 19). The weather camera from Anaktuvuk Pass southwest facing camera images are provided in figures 22 through 27 with times from 1140 AKST through 1230 AKST. The southwest facing weather camera showed similar conditions to the south facing camera, with less than 3.5 miles visibility (with mountain as reference figure 21) and ceiling conditions below 5,000 feet msl, on the southwest facing weather camera between 1140 and 1230 AKST (figures 22 through 27). Given the weather camera conditions, there was likely a restriction to horizontal visibility during descent into Anaktuvuk Pass on the accident flight with mountain obscuration due to snow and clouds. The FAA's Aviation Weather Cameras surrounding the accident site show likely MVFR conditions at the surface with IMC likely along accident flight path into the destination airport with the worst conditions along and near the terrain at the accident time. The accident pilot did check the Anaktuvuk Pass weather cameras before taking off on the accident flight, however, it was still dark at the time of takeoff.
