# NATIONAL TRANSPORTATION SAFETY BOARD

Office of Research and Engineering  
Materials Laboratory Division  
Washington, D.C. 20594

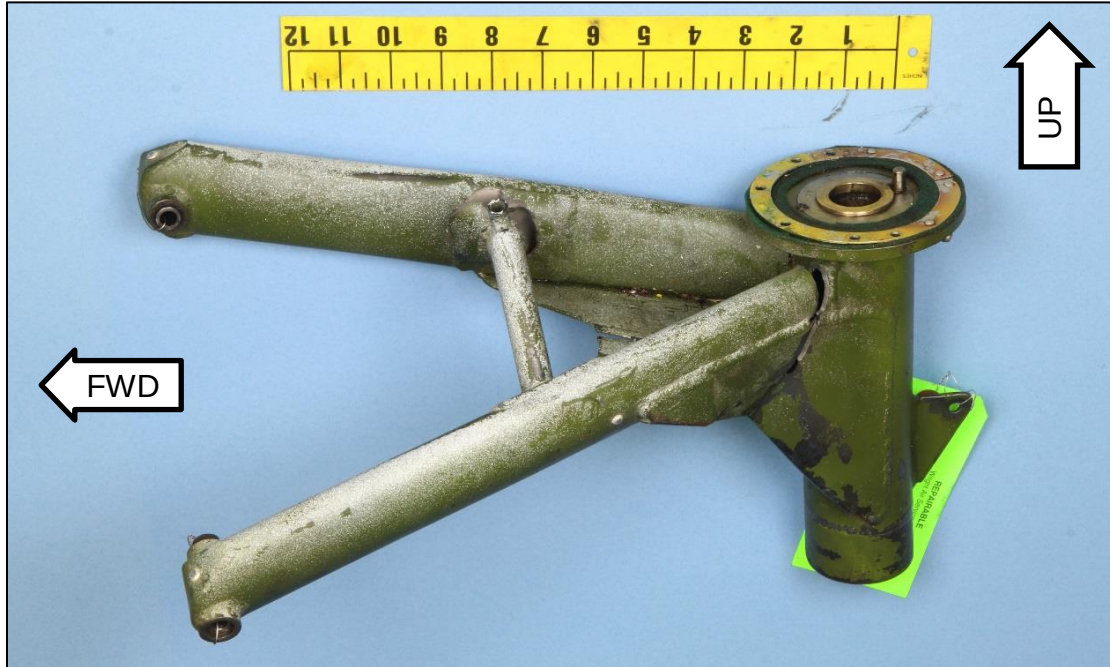
Figure 1. Overall view of the fractured tail wheel frame.

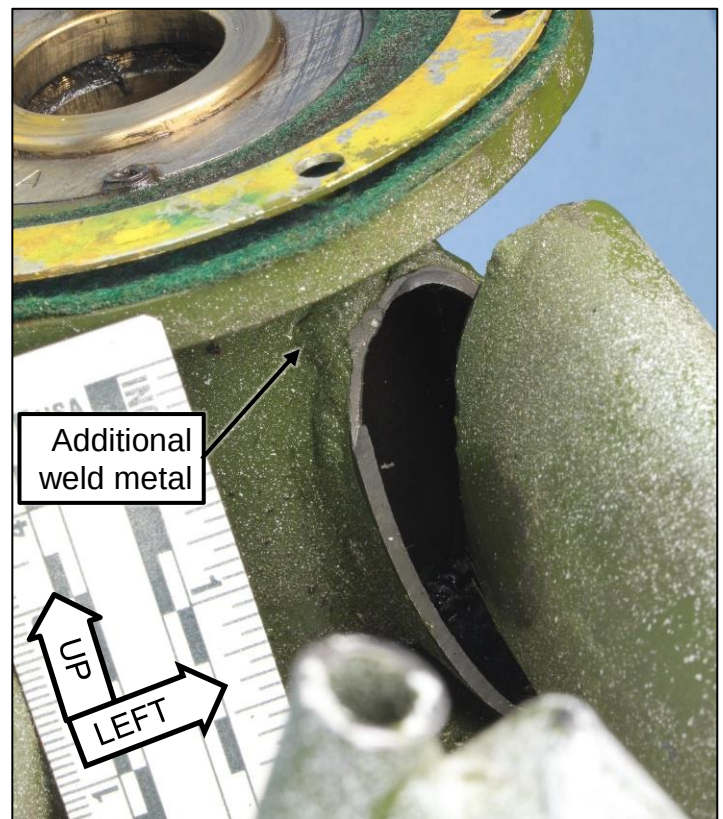
Figure 2. Close view of the fracture in the left arm adjacent to the welded joint with the downtube.

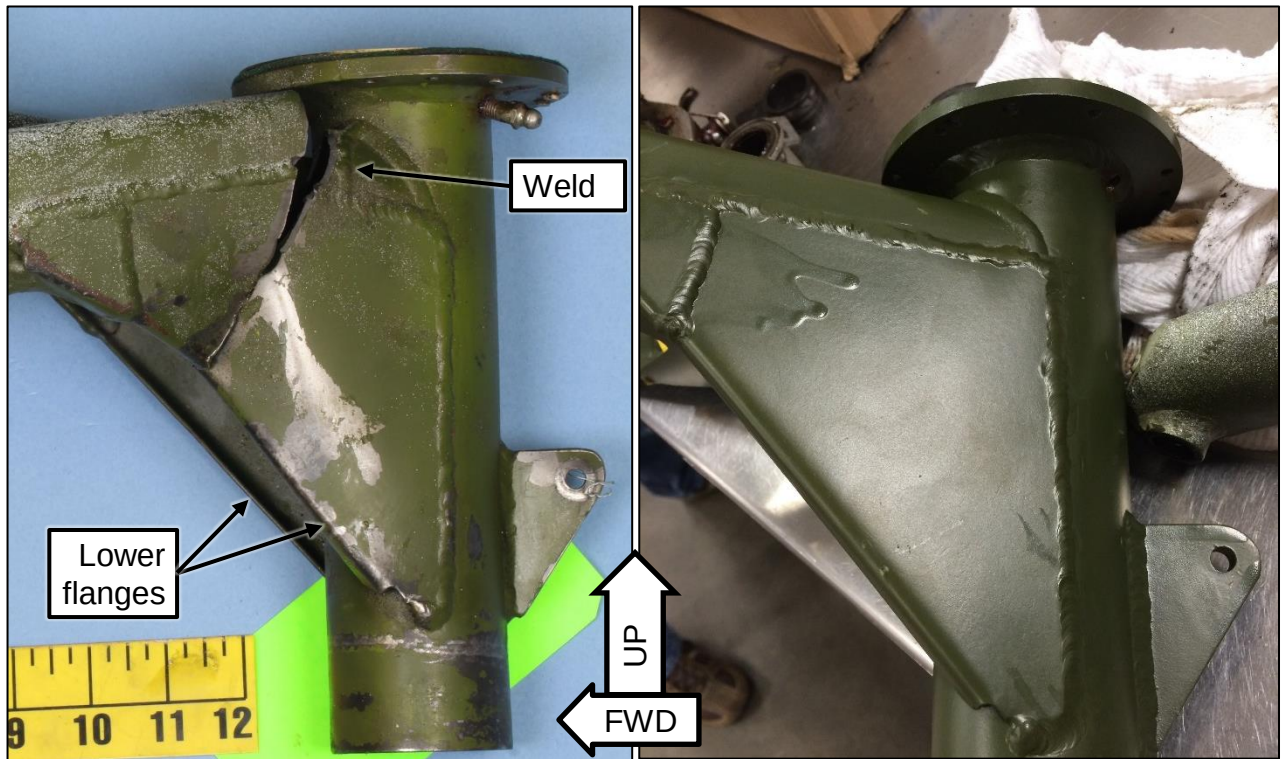
Figure 4. Views of the incident tail wheel frame (left image) and an exemplar frame (right image). The weld indicated on the incident frame was present only on the left side of the left arm of the incident frame.

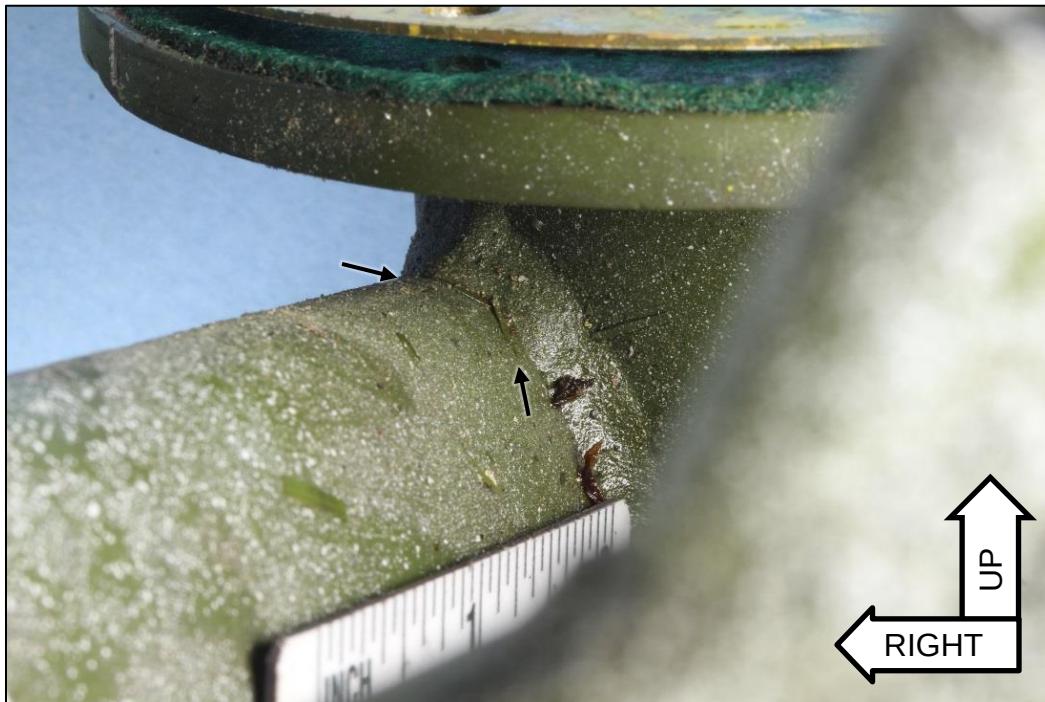
Figure 3. Upper side of the right arm showing a crack indication at the toe of the weld between the unlabeled arrows.

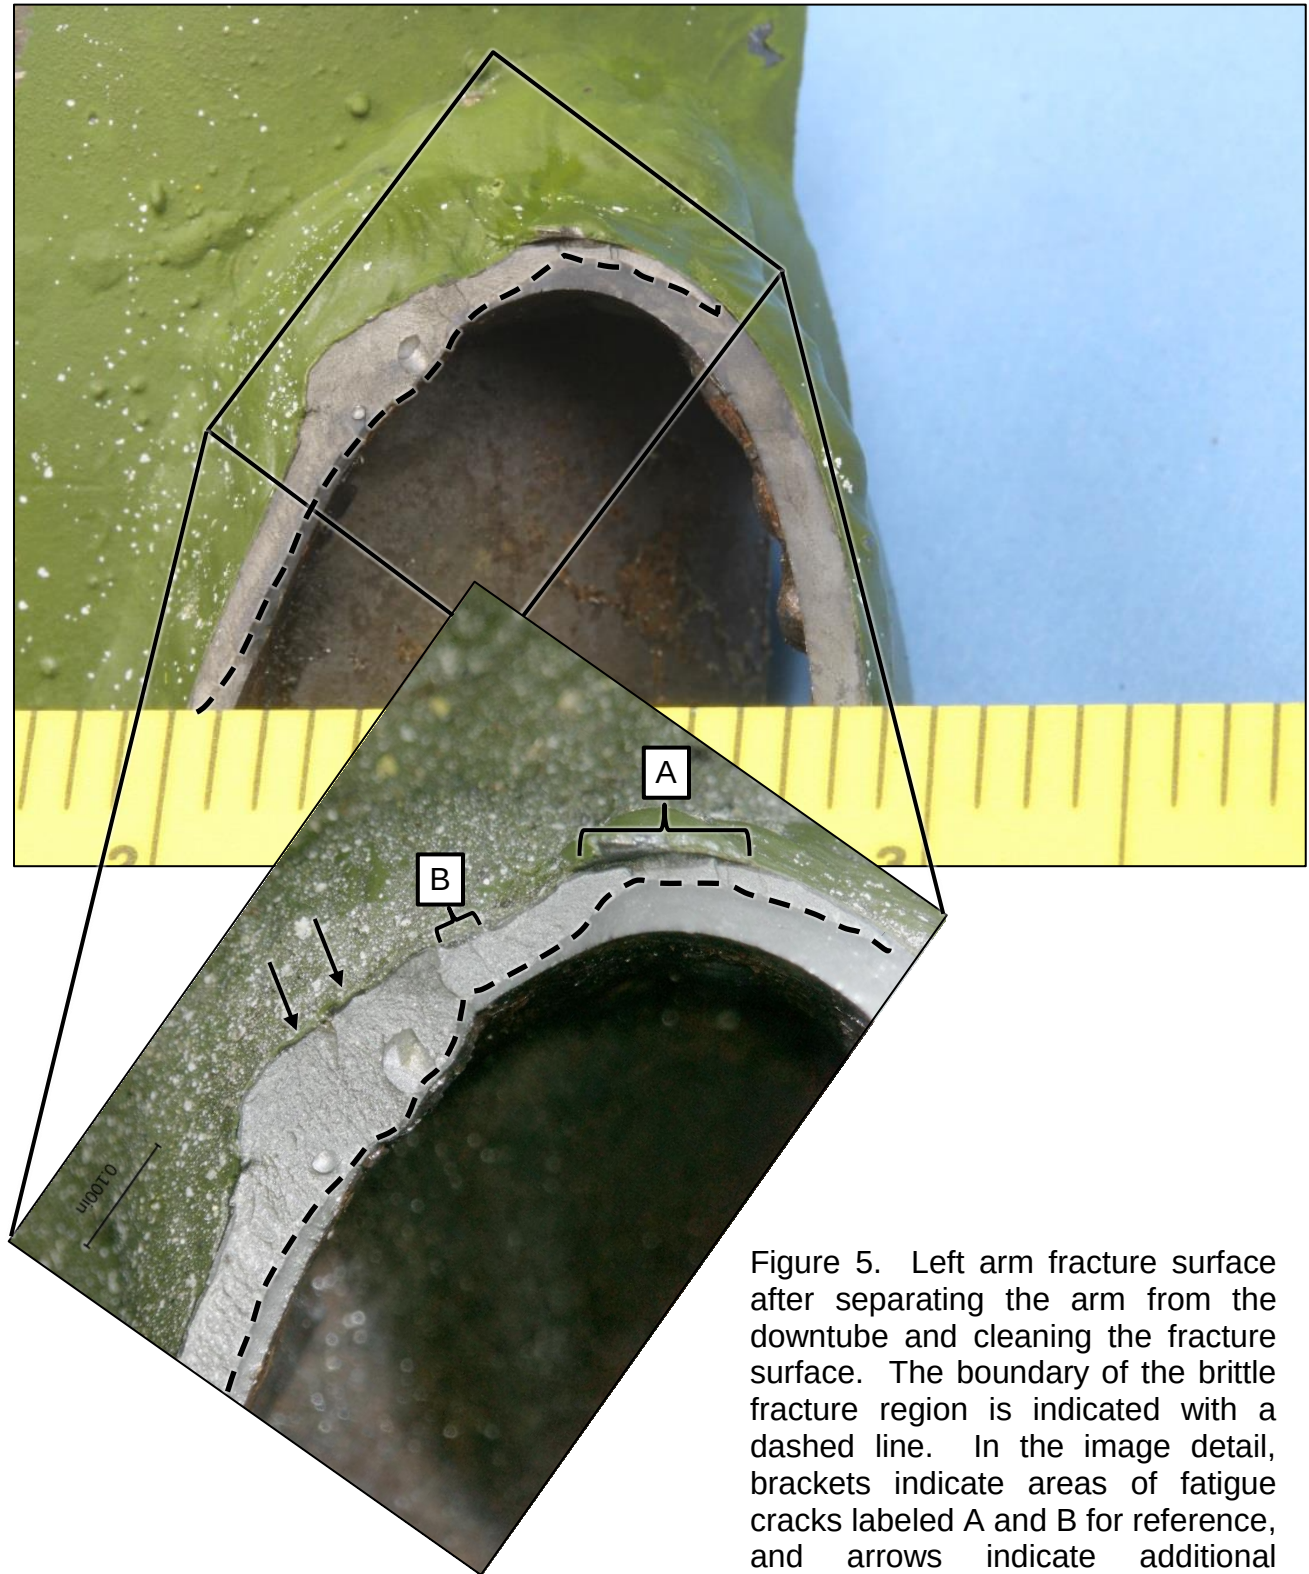
Figure 5. Left arm fracture surface after separating the arm from the downtube and cleaning the fracture surface. The boundary of the brittle fracture region is indicated with a dashed line. In the image detail, brackets indicate areas of fatigue cracks labeled A and B for reference, and arrows indicate additional fracture initiation areas.

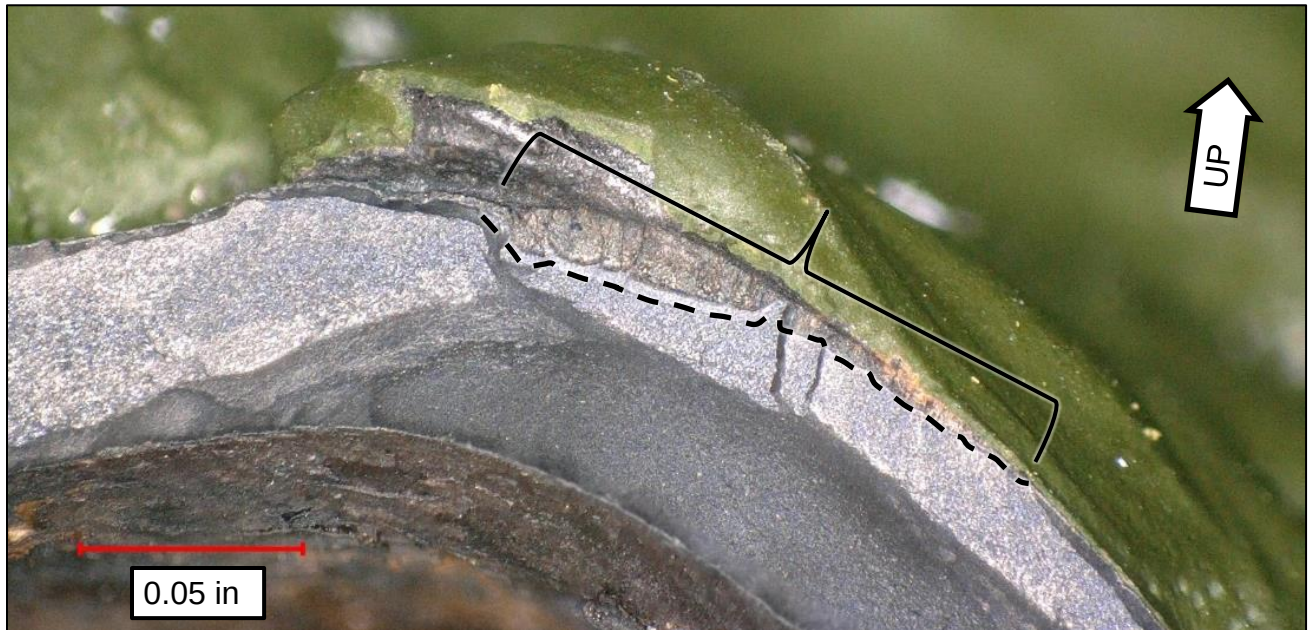
Figure 6. Closer view of fatigue region A on the left arm fracture (see figure 5). A bracket indicates the extent of the fatigue region, and a dashed line indicates the fatigue boundary.

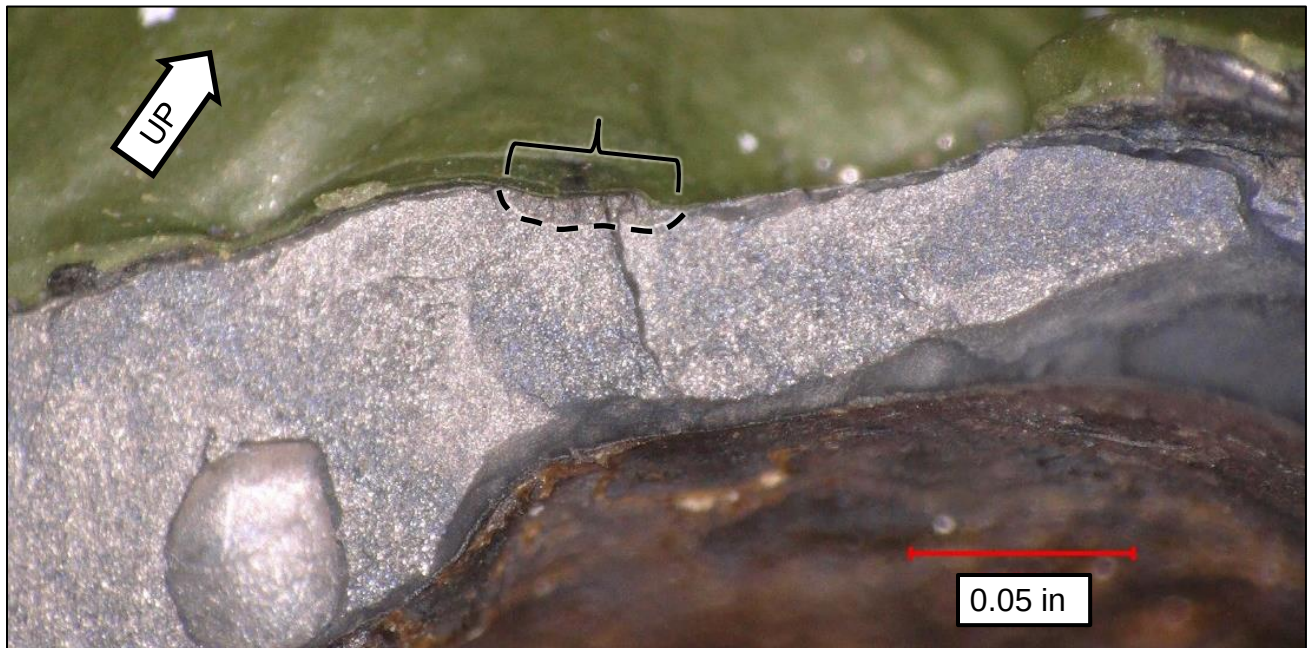
Figure 7. Closer view of fatigue region B on the left arm fracture (see figure 5). A bracket indicates the extent of the fatigue region, and a dashed line indicates the fatigue boundary.

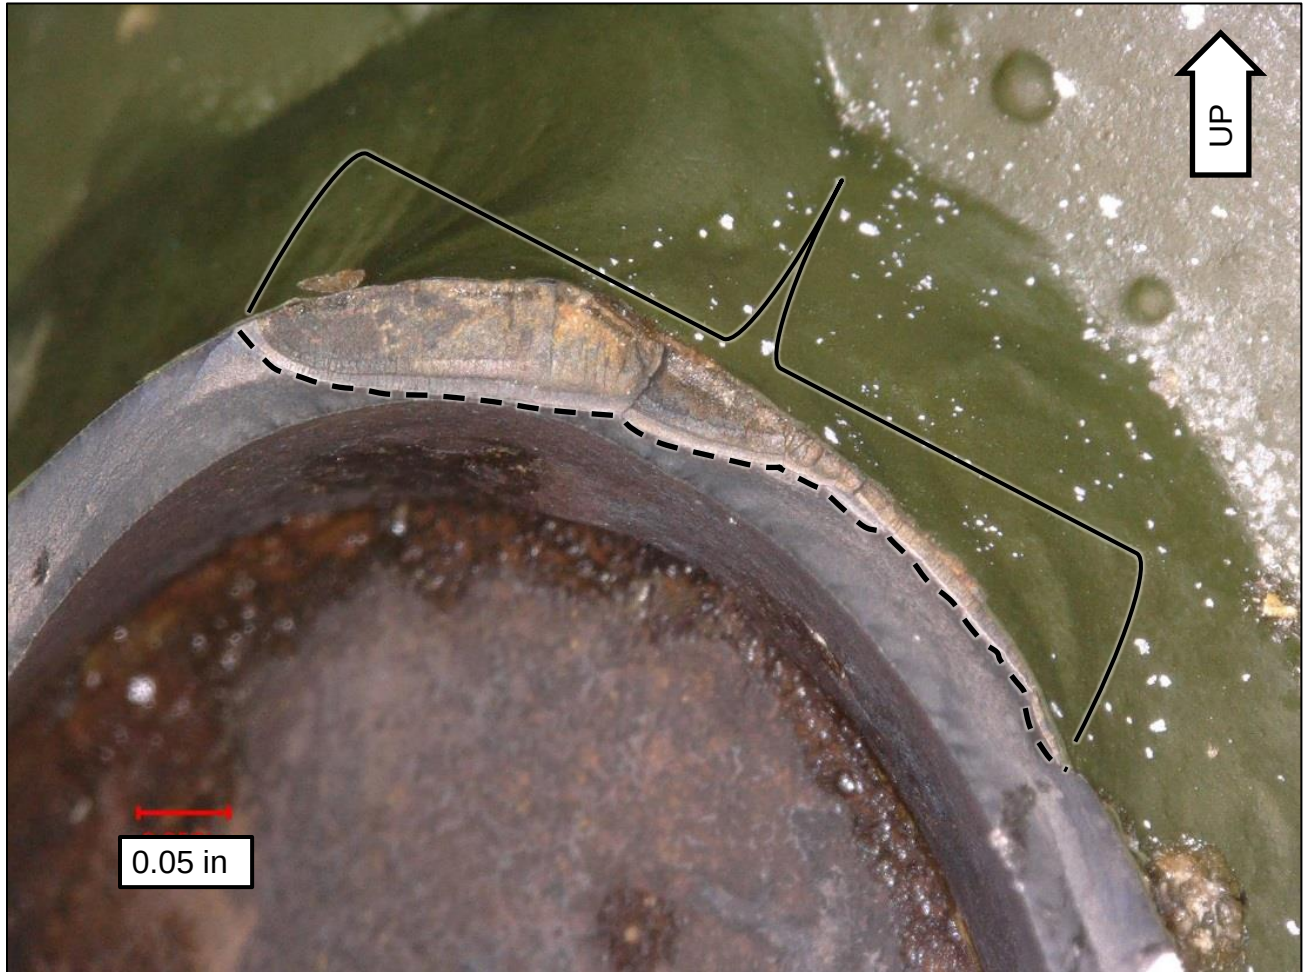
Figure 8. Close view of the fracture surface after the crack in the right arm was opened in the laboratory. A bracket indicates the extent of the fatigue crack, and a dashed line indicates the fatigue boundary.

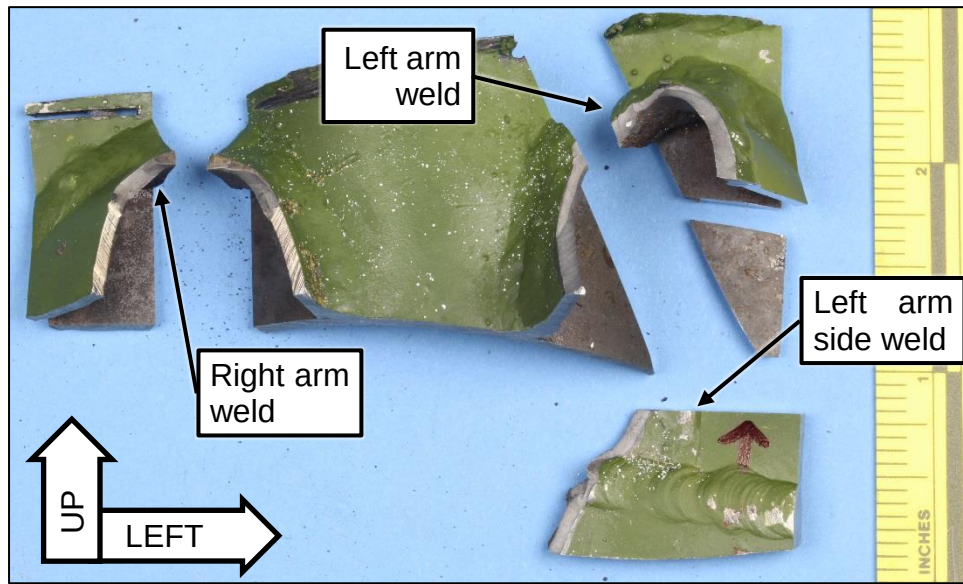
Figure 9. Downtube and arm pieces after sectioning for metallographic examination. Labels indicate surfaces that were mounted and examined in cross-sections through three welds.

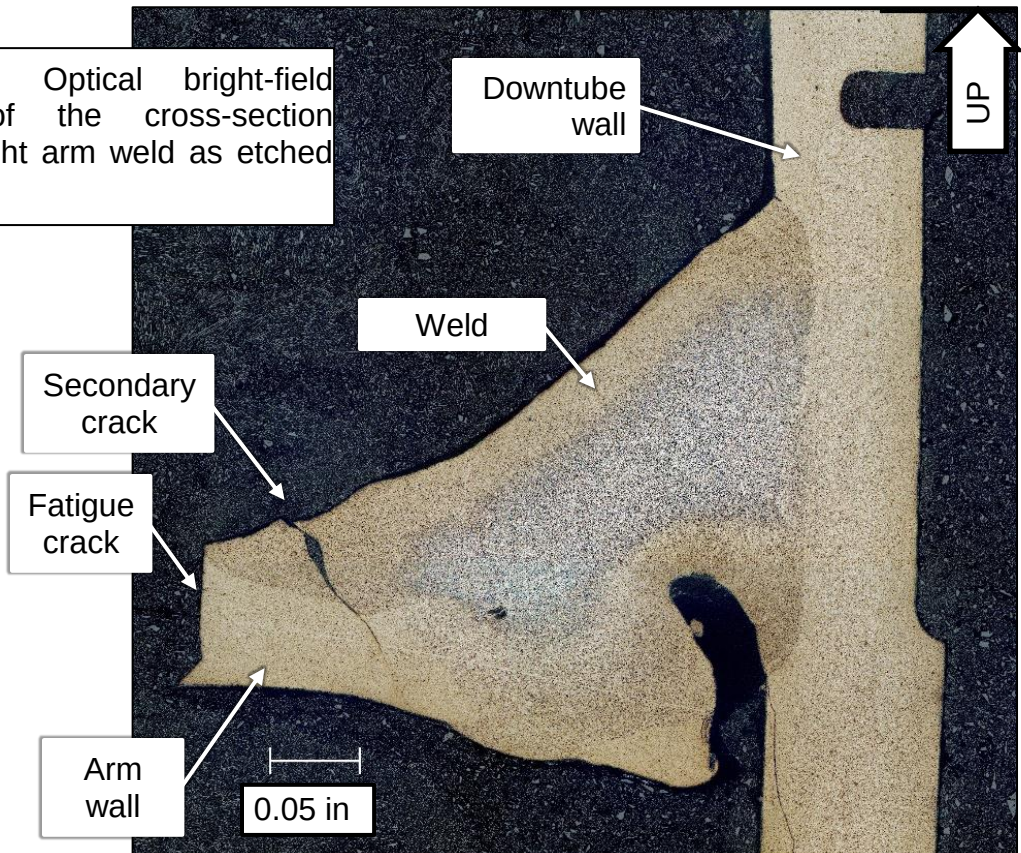
Figure 10. Optical bright-field micrograph of the cross-section through the right arm weld as etched with 4% nital.

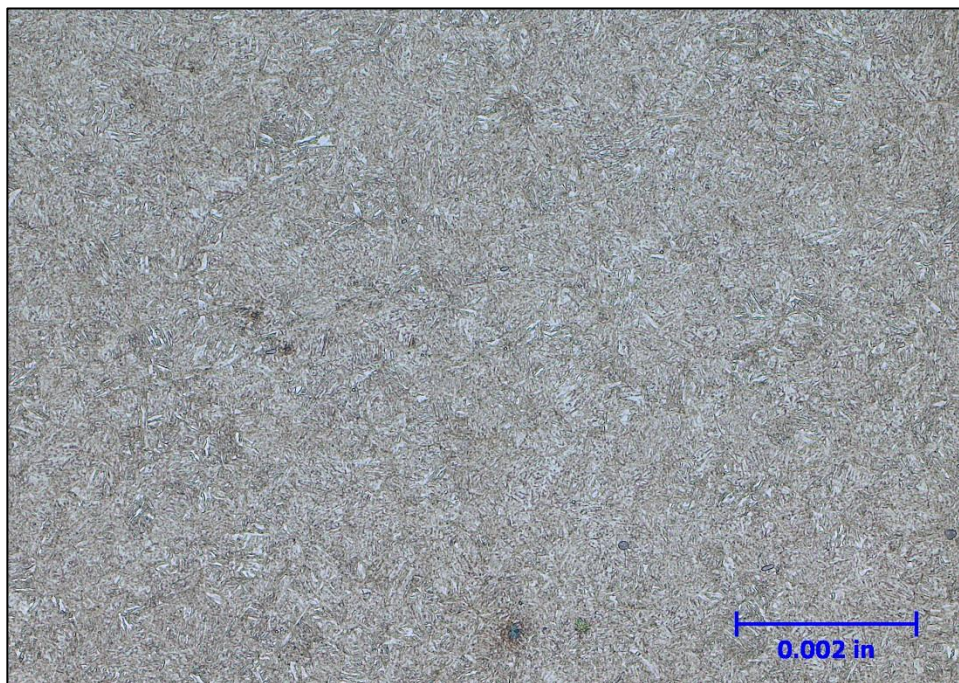
Figure 11. Optical bright-field micrograph of typical arm wall microstructure consistent with tempered martensite (4% nital etch).

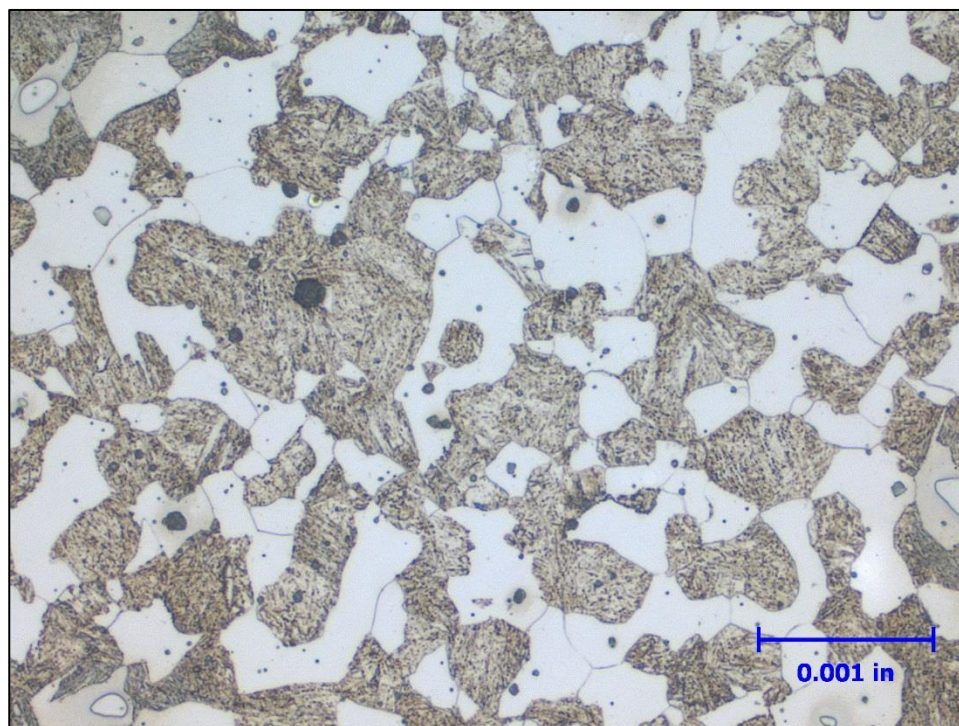
Figure 12. Optical bright-field micrograph of typical microstructure in the core portion of the weld showing a mix of ferrite (white) and bainite (brown) etched with 4% nital.

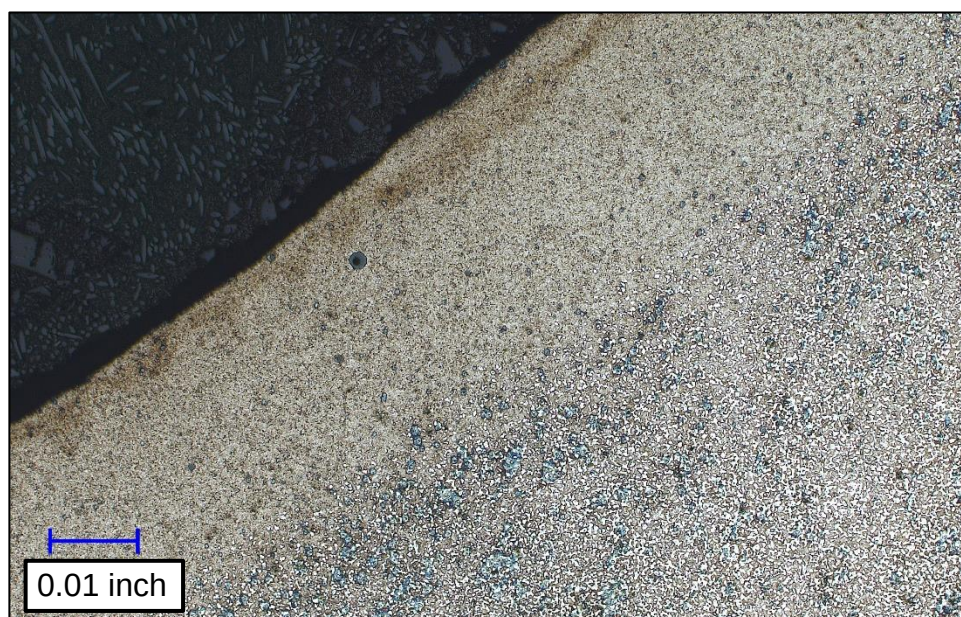
Figure 13. Optical bright-field micrograph of the surface of the right arm weld showing the transition from the surface microstructure to the core microstructure (4% nital etch).

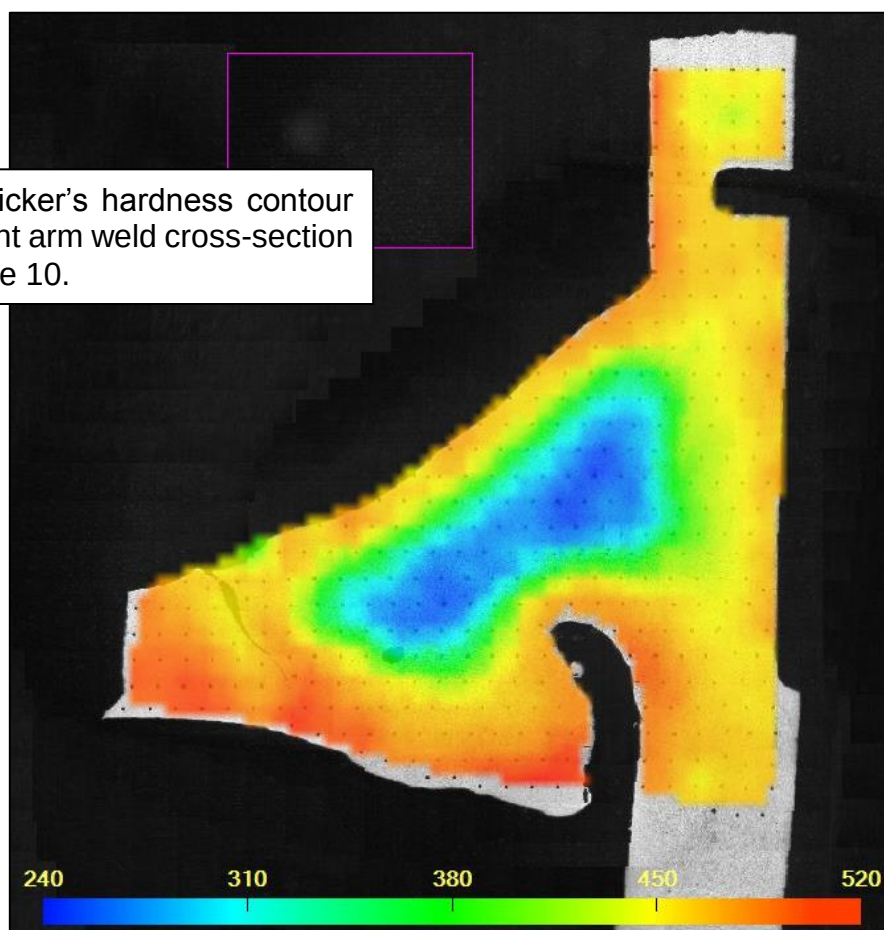
Figure 14. Vicker's hardness contour map of the right arm weld cross-section shown in figure 10.

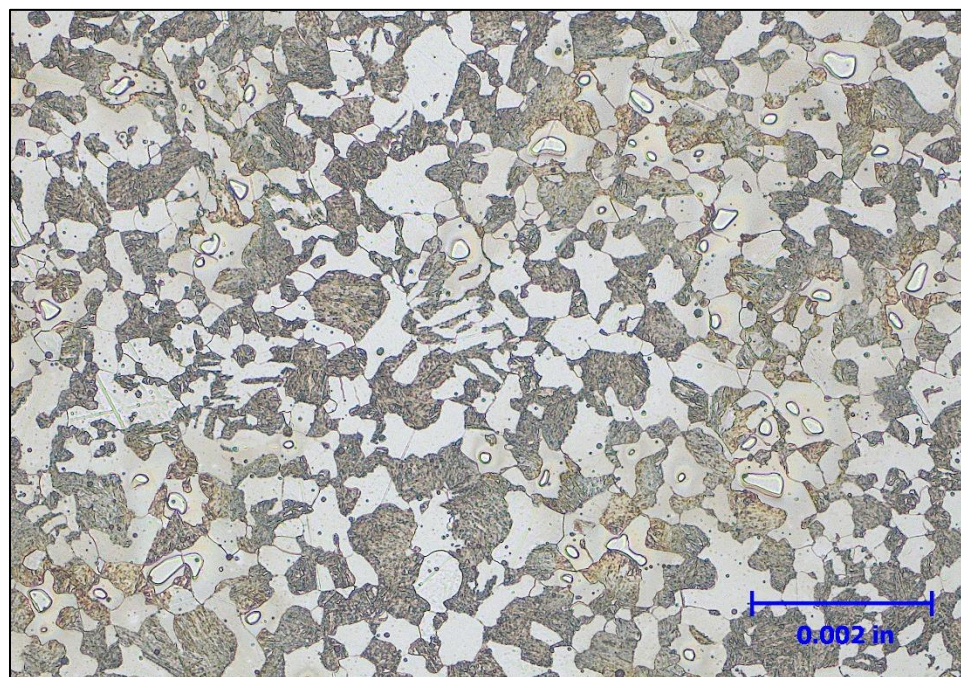
Figure 16. Optical bright-field micrograph of typical microstructure at the core of the left arm weld showing a mix of ferrite (white) and bainite (brown) as etched with 4% nital.

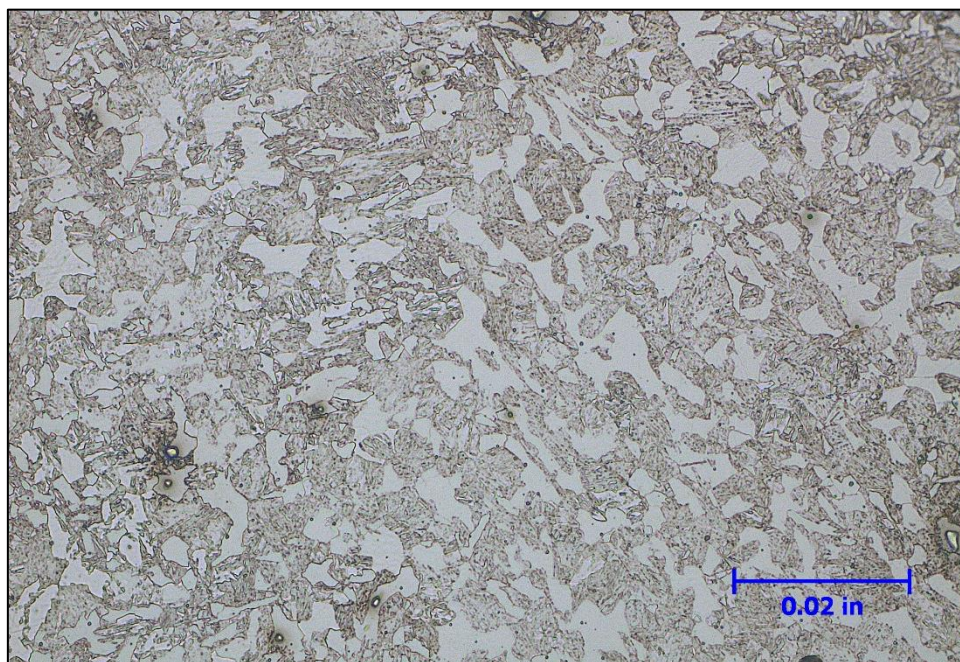
Figure 17. Optical bright-field micrograph of typical microstructure at the core of the second weld showing a mix of ferrite (white) and bainite (brown) as etched with 4% nital.

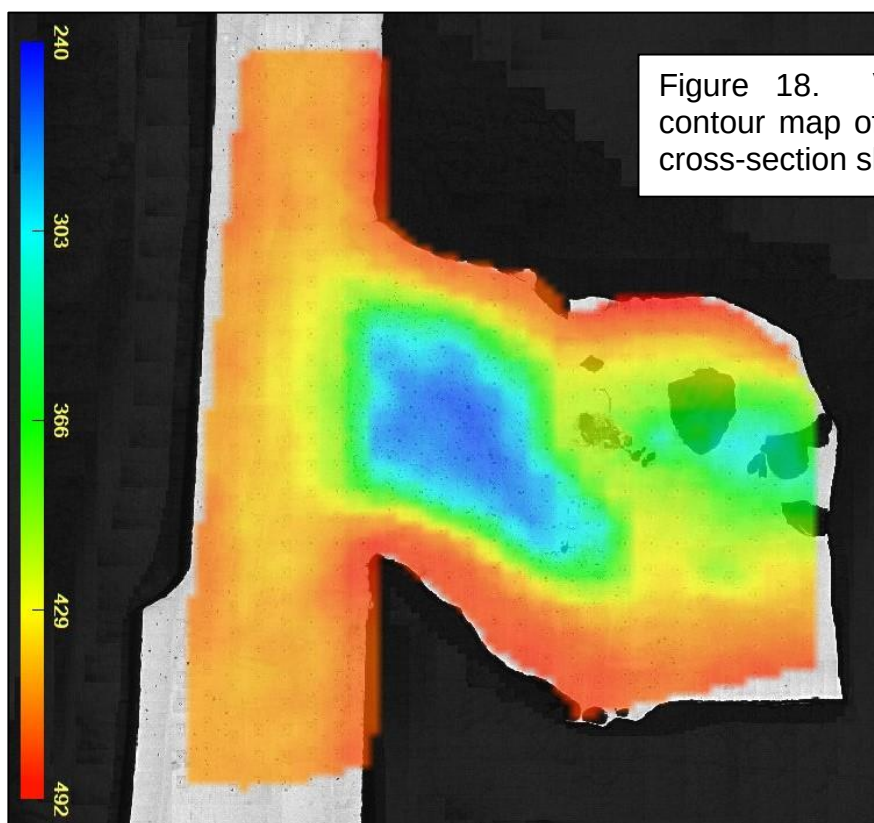
Figure 18. Vicker's hardness contour map of the left arm weld cross-section shown in figure 15.

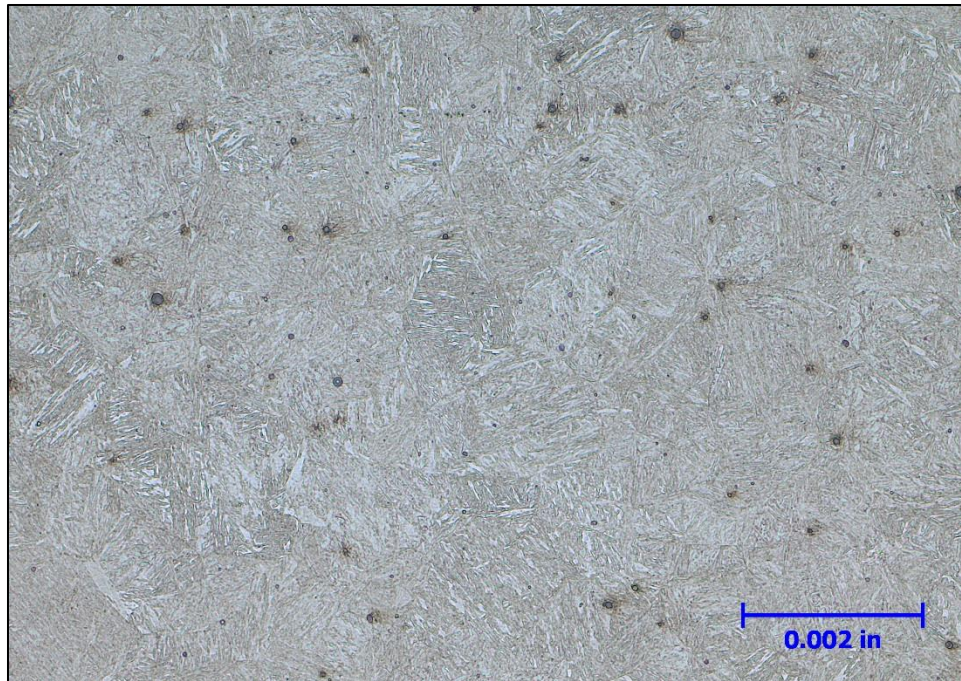
Figure 19. Optical bright-field micrograph of typical microstructure at the middle of the left arm side weld (4% nital etch).

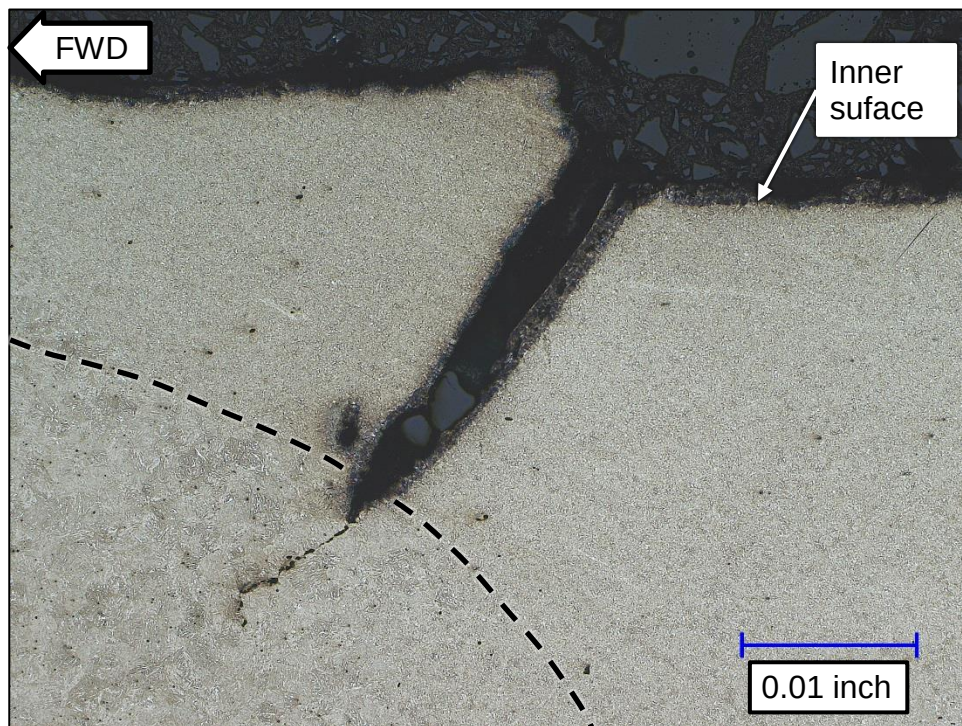
Figure 20. Optical bright-field micrograph of a crack emanating from the inner surface of the left arm near the root of the side weld (4% nital etch). A dashed line indicates the approximate boundary of the altered microstructure associated with the weld.

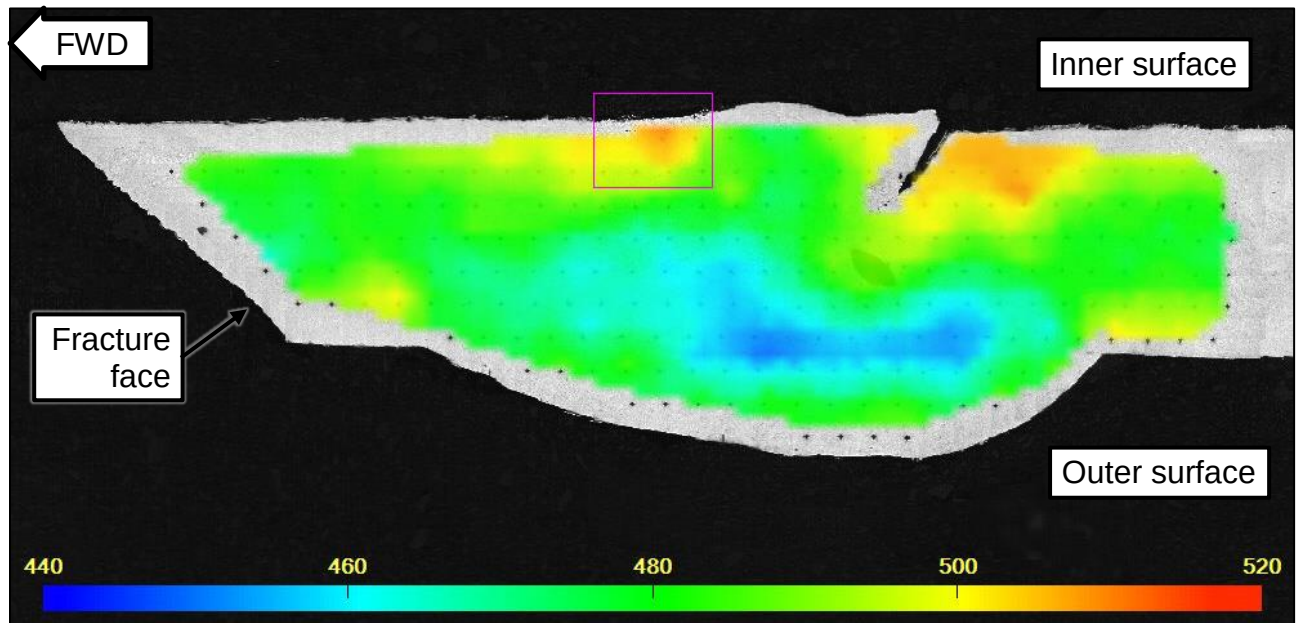
Figure 21. Vicker's hardness contour map of the left arm side weld cross-section. (Note the difference in scale relative to prior contour maps).
