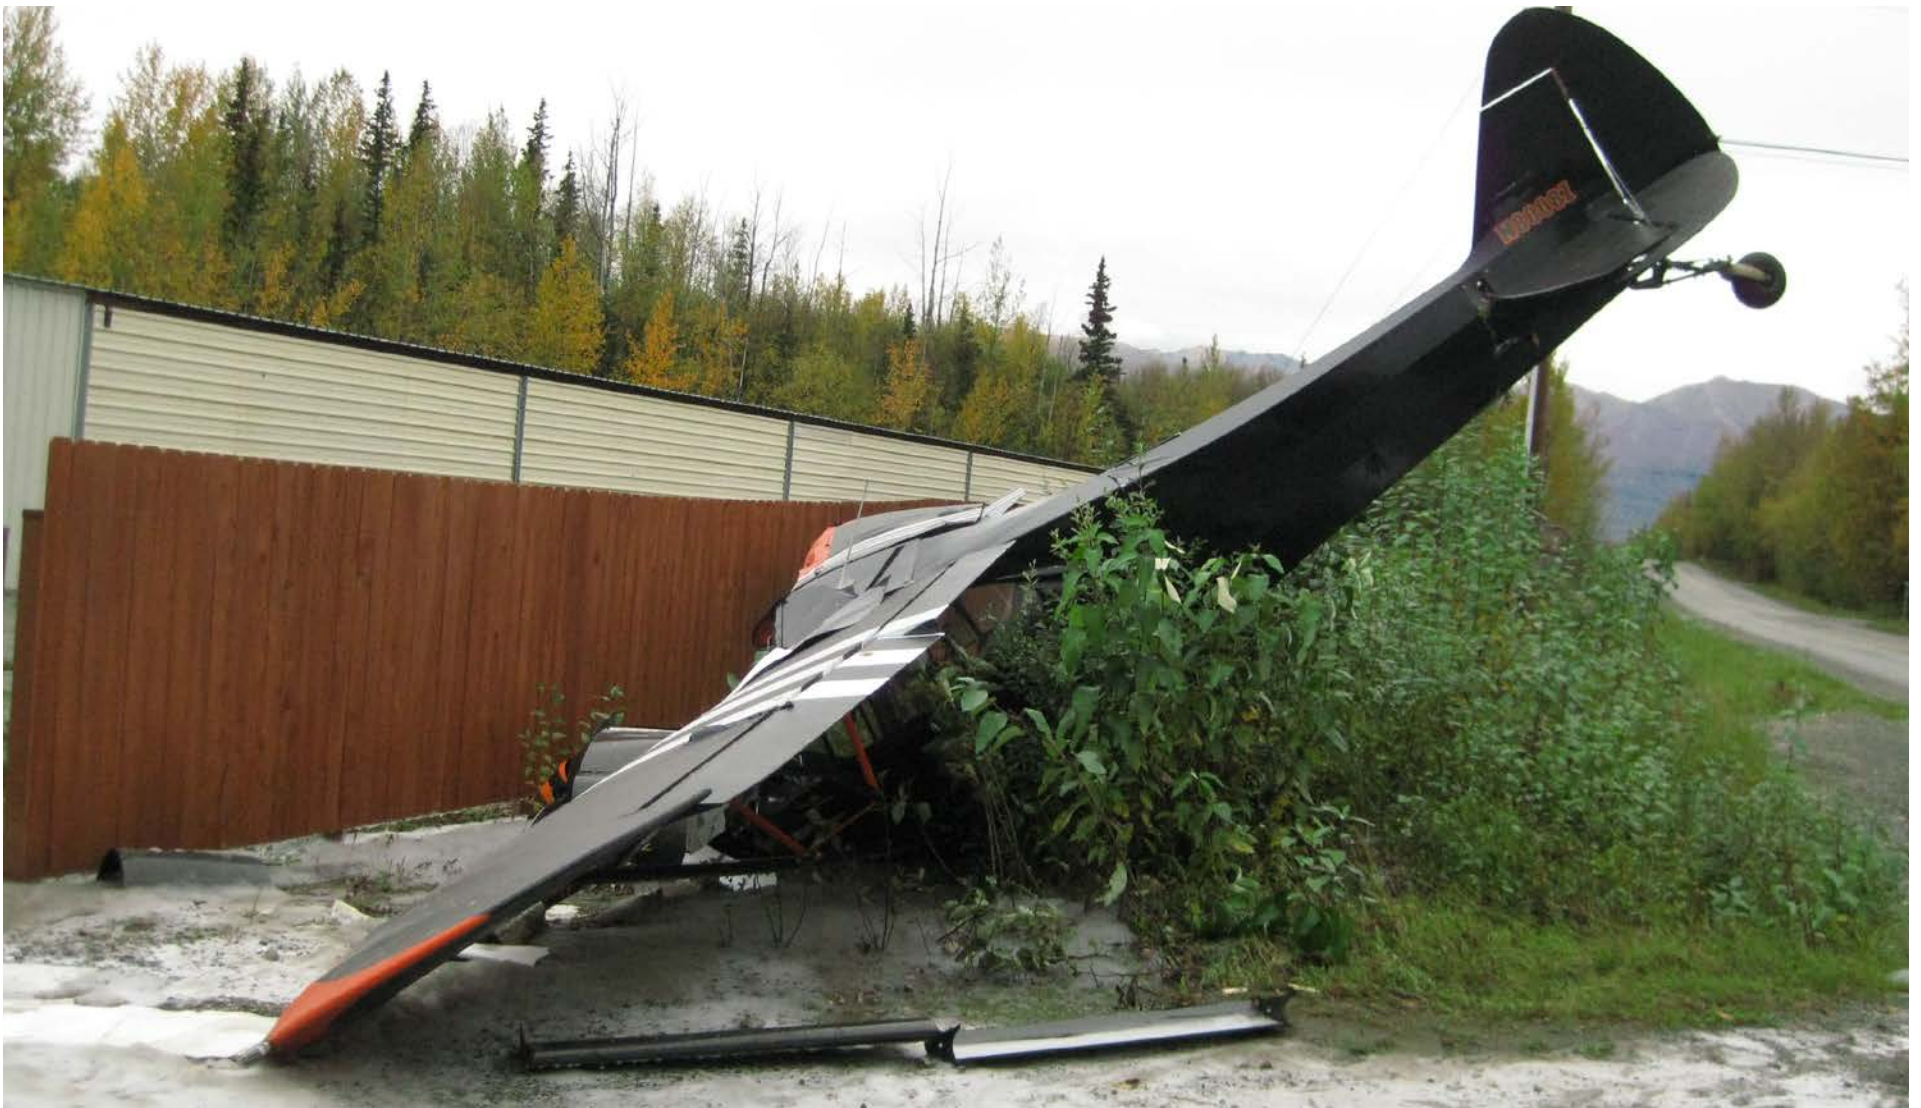
**Photo 1 – Accident airplane at accident site.**

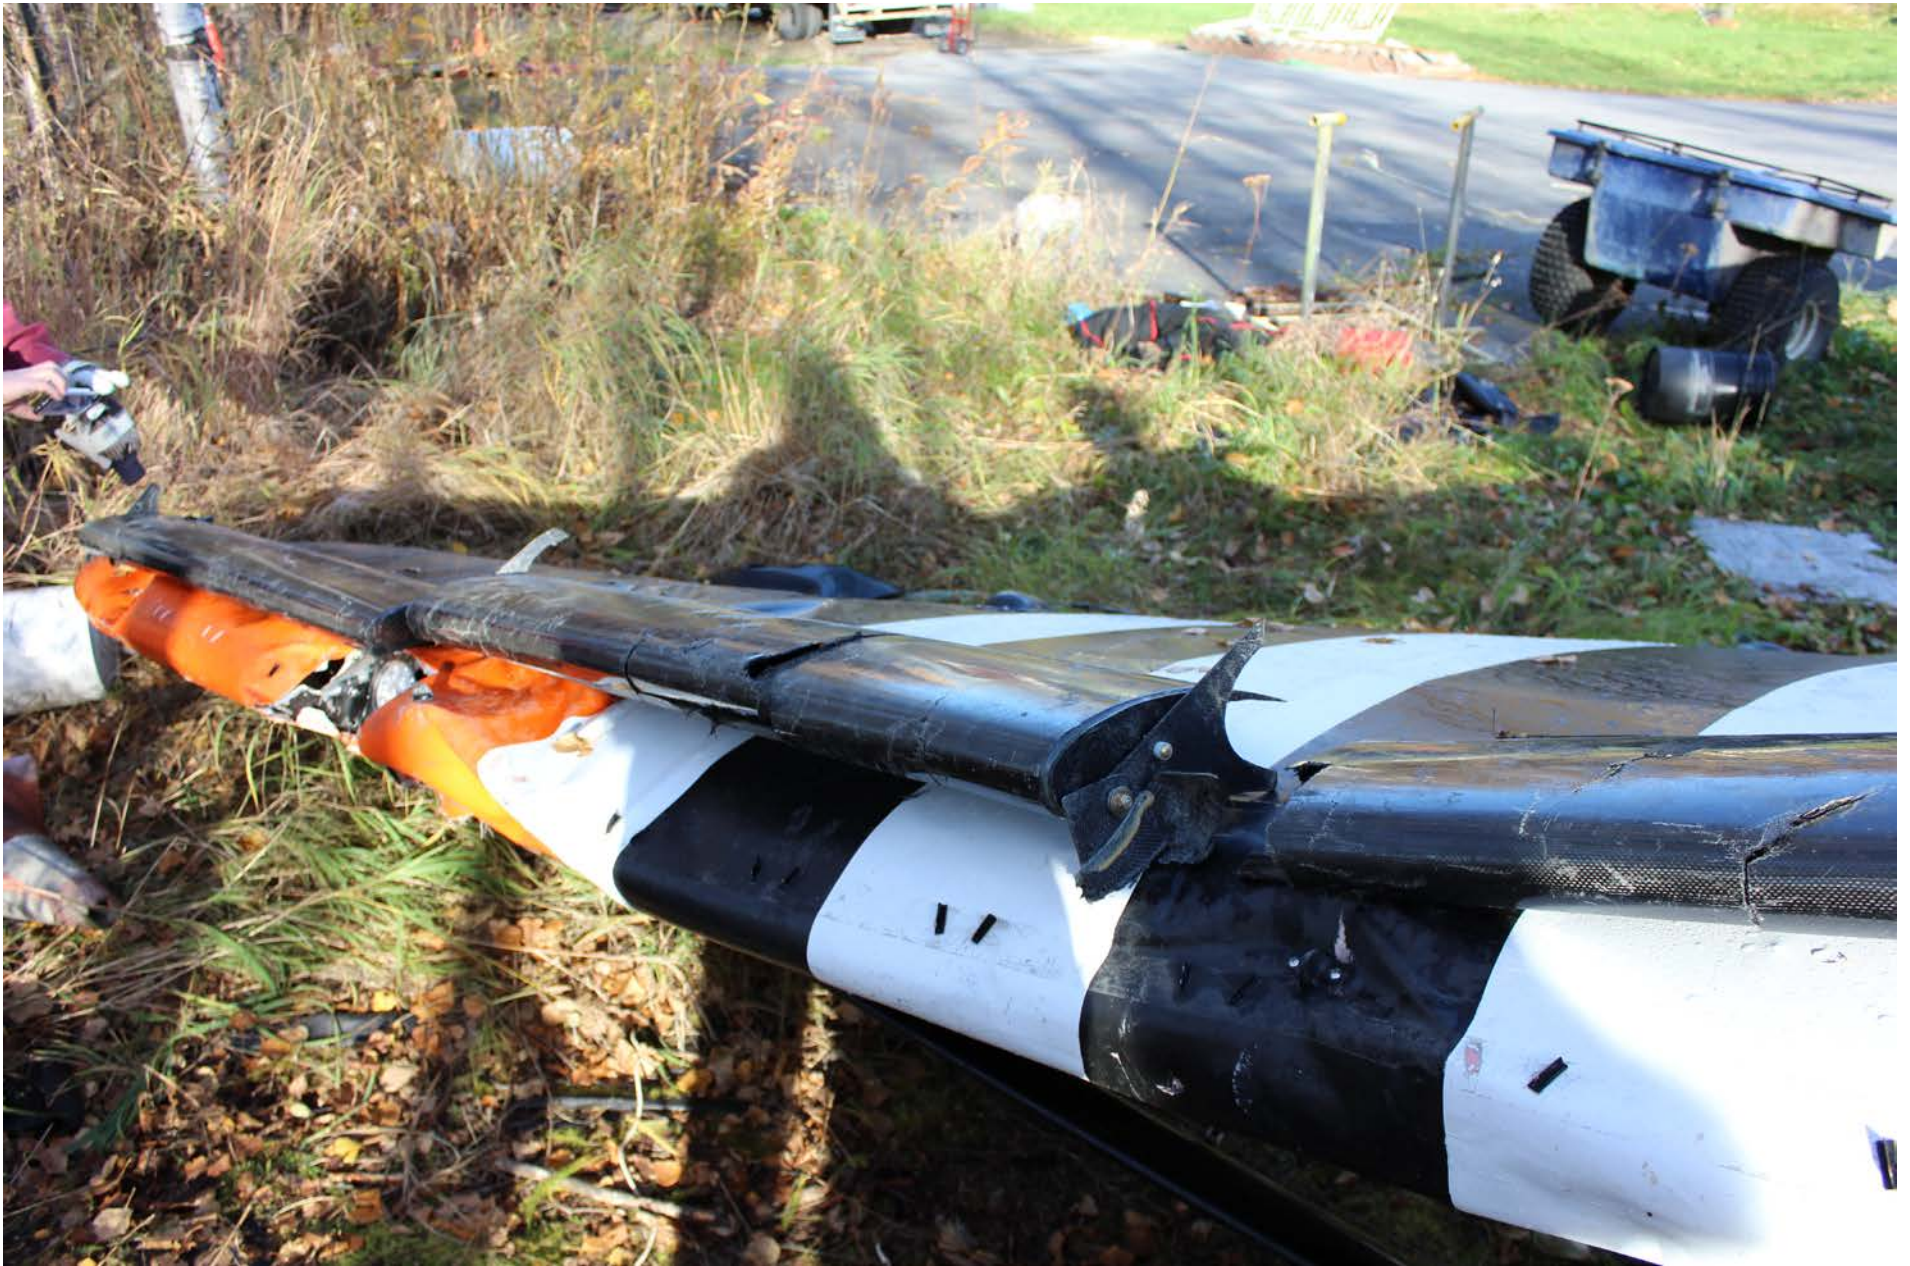
**Photo 2 – Right wing's leading-edge slats.**

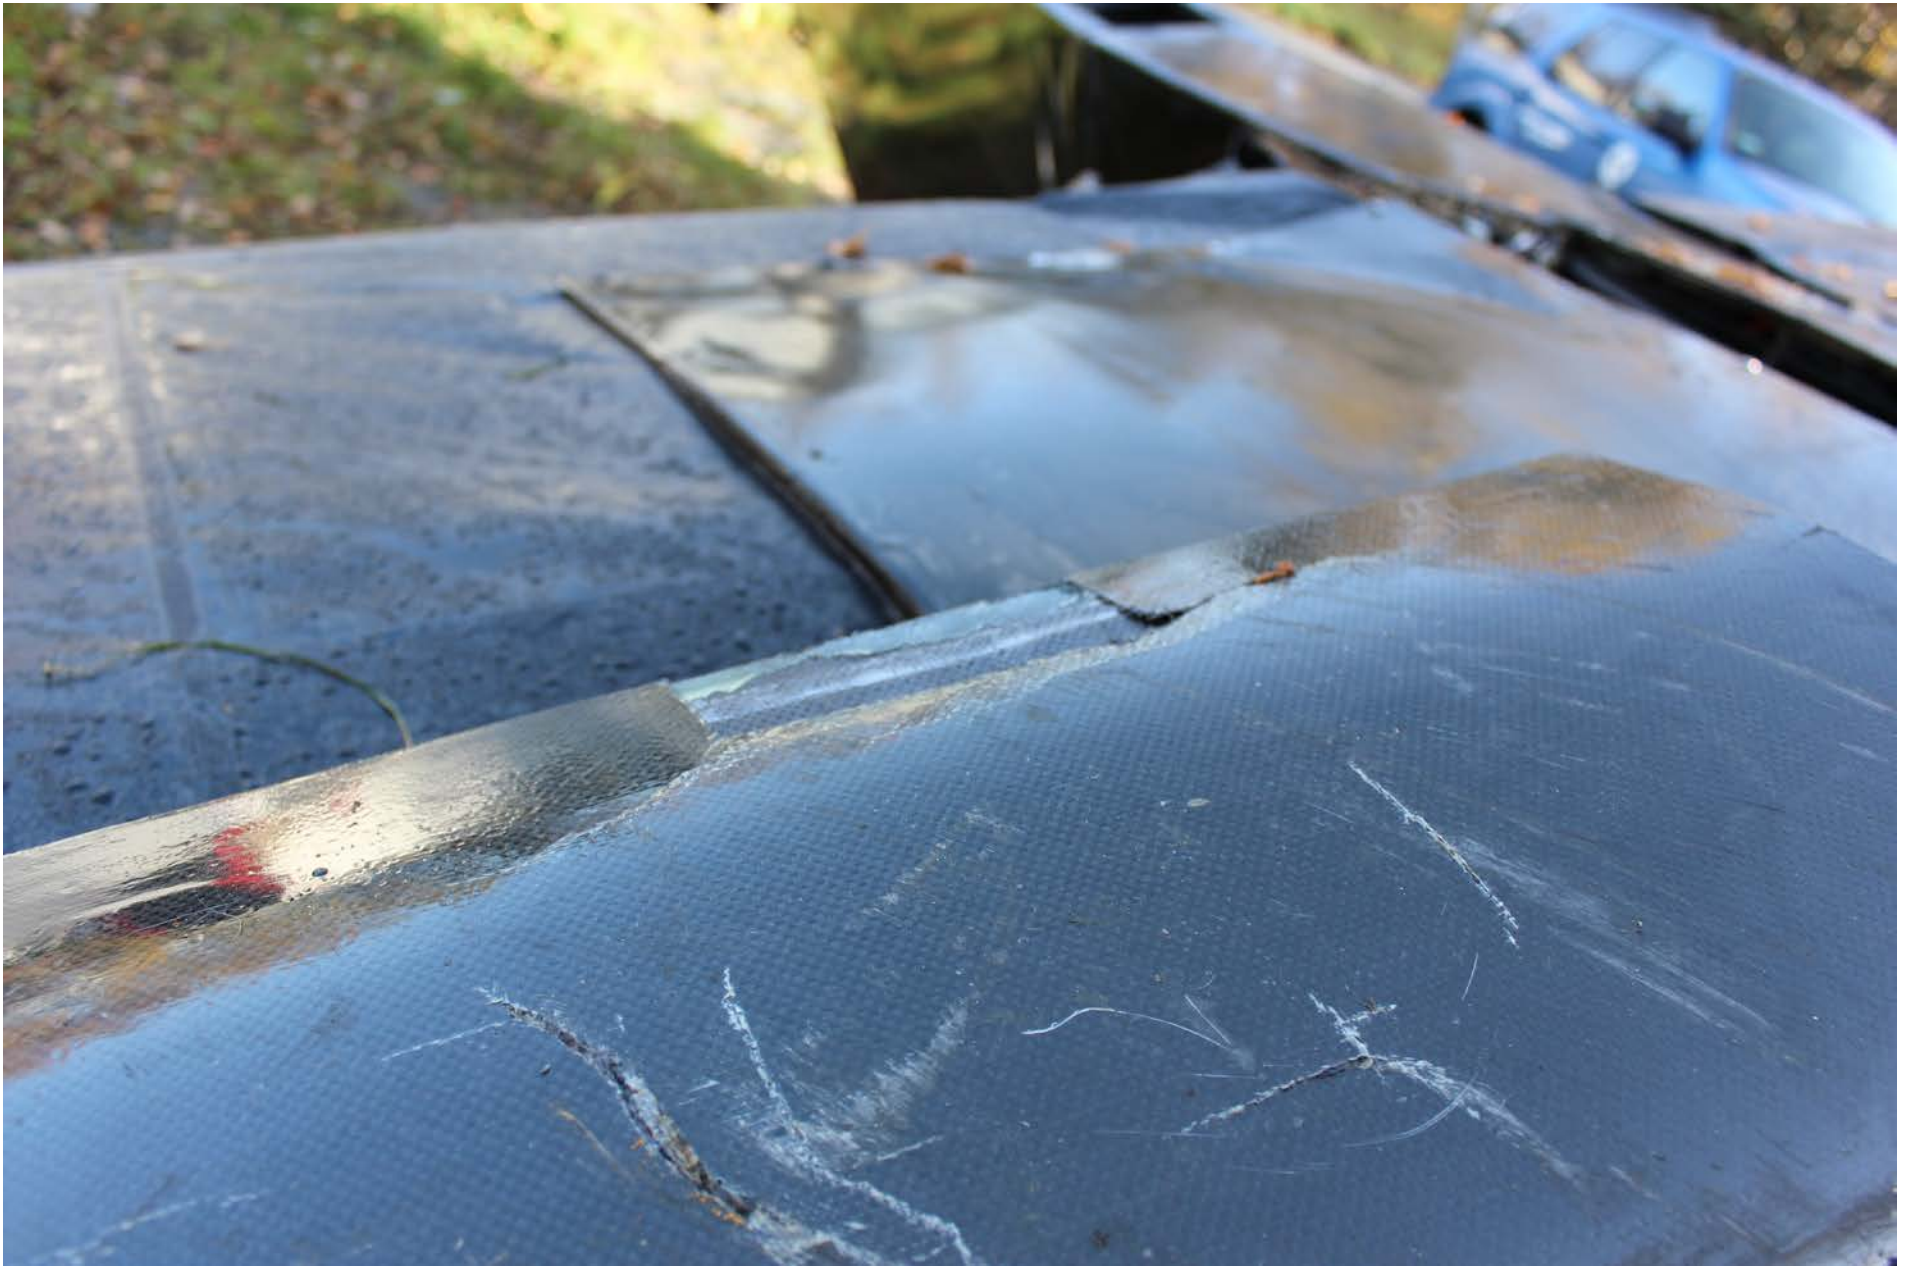
**Photo 3 – Right wing leading-edge slat trailing edge bond failure**

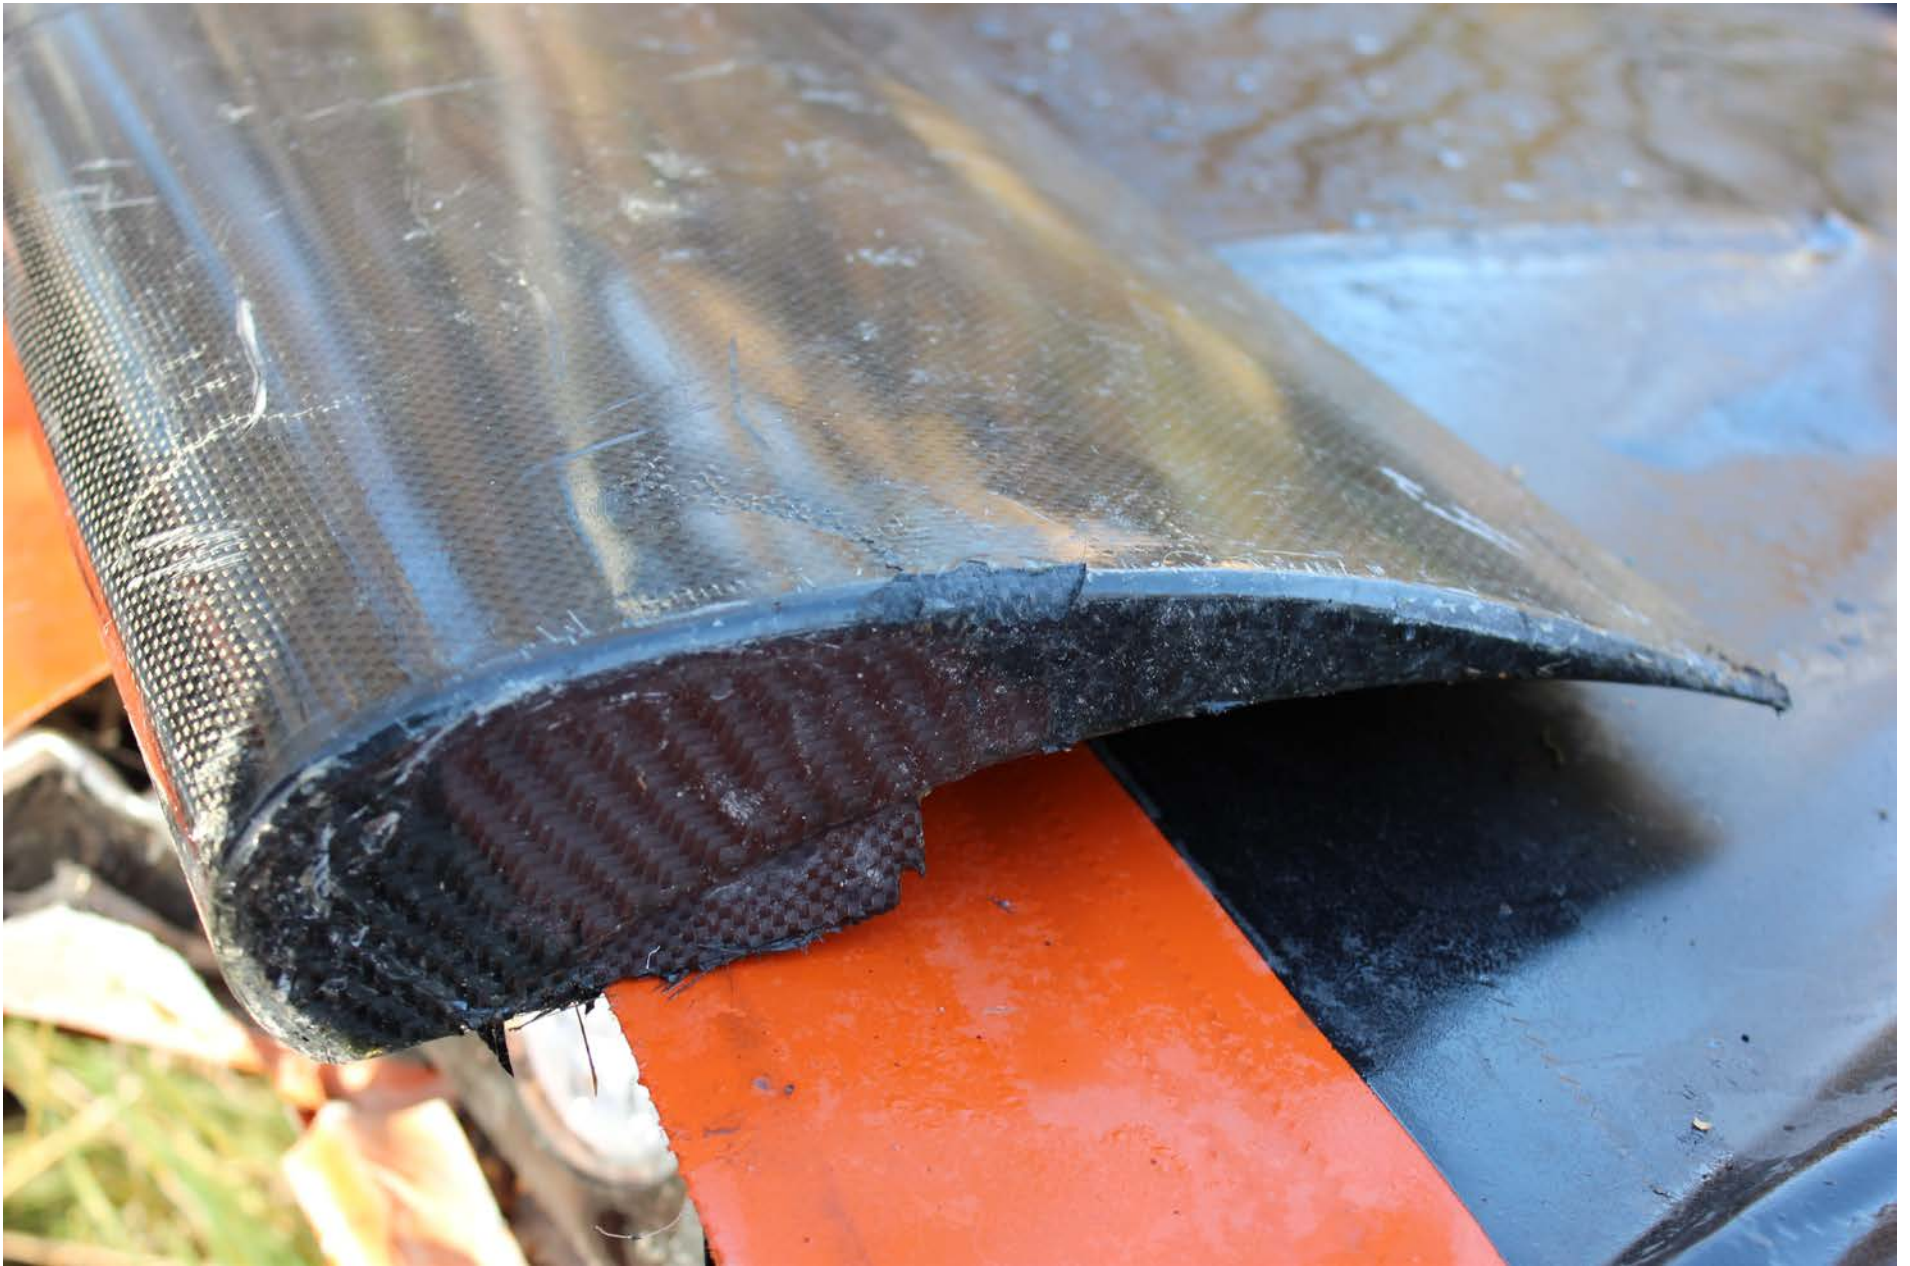
**Photo 4 – Right wing leading-edge slat ply bridging.**

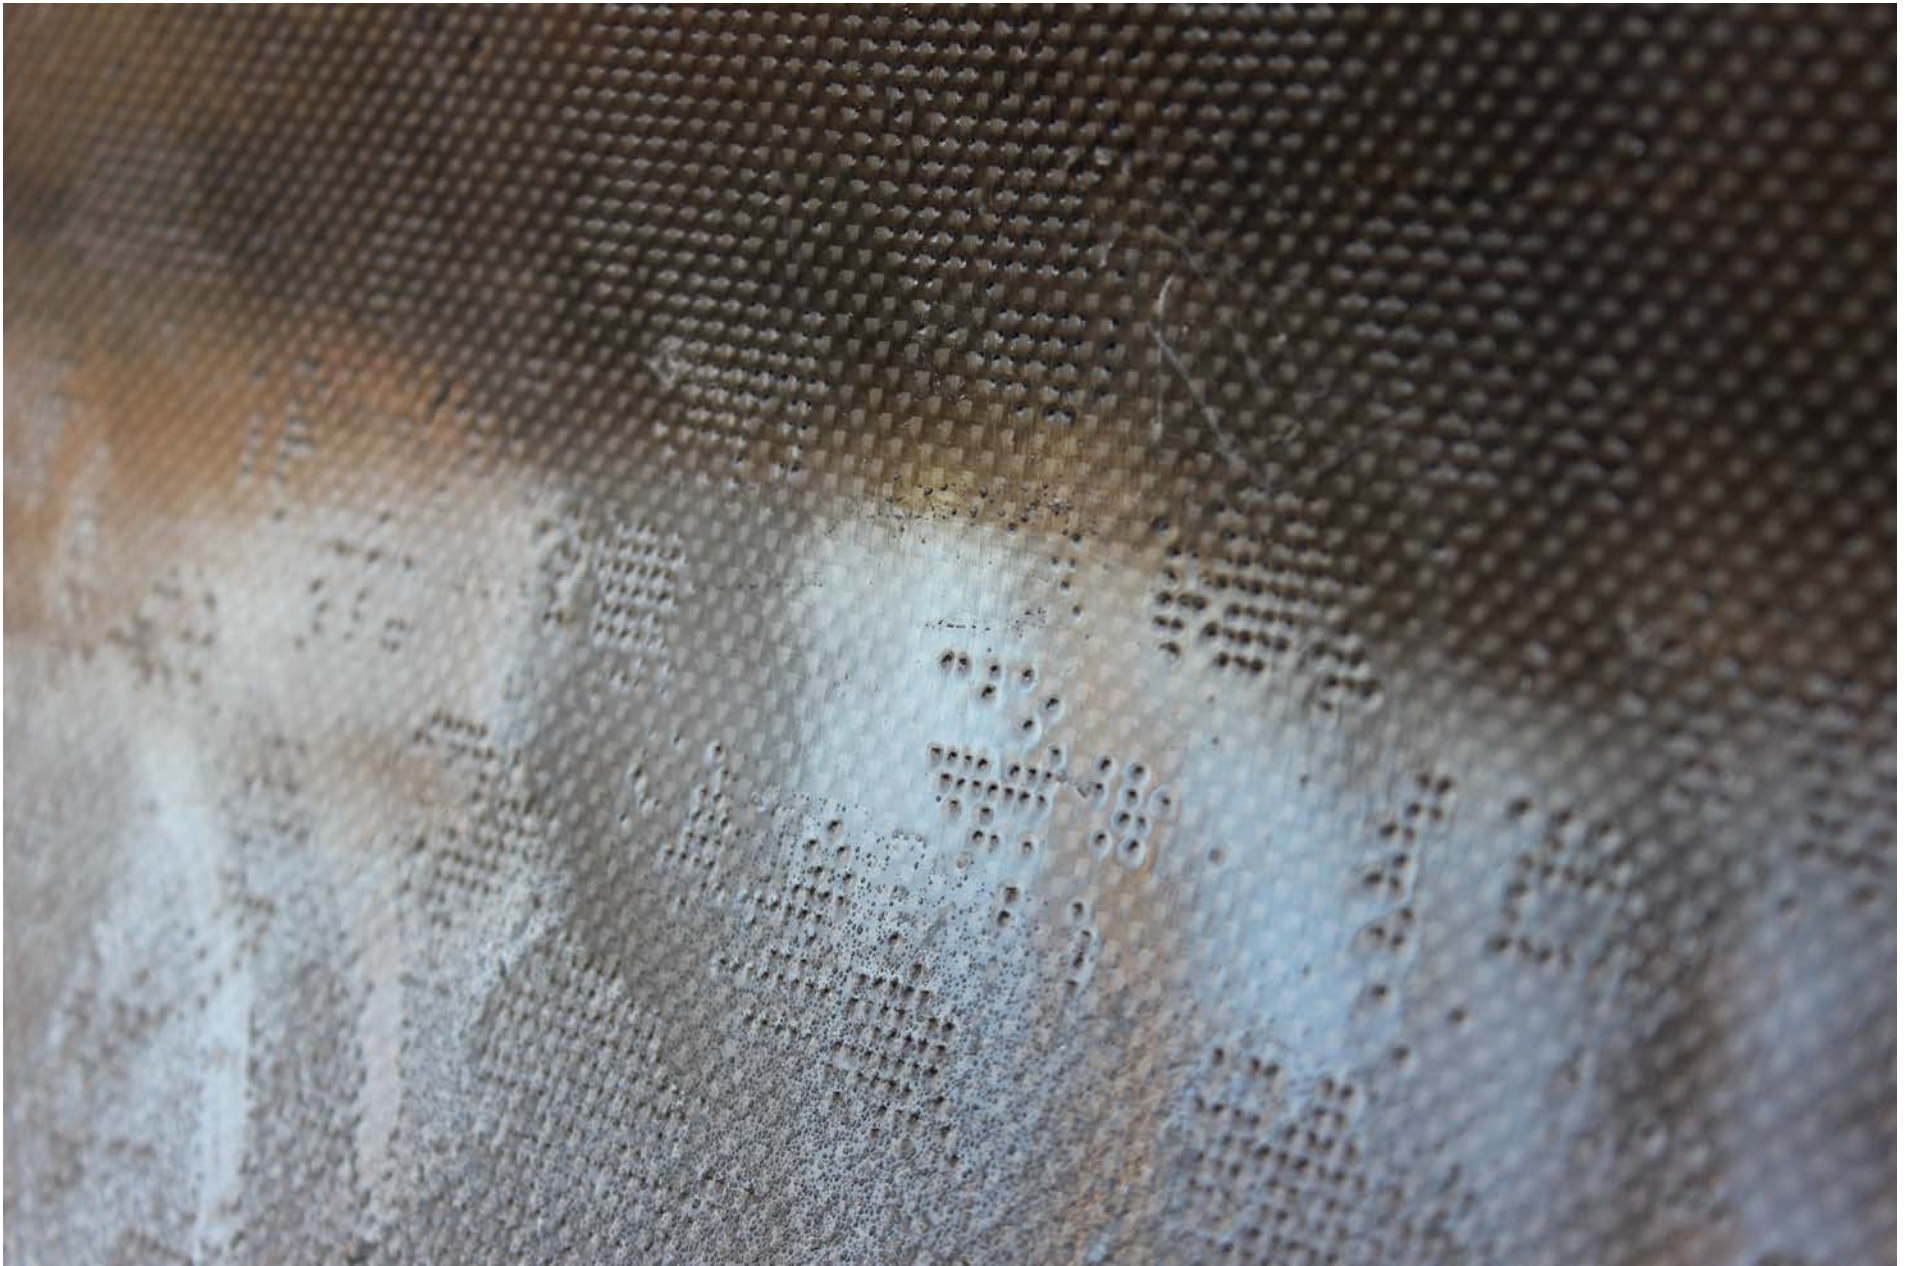
**Photo 5 – Left wing leading-edge slat resin starvation.**

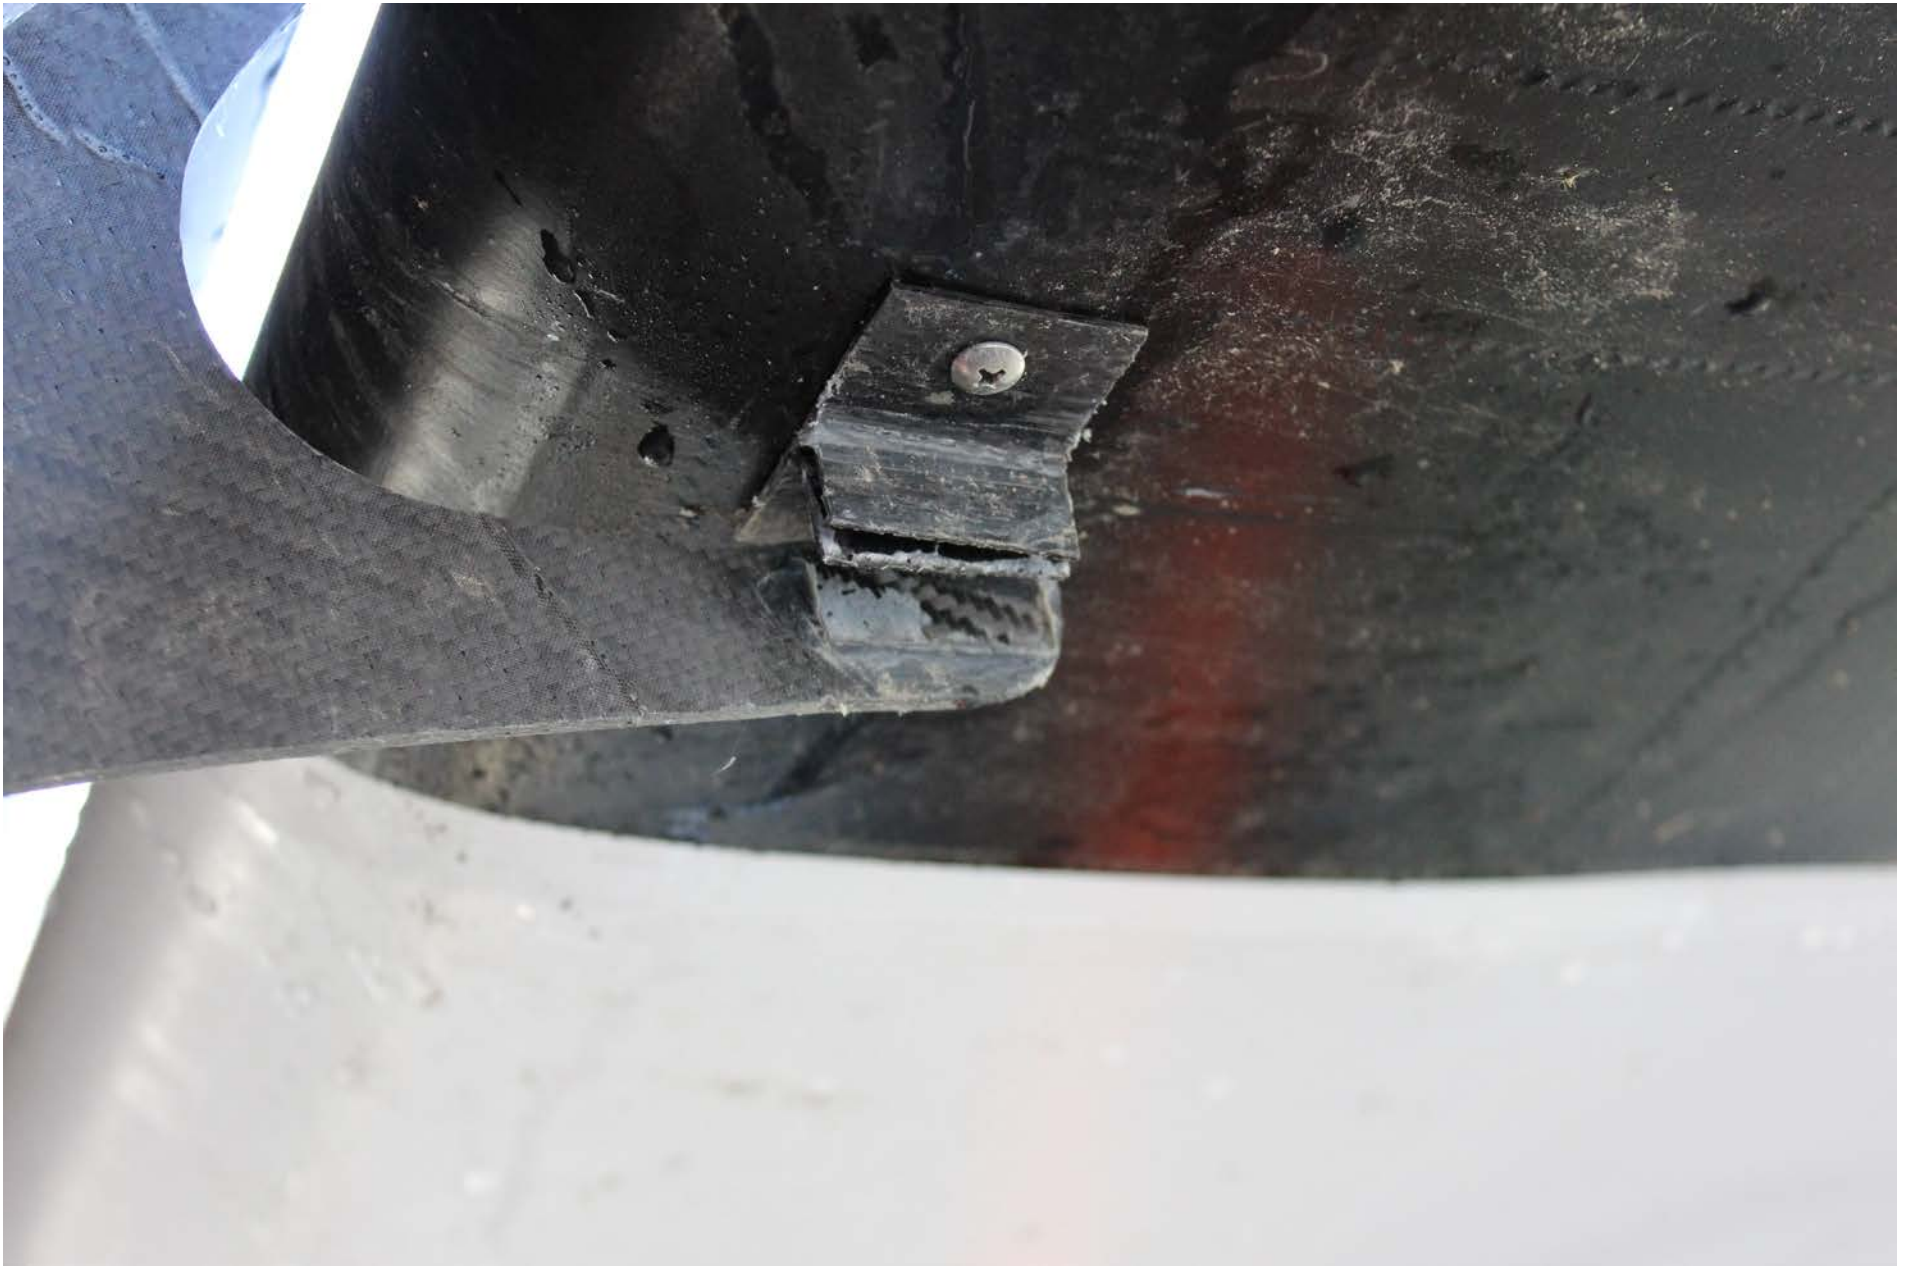
**Photo 6 – Left wing leading-edge slat attachment bracket adhesive failure and a disbond at the attachment.**

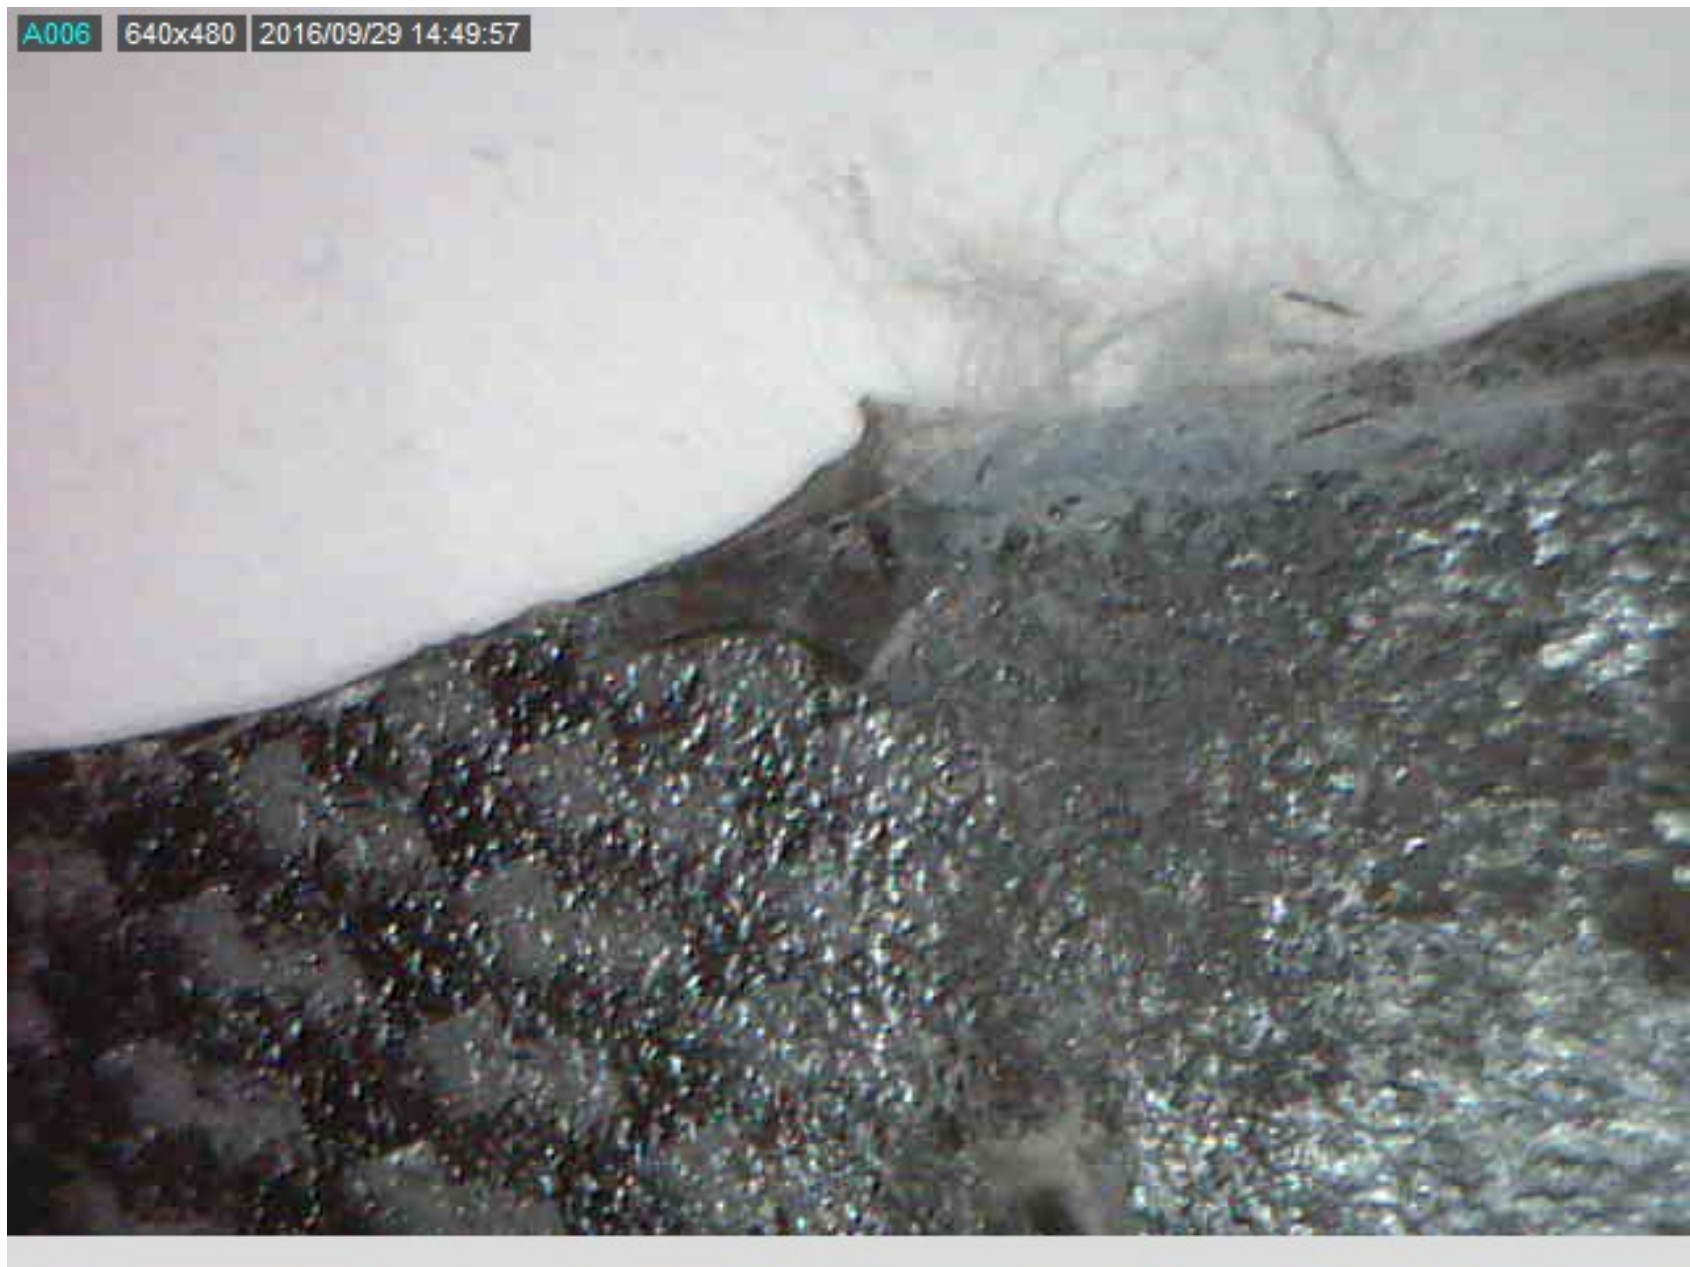
**Photo 7 – Microscopic inspection of leading-edge wing slat attachment bracket reveals a lack of adhesion, improper surface preparation and improper adhesive thickness.**
