**NATIONAL TRANSPORTATION SAFETY BOARD  
Office of Research and Engineering  
Vehicle Recorder Division  
Washington, D.C. 20594**

# **GROUP CHAIRMAN'S FACTUAL REPORT OF INVESTIGATION**

**ANC17FA003**

Location: Palmer, Alaska  
Date: October 29, 2016  
Aircraft: Cessna 172  
Registration: N6353E  
Operator: Private  
NTSB Number: ANC17FA003

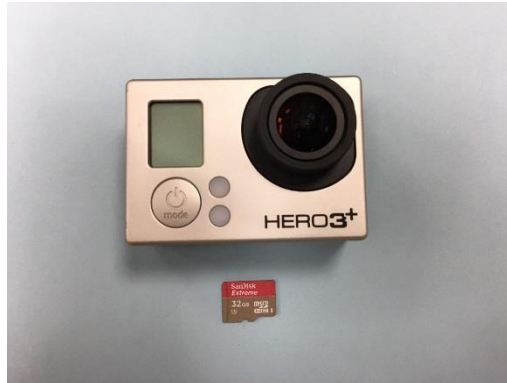
The device arrived at the Vehicle Recorder Laboratory with no visible physical damage. Figure 1 shows the condition of the front of the unit as well as the undamaged microSD card.

**Figure 1. The condition of the GoPro Camera.**
