# National Transportation Safety Board

ANC17FA009

## **AIRPLANE PERFORMANCE STUDY**

Location: Fairbanks, Alaska  
Date: December 7, 2016  
Time: 1043 AST  
1943 GMT  
Airplane: Bellanca 7GCBC, N88452

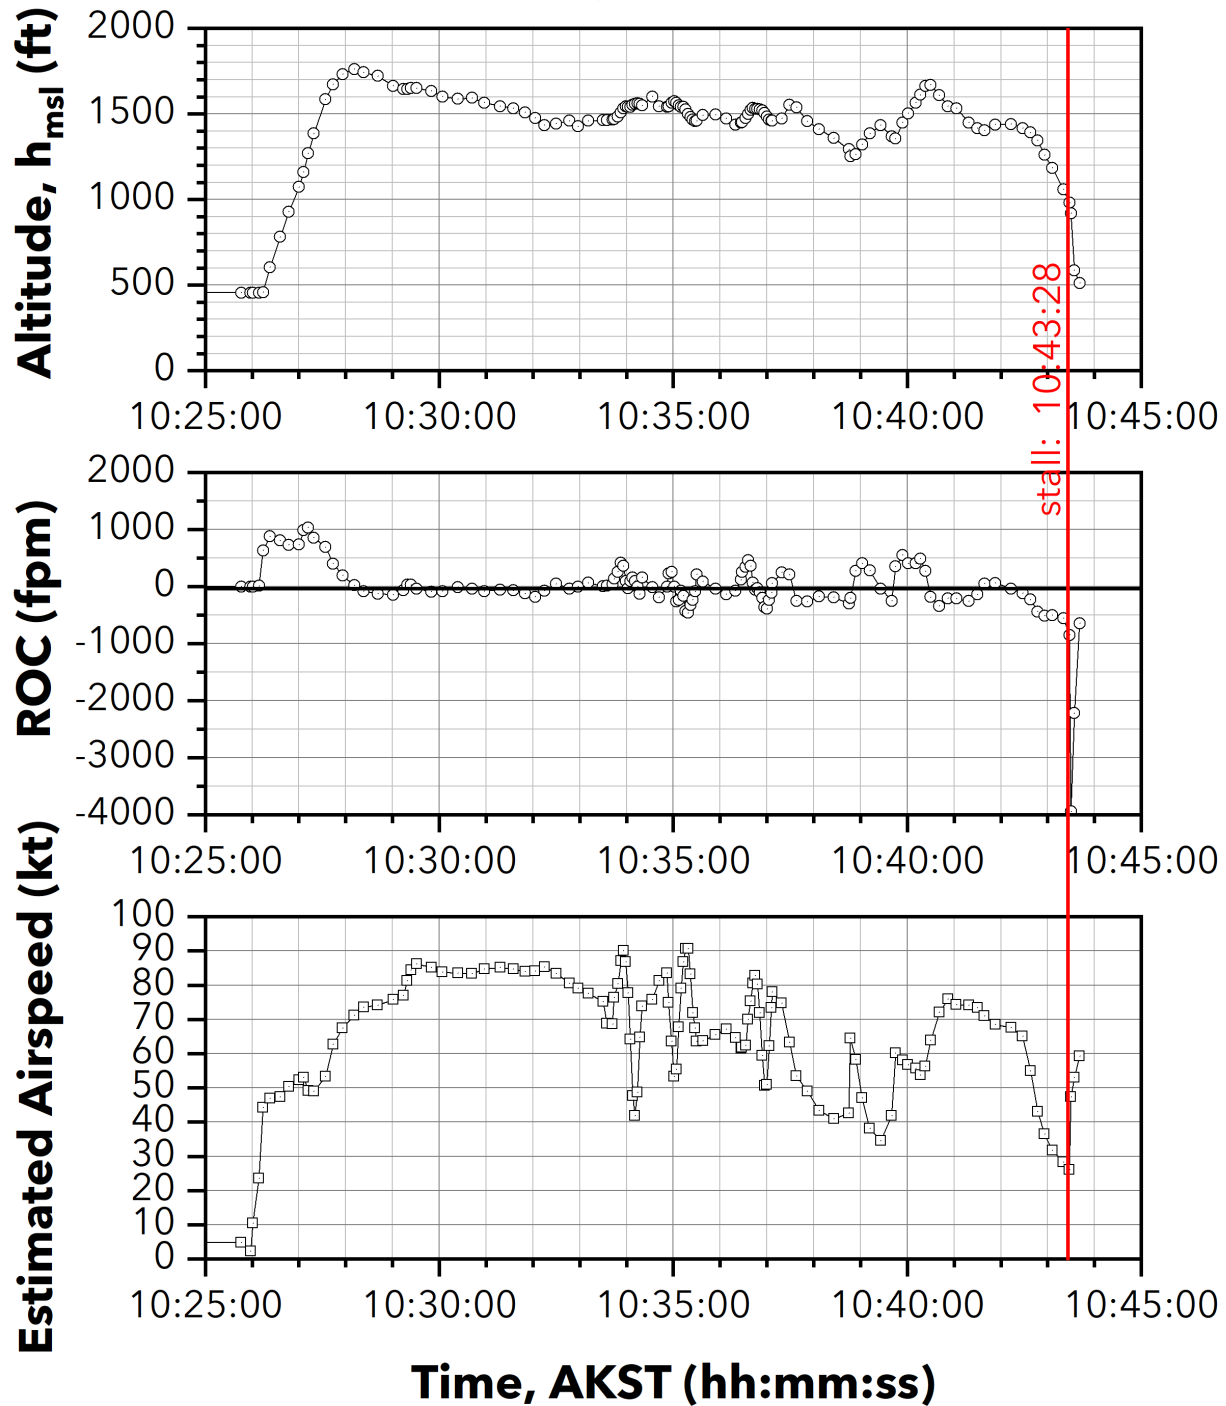
**3.0 GPS-Derived Altitude, ROC, and Airspeed for Accident Flight**

Figure 3 shows that the estimated airspeed remained between about 40 kt and 85 kt for most of the flight. However, in the final 90 seconds, the airplane began to slow while setting up a 500 feet per minute (fpm) descent. The airspeed slowed to less than 40 kt at 10:42:50 and reached a low of about 26 kt at 10:43:28.

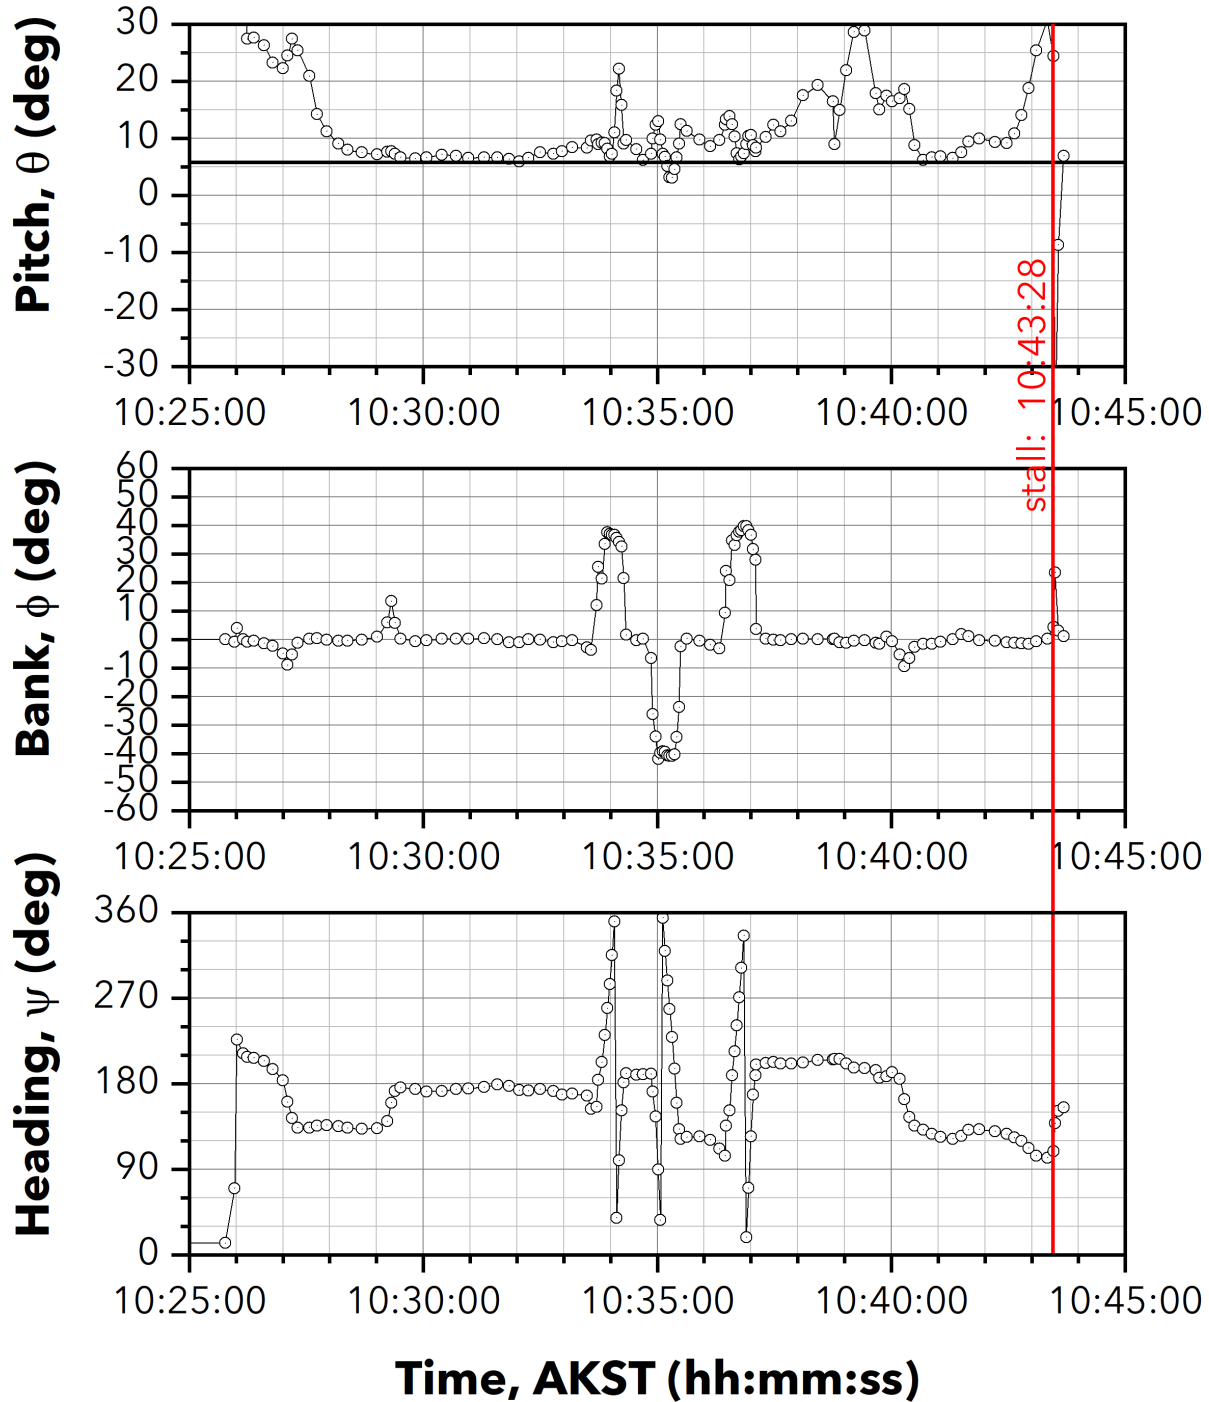
**4.0 GPS-Derived Euler Angles for Accident Flight**

Figure 4 includes the estimated airplane pitch, roll, and heading angles. The airplane began to pitch up while entering the 500 fpm descent. The descent rate increased to almost 4,000 fpm as the airspeed reached 26 kt at 10:43:28. The airplane abruptly rolled right to 24° at 10:43:28.

The GPS data recovered from the accident airplane show the airplane slowing to approximately 26 kt when the GPS-derived acceleration data show a "stall break", an abrupt right roll, and a descent rate of almost 4,000 fpm. The wing likely reached the critical angle-of-attack, and the airplane stalled at 10:43:28.

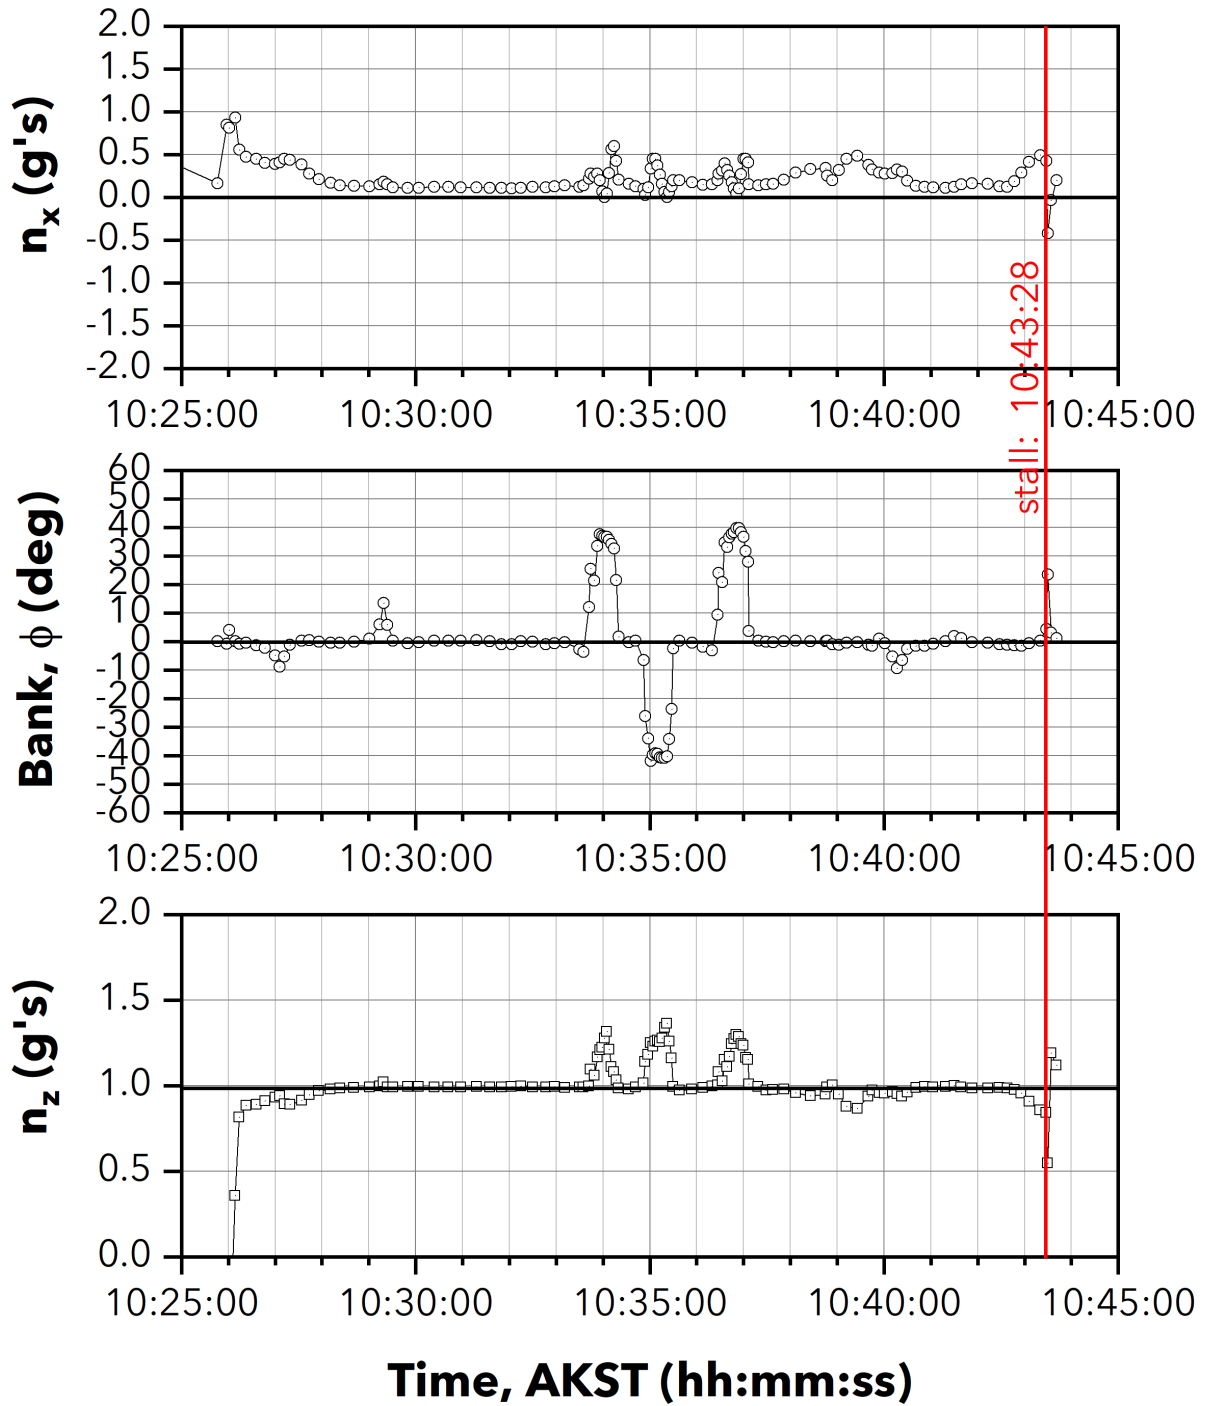
**5.0 GPS-Derived Airplane Accelerations for Accident Flight**

Finally, Figure 5 shows the accelerations estimated from the GPS data. The vertical load factor,  $n_z$ , shows a sudden decrease of approximately 0.5g's as the airspeed reached 26 kt.
