## **NATIONAL TRANSPORTATION SAFETY BOARD**

### **Weather Study**

# **METEOROLOGY**

ANC17FA009

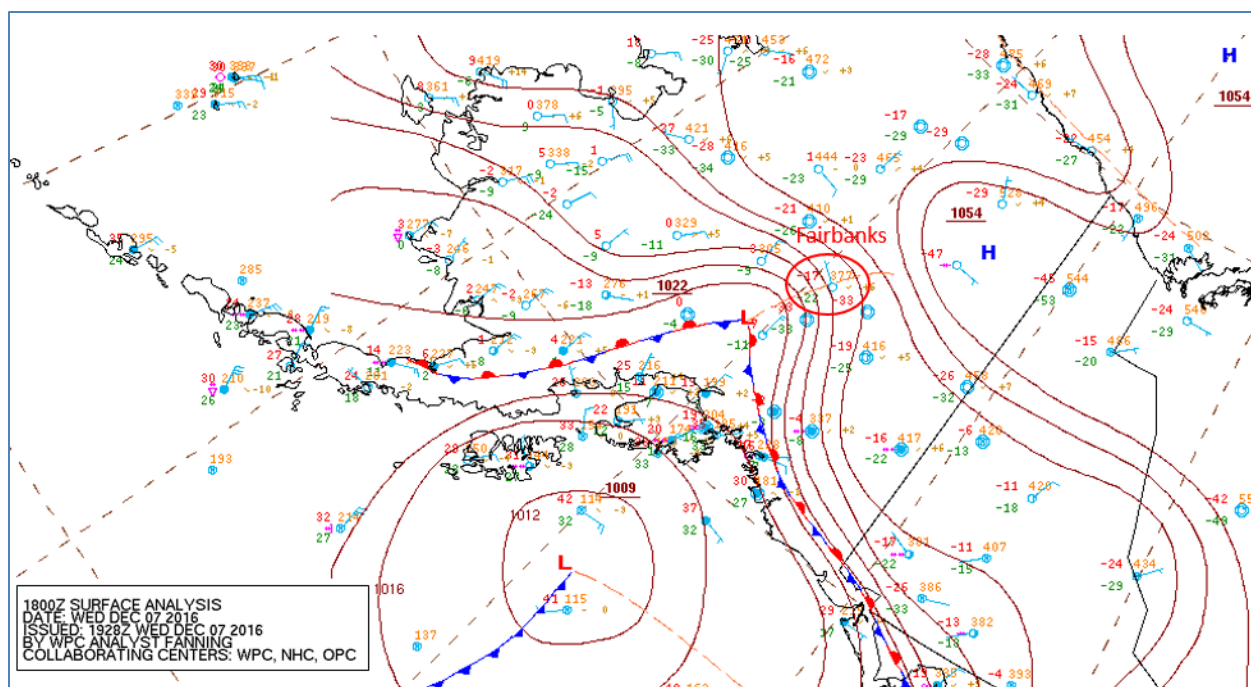
**Figure 1 - Alaska Surface Analysis Chart for 0900 AKST**

The NWS Alaska Surface Analysis Chart for 0900 AKST (1800Z) on December 7, 2016 is included as figure 1 with the approximate accident site marked by a red star. The chart depicted a cold-core high pressure system over northeastern Alaska at 1054-hectopascals (hPa)<sup>1</sup> with a ridge of high pressure dominating over northern Alaska. To the south of the accident site over the Anchorage area the chart depicted a low pressure system at 1022-hPa along a stationary front which stretched southwestward and southeastward across the coastal sections of Alaska and the Alaska Range and Chugach Mountain ranges. A trough of low pressure also extended north and then northeastward from the low pressure system into the Fairbanks area, which is noted in the red circle. Further south in the Gulf of Alaska was another closed low pressure system at 1009-hPa with a cold front stretching southward with a defined cyclonic or counterclockwise wind flow in the northern hemisphere. The accident site was located under the cold air mass north of the front and near the trough of low pressure with a ridge of high pressure to the north producing an extensive area of clear and stable conditions.

The station model for Fairbanks depicted wind as calm, clear skies, with a temperature of -17° Fahrenheit (F), dew point of -22° F, with a sea level pressure of 1039.3-hPa. No significant weather or clouds were depicted in the immediate area surrounding the accident site, even with the trough extending over the area. Further south along and north of the stationary front to the southeast of the area several stations reported light snow and overcast clouds.

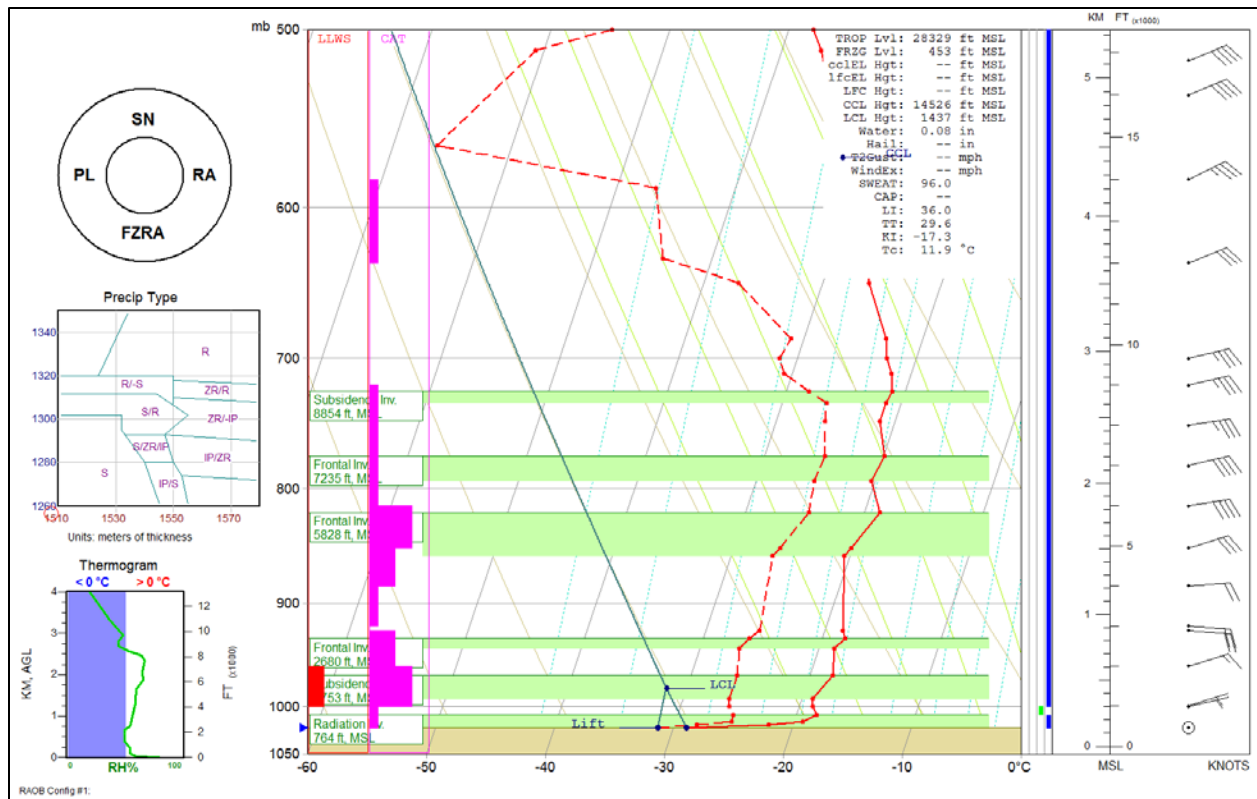
Figure 2 - NWS Fairbanks 1500 AKST sounding

The Fairbanks 1500 AKST sounding depicted a surface based temperature inversion with several other inversions or layers where there was an increase in temperature with altitude below 9,000 feet (shown in green shading on the diagram). The inversions resulted in a Lifted Index (LI)<sup>4</sup> value of 36.0, which indicated an absolutely stable atmosphere. The lifted condensation level (LCL)<sup>5</sup> was identified at 984 feet agl, and the convective condensation level (CCL)<sup>6</sup> at 14,073 feet. No layers were identified with a relative humidity greater than 80% to support clouds, and thus no structural icing conditions were identified.

The sounding wind profile indicated calm surface wind, with winds from the east increasing with height over 20 knots above 2,000 feet with a low-level wind maximum was identified near 6,000 feet with wind from 080° at 38 knots. The mean 0 to 6 kilometer or 18,000 feet wind was from 069° at 31 knots, with the maximum wind was identified at 060° at 52 knots at 24,000 feet with the tropopause height at approximately 28,300 feet.

The sounding thermal and wind profiles depicted several layers of strong vertical wind shear between 1,700 and 3,000 feet and near the low-level wind maximum between 4,500 and 6,000 feet and indicated a high probability of 80% and greater for moderate and greater turbulence in these layers (indicted in pink bars on the left side of the diagram). In addition, due to the calm surface wind and increase in wind immediately above the surface based inversion, a slight low-level wind shear (LLWS) environment also existed (shown in red on left of the chart). The turbulence potential was not verified by any pilot reports surrounding the period (see section 4.0 below). The observed wind at 983 feet or approximately 1,000 feet was from 075° at 5 knots.

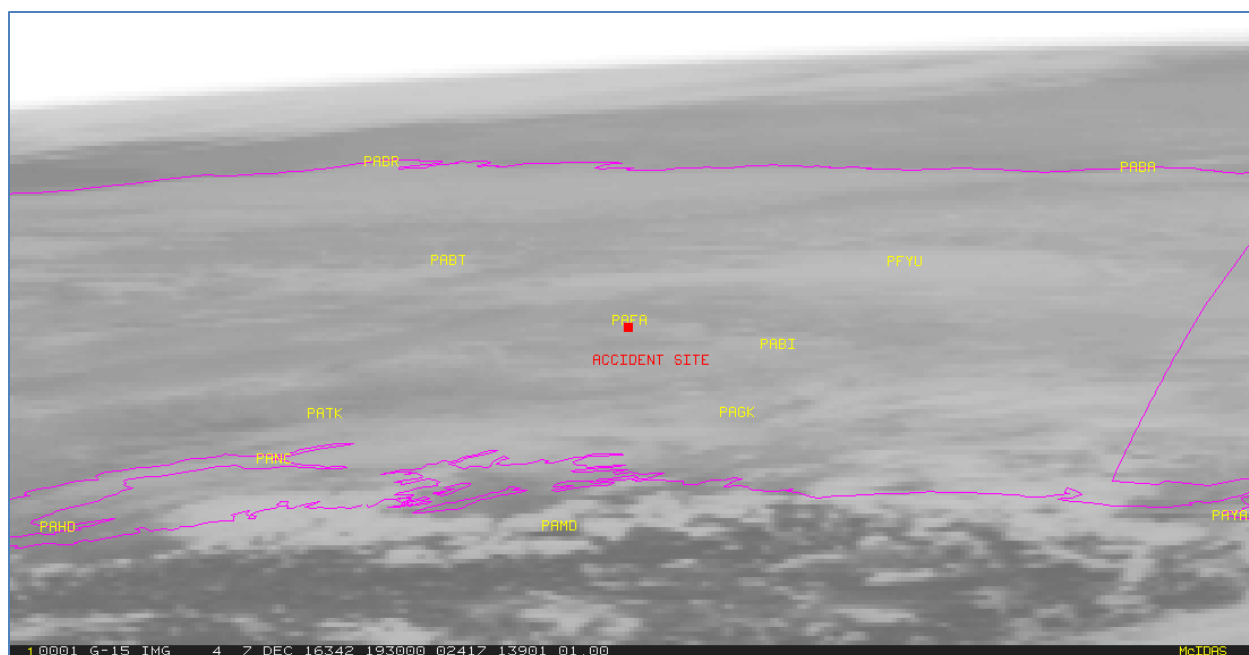
Figure 4 is the GOES-15 infrared image at 1030 AKST at 4X magnification with the accident site in red, with a resolution of 4 kilometers. The thermal image depicted clear skies over a snow covered terrain in the vicinity of the accident site, which is marked by the red square. Low to mid-level clouds were identified along and north of the stationary front along the coastal sections of Alaska with little clouds over central and northern Alaska.

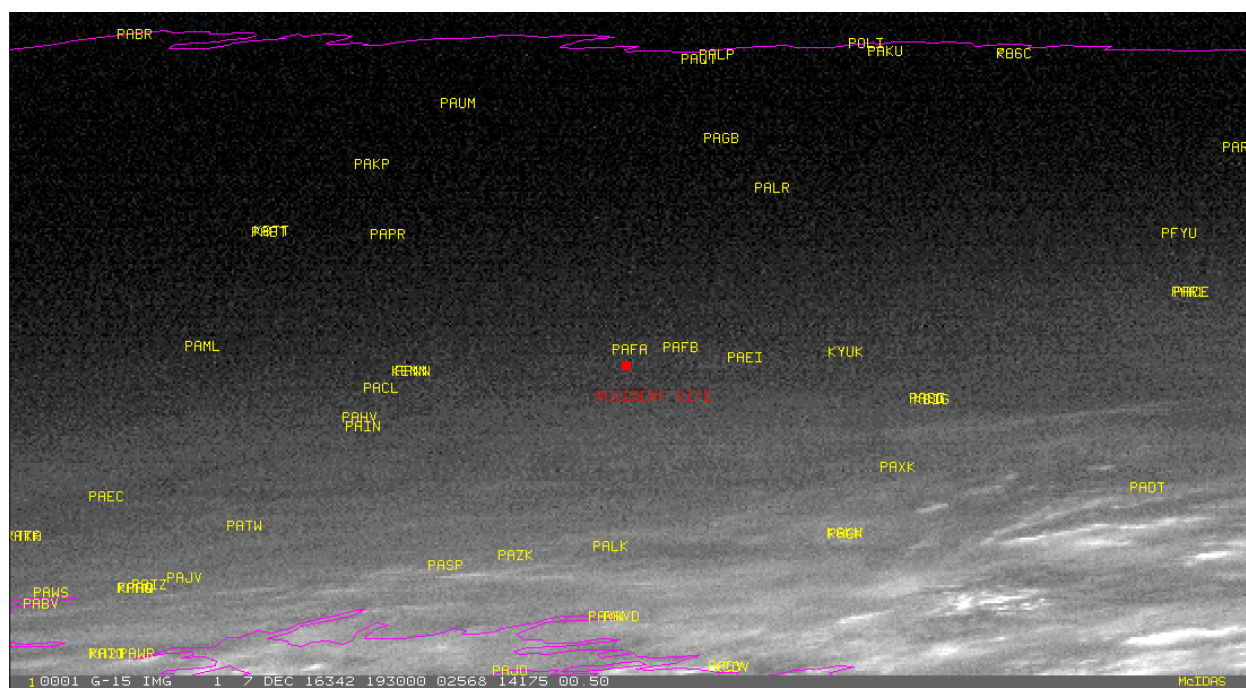
Figure 5 is the GOES-15 visible image at 2X magnification at 1030 AKST with a resolution of 1 kilometer and with the accident site noted. The image depicted clear skies over the accident site with snow covered terrain. The extreme north latitude and diminishing light conditions limited a more complete satellite analysis over the region during the period.

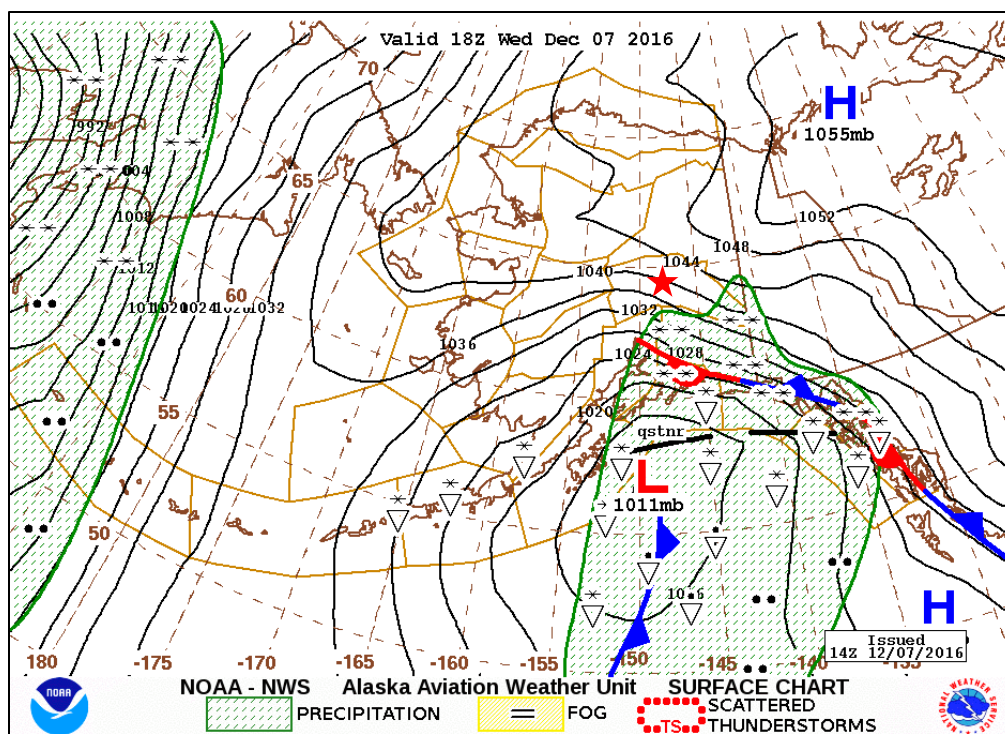
Figure 6 – AAWU Surface Forecast valid at 1000 AKST

The NWS Alaska Aviation Weather Unit (AAWU) graphic version of the area forecast are included below. Figure 6 is the AAWU Surface Forecast issued at 0500 AKST and valid for 0900 AKST (1800Z) with the approximate accident site marked by the red star. The chart depicted a high pressure ridge extending over the region with no significant weather over the Fairbanks area; however, an area of precipitation in the form of snow was expected to the south and southeast of the area associated with the trough of low pressure extending from the low pressure system in the Anchorage area northward and the stationary front along the coastal region.

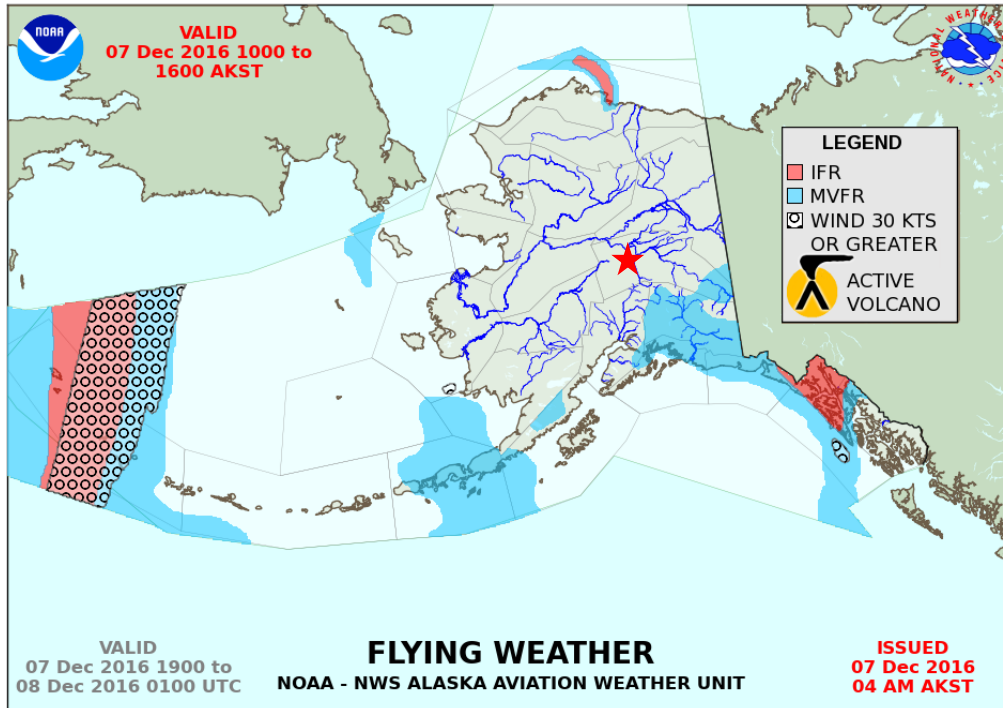
Figure 7 - AAWU Flying Weather forecast

Figure 7 is the AAWU Flying Weather Forecast providing the general flight category<sup>7</sup> and where strong surface winds of 30 knots or more are expected for the period from 1000 through 1600 AKST, which was issued at 0400 AKST. The chart depicted VFR conditions expected to prevail over the Fairbanks area with MVFR conditions to the south-southeast and extending along the southeast Alaska coastal region.

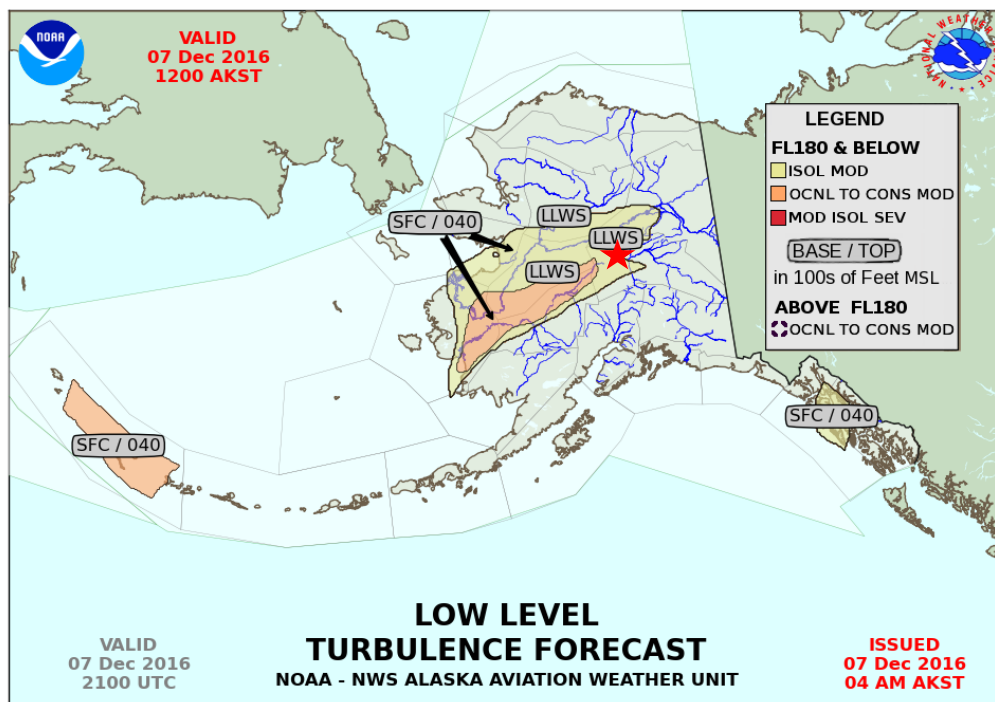
Figure 8 - Low-Level Turbulence Forecast valid for the period

The low-level turbulence forecast issued at 0400 AKST and valid for the period is included in figure 8. The morning forecast included a risk of low-level wind shear over the region and isolated moderate turbulence below 4,000 feet.

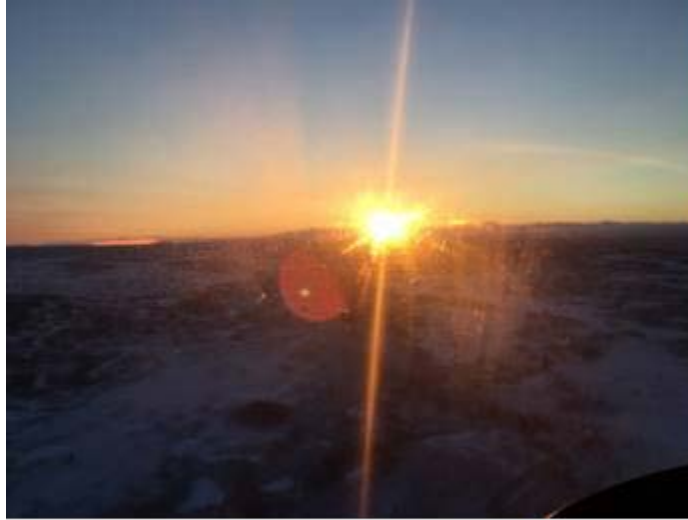
**Figure 9 - Approximate Sun location at the time of the accident**

At the approximate time of the accident the sun was 0.1° above the horizon at an azimuth of 153°.
