**From:** Price Noreen  
**To:** [Budinski Michael](#)  
**Subject:** RE: ANC17FA009 Fairbanks, AK Email Report  
**Date:** Thursday, March 29, 2018 11:04:00 AM

Fairbanks, AK  
December 15, 2016  
Bellanca Citabria, N88452  
ANC17FA009  
Noreen Price, ASI-ANC

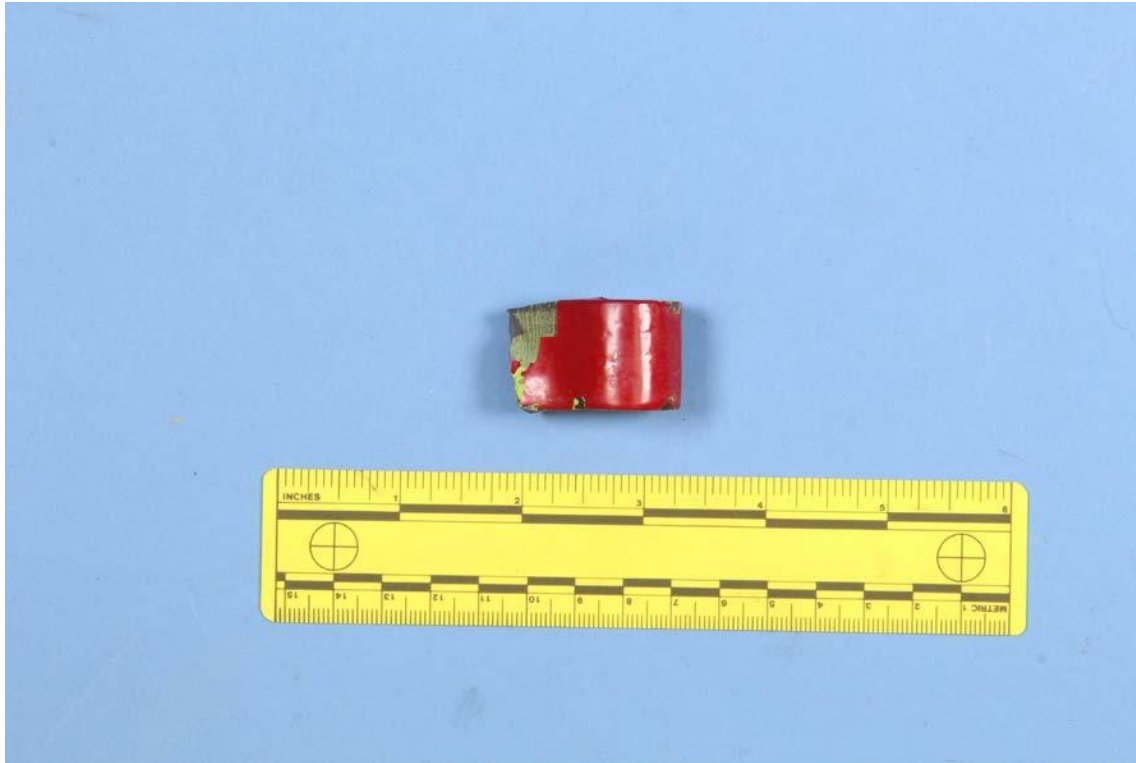
The strut attachment was separated near the attaching bolt hole. The fracture displayed fracture features and deformation patterns indicating a bending overstress separation. The bending plane was aligned with the axis of the bolt hole. No corrosion or preexisting cracking were noted.

**1- Left wing strut end**

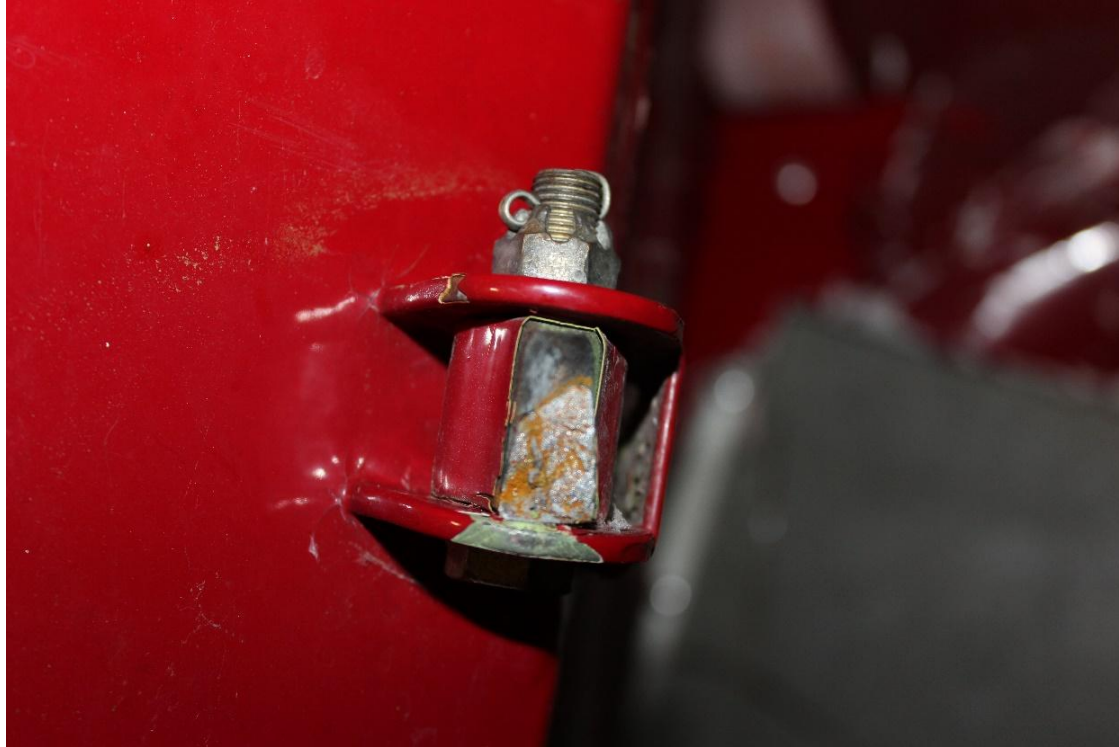
**2- Left wing strut fracture, attached to airframe mount**
