# NATIONAL TRANSPORTATION SAFETY BOARD

## MATERIALS LABORATORY FACTUAL REPORT

Report No. 18-013

Place : Chignik Lake, AK  
Date : 5/1/2017  
Vehicle : Cessna 208B, N803TH  
NTSB No. : ANC17FA021  
Investigator : Noreen Price

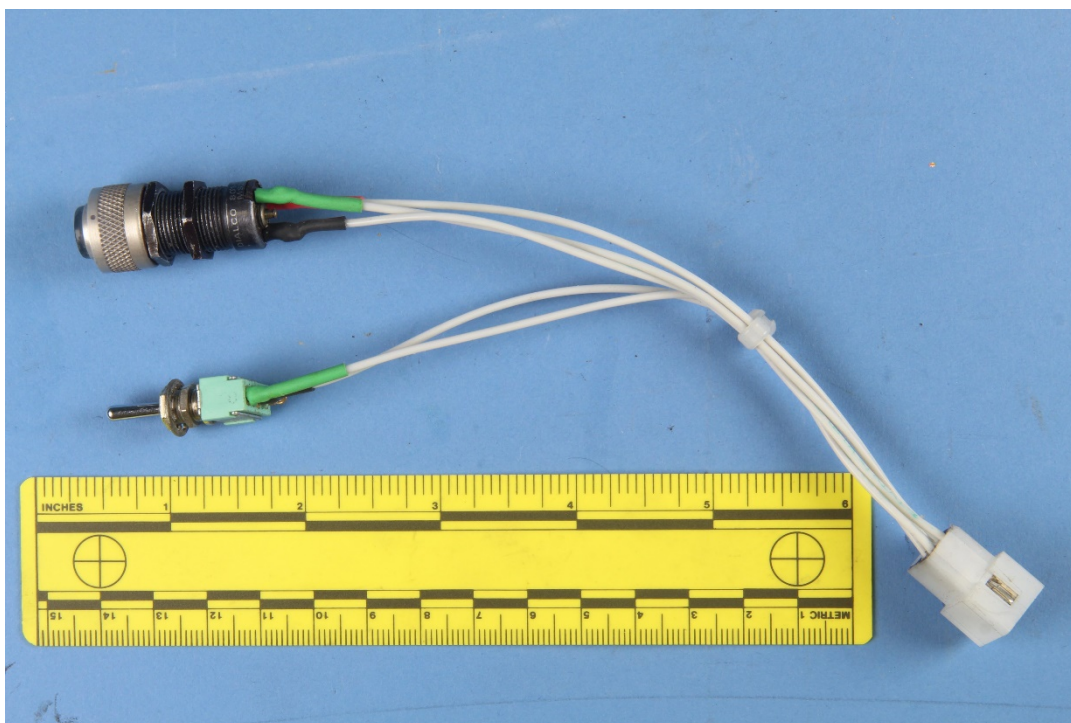
The TAWS warning light and reset switch did not exhibit evidence of mechanical or thermal damage. The continuity of the wiring harness for both the reset switch and warning lamp holder (DIALCO 801-1030-0334-504) was verified using a digital multi meter (DMM). The function of the reset switch was also verified and found to function normally using a DMM. The resistance of the bulb was measured and found to be 58 Ohm.

Figure 1: TAWS warning light and reset switch as received.

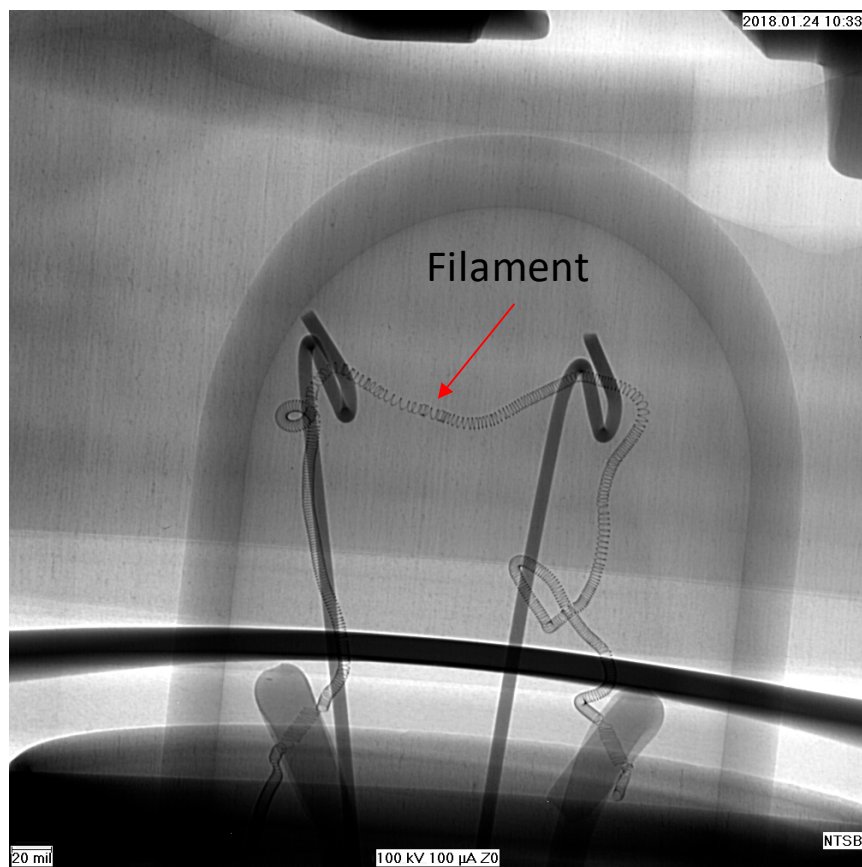
Radiographic examination of the light bulb filament (figures 2 -4) did not reveal evidence of stretching of the filament coil.

Figure 2: Radiographic image of the filament (side view).

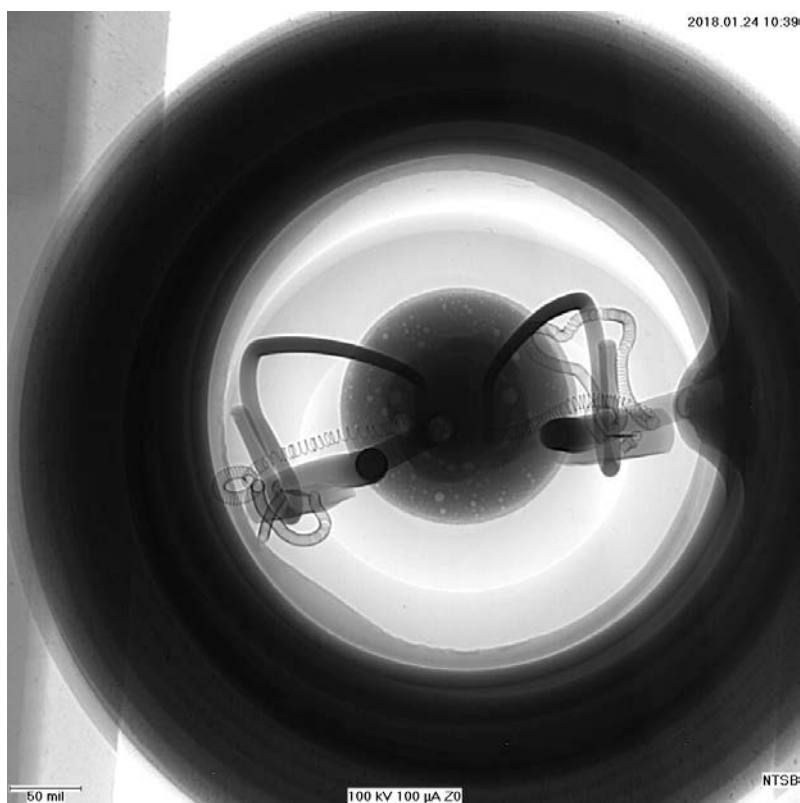
Figure 3: Radiographic image of the filament (top view).

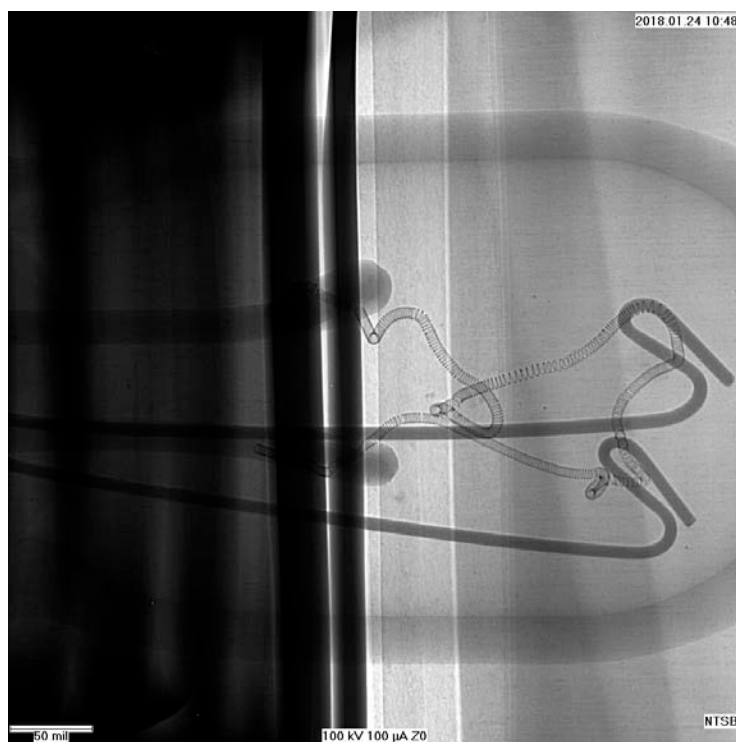
Figure 4: Radiographic image of the filament (side view).
