**Photo 1 – N803TH at the accident site (courtesy of the Alaska Mountain Rescue Group)**

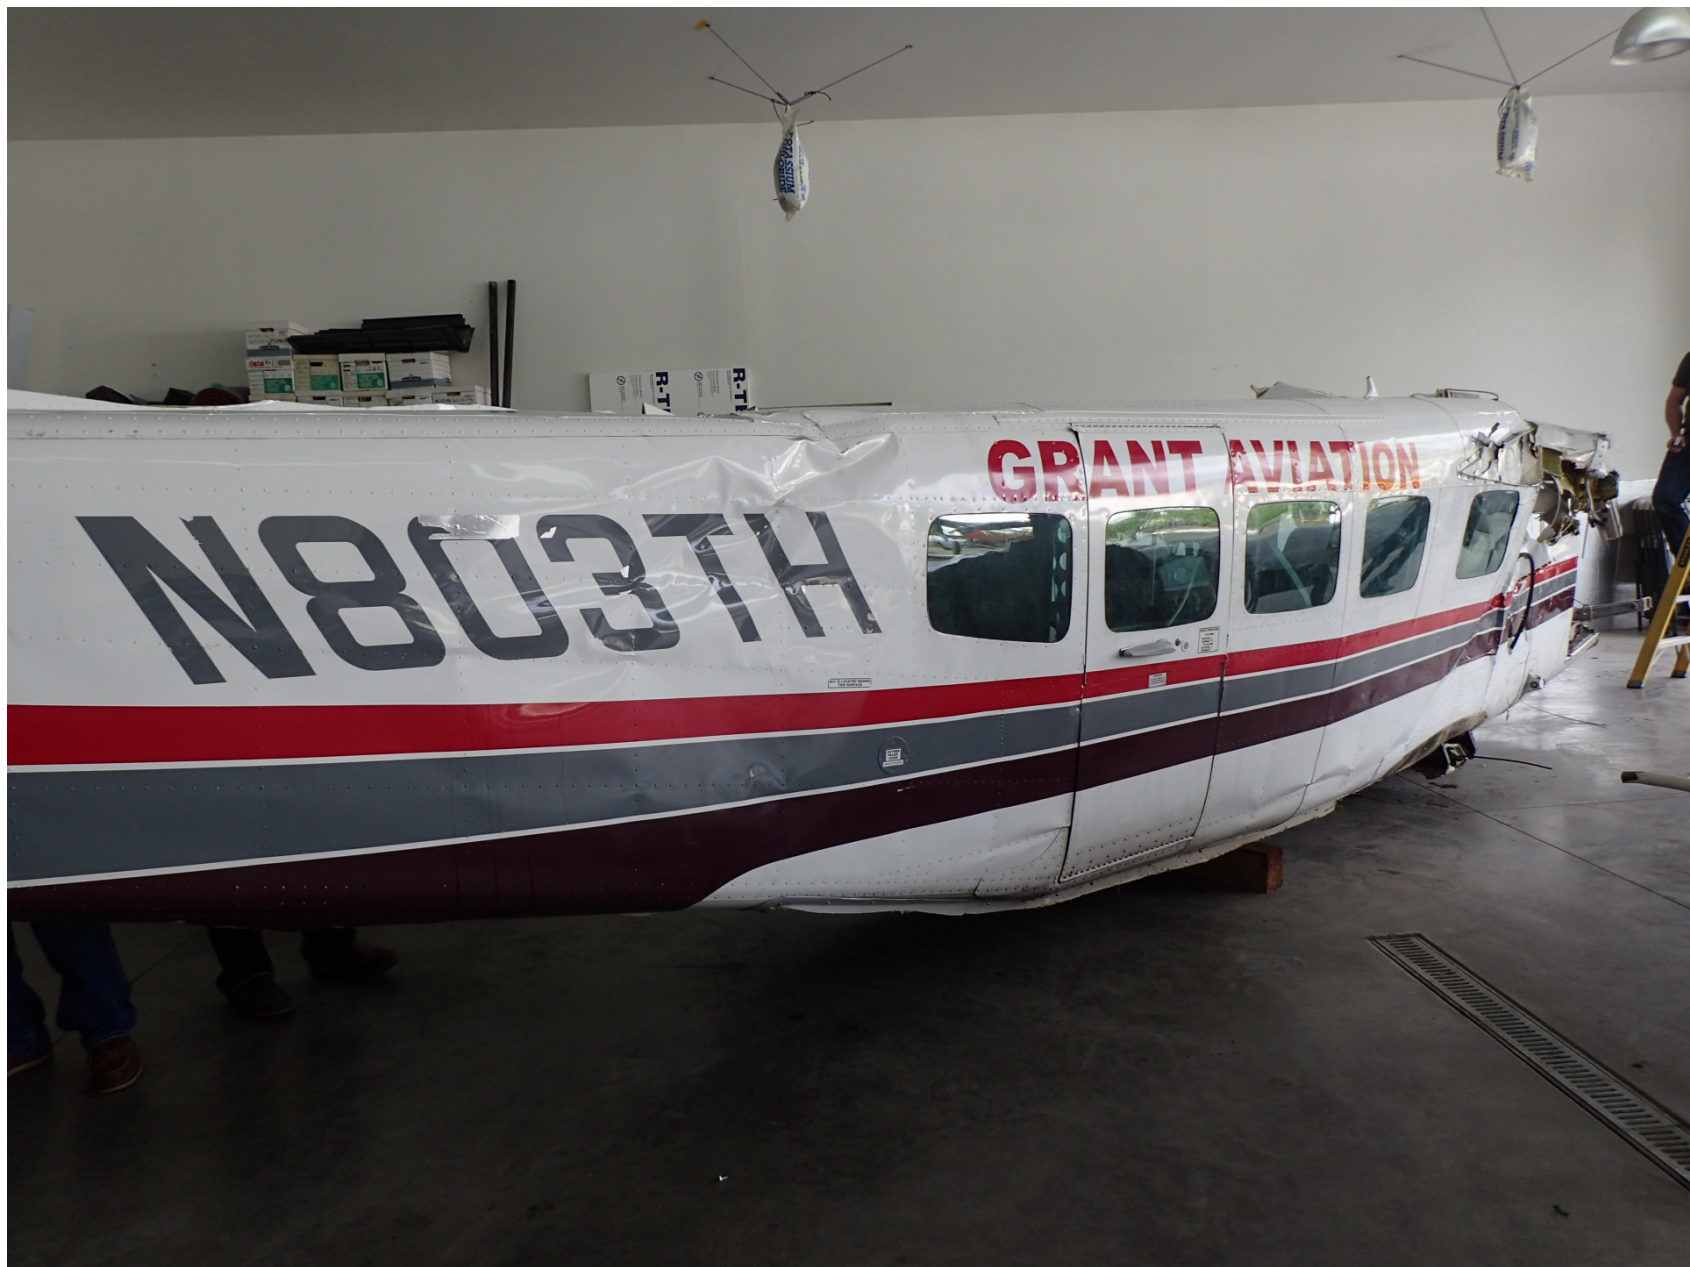
**Photo 2 - Right side of fuselage during detailed examination**

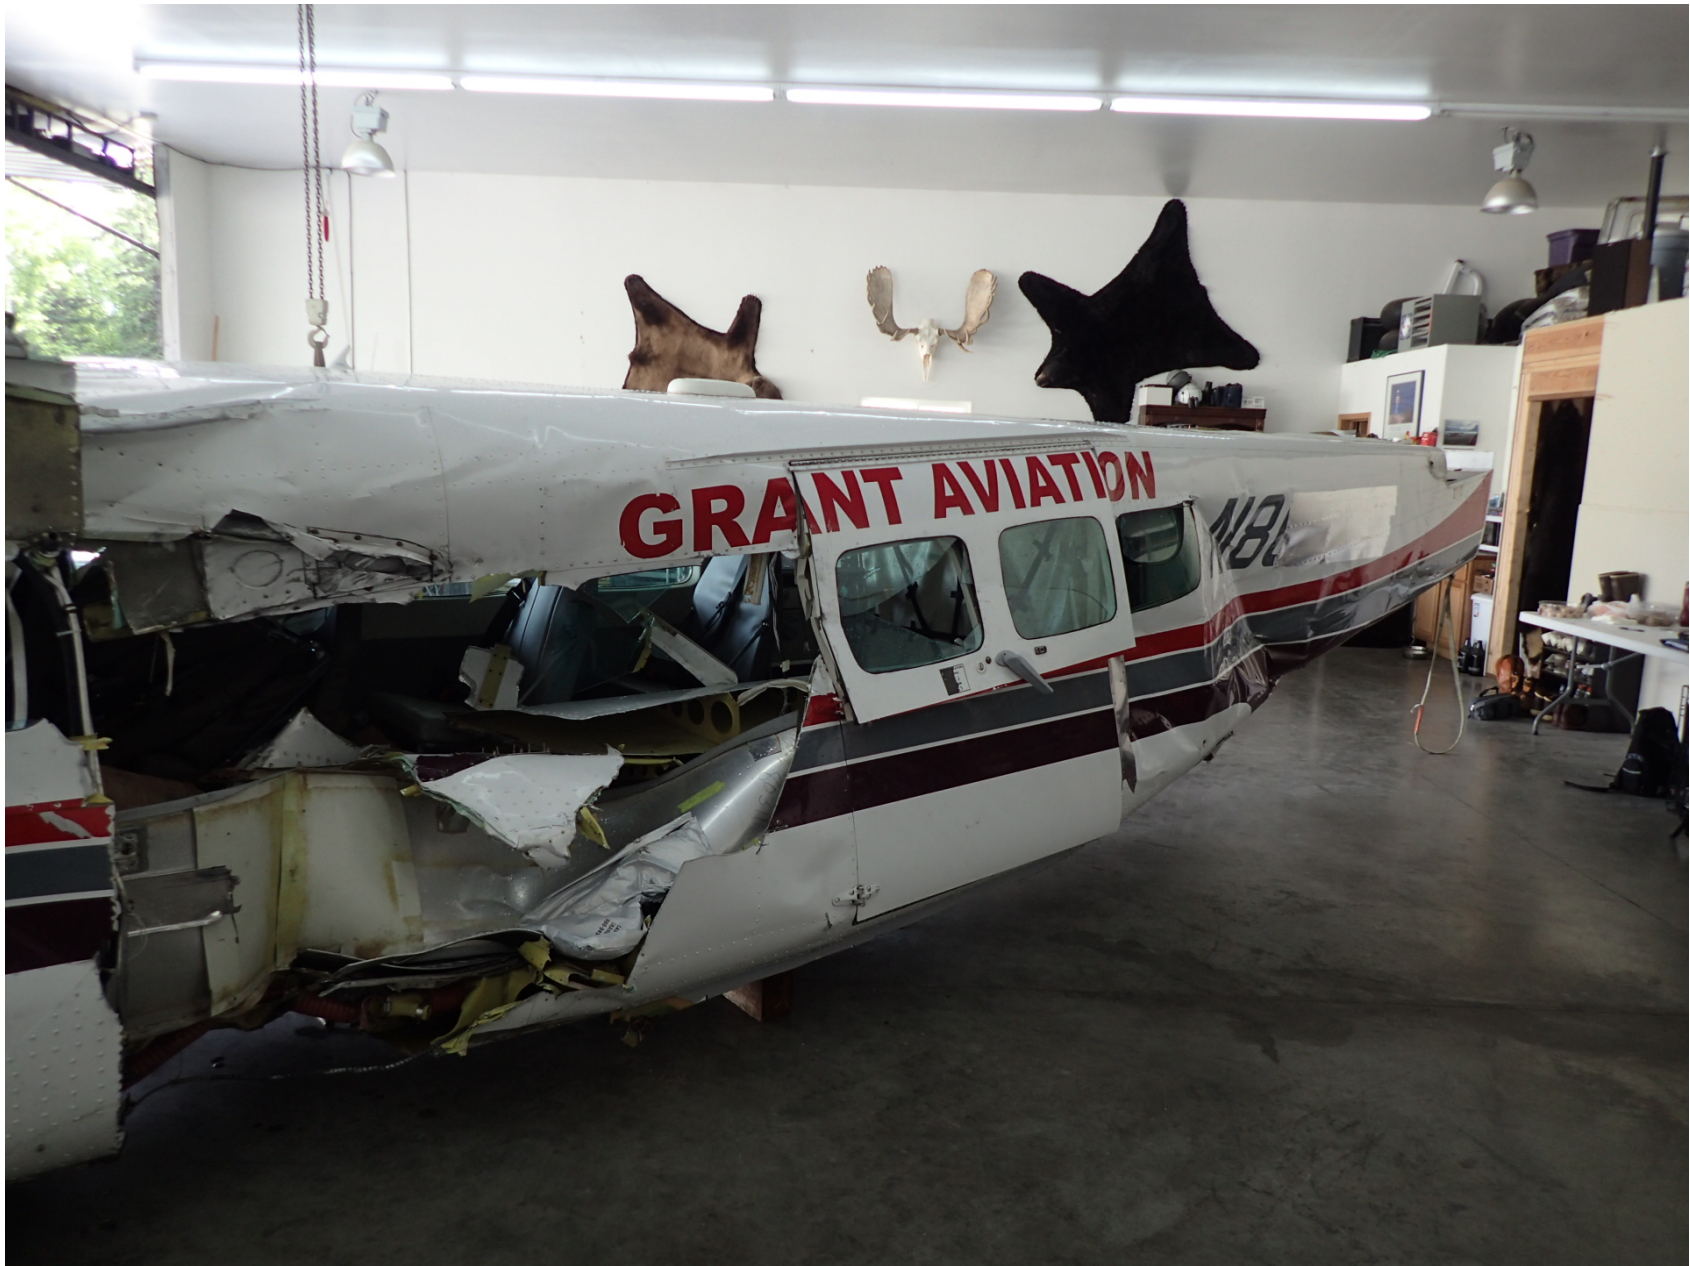
**Photo 3 - Left side of fuselage at detailed examination**

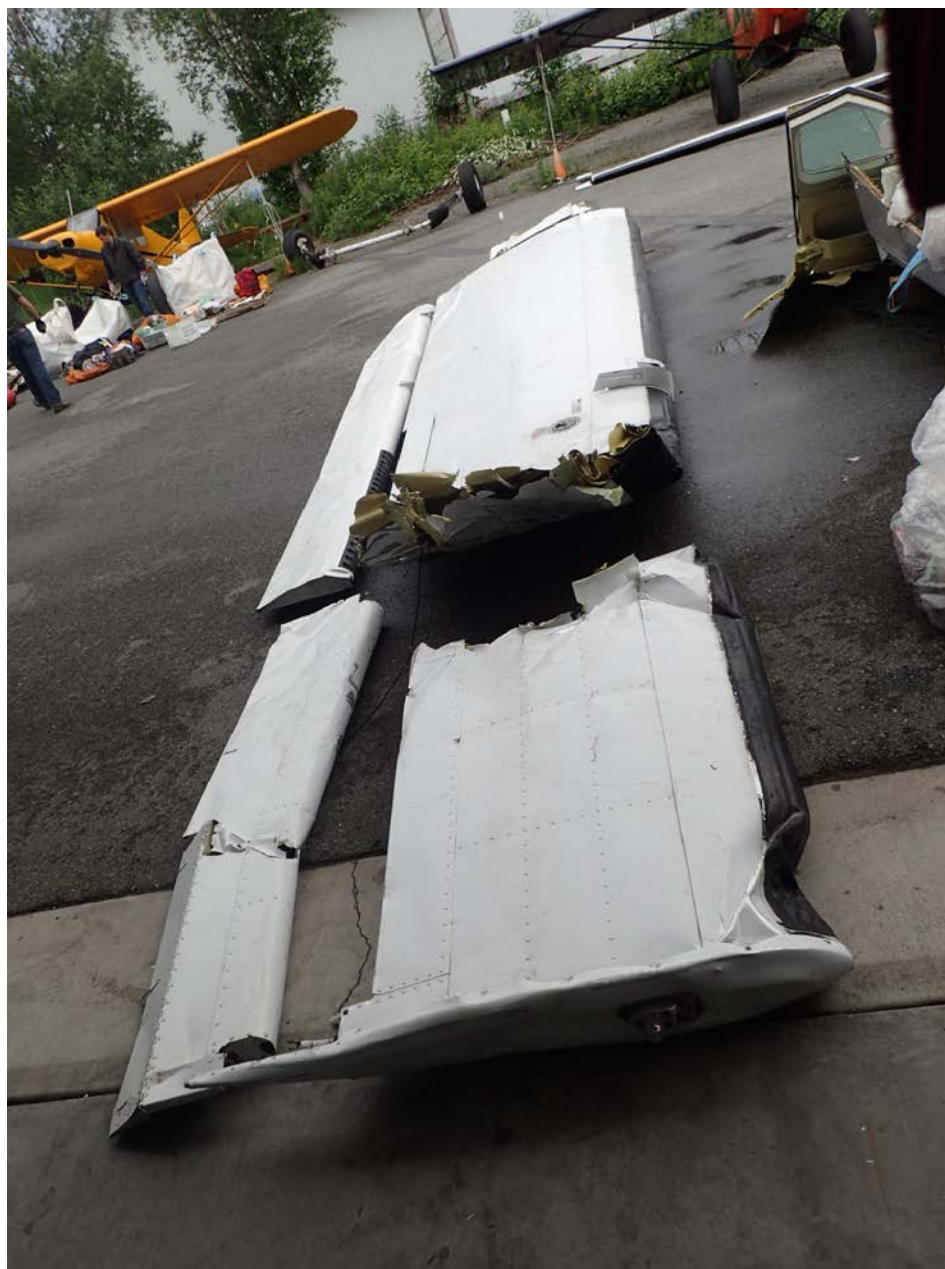
**Photo 4 - Right wing sections during detailed examination**

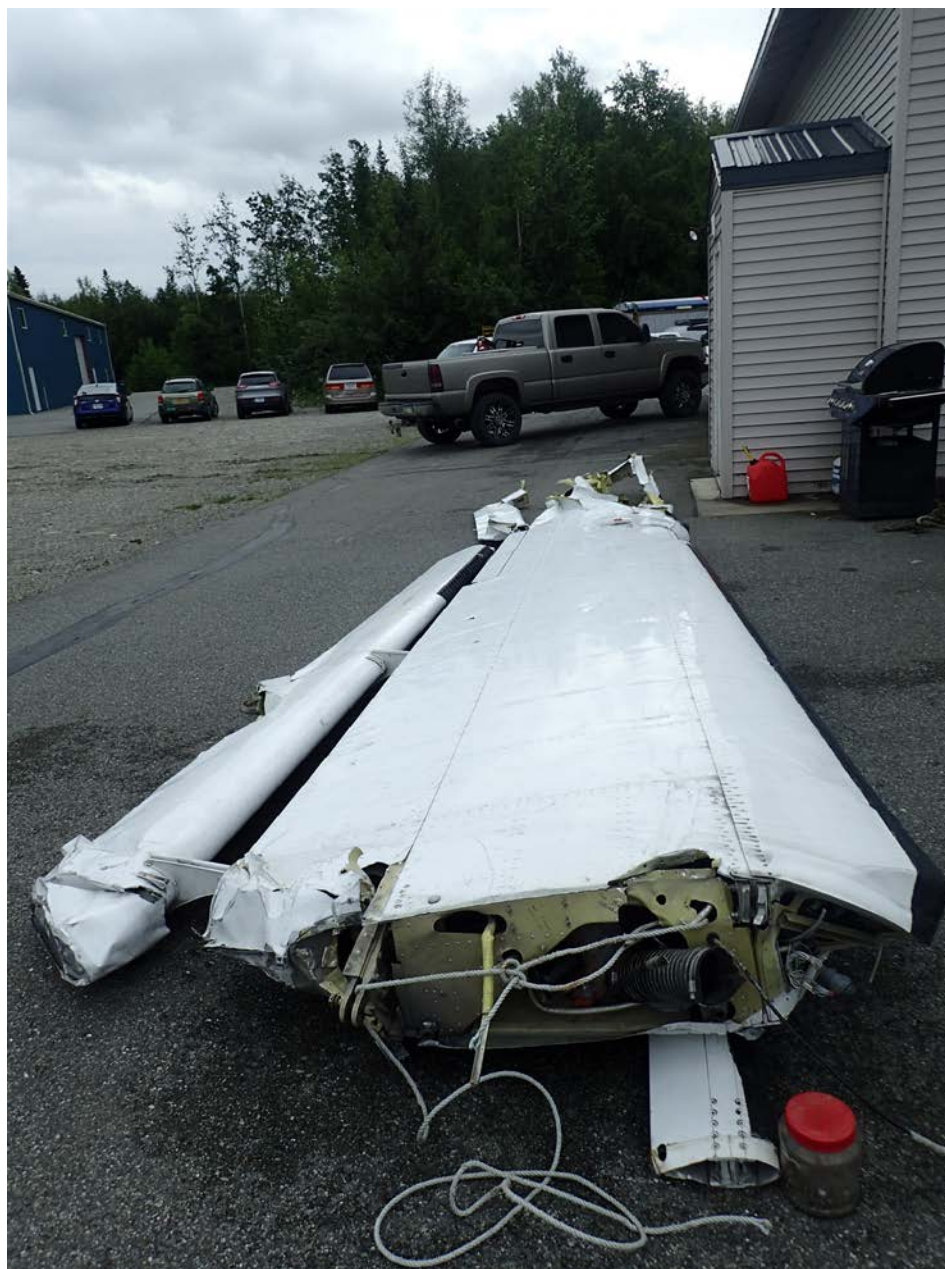
**Photo 5 - Left wing sections at detailed examination**

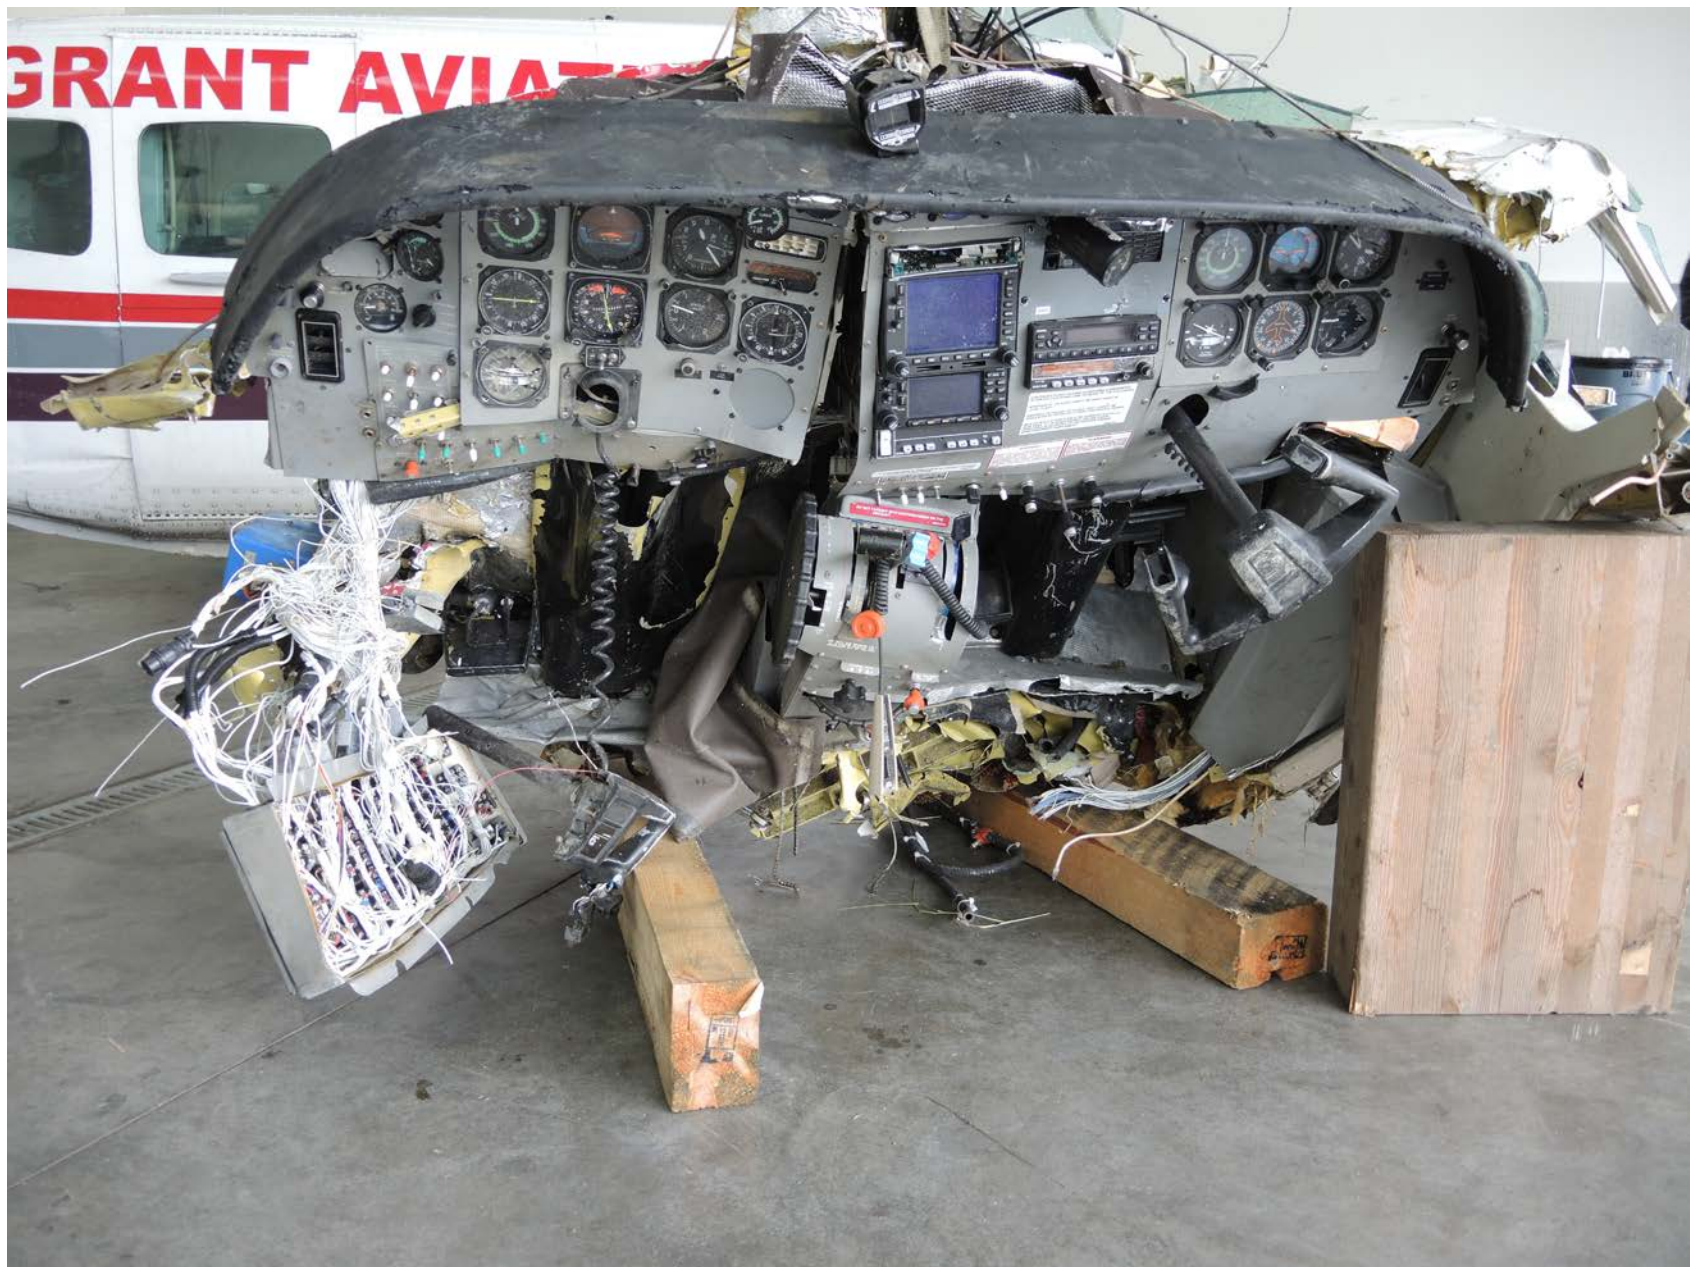
**Photo 6 - Cockpit and instrument panel**

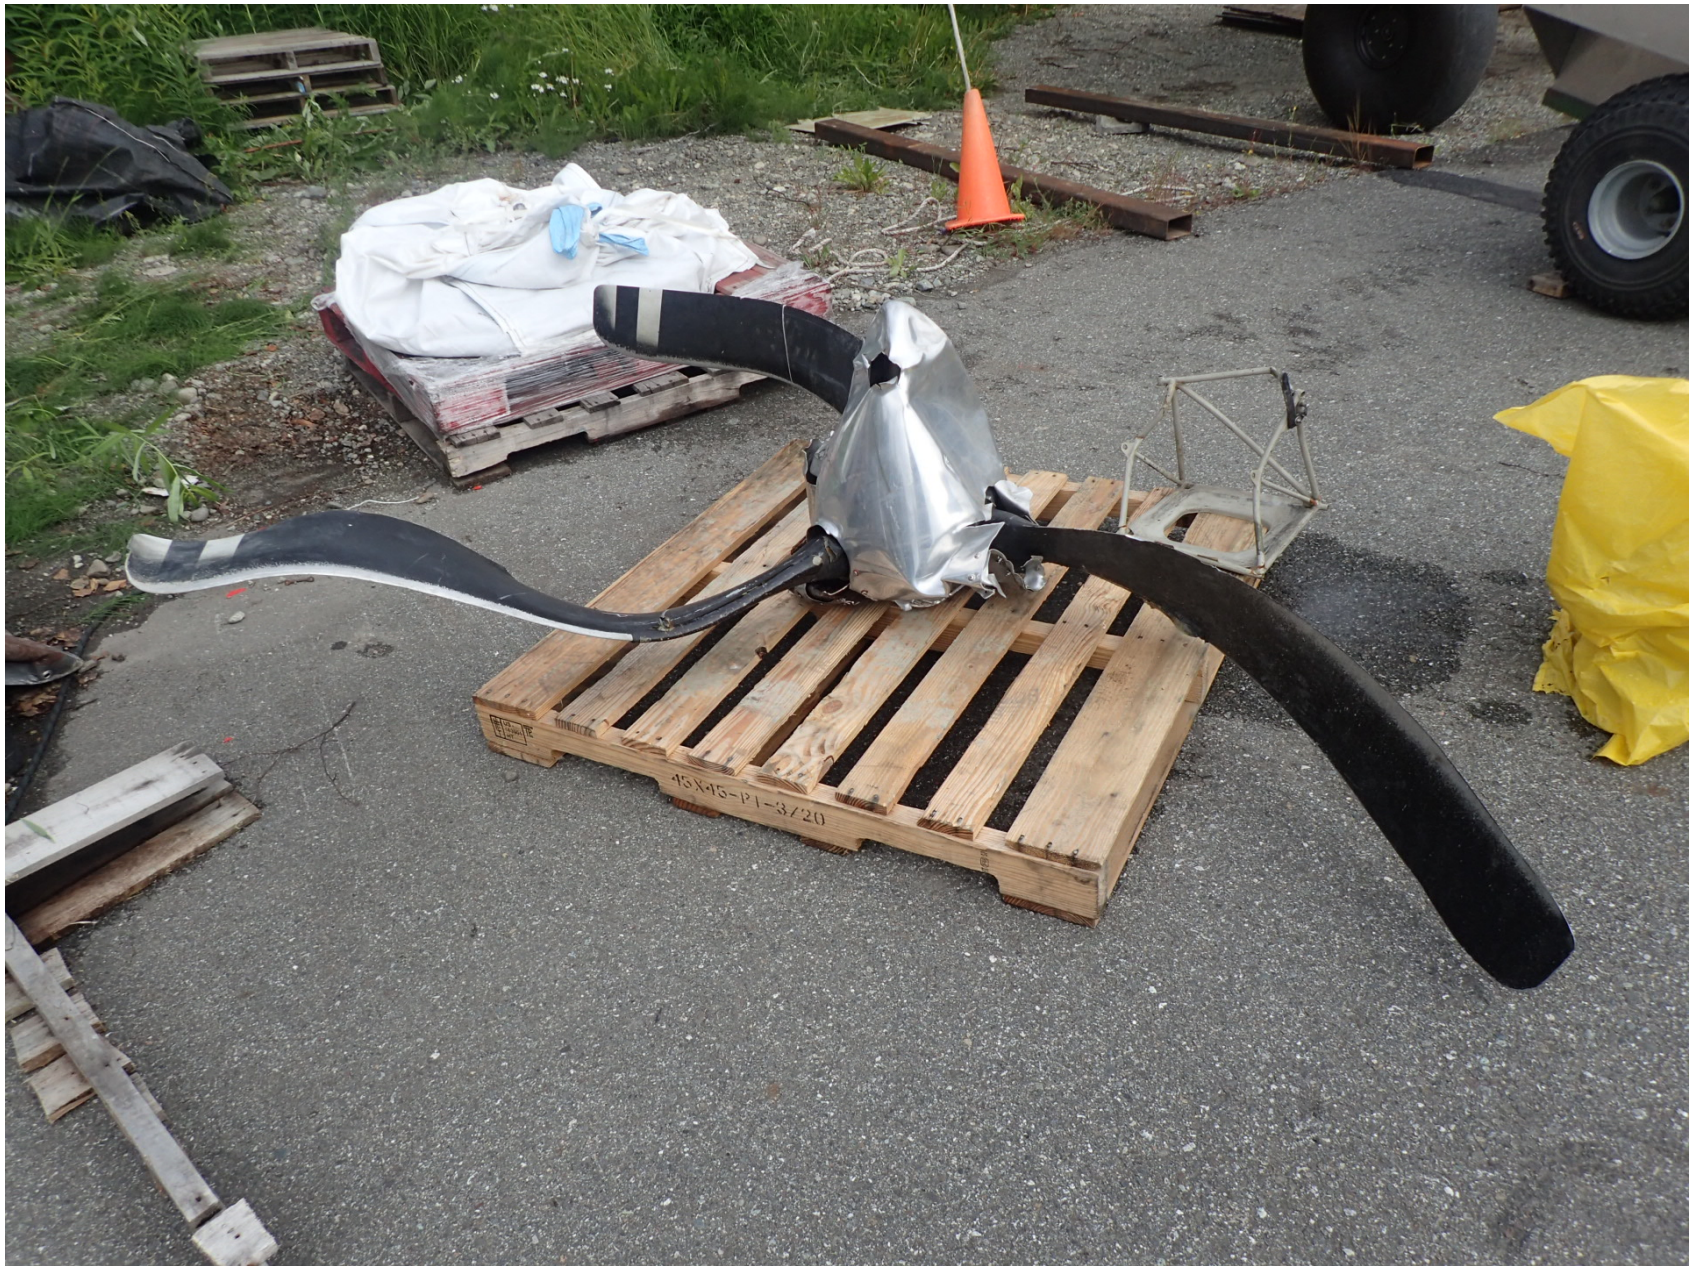
**Photo 7 - McCauley model 3GF34C703 propeller indicating blade deformations**

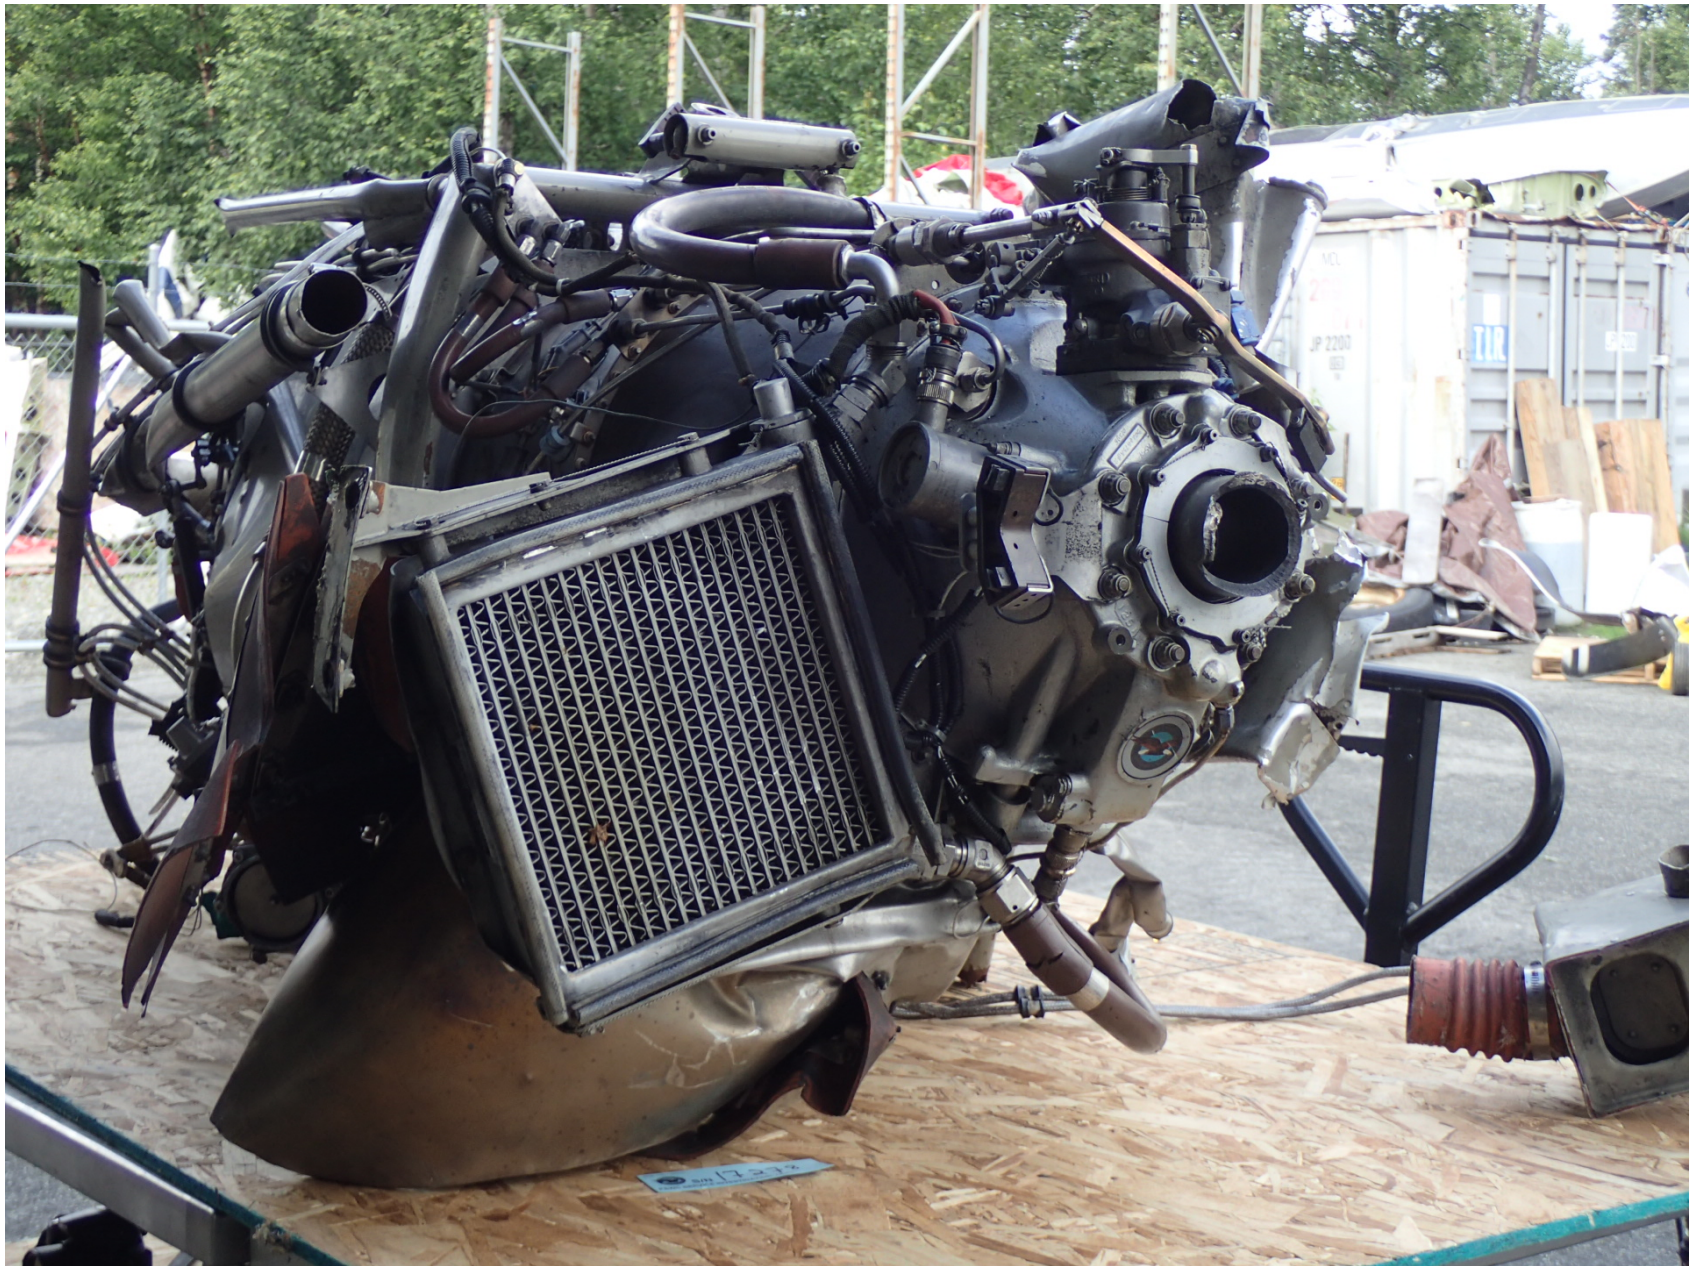
**Photo 8 - Pratt & Whitney PT6-114A turbine engine indicating fractured shaft**

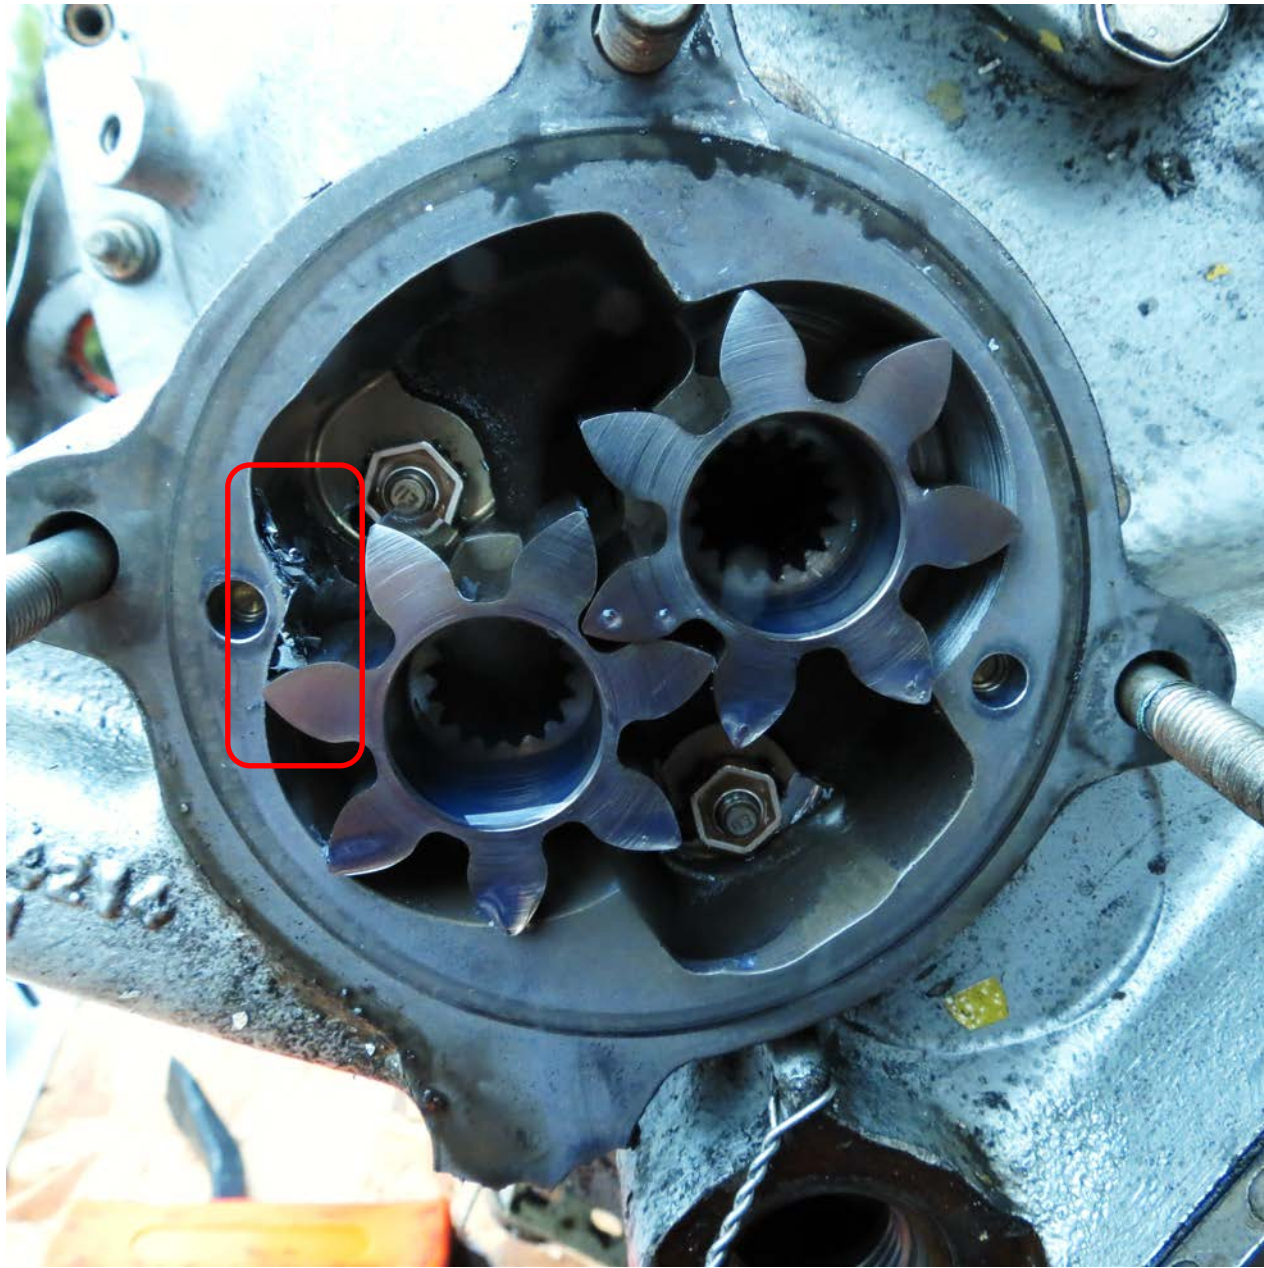
**Photo 9 - No. 3 and 4 bearing scavenge pump indicating metallic debris**

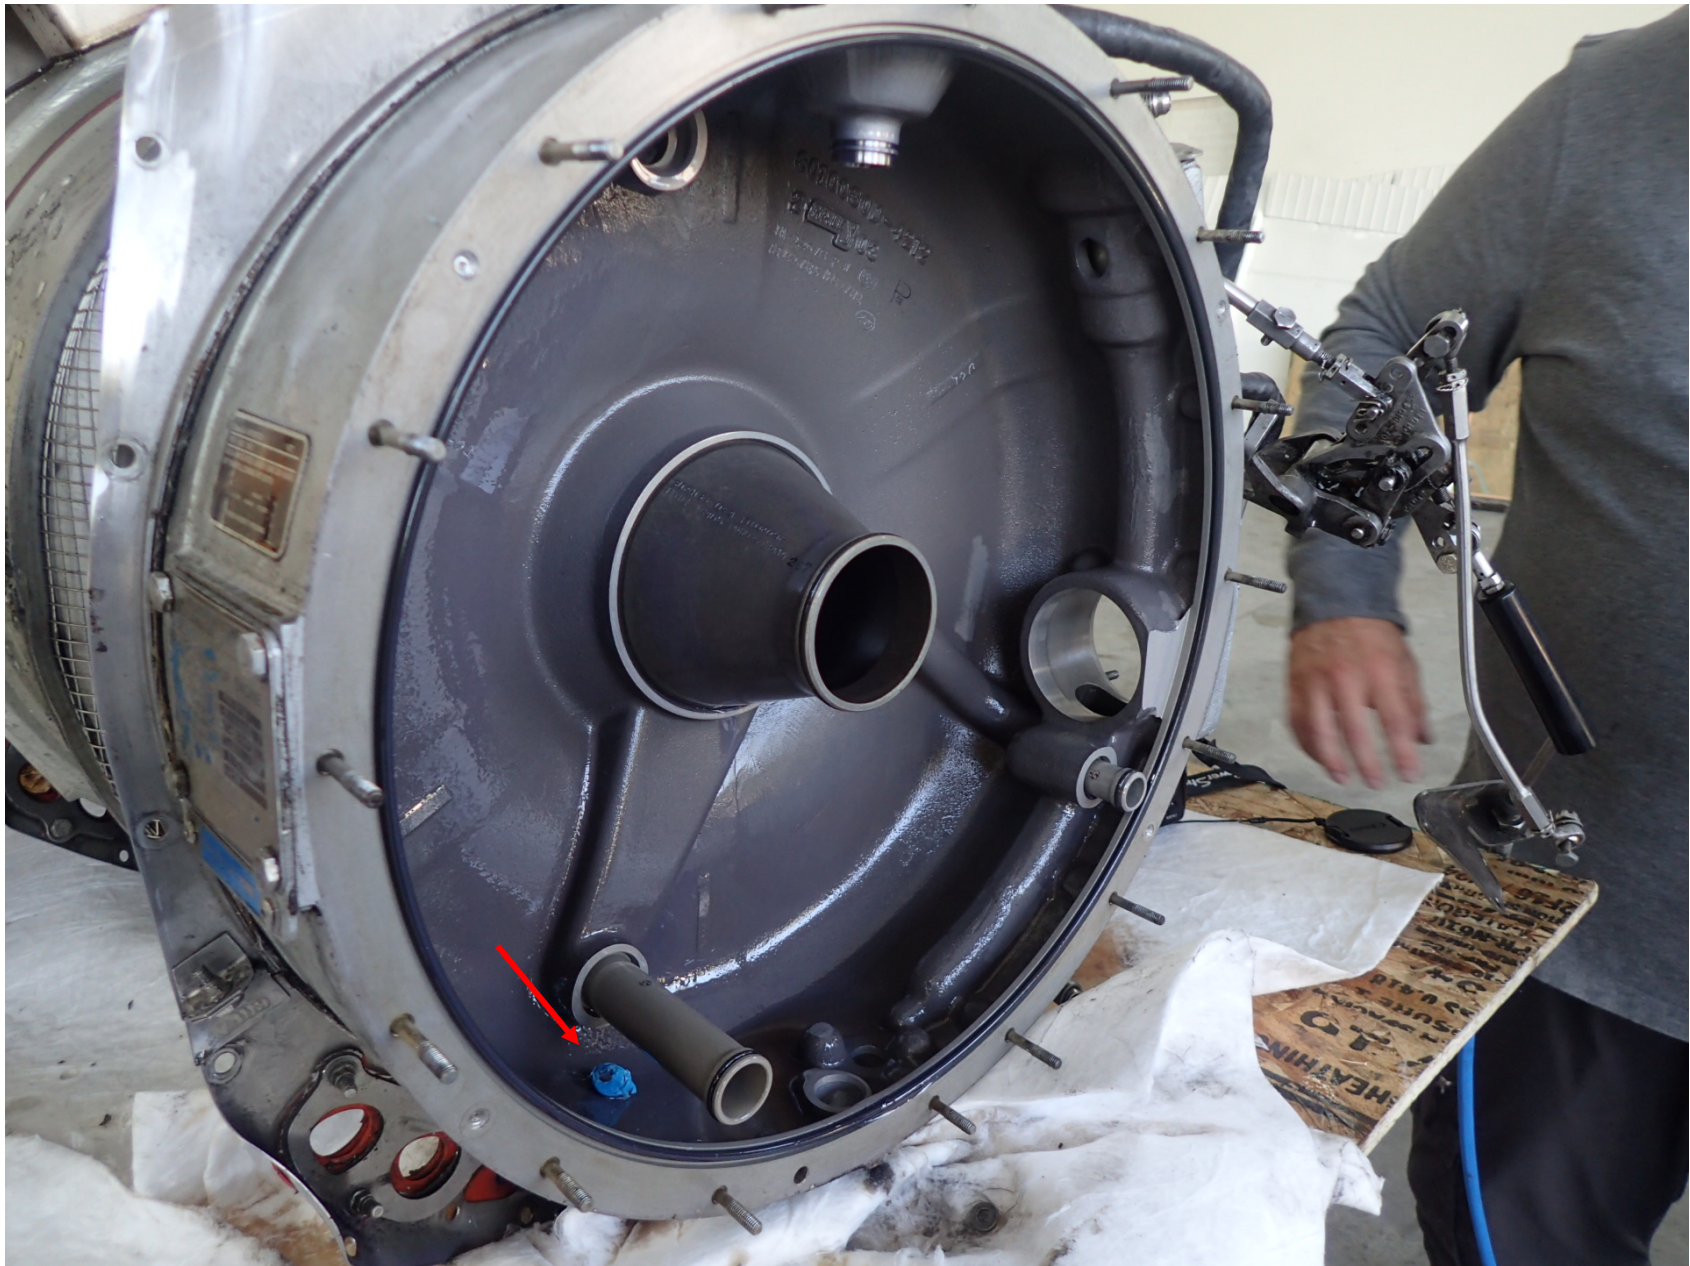
**Photo 10 - Engine oil tank with small blue plastic cap evident**

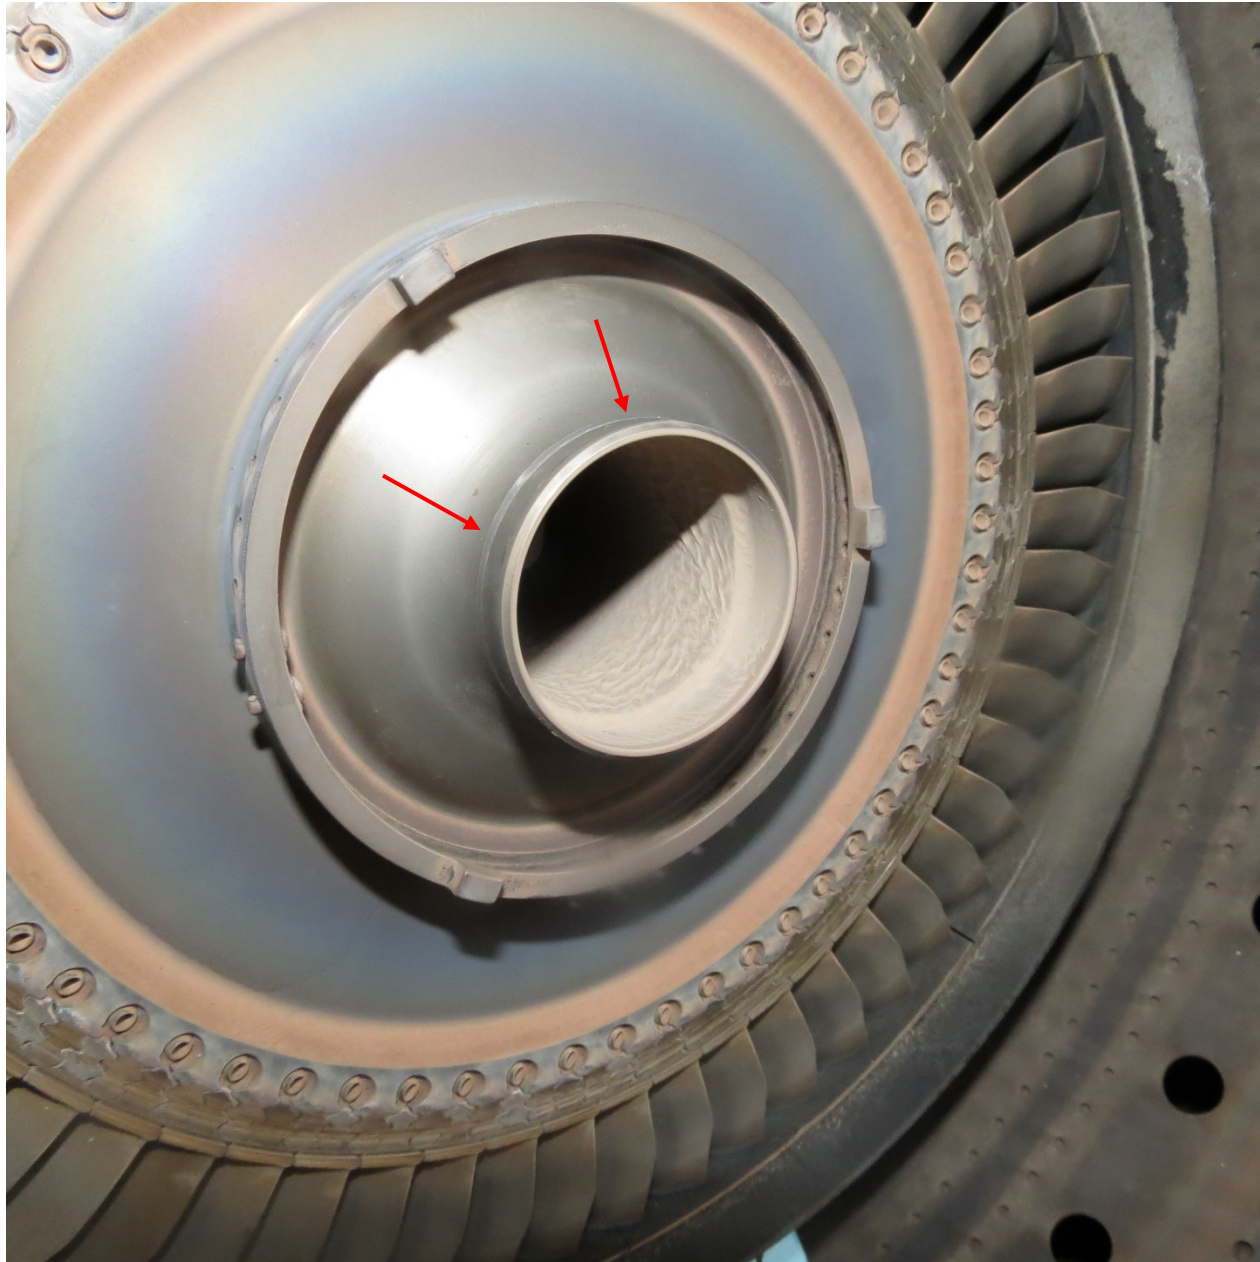
**Photo 11 - Engine Compressor turbine (CT) disk bore area with circumferential rubbing marks**
