# NATIONAL TRANSPORTATION SAFETY BOARD

## MATERIALS LABORATORY FACTUAL REPORT

Report No. 17-069

Place : Bethel, Alaska  
Date : November 11, 2016  
Vehicle : Piper PA-32R-301, N9084J  
NTSB No. : ANC17LA006  
Investigator : Noreen Price, AS-ANC

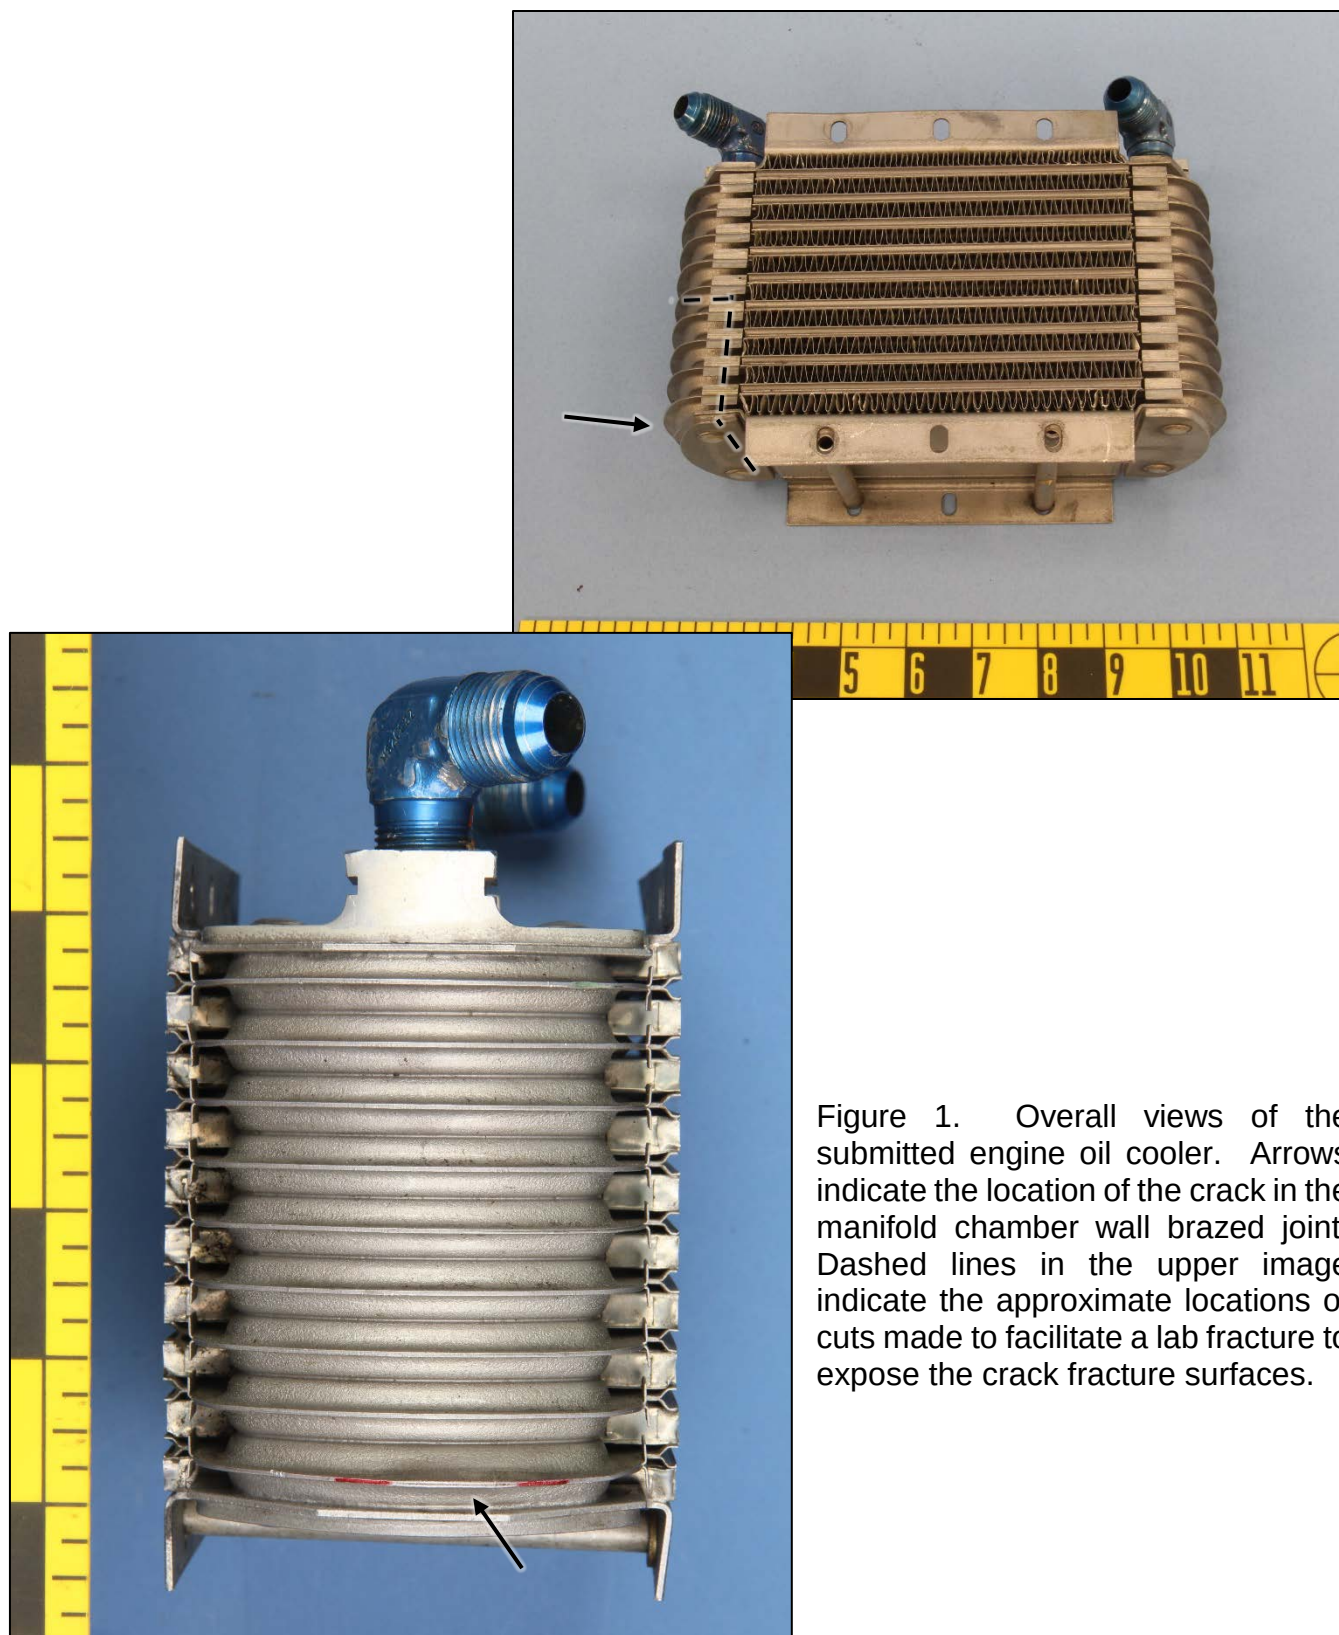
The engine oil cooler submitted for examination is shown in figure 1. The oil cooler was an Aero-Classic part number 8000074, serial number 1041902, manufactured in October, 2009. The oil cooler was cracked at a brazed seam in the manifold at the location indicated with arrows in figure 1. The remainder of the oil cooler was intact and was free of visible deformation or bulging.

Figure 1. Overall views of the submitted engine oil cooler. Arrows indicate the location of the crack in the manifold chamber wall brazed joint. Dashed lines in the upper image indicate the approximate locations of cuts made to facilitate a lab fracture to expose the crack fracture surfaces.

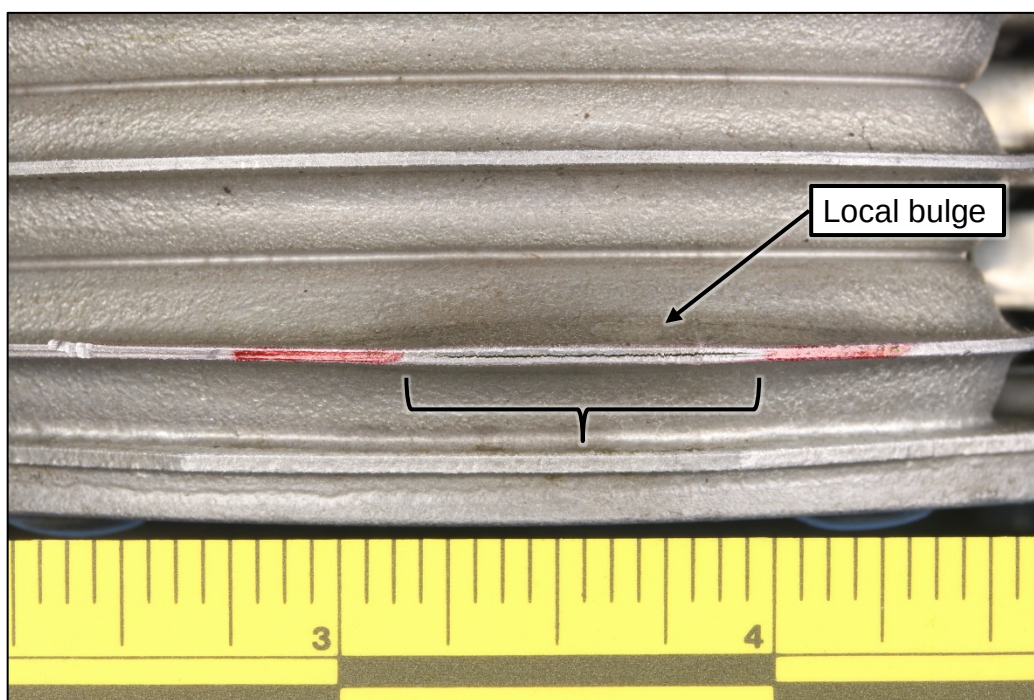
A closer view of the crack is shown in figure 2. The crack intersected the exterior surface of the oil cooler at the area indicated with a bracket in figure 2. Local bulging deformation of the wall adjacent to the crack was observed.

Figure 2. Closer view of the crack as indicated with a bracket.

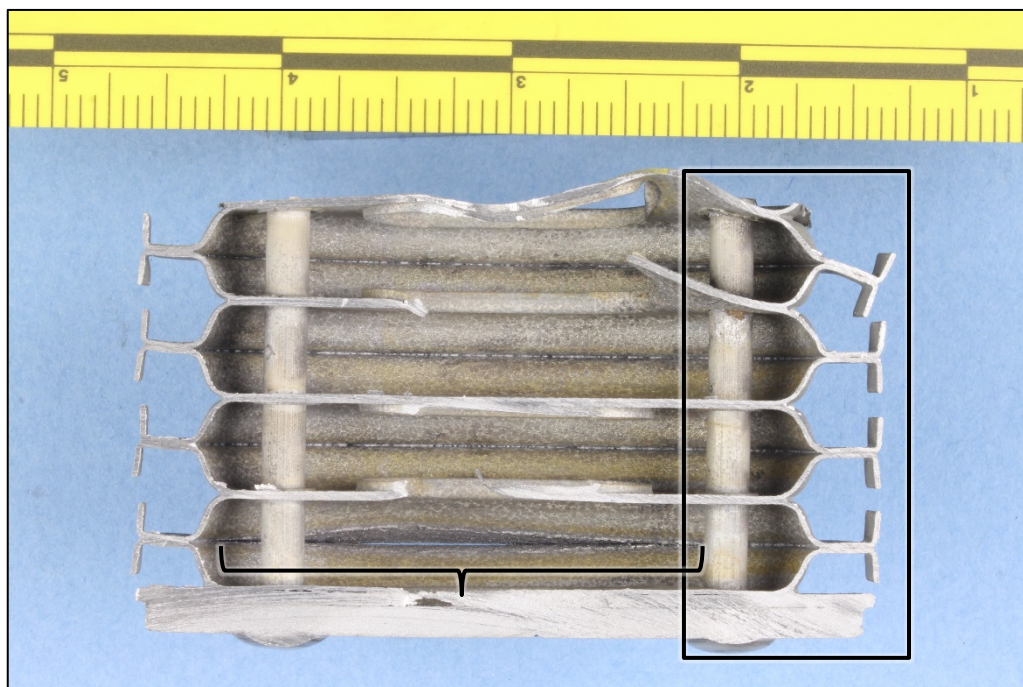
Next, the oil cooler was cut at locations indicated with dashed lines in figure 1 to remove a section of the manifold containing the crack. The sectioned piece was then cleaned in acetone using an ultrasonic cleaner. A view of the interior surface of the cleaned manifold piece is shown in figure 3, and a closer view of the interior edge of the crack is shown in figure 4. A bracket in figure 3 indicates the location of the crack at the interior surface.

Figure 3. View of the manifold interior after sectioning and cleaning with acetone in an ultrasonic cleaner. The rectangle indicates the area of the cross-section prepared for metallographic examination, and a bracket indicates the crack location.

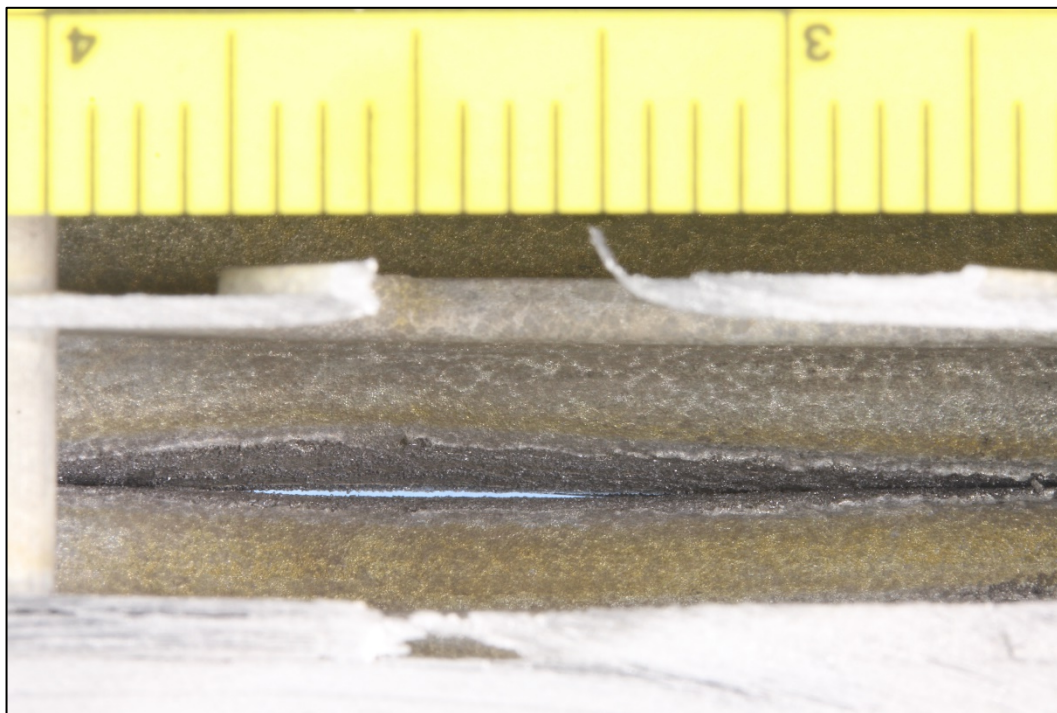
Figure 4. Closer view of the manifold interior at the crack location.

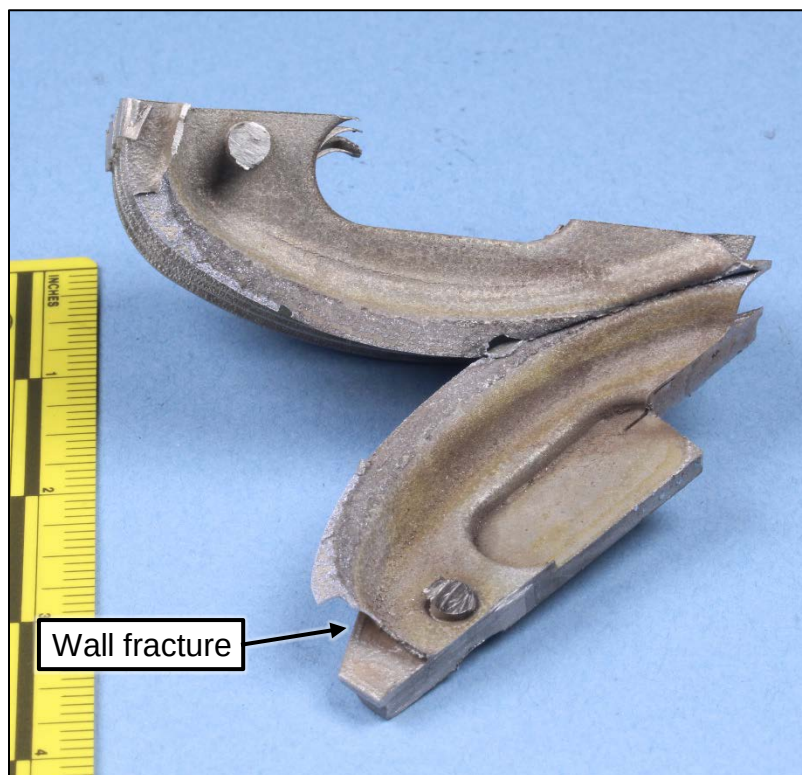
of the seam. Walls of the manifold deformed during the lab fracture process, and in some areas, the wall fractured, leaving the seam intact (see figure 5).

Figure 5. Lab fracture to open the crack.

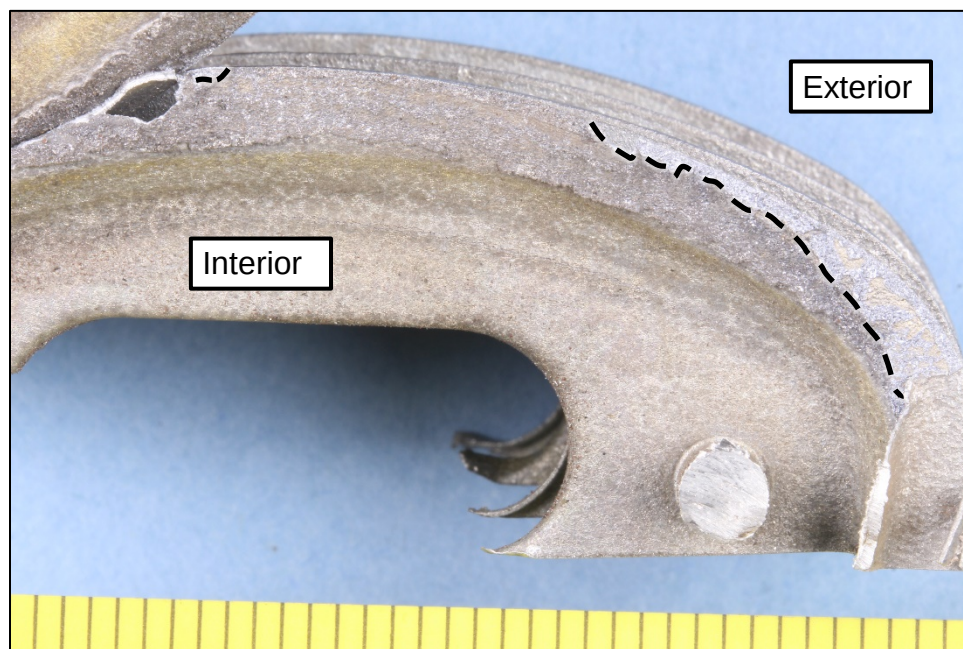
A view of the exposed crack is shown in figure 6. The surface of the crack had a dark color compared to the lab-induced fracture surfaces. Dashed lines in figure 6 indicate the crack boundary. The overall shape of the crack was consistent with initiation from the interior of the manifold. The dark color associated with the crack appeared relatively uniform from the interior to exterior with no indication of crack arrest marks or progressive levels of staining of the surface.

Figure 6. Photograph of the crack as exposed by lab fracture. Dashed lines indicate the crack boundary.

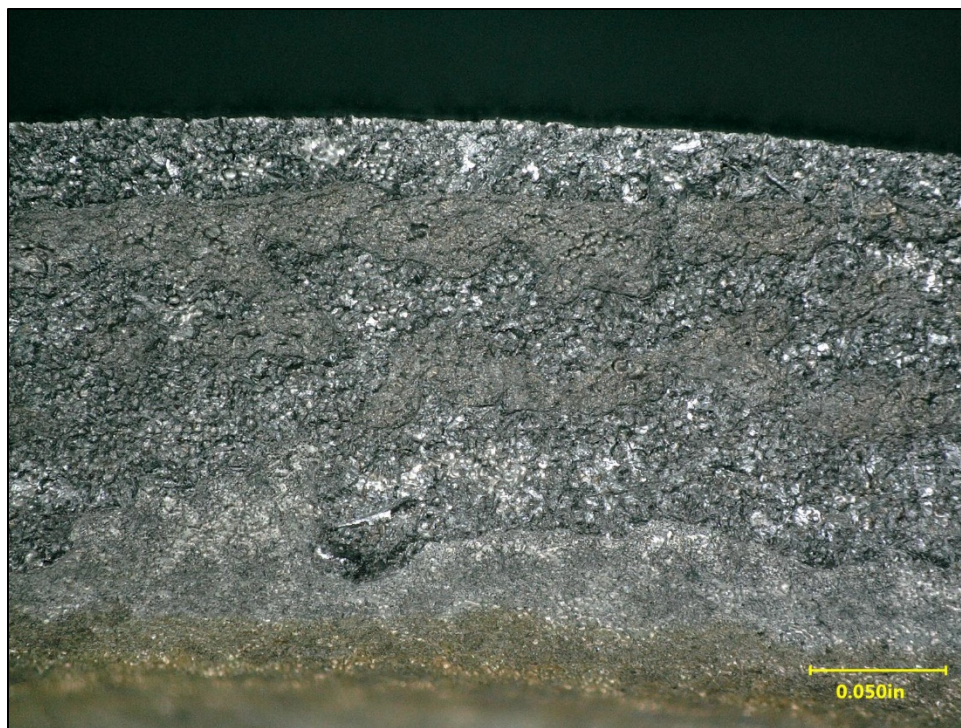
A magnified optical image of the crack fracture surface in an area where the crack extended through the brazed joint is shown in figure 7. The fracture surface had areas with two different general characteristics. Some areas of the crack surface had a brownish gray appearance generally with rounded features in low areas on the fracture surface. Higher areas of the fracture surface had a more silver-gray color with rougher faceted features. The outer edge of the surface consisted entirely of the silver gray area, and the remainder of the surface was intermixed with the two characteristic areas. Overall, approximately half the crack surface was characterized by the features with the brownish gray color, and the remaining half was characterized by the features with the silver-gray color. Similar characteristics were observed on the lab fracture where the brownish gray and silver-gray areas from the crack had a shinier gold color and a lighter silver color, respectively, as shown in figure 8.

Figure 7. Magnified optical image of the crack fracture surface near the middle of the crack.

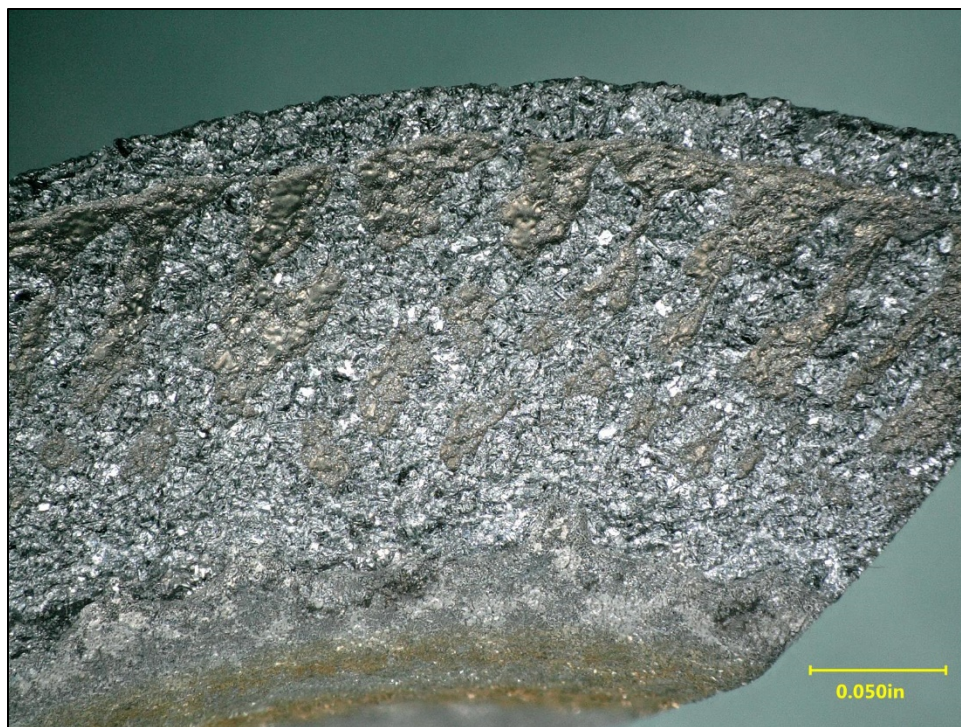
Figure 8. Magnified optical image of the lab-induced fracture surface beyond the crack boundary.

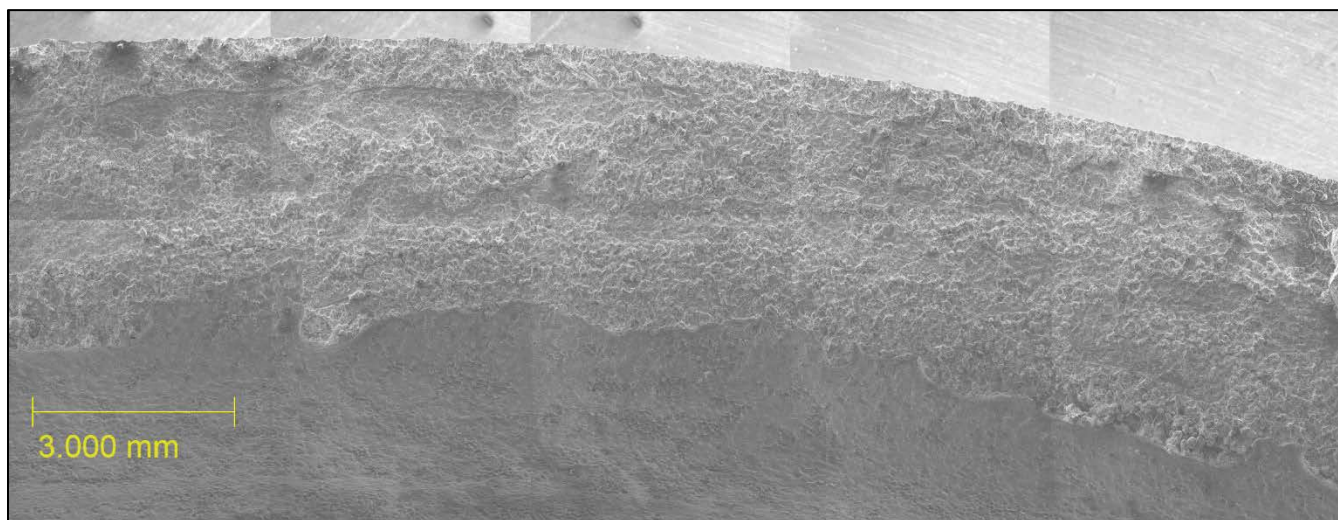
After an initial examination, the lab fracture of the seam was completed by peeling the pieces shown in figure 5 apart the rest of the way, producing both wall fractures and fractures along the seam. The smaller piece was then examined using a scanning electron microscope (SEM). SEM images of the crack surface are shown in figures 9 through 11. The areas that appeared brownish gray in optical images had rounded features with dendritic shapes on the surface, features consistent with a void. The silver—gray areas generally showed quasicleavage fracture features where tear ridges and isolated dimples were intermixed with cleavage fracture features. No evidence of crack arrest lines or striations were observed. Similar features consistent with voids and quasicleavage fracture were also observed in areas associated with the lab-induced fracture.

Figure 9. SEM images stitched together to show a portion of the crack fracture surface.

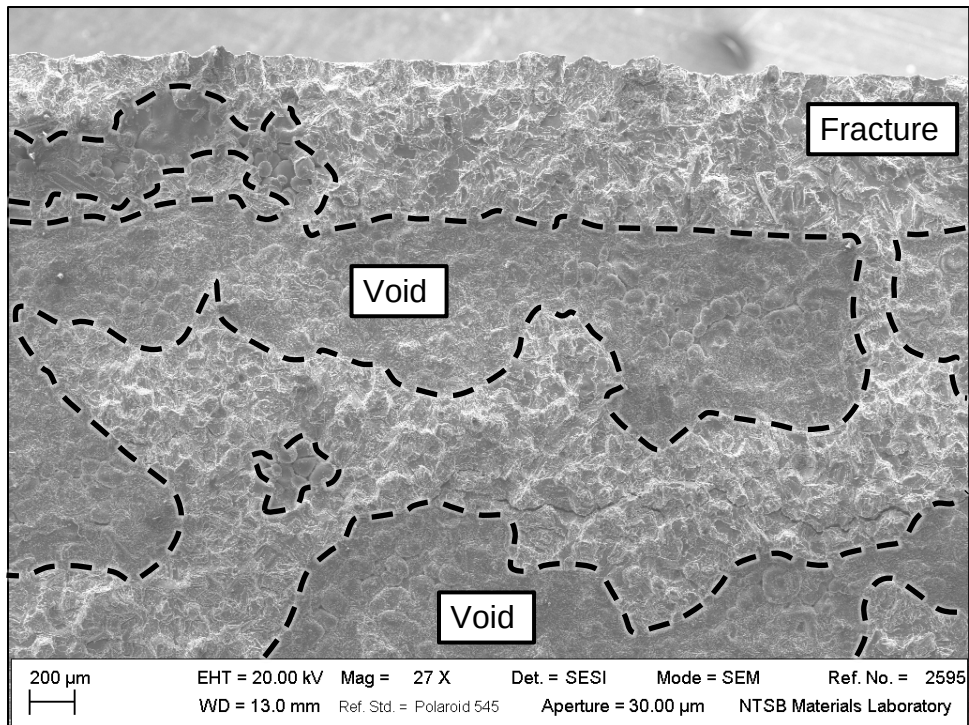
Figure 10. SEM image of an area of the crack fracture surface. Dashed lines indicate boundaries between voids and fractured surfaces.

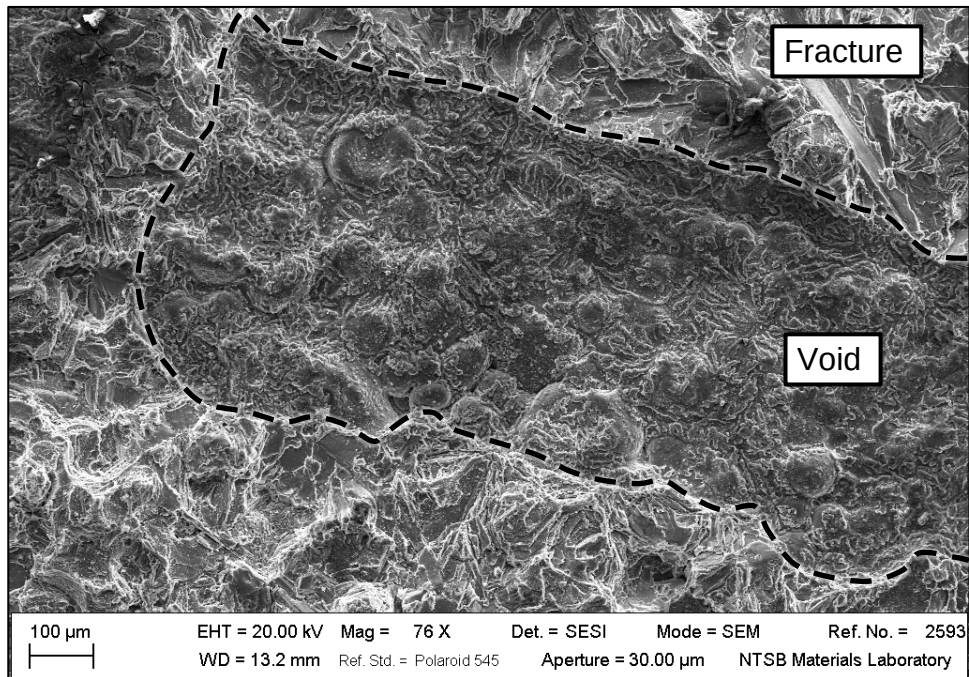
Figure 11. SEM image at higher magnification showing void and fracture surface features.

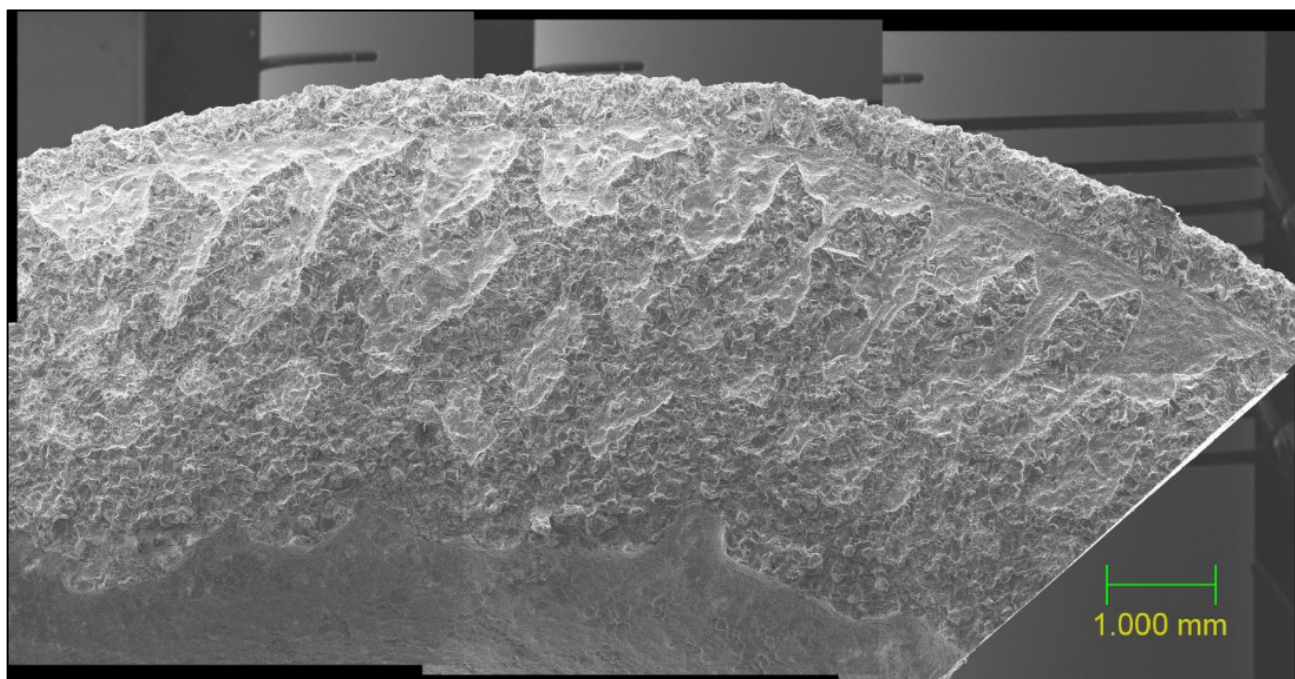
Figure 12. SEM images stitched together to show a portion of the lab-induced fracture surface features.

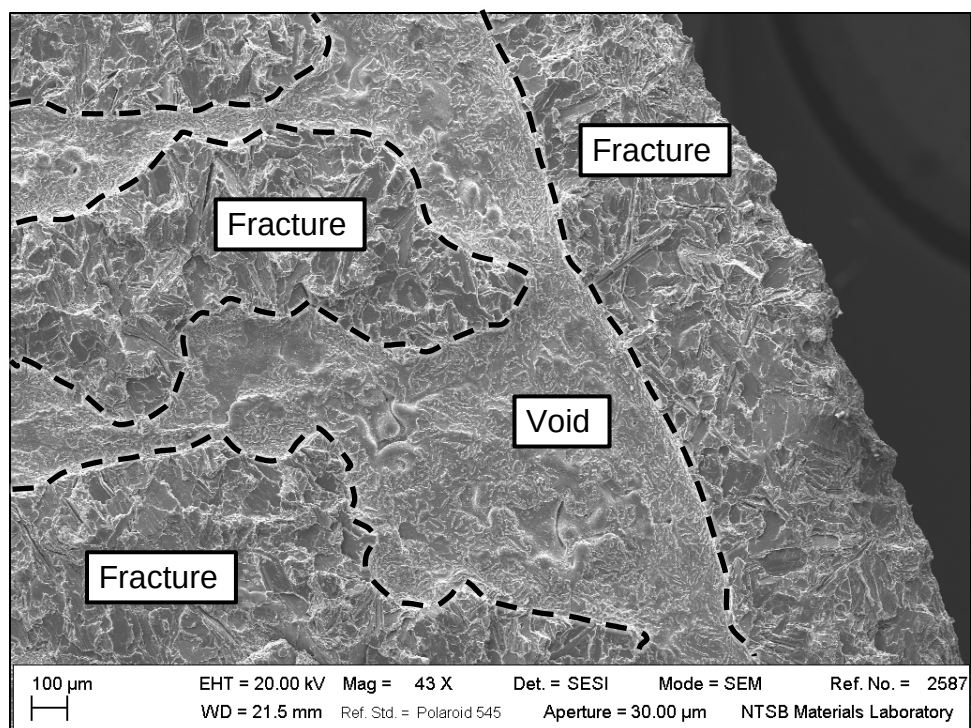
Figure 13. SEM image of lab fracture features where dashed lines indicate boundaries between voids and fractured surfaces.

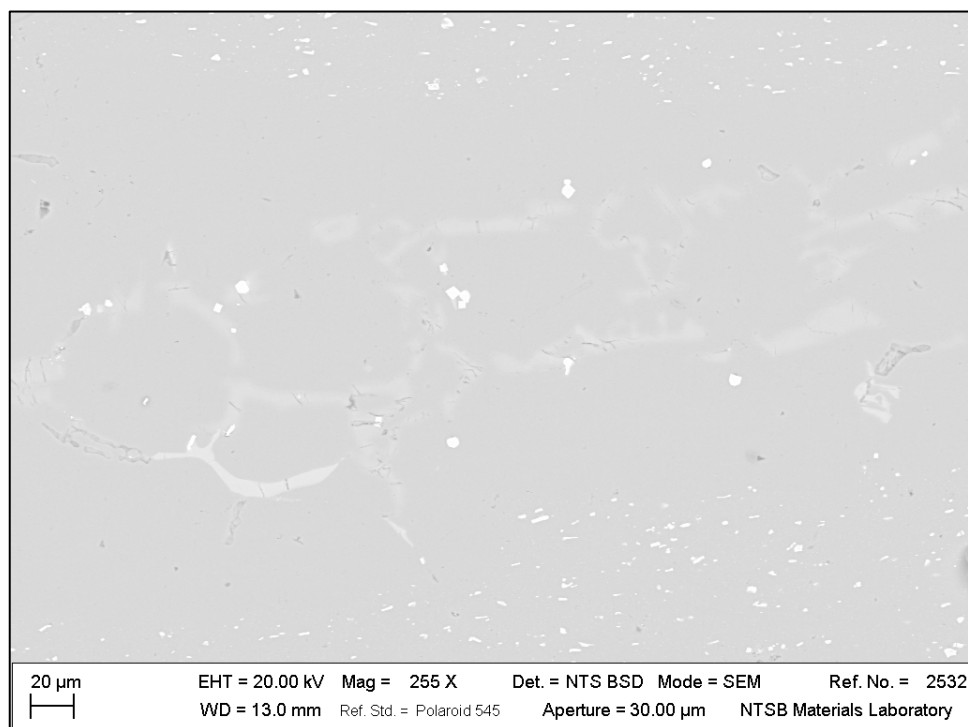
The mount containing the 3 seams was examined using an SEM. An image of the seam interface in one of the seams is shown in figure 14 as viewed in the SEM using the

backscattered electron detector in composition mode.<sup>1</sup> The composition of the features of the interface were also analyzed and mapped using energy dispersive x-ray spectroscopy (EDS). The bulk of the area had a high peak of aluminum in the EDS spectrum. Small areas appearing nearly white scattered across the image in figure 14 were associated with concentrations of iron and manganese, consistent with a 3xxx-series aluminum alloy. The phases appearing a slightly lighter shade of gray relative to the background in a band across the middle of the image were associated with concentrations of silicon, consistent with a 4xxx-series aluminum alloy. Sheet consisting of 3xxx-series aluminum alloy clad with a 4xxx-series aluminum alloy is commonly used for vacuum brazing of heat transfer components.

Figure 14. SEM image of a brazed seam in the metallurgical mount as viewed using a backscattered electron detector in composition mode. Phases containing higher concentrations of iron and manganese appear nearly white, and phases with a high concentration of silicon appear a slightly lighter shade of gray relative to the background.
