## **NATIONAL TRANSPORTATION SAFETY BOARD**

### **Engine Examination Summary**

NTSB Number: ANC17LA006  
Location: Bethel, Alaska  
Date: November 11, 2016  
Aircraft: Piper PA-32R-301, N9084J  
Engine: Lycoming IO-540-K1G5, SN RL-26585-48E  
Engine TT: 2266.8 hours  
Engine TSOH: 213.4 hours  
Last Inspect: 8/31/16

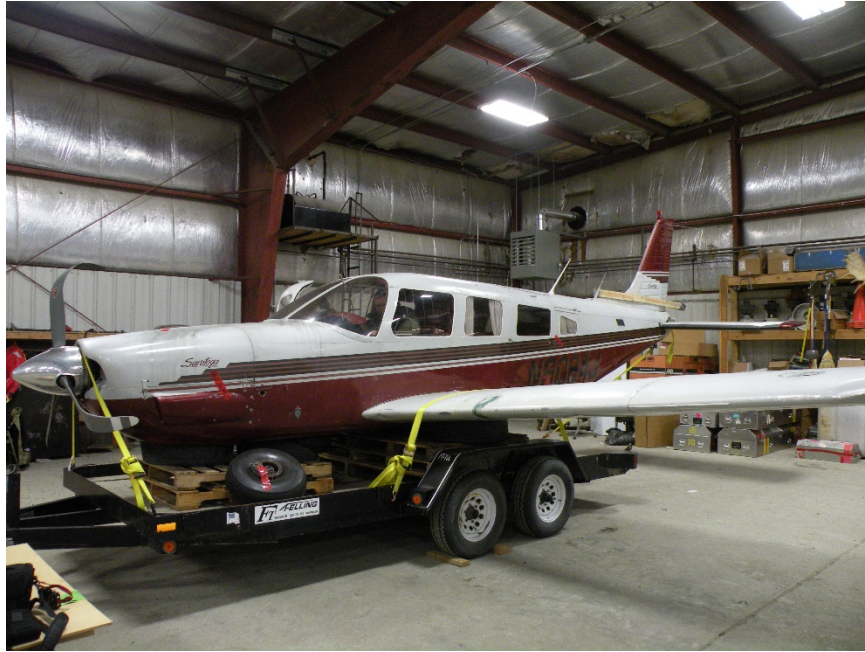
- The airframe sustained substantial damage to the left wing and fuselage. Refer to figure 1.
- The engine remained attached via all mounts to the airframe. Refer to figure 2.

*Figure 1. N9084J PA-32-301 at the Bethel hangar*

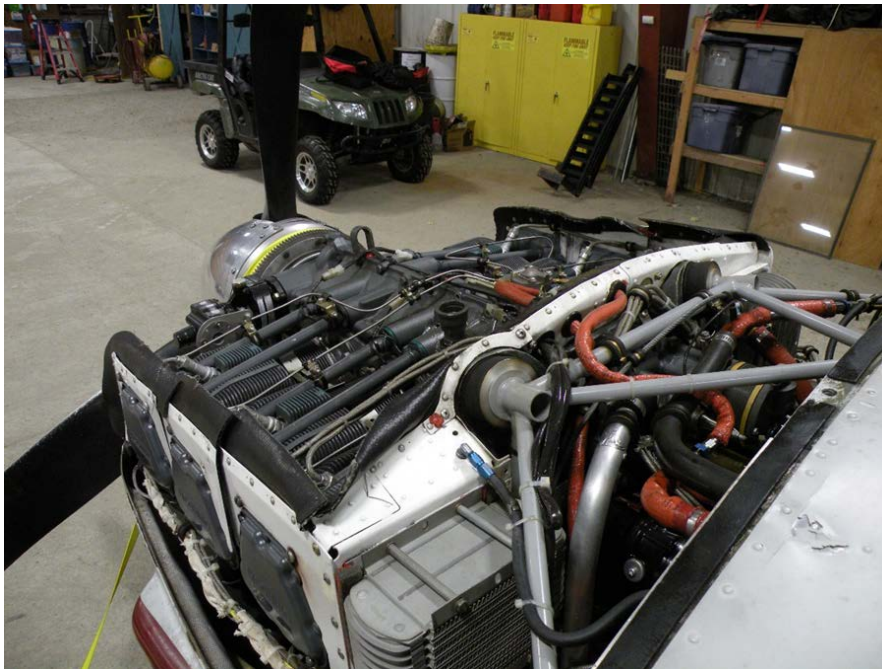
*Figure 2. Top view of Lycoming IO-540-K1G5 engine*

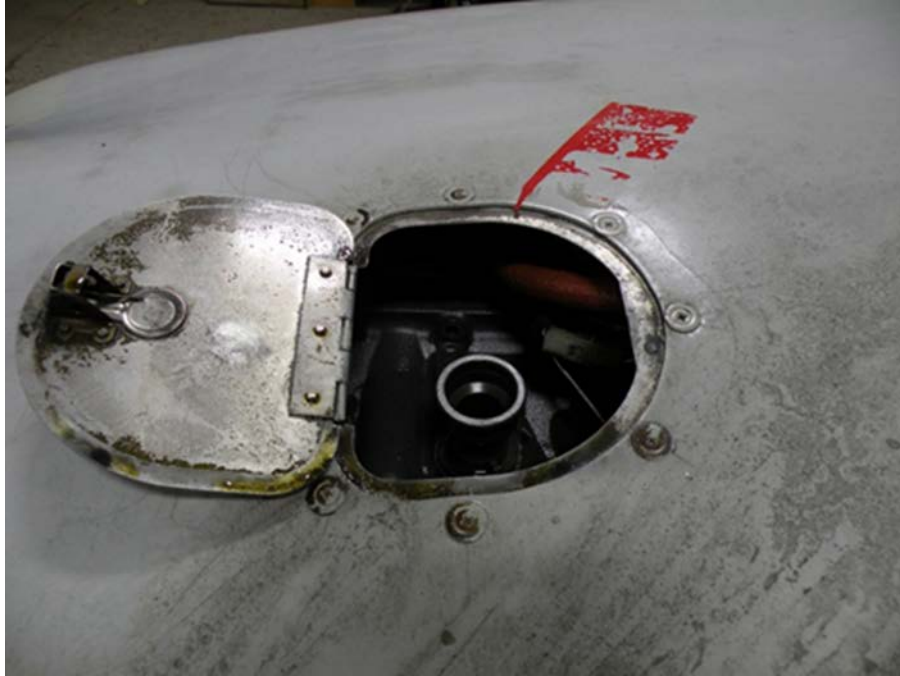
- All accessible fuel and oil lines remained secure to their respective fittings.
- The oil dipstick was missing. The oil access panel had outward radial scratches and shiny surface area near the center of the underside that corresponded to the size of the dipstick top. Refer to figure 3. The latching mechanism operated normally.

*Figure 3. Oil dipstick access panel*

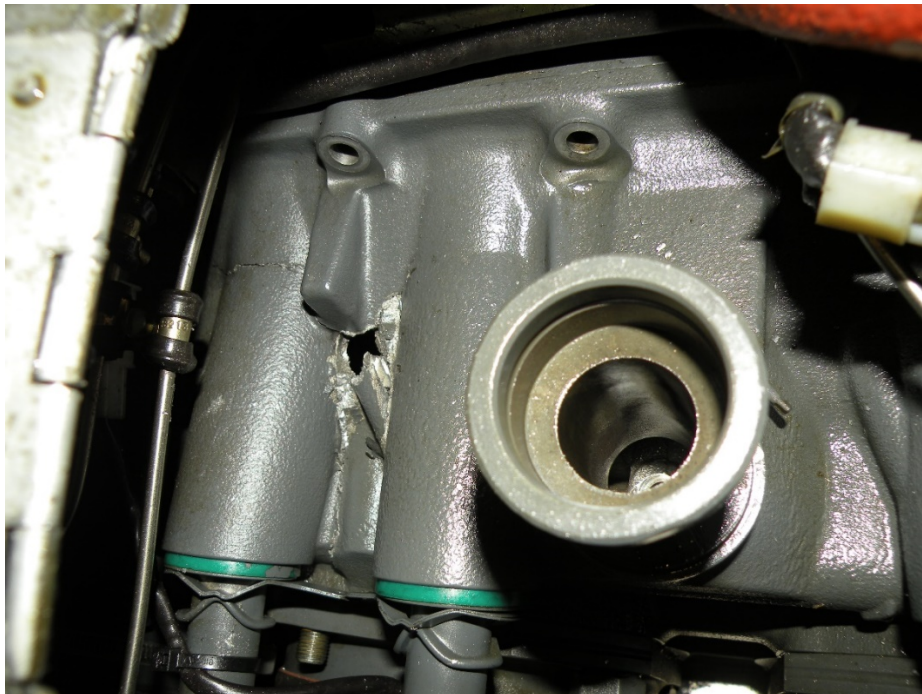
- The left (2/4/6 cylinder) side of the crankcase exhibited a 0.4-inch hole at the top of the no. 4 cylinder bay. Refer to figure 4.
- Two fractures about 5 inches each, emanated from the hole and across the top of the case.

- The two spine attachment bolts above cylinder 4 were both missing.
- Two of the four nuts on number 4 cylinder base were backed off. One nut was missing.

*Figure 4. Hole in the crank case near the no.4 cylinder, no oil dipstick present*

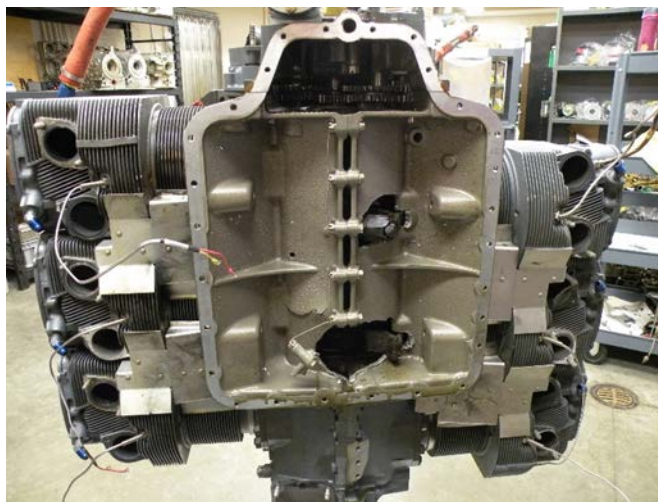
The oil sump pan was removed and large quantities of metal debris and fractured rods were observed. Two large holes were evident on the bottom of the crank case inboard of the no. 3 and no. 5 cylinders near the spine. One 4 inch fracture was located inboard of the no. 4 cylinder. Refer to figure 5. The oil suction screen was removed and indicated pieces of non-ferrous metal particles. The thermostatic oil cooler bypass valve was removed and examined. The crimp nut and valve seat remained intact and the spring was secure. Refer to figure 6. The oil pump impeller turned with no anomalies observed.

*Figure 5. Bottom of fractured crank case*

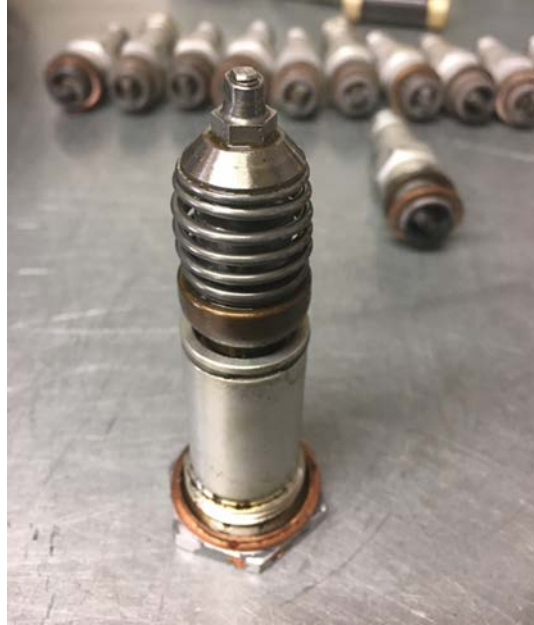
*Figure 6. Oil cooler thermostatic bypass valve*

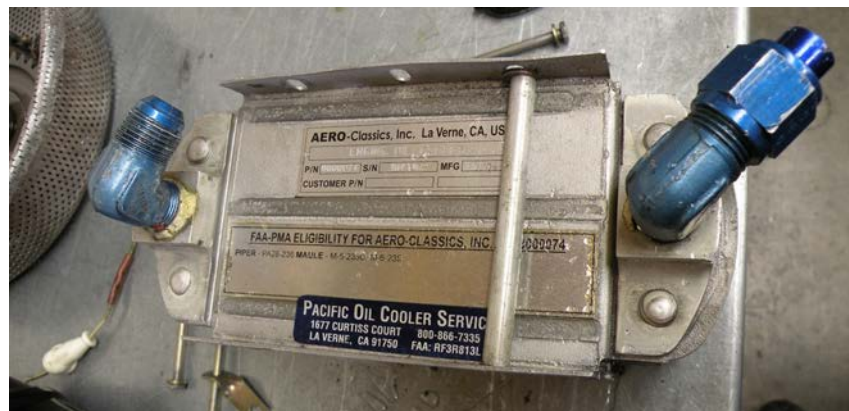
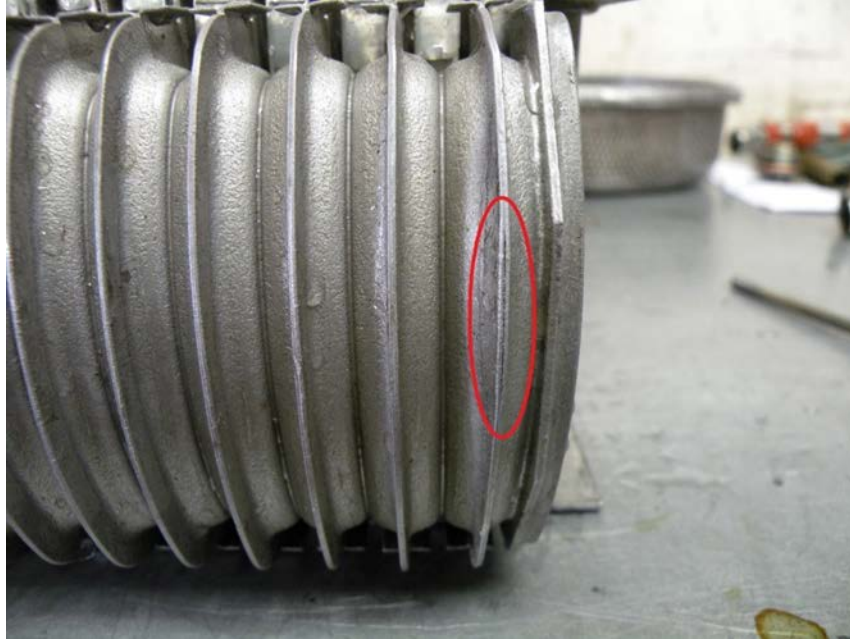
The oil coolers were each capped off at one end and 100 psi air pressure was applied. The left oil cooler exhibited no leaks. The right oil cooler (Aero-Classics, Inc. P/N 8000074, S/N 1041902) exhibited an air leak through a 2 inch separation at a mated brazed plate that was undetected during a visual exam. Refer to figures 7 and 8. The right oil cooler was sent to the NTSB Materials laboratory for detailed examination.

*Figure 7. Aero-Classic Oil Cooler, (right)*

*Figure 8. Aero-Classic oil cooler with fracture at seam*

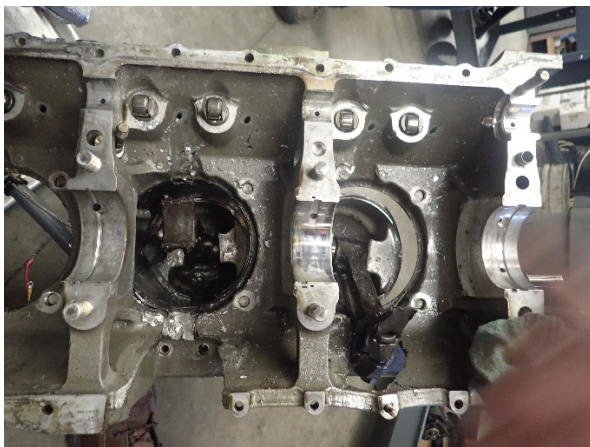
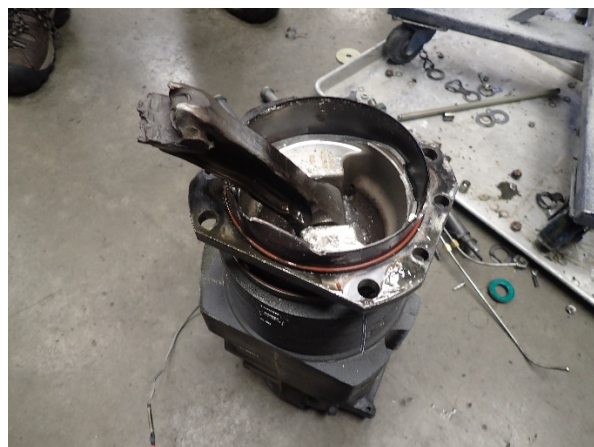
An examination of the no. 1 cylinder revealed no evidence of foreign object damage or mechanical malfunction. The no. 2 and 6 connecting rods were in place; however, the no. 2 rod had dark discoloration and extrudence at the rod cap and no. 6 piston skirt exhibited extensive scoring and carbon deposits in the direction of travel. The no. 3, 4 and 5 connecting rods were separated from the crankshaft by rod shank fractures with extensive thermal discoloration and deformation. Refer to figure 9. Signatures were all indicative of engine operation without sufficient oil lubrication.

*Figure 9. No. 3 and 5 connecting rod fractures and deformation (left) and no. 4 cylinder, piston and damaged connecting rod (right)*

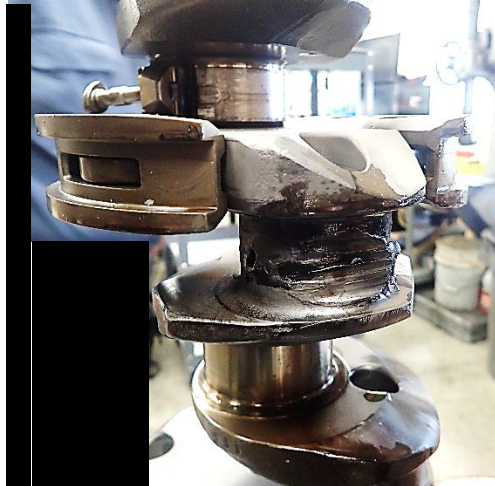
The crank shaft exhibited extensive thermal discoloration and deformation at the middle crankpin journals. Refer to figure 10.

*Figure 10. Crank shaft thermal discoloration and deformation*

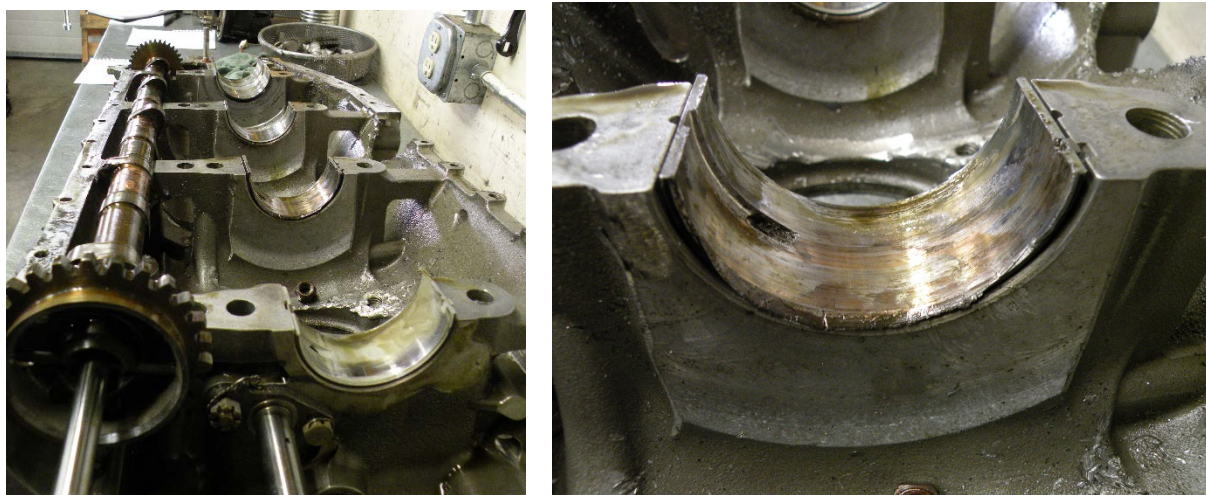
The no. 1 main crank shaft bearing (forward) remained intact with normal wear signatures. The no. 2 main bearing was displaced with some black scoring present. The no. 3 main bearing exhibited thermal discoloration and deformation indicative of oil starvation. The no. 4 bearing (rear) exhibited minor thermal damage. Refer to figure 11.

*Figure 11. Cam shaft and crank shaft bearings(left), no. 3 main bearing (right)*
