**Photo 1 – N9084J PA-32R-301 at the accident scene near Bethel. (Compliments of Alaska State Troopers)**

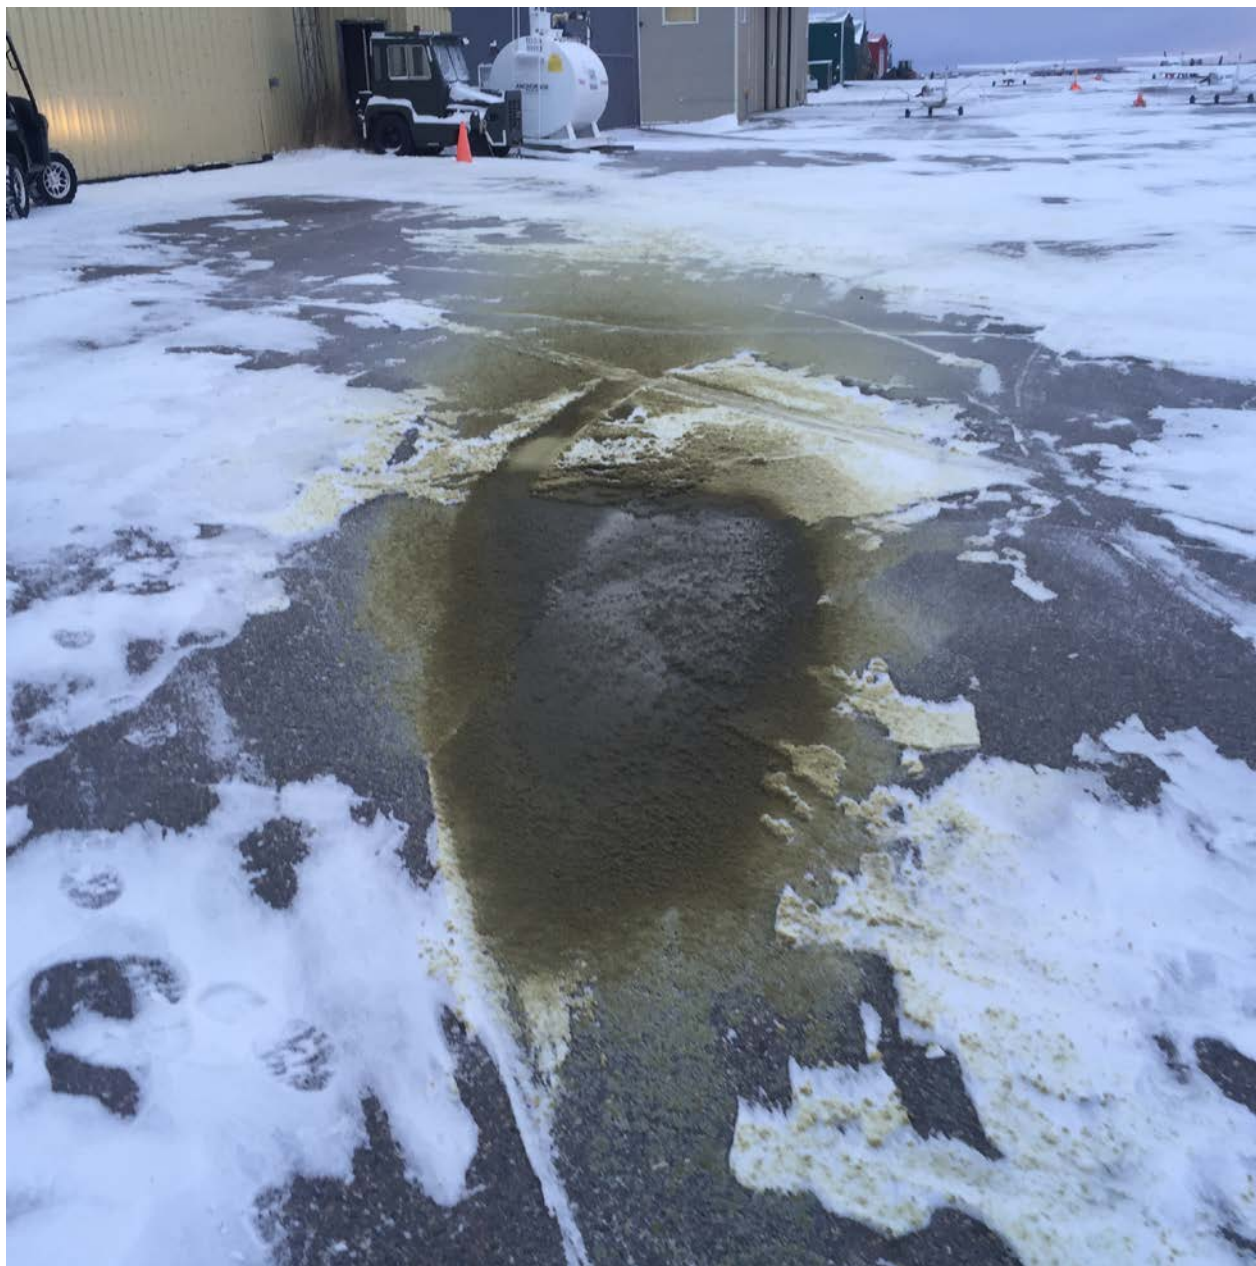
**Photo 2 - Engine Oil deposit on the airport ramp. (Compliments of Alaska State Troopers)**

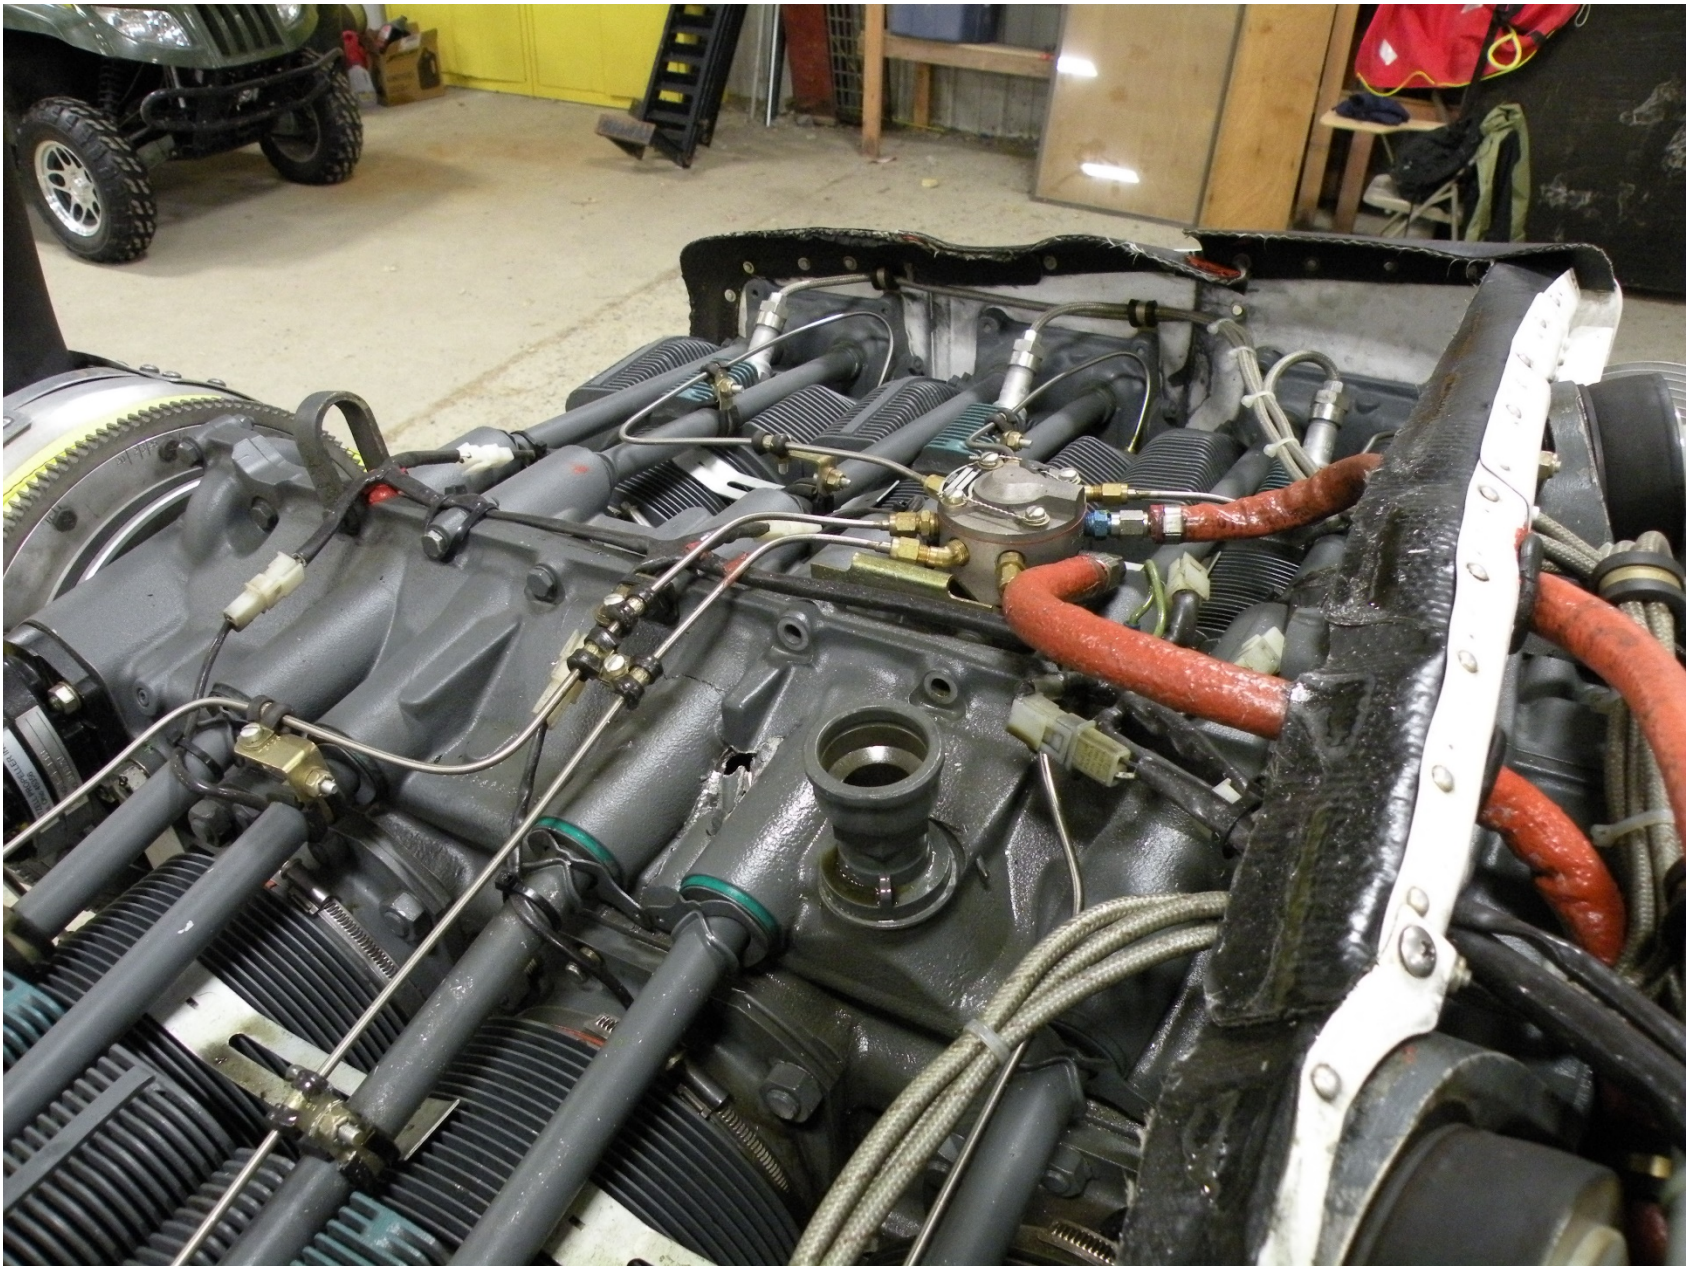
**Photo 3 - Top left view of Lycoming IO-540-K1G5 exhibiting a hole and fractures at the no. 4 cylinder and a missing oil dipstick.**

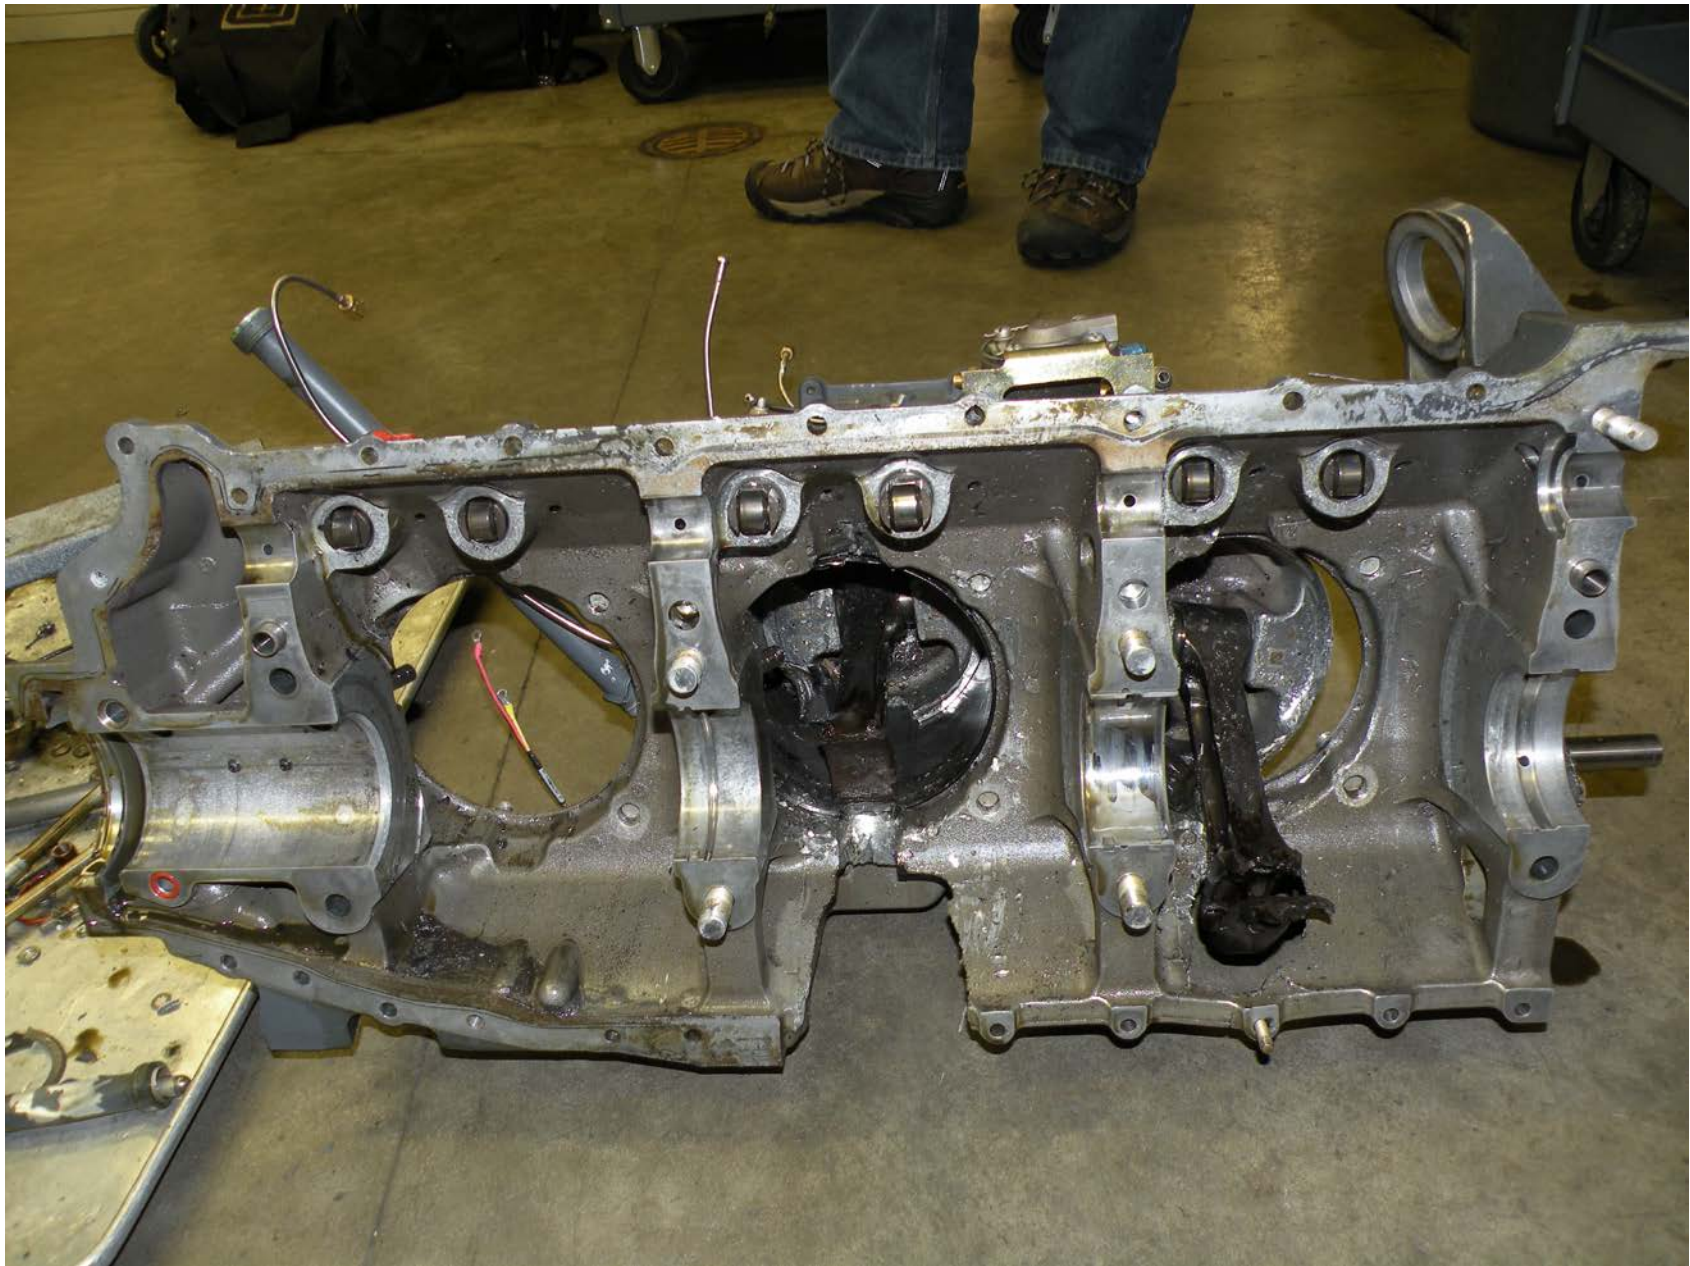
**Photo 4 - No. 3 and 5 pistons and connecting rods exhibiting thermal damage and fractures.**

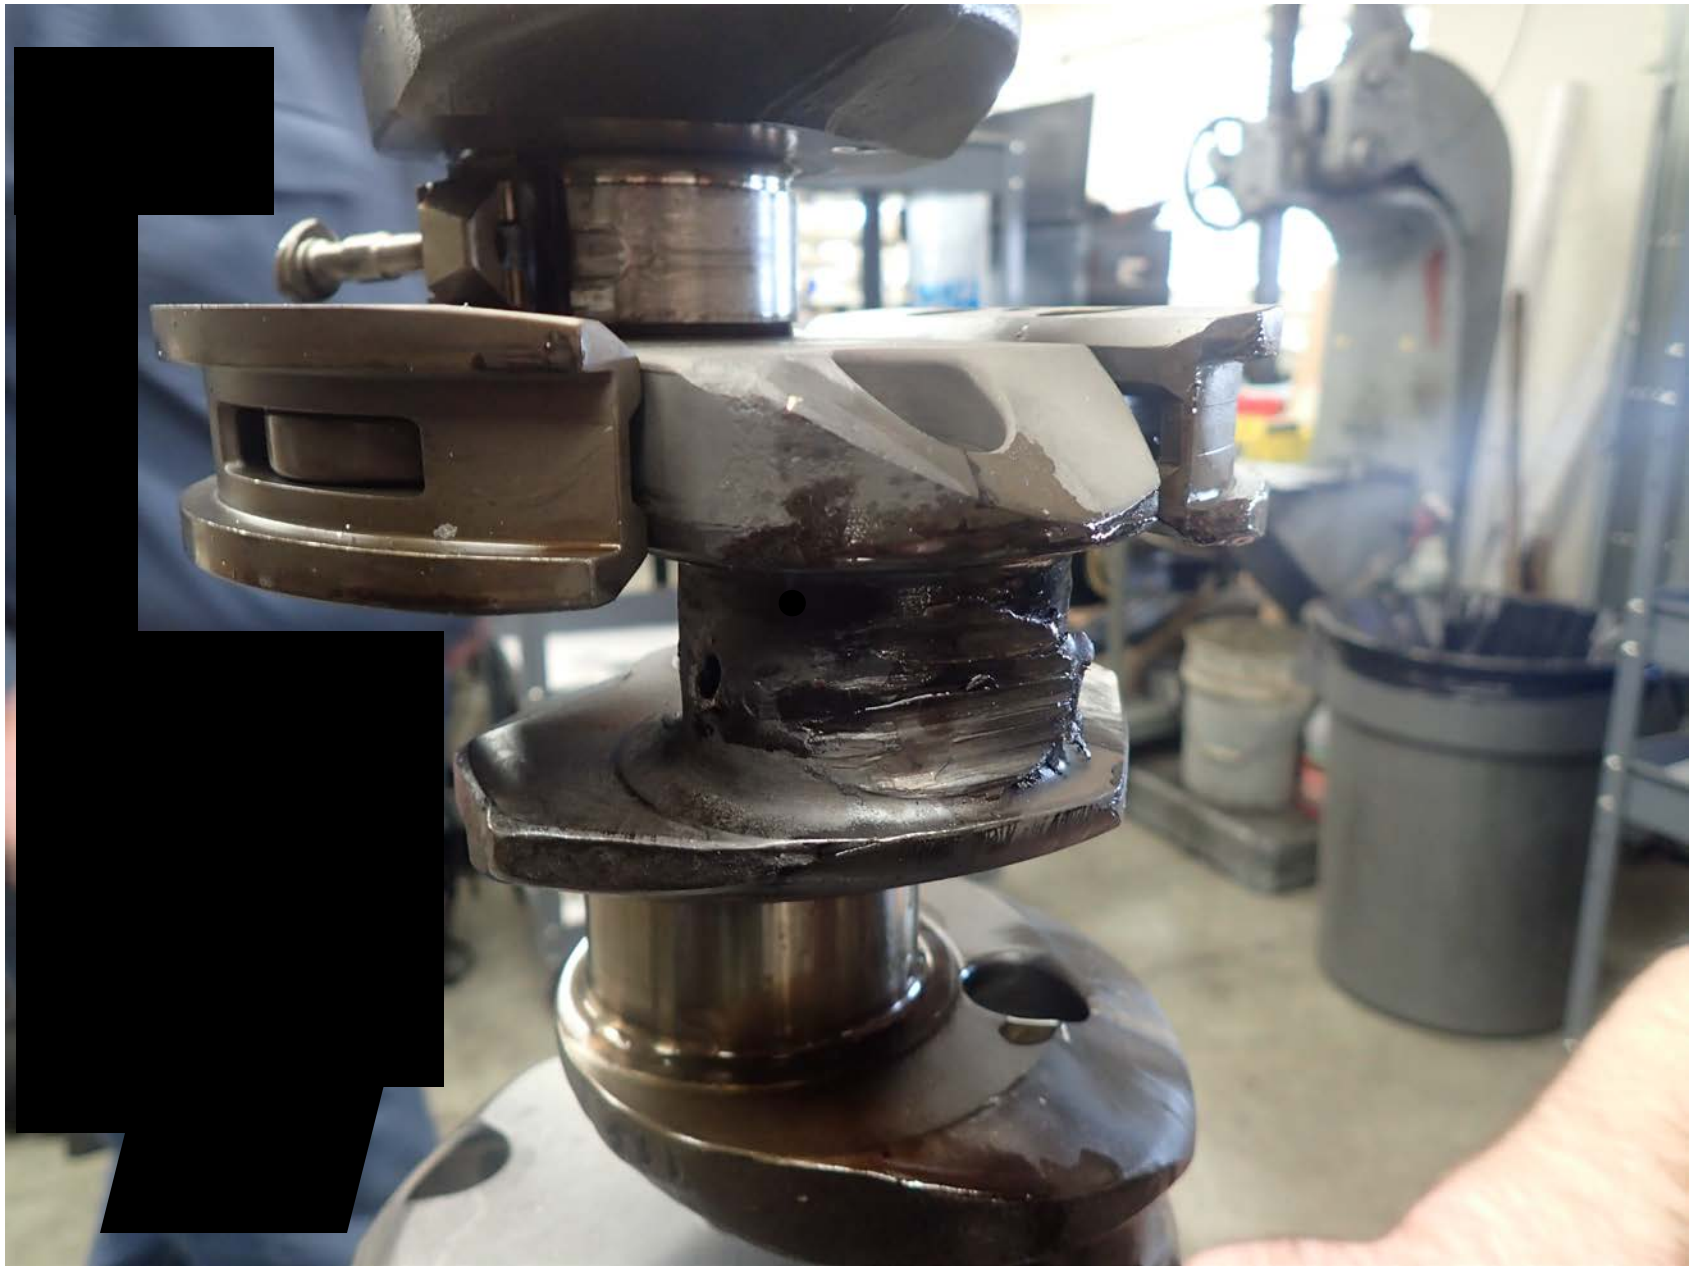
**Photo 5 - Crank shaft journals exhibiting thermal discoloration and damage.**

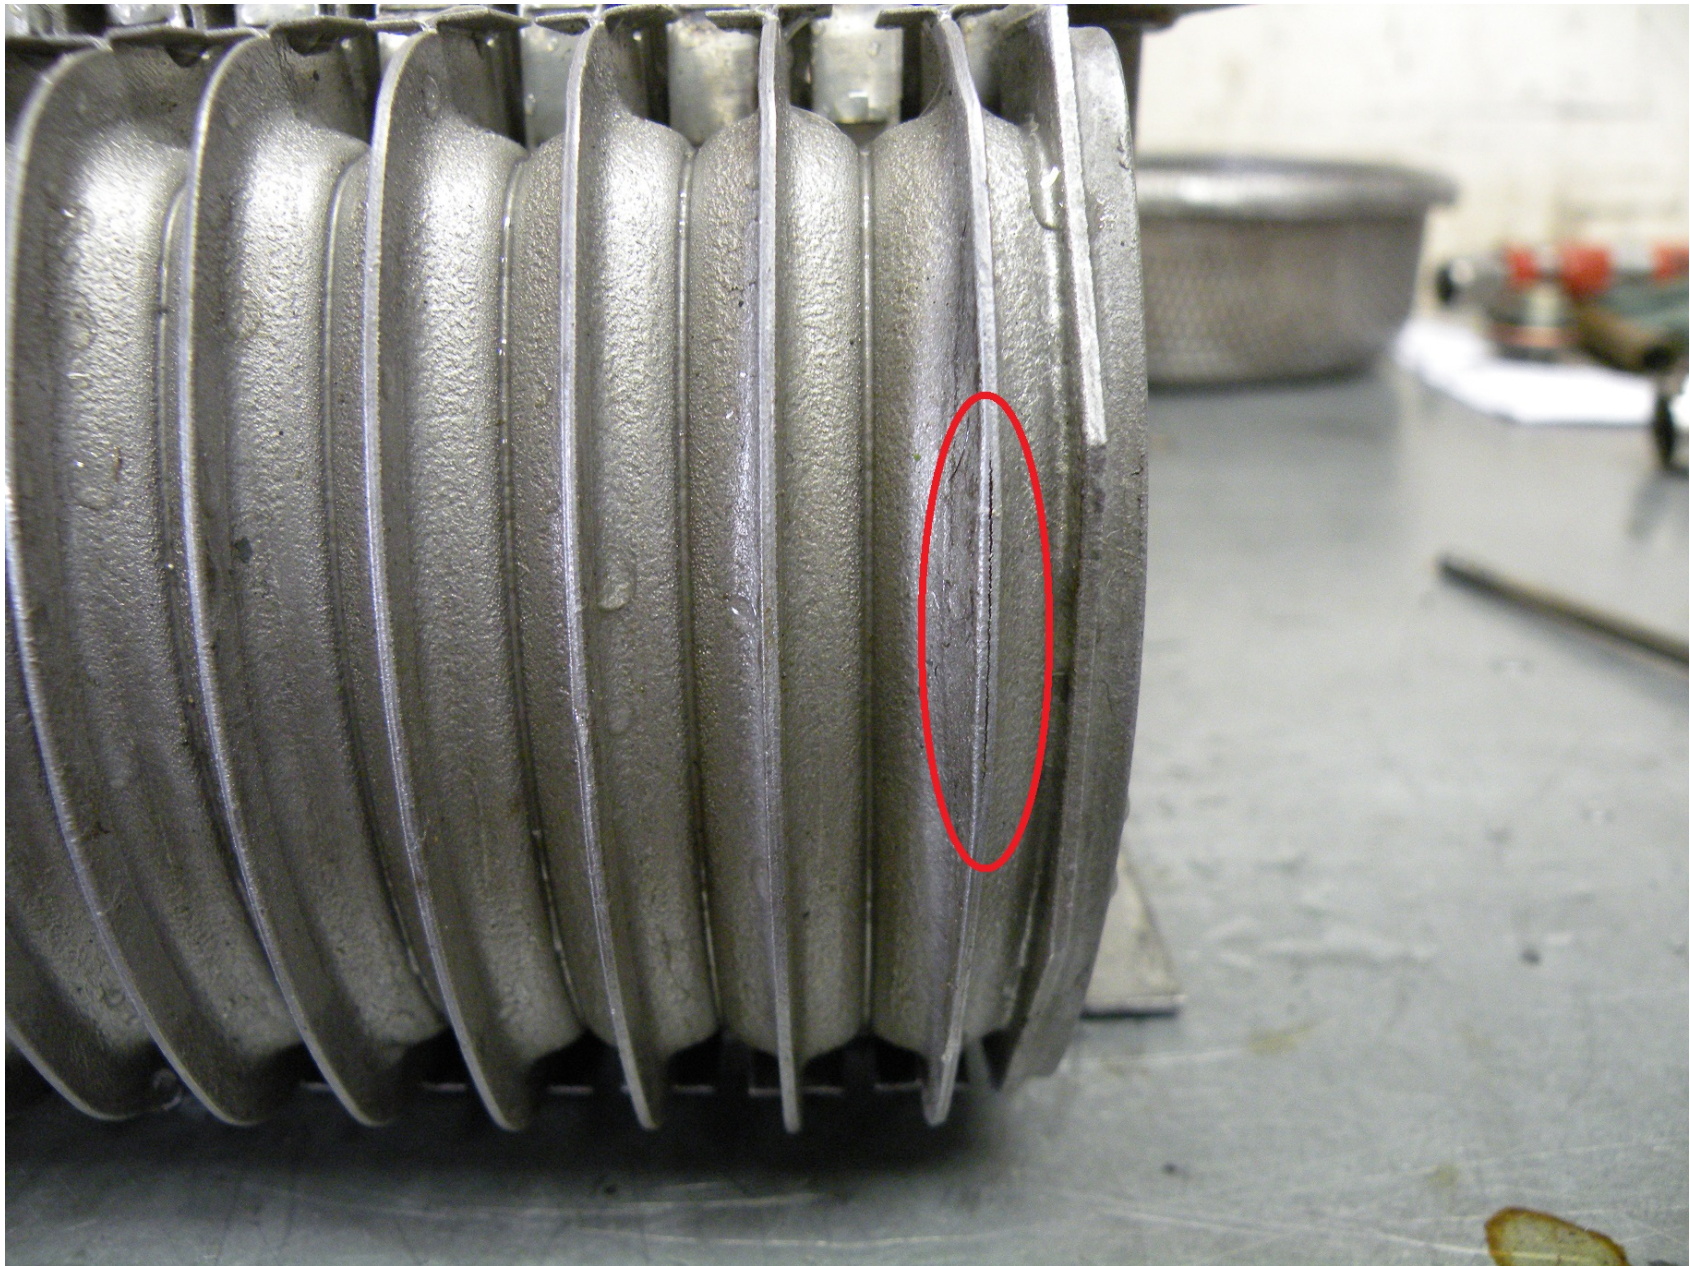
**Photo 6 - Right oil cooler (Aero-Classic P/N 8000074) with fracture at the brazed plates.**
