## **NATIONAL TRANSPORTATION SAFETY BOARD**

#### **Airframe and Engine Examination Summary**

NTSB Number: ANC17LA020

Aircraft: Cessna 182E, N9362X, S/N 18253768, TT 5016.95

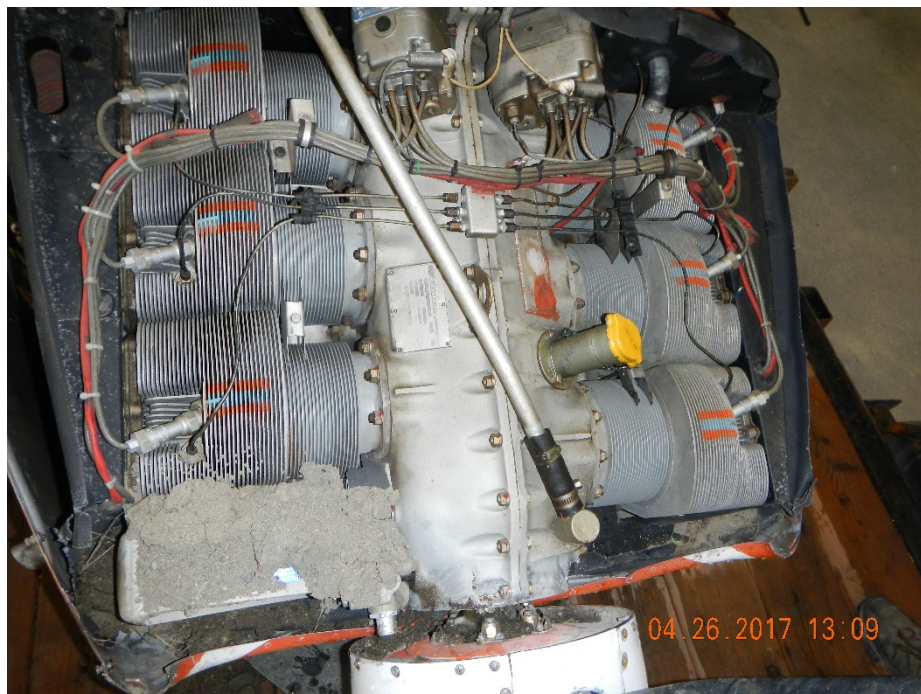
*Figure 1. Continental O-470R*

Initial examination revealed that engine mounts were in tact and all accessories, fuel and oil lines secure, except as noted. See figure 1. The right forward and aft engine case mounts were fractured and displaced near the base. The engine case vent tube was disconnected and slightly ajar at the clamp. The lower cowling had impact scrapes and compression from fore to aft through the entire cowling. The air intake and filter were buckled with imbedded dirt and debris. The right cowl flap was open slightly and the left cowl flap was closed and exhibited impact impressions. The exhaust pipe was buckled and bent aft. The total time indicated on the cockpit tachometer gage was 1830.65 hours.

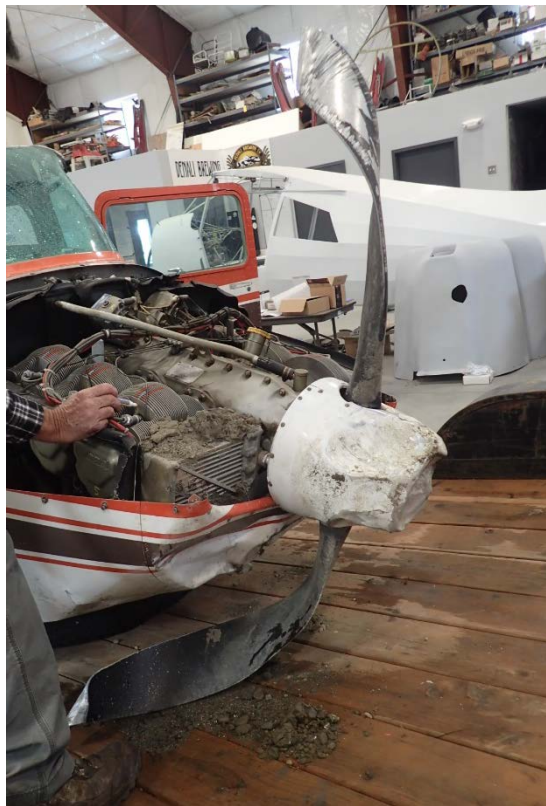
*Figure 2. Propeller spinner and blades*

The propeller was a McCauley two bladed, constant speed propeller. The hub was identified as a model 2A36C20AEG, serial number 611500. The spinner was significantly crushed around the circumference forward of the blade attachment points. See figure 2. The propeller was rotated by hand and moved freely.

- Propeller blade A revealed torsional S bending from about 10 inches from blade butt out to the tip. Significant chordwise scratches at the midspan section on the cambered face. Multiple leading edge nicks and impact marks through the span of the blade.
- Propeller blade B revealed similar signatures as blade A. There was torsional twisting along its blade length beginning approximately 8 inches outboard of the blade root with scoring and scratching of the cambered face and leading edge at the blade tip. Blade B was loose and could be rotated within the hub.
- The propeller governor (McCauley M/N 2A36C29AEG, S/N 611500) did not exhibit damage. The propeller control cable was intact and the propeller control arm articulated properly.
