# Continental Motors

## ENGINE FIELD INSPECTION REPORT

| ENGINE MODEL | O470R |
| FILE NUMBER | 16-551 |

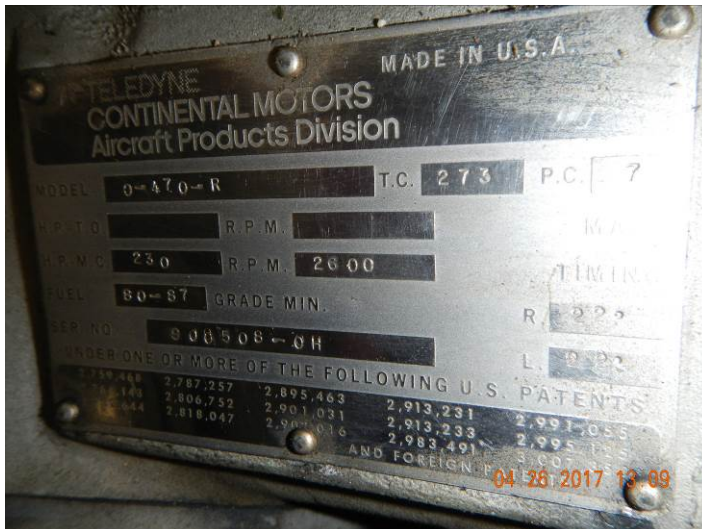
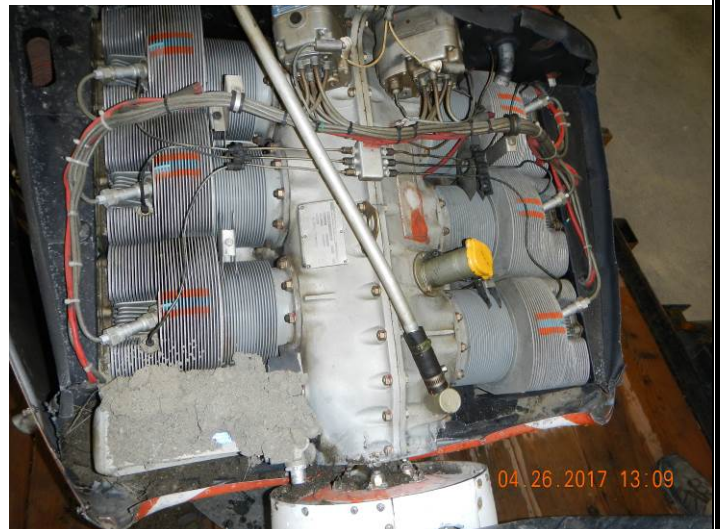
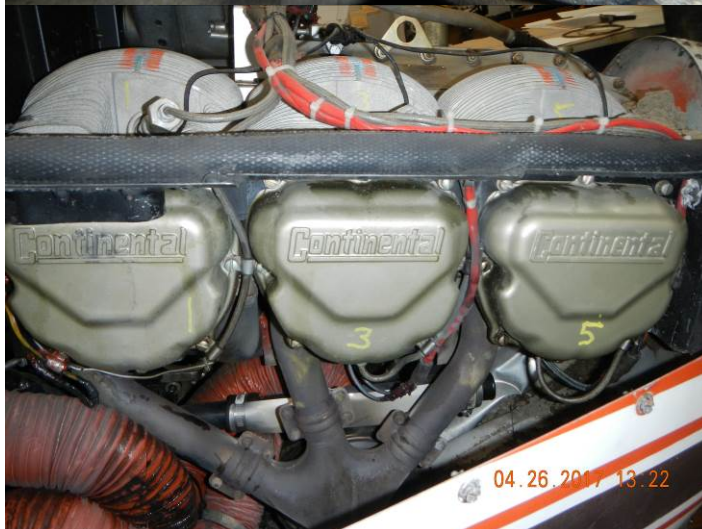
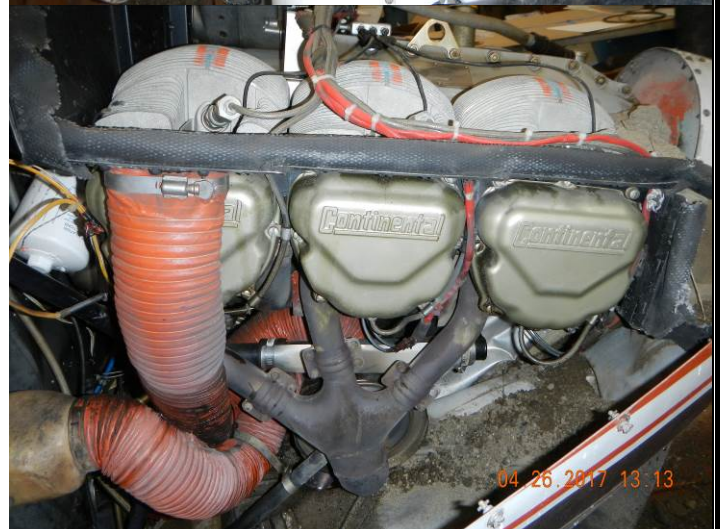
An examination of the engine indicated that the engine, engine accessories and individual components were intact except for the right forward and right rear engine mounts which were impact damaged. Red arrow depicts broken right-forward engine mount.

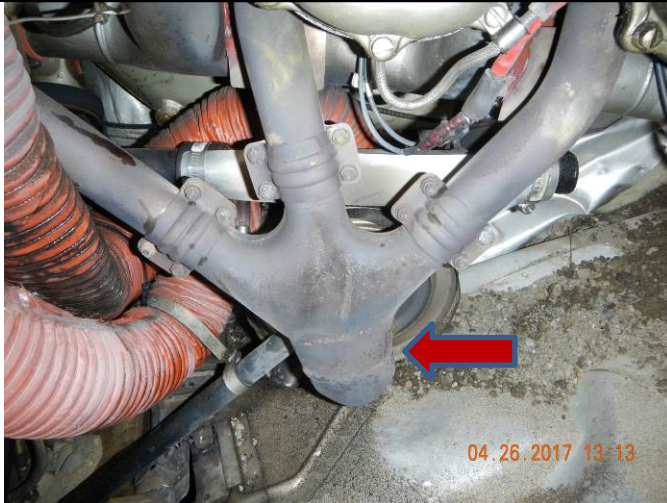
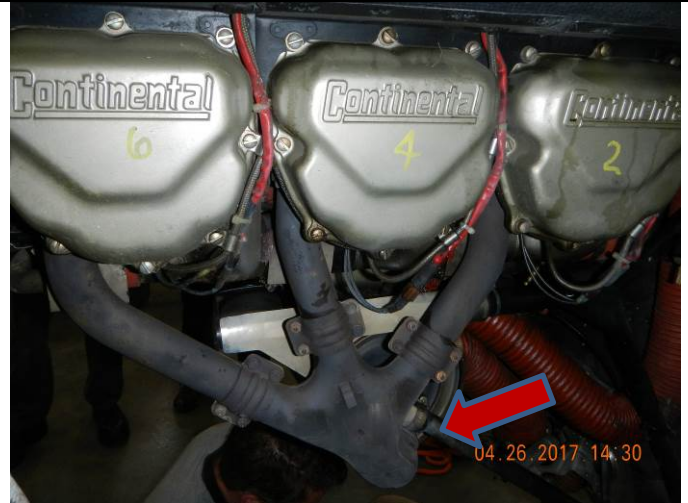
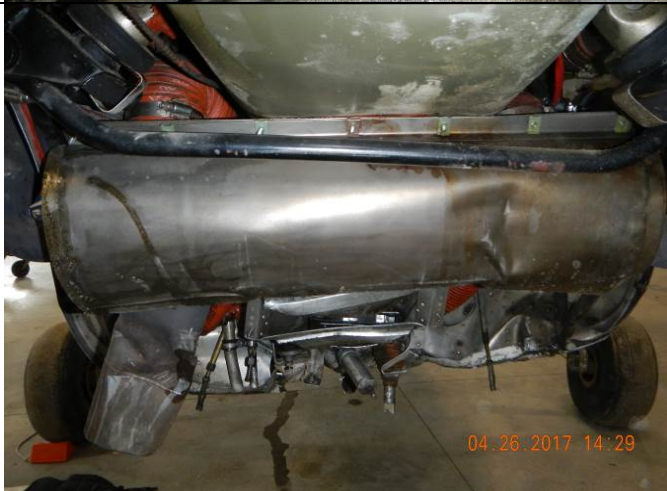
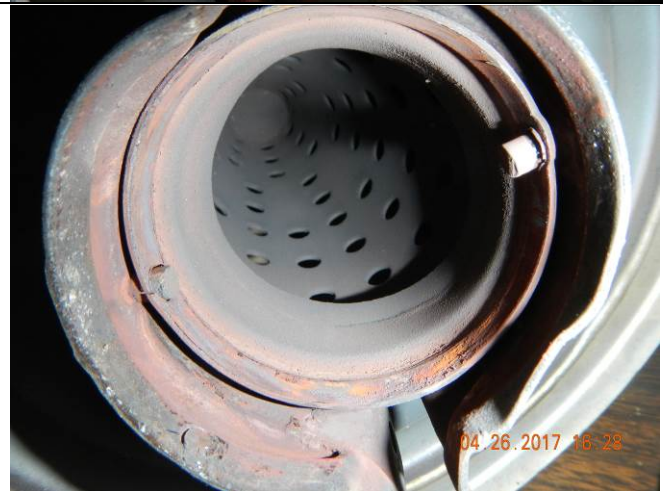
#### EXHAUST SYSTEM

The exhaust collectors exhibited upward bending damage due to impact forces which forced the muffler upward. The muffler was disassembled and no internal failure was evident. Red arrows point to collector outlet area where bending was evident. The muffler heat shield was removed and the muffler inspected. No defects were found. The flame cone was intact and the exhaust path was open. The tail pipe was impact damaged.

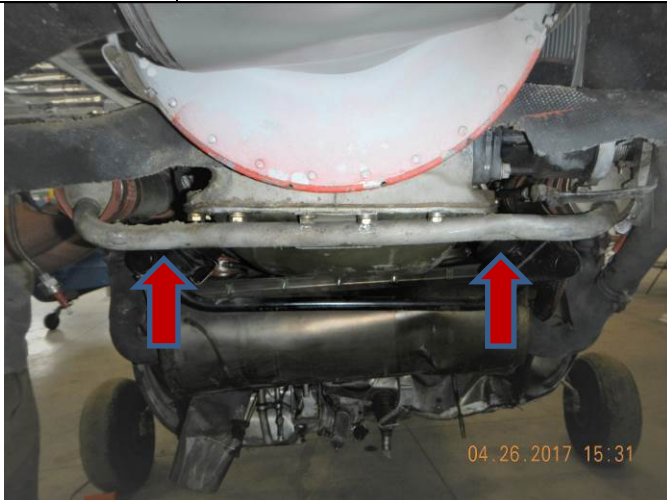
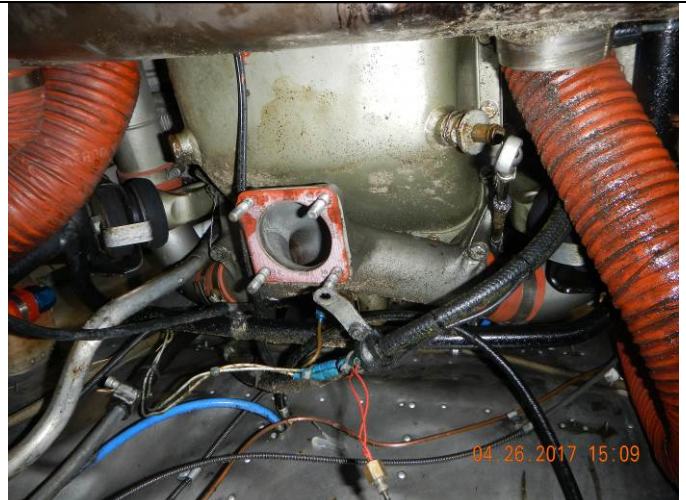
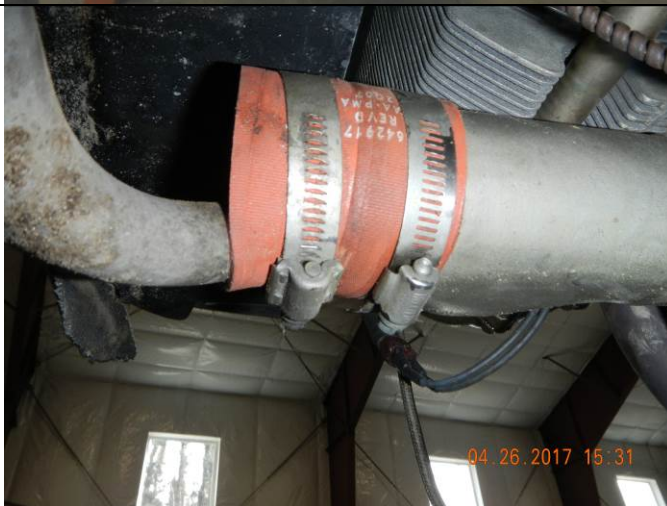
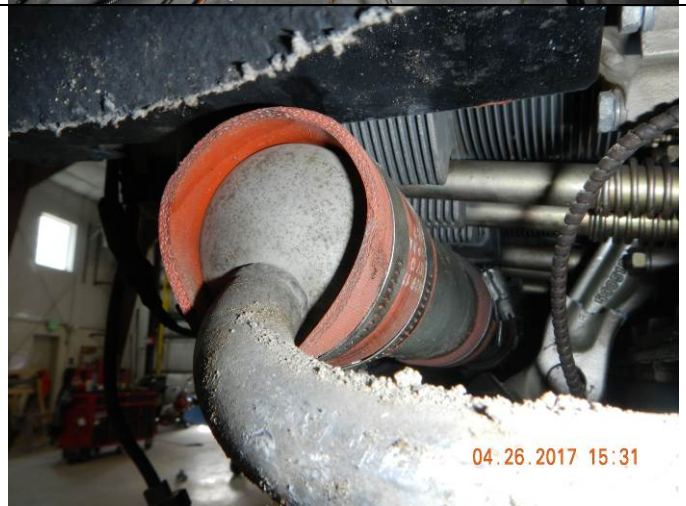
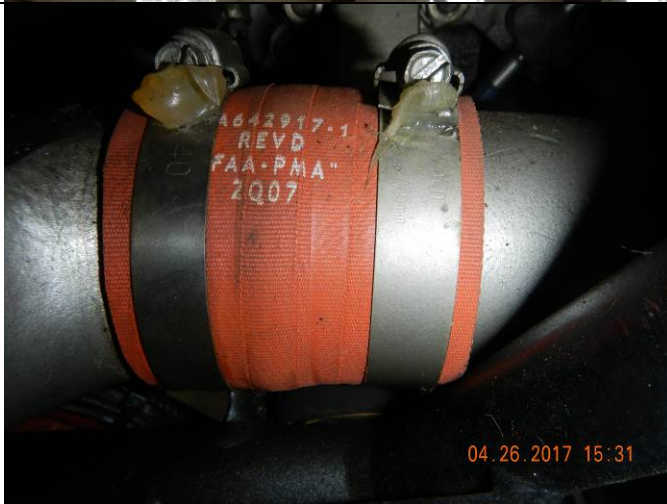
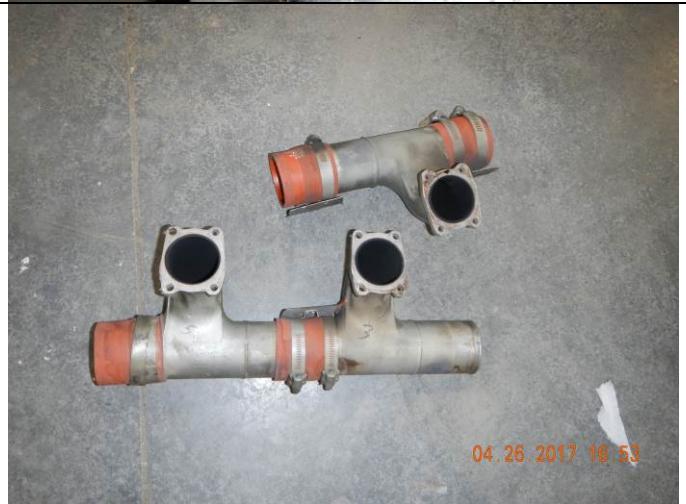
## INDUCTION SYSTEM

All intake tube elbows were intact and the forward balance tube assembly exhibited minor impact damages. See red arrows. The forward balance tube was pushed rearward into the intake hose on the right, forward side due to impact forces. All intake hose clamps exhibited a small amount of silicone at the screw head.

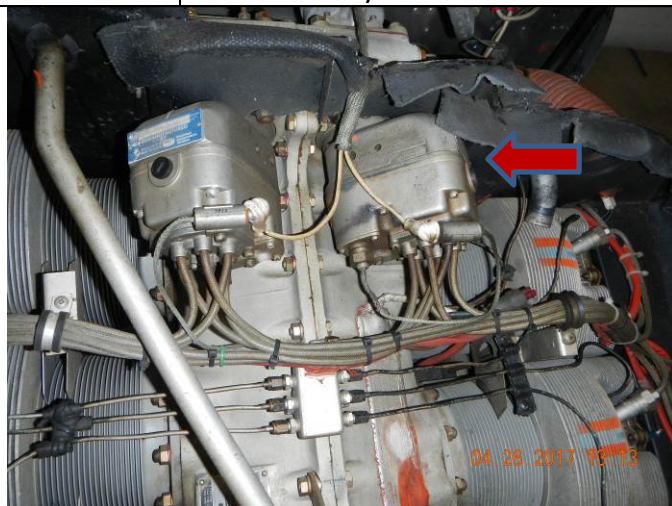
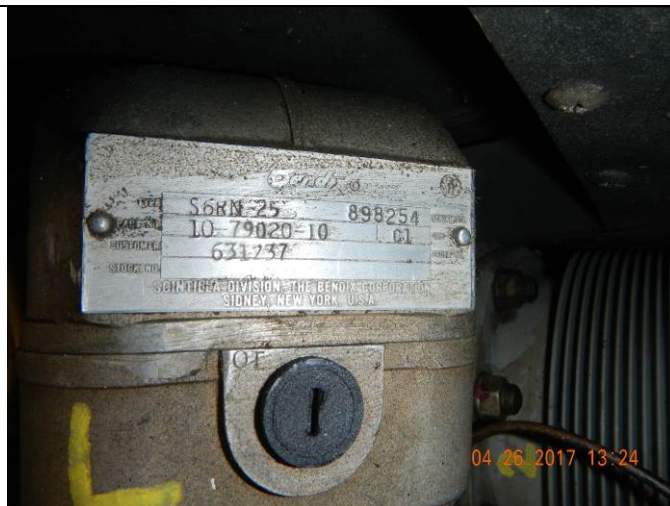
### LEFT MAGNETO

The magneto was intact and produced spark at appropriate ignition lead when the engine was manually rotated.

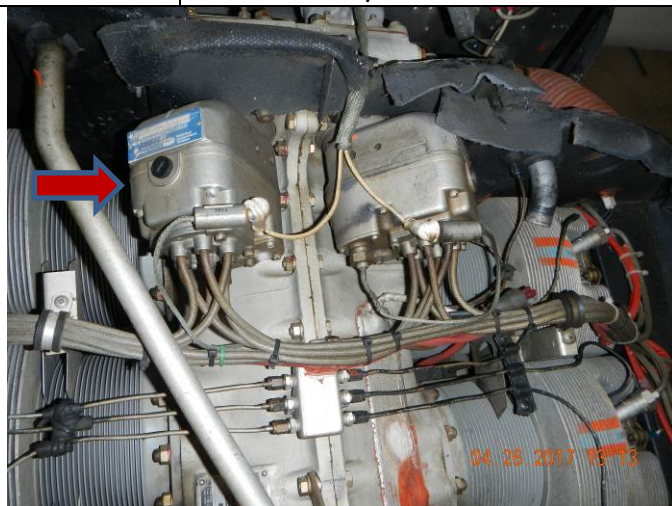
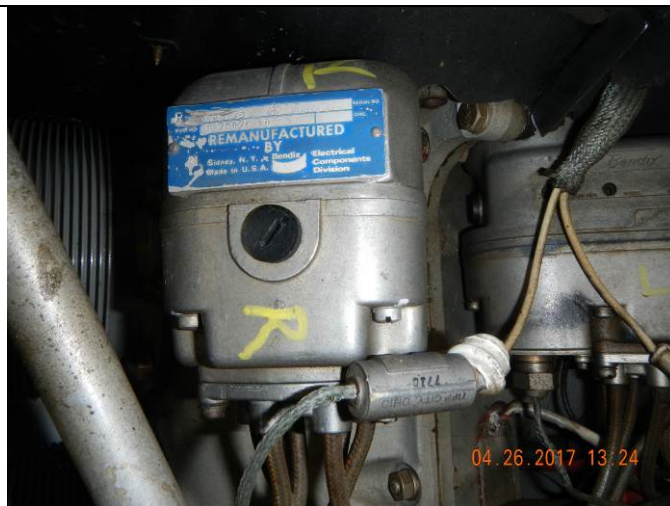
### RIGHT MAGNETO

The magneto was intact and produced spark at appropriate ignition lead when the engine was manually rotated.

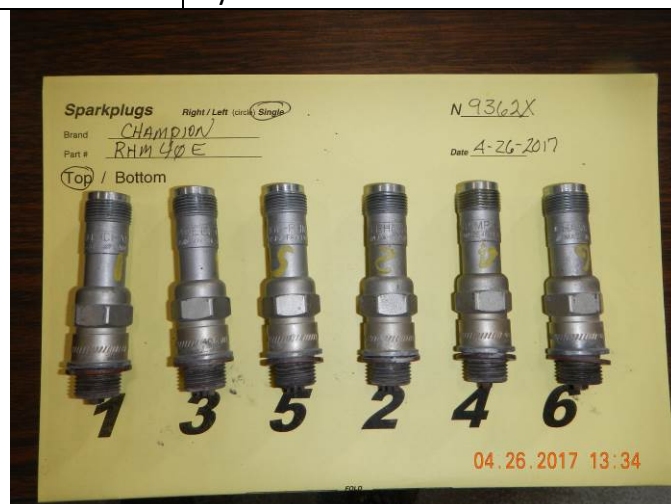
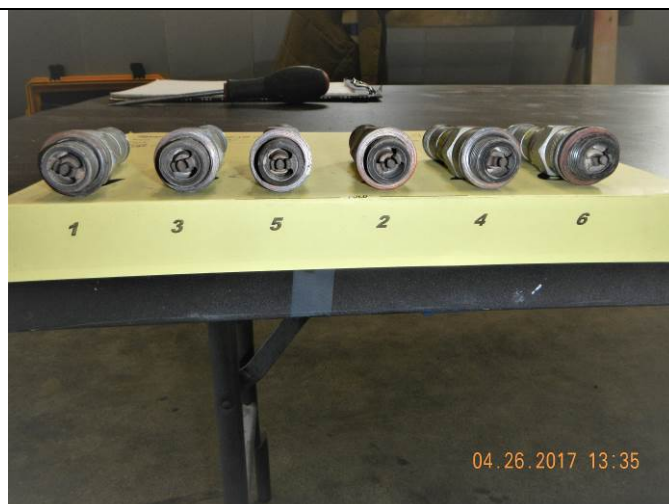
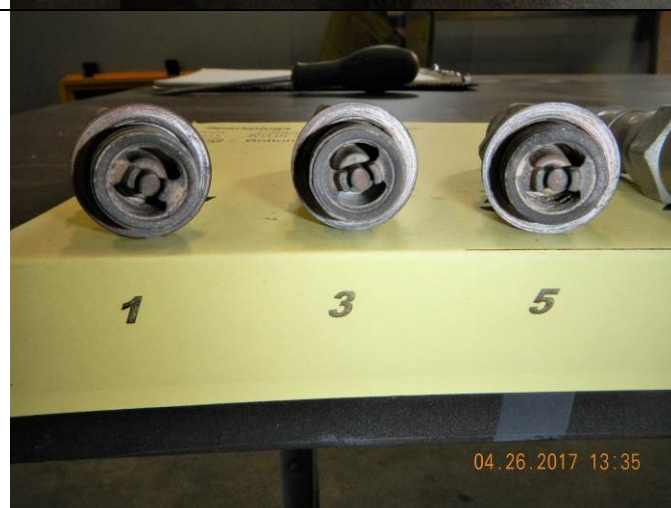
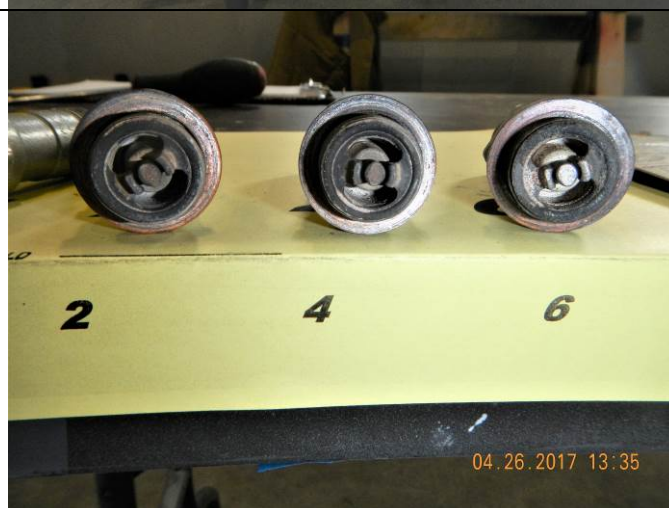
## SPARK PLUGS

The top sparkplugs were removed and examined. When compared to a Champion Aviation "Check A Plug" chart, each sparkplug condition resembled "normal worn out" with normal coloration. The bottom sparkplugs were removed and examined. All bottom sparkplugs appeared "normal" in wear and coloration except for the sparkplugs removed from cylinders 5 and 6 which were oil contaminated.

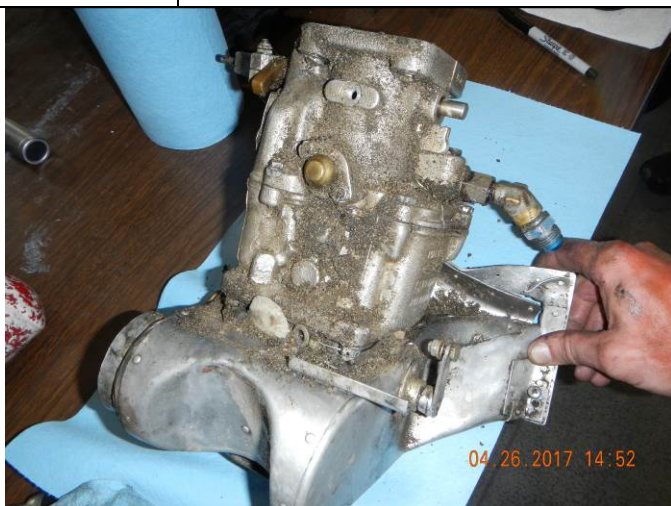
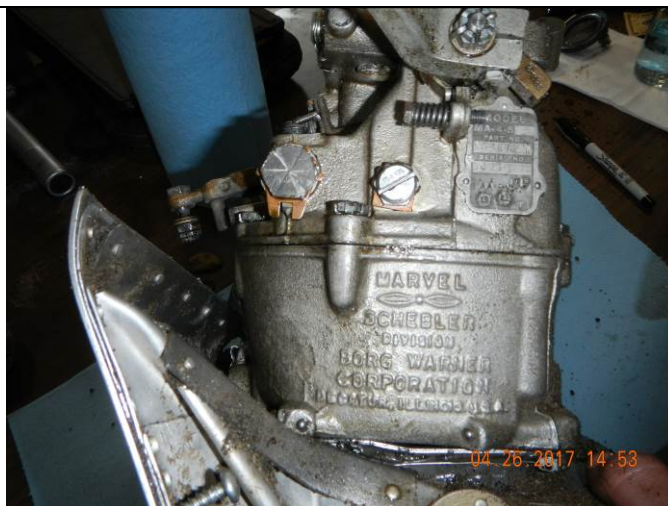
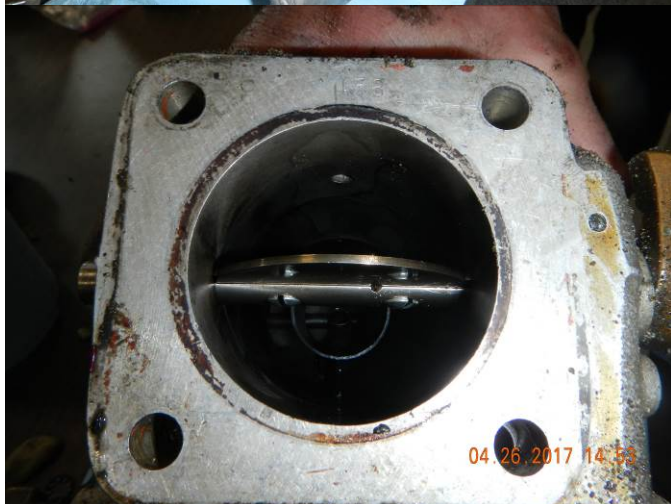
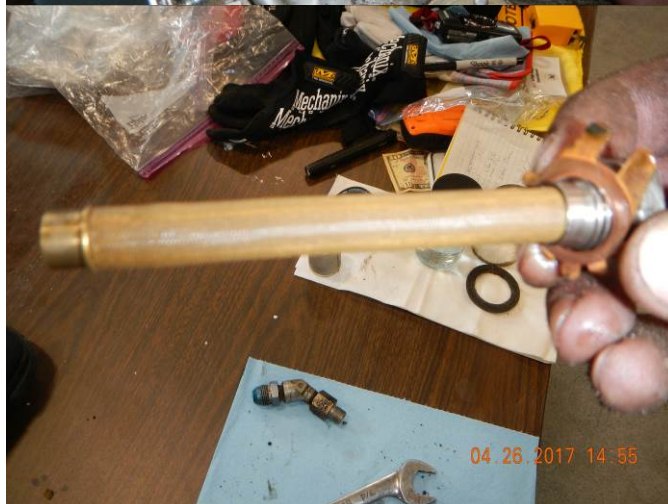
| Condition: | The carburetor exhibited no damage. All engine controls operated normally and control attachments for throttle and mixture were secured correctly. The fuel inlet finger screen was uncontaminated. The accelerator pump operated normally when the throttle arm was manually actuated. The carburetor was disassembled and examined. The plastic float assembly appeared normal and operated the needle correctly. No contamination was discovered inside the float chamber. The main jet and master orifice was removed and found to be uncontaminated. | | |

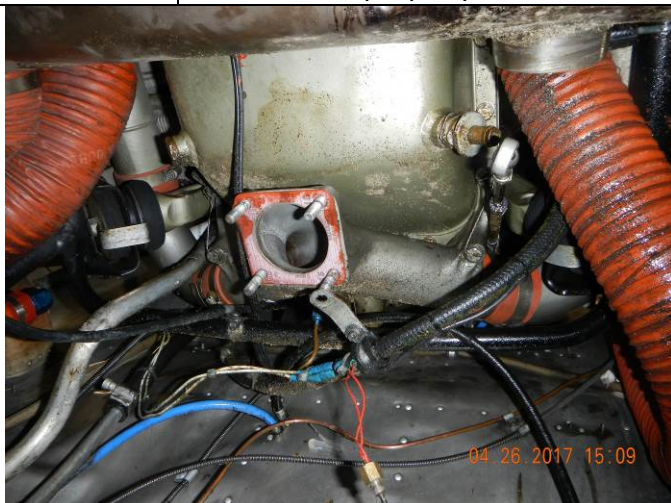
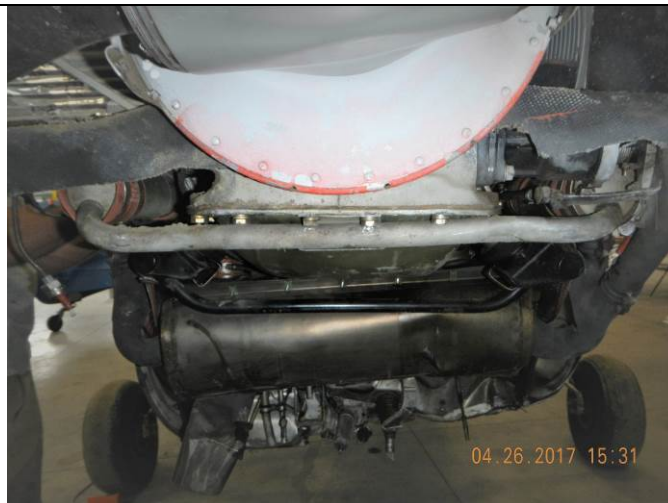
### OIL SUMP

The oil sump was undamaged. The oil sump drain plug and quick-drain valve were intact and secured properly.

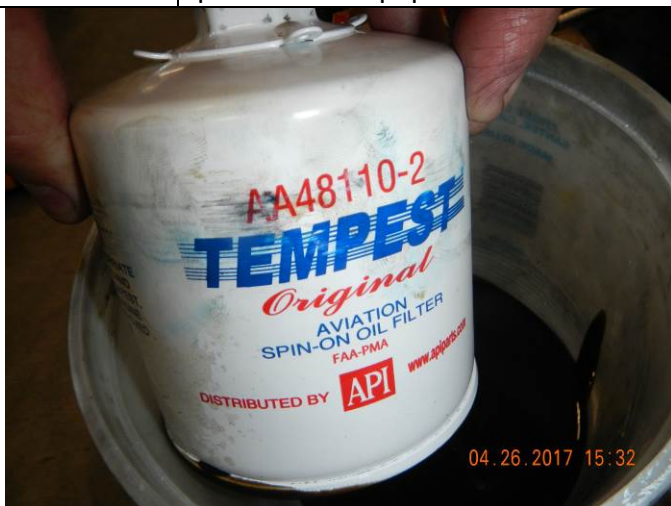
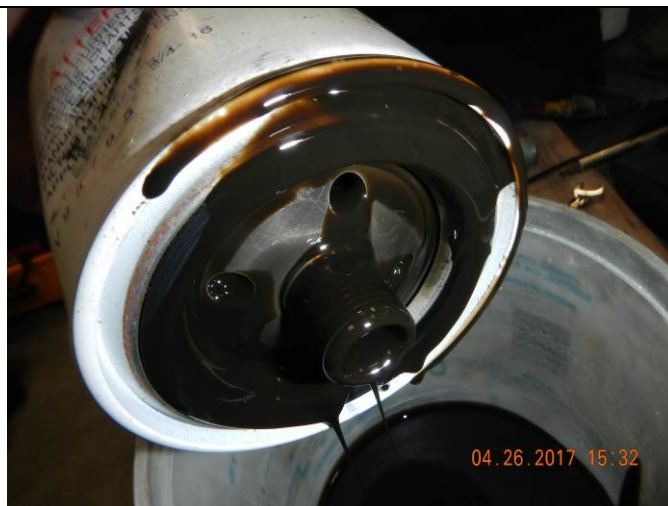
### OIL FILTER

The oil filter was installed and secured correctly. The filter was removed and opened to inspect for contamination. The oil was dark in color but did not contain visible metal particles. The paper filter medium had traces of carbon but no metal contamination.

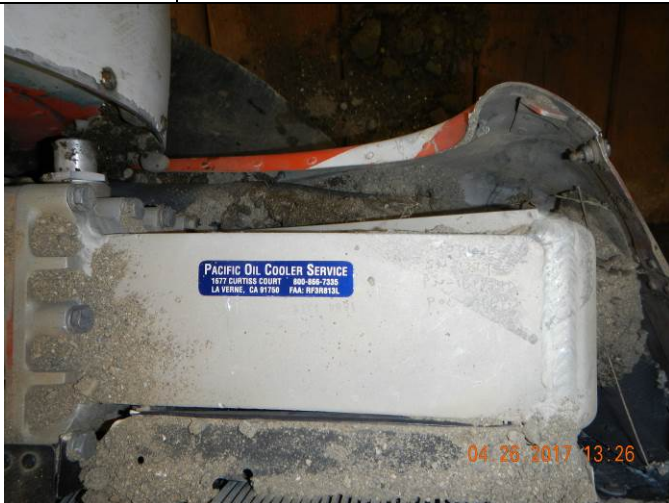
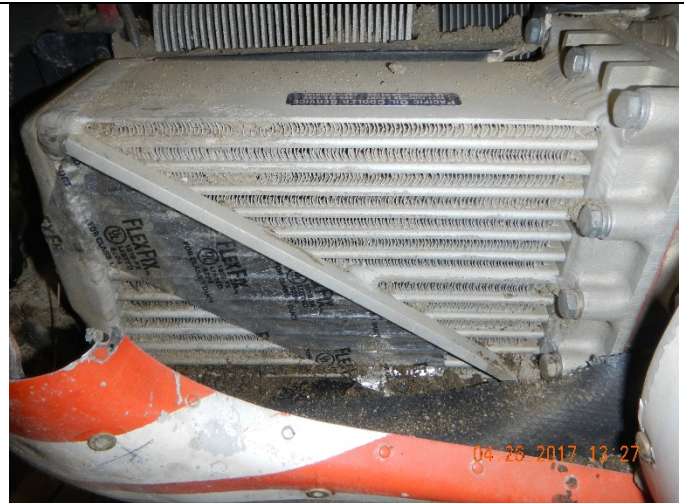
## OIL COOLER

The exterior of the oil cooler was contaminated with dirt but undamaged. A strip of foil tape was installed at a 45 degree angle under the brace on the front radiator coils.

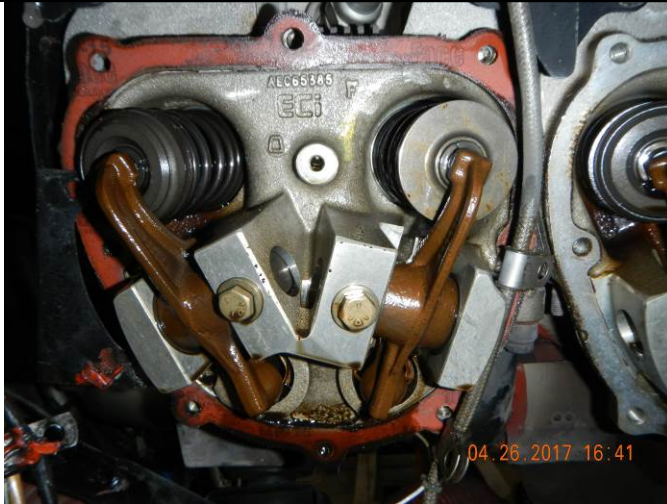
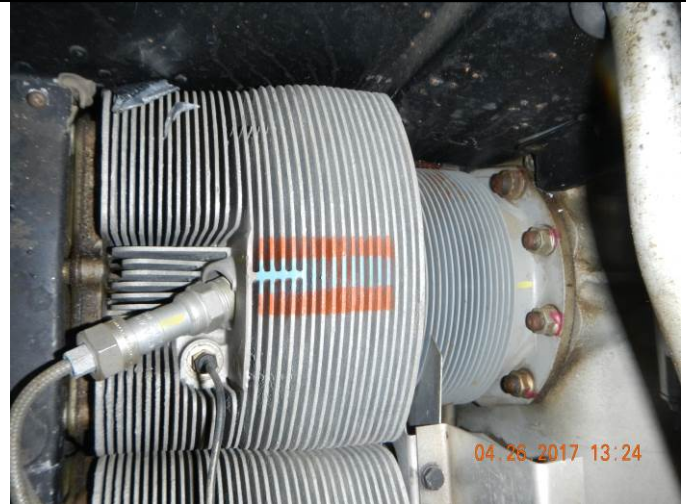
| CYLINDER #1 | P/N: AEC65385 | S/N: G845G | Head Date: Undetermined |

| Condition: | Thumb compression was achieved by manually rotating engine. A lighted borescope inspection revealed normal combustion signatures on valve faces. All rocker arms moved correctly and valve springs were intact. | | |

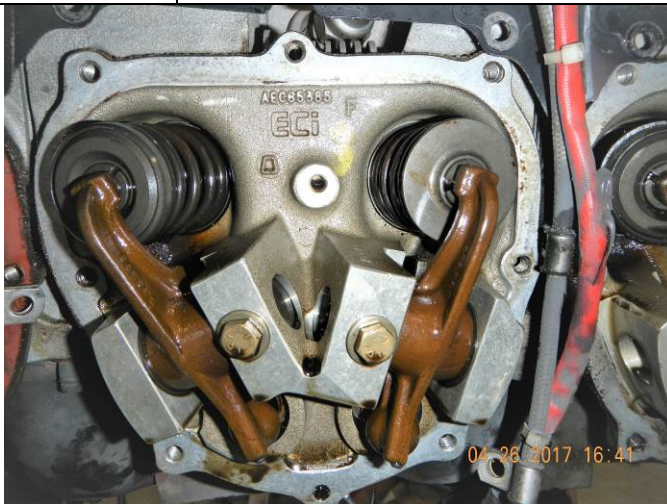
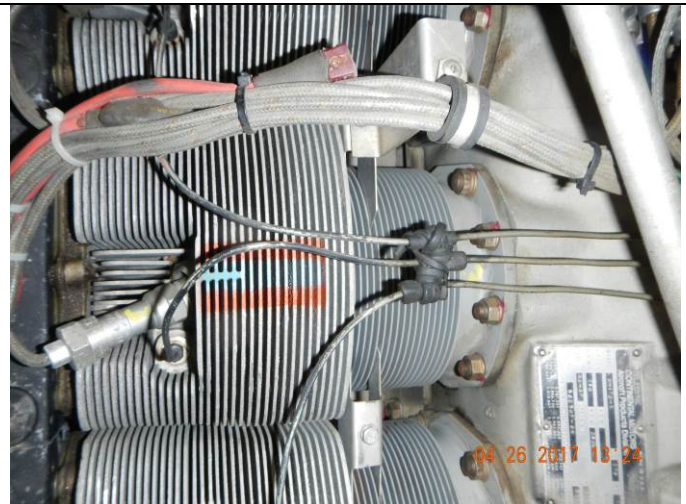
| CYLINDER #3 | P/N: AEC65385 | S/N: G835H | Head Date: Undetermined |

| Condition: | Thumb compression was achieved by manually rotating engine. A lighted borescope inspection revealed normal combustion signatures on valve faces. All rocker arms moved correctly and valve springs were intact. | | |

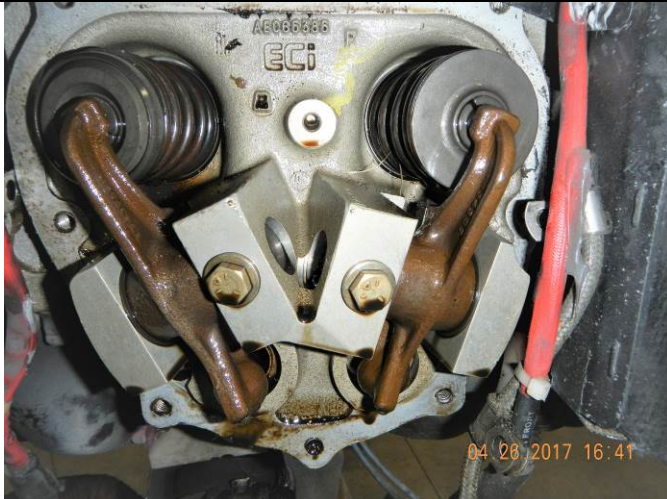
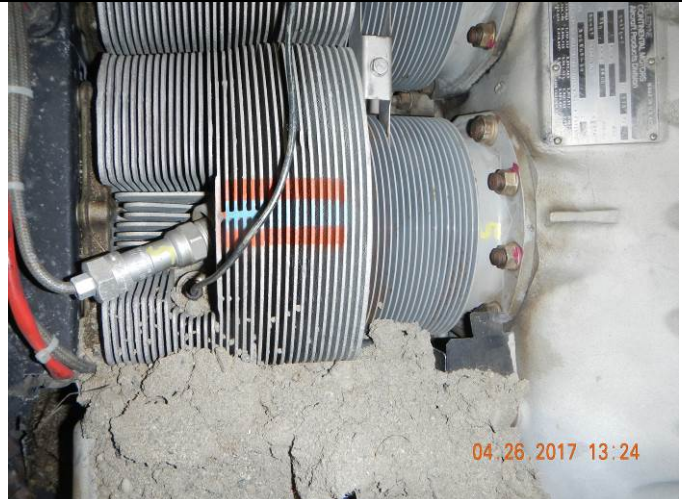
CYLINDER #5

Thumb compression was achieved by manually rotating engine. A lighted borescope inspection revealed normal combustion signatures on valve faces. All rocker arms moved correctly and valve springs were intact.

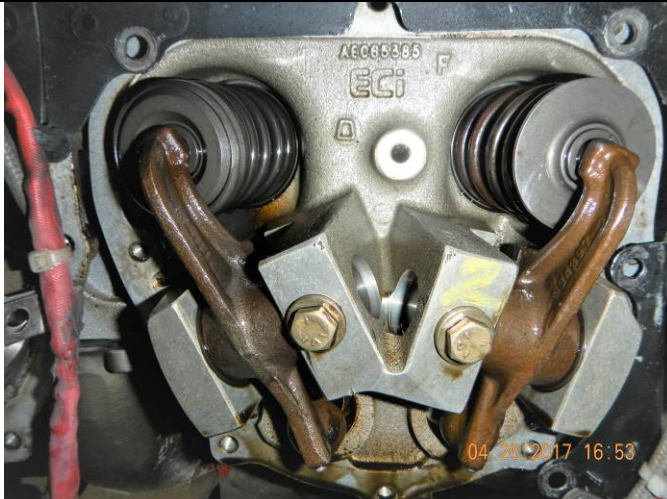
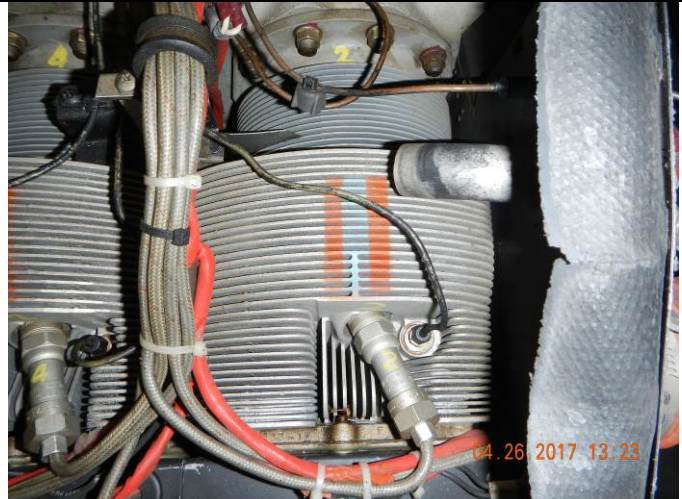
CYLINDER #2

Thumb compression was achieved by manually rotating engine. A lighted borescope inspection revealed normal combustion signatures on valve faces. All rocker arms moved correctly and valve springs were intact.

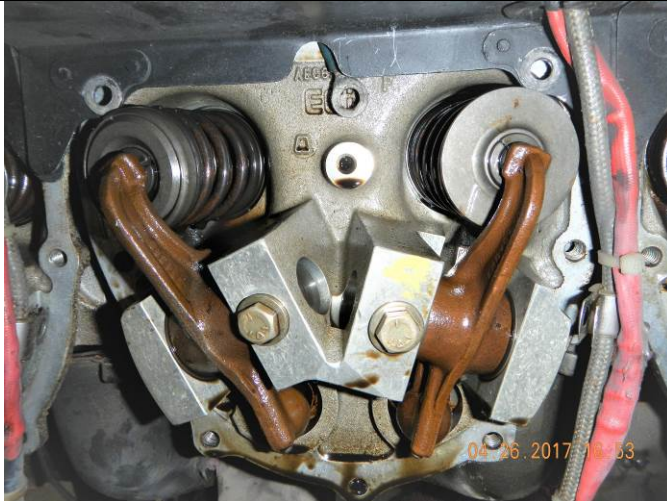
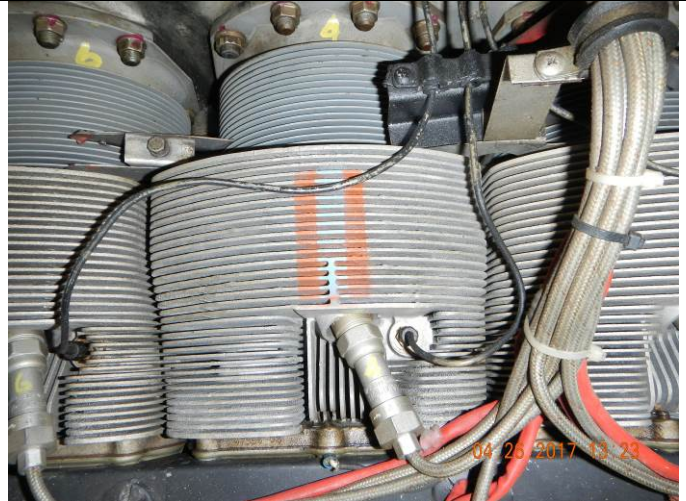
## CYLINDER #4

Thumb compression was achieved by manually rotating engine. A lighted borescope inspection revealed normal combustion signatures on valve faces. All rocker arms moved correctly and valve springs were intact.

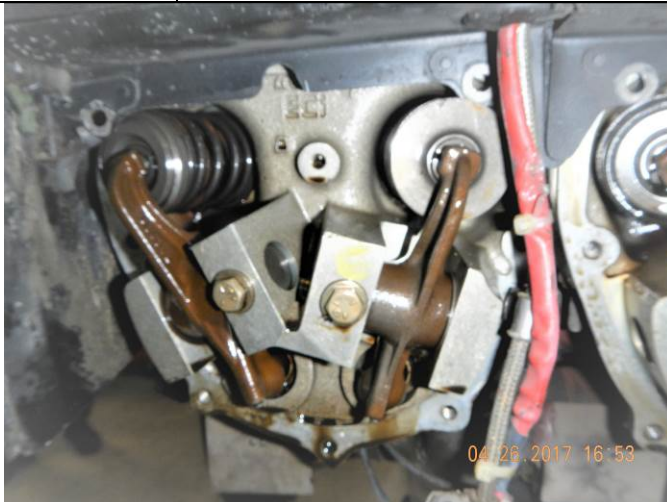
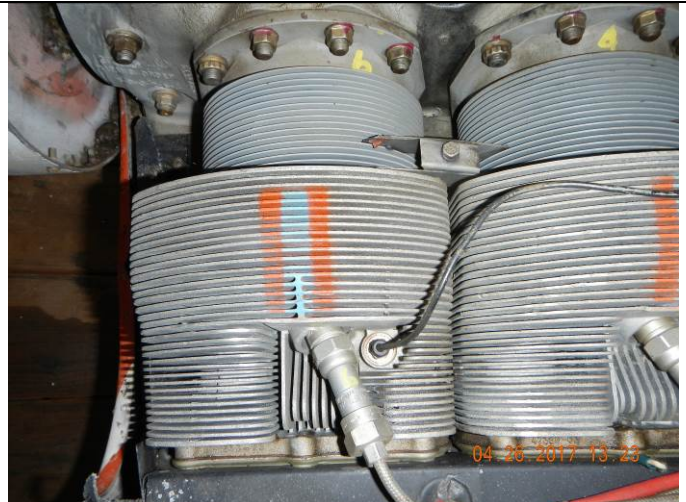
## CYLINDER #6

Thumb compression was achieved by manually rotating engine. A lighted borescope inspection revealed normal combustion signatures on valve faces. All rocker arms moved correctly and valve springs were intact.

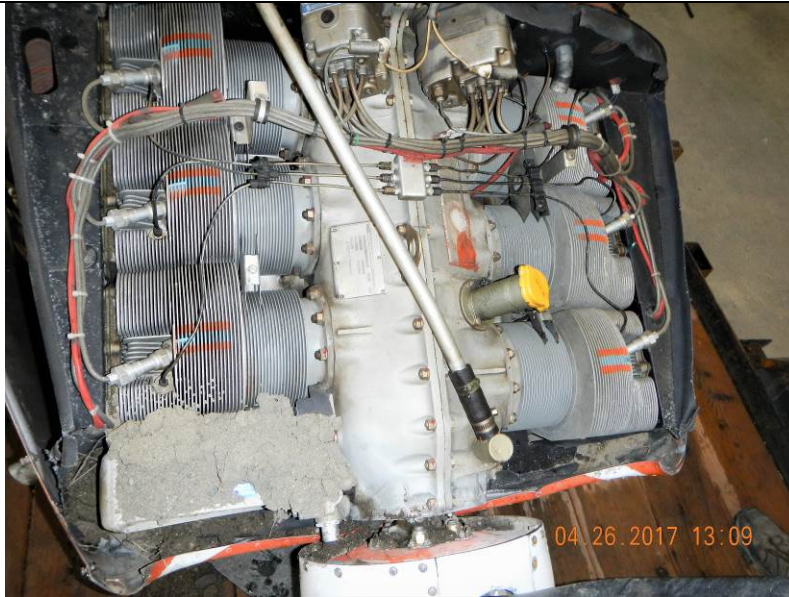
| Condition: | The crankcase did not exhibit damage. | | | |

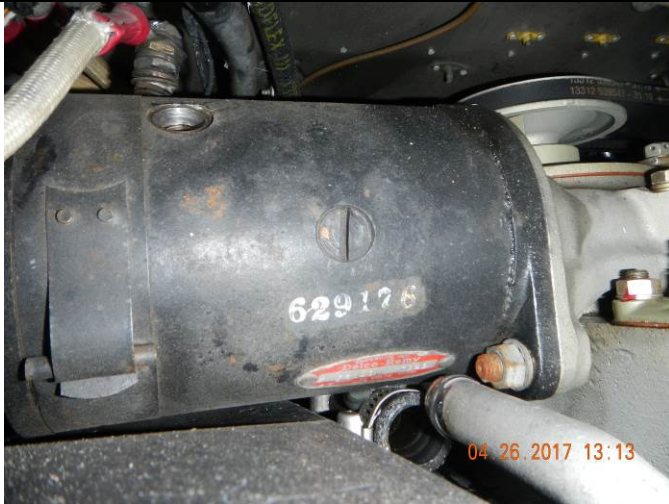
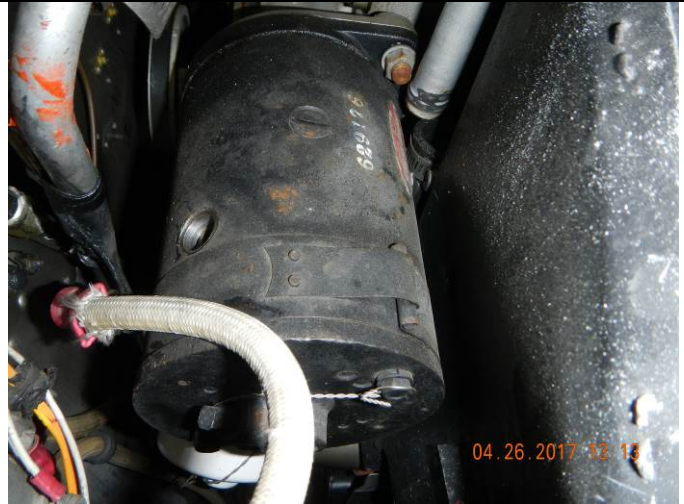
### STARTER

The starter motor was missing a dust cap but otherwise did not exhibit any damage.

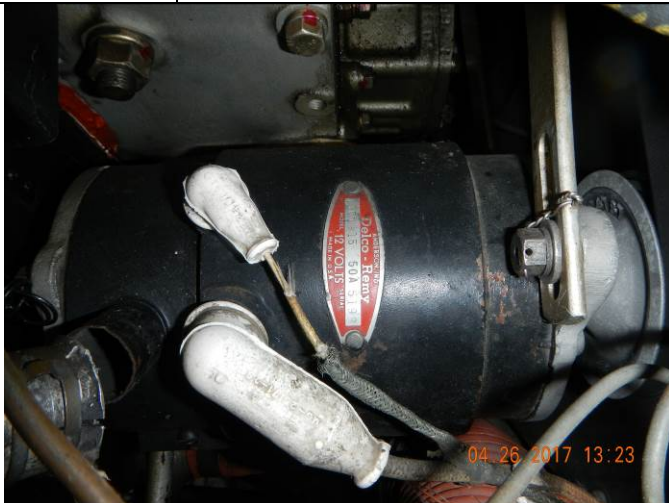
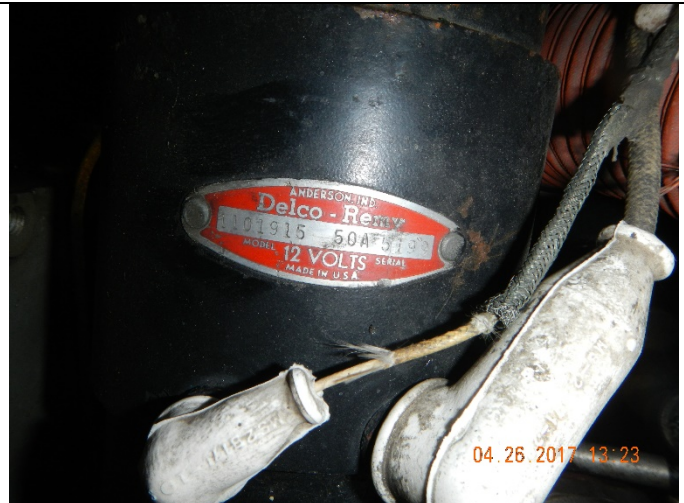
### ALT/GEN #1

The generator did not exhibit damage.

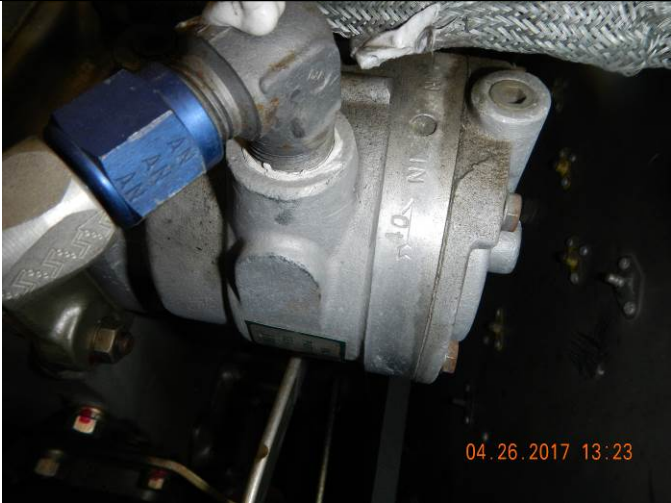
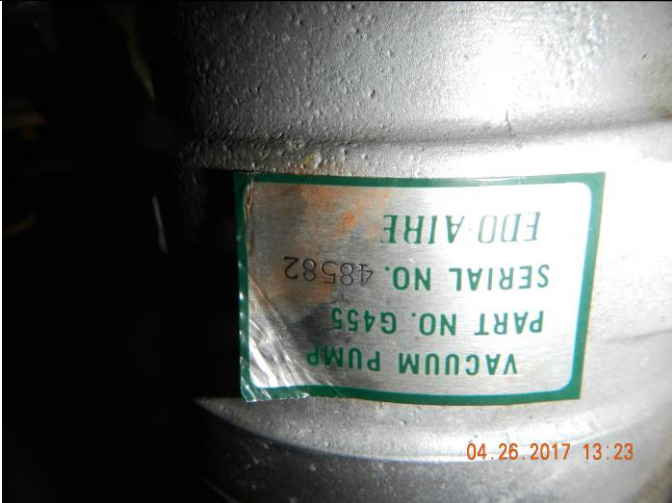
| Condition: | The “wet type” vacuum pump did not exhibit damage. The pump was not tested for operation. | | |

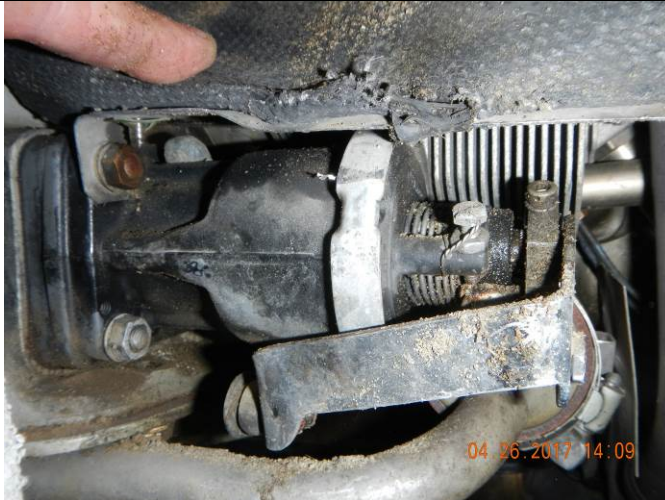
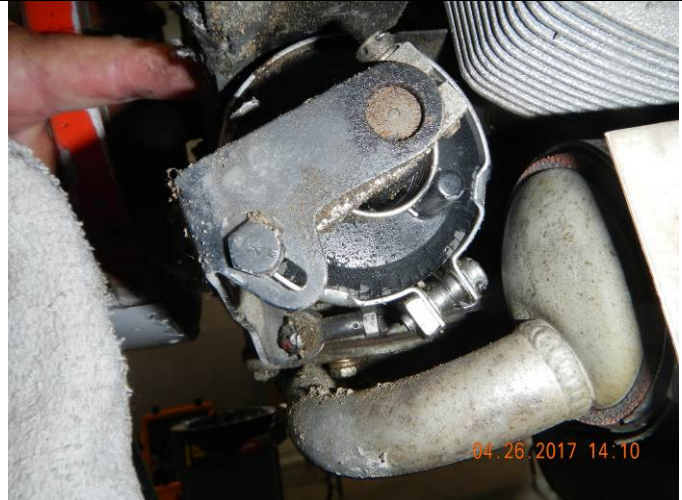
### PROPELLER GOVERNOR

The propeller governor did not exhibit damage. The propeller control cable was intact and the propeller control arm articulated properly.

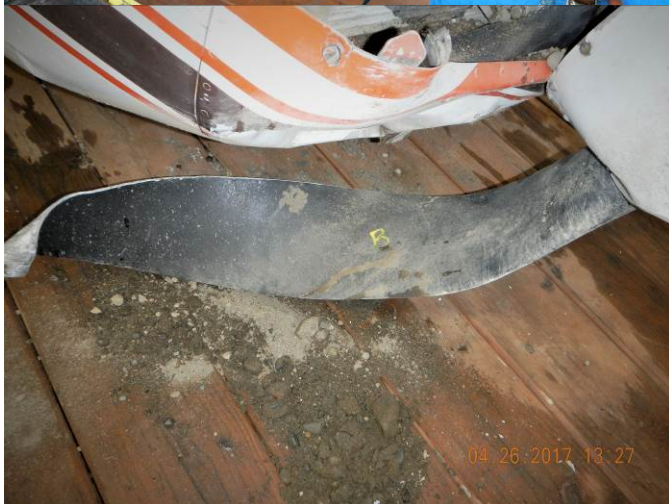
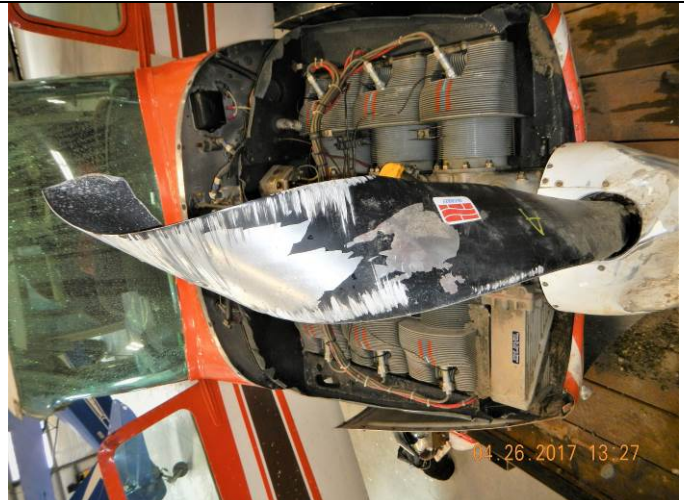
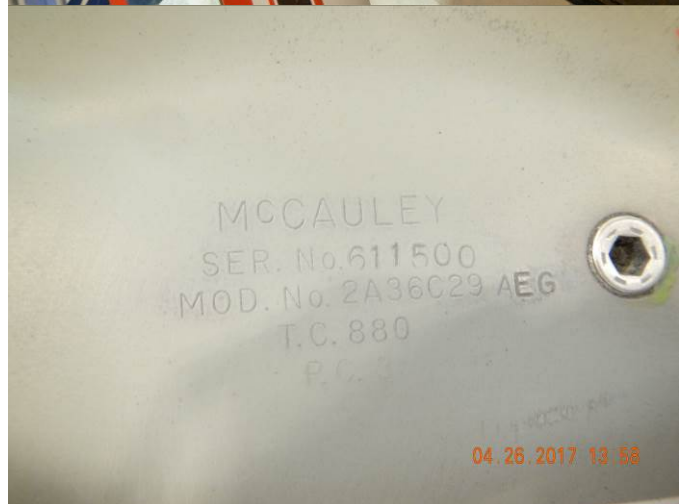
### PROPELLER

The propeller was a McCauley two blade, constant speed propeller controlled by an engine driven propeller governor. The propeller spinner was impact damaged and exhibited rotational damage. Each blade was marked with a letter "A" or "B" for photo identification. Blade "A" exhibited torsional twisting along its blade length beginning approximately 10 inches outboard of the blade root with scoring and scratching of the cambered face and leading edge at the blade tip. Blade "B" exhibited torsional twisting along its blade length beginning approximately 8 inches outboard of the blade root with scoring and scratching of the cambered face and leading edge at the blade tip. Blade "B" was loose and could be rotated within the hub.
