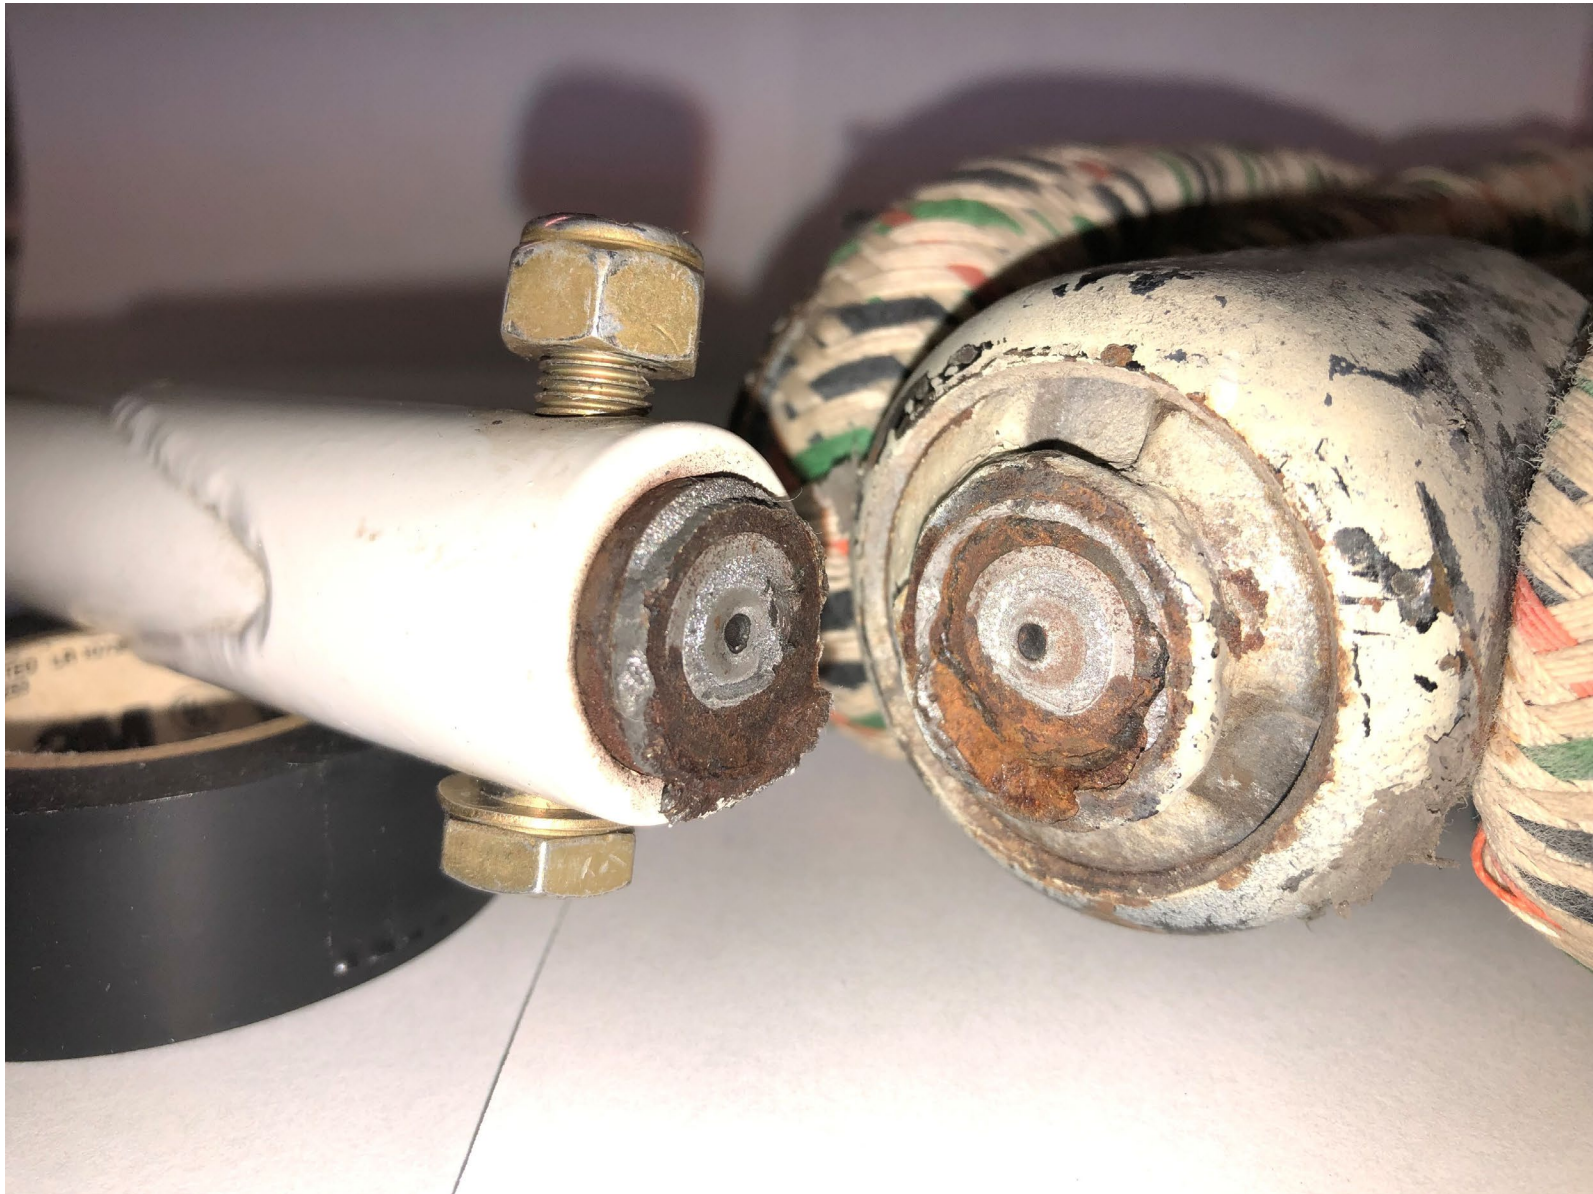
**Photo 1 – Both Fracture Surfaces of Lug Fitting**

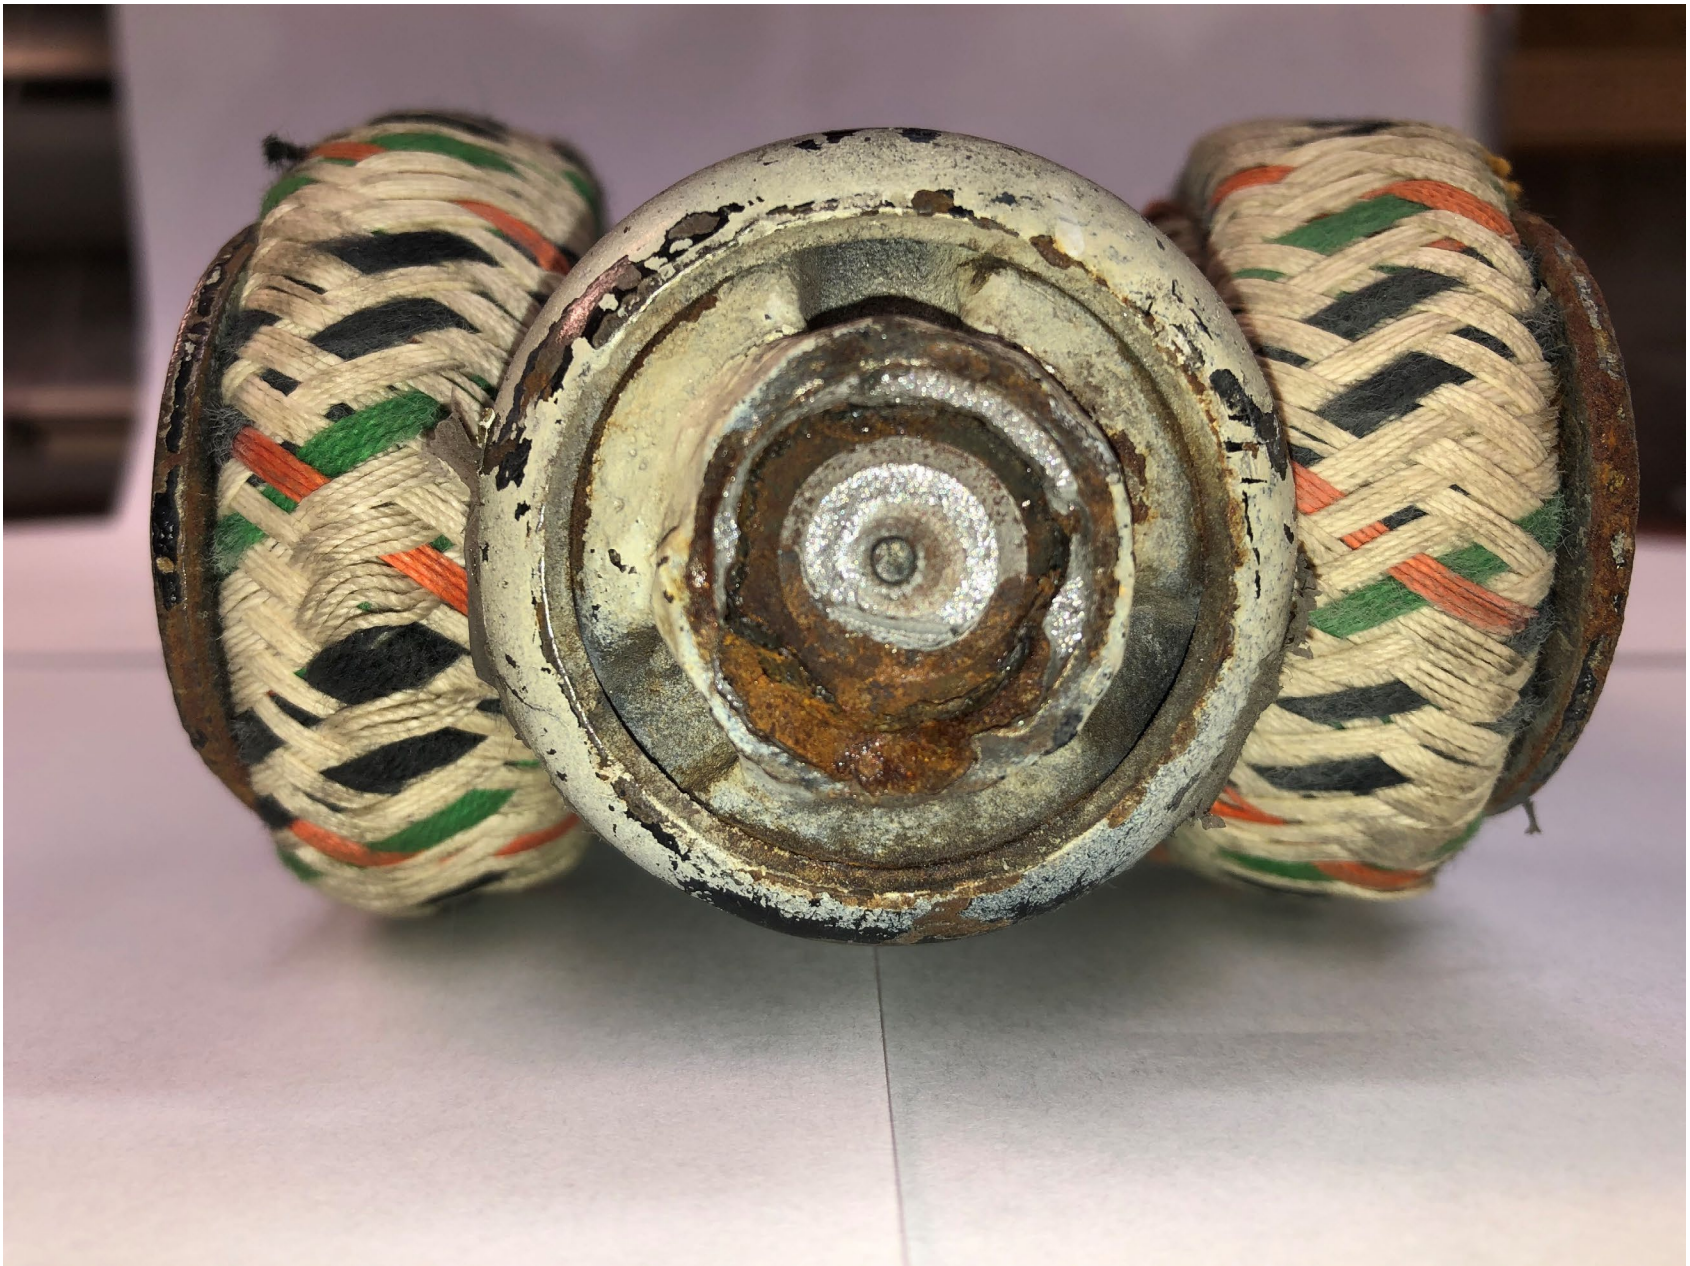
**Photo 2 – Fracture Surface of Lug Fitting on Hydrasorb Side**

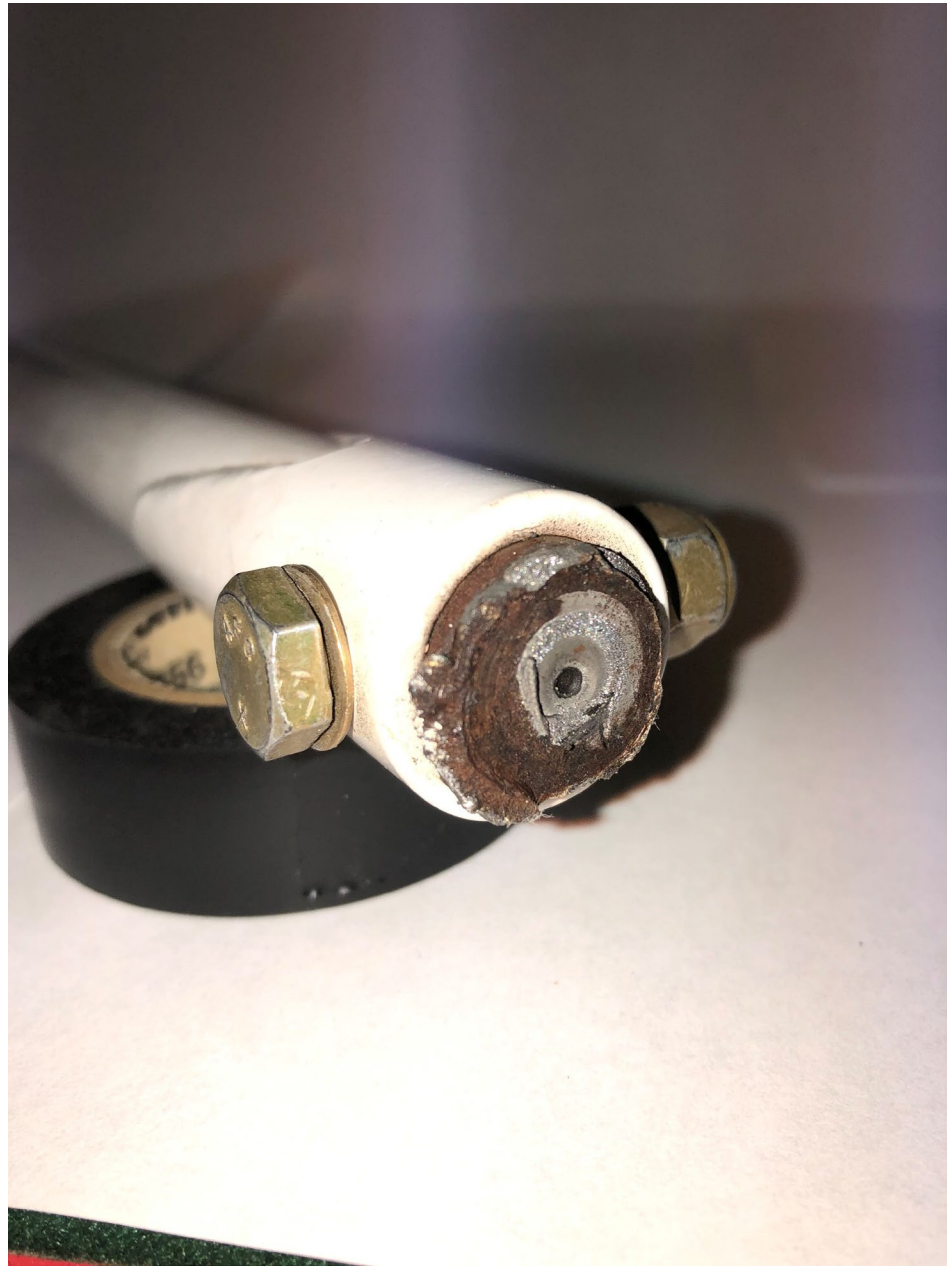
**Photo 3 – Fracture Surface of Lug Fitting on Extension Tube Side**
