## **NATIONAL TRANSPORTATION SAFETY BOARD**

### **Weather Study**

# **METEOROLOGY**

ANC17LA025

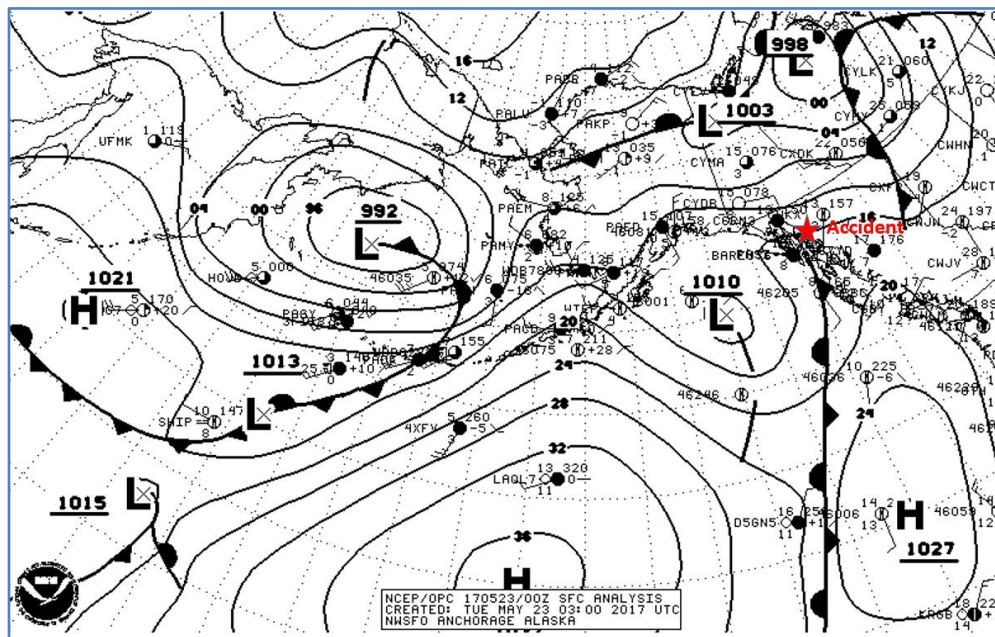
Figure 1 is the NWS Alaska Surface Analysis Chart issued prior to the accident for 1600 AKDT indicated a stationary front immediately west of the Juneau area extending south-southwestward off the southeast Alaska Coast, with another stationary front to the east across eastern British Columbia and western Alberta. A low pressure system was located about 350 miles west-southwest of the accident site in the Gulf of Alaska at 1010-hectopascals<sup>2</sup> with a trough of low pressure extending southward. To the south a high pressure system at 1027-hPa was located off northern California with a ridge of high pressure extending northward immediately south of the Juneau area.

Figure 1 - NWS Alaska Surface Analysis Chart for 1600 AKDT

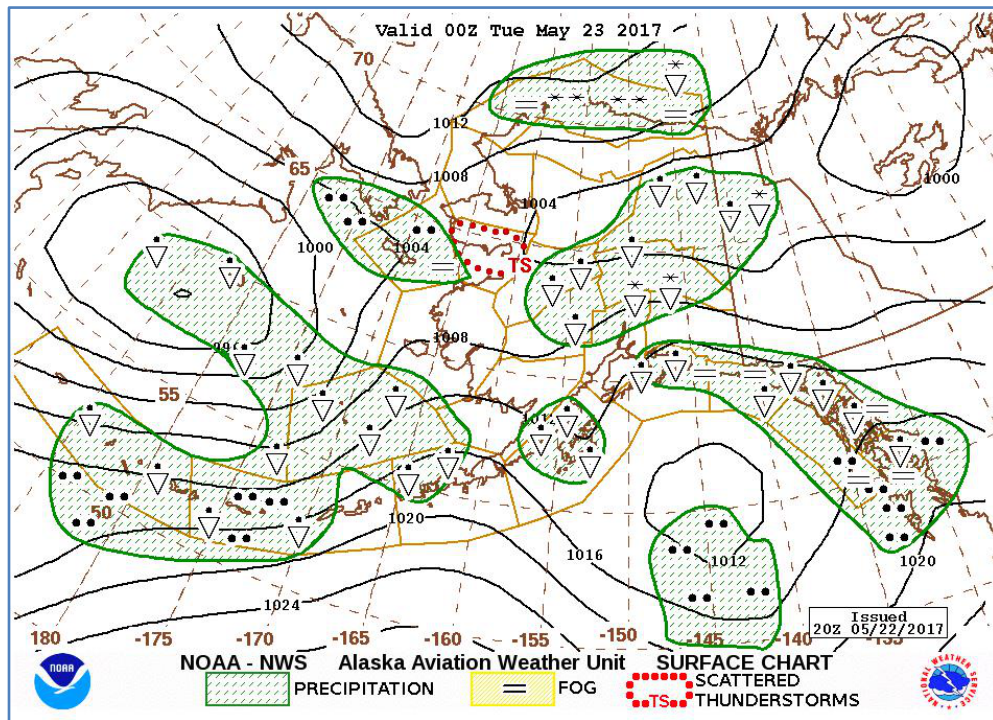
Figure 2 is the AAWU issued Surface Prognostic Chart valid for 1600 AKDT on May 22, 2017 for expected areas of precipitation and thunderstorms across Alaska during the period. The chart depicted most of all of southeast Alaska expecting rain showers and mist during the period.

Figure 2 - AAWU Surface Prognostic Chart for 1600 AKDT

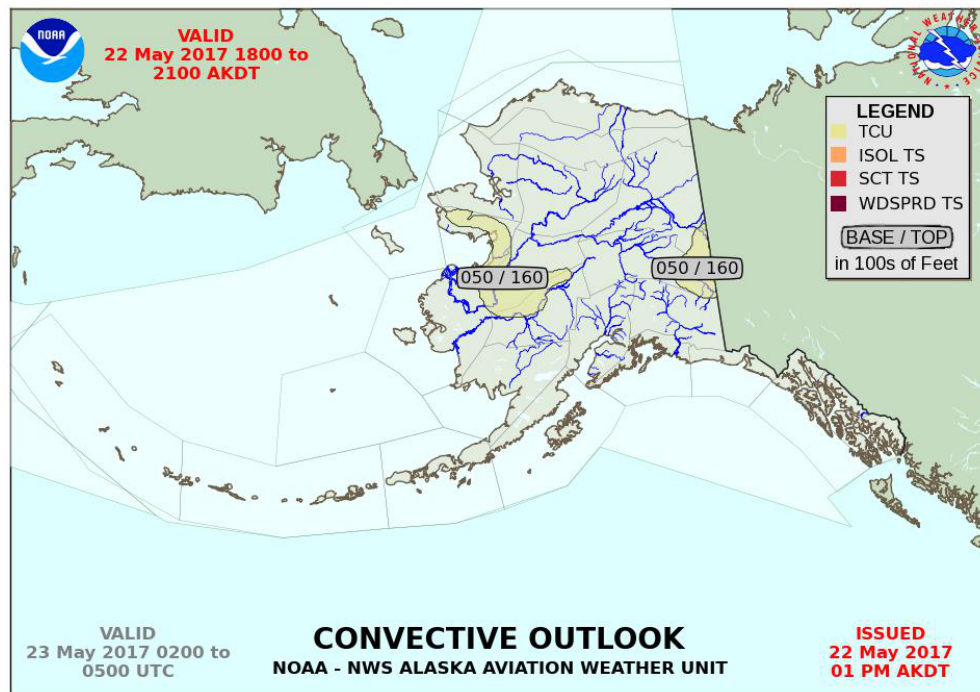
The Alaska Convective Outlook valid for the period (figure 3) depicted no significant convective activity or thunderstorm development was expected for southeast Alaska during the period. The Alaska Flying Weather Chart (figure 4) depicted VFR conditions<sup>3</sup> over the Juneau

Figure 3 – NWS AAWU Convective Outlook

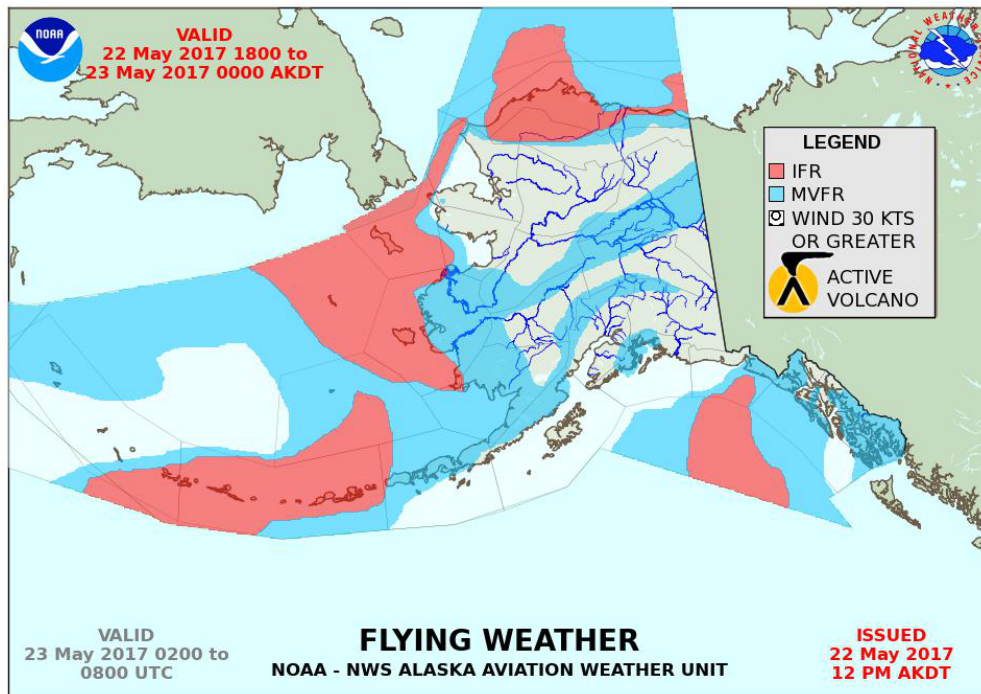
and Glacier Bay areas, with marginal flight rule (MVFR) conditions<sup>4</sup> to the west and south, with no large areas of instrument flight rule (IFR) conditions<sup>5</sup> over land. The chart also depicts areas where wind of 30 knots or greater are expected and volcanic activity in which none were expected for the region. The Low-Level Turbulence (figure 5) and Icing Forecast (figure 6) depicted no significant areas of turbulence or icing over the region, with the freezing level depicted at about 4,000 ft over the region.

Figure 4 - NWS AAWU Flying Weather Graphic

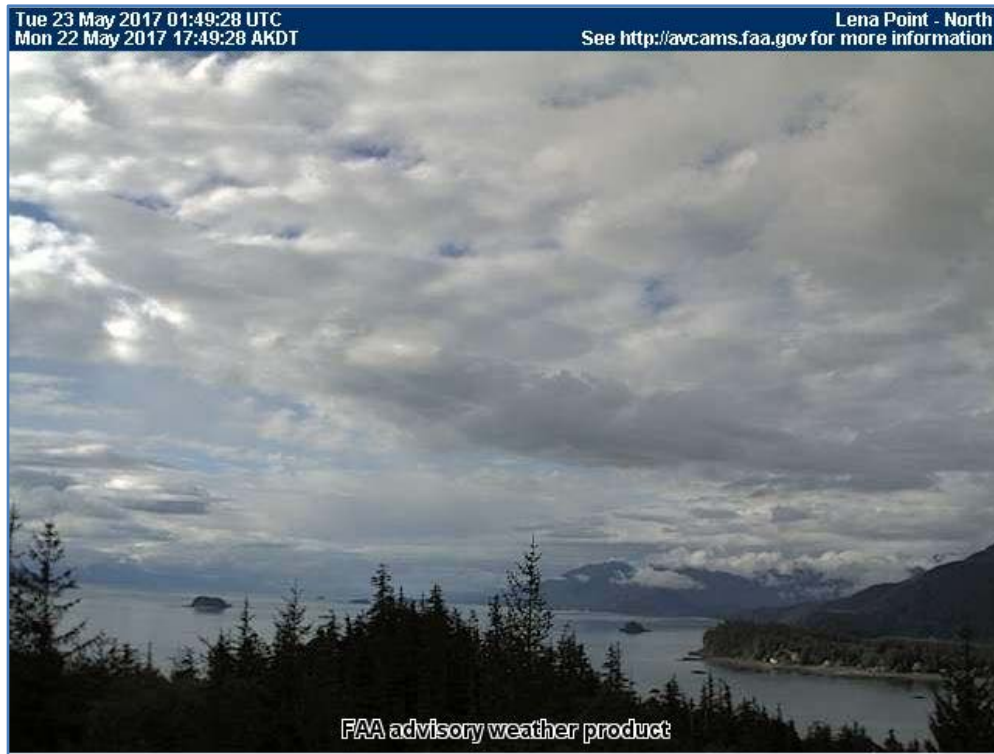
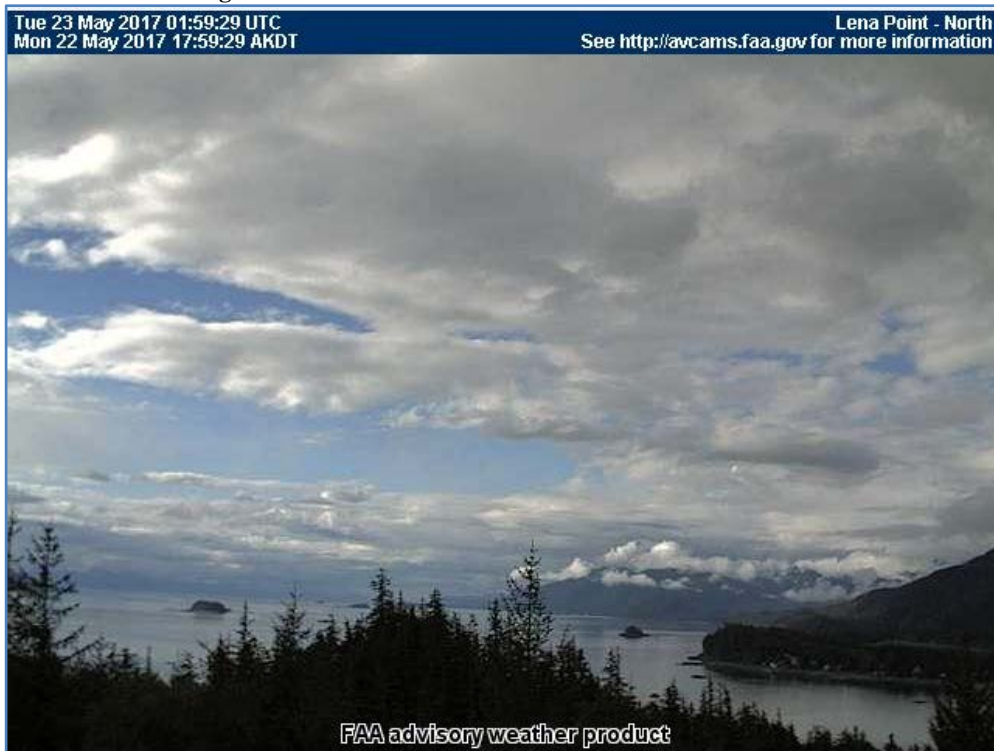
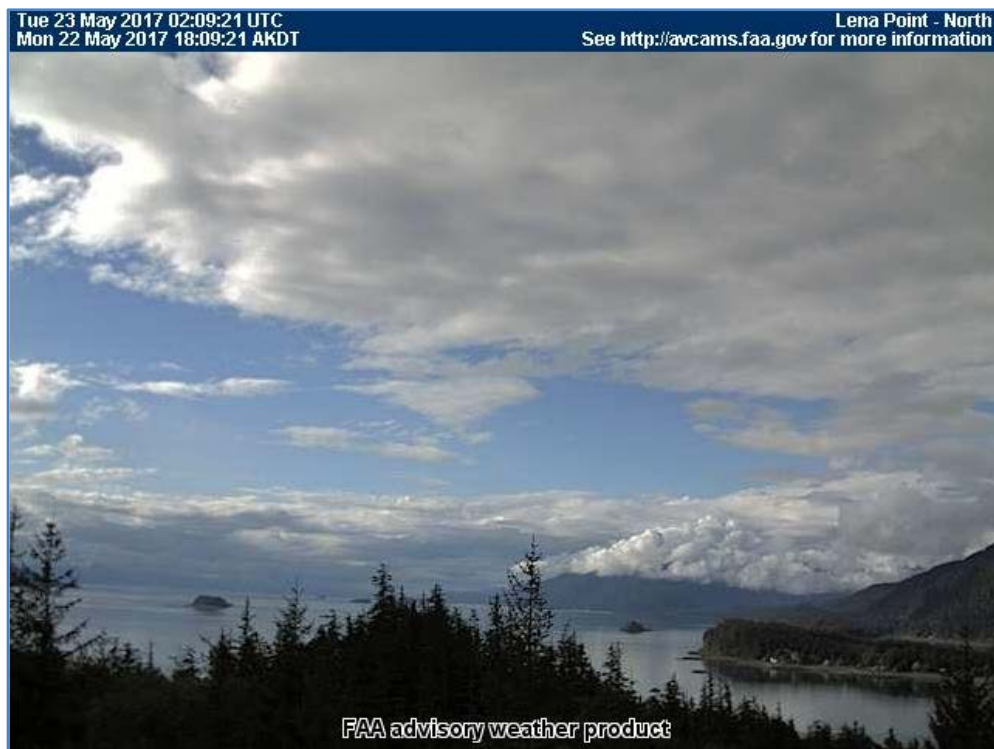
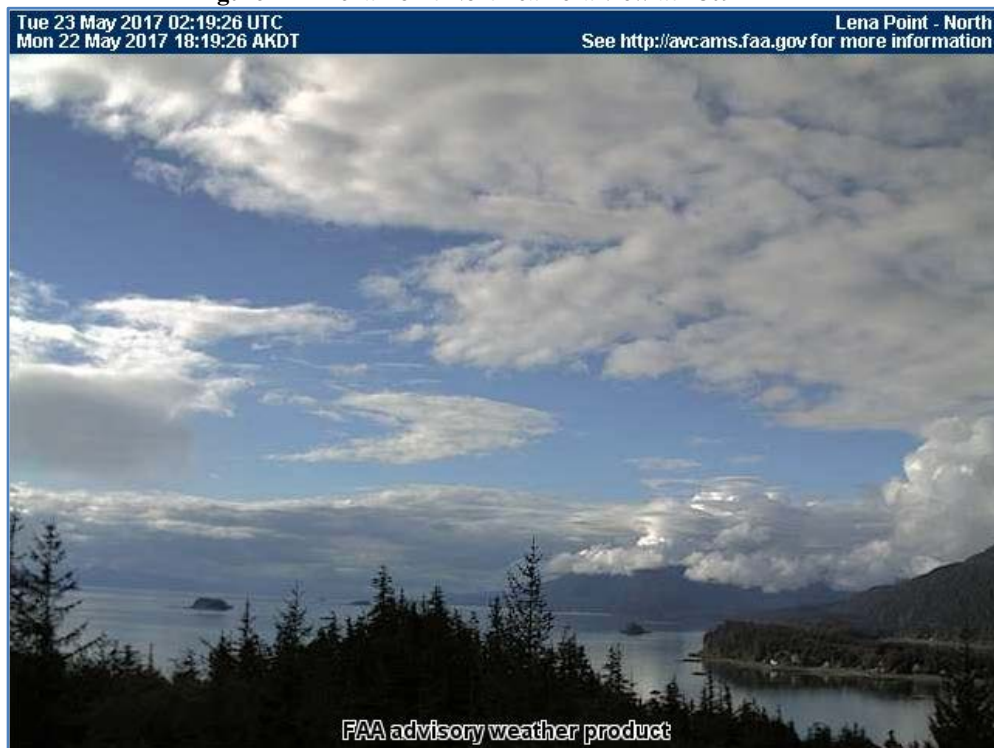
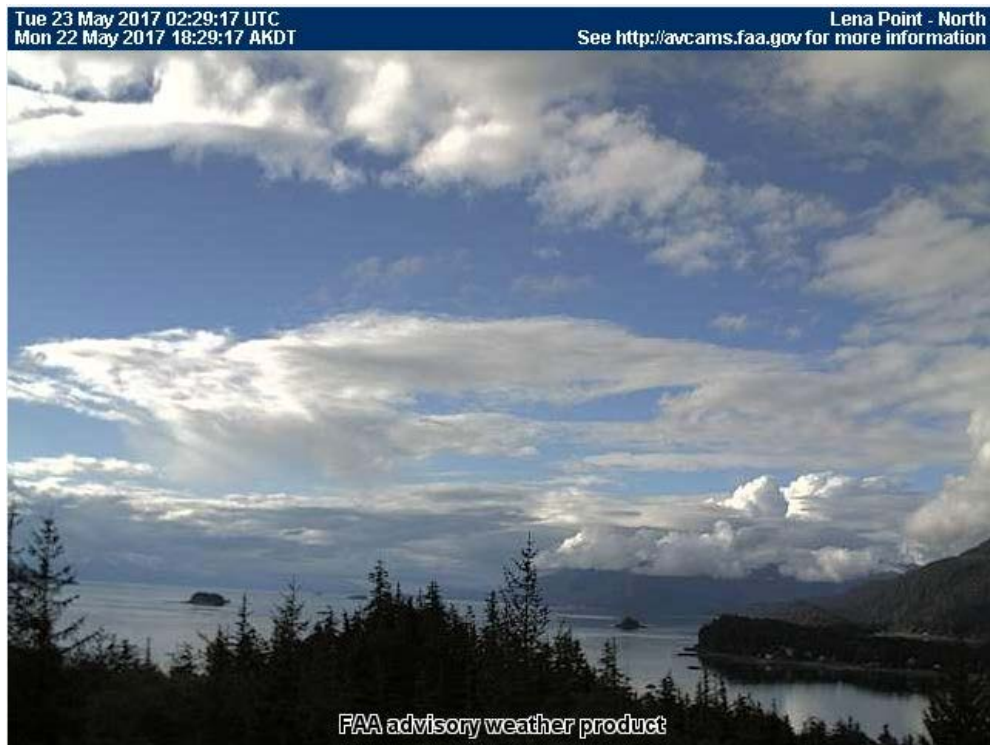
Figures 10 through 14 are the Lena Point north camera images from 1749 through 1829 AKDT, at 10-minute intervals viewing the conditions immediately west of the accident site. The images show two to three layers of clouds; one below 2,000 ft in the valley, another obscuring the high peaks, and the other a band of altocumulus to stratocumulus type clouds, with some nimbostratus clouds in the distance. No indications of precipitation was evident over the camera site; however, dark clouds to the northwest indicated possible precipitation beyond 15 miles. The high terrain 19.5 miles north at 5,500 ft was totally obscured by clouds surrounding the entire period with no clear depiction of the terrain or peaks beyond 14 miles. The higher terrain at 13.5 miles away at 2,800 ft was at first identifiable but becomes obscured by clouds with time, the lower band of clouds extend in the valley leading to the glacier. No significant wind was noted by any trees swaying or indications in the water.

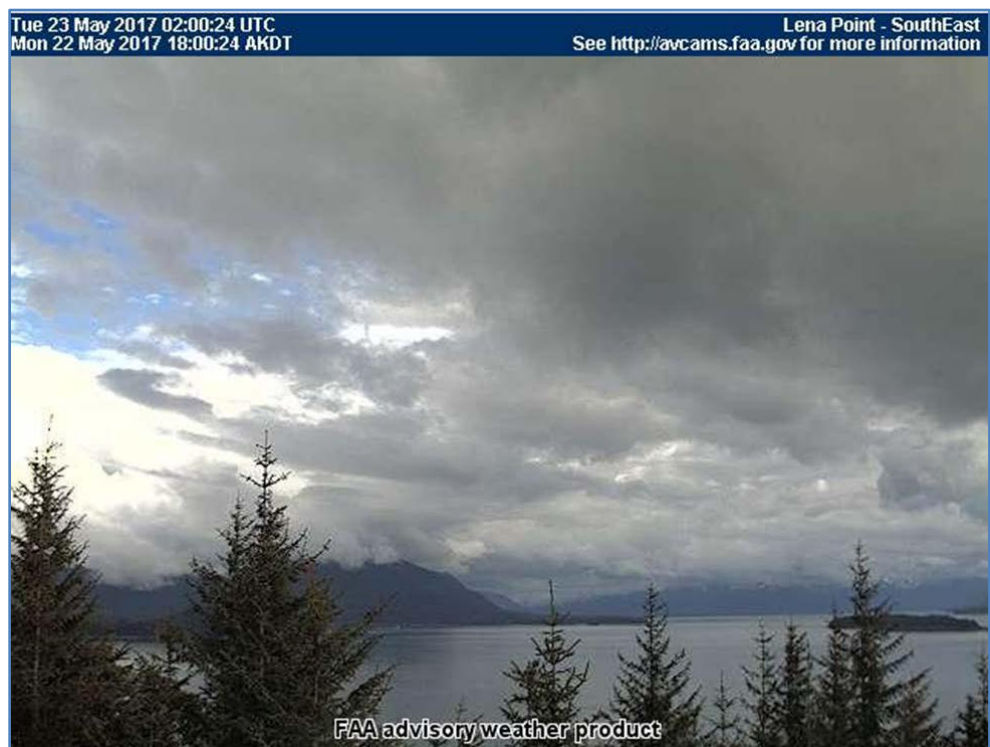
Figure 15 is the Lena Point southeast camera view at 1800 AKDT which showed the higher terrain also obscured by clouds about the time of the accident.

Figure 15 - Lena Point Southeast camera view at 1800 AKDT

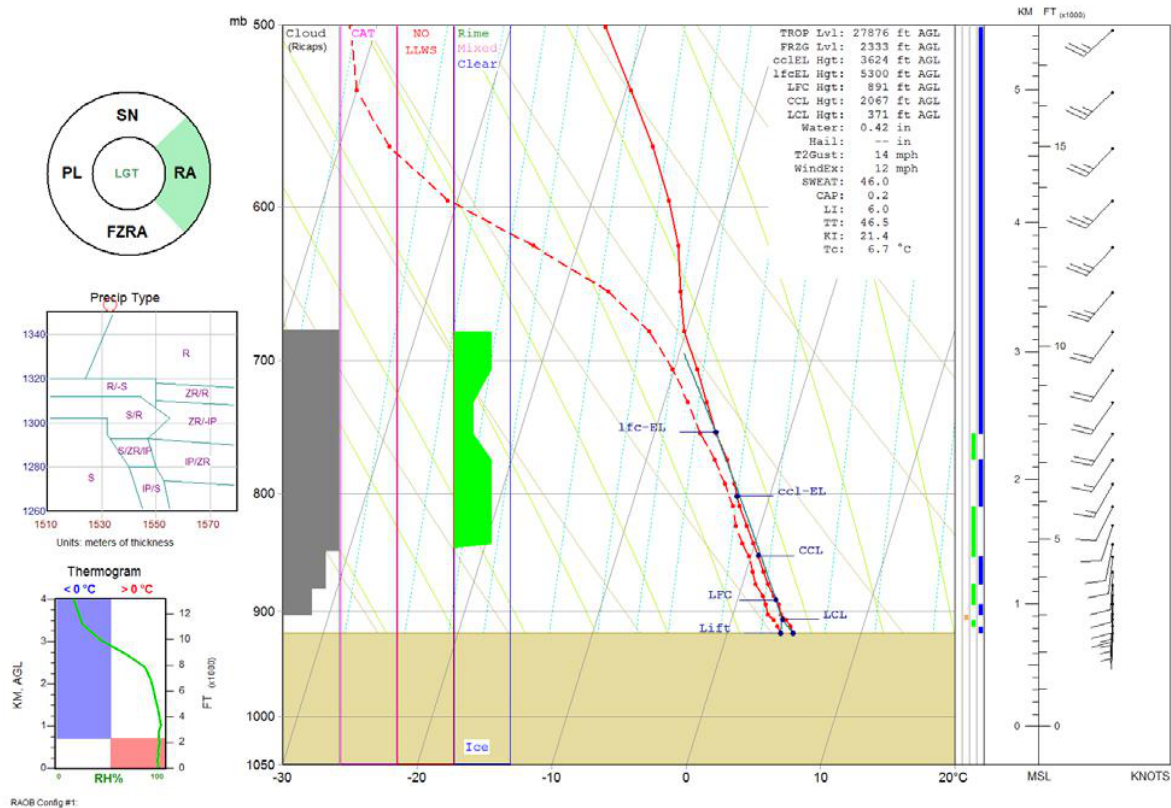
**Figure 16 - GDAS numerical model sounding for 1600 AKDT over the accident site**

The model sounding estimated the elevation at 2,500 ft with a surface temperature of 5° C, a dew point temperature of 4° C, and a relative humidity of 93%, and the surface wind from the south at 180° at 6 knots. The sounding indicated a lifted condensation level (LCL)<sup>8</sup> at about 370

ft agl, a level of free convection (LFC)<sup>9</sup> at 890 ft agl, and a convective condensation level (CCL)<sup>10</sup> at 2,070 ft agl with the estimated top of the clouds at 10,420 ft based on the relative humidity greater than 85%. The atmosphere was classified as stable based on the lifted index (LI)<sup>11</sup> of 6.0, with the layer below 8,000 ft showing general conditional unstable conditions (indicated by green on the far right side of diagram, blue being stable) and supported several layers of low to mid-level clouds with stratocumulus to nimbostratus type clouds with light precipitation. The freezing level was at 4,830 feet and the sounding supported icing in clouds and precipitation above that level. The wind profile indicated southerly winds veering to the southwest with height. No strong vertical shears were noted to indicate any potential turbulence or low-level wind shear.

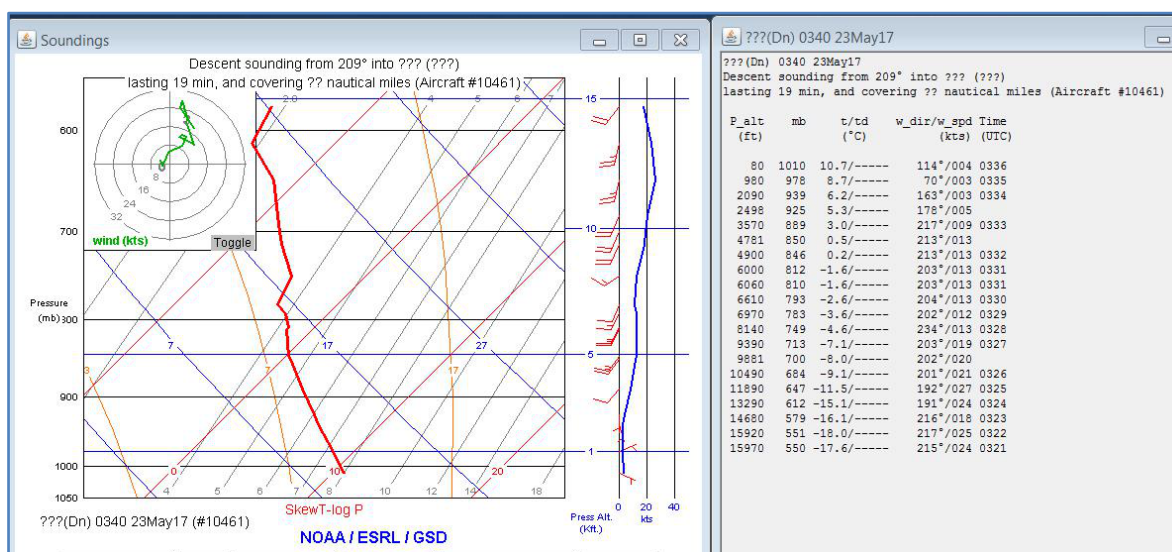
In-situ aircraft reports were also reviewed from the NOAA Aircraft Meteorological Data Relay (AMDAR) observations. An aircraft identified as #10461 landed at PAJN at 1932 AKDT and provided a descent sounding, which is included as figure 17 with the observed data. The freezing level was near 5,000 ft with light winds below 3,000 ft.

Figure 17 - AMDAR descent sounding into PAJN at 1936 AKDT

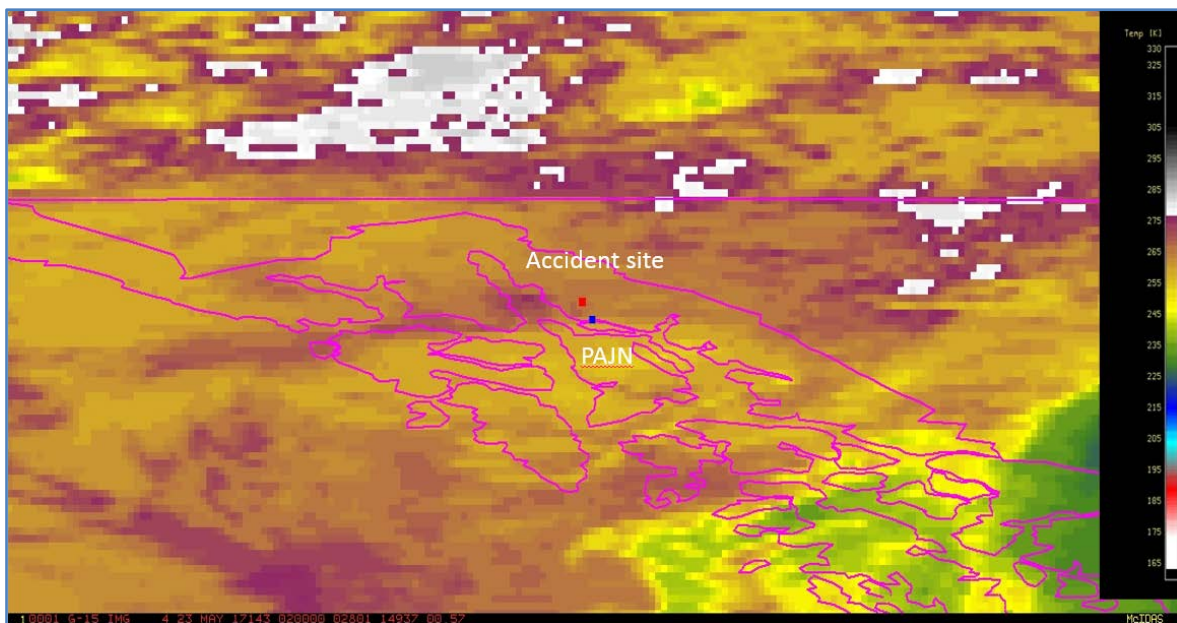
Figure 18 is the GOES-15 infrared image at 1800 AKDT at 7X magnification with a temperature enhancement curve applied. The image depicted an extensive area of low to mid-level clouds over the region, with several breaks in the clouds indicated by the reddish-brown areas. The accident site is marked by a red square and PAJN by a blue square. The image depicted a radiative cloud top temperature of 267° Kelvin or -6.16° C over the accident site, which corresponded to a cloud tops near 8,200 ft based on the GDAS sounding.

**Figure 18 - GOES-15 infrared red image at 1800 AKDT at 7X magnification**

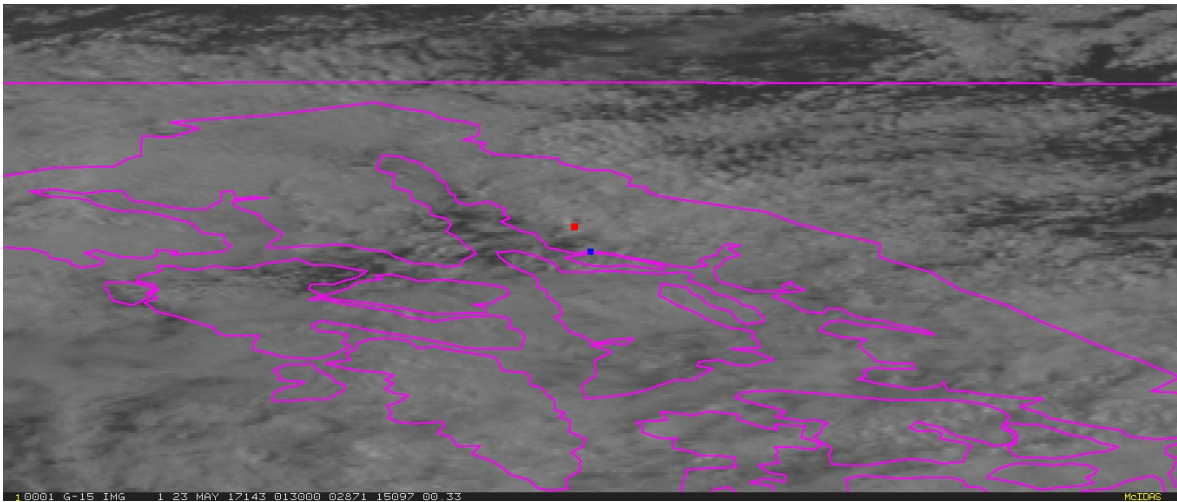
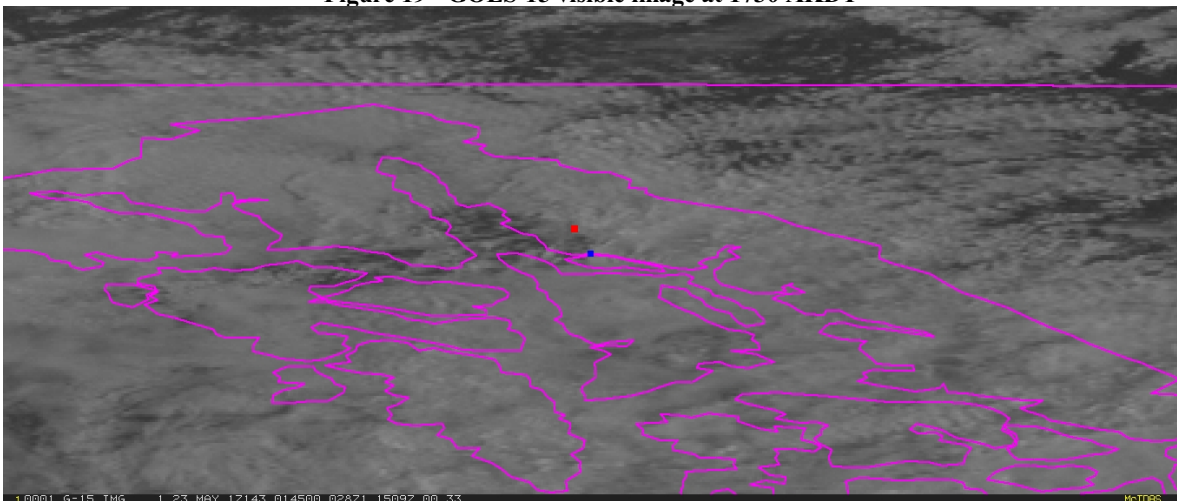
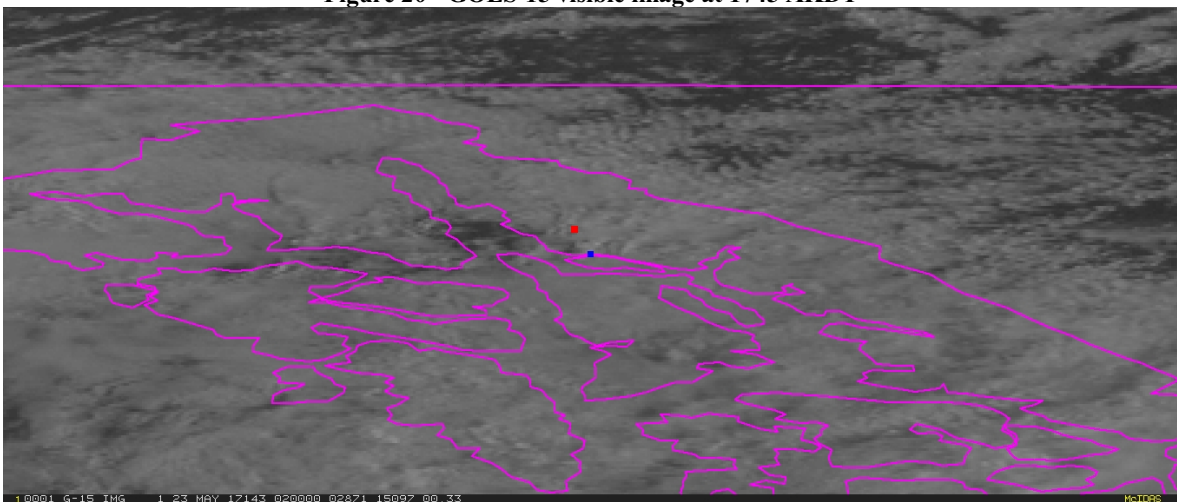
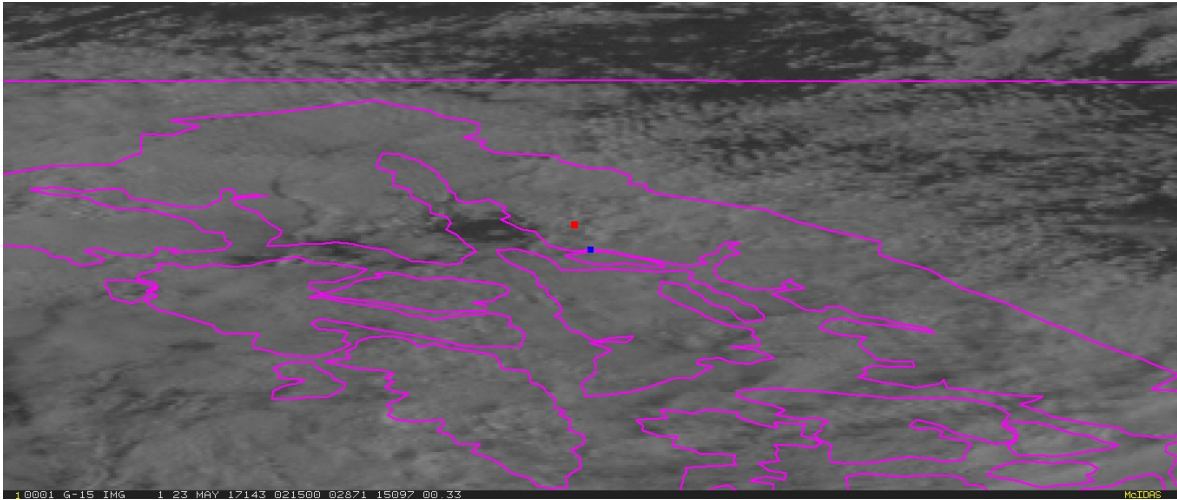
Figures 19 through 22 are the GOES-15 visible images at 1730, 1745, 1800, and 1815 AKDT at 3X magnification, with the accident site indicated by the red and PAJN by the blue square. The images show an overcast layer of clouds over the accident site during the period with a broken coverage between the accident site and PAJN between 1730 and 1745 AKDT. A break in cloud cover was evident over Lynn Channel to the west, as confirmed by the Lena Point weather camera images.

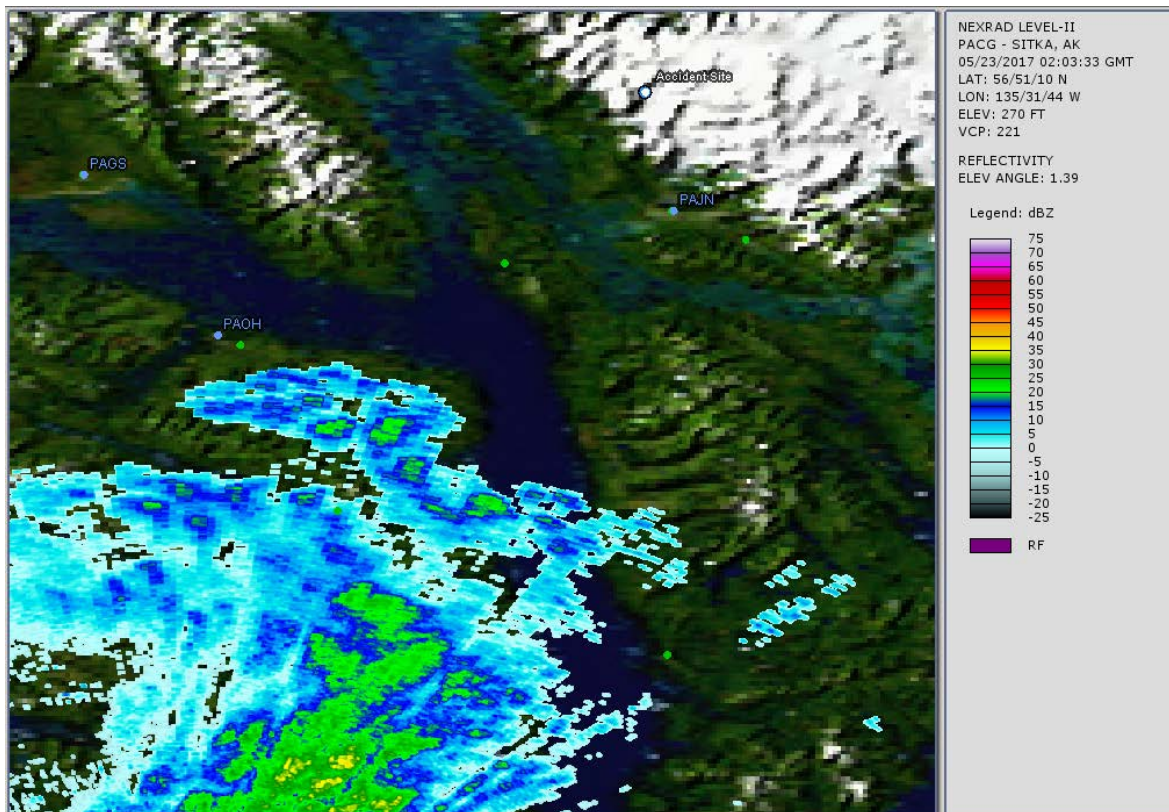
Figure 23 is the PACG WSR-88D 1.4° base reflectivity image at 1803 AKDT which depicted echoes extending out to 60 miles from the radar site, but due to range limitations and potential beam blockage due to higher terrain in the area was unable to see any low-level echoes over the accident site.

Figure 23 - FAA Sitka WSR-88D image at 1803 AKDT

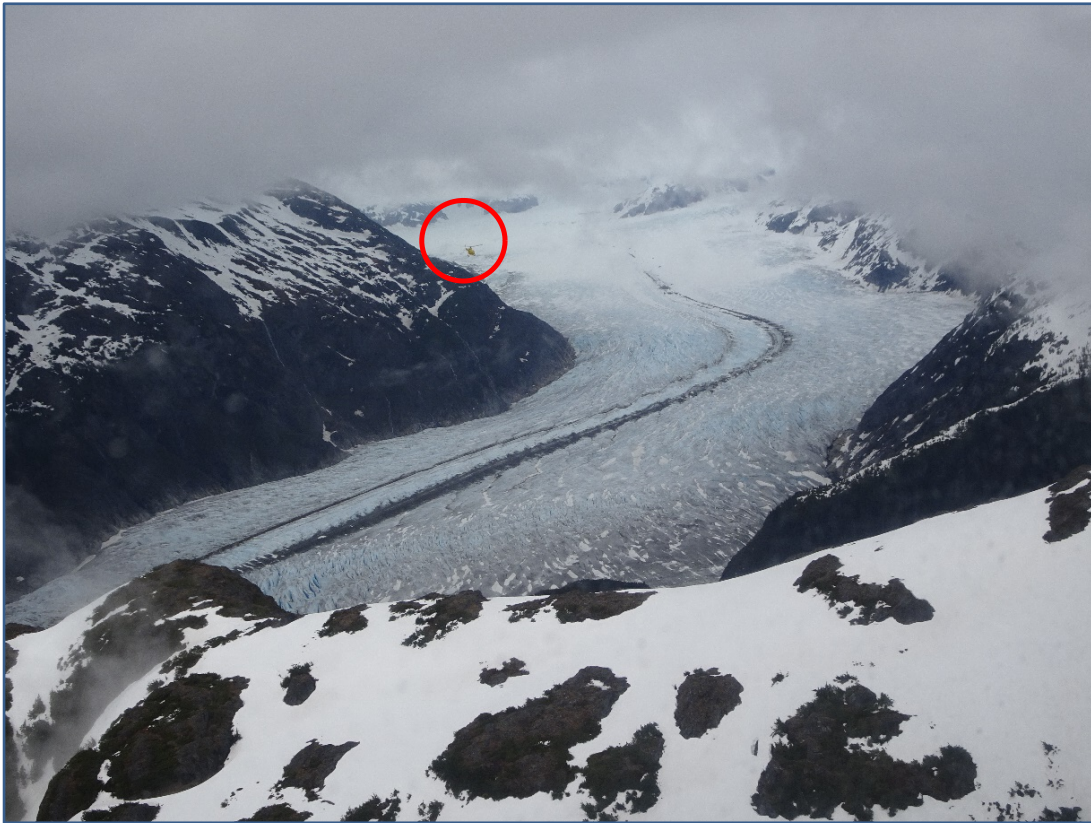
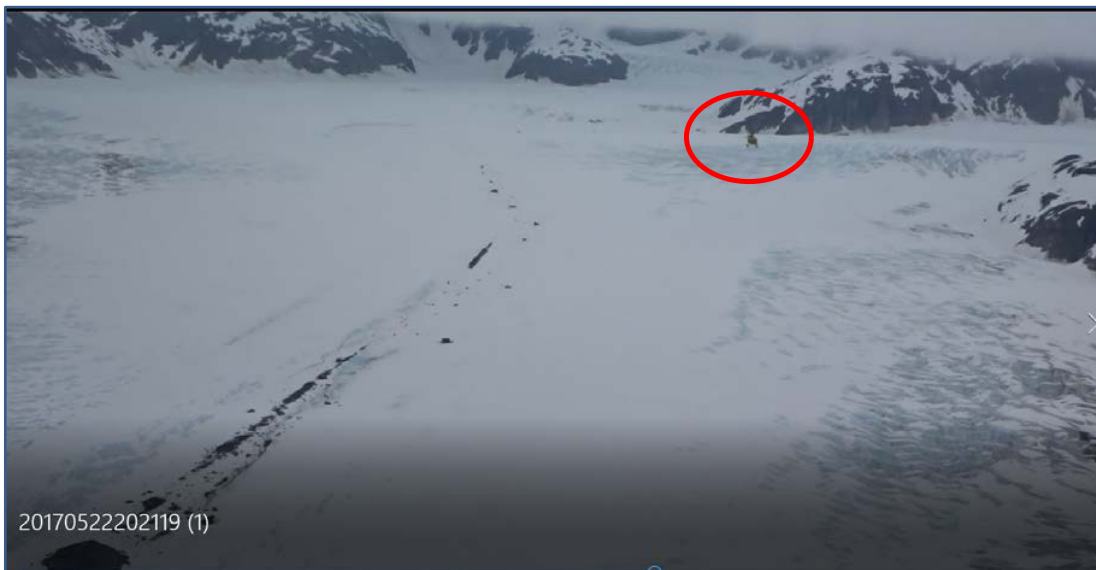
Figures 25 and 26 are pictures taken by one of the passengers on board the helicopter approaching Herbert Glacier and the dog sled camp on the day of the accident. The image shows another company helicopter immediately ahead and below the flight path (within the red circle) near the side of the mountain and under a layer of clouds, which is beginning to obscure the higher mountain tops.

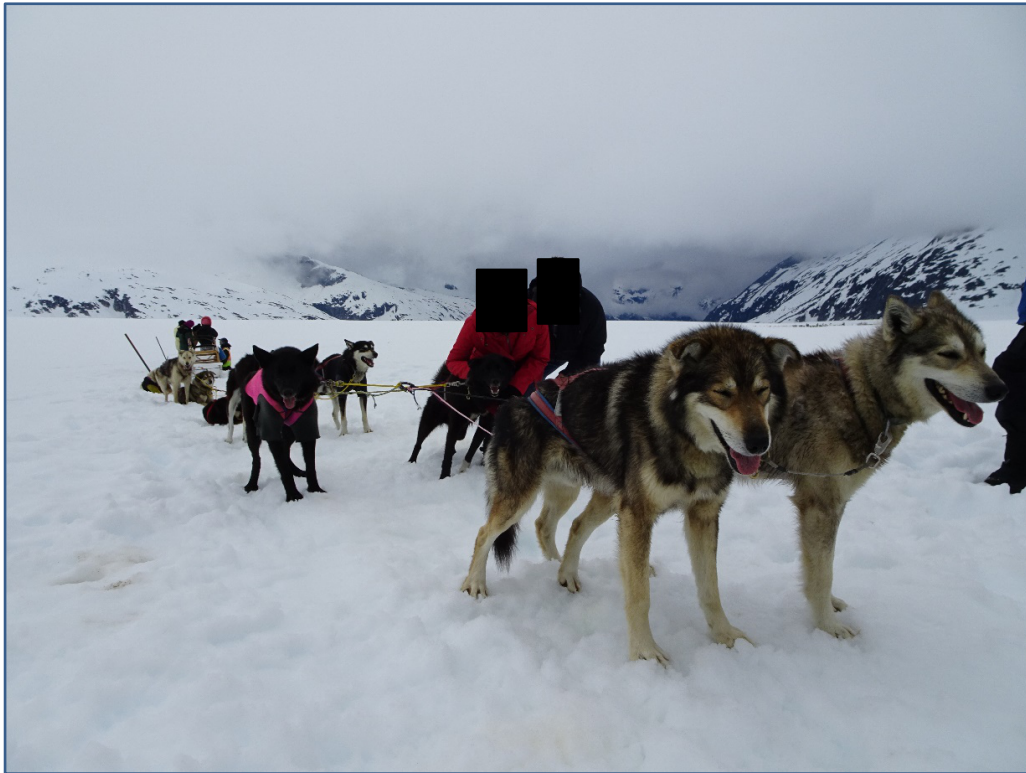
**Figure 27 - low clouds towards the departure route off the glacier.**

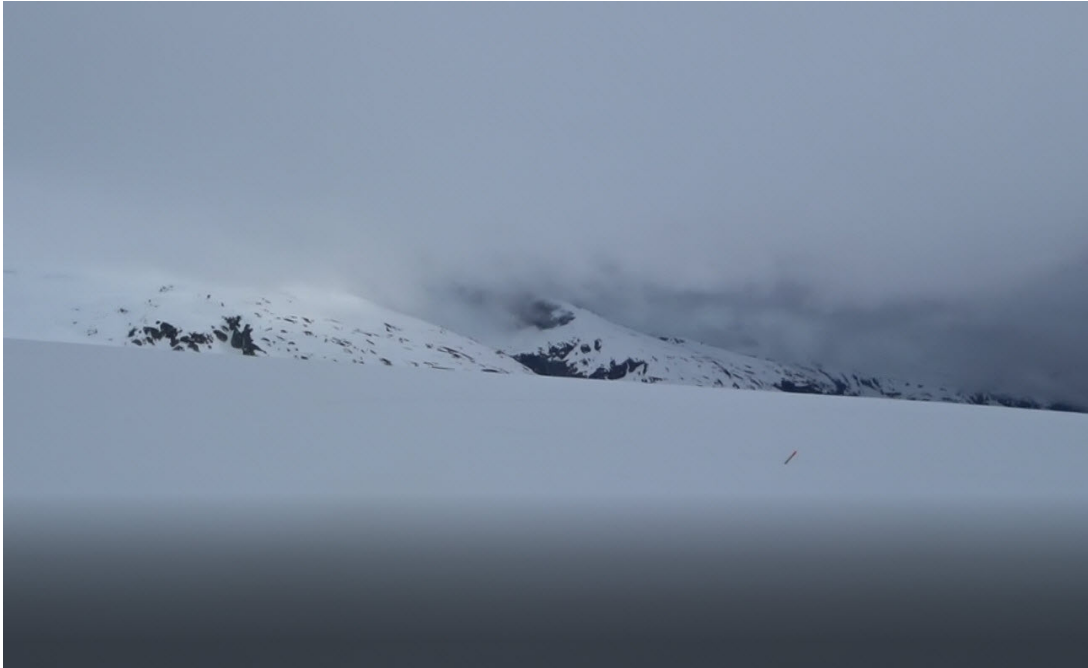
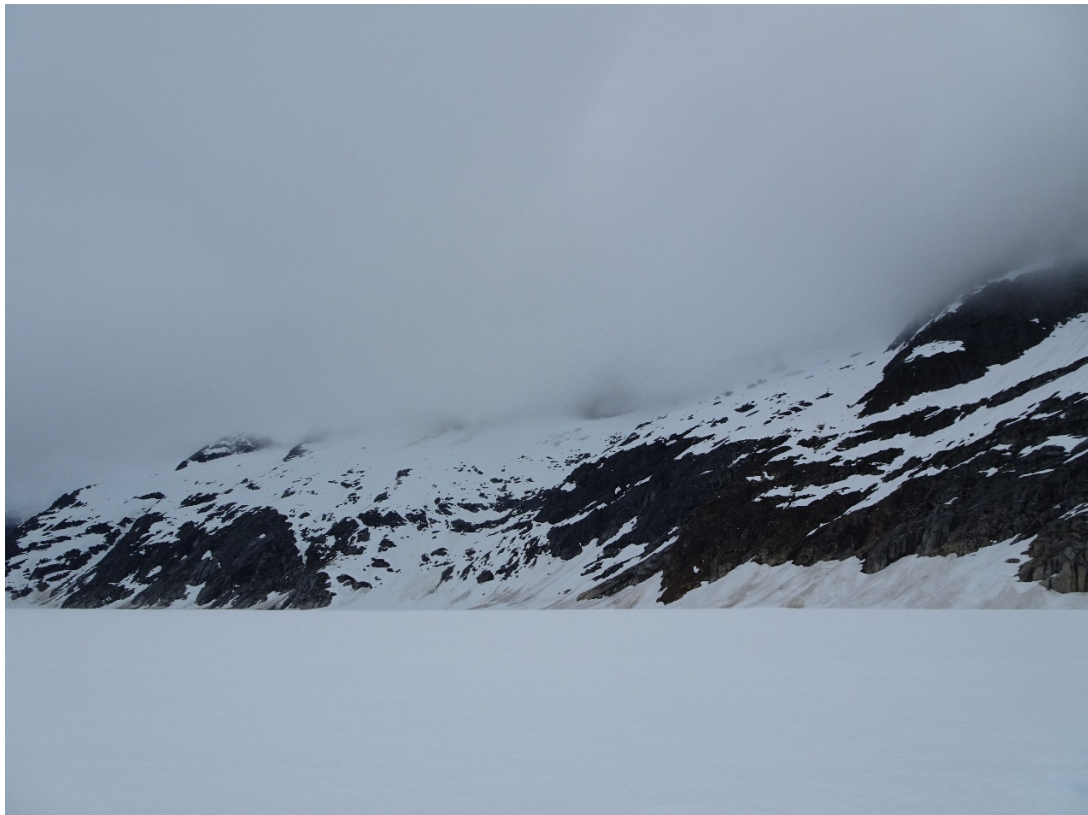
Figures 29 and 30 were taken during the dog sled run looking at the glacier and the low overhanging clouds.

**Figure 30 - Low clouds over the glacier**

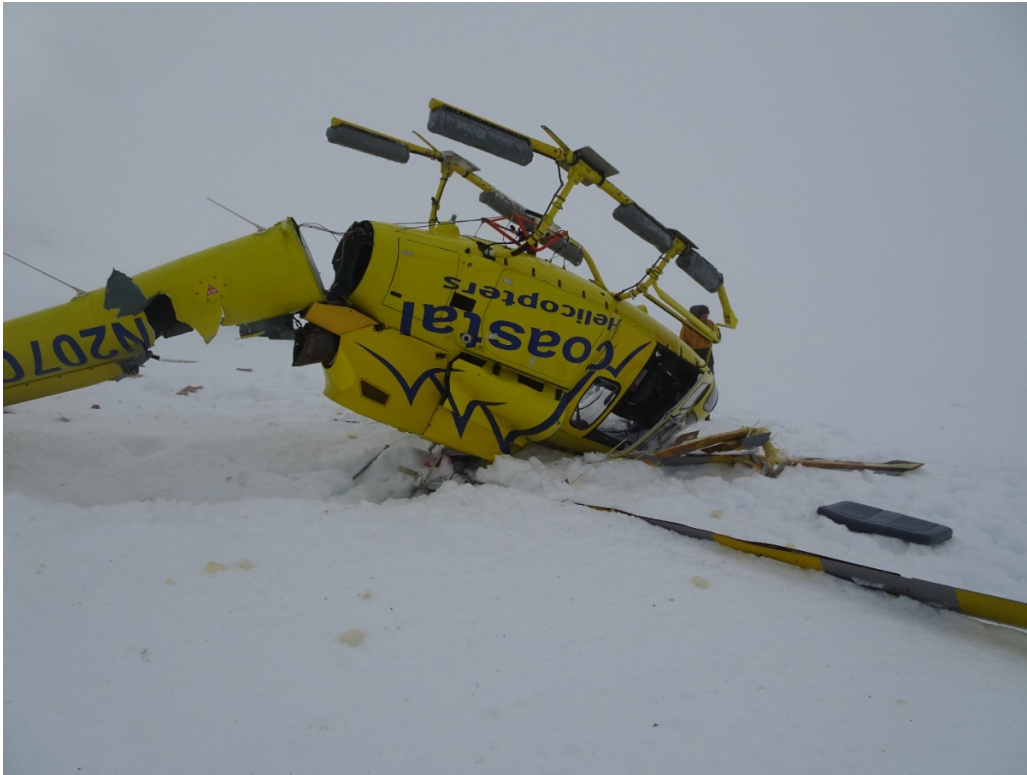
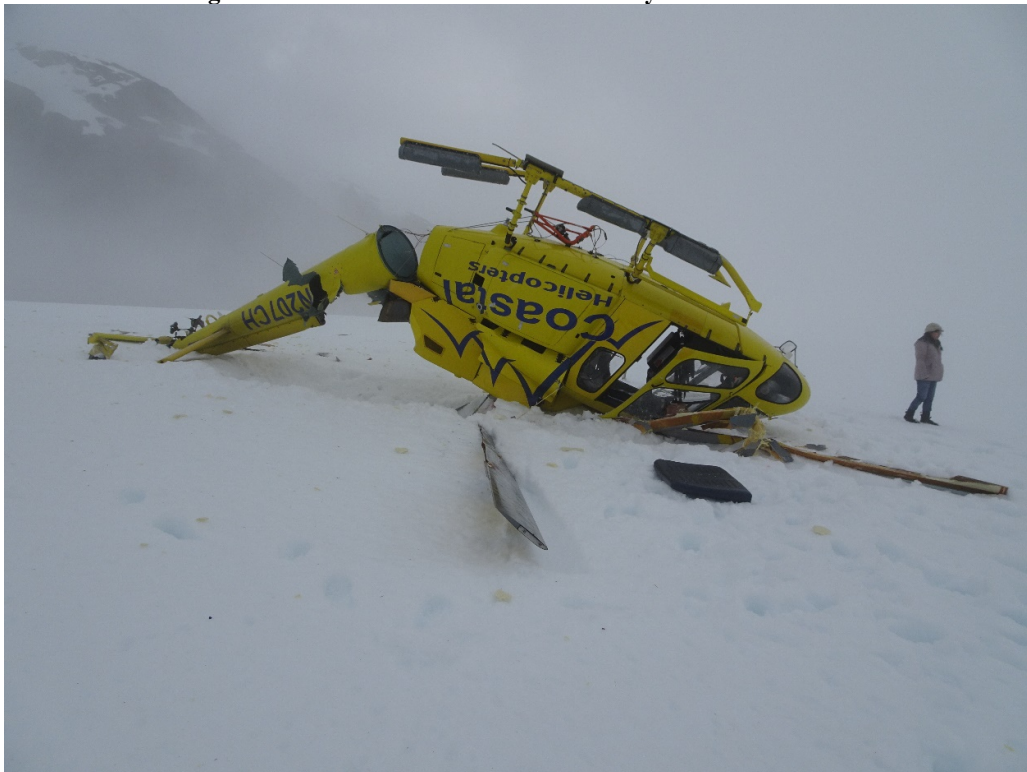
The next photographs taken were immediately after the accident at approximately 1820 AKDT. Figures 32 through 33 are of the accident site with the terrain obscured by clouds and fog, and general flat light conditions at the site.

**Figure 32 - Weather conditions immediately after the accident**

**Figure 33 - Accident site with obscured sky cover and flat light conditions**
