## **NATIONAL TRANSPORTATION SAFETY BOARD**

#### **On Scene, Airframe and Engine Examination Summary**

NTSB Number: ANC17LA034

Aircraft: N2429C, Cessna 180

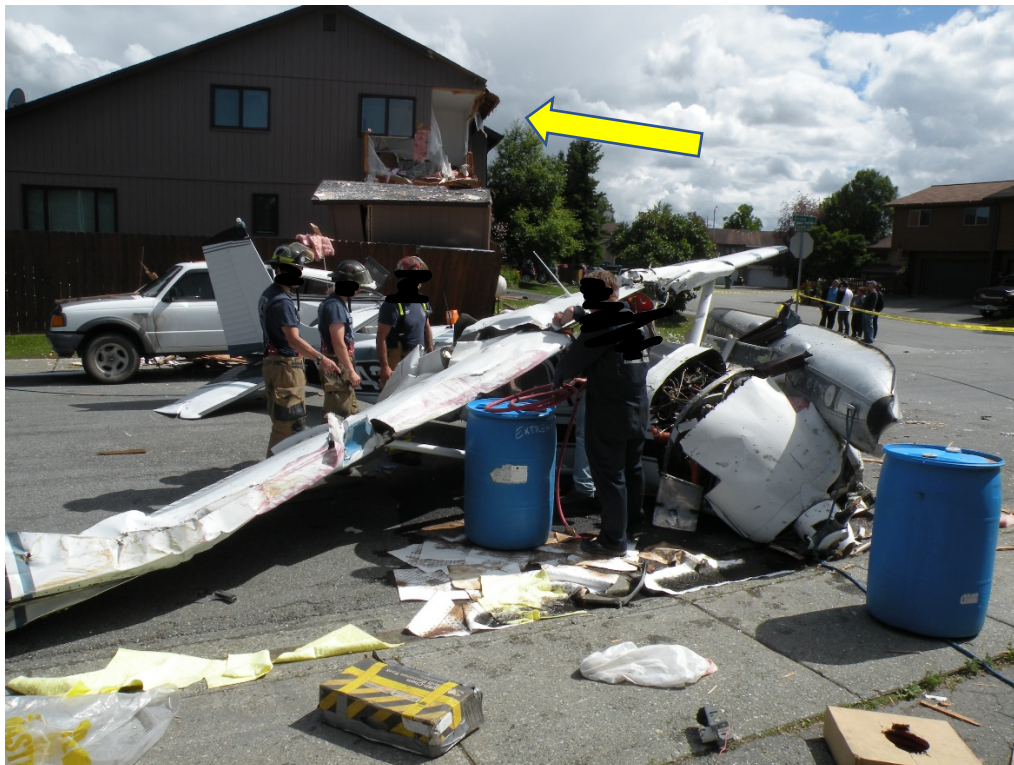
*Figure 1. First responders defueling the airplane at the scene and the damaged house, (yellow arrow).*

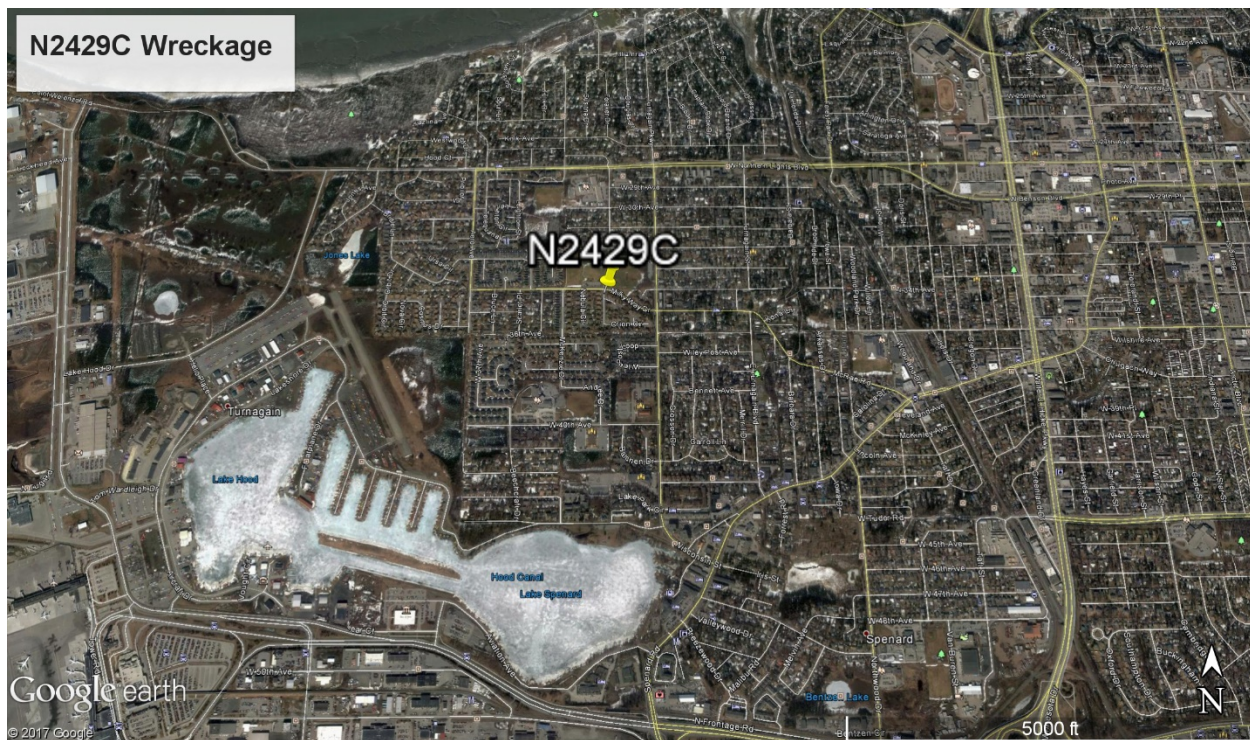
*Figure 2. Wreckage location north of LHD.*

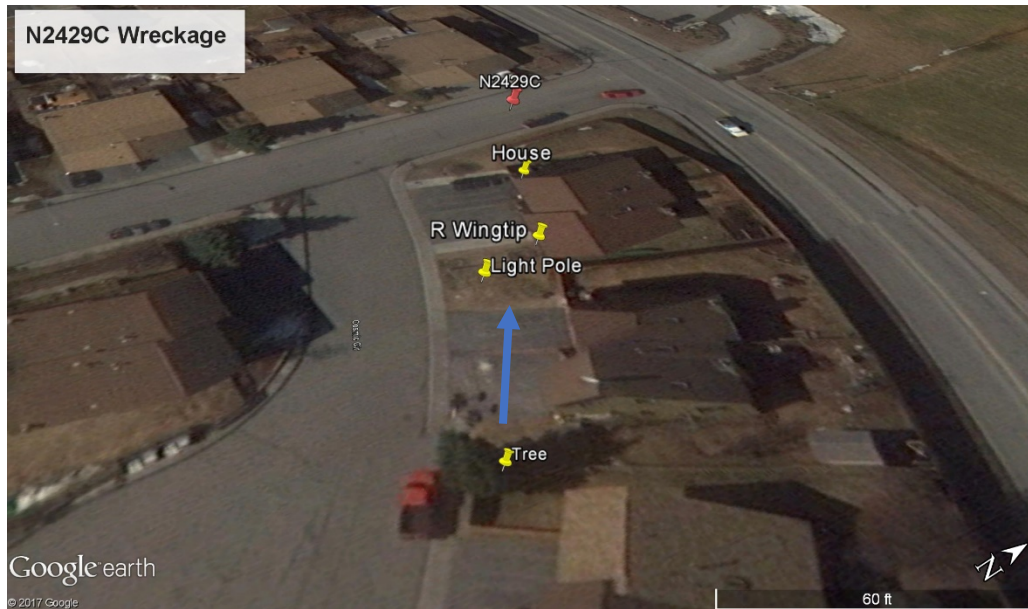
The airplane wreckage and impact evidence began at the top of a 40-foot spruce tree and continued on a course of about 320° to a downed light pole, a house gutter and window impact, a second story bedroom structure, a shed roof, and a pickup truck parked in the road and then the street. The wreckage debris pattern was about 200 feet long. See figures 3 and 4. The airframe had impact indentations on the leading edge of both wings that were consistent with impact damage to ground objects at the scene. The composite propeller blades were fractured and fragmented into pieces found through most of the debris field. The pilot's 4-point seat harness was intact and functional. The the right seat (which had no occupant) headset cord was wrapped around the base of the flap control lever, which was in the 20° detent. The right seat lap belt was not fastened and located near the flap lever base after the accident. See figure 5. Wood debris from the house and shed was present in and around the airplane. All the airplane's major components were found at the accident site.

*Figure 3. Impact sequence.*

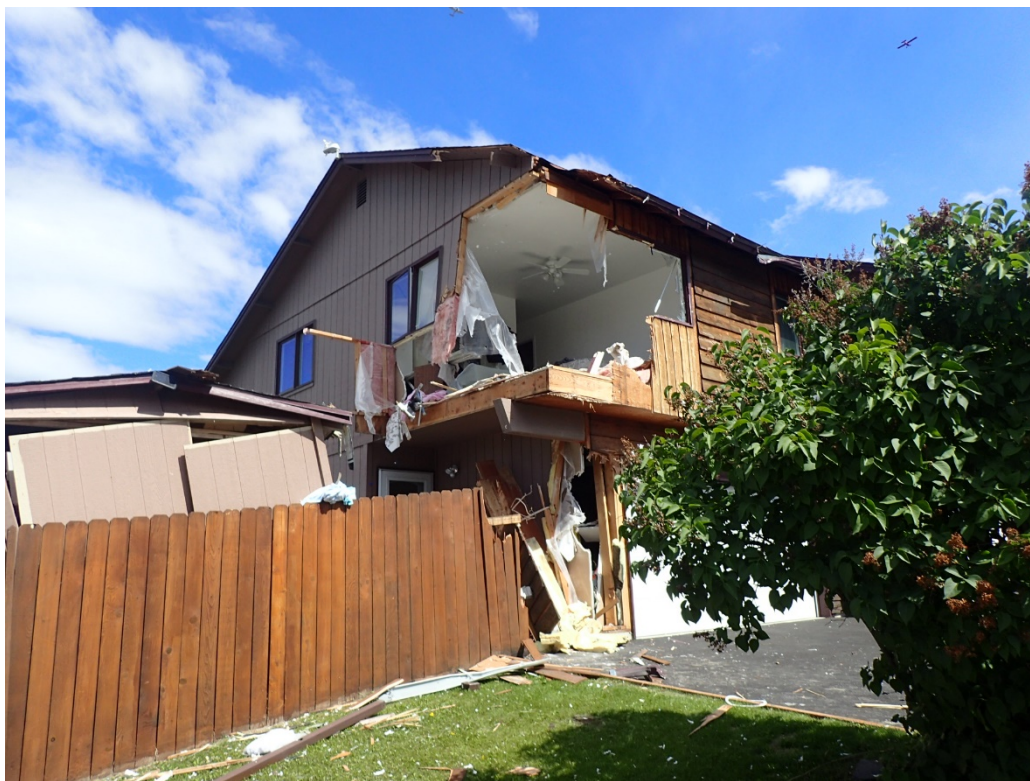
*Figure 4. Damaged house and shed.*

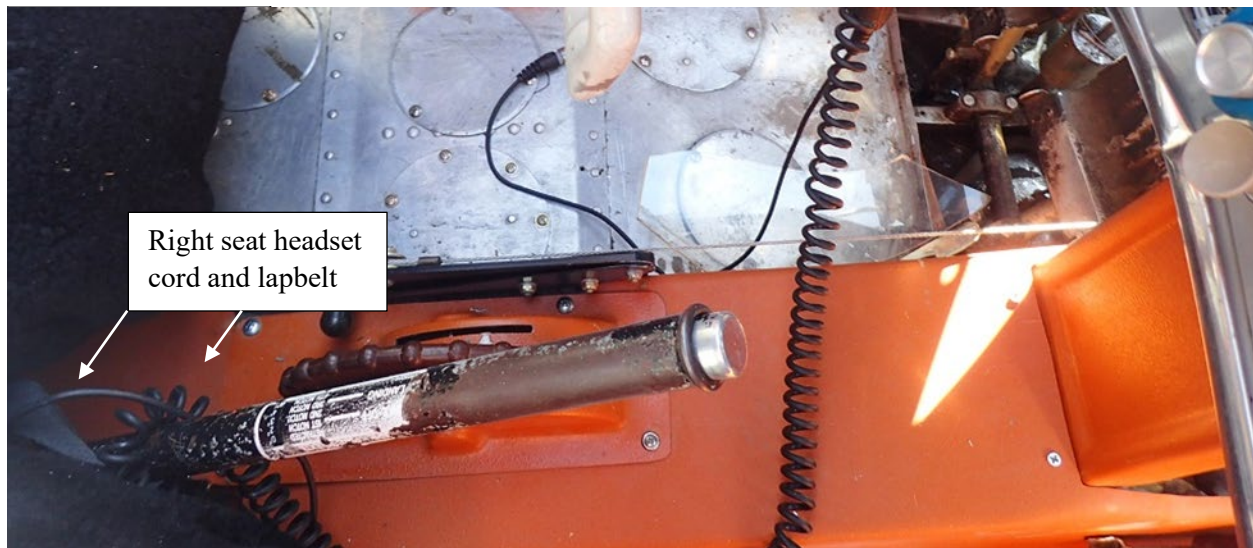
*Figure 5. The flap handle with right headset cord and lap belt.*

The flap handle moved through all detents without restriction. There was some binding at the retracted position (full down) due to impact deformation in the bracket and floorboards. The right-wing flap cable separated near the wing root and exhibited broom straw signatures indicative of tension overload failure. The left flap control continuity was established from the wing root cut ends to the bellcrank and pushrod.

The postaccident examinations of the airframe and engine revealed no evidence of mechanical malfunctions or failures that would have precluded normal operation. It was not determined whether the loose right headset and lapbelt may have interfered with flap lever movement before the accident, but it was unlikely that they interfered with engine operation.

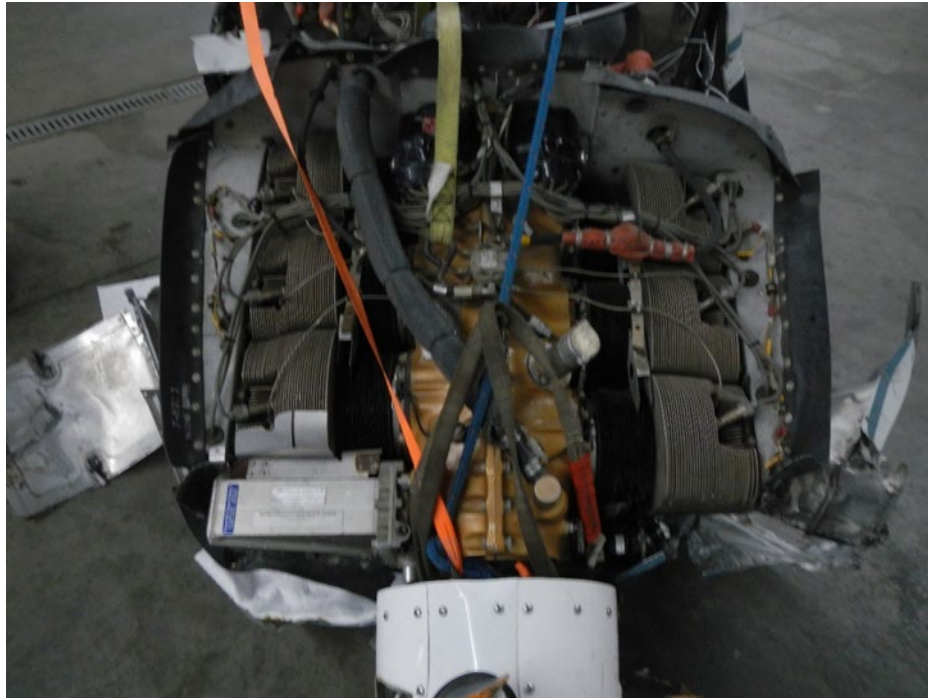
Two of the engine mounts were fractured and engine was intact with all lines attached and finger tight. There was some evidence of oil on the forward left bottom of the engine. The propeller governor control shaft was fractured and bent rearward. There were no signs of fuel leaks. The crank case and cylinders were all secure with no leaks present. See figure 6. The induction and exhaust systems exhibited minor impact damage. Engine control continuity was verified from the cockpit to the throttle valve/metering unit. All spark plugs exhibited normal wear signatures with little or no combustion deposits. Thumb compressions were verified on all six cylinders. The ignition harness was intact and both magnetos secure in their respective mounting pads. Spark was produced in proper firing order when the crank shaft was rotated. The cylinders, pistons, valves, and bottom spark plugs were examined with a lighted borescope. There were no anomalies observed, except for debris in the #6 cylinder and a fractured #6 rocker cover, which corresponded to impact damage and a slightly stuck exhaust valve that moved once tapped with a soft mallet. The oil sump remained attached with some impact damage evident on the bottom. Oil was drained from the sump.

The fuel lines were intact and secure at their fittings. The engine driven fuel pump was attached and secure with no sign of leaks. The fuel inlet line to the metering unit was removed and fuel was observed pouring out. The fuel inlet screen was removed and noted as clean with no obstructions. The fuel manifold valve remained attached to the topside of the engine and the fuel injection lines were in place. The cap of the fuel manifold was removed, and a very small amount of residual fuel was observed beneath the plunger. The plunger and diaphragm remained intact and no obstructions were on the screen. The fuel line from the fuel flow transducer to the manifold valve was opened and no fuel was present. Air was blown through the fuel flow transducer with no obstructions noted.

Figure 6. Continental IO-520 before the engine examination.
