## ENGINE FIELD RUN REPORT

| ENGINE MODEL | IO-520-D139B |
| FILE NUMBER | 17-042 |

**PAGE 2 of 11****GENERAL INFORMATION****EXAMINATION****DATE** 08/04/2017**FACILITY** Private Hangar**ADDRESS** [REDACTED]  
Anchorage, Alaska 99502**ACCIDENT DATA****NTSB ACCIDENT #** ANC17LA037**NTSB INVESTIGATOR** Noreen Price**FAA INVESTIGATOR** Gregory Varner**ACCIDENT DATE** 07/15/2017**ACCIDENT LOCATION** Wasilla, Alaska**ENGINE INFORMATION****ENGINE POSITION** Single-Engine**TOTAL TIME** Unknown**TIME SOH** 251.0 hours**TYPE & TIME SLI** 16 hours since last Annual Inspection; 07/27/2016**BUILD DATE** 10/14/1997**IN SERVICE DATE** Unknown**Significant logbook information:**

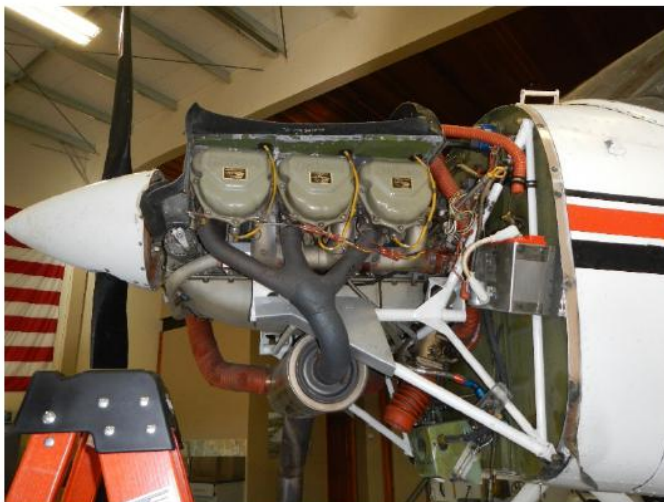
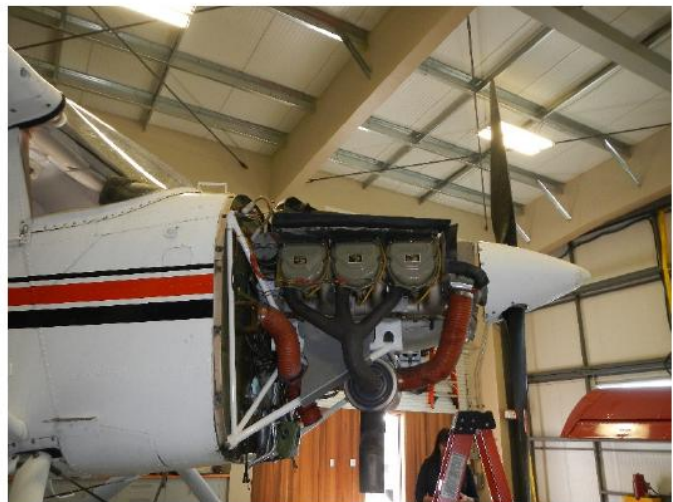
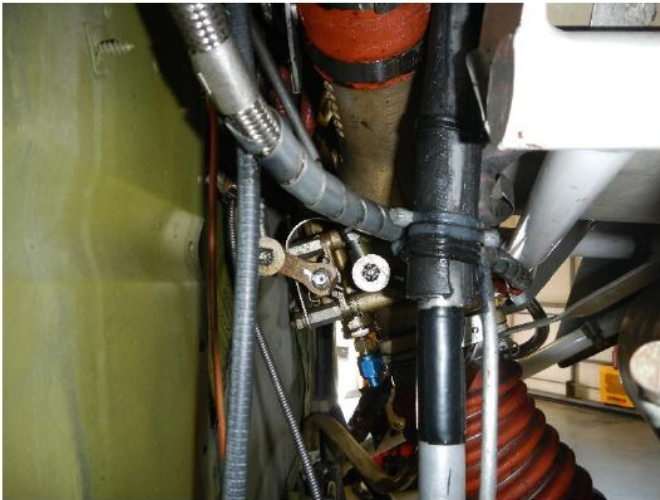
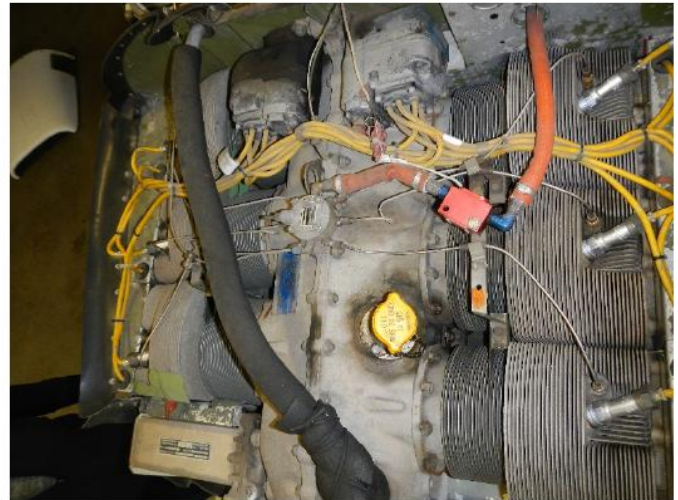
The engine remained attached to the airframe with no pre-accident anomalies noted with any of the structural attachments. The engine cowling was previously removed. One of propeller blades contained dried mud on the face side of the blade and was loose in the hub. The mixture and throttle control levers were examined with no pre-accident anomalies noted. The throttle and mixture controls were manually manipulated in the cockpit and a coinciding movement of the throttle and mixture control levers/shafts was observed at the fuel metering unit with no signs of slipping or binding noted. All of the fuel lines were secured to their respective fittings with no signs of fuel leaks noted. There was no sign of any oil leaks.

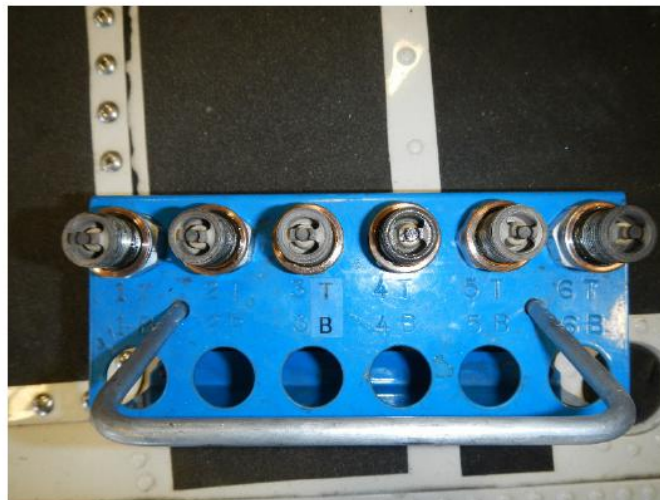
The top sparkplugs were removed from their respective cylinders and a borescope inspection was performed and documented (see borescope images below). The top sparkplugs appeared to be in a near-new wear condition with no signs of lead or carbon fouling. No pre-accident anomalies were noted with the internal components. The propeller was manually rotated and a spark was observed on the ignition leads. The top sparkplugs were reinstalled in their original cylinders and their ignition leads were reattached. The fuel that was drained from the wing tanks following the accident was poured into the fuel tanks in preparation for the test run.

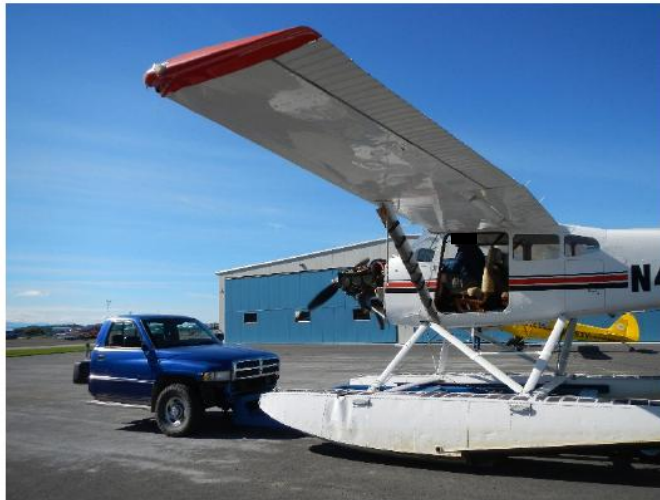
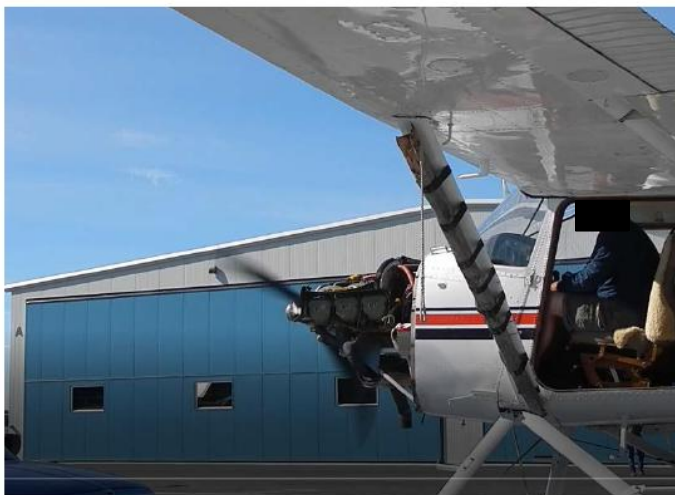
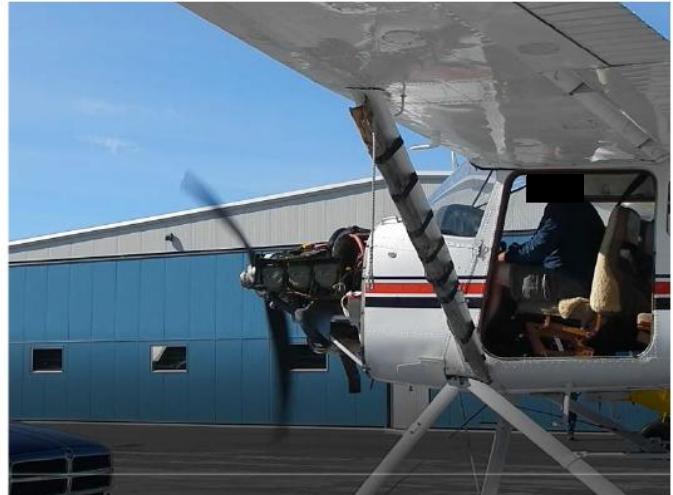
The engine was started utilizing the normal aircraft starting system after a replacement battery was installed. The engine started without hesitation and was run at a low RPM due to the vibrations induced by a loose propeller blade. The engine RPM was increased to 900 RPM for a magneto check with no pre-accident anomalies noted. The test run was kept short to prevent any damage due to the loose propeller blade.
