## **NATIONAL TRANSPORTATION SAFETY BOARD**

#### **Airframe and Engine Examination Summary**

NTSB Number: ANC17LA037  
Location: Wasilla  
Date: July 15, 2017  
Aircraft: N401WC, Cessna A185F, S/N 18502235  
Engine: Continental IO-520-D139B

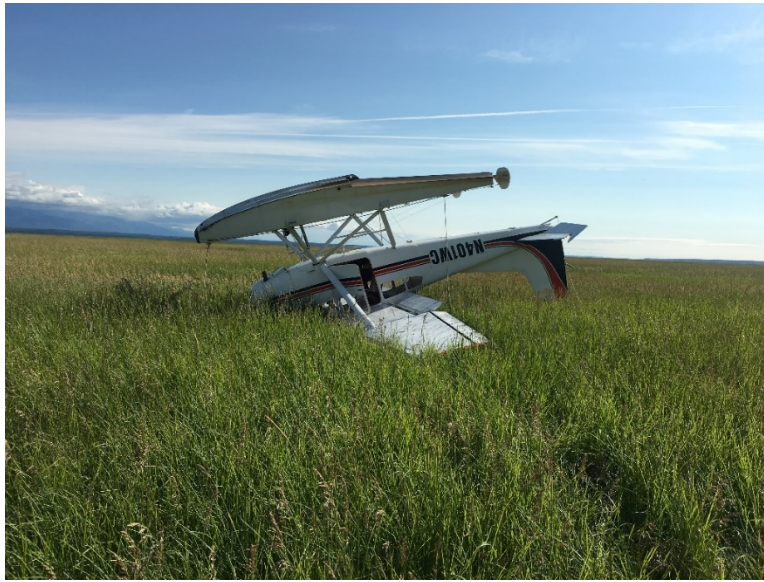
On July 15, 2017, about 1700 Alaska daylight time, a float-equipped Cessna A185F airplane, N401WC, sustained substantial damage when it nosed over during a forced landing following a complete power loss near Wasilla, Alaska. The airplane was registered to the pilot and was being operated as a personal flight under the provisions of 14 *Code of Federal Regulations* (CFR) Part 91 and visual flight rules (VFR). The private pilot and sole occupant, sustained no injuries. See figure 1.

*Figure 1. N401WC Cessna 185 inverted at the accident site. (Courtesy of the FAA)*

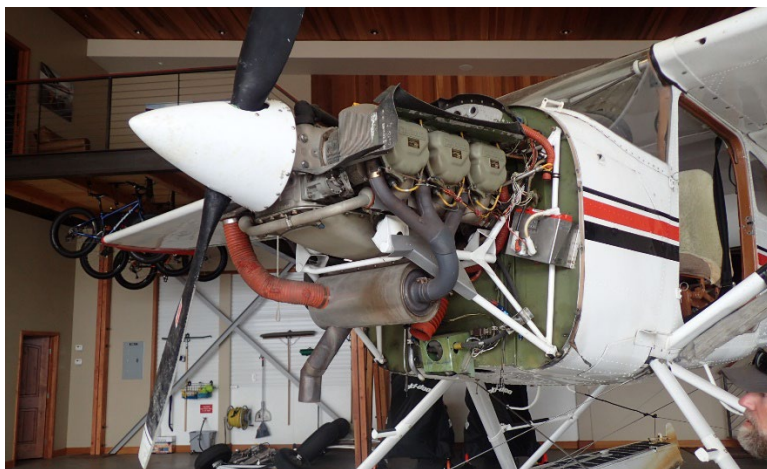
The engine remained attached to the airframe with all lines intact with no fuel or oil leaks observed. See figure 2. The mixture and throttle control levers were attached and engine control continuity to the fuel metering unit was established. No slippage or binding of the cables was noted.

*Figure 2. Continental IO-520 engine during examination.*

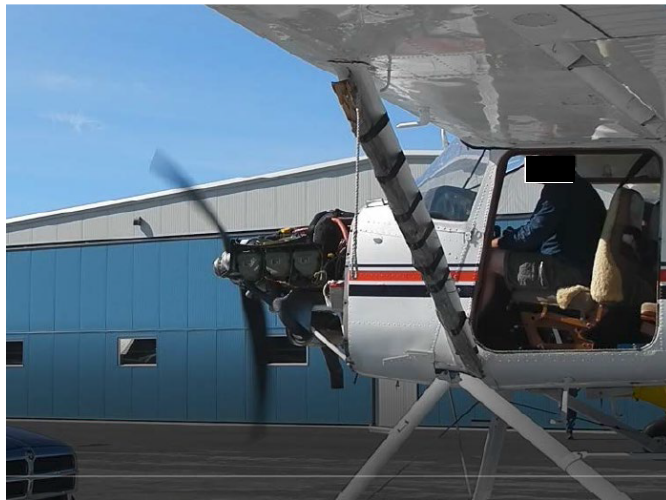
The engine started without hesitation and was run at low RPM due to a loose propeller blade. A satisfactory magneto check was conducted at 900 RPM. No anomalies were noted. The engine was shut down normally. See figure 3.

*Figure 3. Engine test run.*

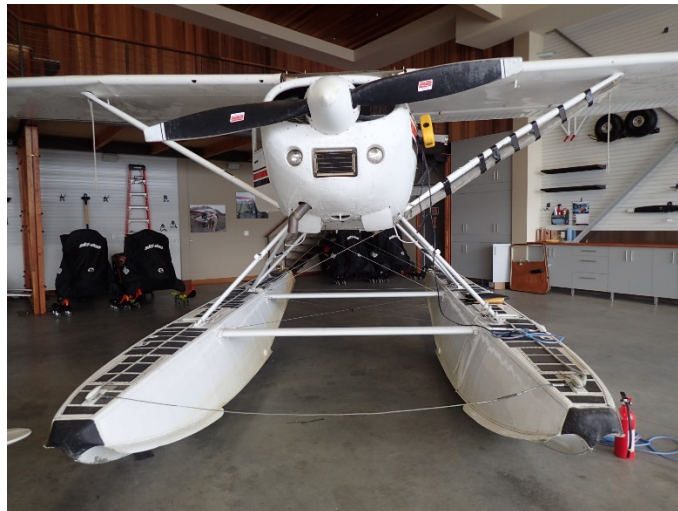
*Figure 4. Airplane during the airframe examination with evident lift strut damage.*

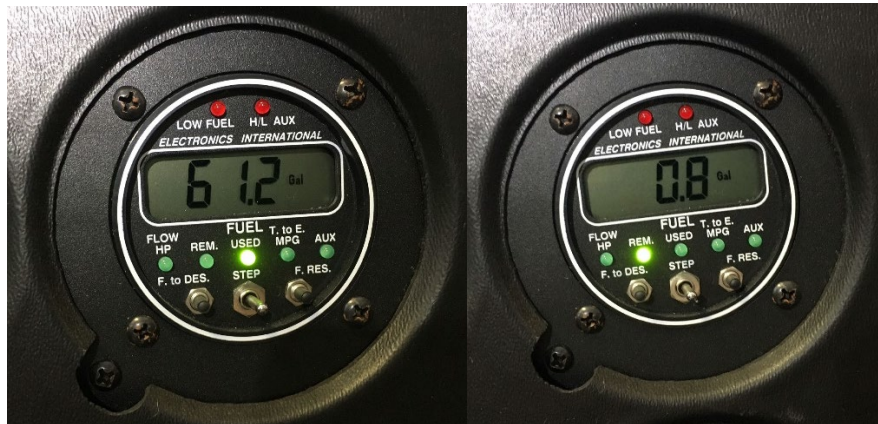
Electrical power was applied; the fuel quantity gauges indicated that the left fuel tank was empty and the right tank was 1/2 full. The Electronics International digital fuel flow gauge indicated

that 61.2 gallons had been used since the last time it was set and 0.8 gallon remained (of the manually set fuel quantity). See figure 5. Fuel samples exhibited qualities consistent with 100 low lead aviation fuel. About 8 gallons of fuel were drained from the right tank and 1.75 gallons from the left, which was less than the tank's unusable amount of 3 gallons. The fuel quantity gauges each indicated empty after draining the tanks. The four fuel tank caps were in place and secure. The fuel tank vents were in place and clear of debris. No leaks were observed. The fuel selector valve and auxiliary fuel pump were functionally tested and operated normally.

*Figure 5. Digital fuel “used” and “remaining” indications.*

Examination of the airframe and engine revealed no evidence of mechanical malfunctions or failures that would have precluded normal operation. There was no evidence suggesting the cause of the fuel tank imbalance. The left tank had less than usable fuel remaining, and the right tank had about 30 minutes of fuel remaining.
