# NATIONAL TRANSPORTATION SAFETY BOARD

## MATERIALS LABORATORY FACTUAL REPORT

Report No. 18-048

Place : Talkeetna, AK  
Date : 8/16/2017  
Vehicle : Thrush S-2R  
NTSB No. : ANC17LA046  
Investigator : Mike Hodges

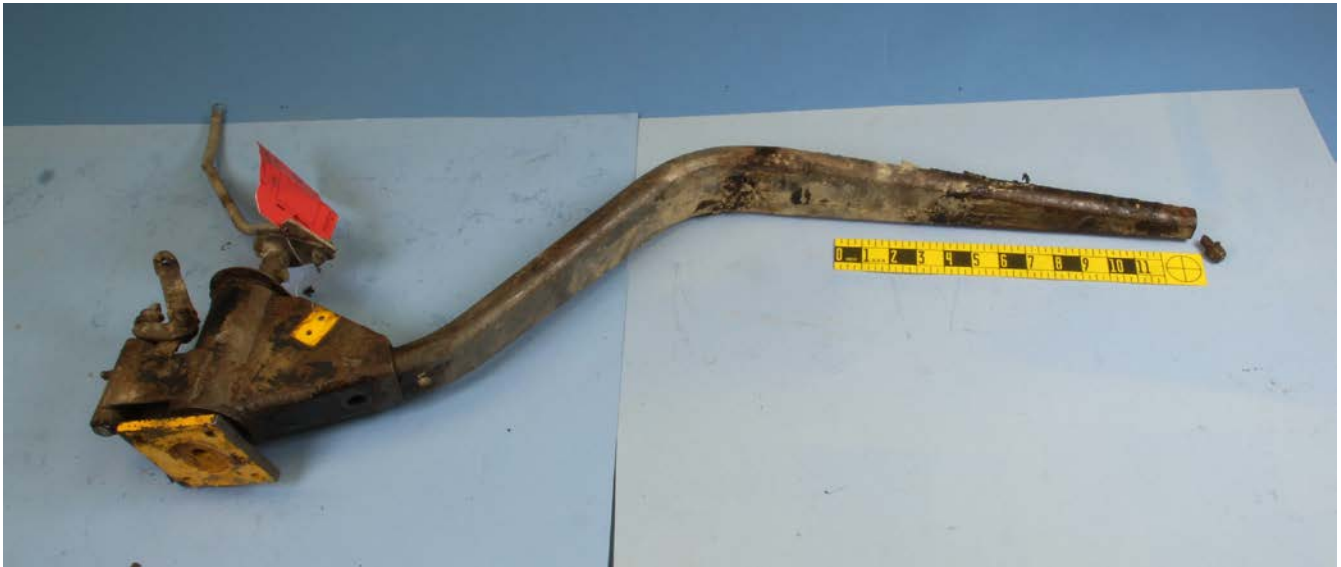
Tail wheel spring assembly and portion of attachment bolt with nut (figure 1)

Figure 1: Tail wheel spring assembly and fractured bolt

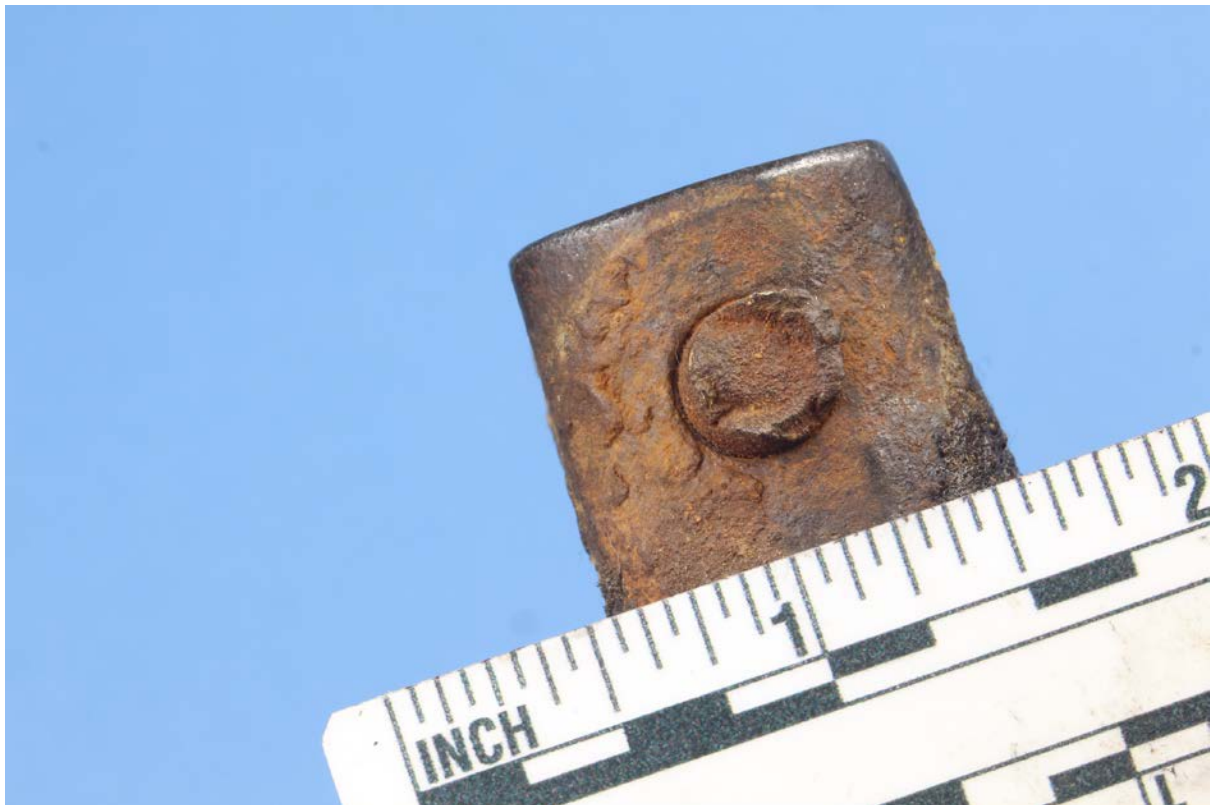
The tail wheel spring assembly had a portion of a fractured bolt shank protruding from the attachment bolt hole on one side (figure 2) and a portion of bolt shank recessed in the bolt hole on the other side (figure 3). The spring and protruding portion of the bolt exhibited corrosion and pitting. The fracture surface of the recovered portion of the bolt with the nut still attached matched the portion of the bolt protruding from the spring (figure 3). The deformation of the bolt and appearance of the fracture surface are consistent with bending overstress.

Figure 2: Portion of fractured bolt protruding from the spring's attachment bolt hole.

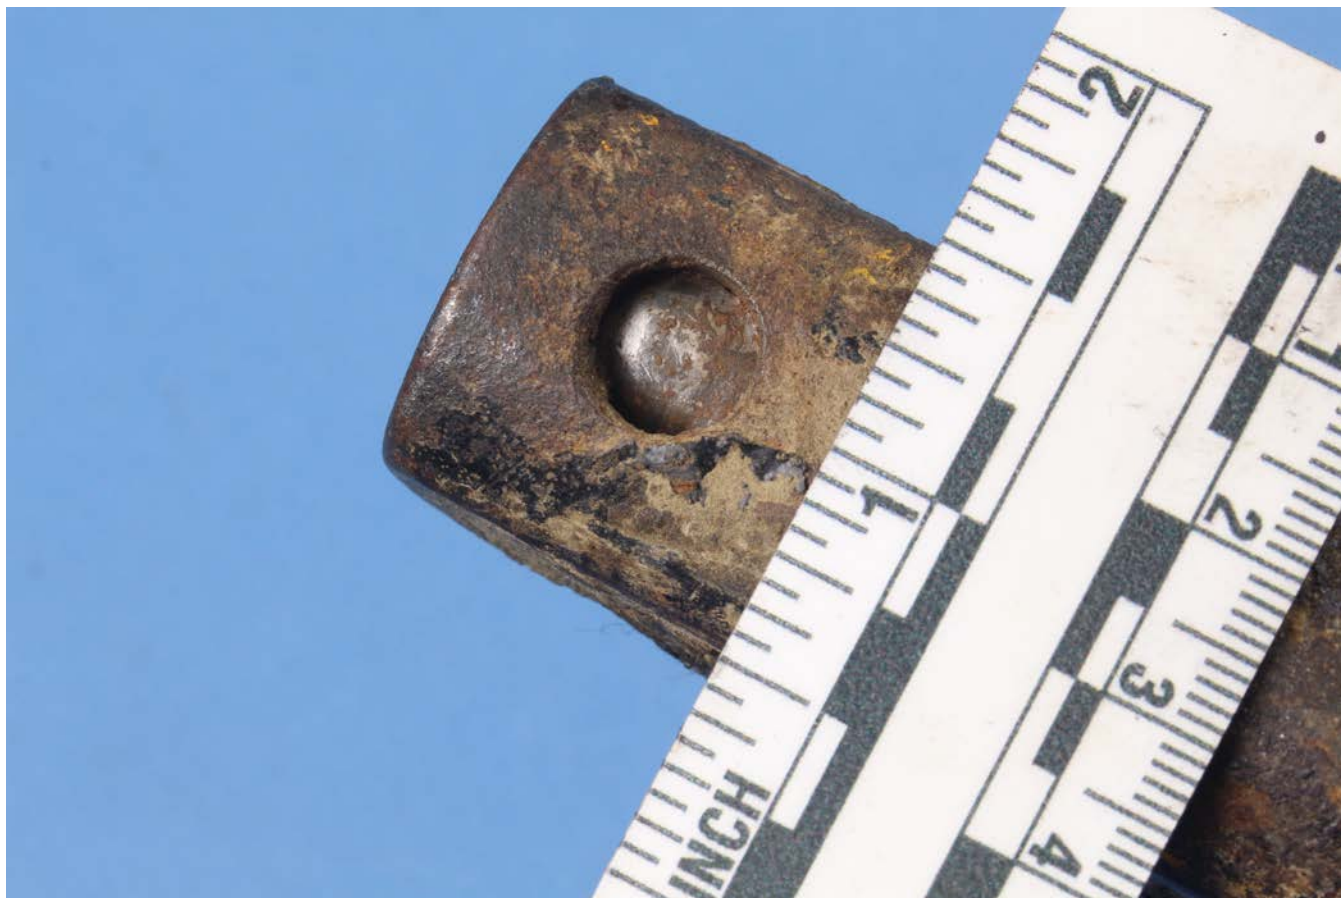
Figure 3: Bolt shank recessed in tail wheel spring's attachment bolt hole.

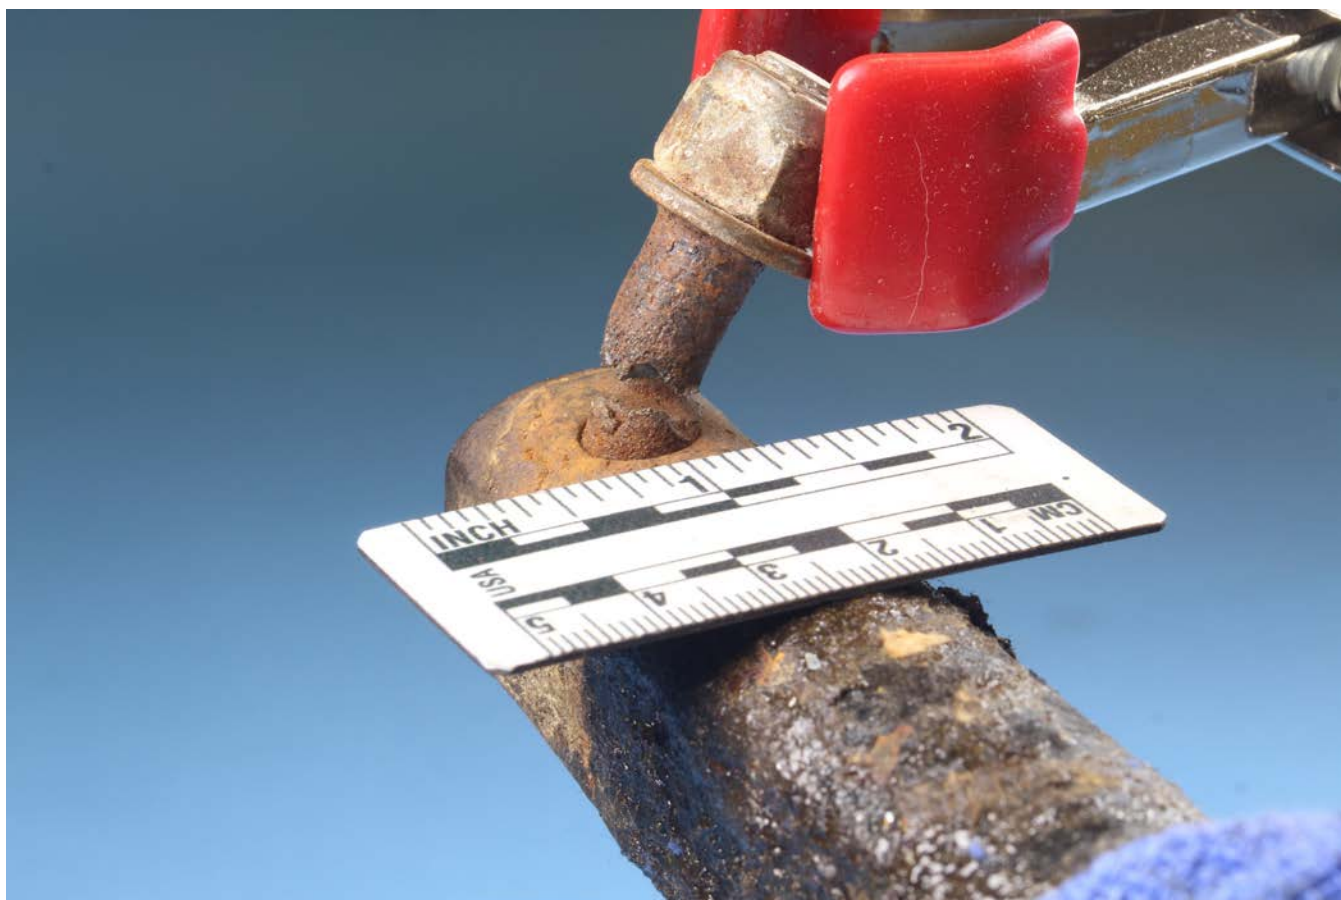
Figure 4: Alignment of protruding bolt shank and recovered portion of attachment bolt.
