## MPFR Factual Report

### Accident

AW139, S/N 41528, R/M N304FD

2<sup>nd</sup> September 2017

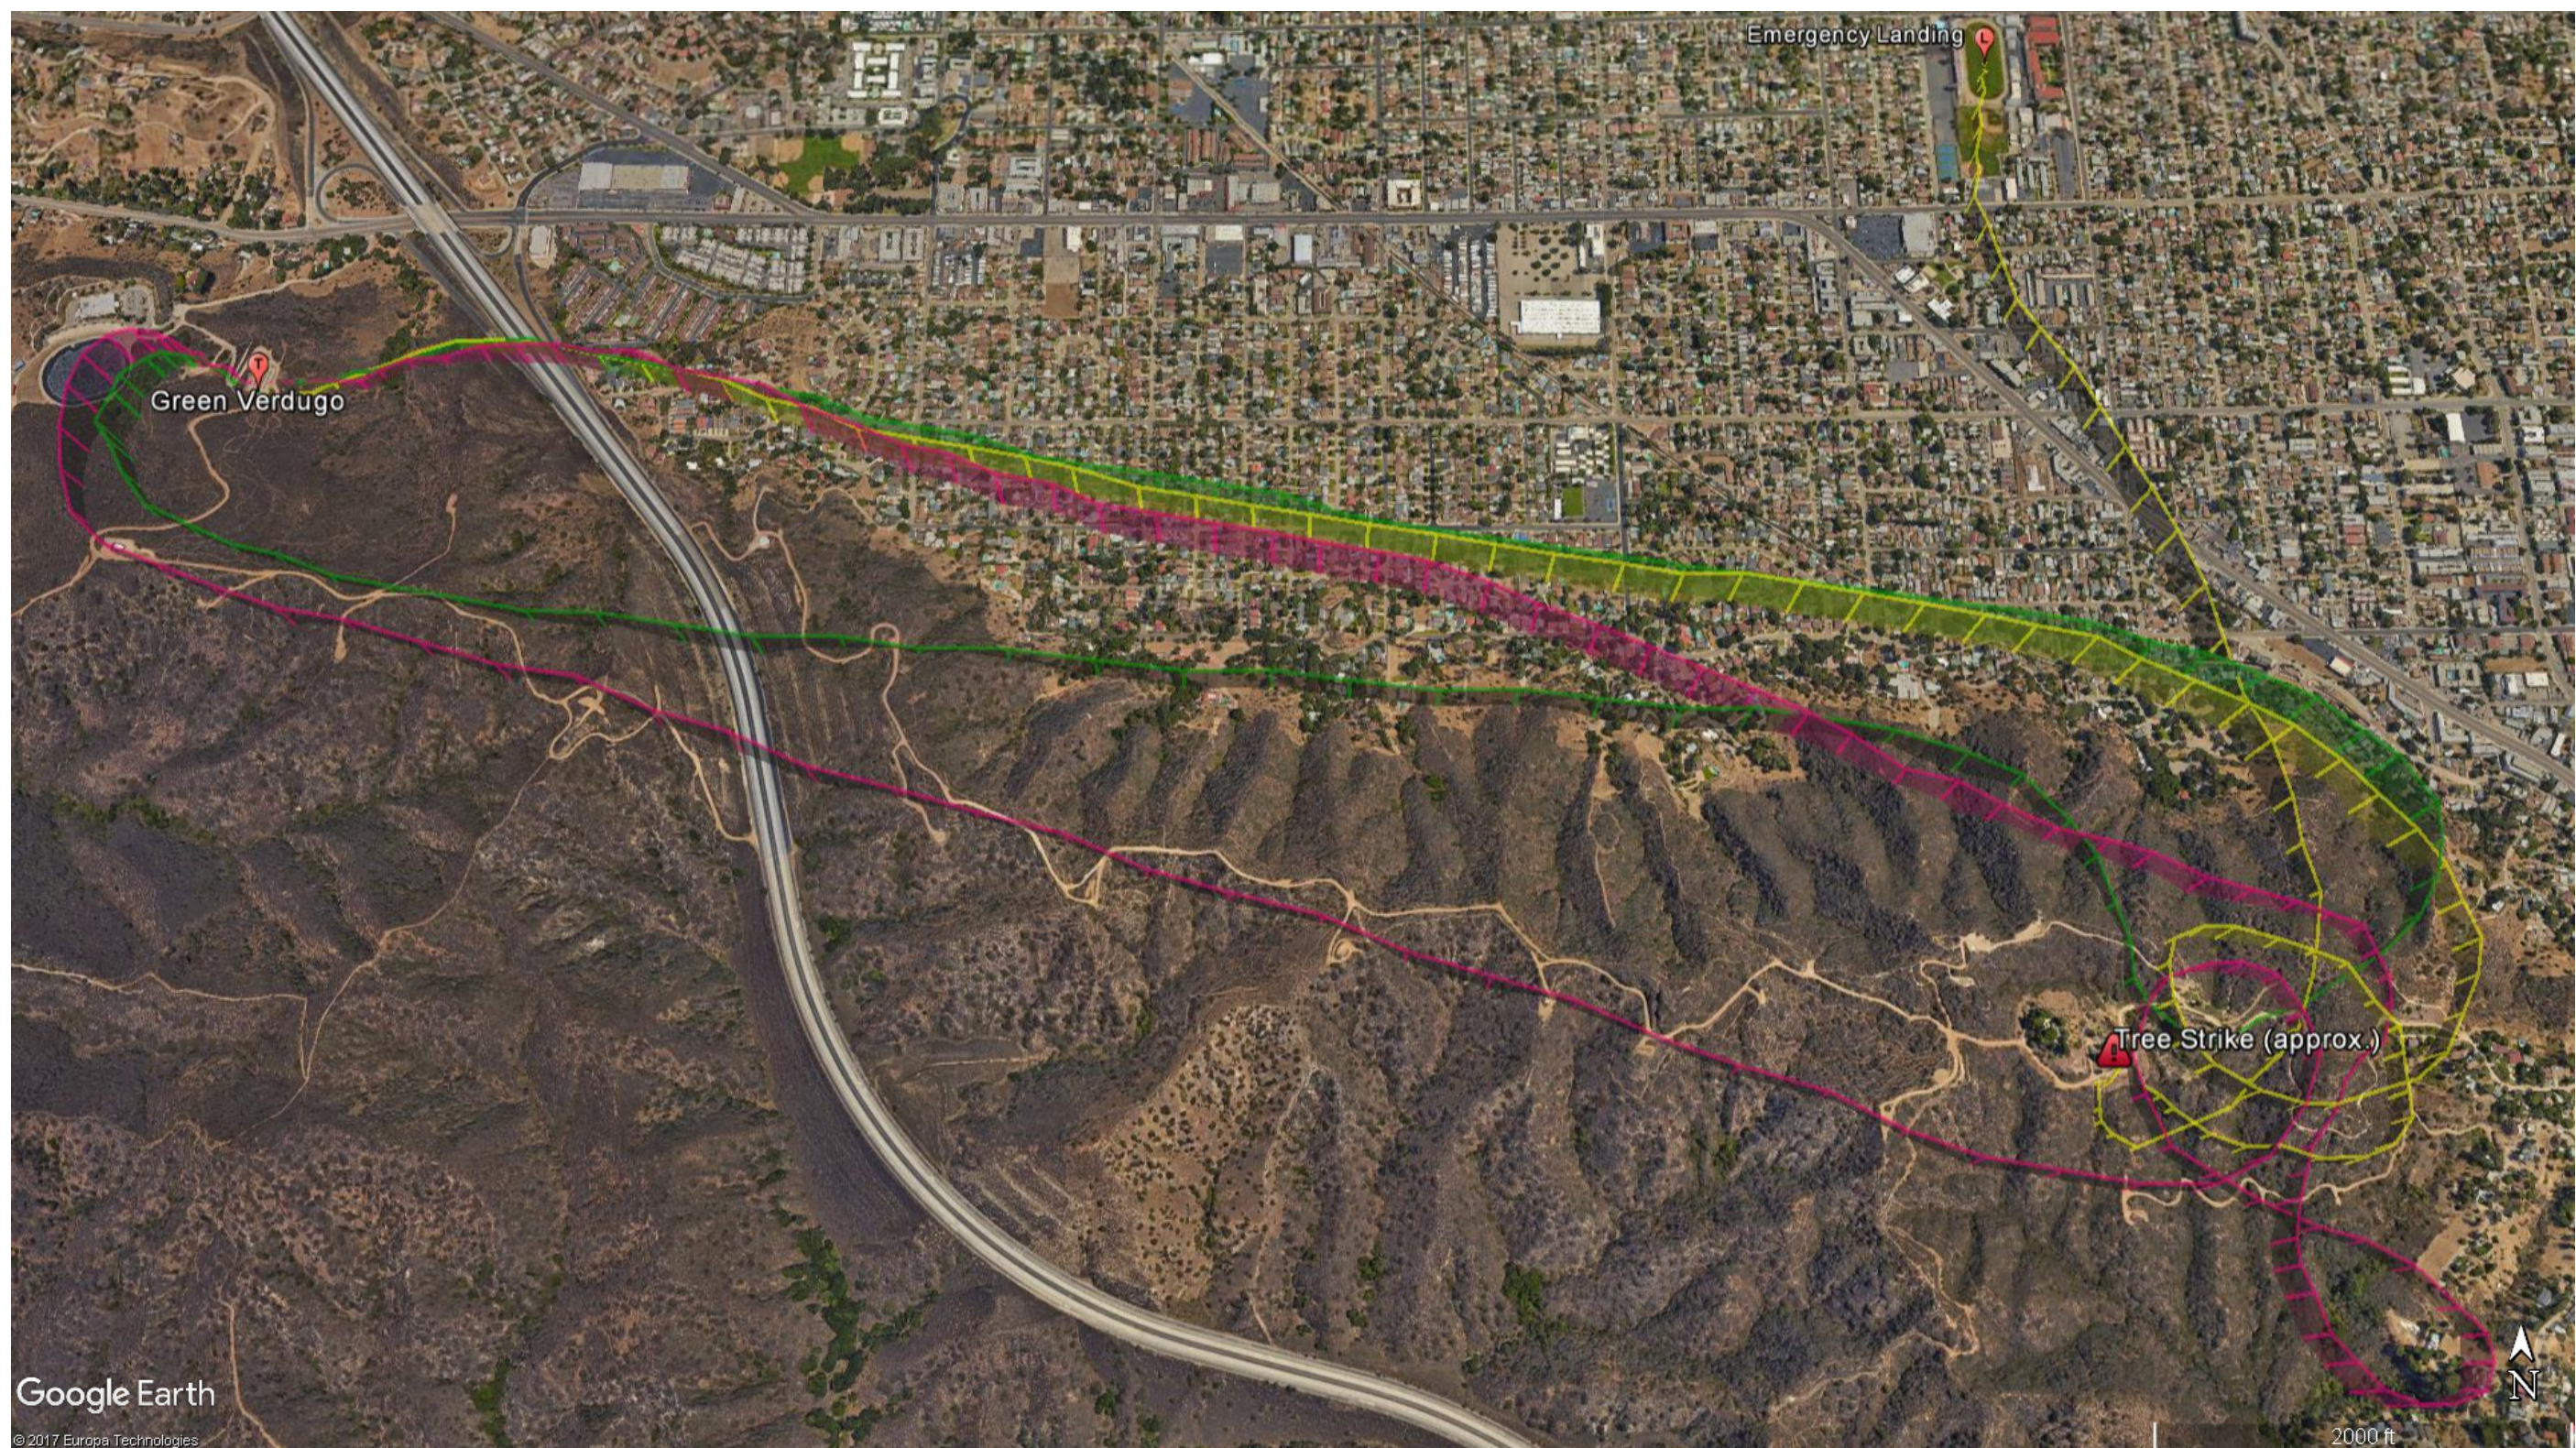
A dedicated plot for the final 3 flights is also provided: as these flights were aimed at dropping water roughly in the same spot a comparison can be made to highlight differences and commonalities in the piloting technique and in the A/C's response to said inputs, to identify possible abnormalities which may have arisen between the 2<sup>nd</sup> and 3<sup>rd</sup> water drops and could have contributed to the perceived loss of control by the Crew and/or to the tree strike.

Figure 3 – Flight Path of N304FD (last 3 flights of the recordings: **Yellow**: Last Flight; **Green**: 2<sup>nd</sup> to last Flight; **Magenta**: 3<sup>rd</sup> to last Flight)

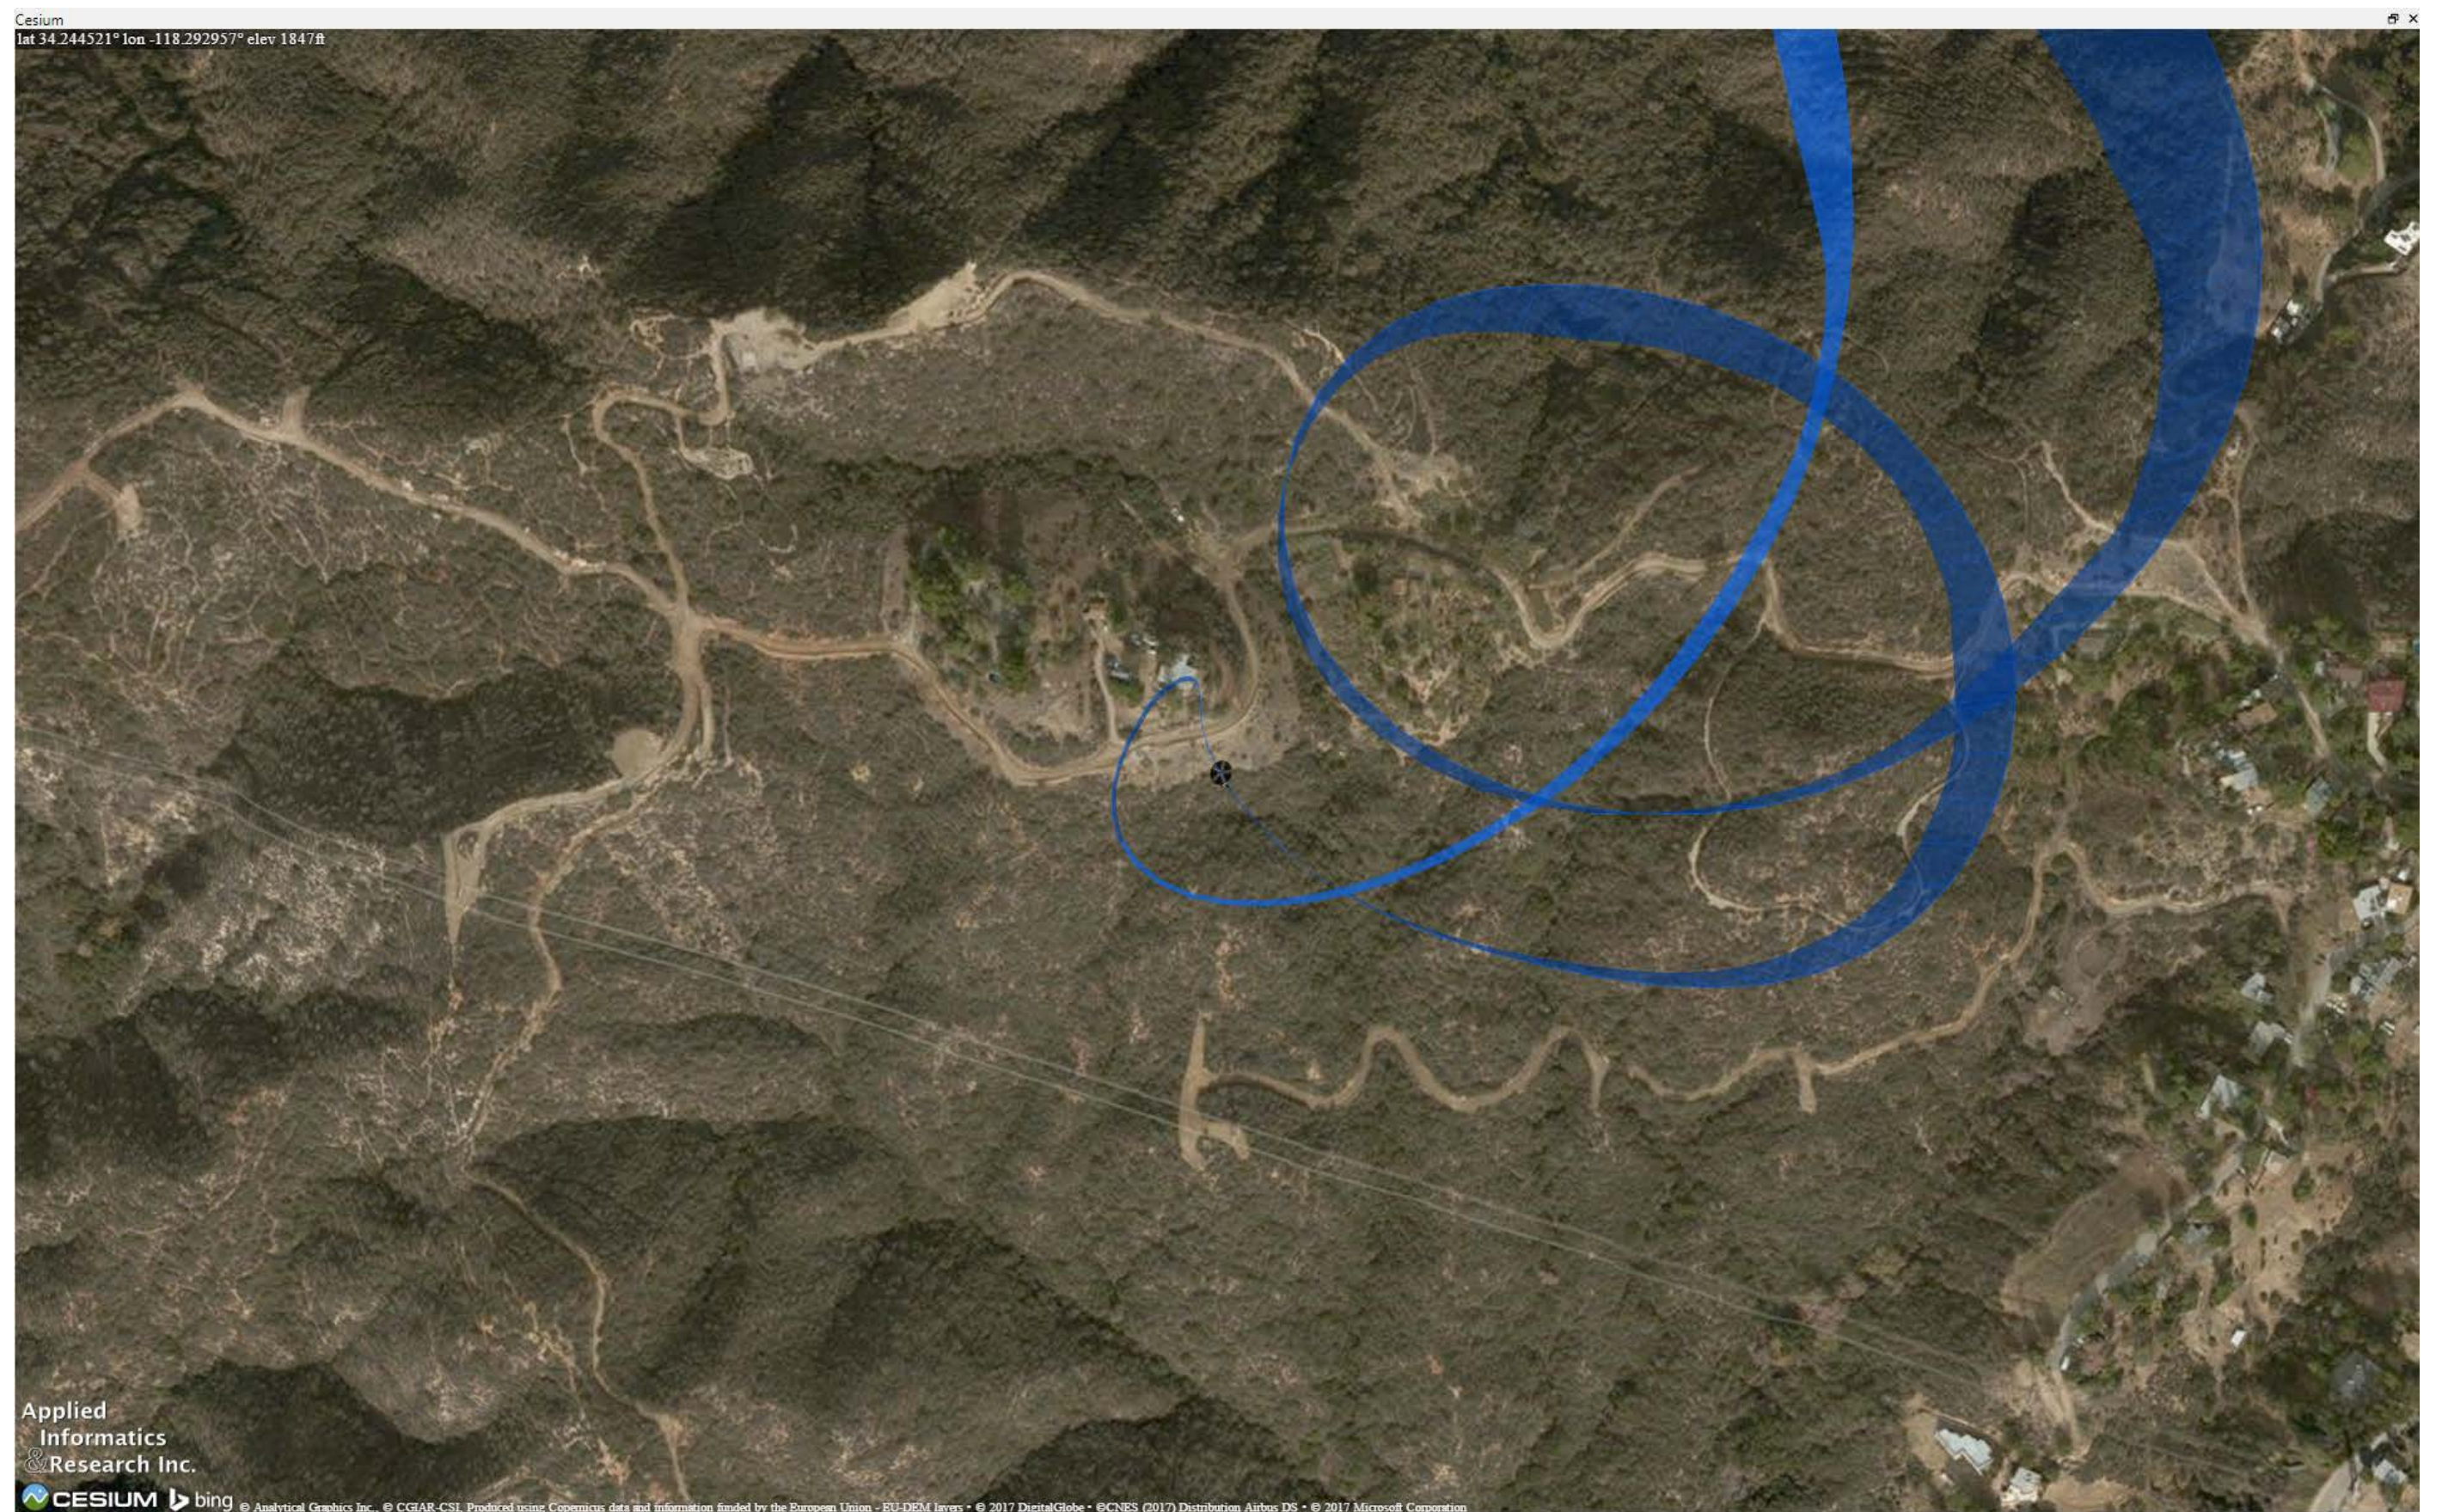
The A/C was still flying above the residential complex, at approximately 20ft AGL (note that the Radar Altitude value cannot be fully relied upon in presence of multiple ground obstacles) and yawing towards RH with a commanded ~40°/s rate. This event may be compatible with the reported impact of the Tail and Rear Fuselage with trees.

Figure 4 – 3D close-up detail of the flight path near the tree strike event

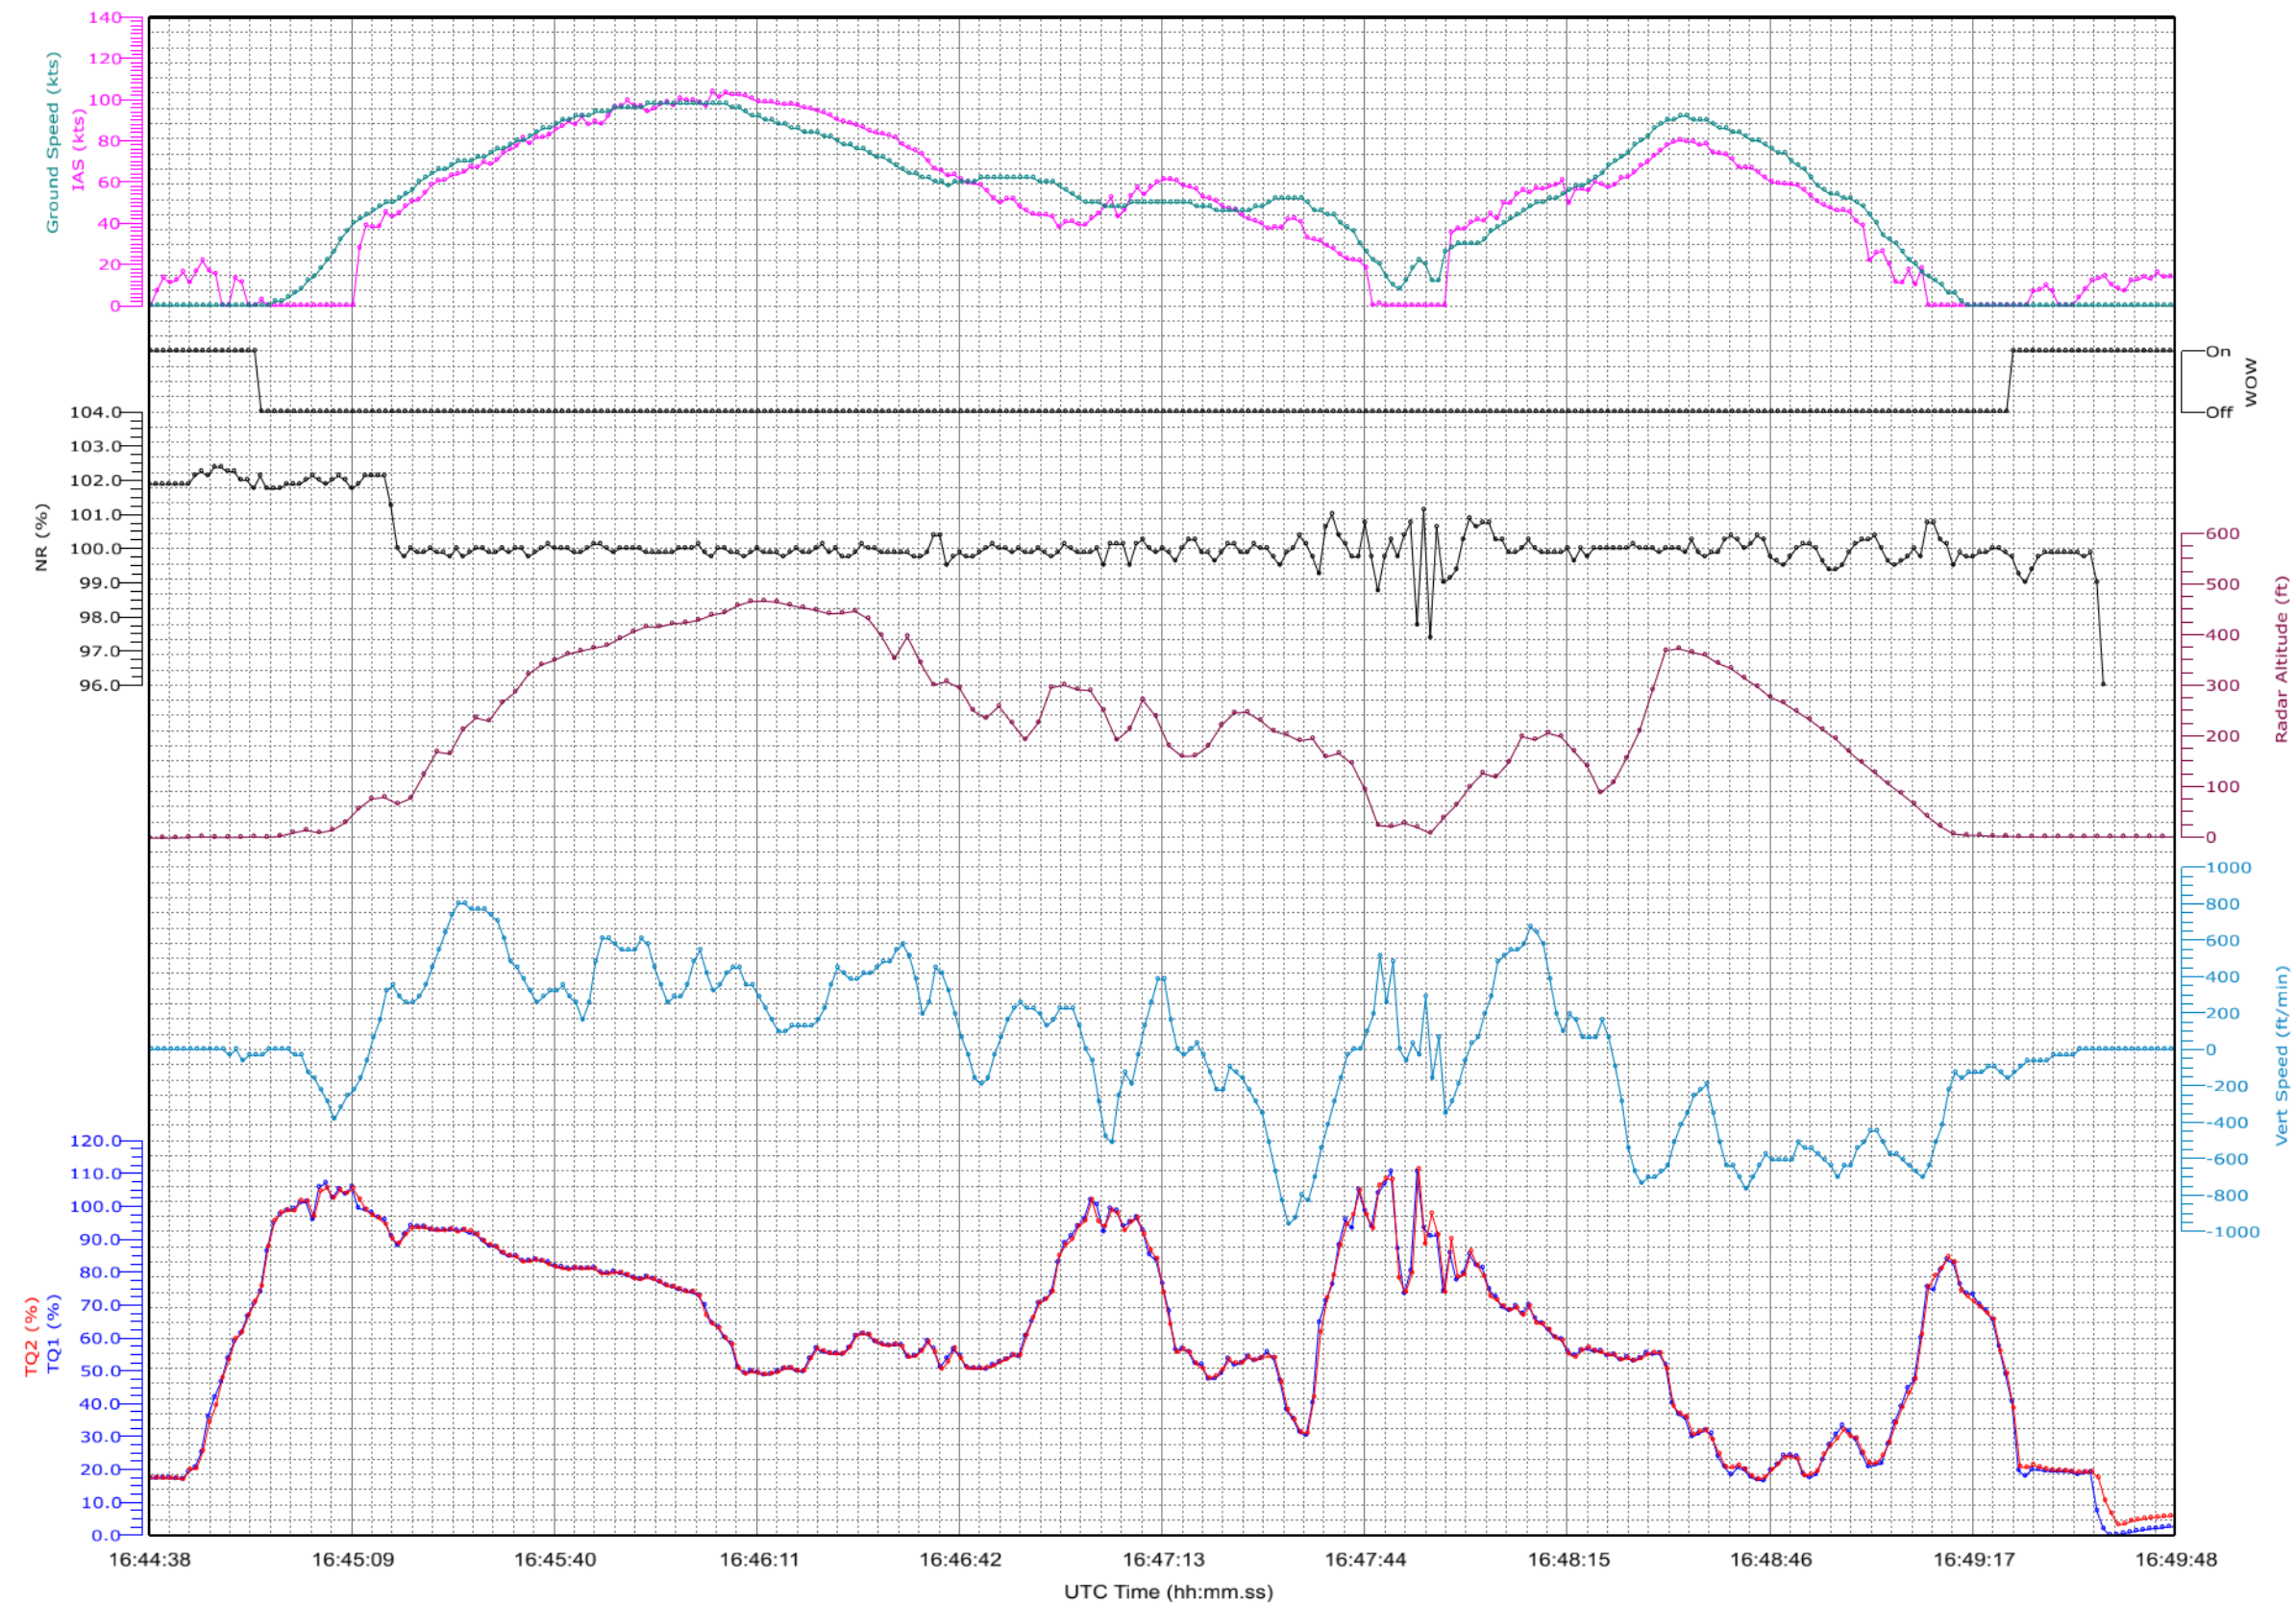
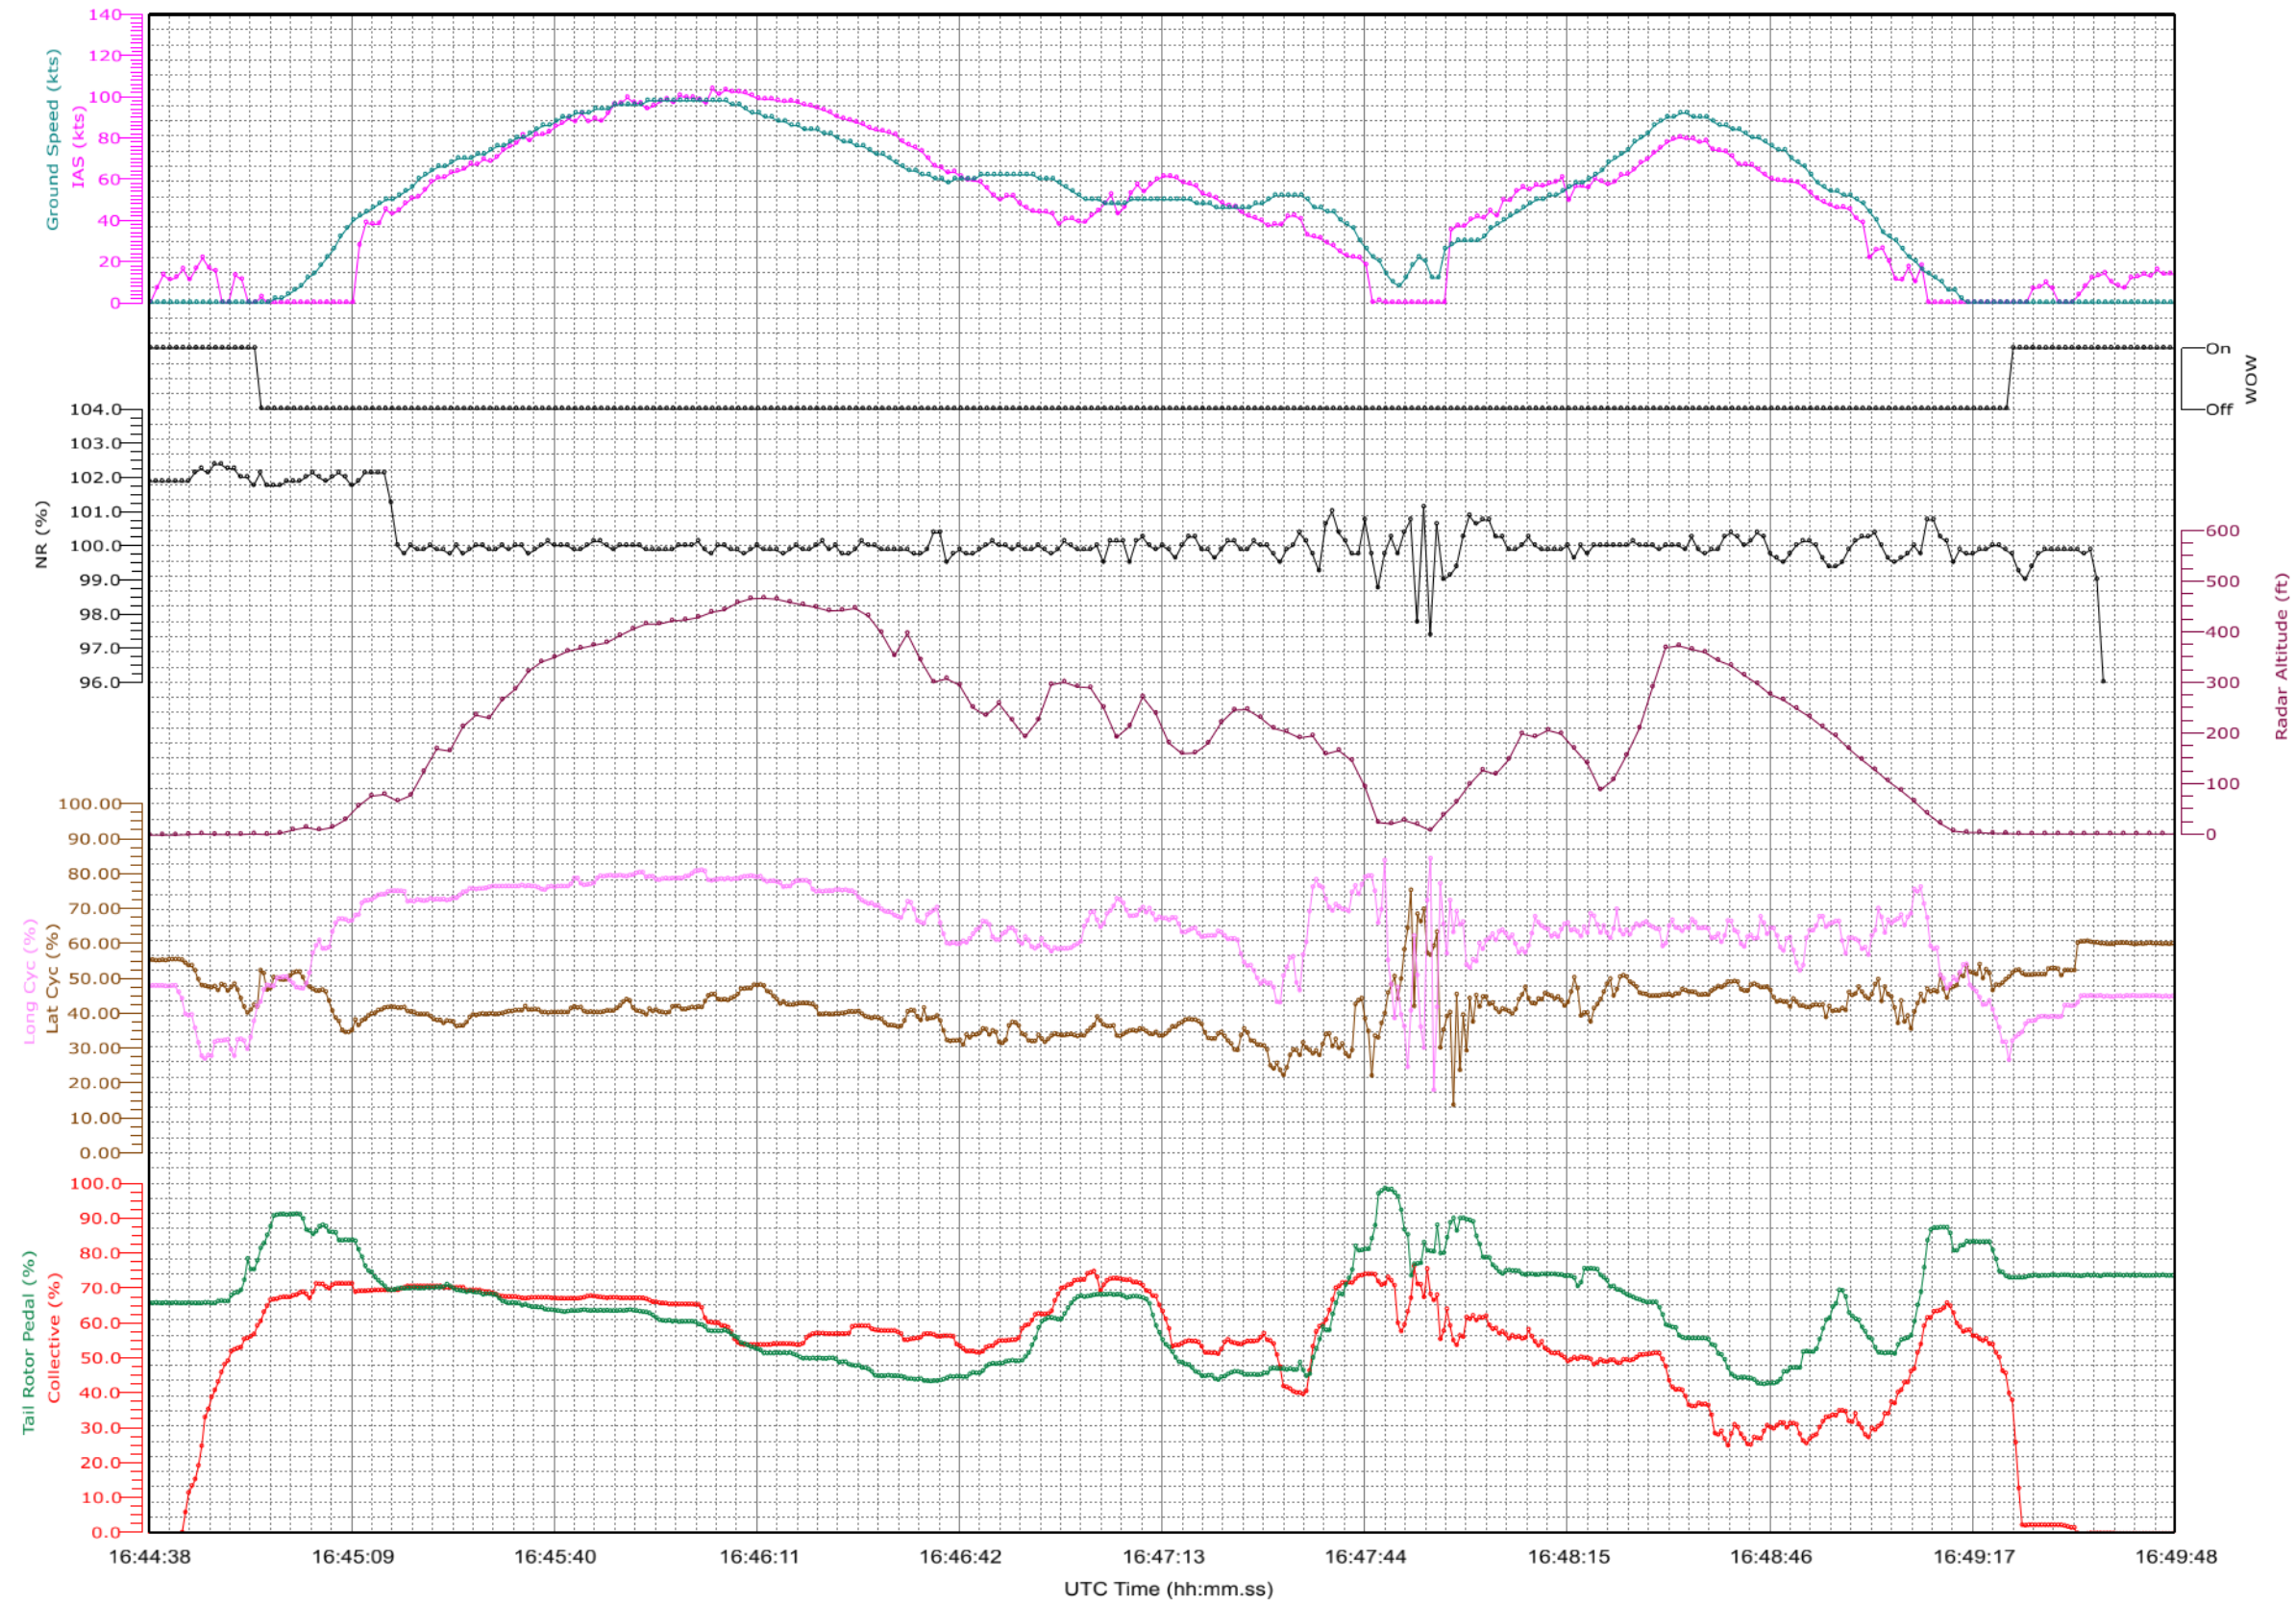
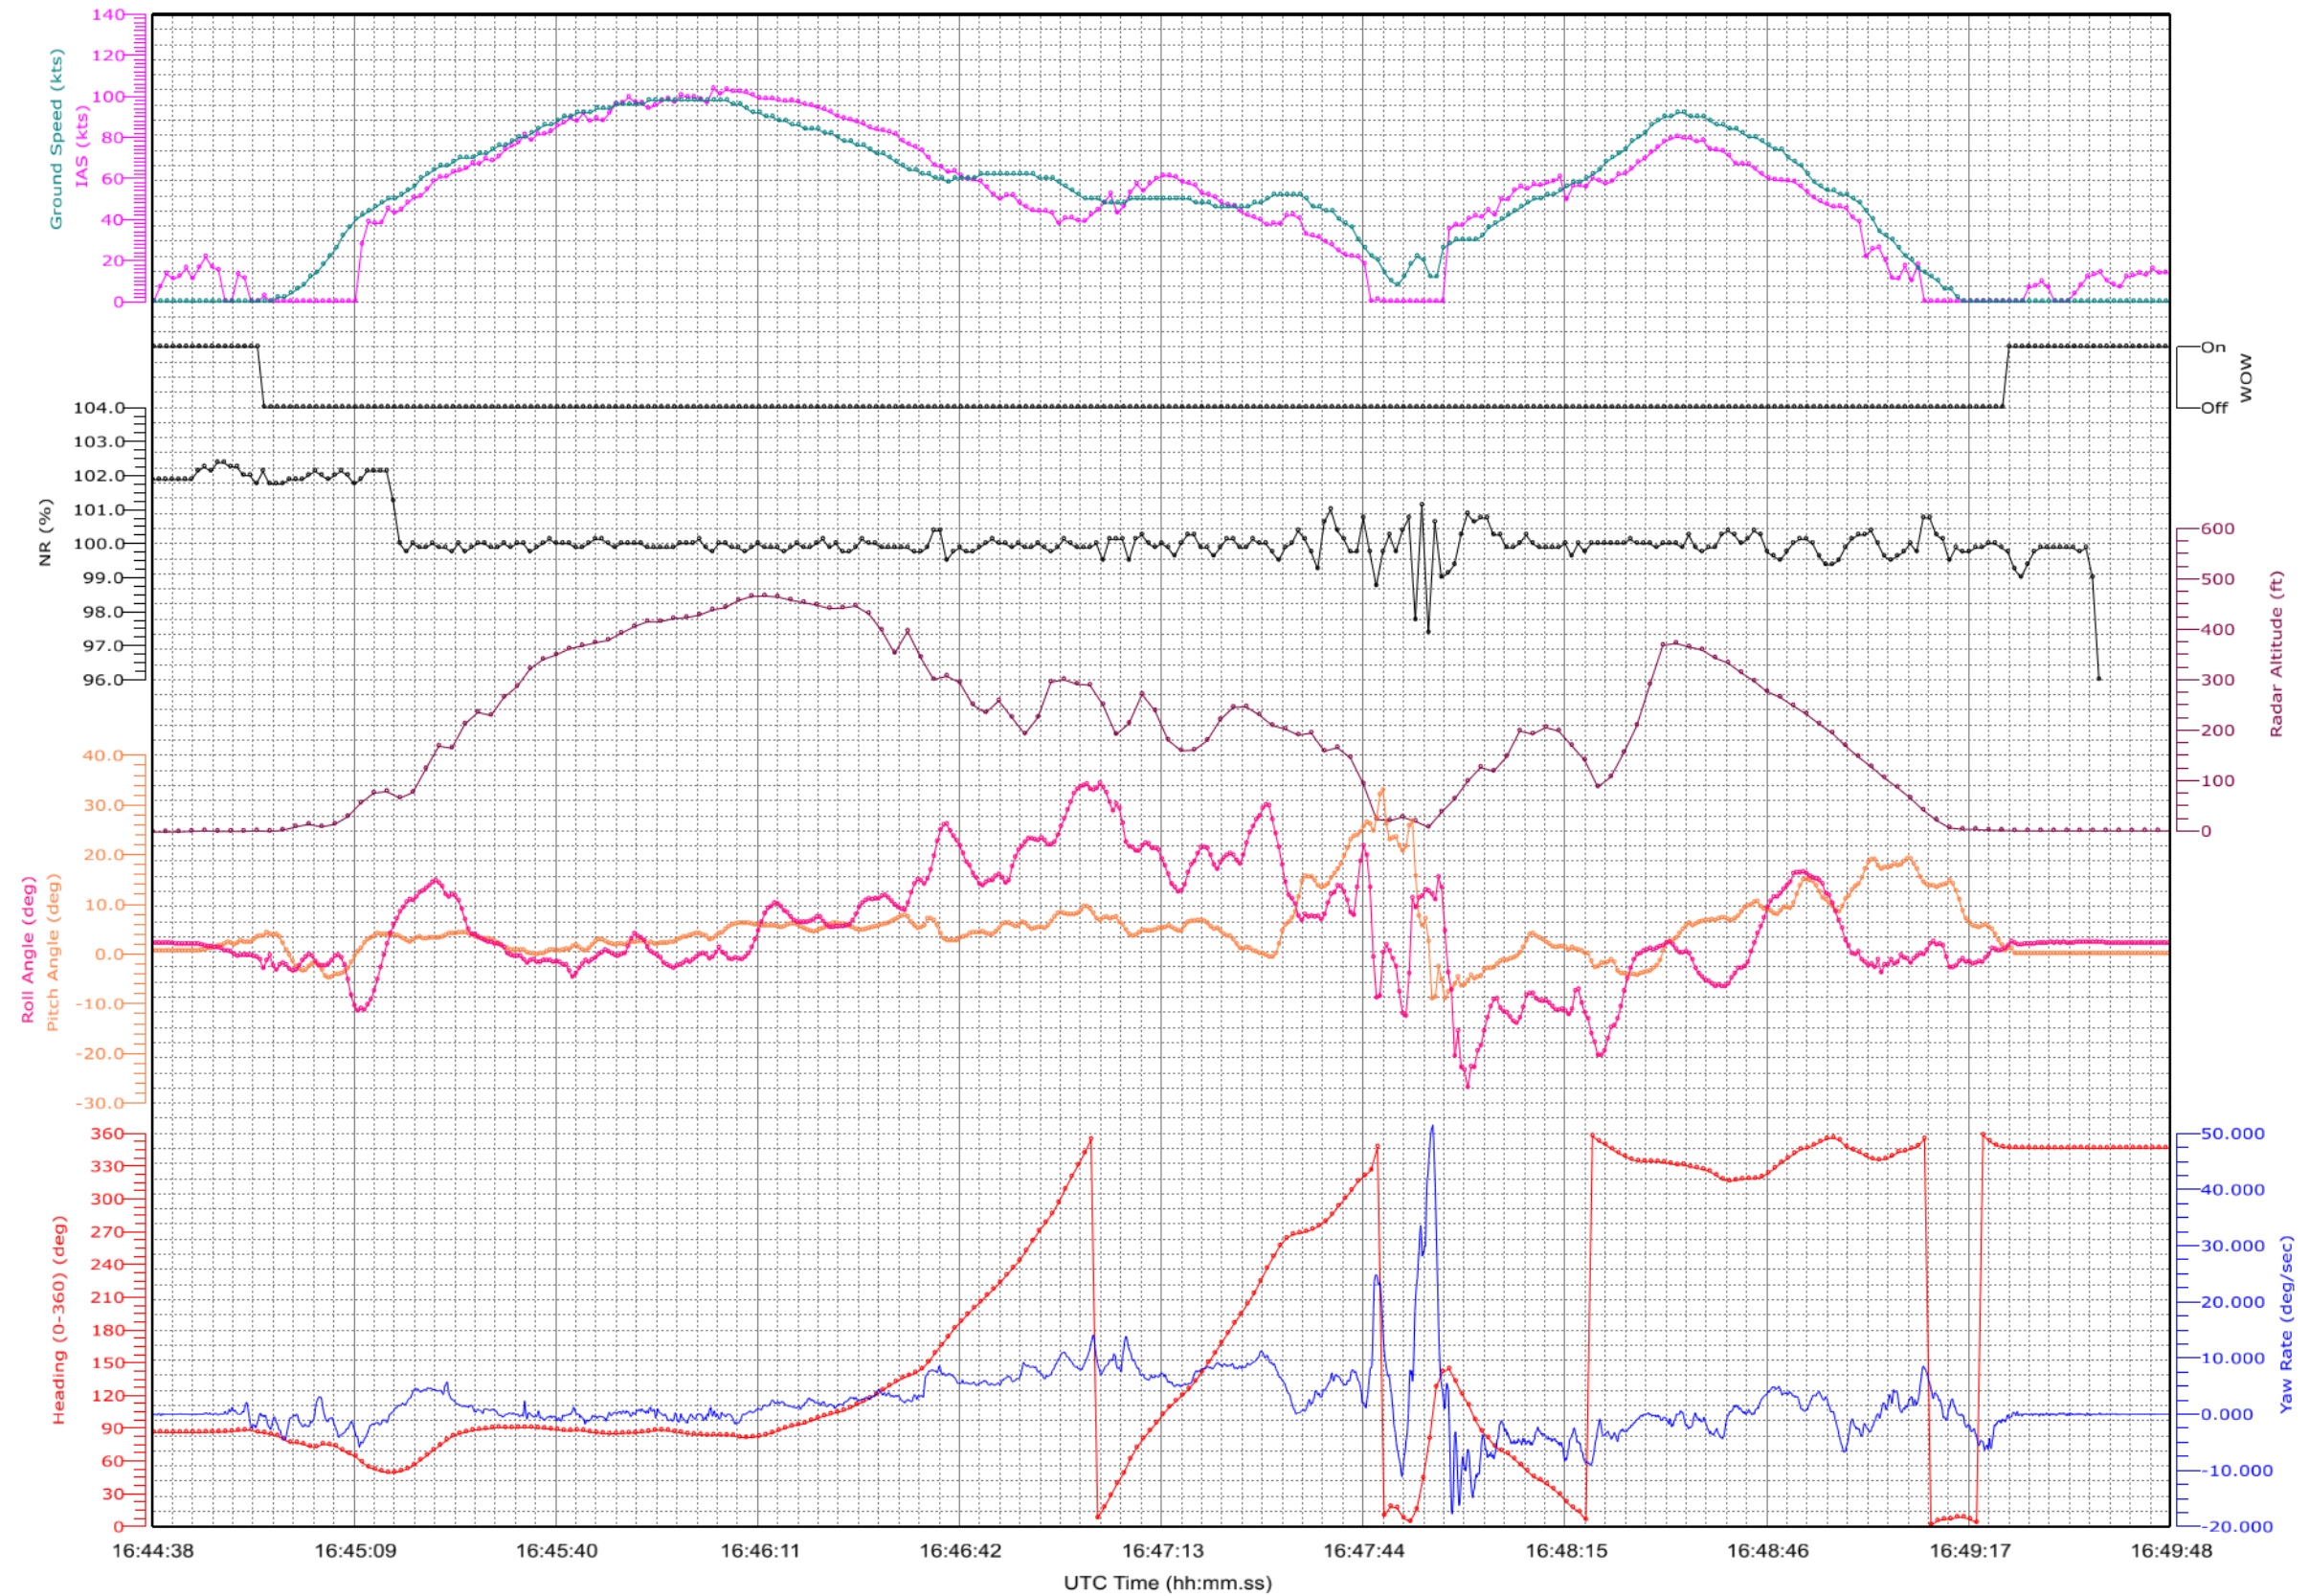
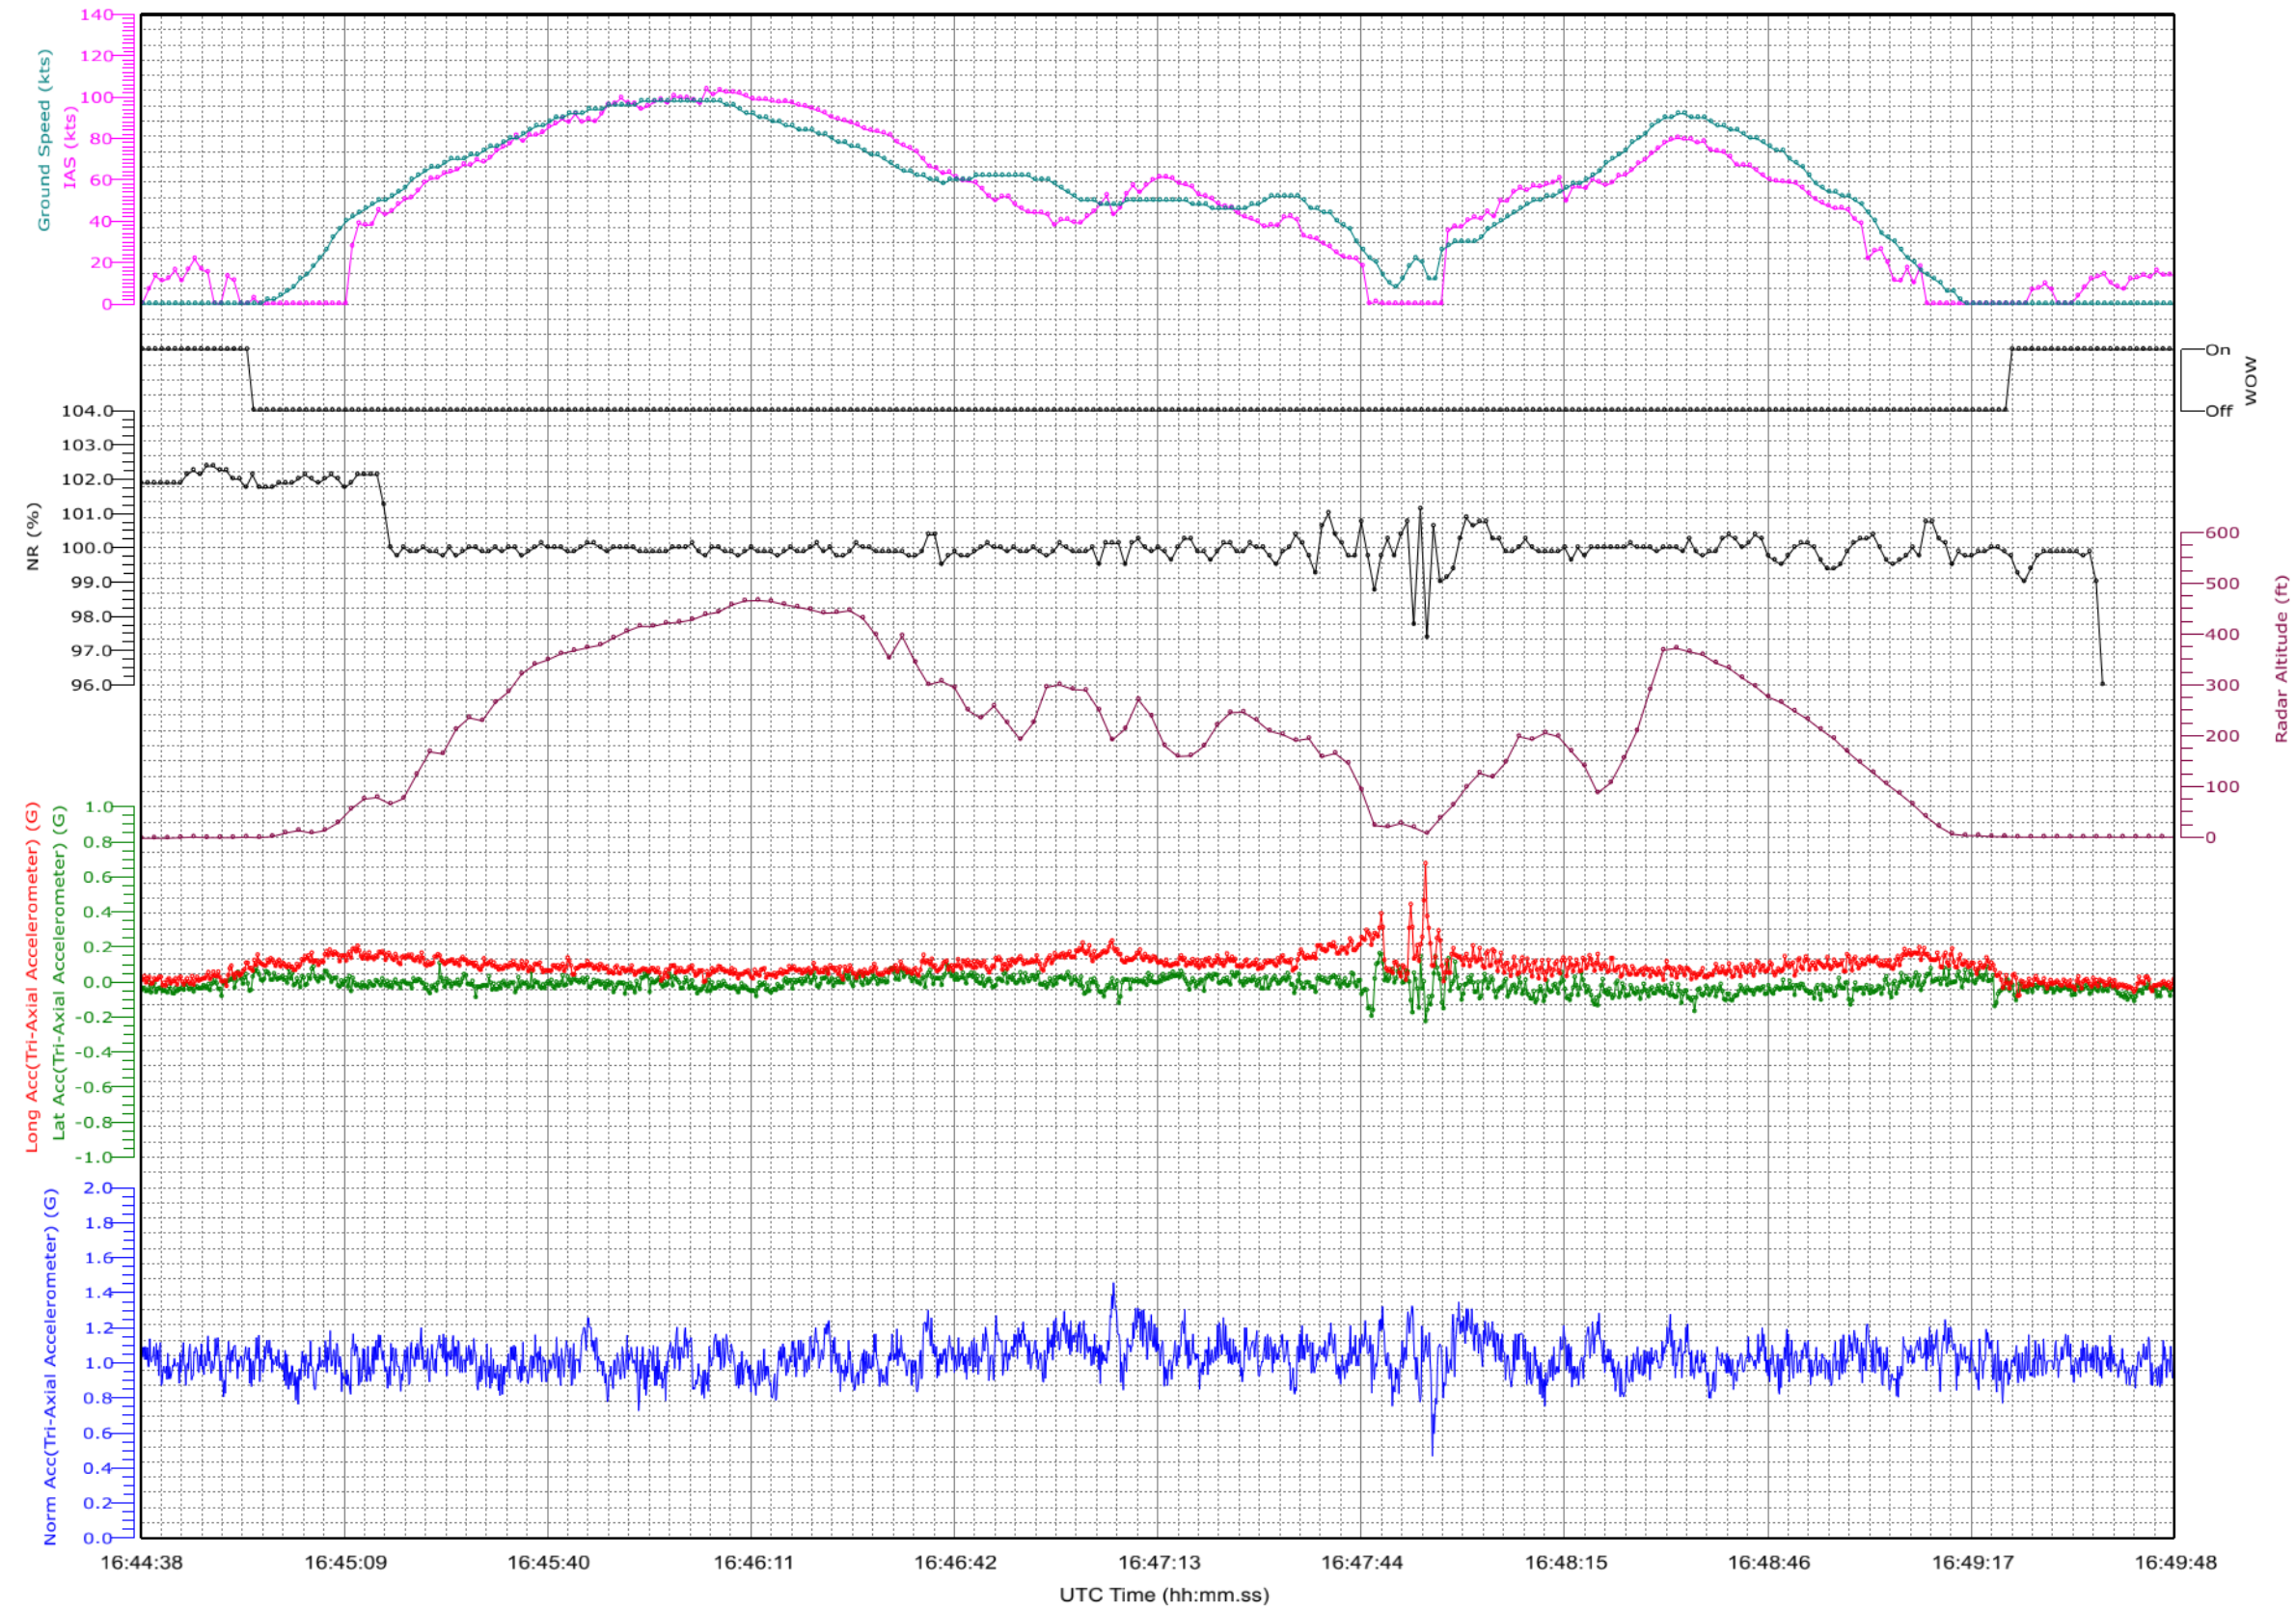
As the Collective movement caused the TQ provided by the Engines to increase (up to 110% of AEO MCP), the Pilot progressively moved the Pedal command towards LH, to counteract for the CW momentum applied to the A/C by the CCW Main Rotor and to maintain the desired heading. As shown in Figure 24 below, 100% of the Pedal command was recorded at approximately 16:47:47 UTC. The 100% Pedal command was accompanied by a commanded peak in the A/C pitch angle, which reached 33° nose up and 16:47:48 UTC.

From 16:47:49 UTC onwards the Longitudinal and Lateral Cyclic tracks show large and uncoordinated inputs for at least 10-12 seconds, while the A/C was flying above the mentioned residential complex with backwards ground speed between 8 and 26kts (the direction of the A/C flight path is deduced by combining heading, GPS track, drift and ground speed data).

During this phase, between approximately 16:47:54-55 UTC a moderate spike in the lateral, longitudinal and vertical accelerations is recorded by the dedicated sensor in the Baggage Compartment (referred to as Tri-Axial Accelerometer in the below graphs), together with minor NR oscillations (down to 97%). Maximum values were 0.5-0.6g on all three axes, but as the sampling rate for these signals is limited to 4-8Hz higher instantaneous values could have been reached.

Figure 5 – Time Histories of the A/C main parameters for the accident flight (1/4)
