## MPFR Factual Report

### Accident

AW139, S/N 41528, R/M N304FD

2<sup>nd</sup> September 2017

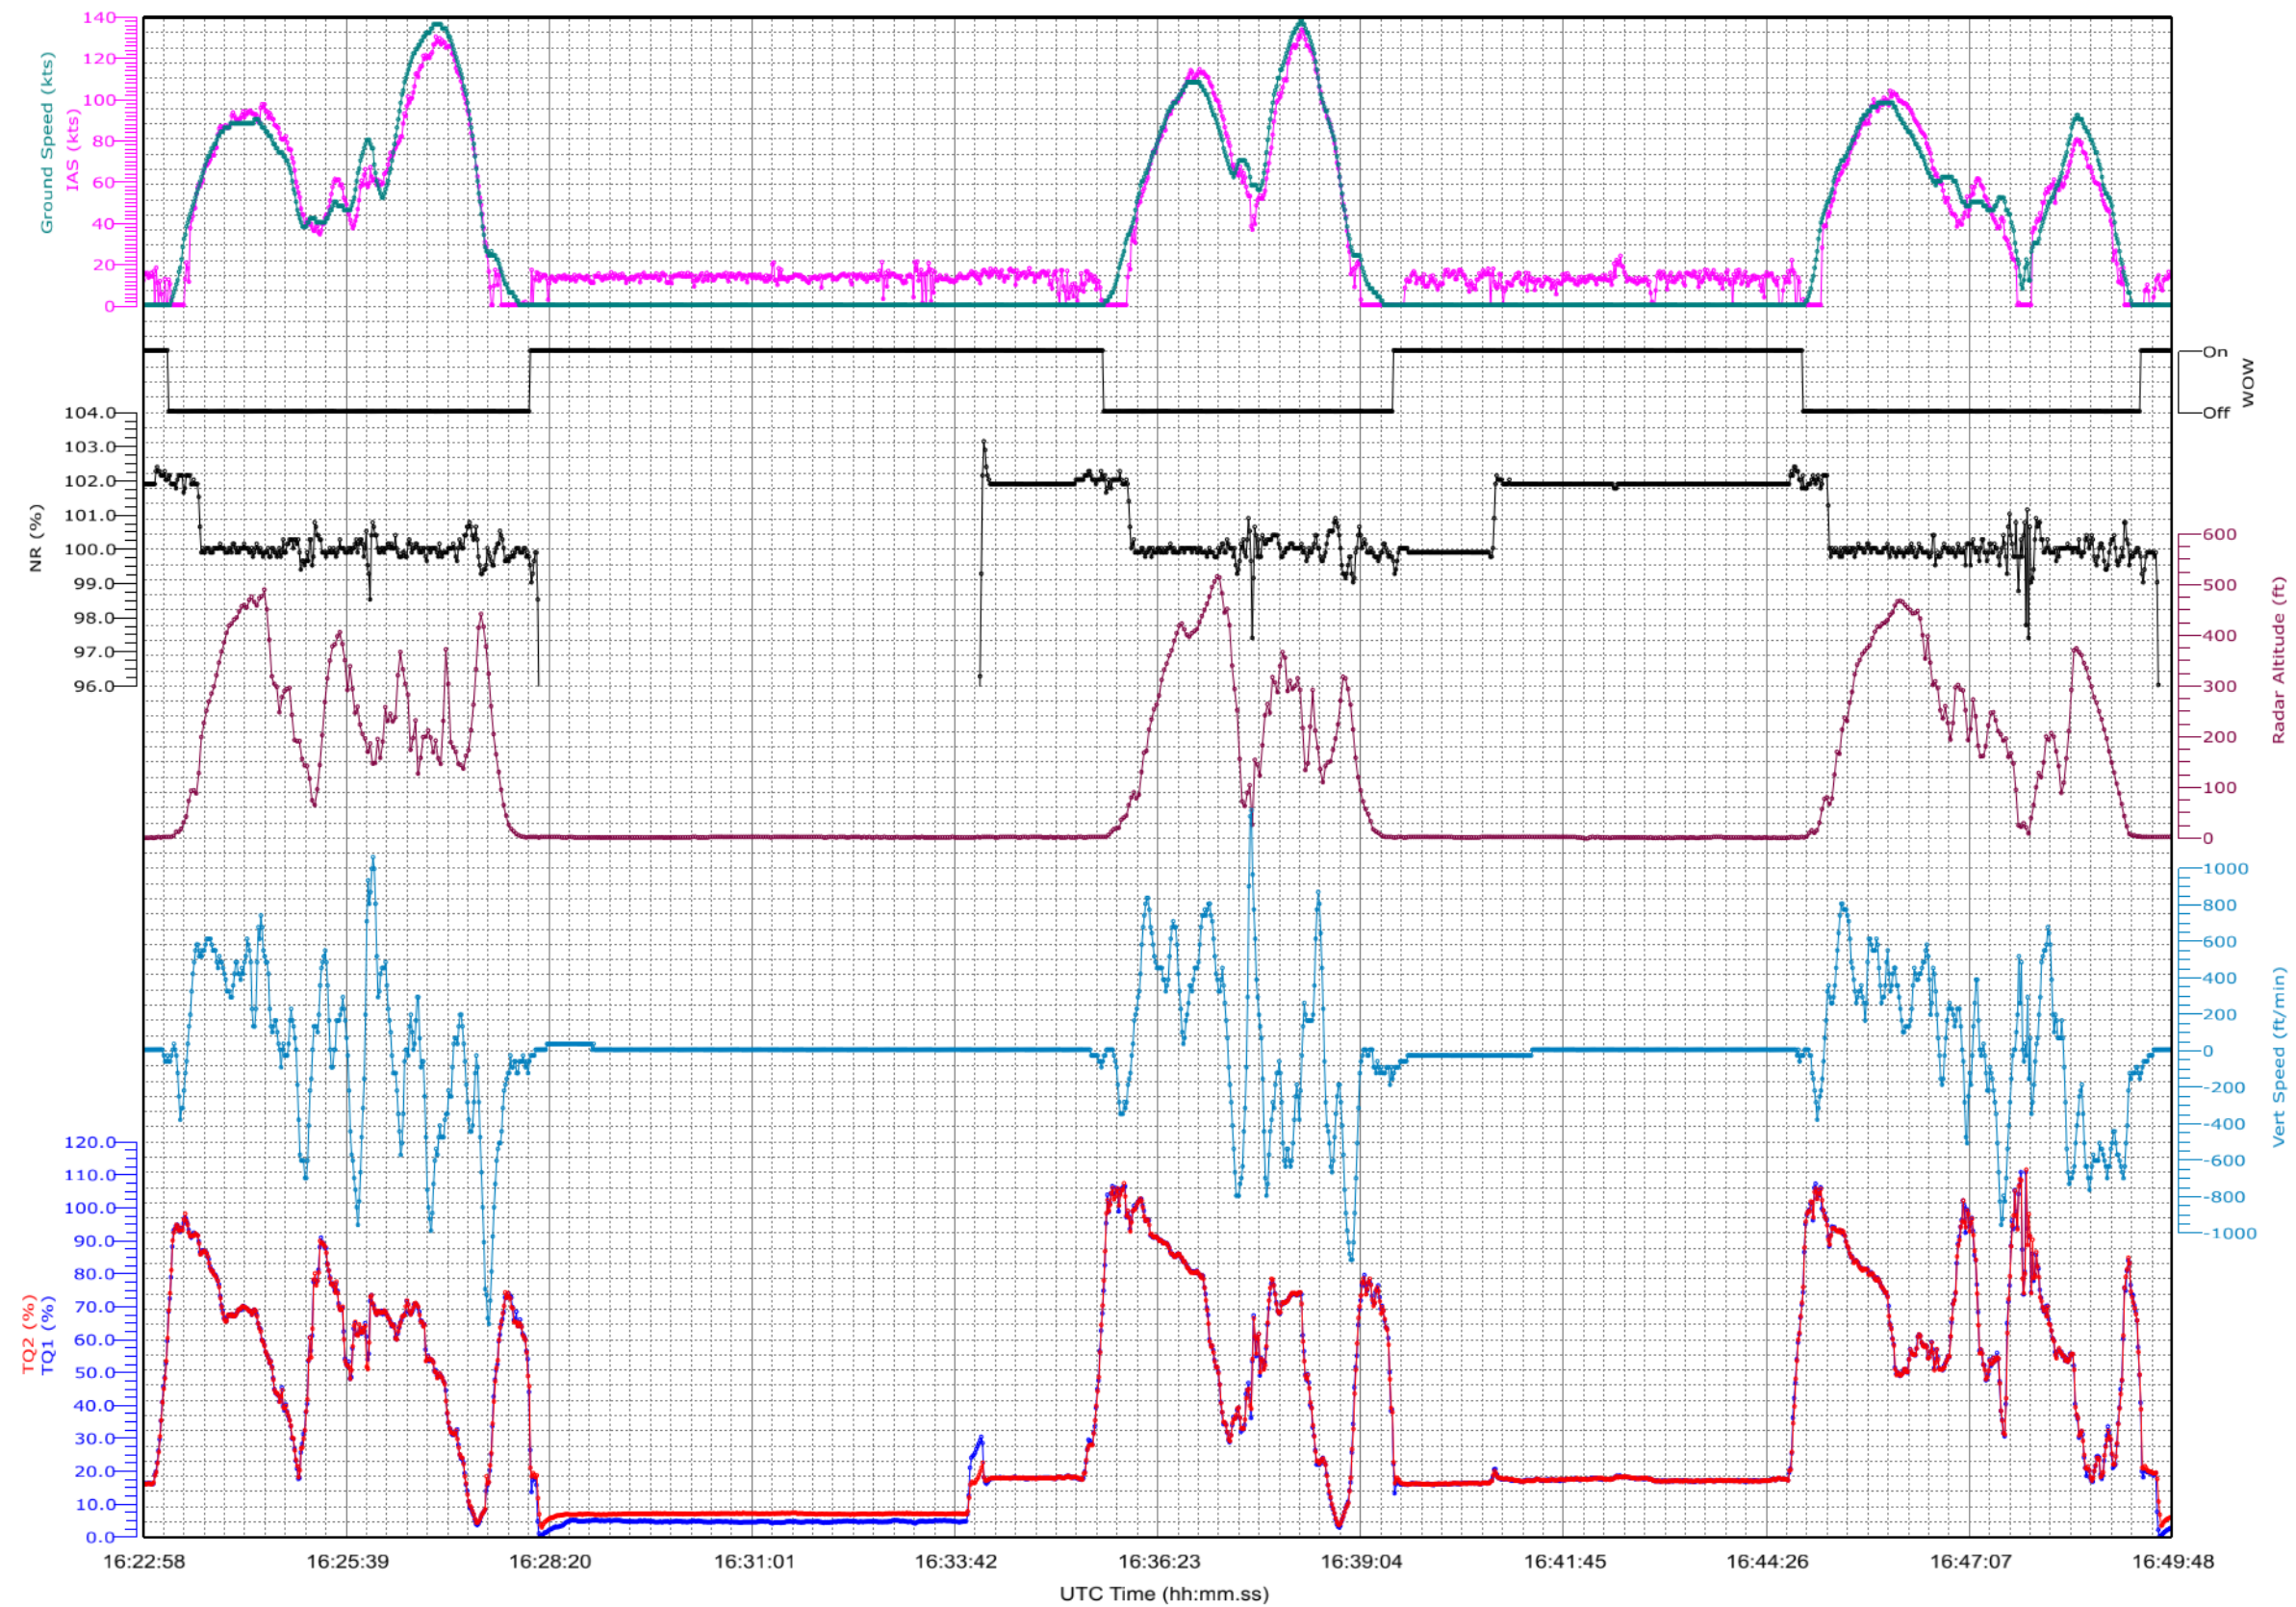
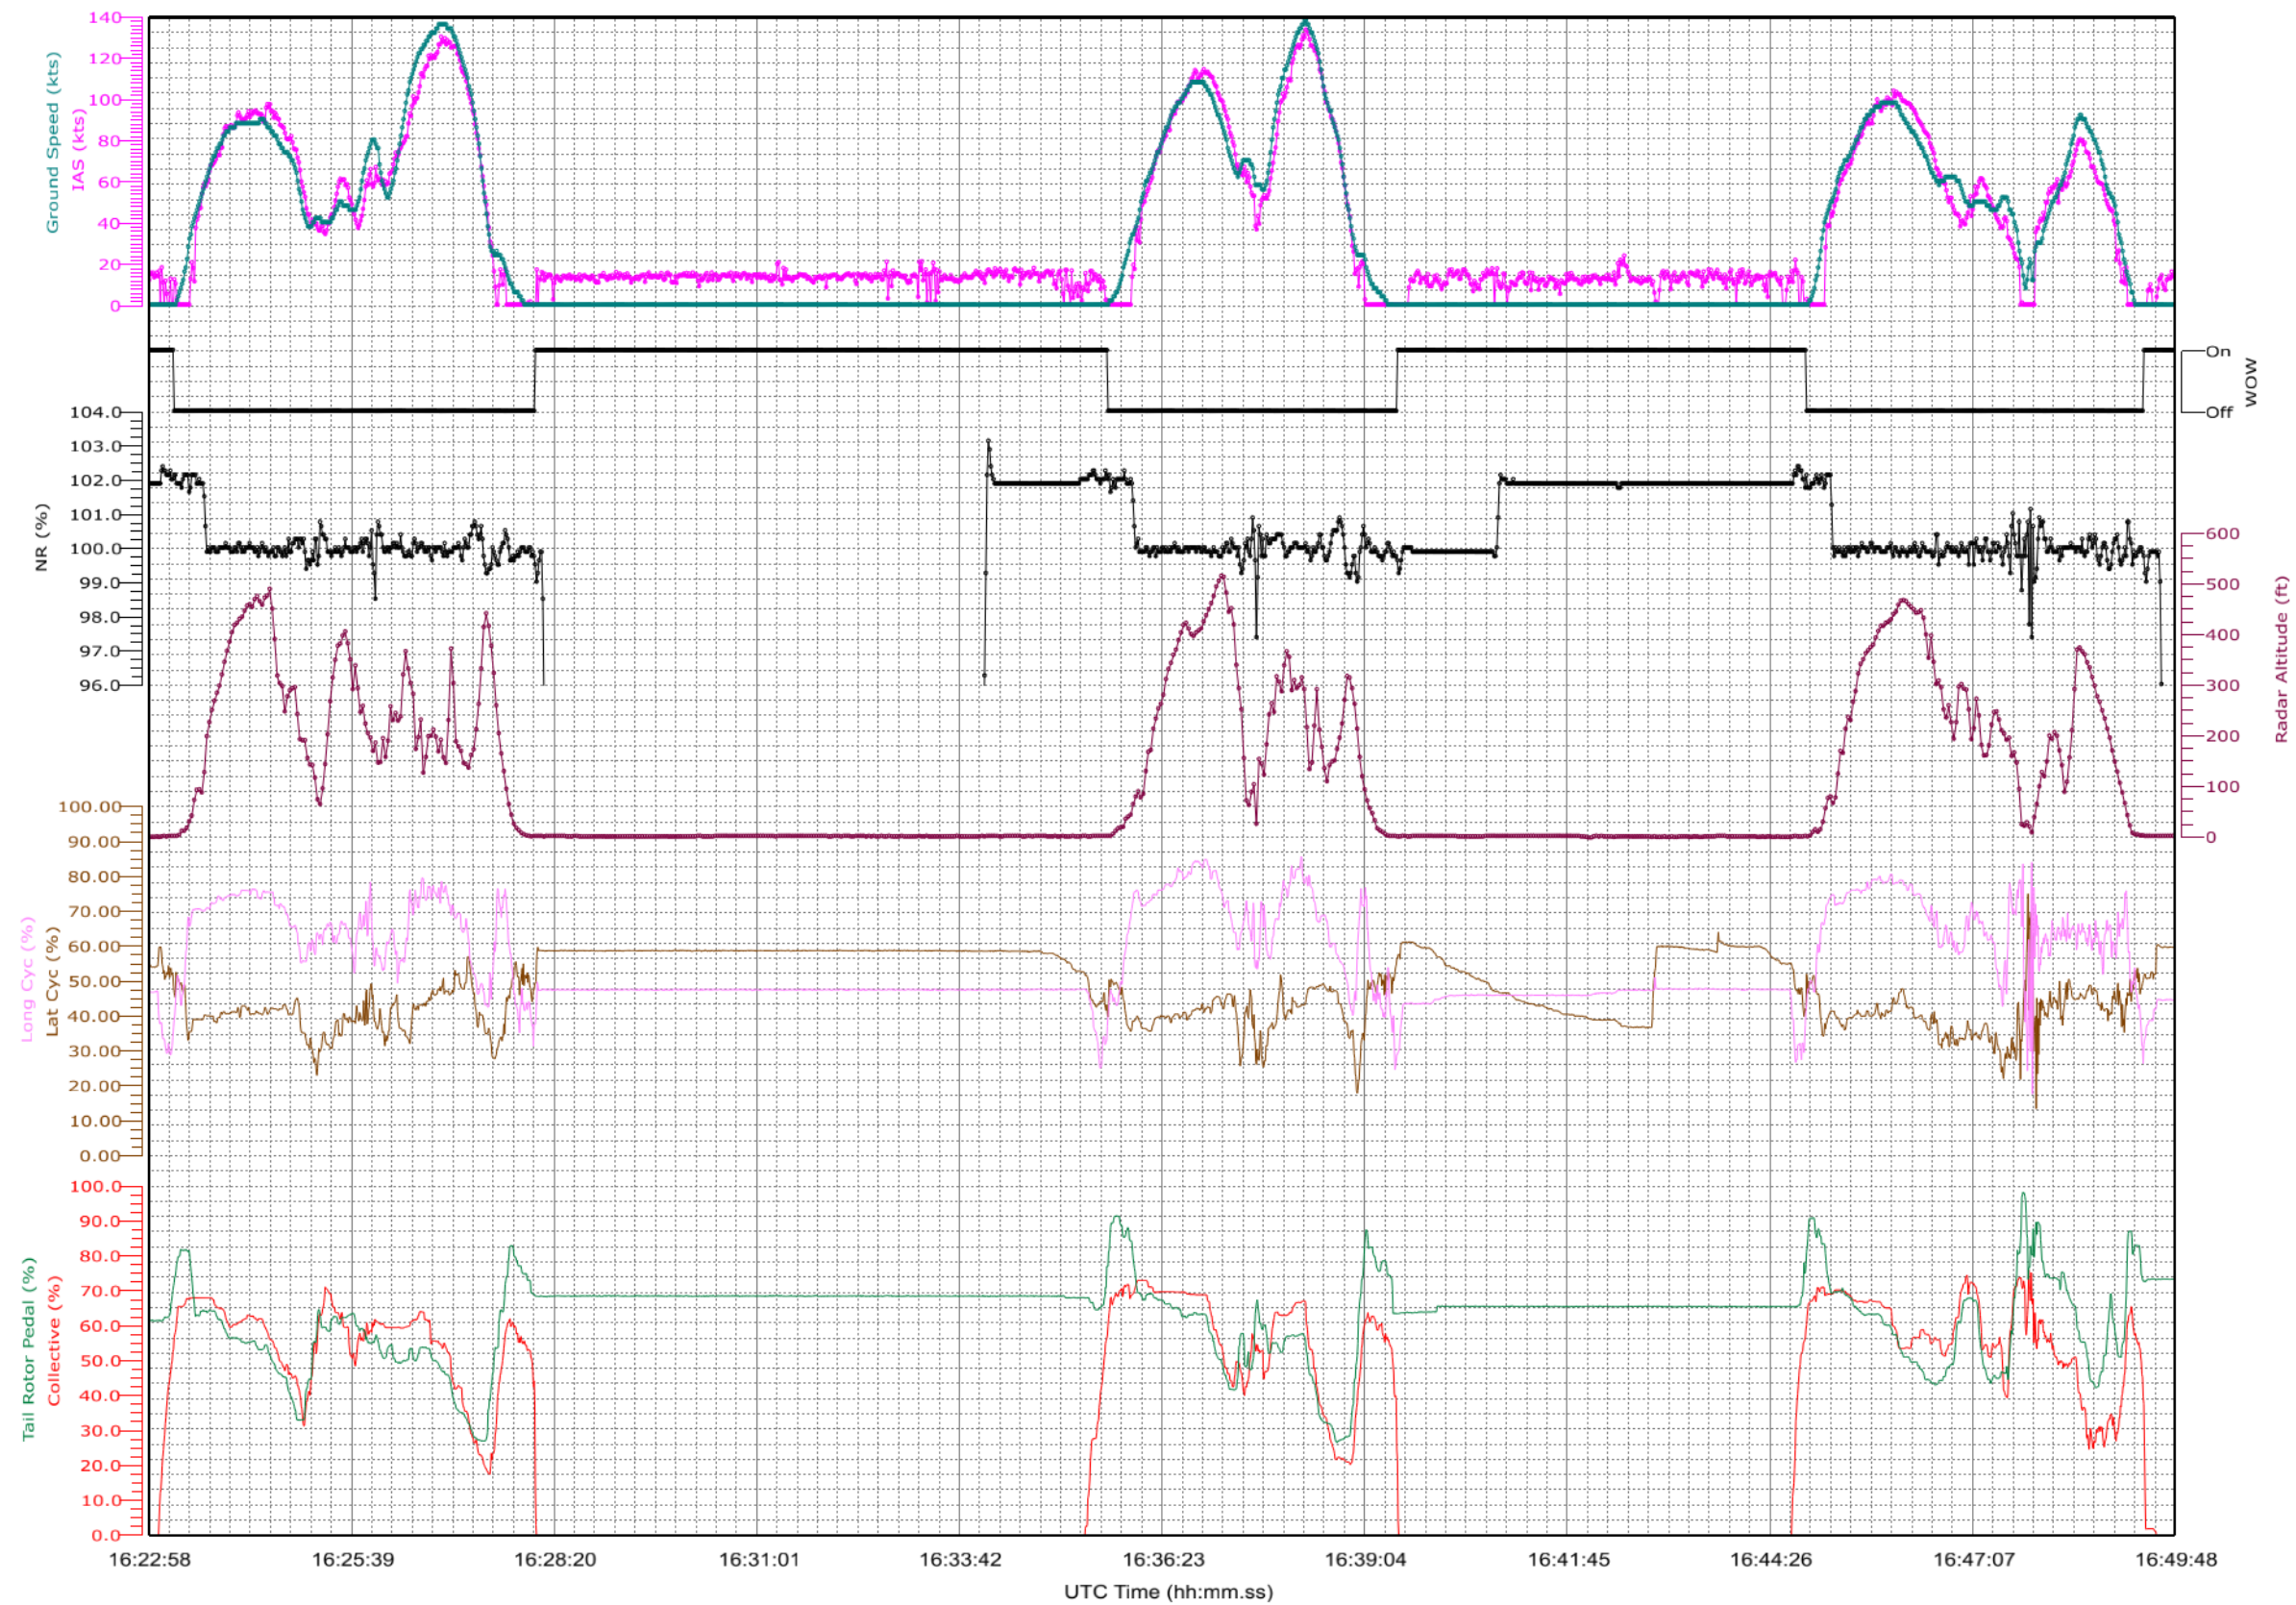
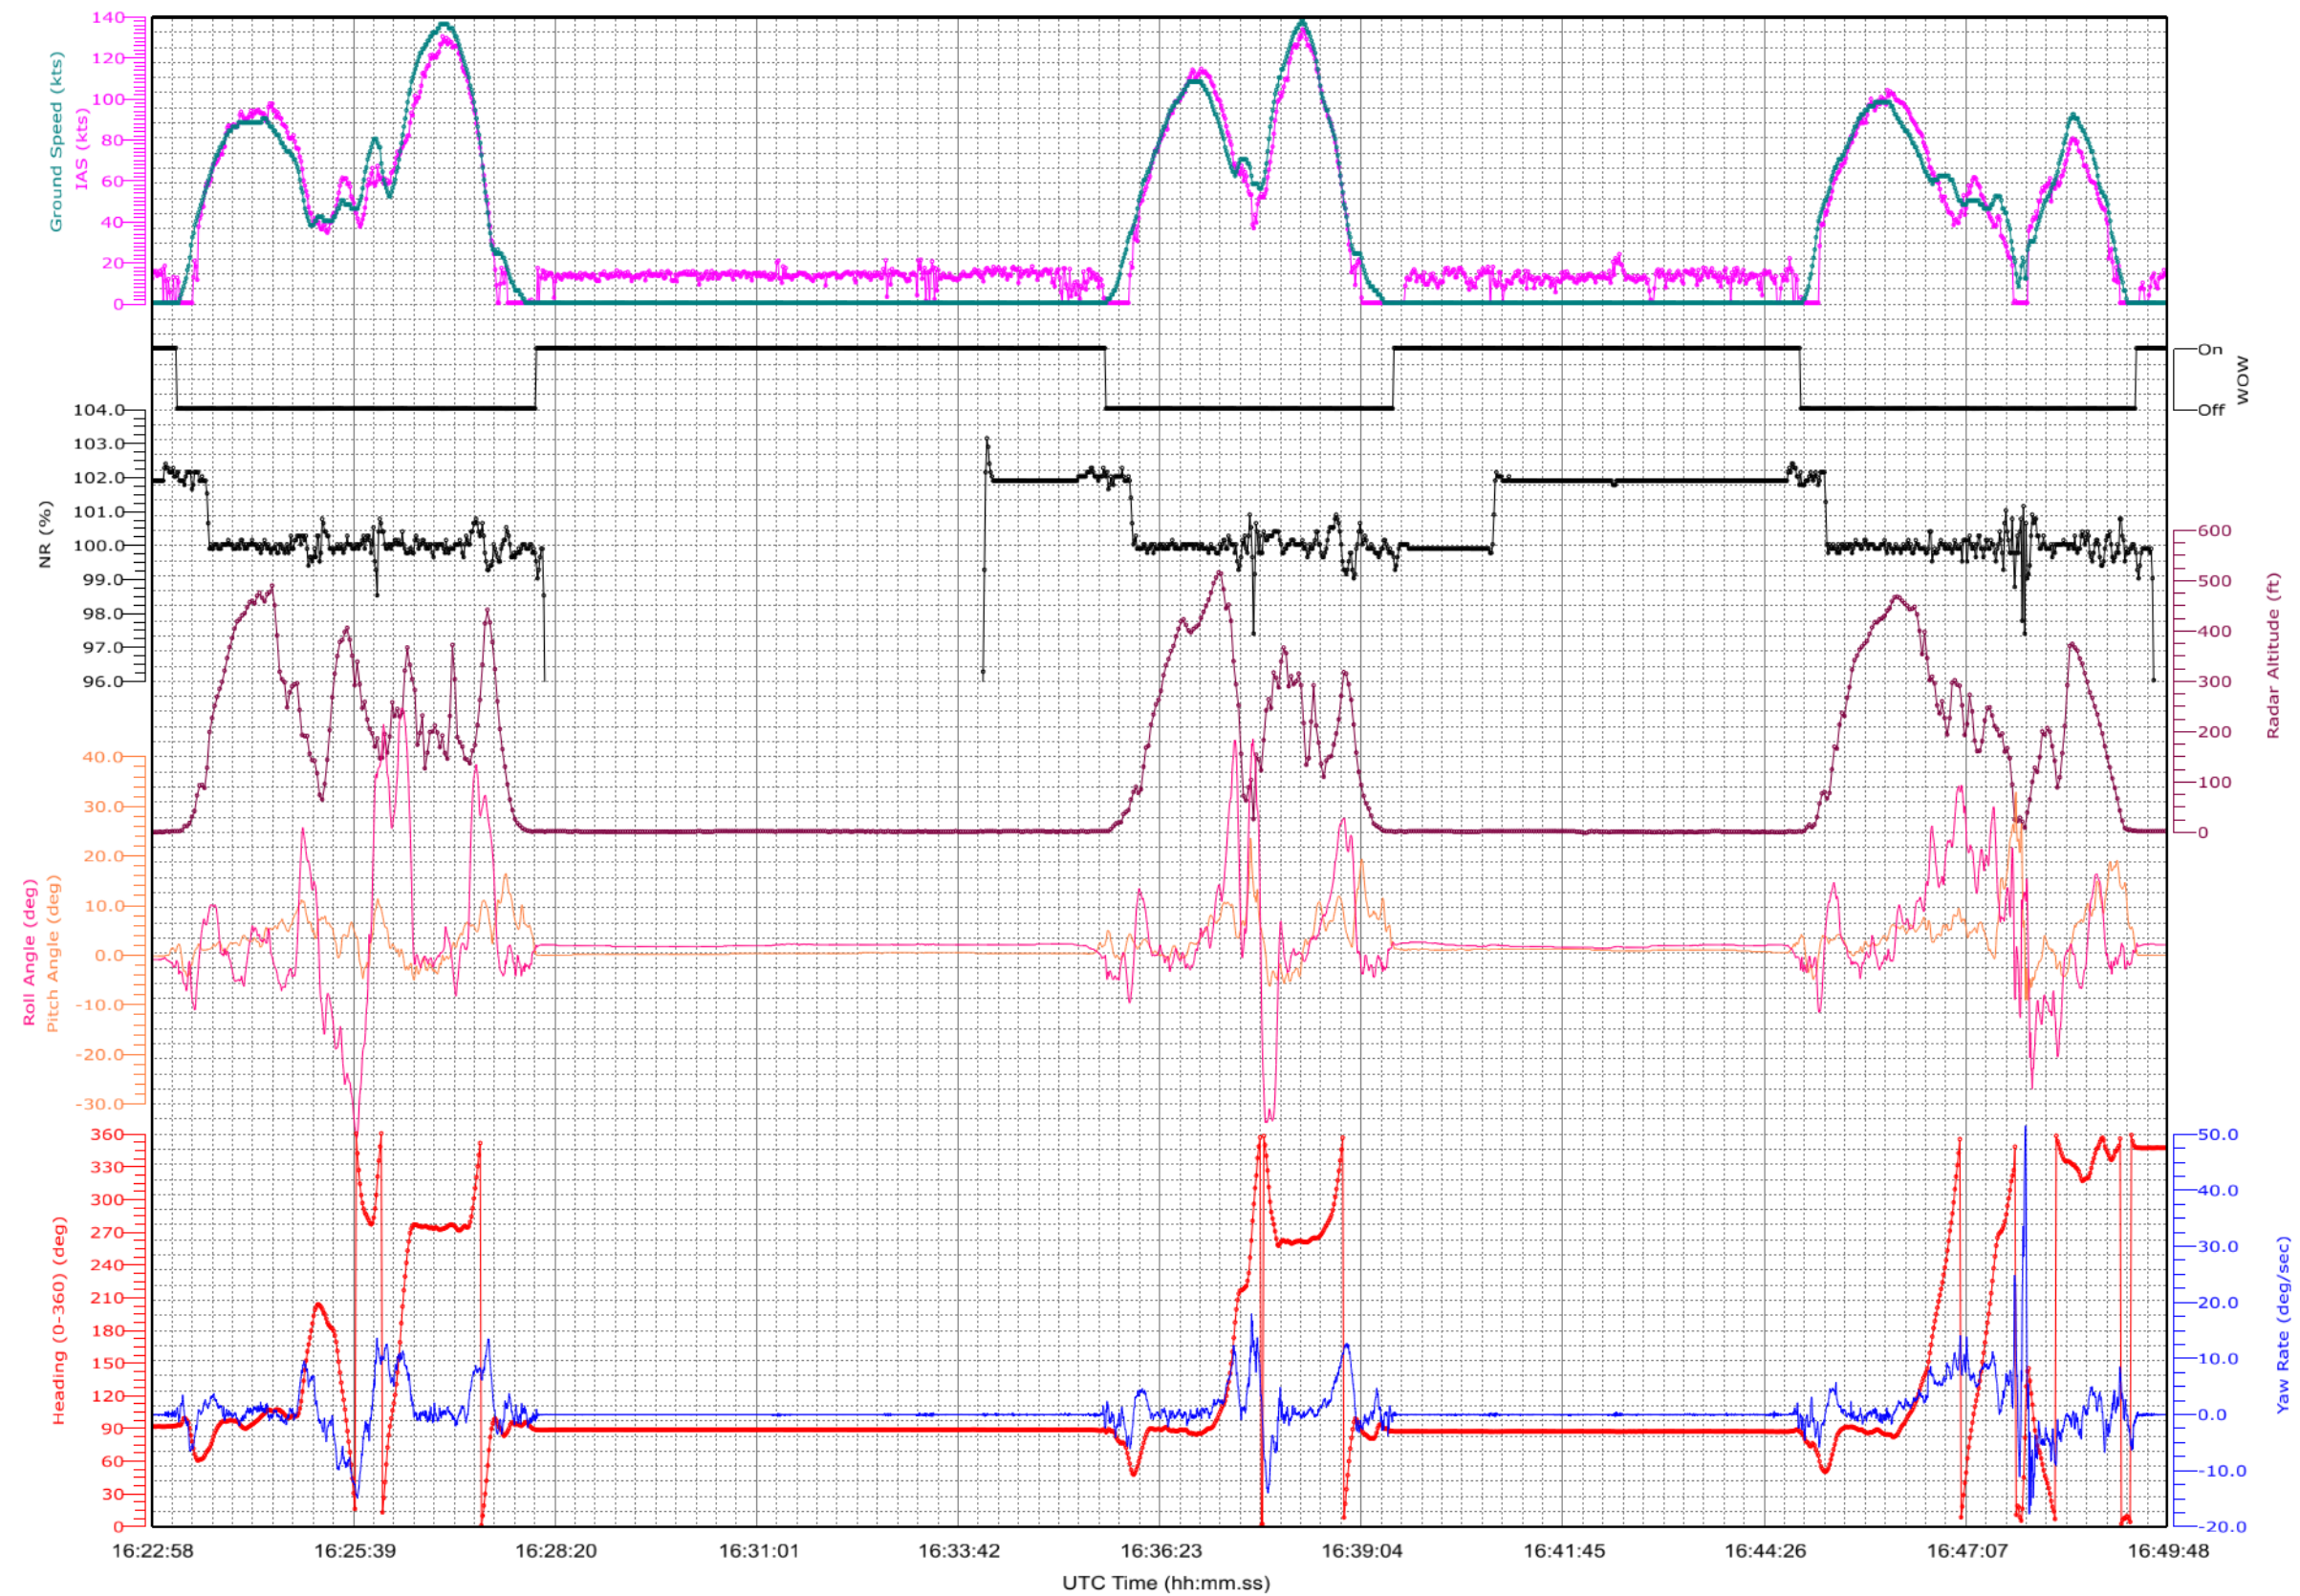
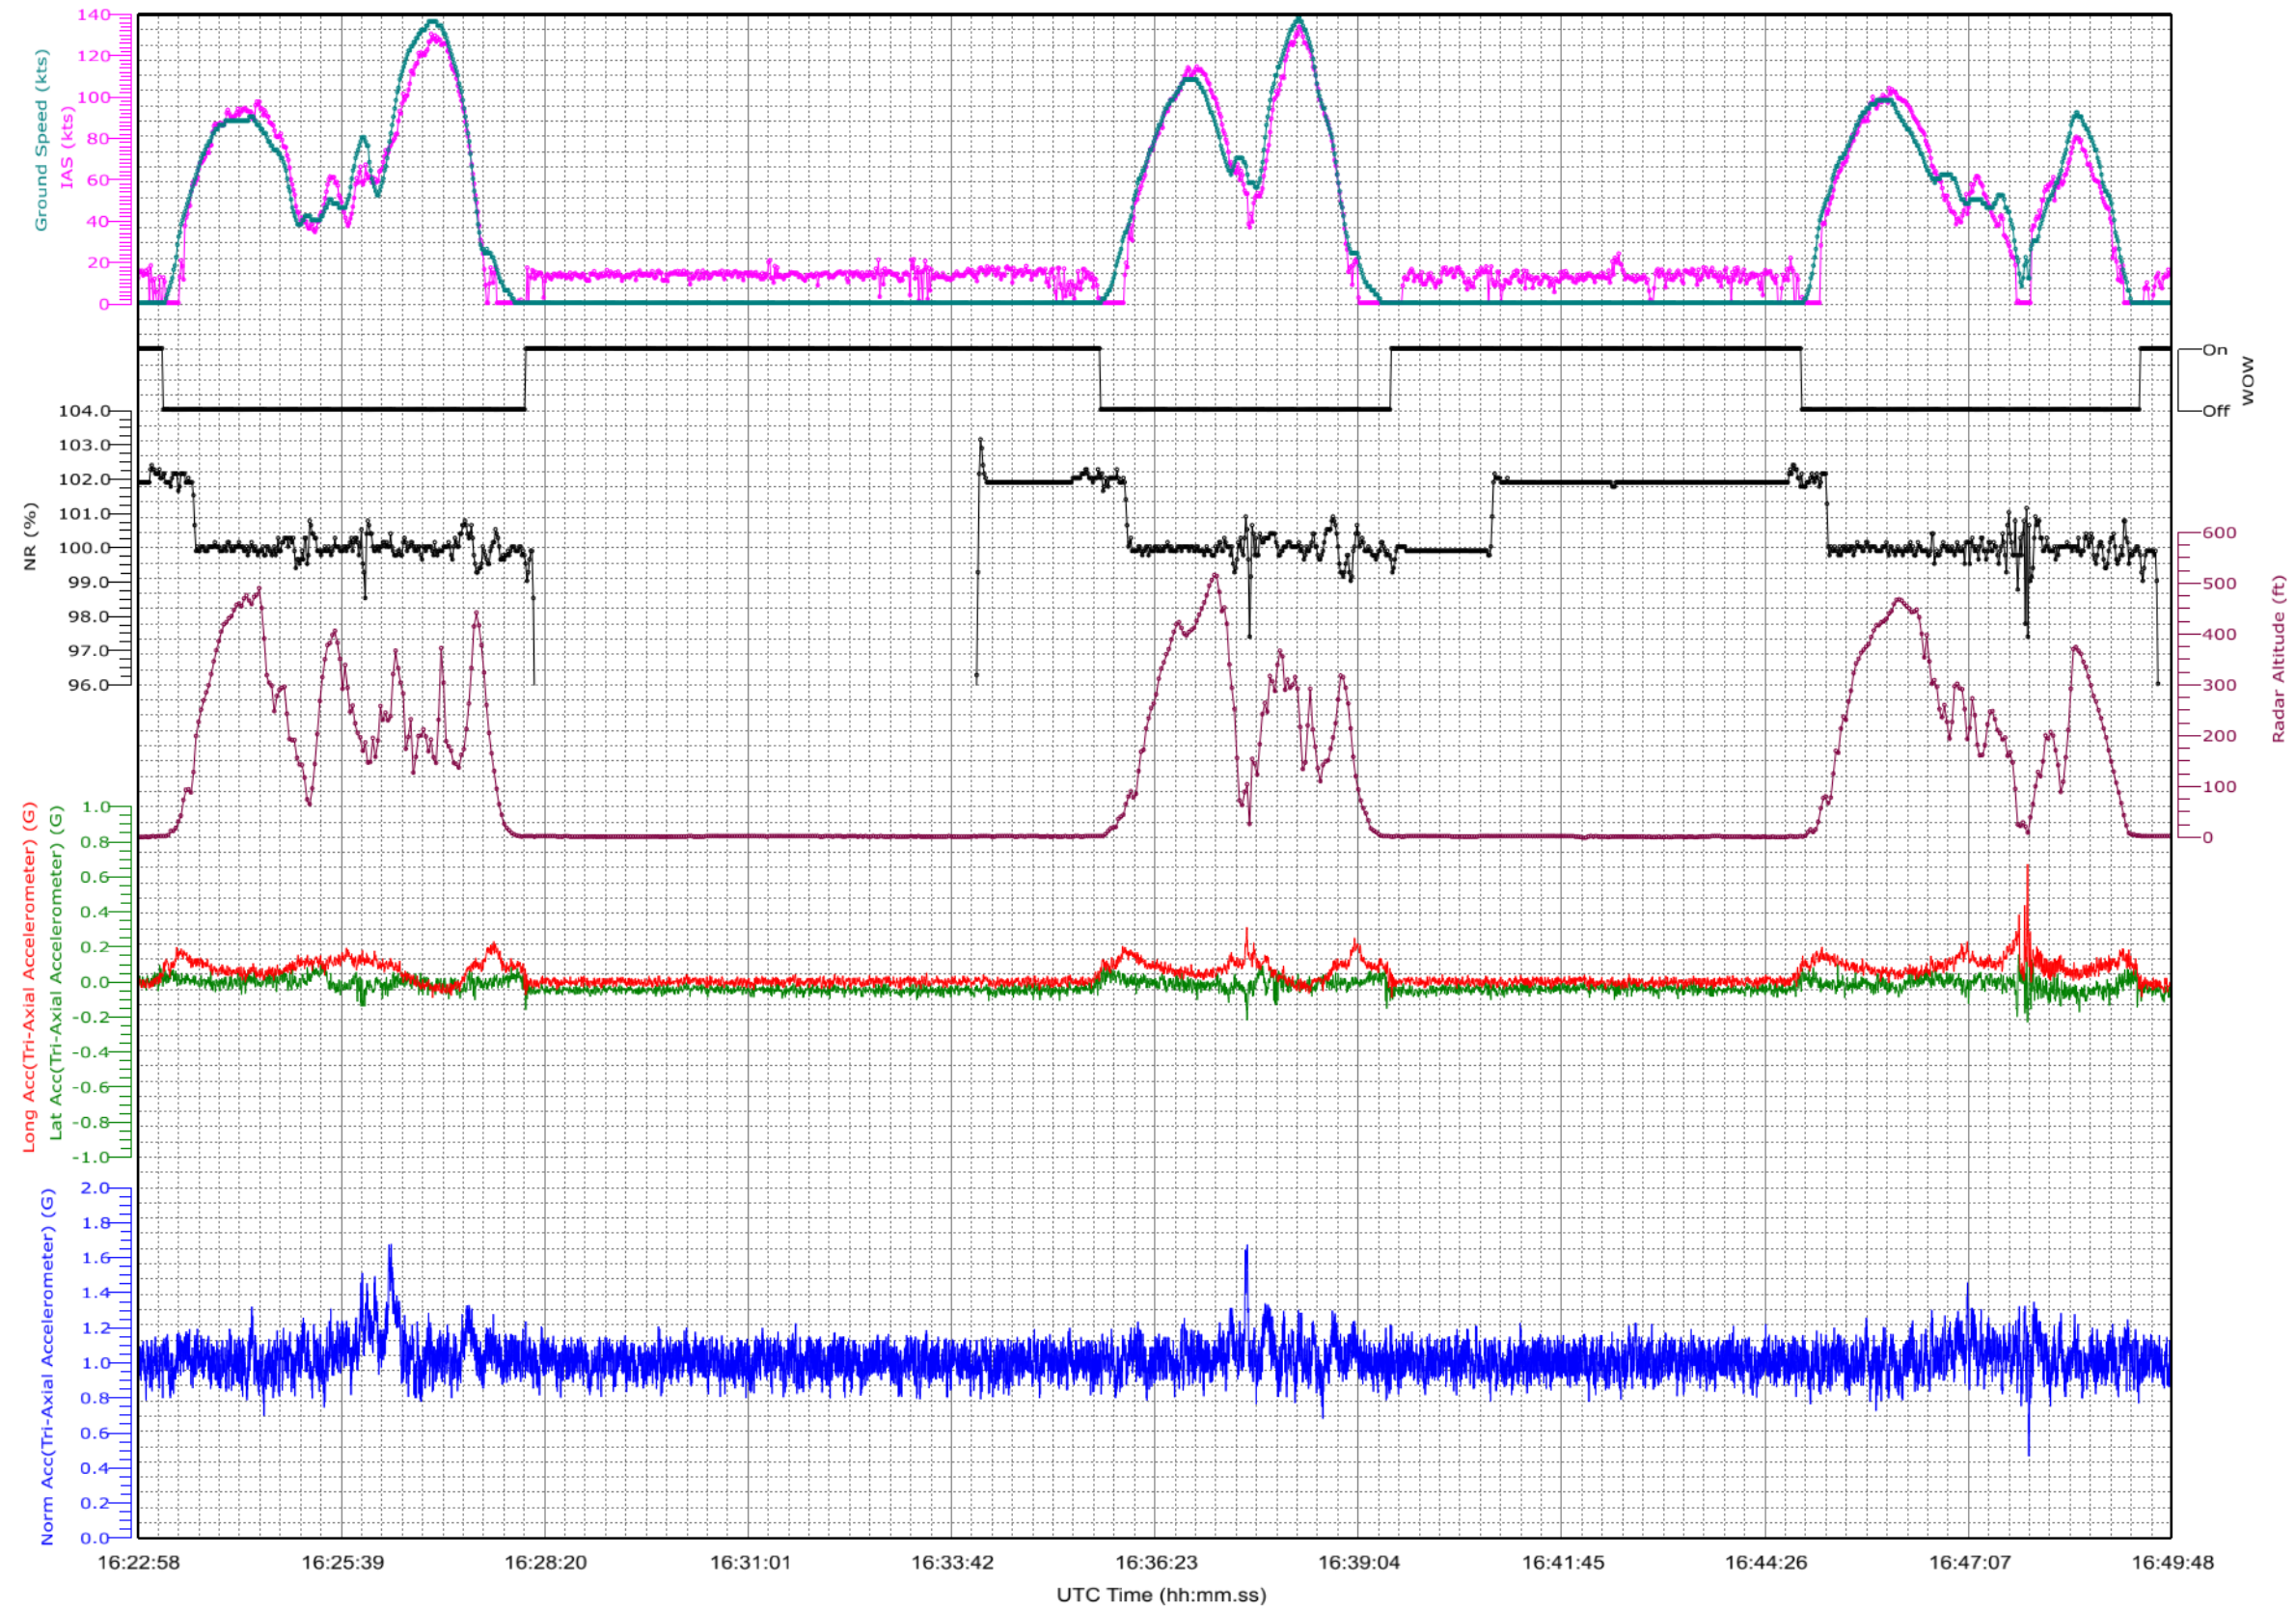
- When performing the two previous water drops (roughly at 16:26 and 16:37 UTC) the A/C did not reach peak commanded pitch attitude values similar to the final flight ( $\sim 33^\circ$ ), remaining below  $24^\circ$  instead
- The A/C maintained higher IAS and Ground Speed, between 40 and 60 KIAS (compared to less than 20 KIAS), while passing over the area of the two previous water drops.
- Lower IAS during the approach translated into higher TQ (and Pedal command) demands during the deceleration phase in the final flight.
- The TQ required to take off from Verdugo is higher in the last two flights of the record by about 10%, compared to the third-to-last flight.
- No significant variation in the A/C behaviour w.r.t the Pilot's commands is recorded for all the flights of the 2<sup>nd</sup> of September

Figure 9 – Time Histories of the A/C main parameters for the last three flights (1/4)

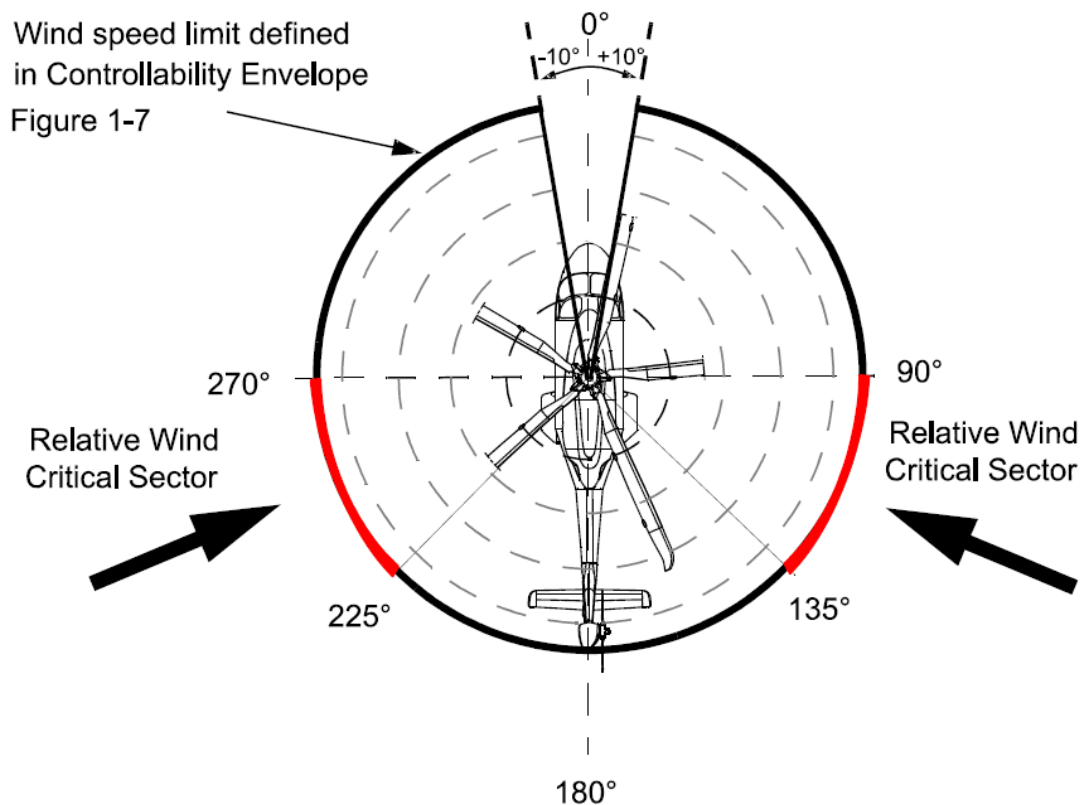
1. MPFR analysis did not evidence any Airframe failure or System malfunction during the flight which led to the event or in any of the flights of the day of the event
2. The Wind calculation performed by the on-board FMS indicates a possible Wind direction of 115-120° with 7-8kts speed prior to the final approach to the wildfire. As the A/C progressively turned the nose towards 360° it is possible that it may have encountered wind blowing from one of the critical azimuths (see Figure 39) while flying at very low speed, reducing pedal margin
3. Comparison between the final water drop and the 2 previous ones highlighted some differences in the piloting technique and in the preparation for the manoeuvre.

Figure 21 – Extract of AW139 RFM (Section 5 Supplement 90), Azimuth critical sectors
