## **FAA interview statements:**

**INTERVIEW WITH KYLE EATON:** KYLE owns and operates a Part 135 float plane out of Trident Basin and was there the morning of 9-4-17. He said the wind was blowing in from the east, which makes a direct crosswind from the regular North / South operations in Trident Basin. He said that DAVID MAGOFFIN was there early, and was talking to several pilots about the weather. He (David) asked KYLE specifically, "what do you think?" and "which way to go?" about takeoff routes.

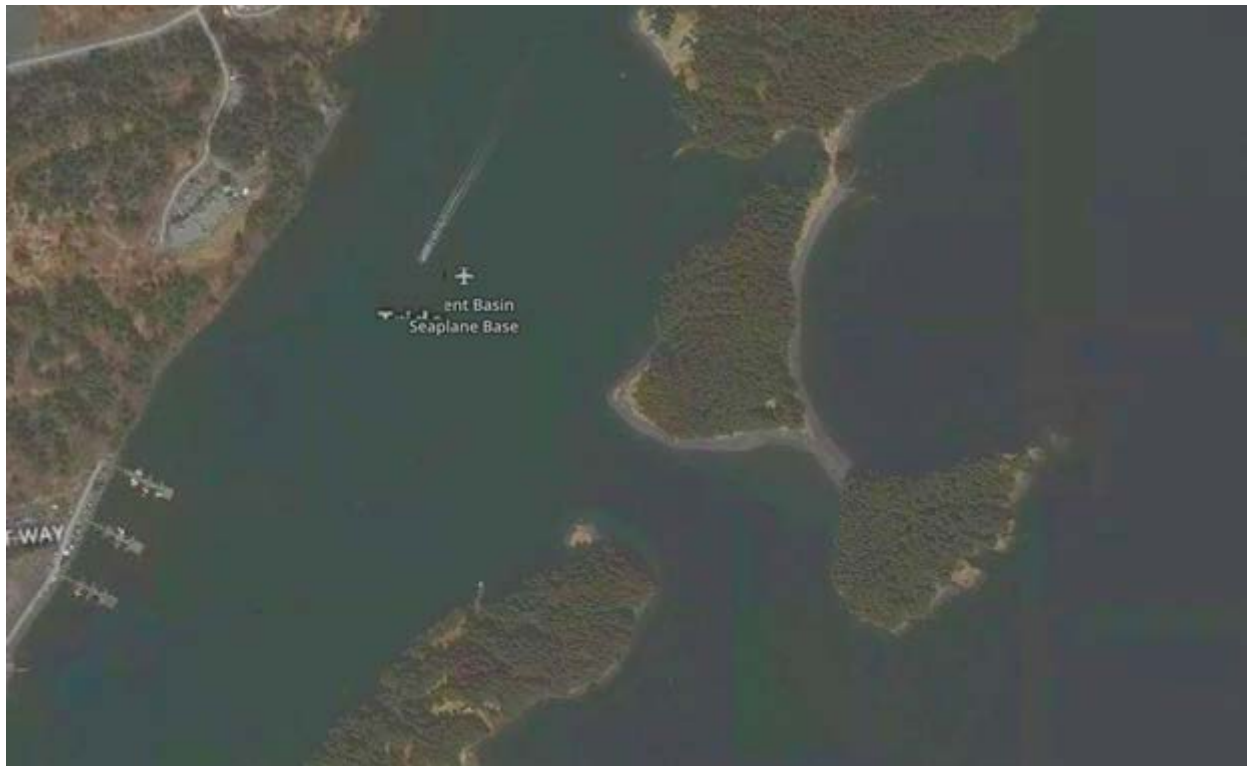
I asked if he could tell if the amphibious gear was up or down, he replied "definitely up". He said when the aircraft was towed back in the gear was in the up position and the floats were not damaged.
