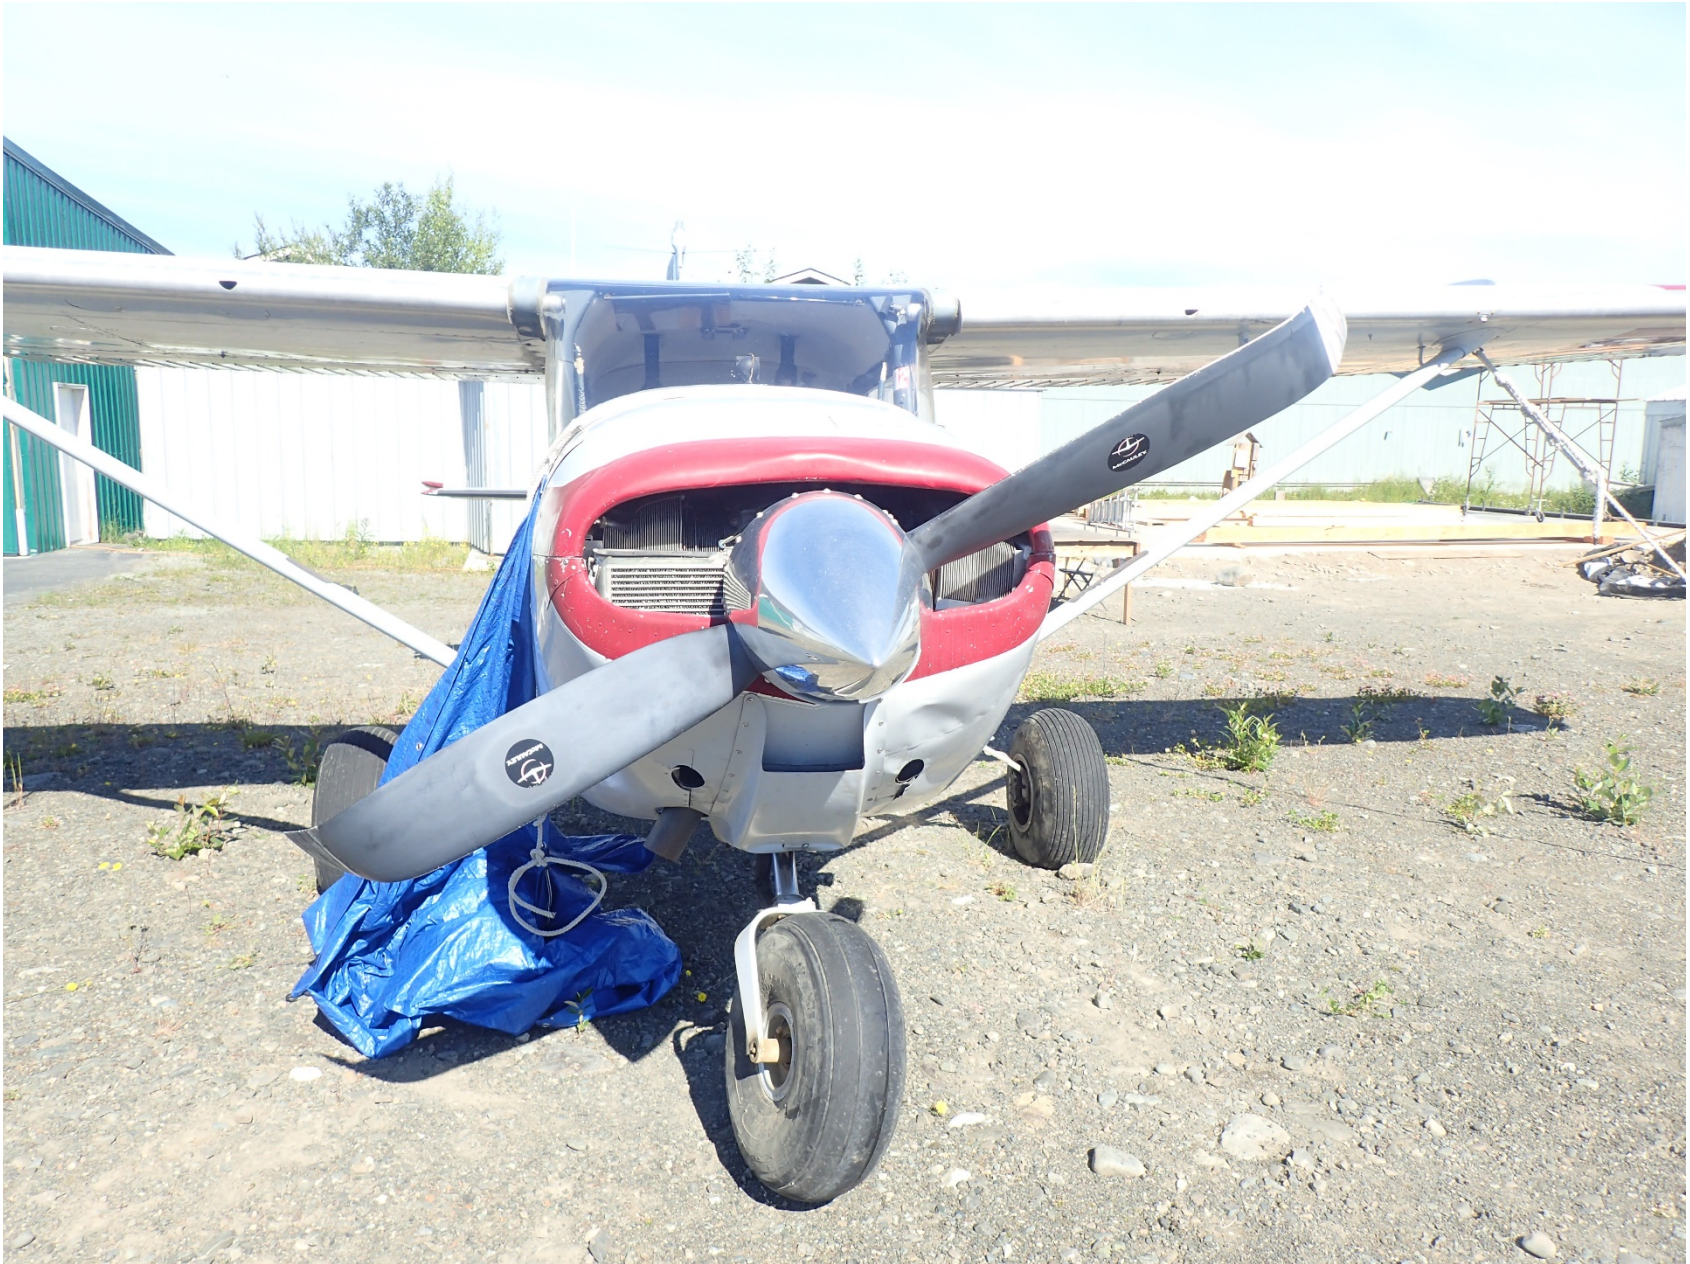
**Photo 1 – N5020D propeller and fuselage damage.**

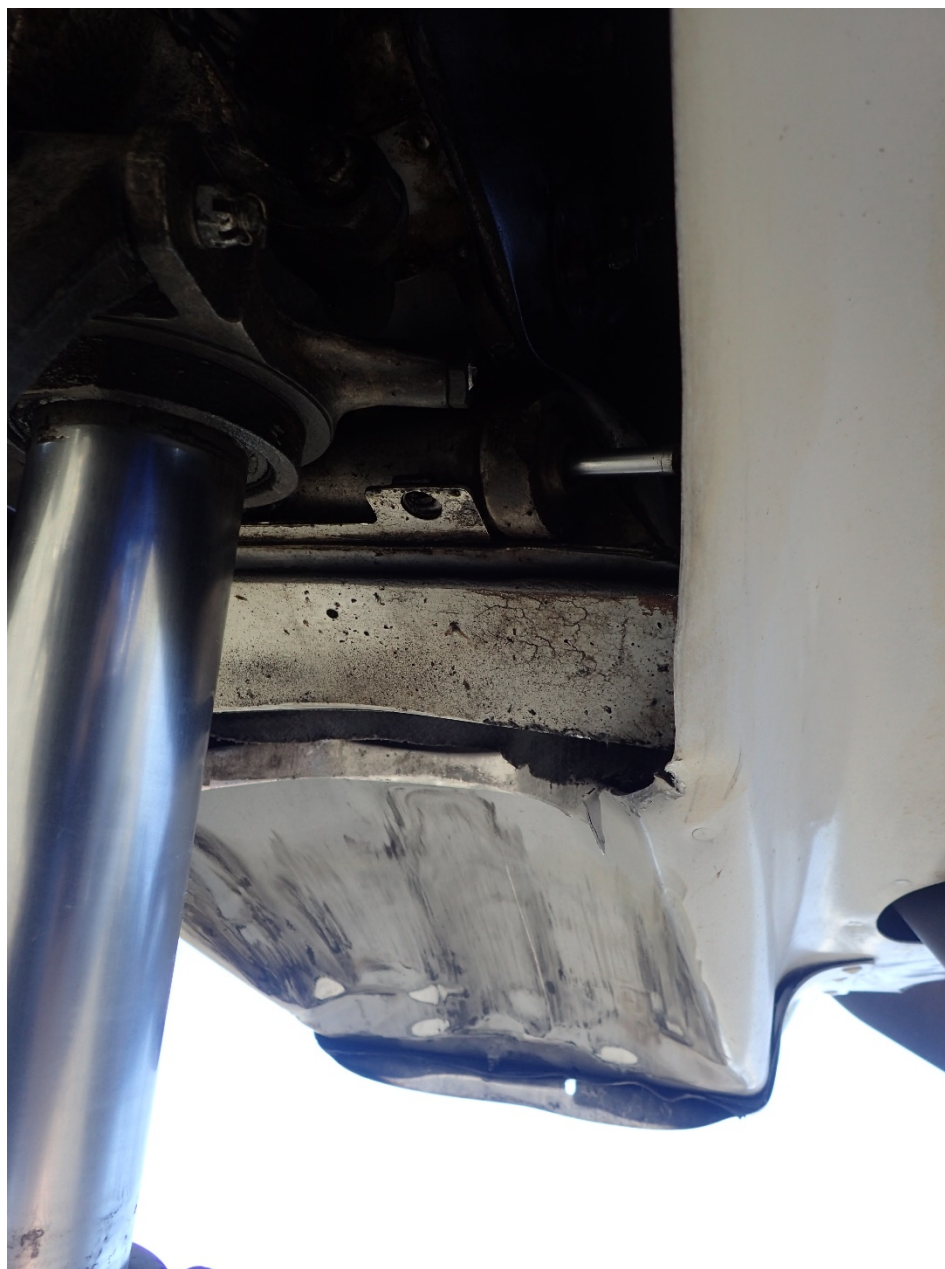
**Photo 2 - N5020D fuselage damage.**

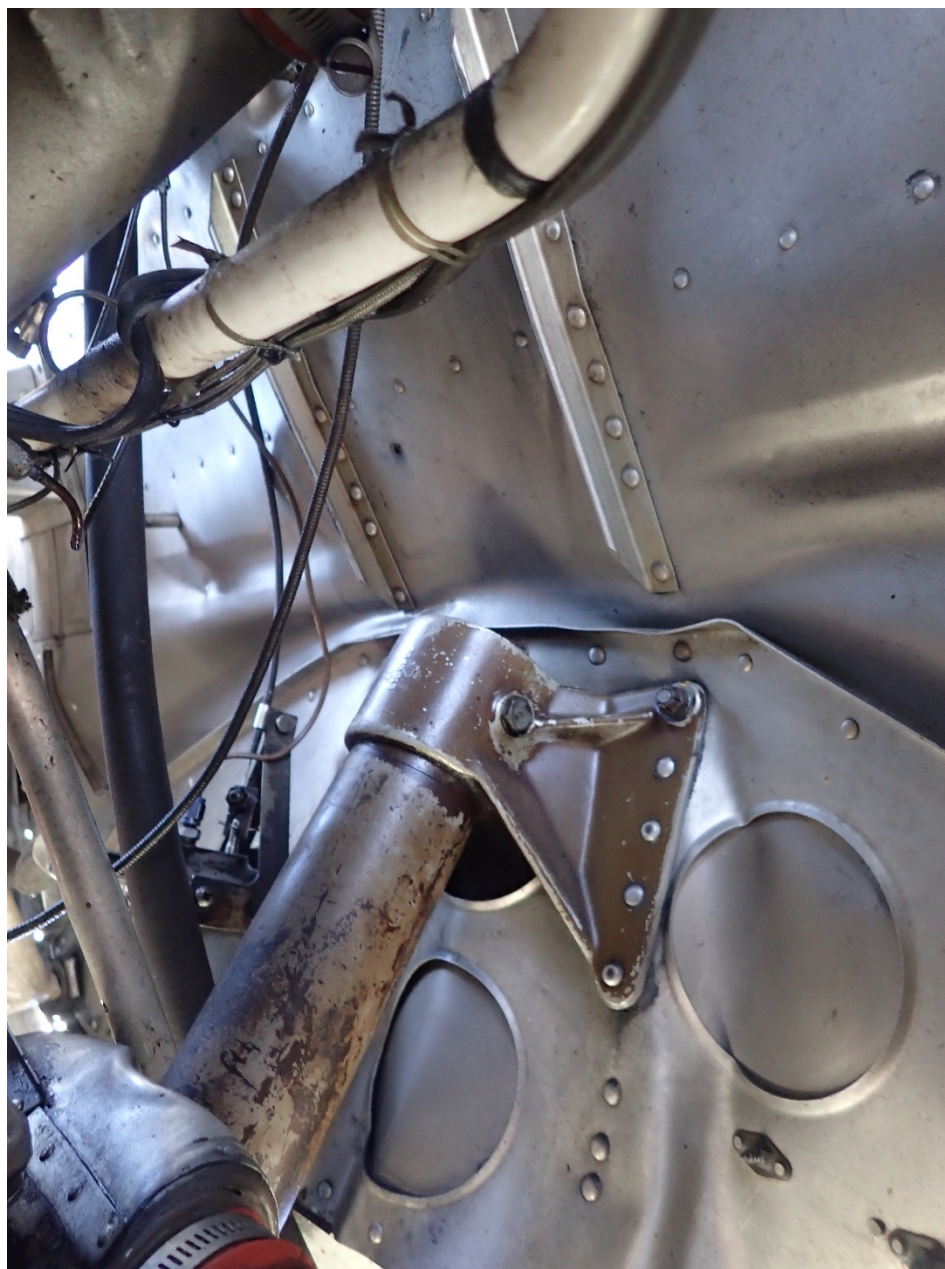
**Photo 3 - N5020D buckled engine firewall.**
