# NATIONAL TRANSPORTATION SAFETY BOARD

MATERIALS LABORATORY FACTUAL REPORT

Report No. 18-045

Place : Russian Mission, AK  
Date : October 16, 2017  
Vehicle : Cessna 210  
NTSB No. : ANC18FA003  
Investigator : Shaun Williams

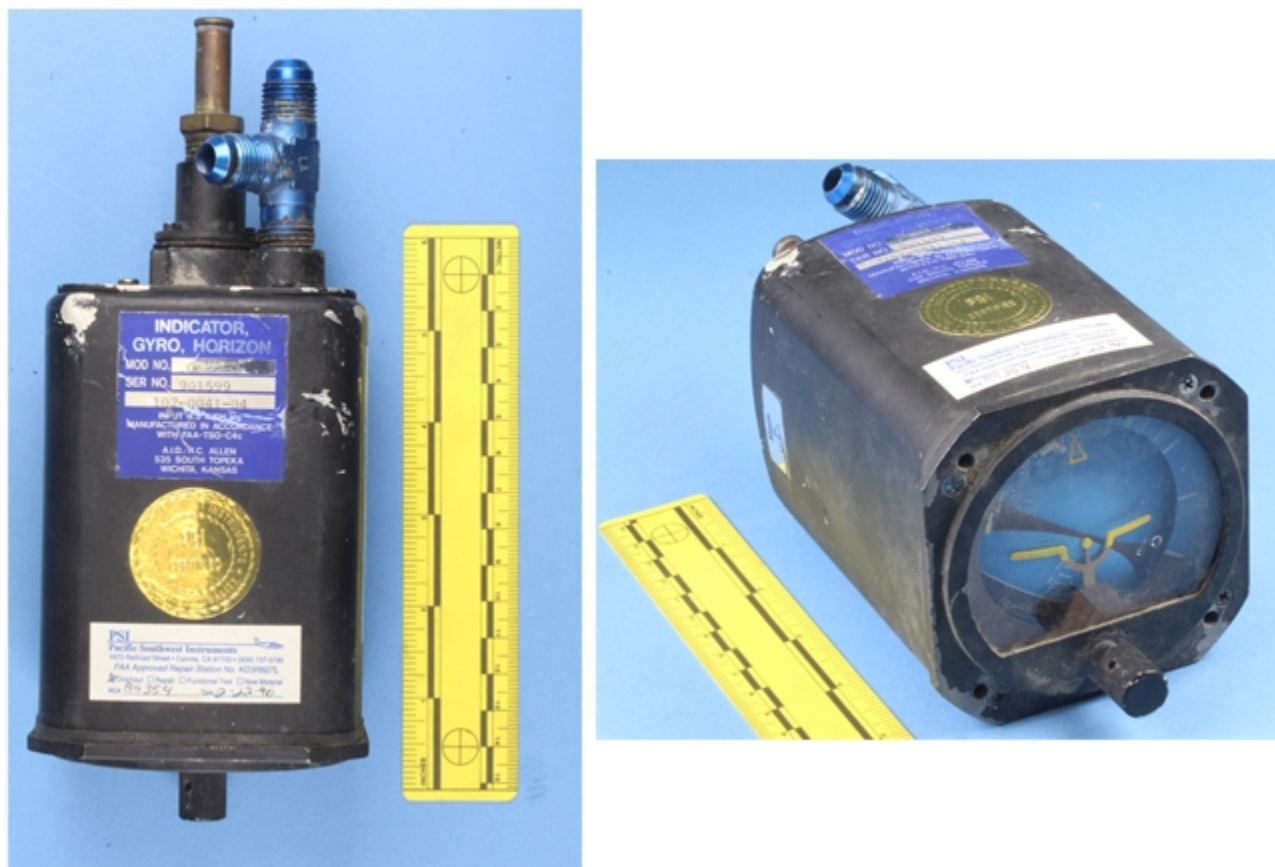
Figure 1 shows two views of the as-received attitude indicator. The corrected model number is observed to be RCA22-7. The unit was overhauled on February 22, 1996. The Materials Laboratory examination included disassembly to inspect for operational damage to the unit. Figure 2 shows a front (facial) view prior to disassembly while figure 3 is a top view of the unit after removing the outside cover. Note the corrosion build-up on many of the parts. The gyro was removed from the unit and disassembled. Figure 4 compares the rotor before (top left image) and after cleaning (top right image) ultrasonically for 10 minutes using a soap/water solution. The bottom image is of the boxed area of a line feature found on the surface of the clean rotor. The line feature, when magnified is a series of horizontal scratches part way across the rotor. Figure 5 shows the two halves of the aluminum rotor housing after cleaning. The housing halves were first cleaned ultrasonically using a soap/water solution. Residual corrosion was observed so a chromic acid/hydrochloric acid/water solution was heated to 75°C and the parts were soaked for 2 minutes.

Figure 1. Two views of the as-received attitude indicator.

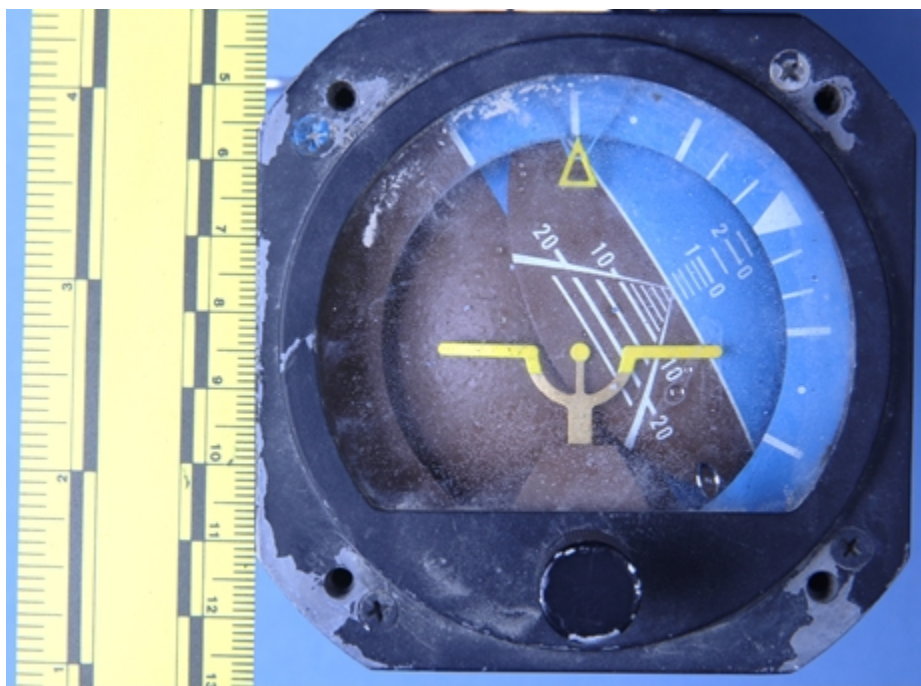
The indicator's glass face was intact with slight scratching damage. There was no significant deformation damage to the outside of the case. After disassembly, the gimbals were found to move freely. Further disassembly to the gyro revealed that although wetness and corrosion were visibly present, the rotor spun freely on the shaft within its housing. No scoring or deep gouge marks were observed in either the rotor or gyro housing surfaces.

Figure 2. Facial view before disassembly.

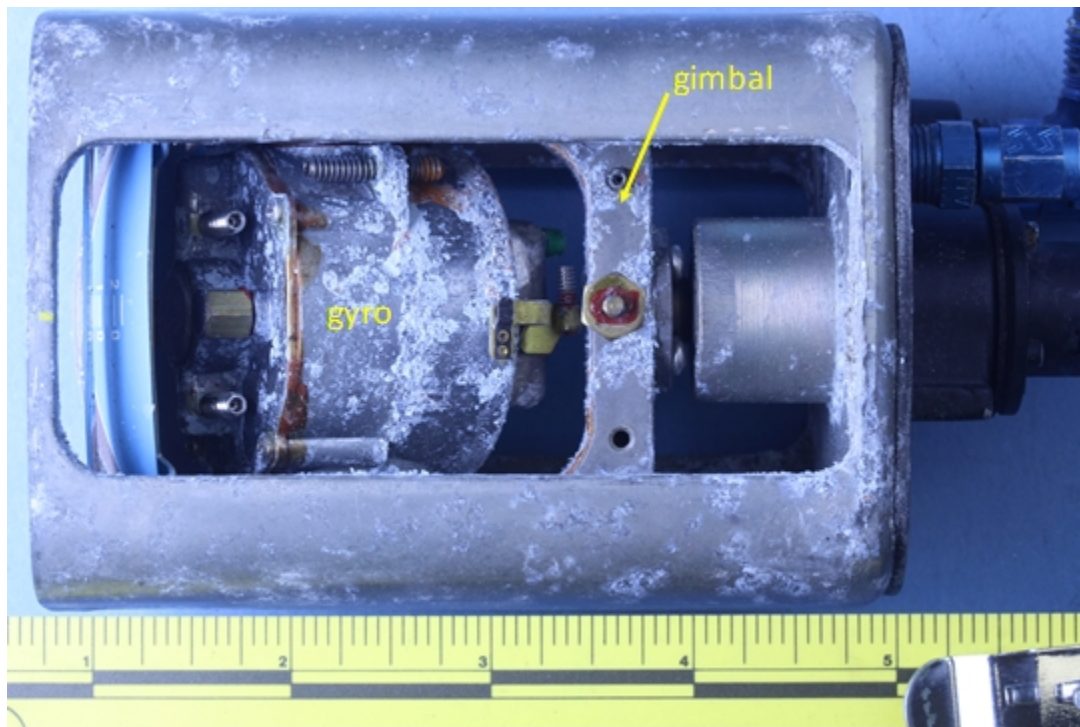
Figure 3. View of gimbal and gyro after removing the cover.

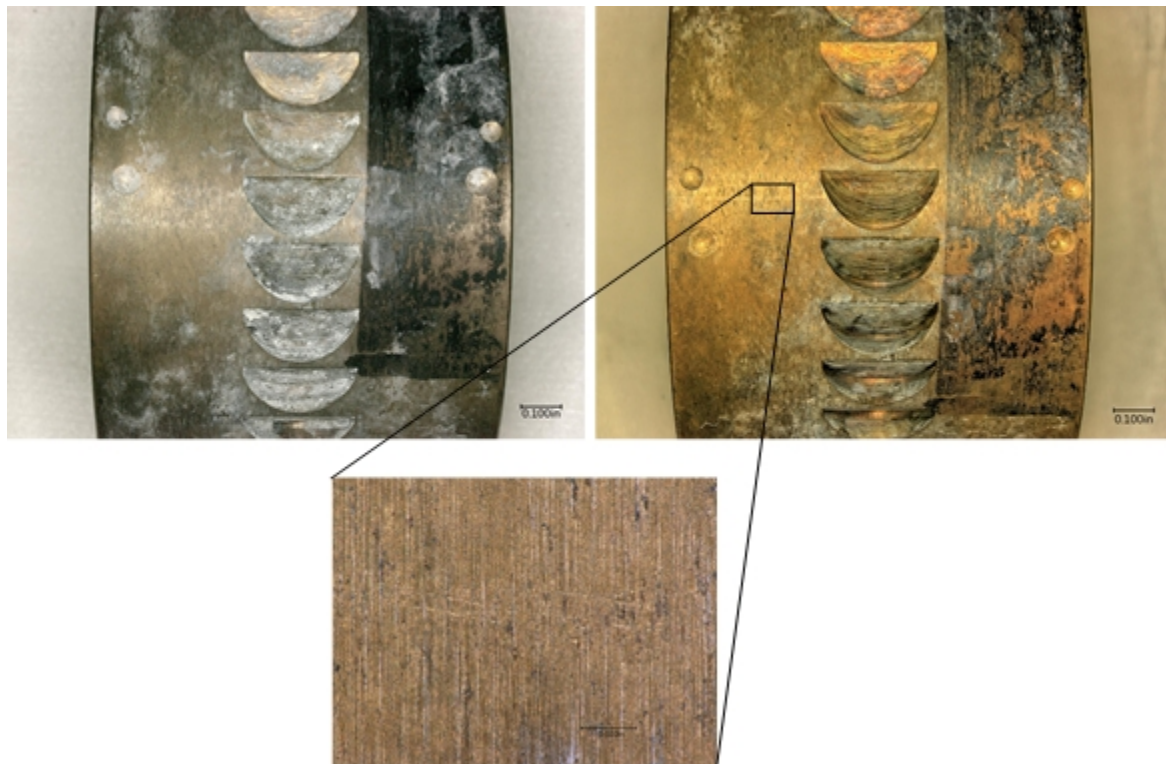
Figure 4. Top left view is of rotor before cleaning. Top right view is of rotor after cleaning. Bottom image is a closer view of scratches making up the horizontal line.

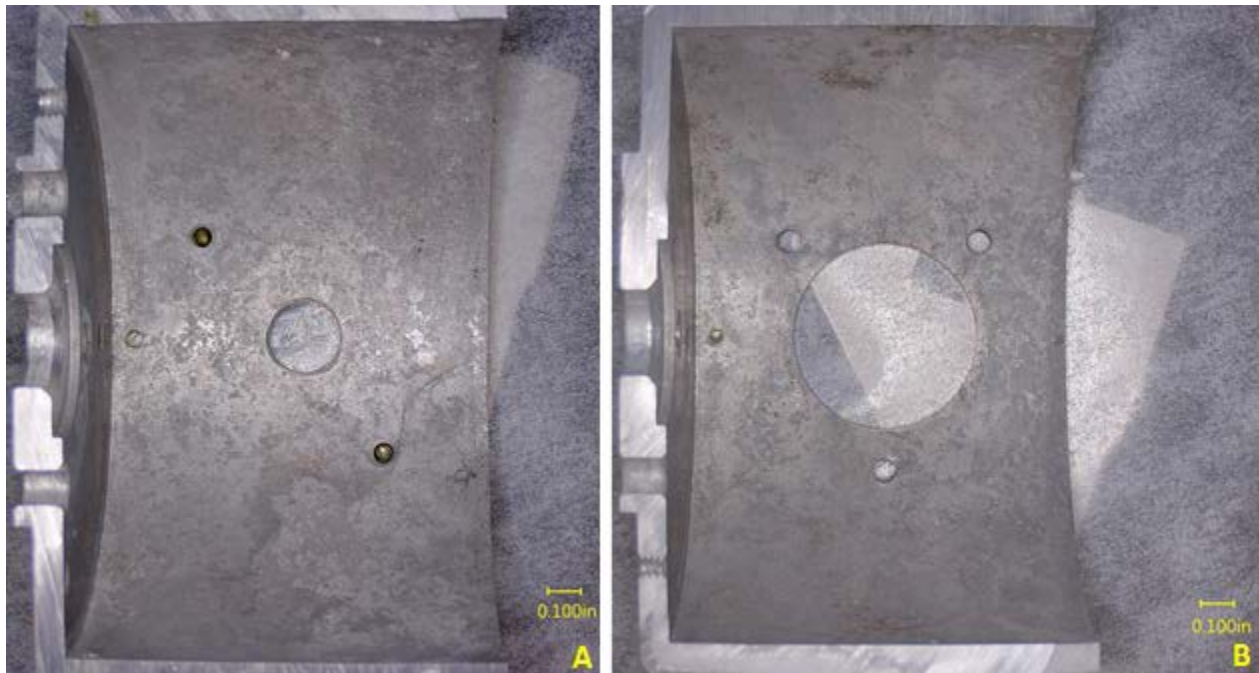
Figure 5. Two halves of the rotor housing after cleaning (halves are arbitrarily labelled).
