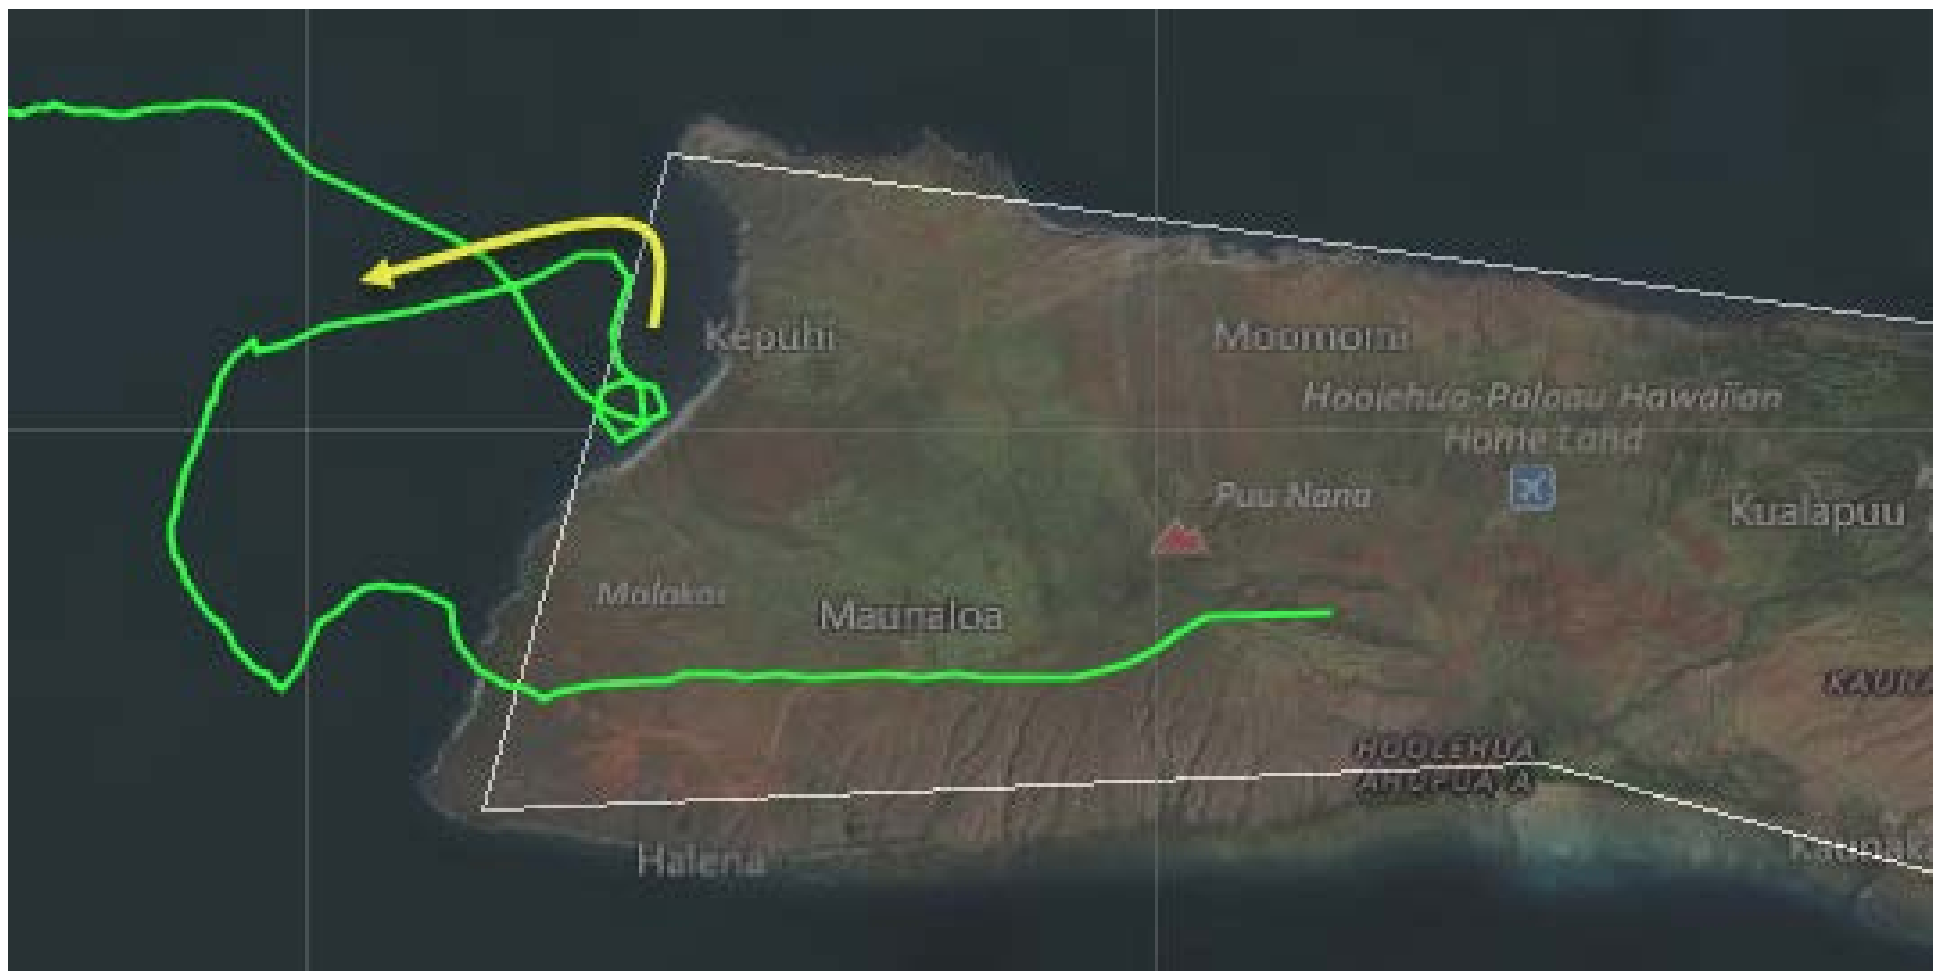
**Photo 1 – View of the flight track information (courtesy of the NTSB).**

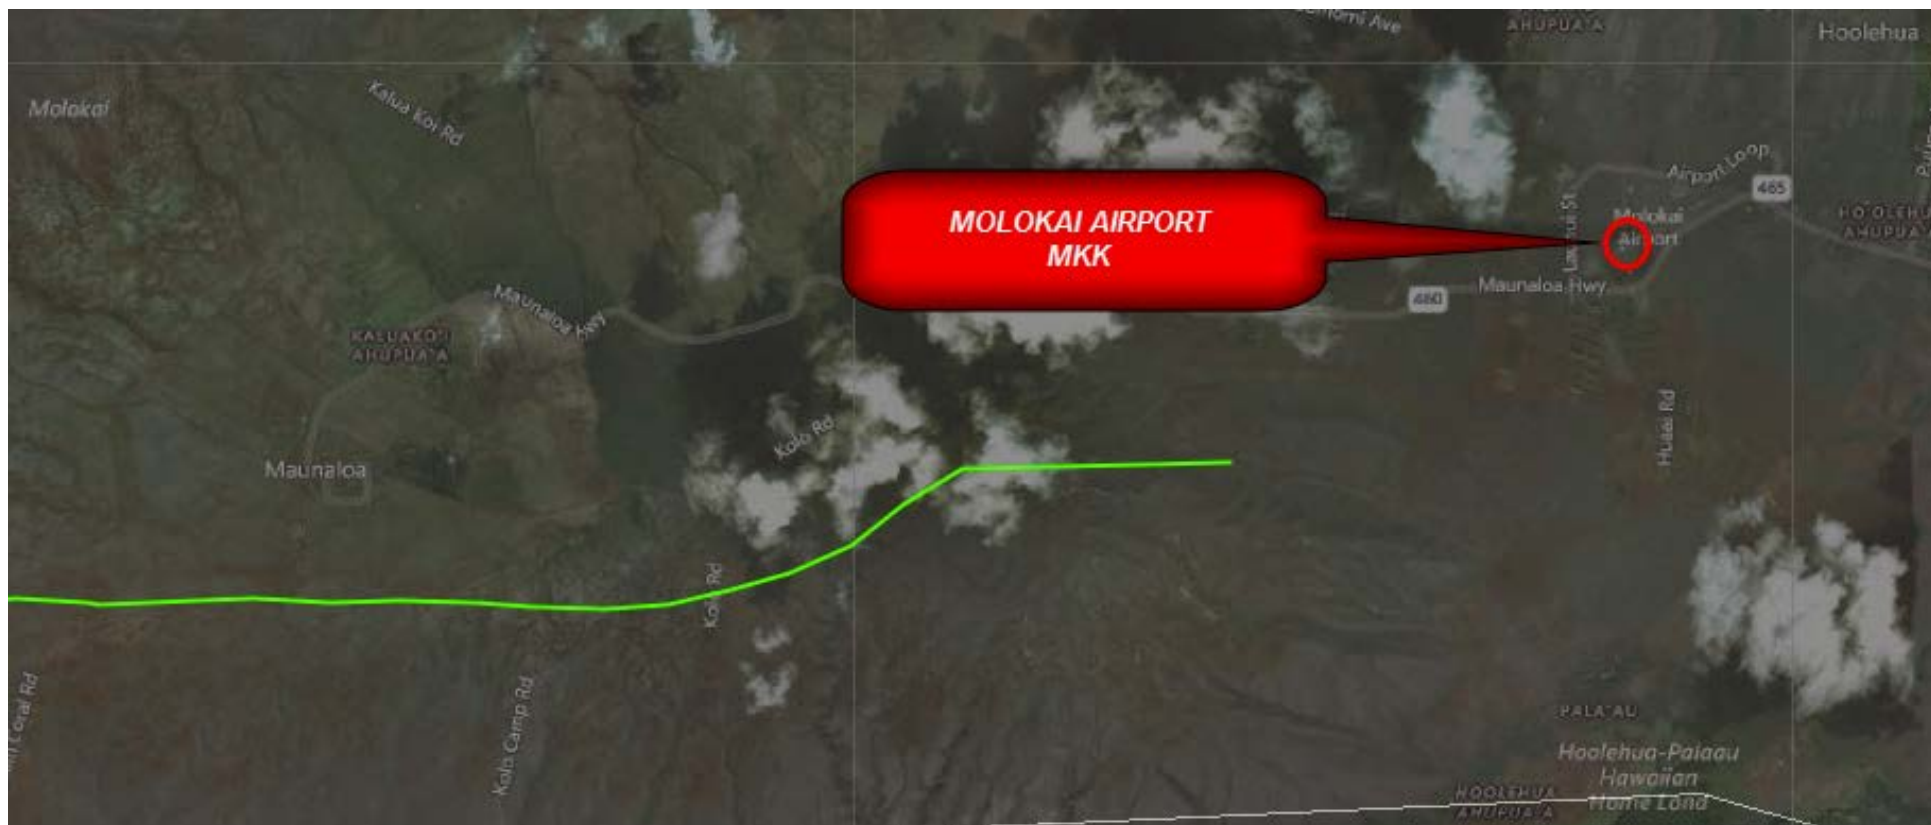
**Photo 2 – View of the termination of the flight track information (courtesy of the NTSB).**

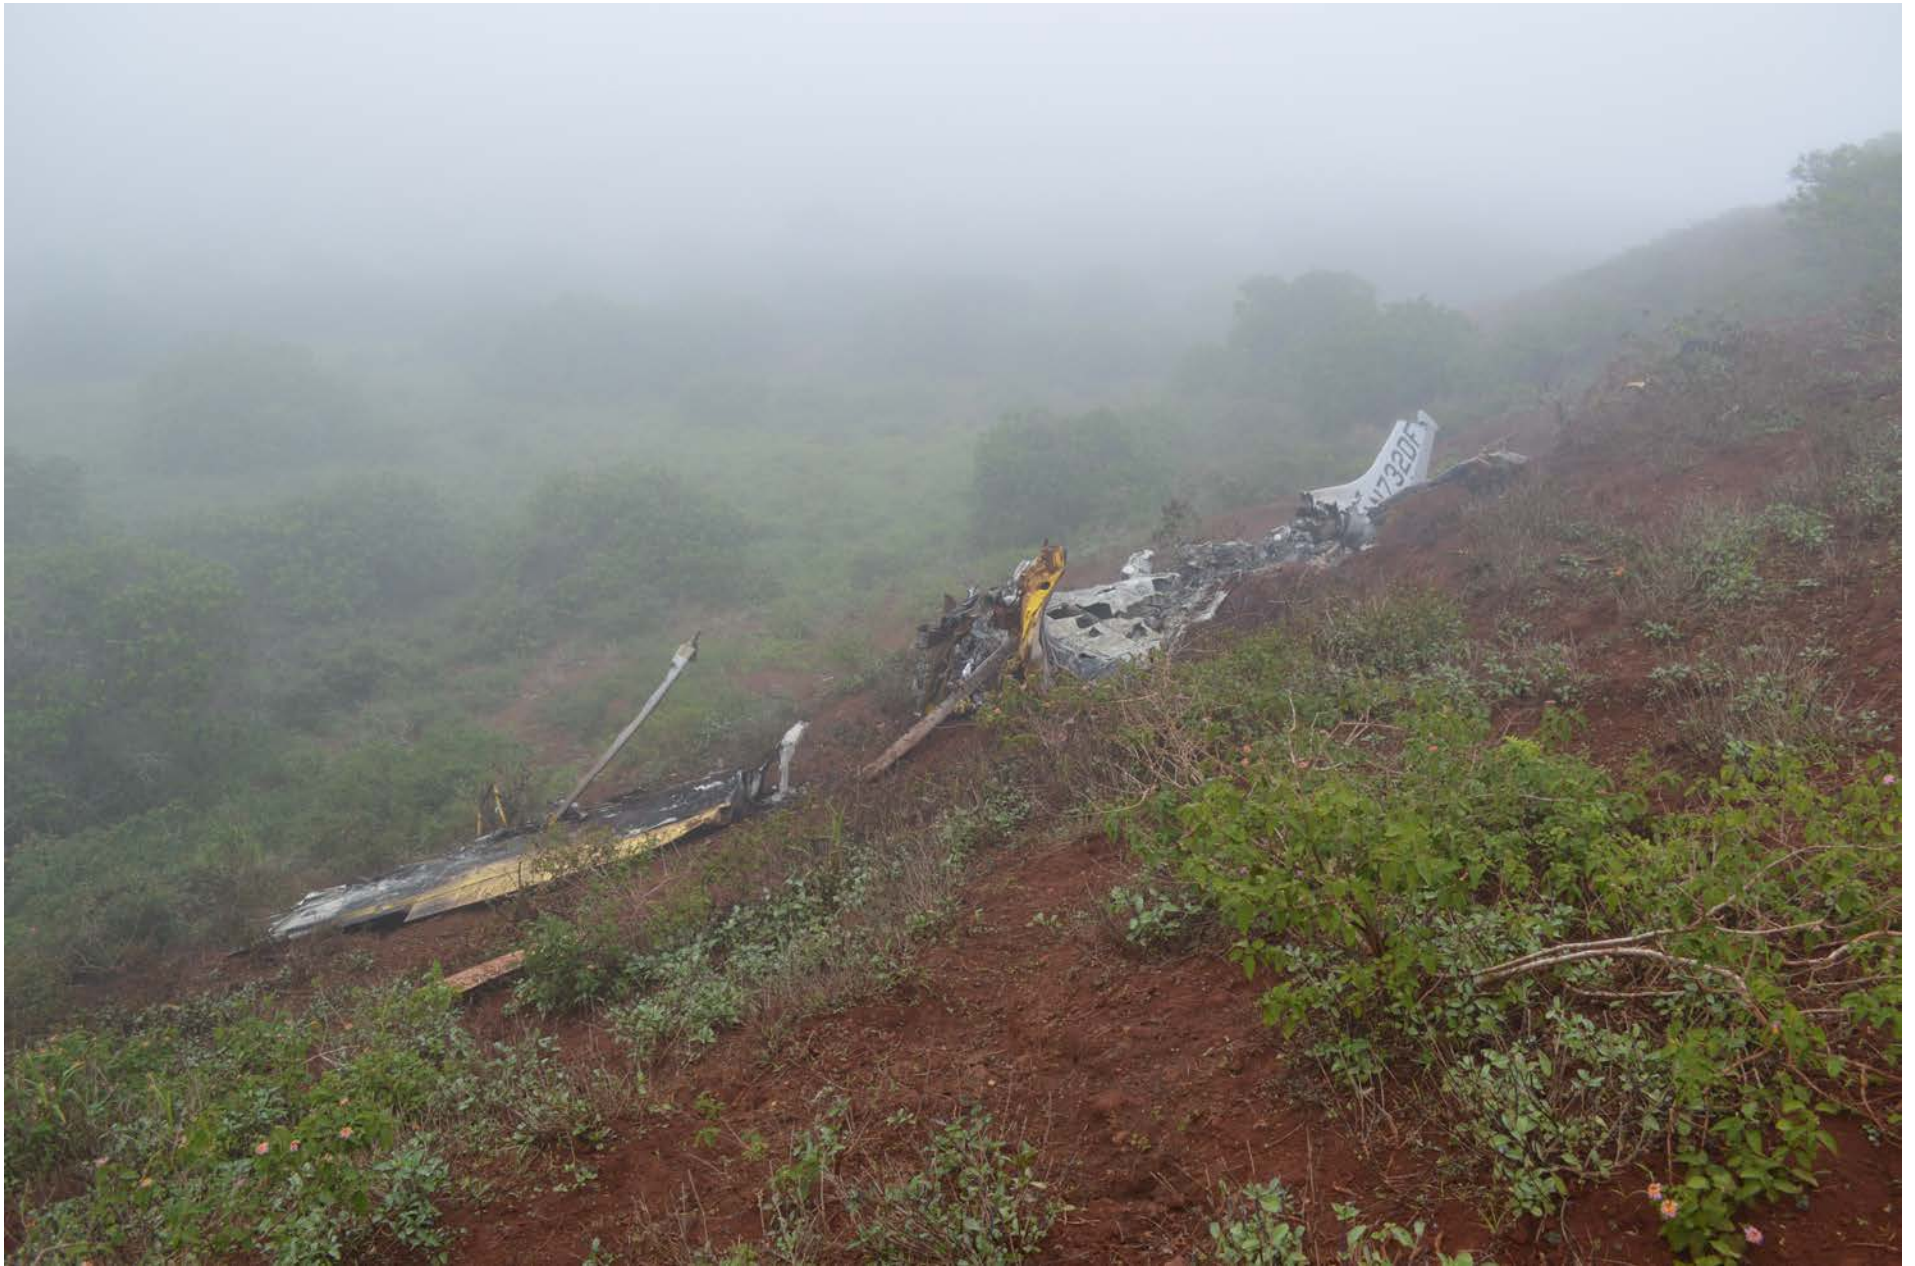
**Photo 3 – View of the accident site with a low cloud layer present, shortly after the accident occurred, looking to the northwest (courtesy of the Maui County Police Department).**

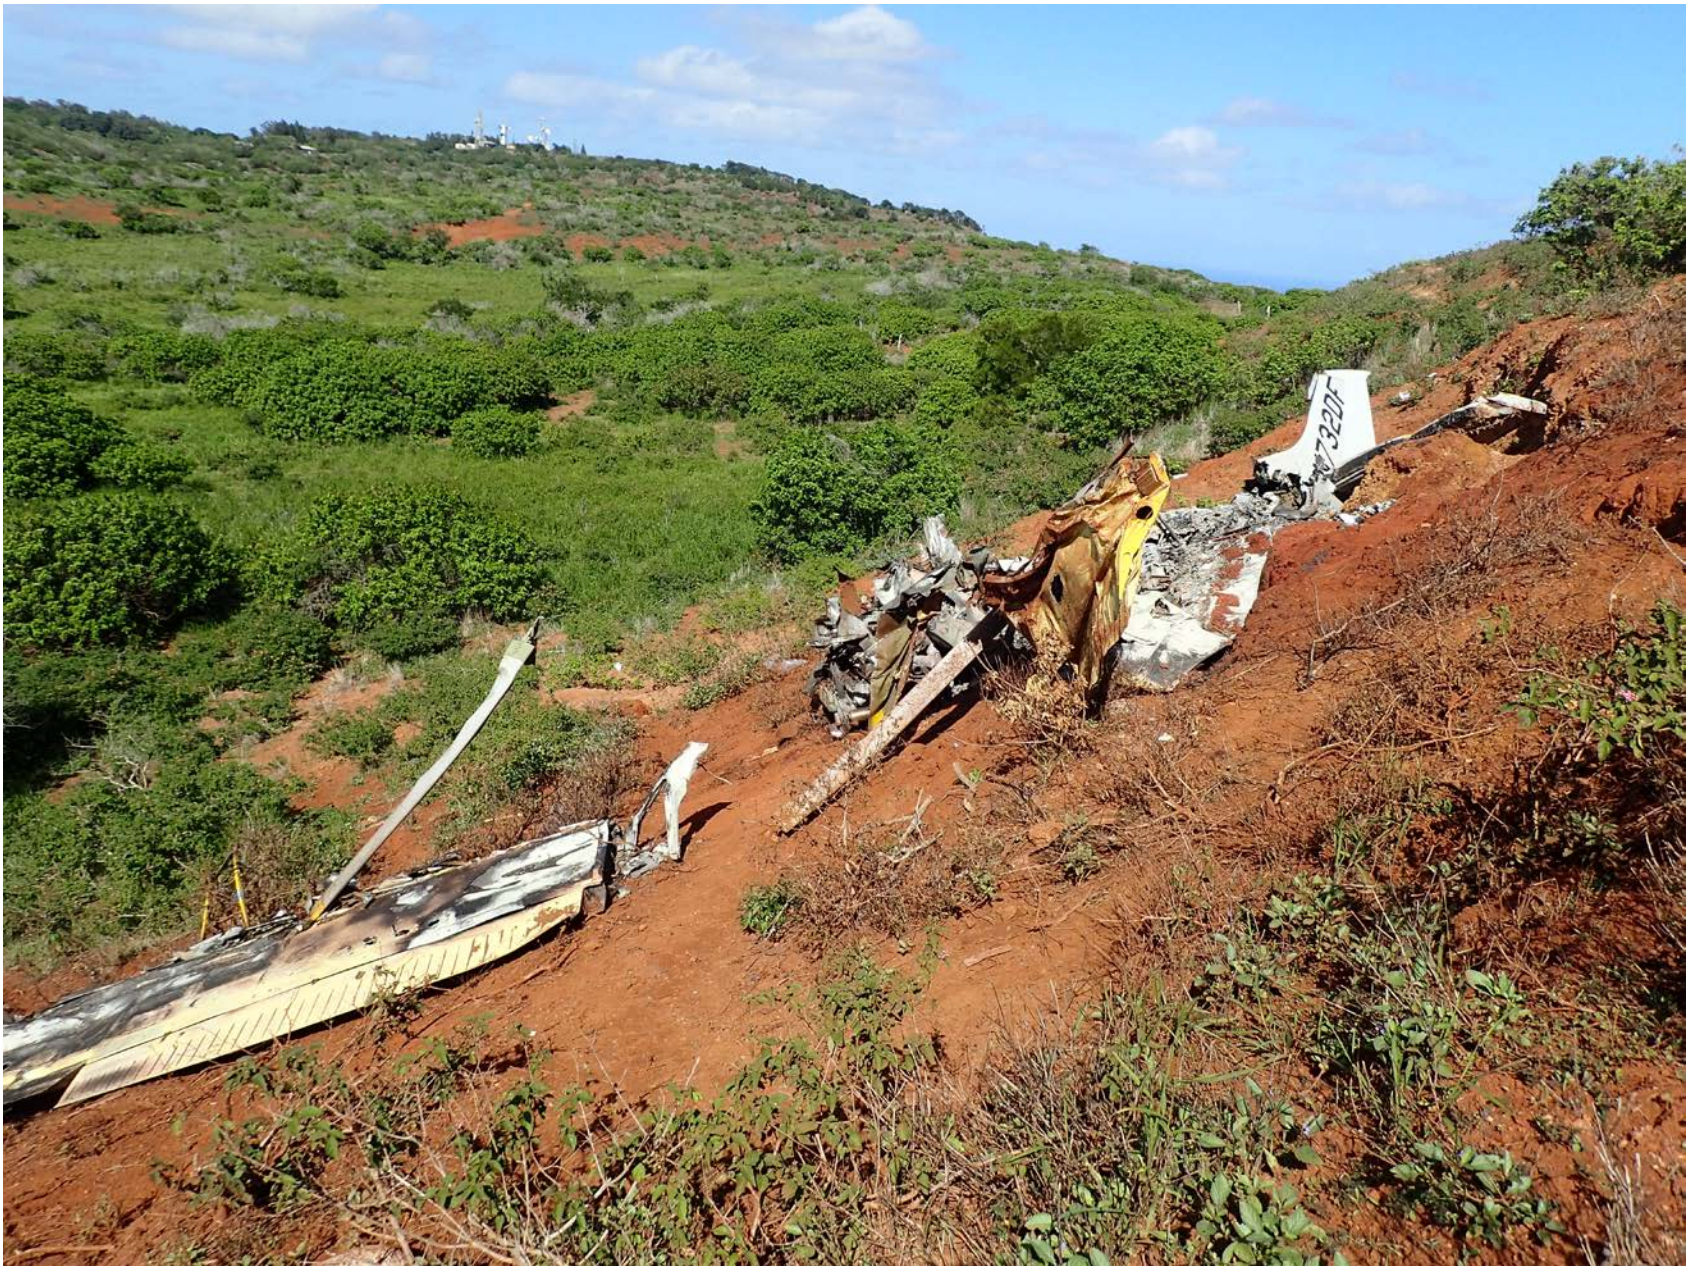
**Photo 4 – View of the accident site on a clear day, looking to the northwest (courtesy of the NTSB).**

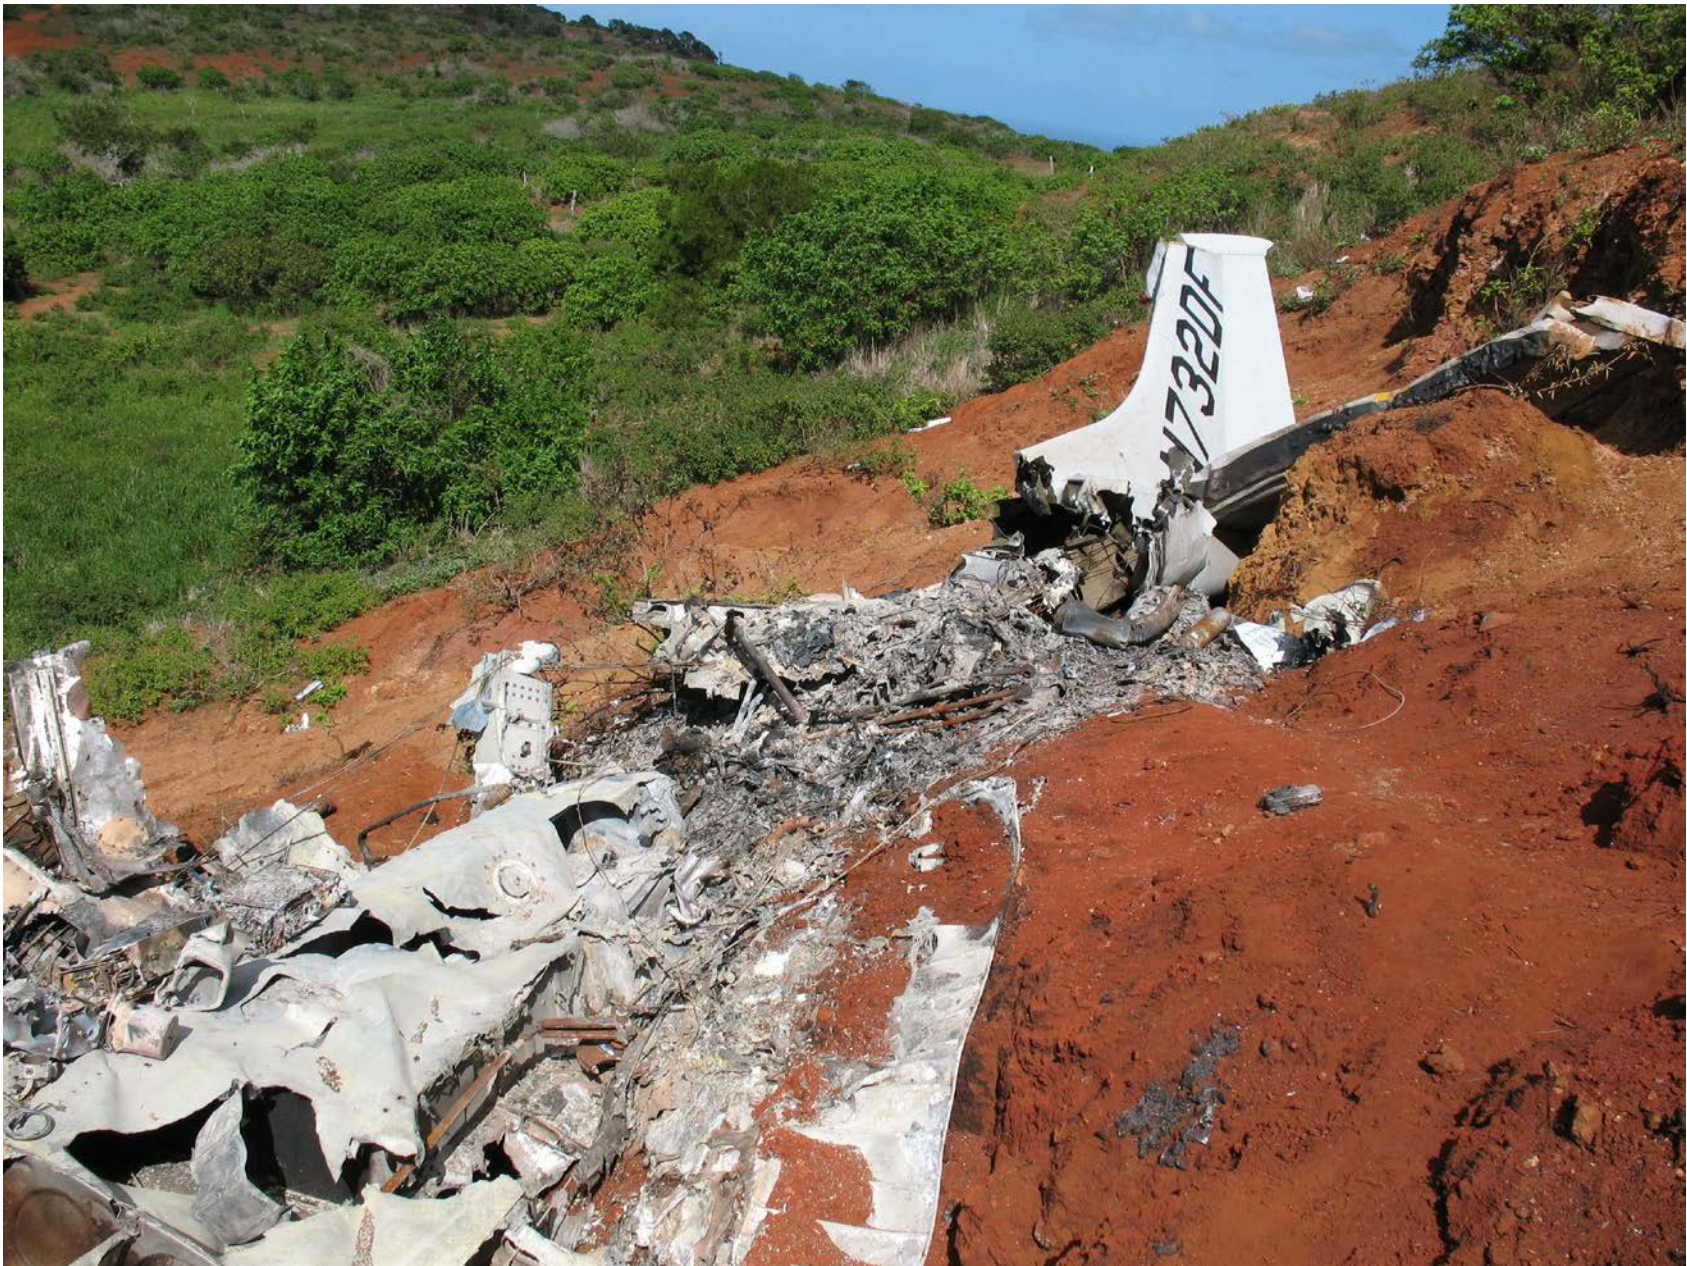
**Photo 5 – View of the fuselage and the empennage (courtesy of the NTSB).**

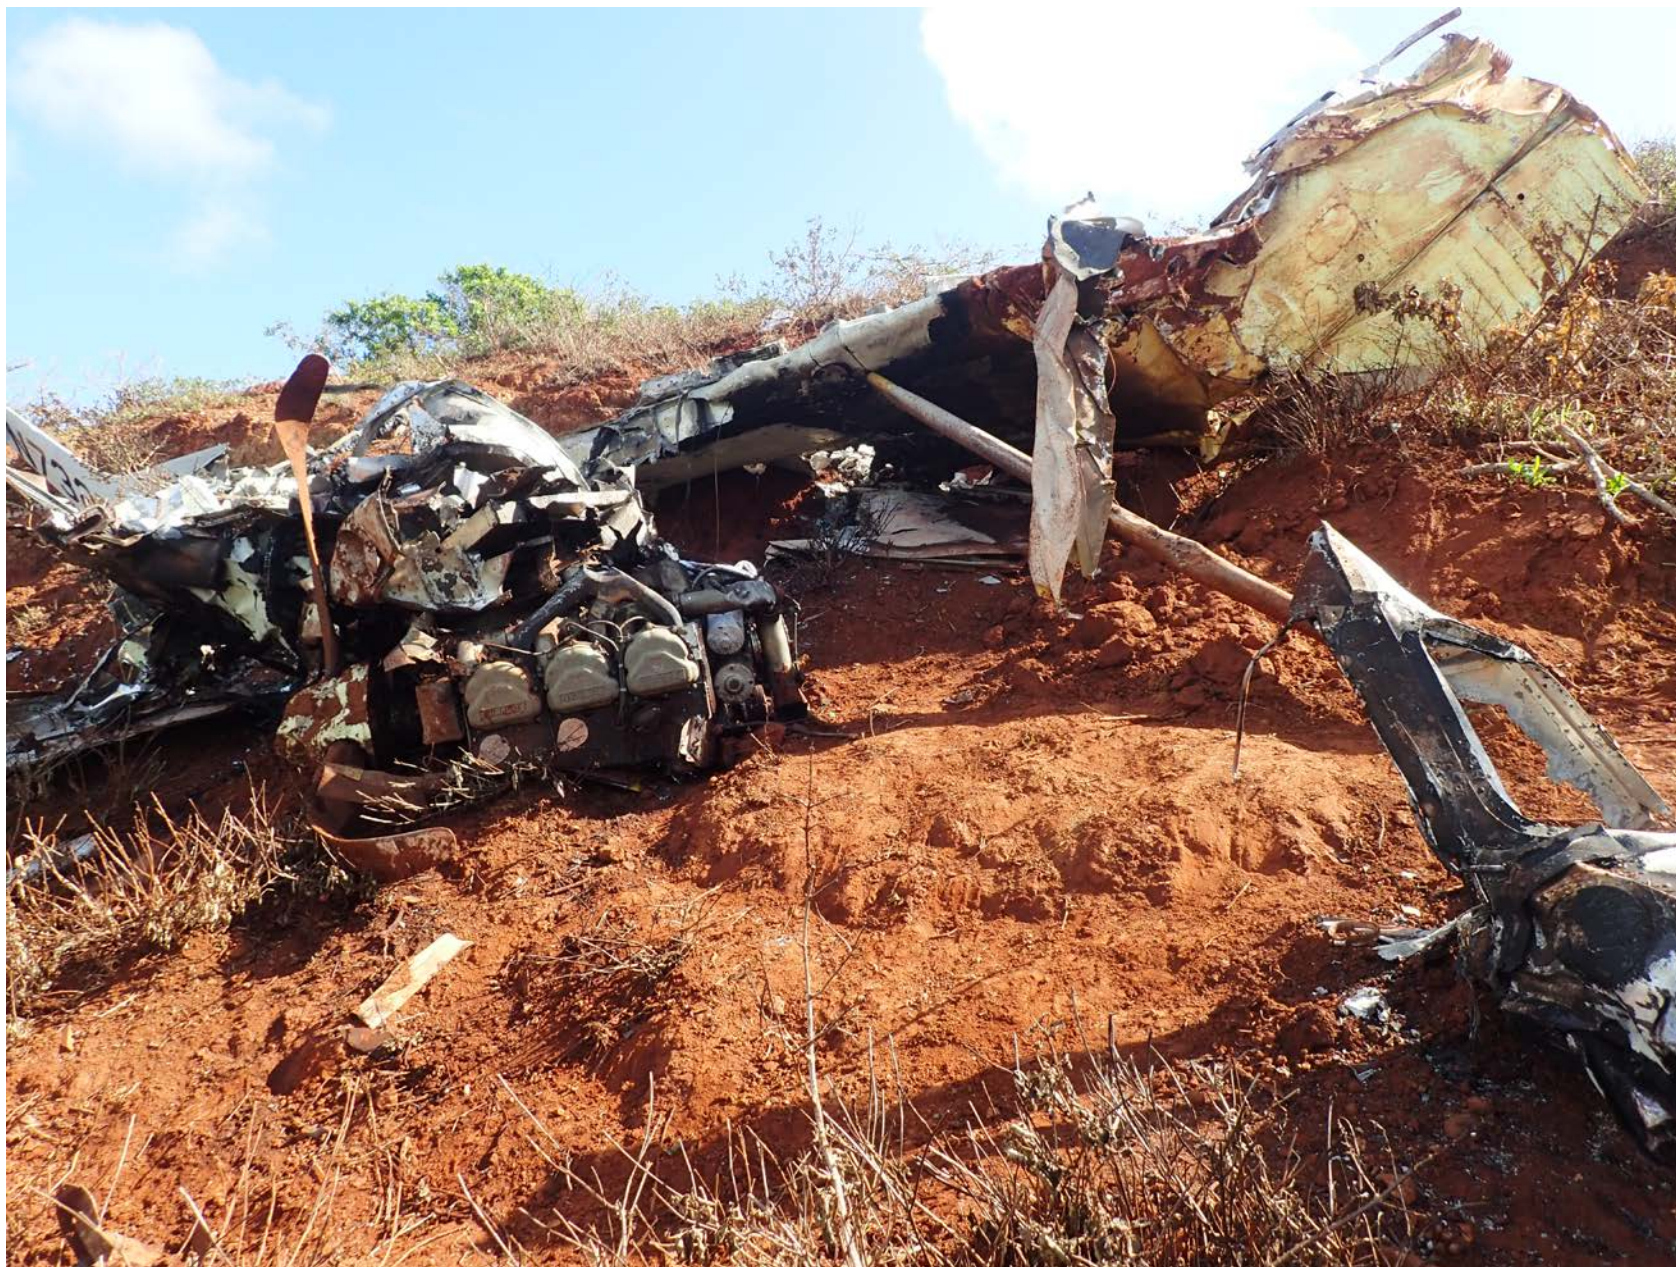
**Photo 6 – View of the fuselage and engine (courtesy of the NTSB).**

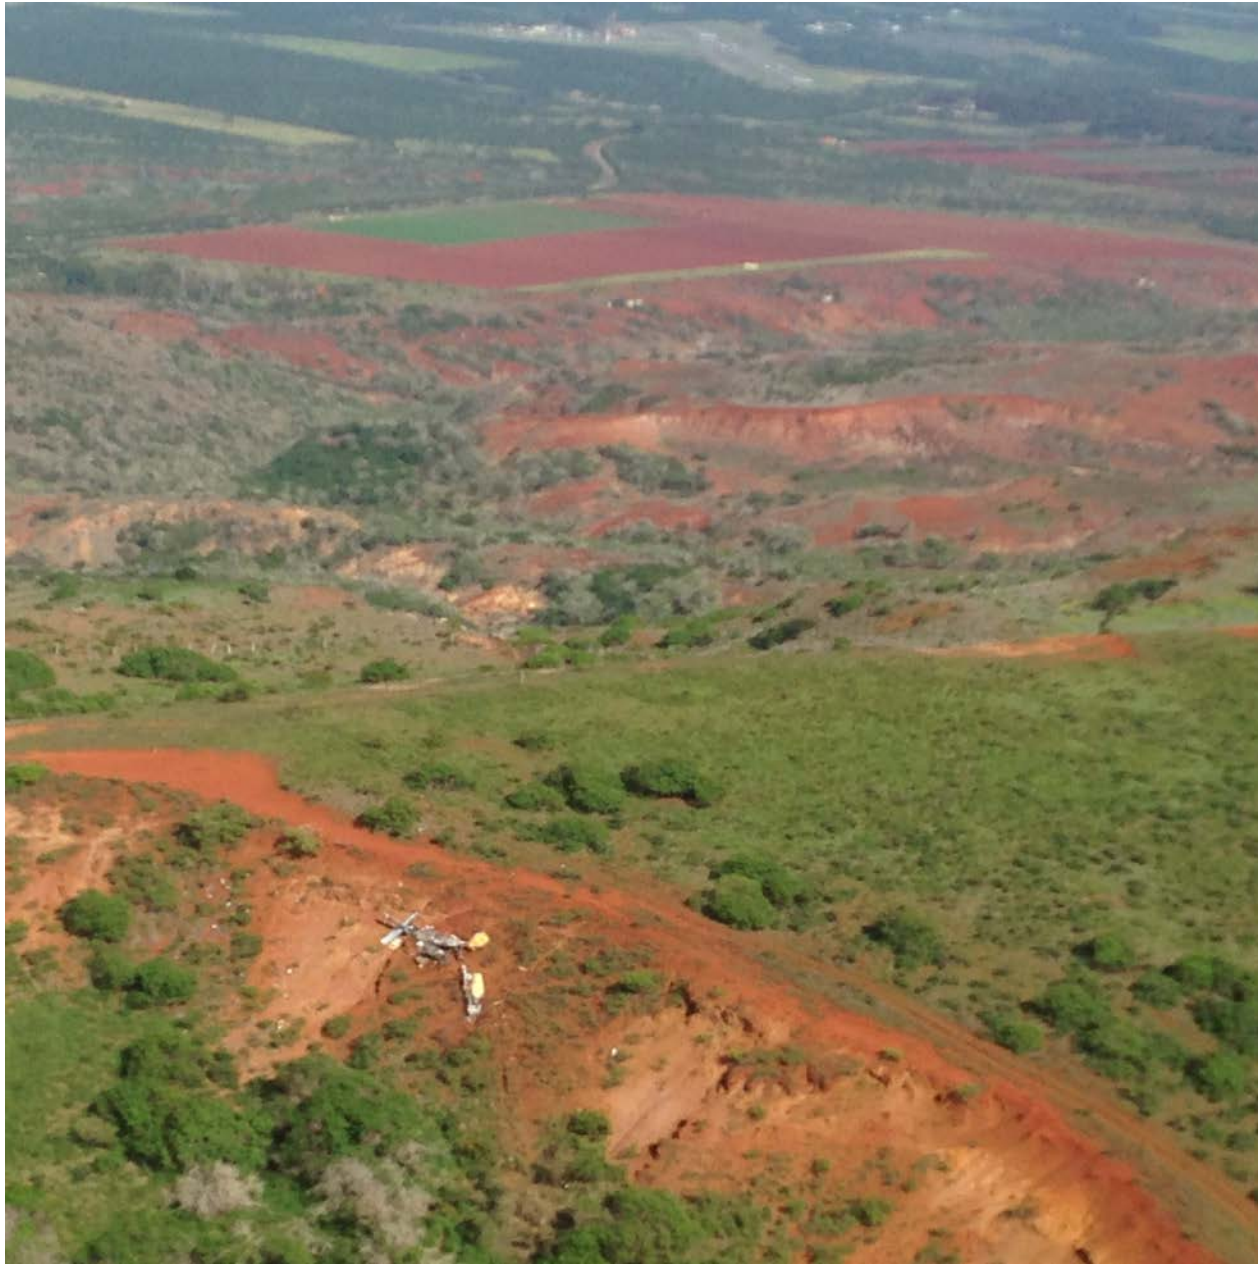
**Photo 7 – Aerial view of the accident site on the mountain and of runway 5 at Molokai Airport (MKK) (courtesy of the Maui County Police Department).**
