## ENGINE EXAMINATION REPORT

| ENGINE MODEL | IO-470-J1B |
| AIRCRAFT REGISTRATION | N9378Y |
| FILE NUMBER | 17-404 |

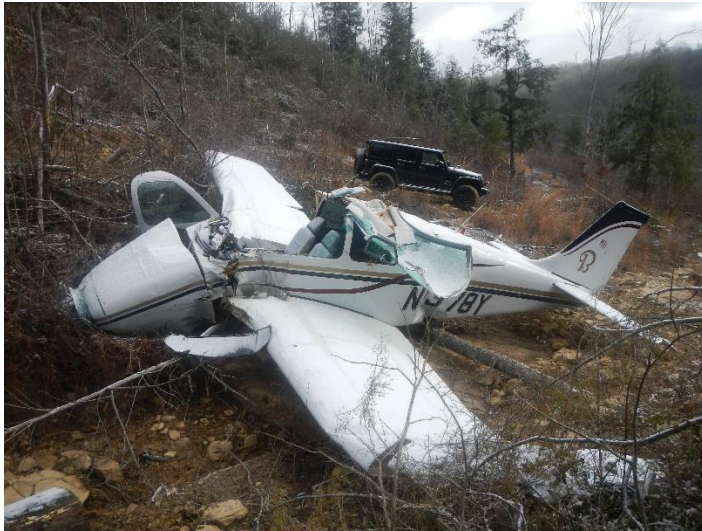
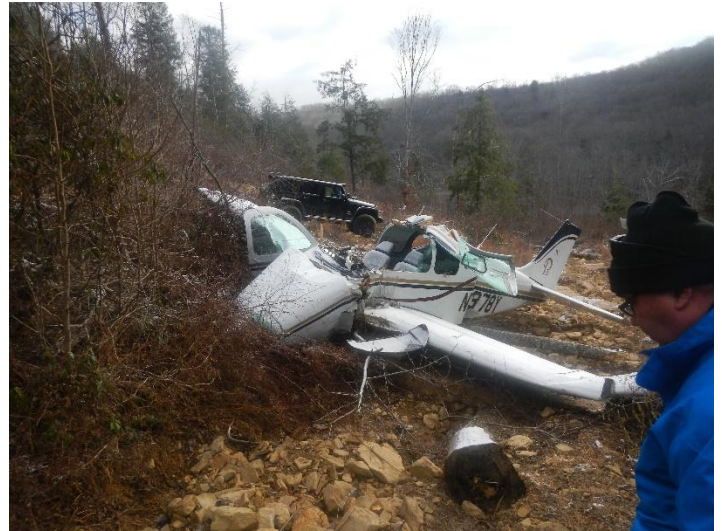
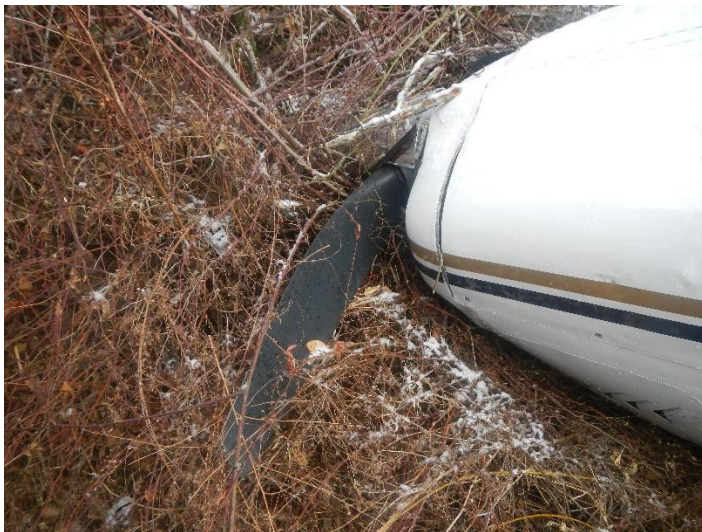
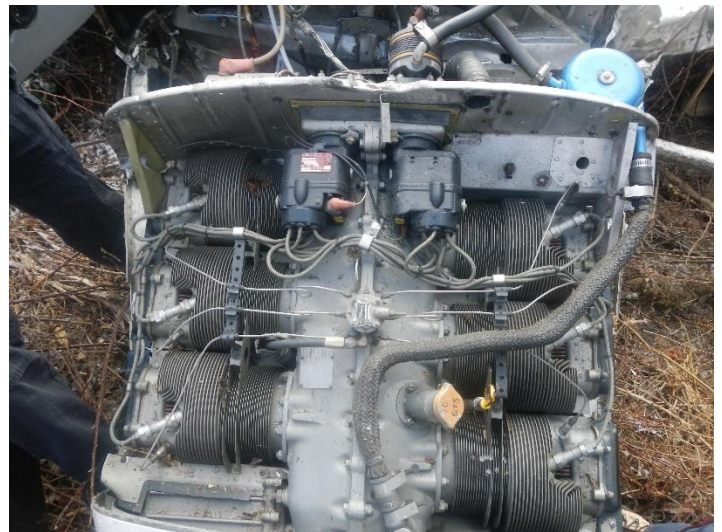
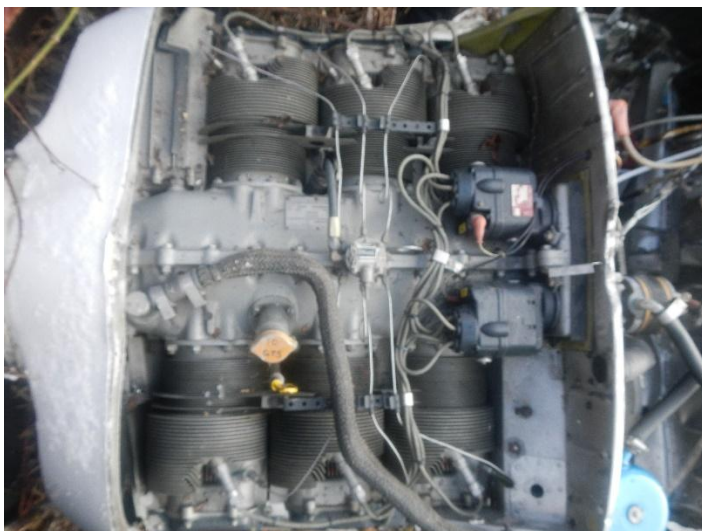
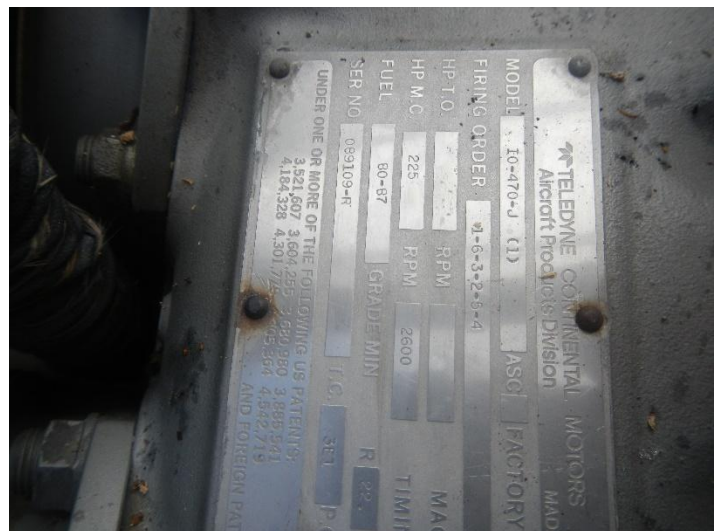
The engine remained attached to the aircraft, which came to rest in a wash on steep terrain, downhill from a mountain top. The two-bladed McCauley propeller remained attached to the engine. The spinner remained in place and displayed a dent on one side. Both blades remained attached to the propeller hub. One blade was bent aft about mid-span and the other was bent aft slightly. The cowling was in place over the engine with no external anomalies noted.

The top engine cowling was removed and there were no signs of oil or fuel leaks. All electrical and fuel lines remained secured in place (the battery cable was cut by first responders). Three of the four engine mounts remained intact. There were no external signs of pre-accident anomalies with the engine. The throttle, mixture and propeller control cables remained attached to their respective control levers. The magnetos remained secured in place with the ignition harnesses attached.

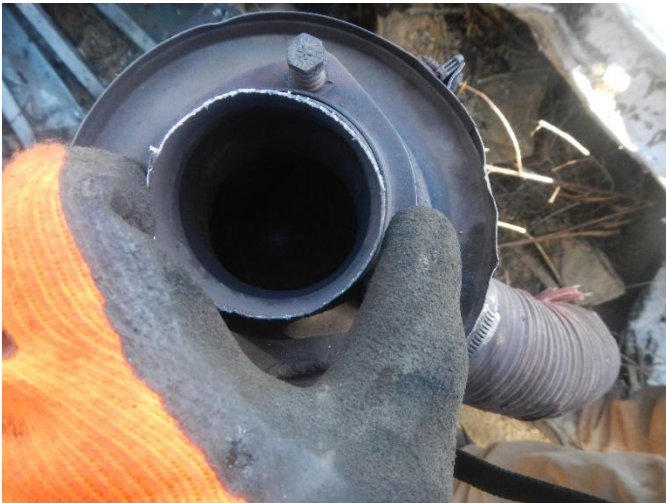
Left

Condition: The exhaust system remained attached to the engine. The left side exhaust system remained intact, but the left muffler/tailpipe was cut away from the exhaust manifold and remained with the aircraft. No pre-accident anomalies were noted with the left side system. The right muffler remained attached to the exhaust system and the right tailpipe was removed from the muffler. No pre-accident anomalies were noted with the right side system.

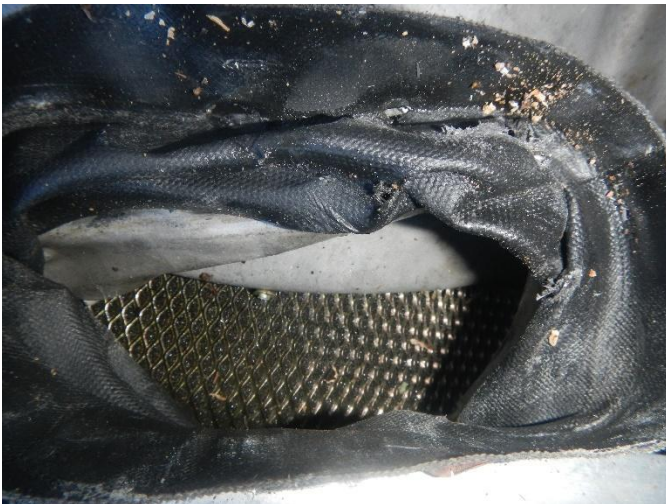
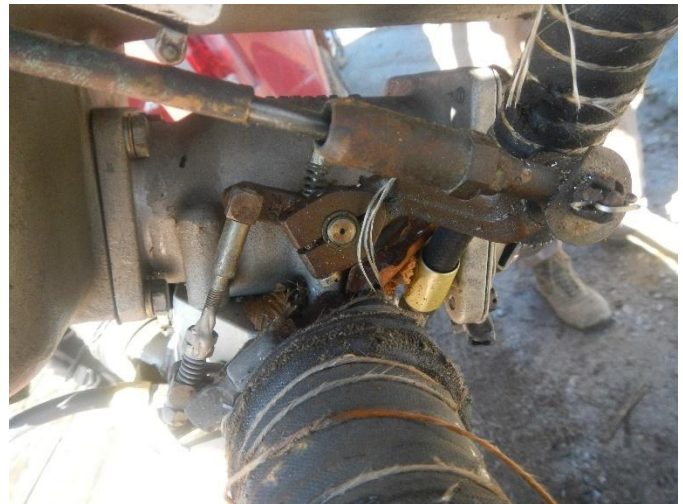
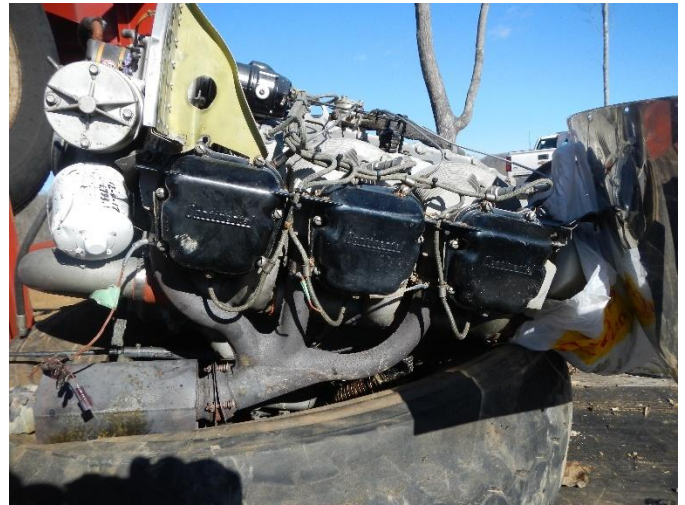
The intake system remained intact with no pre-accident anomalies noted. The induction filter was impinged with debris. Examination of the backside of the filter element revealed no blockages or missing portions. The throttle body remained attached to the front side of the oil sump and the wye plenum remained attached to the backside of the oil sump. The intake risers and tubes remained in place.

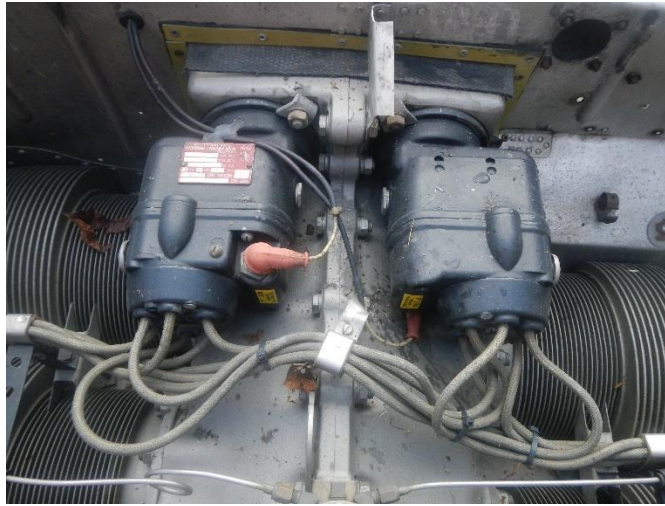
**Condition:** The magneto remained secured in place with the ignition harnesses attached. Each lead remained secured to its respective sparkplug. The sparkplugs were removed from their respective positions and reattached to their respective leads. During manual rotation of the crankshaft, a spark was confirmed on each top sparkplug during an audible snap of the impulse coupling.

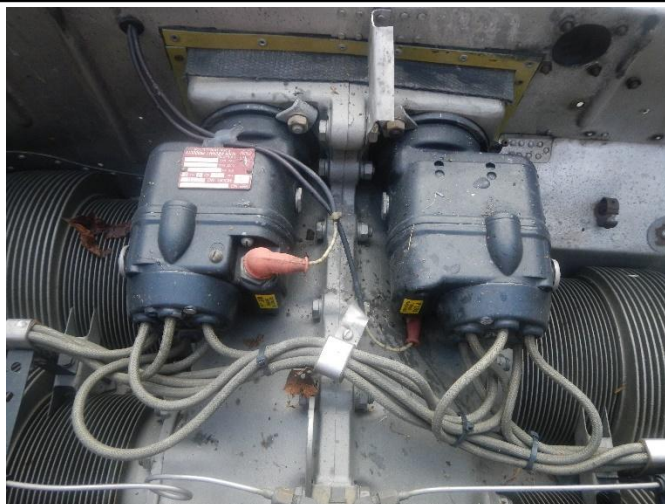
**Condition:** The magneto remained secured in place with the ignition harnesses attached. Each lead remained secured to its respective sparkplug. The sparkplugs were removed from their respective positions and reattached to their respective leads. During manual rotation of the crankshaft, a spark was confirmed on each top sparkplug during an audible snap of the impulse coupling.

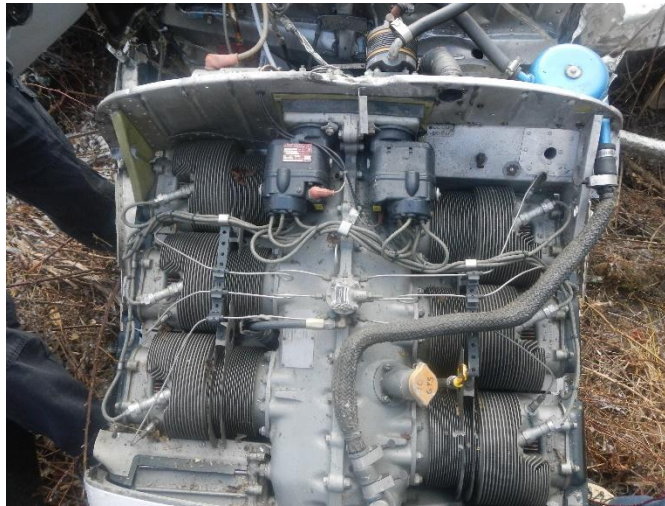
The harness remained in place and intact. Functional testing of the magnetos revealed that the top ignition leads were functional. No pre-accident anomalies were noted.

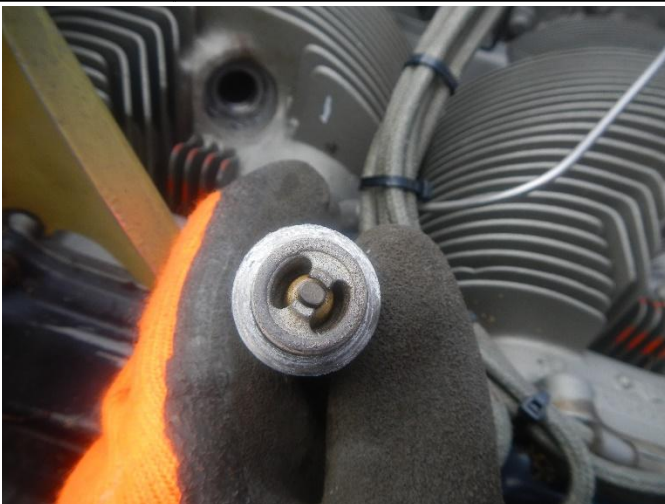
1T

All of the sparkplugs remained secured in place. The top sparkplugs were removed and all displayed a normal worn condition with lean mixture signatures (no signs of lead or carbon fouling). The bottom sparkplugs were examined/documentated with a lighted borescope.

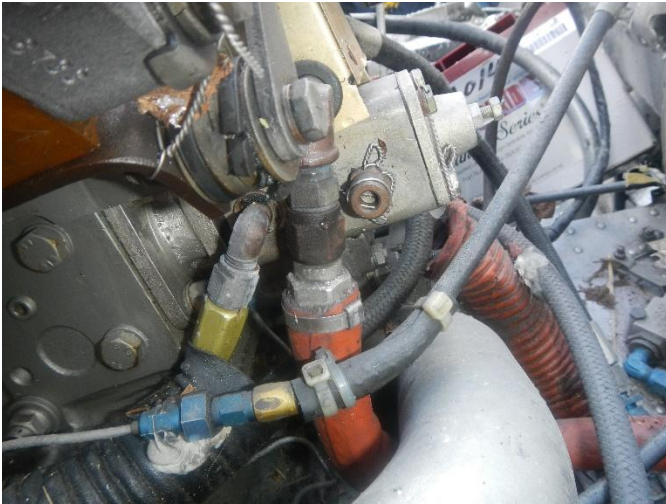
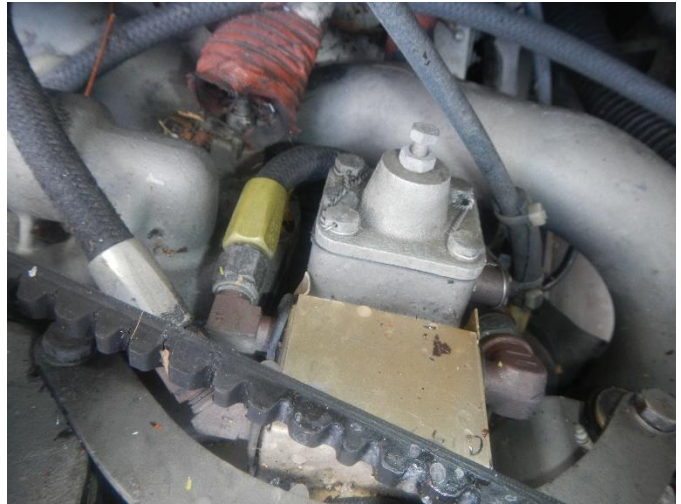
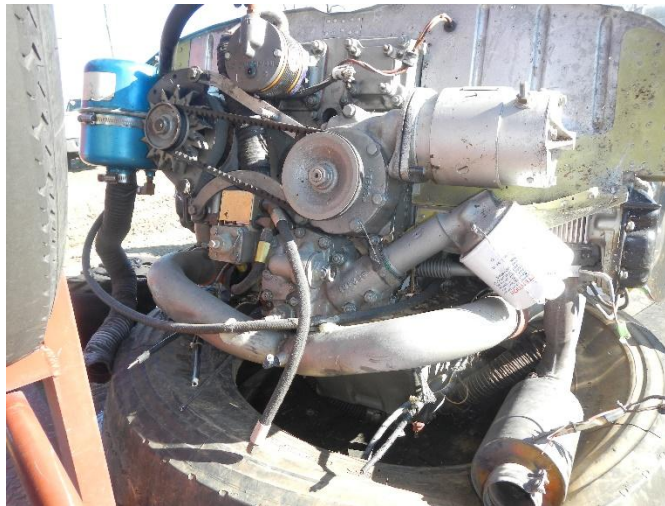
The engine-driven fuel pump remained attached to the back side of the engine and all of the fuel lines to and from the pump remained intact and secured in place. The fuel inlet line was removed from the fuel pump fitting and no fuel was present. The fuel return line was removed from the firewall fitting and no fuel was present.

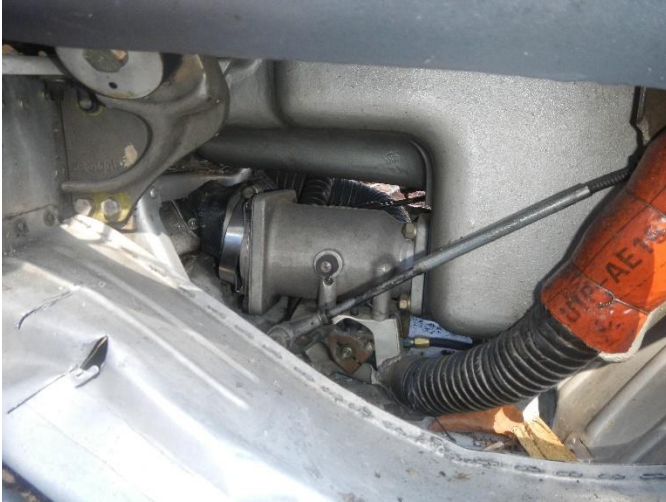
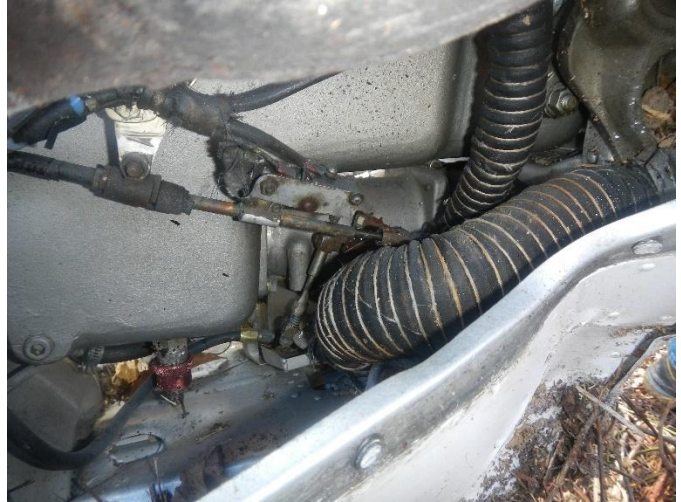
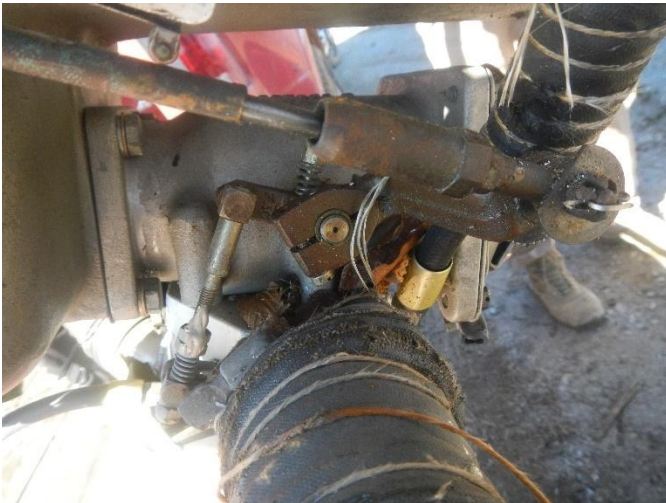
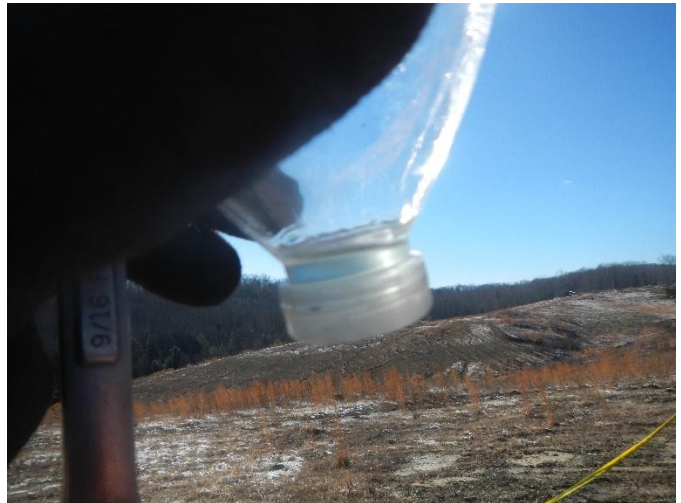
The throttle body remained attached to the front side of the oil sump and the throttle and mixture control cables remained attached to their respective levers. The fuel lines to and from the fuel metering unit remained intact and secured in place. The fuel line from the fuel metering unit to the fuel manifold valve was removed at the metering unit fitting and a capful (approximately a teaspoon) of blue aviation gasoline was retrieved from the line.

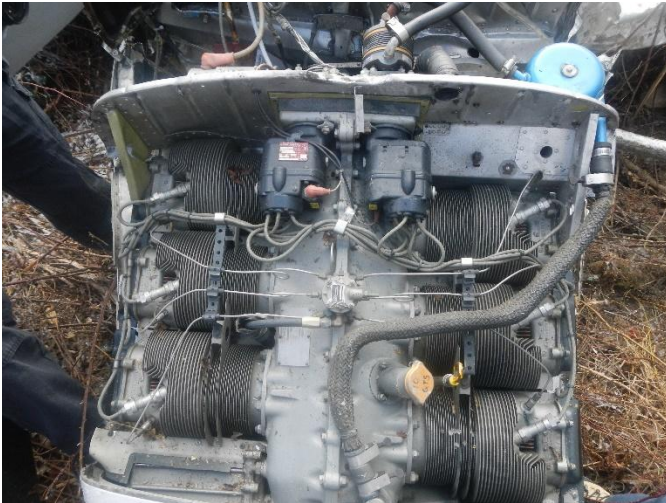
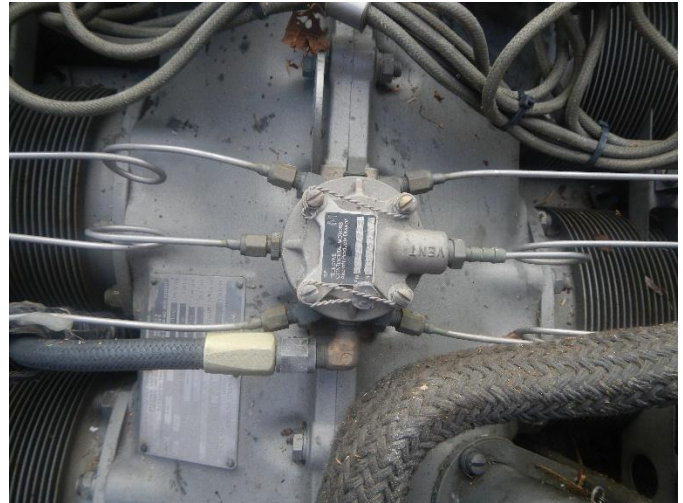
The fuel manifold valve remained secured to the topside of the engine and all the fuel lines remained secured in place. The original safety-wire lead seal was in place.

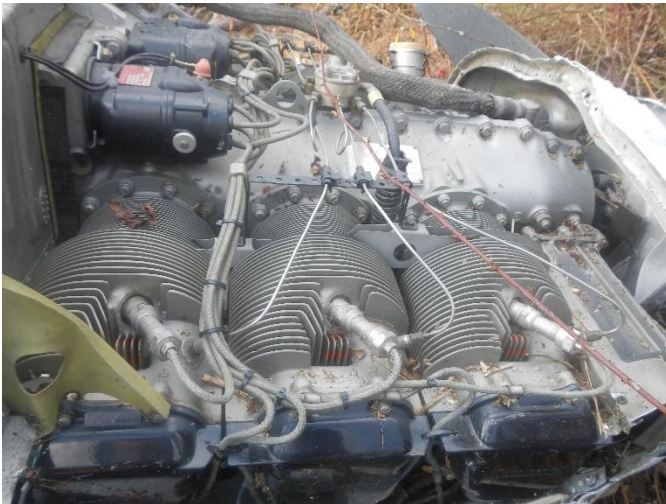
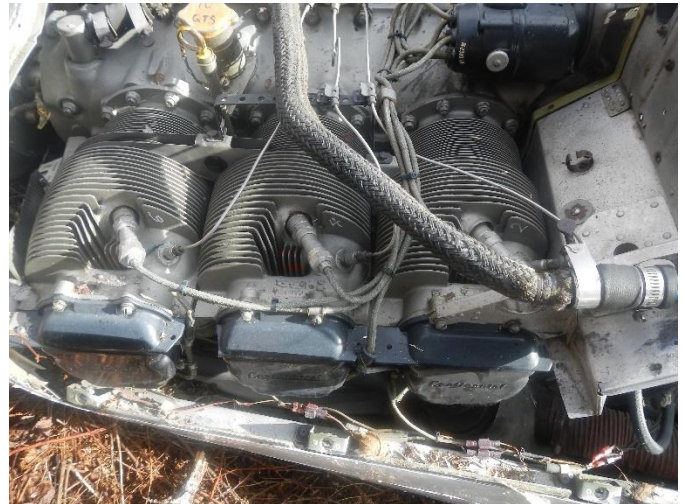
The fuel lines remained secured to their respective fuel injector nozzles. Some blue staining was observed in the vicinity of the #6 fuel injector nozzle.

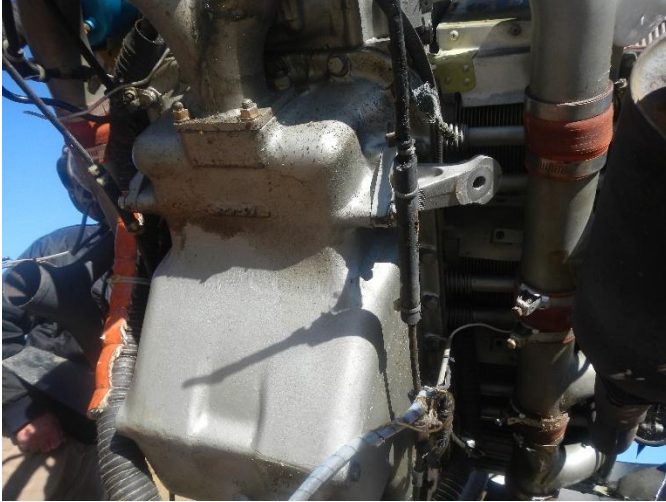
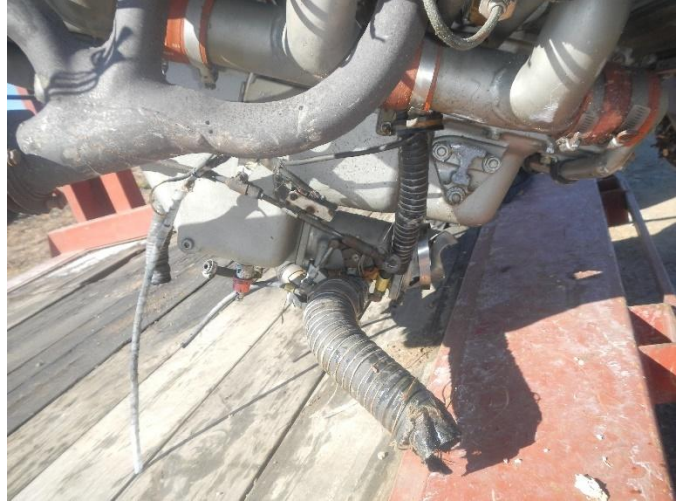
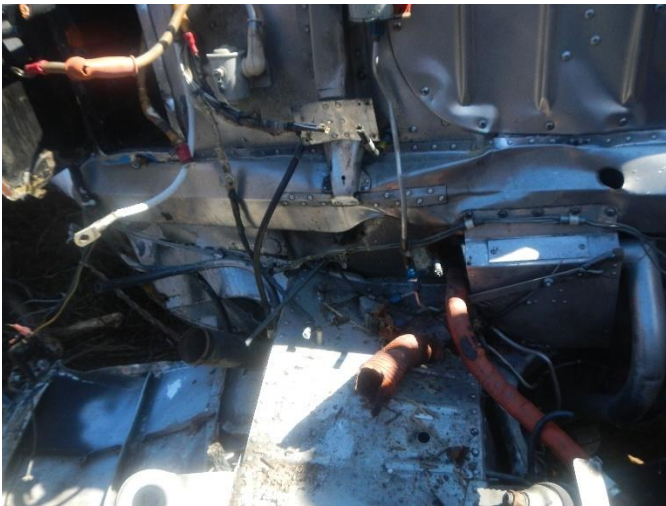
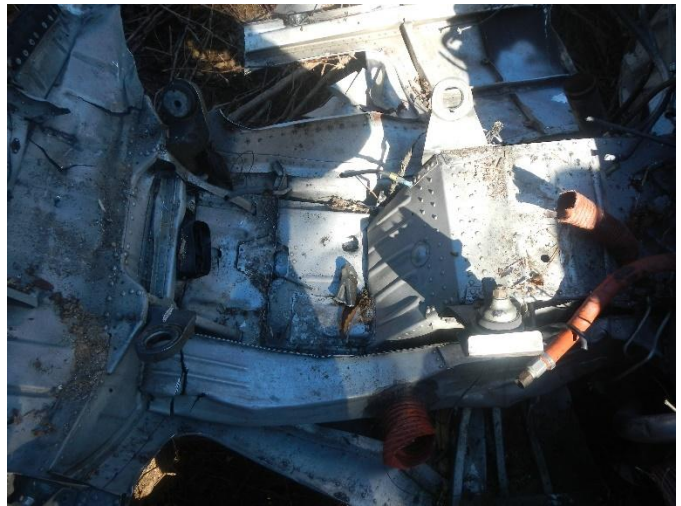
Condition: The oil sump remained in place and intact on the bottom side of the engine. There was no sign of oil leaks and oil registered on the oil dipstick. There was no sign of a pre-existing oil leak on the external engine components, engine nacelle, or firewall.

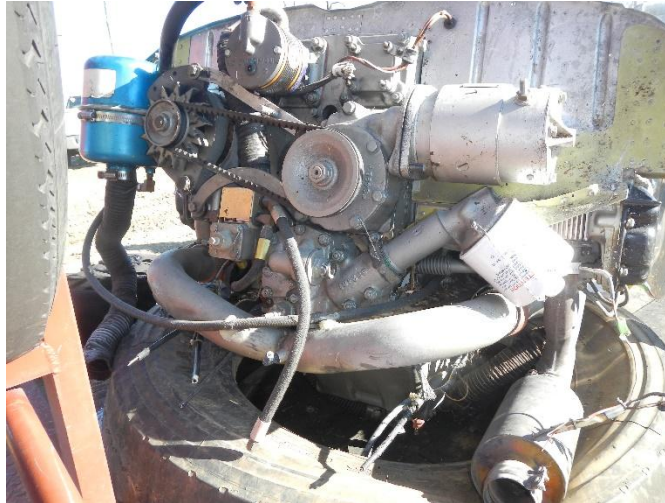
The oil pump remained secured to the backside of the engine with no signs of oil leaks noted.

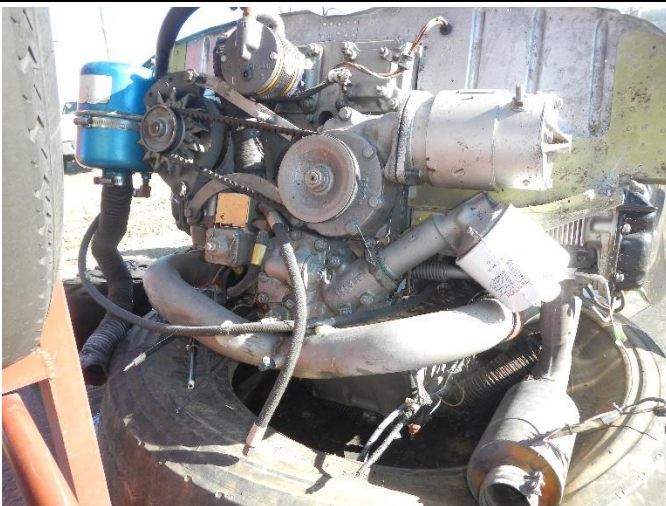
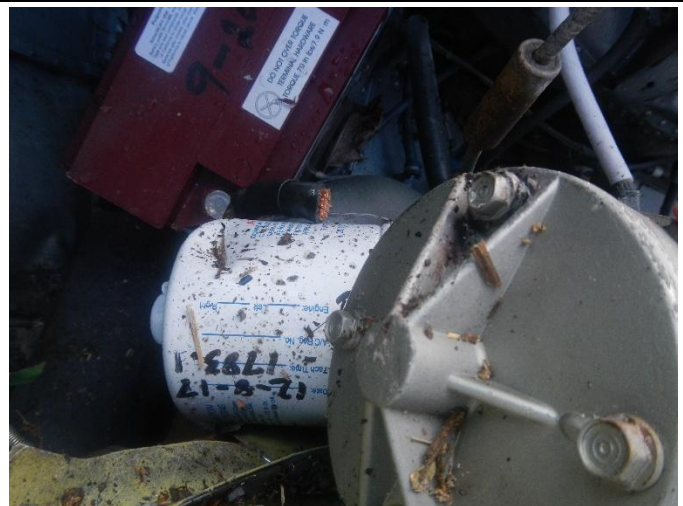
The oil filter remained attached to the oil filter adapter. It displayed a dent, but did not appear to be punctured. The following information was hand-written next to the date and tach time, respectively: 12-8-17 1783.1. The oil filter adapter was loose but the safety wire was intact and it did not display any evidence of a pre-existing oil leak.

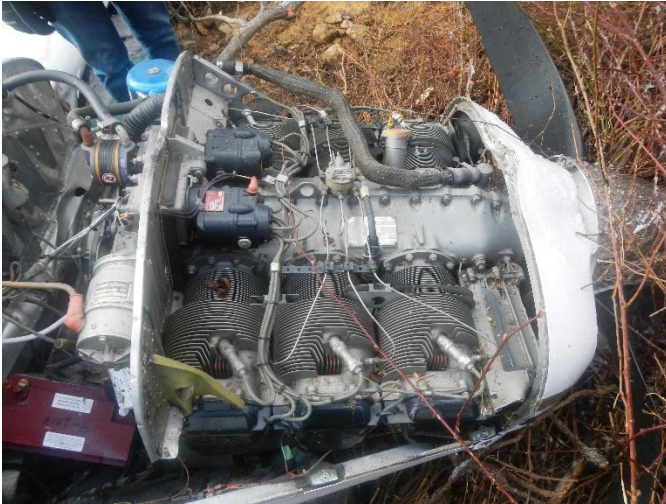
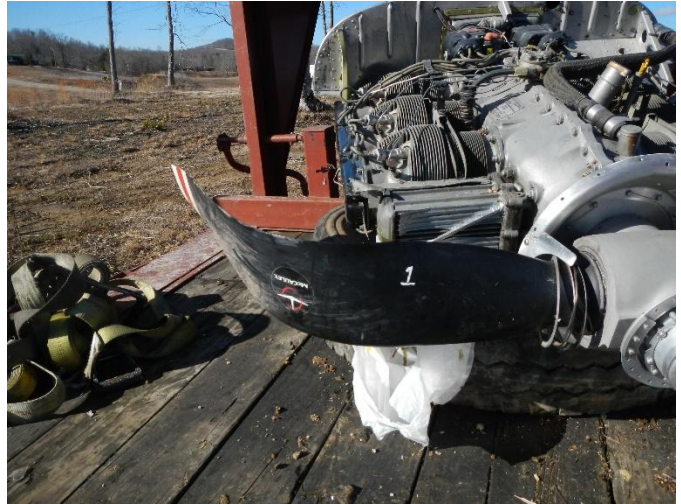
The oil cooler remained attached to the front right side of the engine with no signs of oil leaks noted. Duct tape was placed over some of the cooling fins. The oil cooler was accidentally cut during the aircraft recovery process.

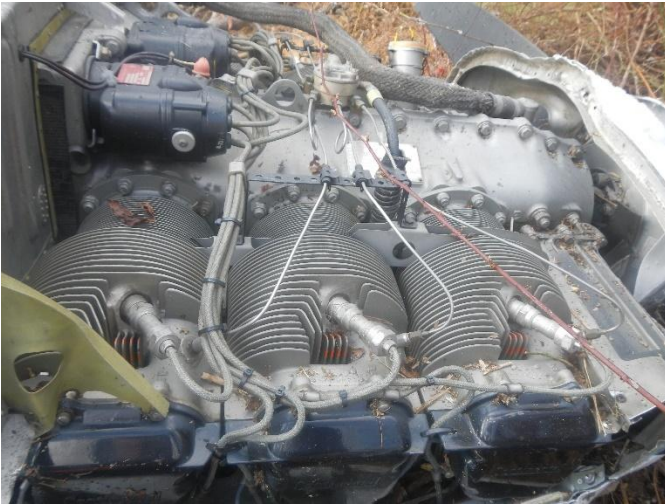
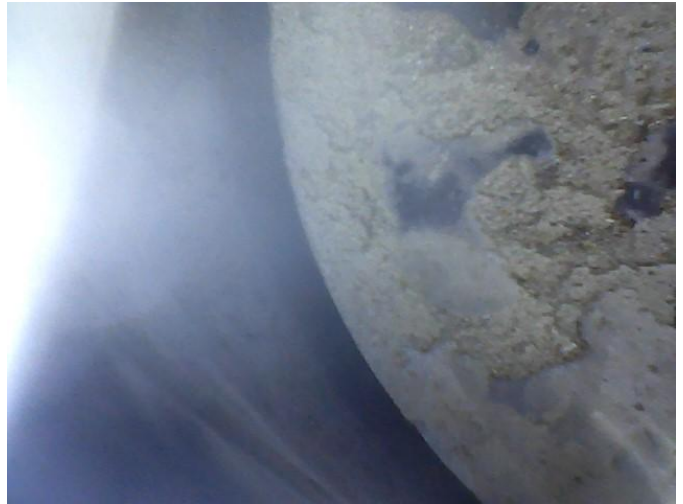
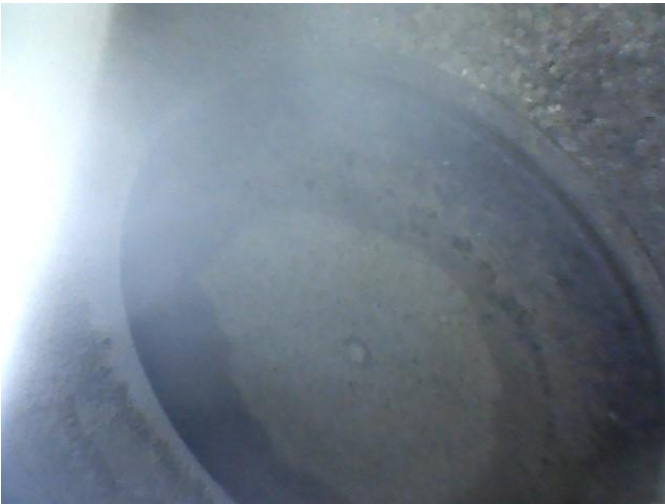
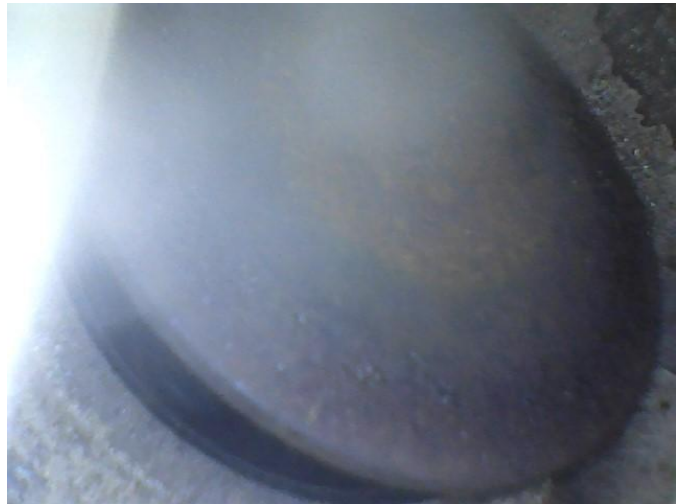
#### CYLINDER #1

The cylinder remained secured to the crankcase with no external anomalies noted. The cylinder was examined/documentated via a lighted borescope and no pre-accident anomalies were noted. The cylinder produced thumb compression during crankshaft rotation.

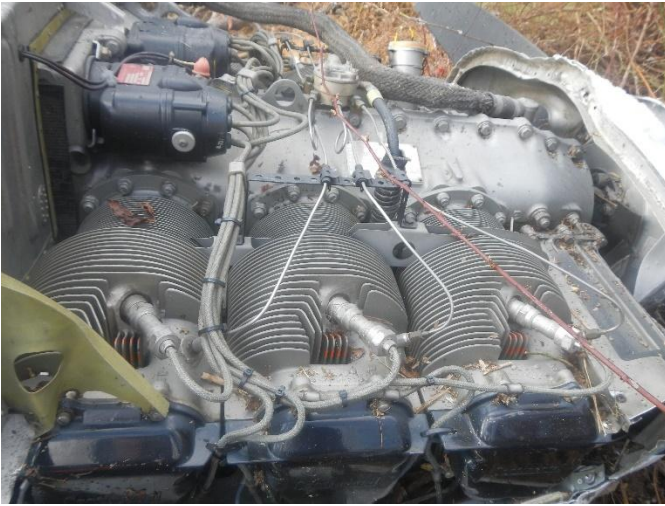
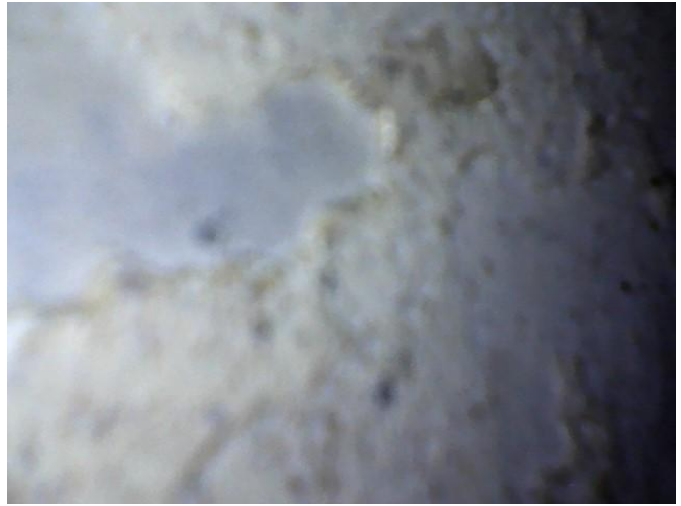
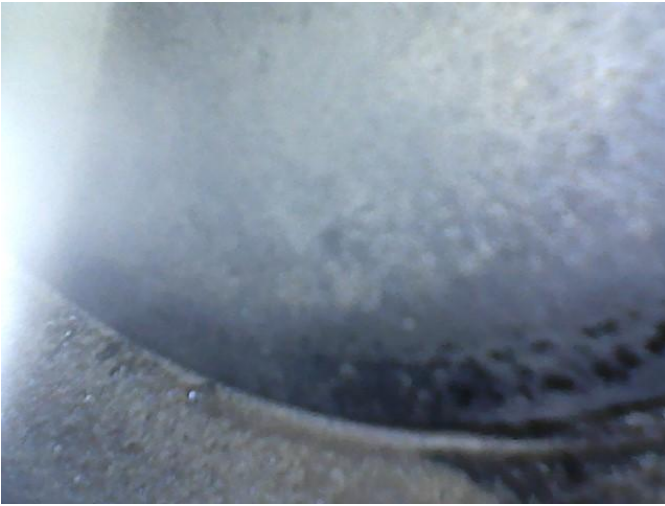
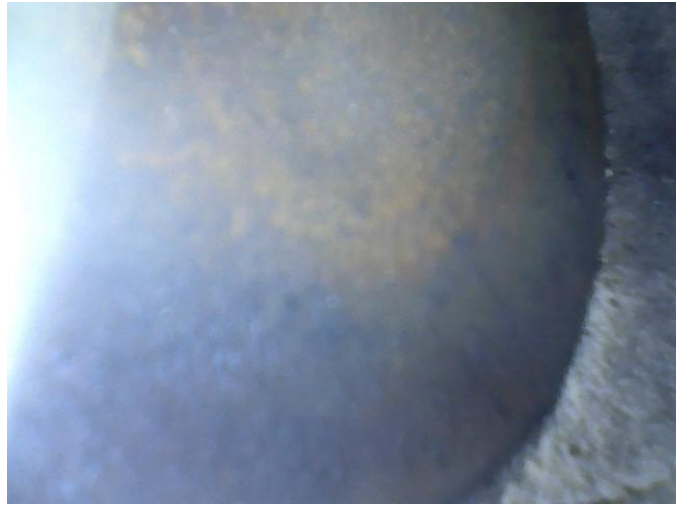
### CYLINDER #3

Condition: The cylinder remained secured to the crankcase with no external anomalies noted. The cylinder was examined/documentated via a lighted borescope and no pre-accident anomalies were noted. The cylinder produced thumb compression during crankshaft rotation.

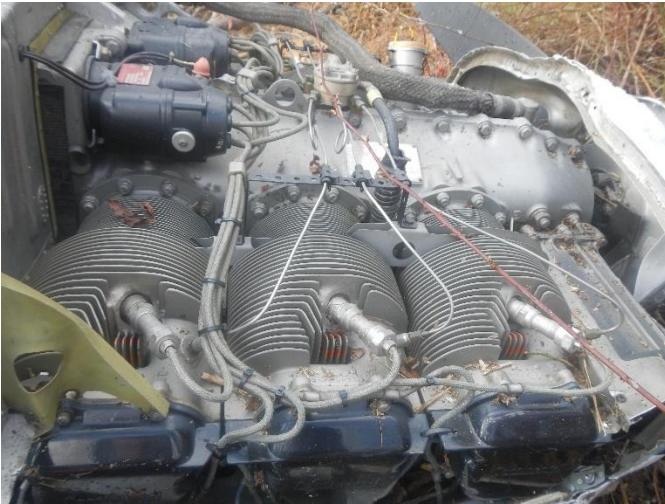
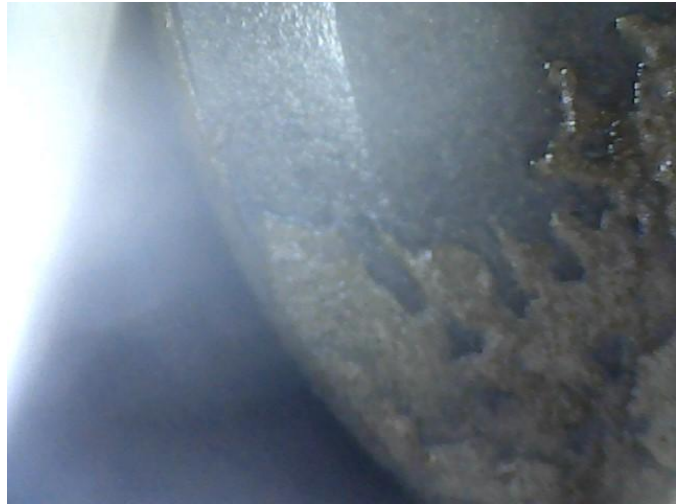
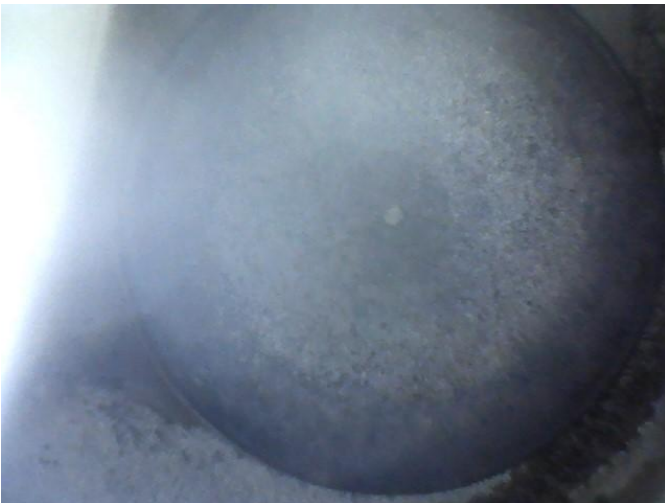
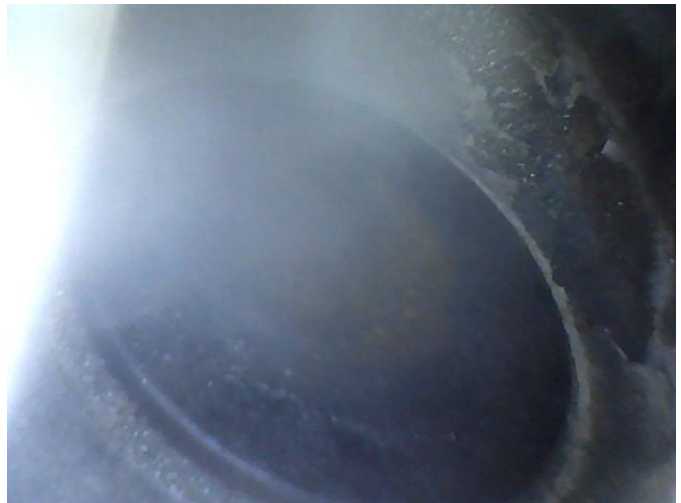
### CYLINDER #5

Condition: The cylinder remained secured to the crankcase with no external anomalies noted. The cylinder was examined/documentated via a lighted borescope and no pre-accident anomalies were noted. The cylinder produced thumb compression during crankshaft rotation.

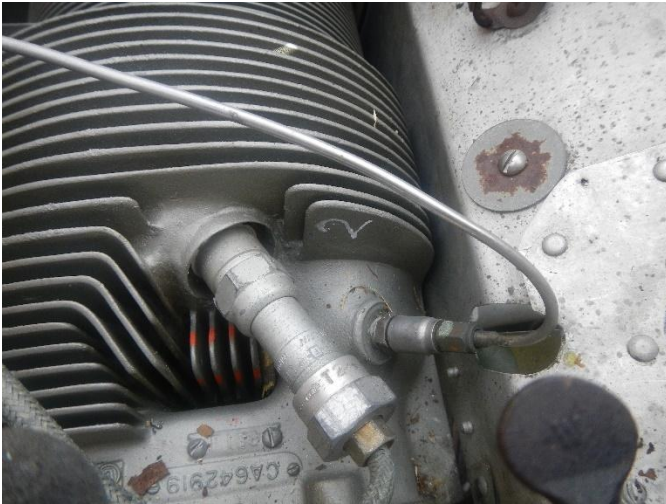
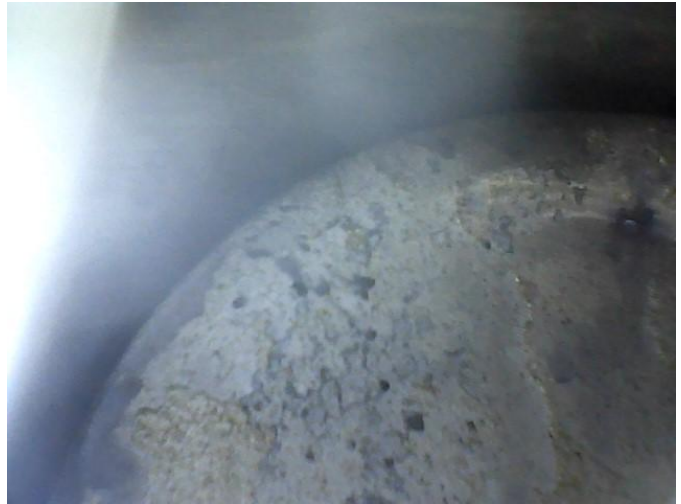
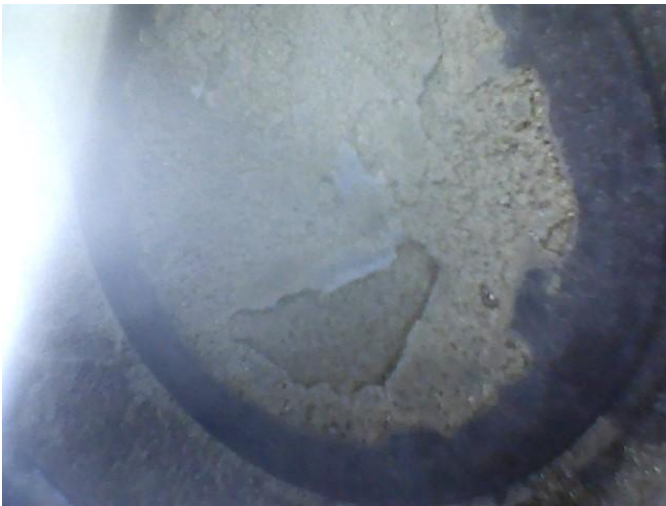
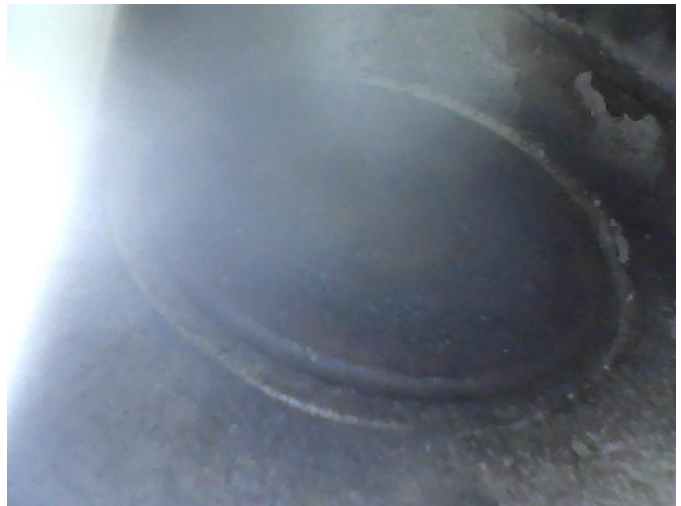
### CYLINDER #2

Condition: The cylinder remained secured to the crankcase with no external anomalies noted. The cylinder was examined/documentated via a lighted borescope and no pre-accident anomalies were noted. The cylinder produced thumb compression during crankshaft rotation.

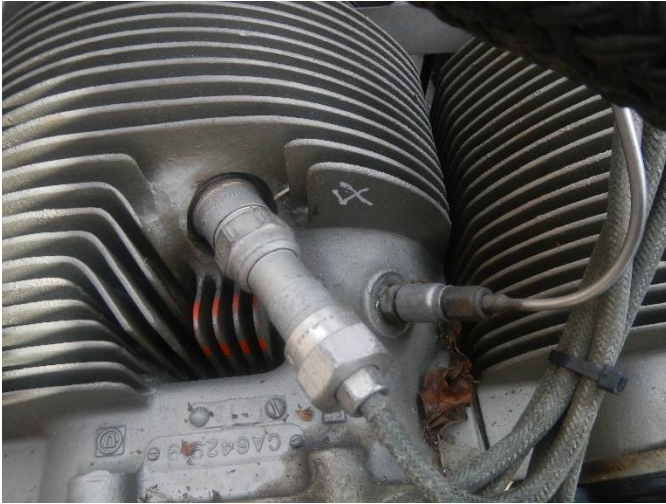
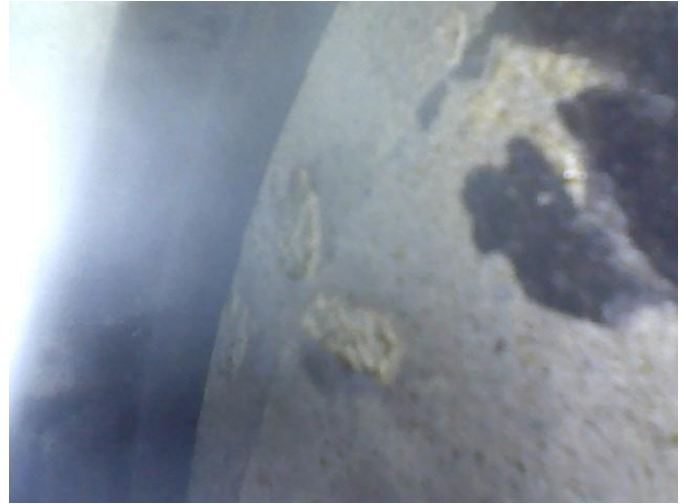
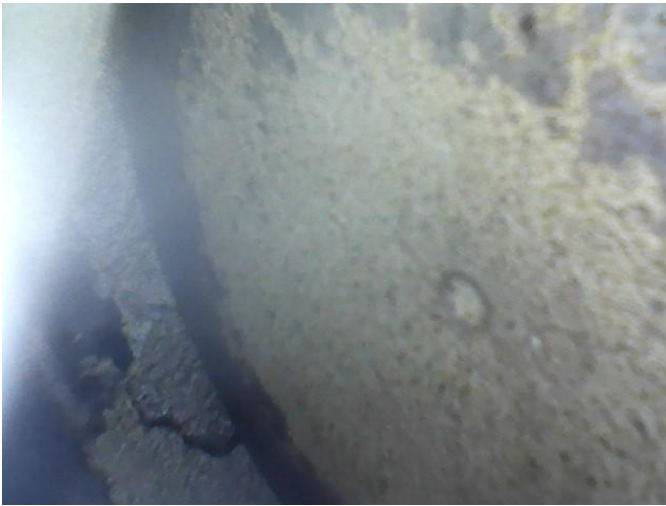
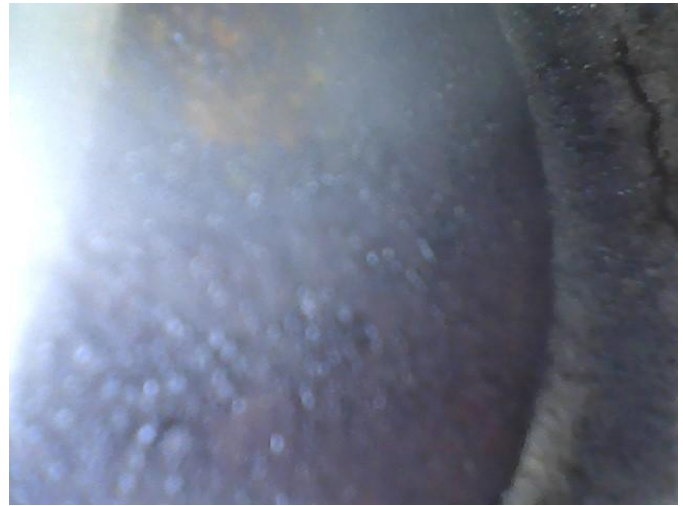
### CYLINDER #4

Condition: The cylinder remained secured to the crankcase with no external anomalies noted. The cylinder was examined/documentated via a lighted borescope and no pre-accident anomalies were noted. The cylinder produced thumb compression during crankshaft rotation.

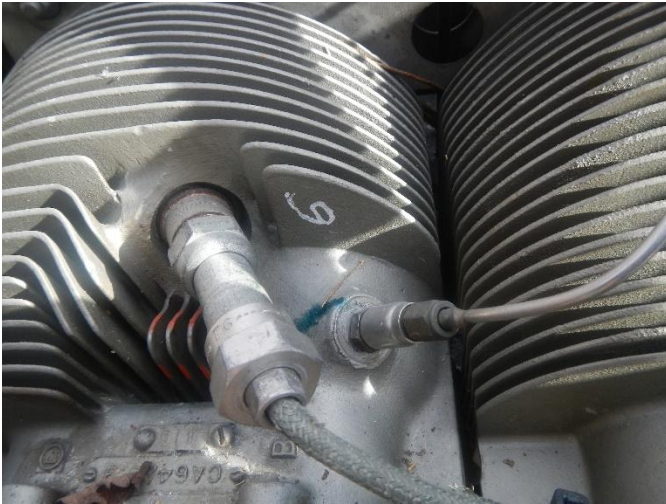
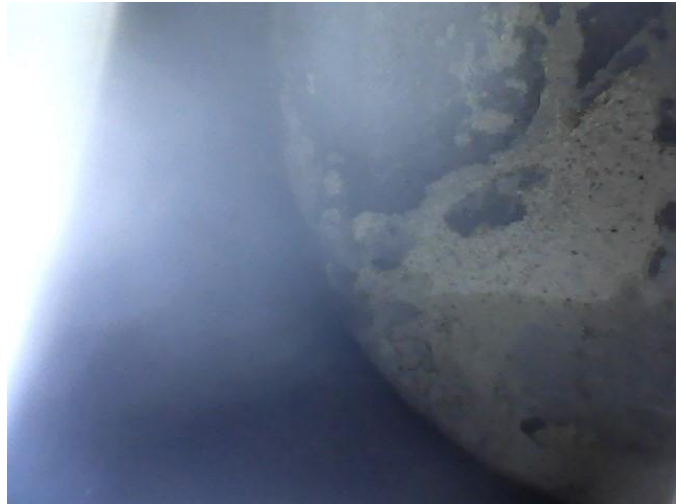
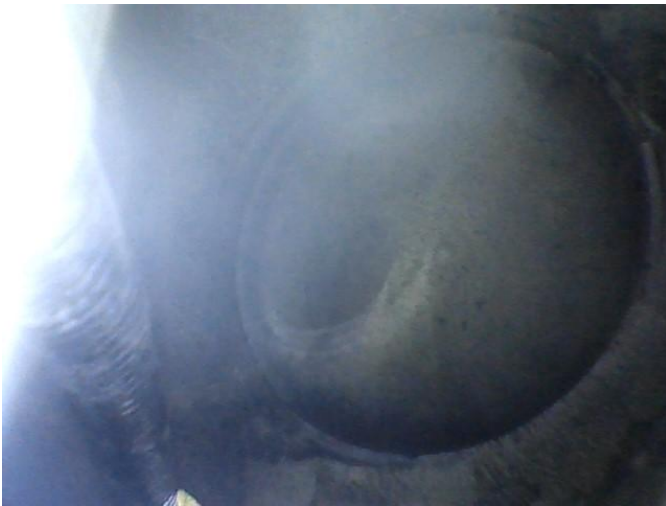
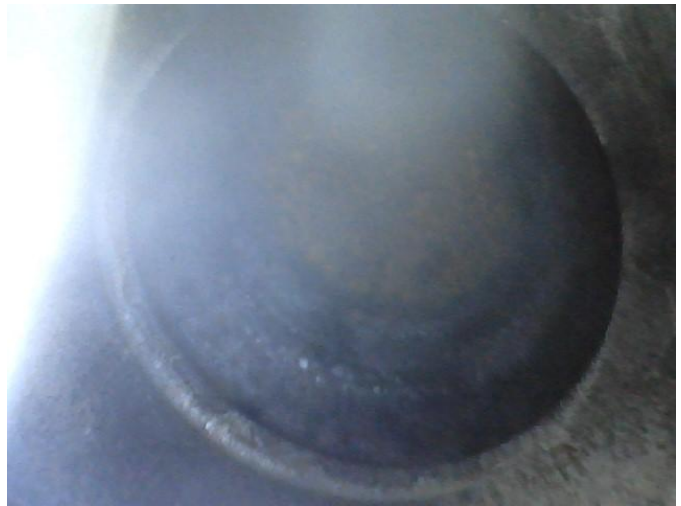
### CYLINDER #6

Condition: The cylinder remained secured to the crankcase with no external anomalies noted. Some blue staining was observed near the fuel injector. The cylinder was examined/documentated via a lighted borescope and no pre-accident anomalies were noted. The cylinder produced thumb compression during crankshaft rotation.

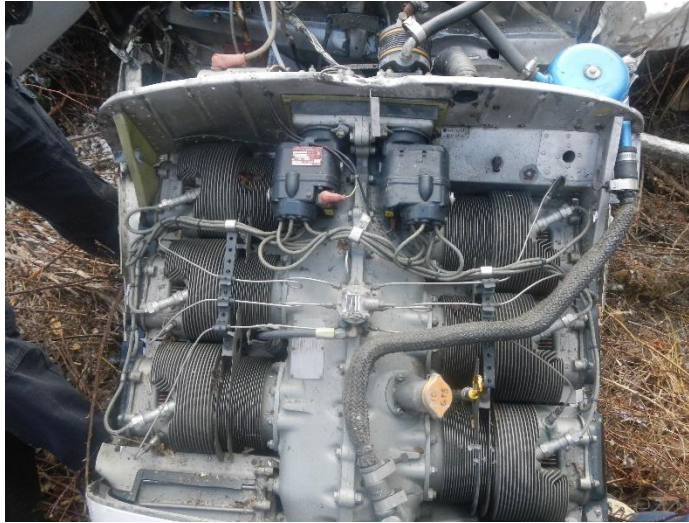
| Condition: | The crankcase remained intact with no external anomalies noted. Rotation of the crankshaft did not result in any binding from the main bearings. | | | |

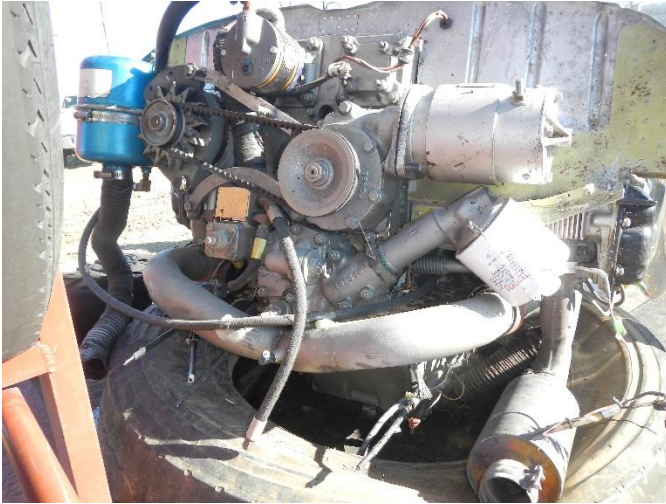
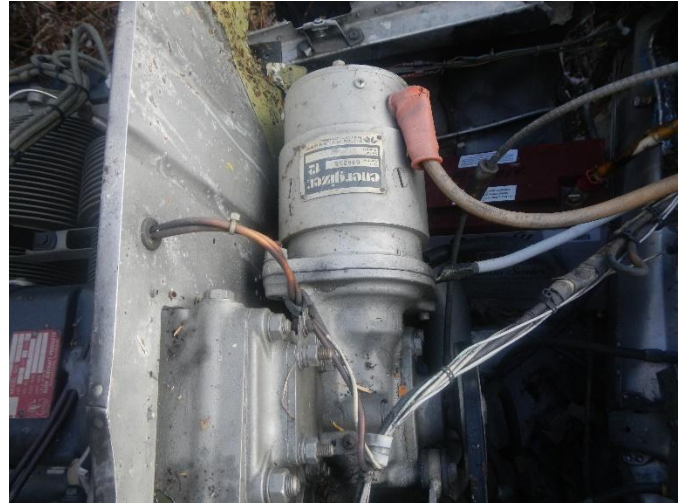
The starter motor remained attached to the adapter with no external pre-accident anomalies noted.
