## ENGINE EXAMINATION REPORT

| ENGINE MODEL | IO-470-J1B |
| AIRCRAFT REGISTRATION | N9378Y |
| FILE NUMBER | 17-404 |

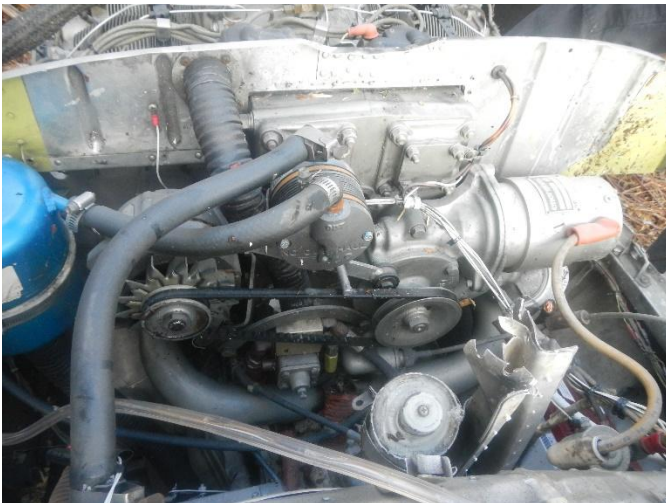
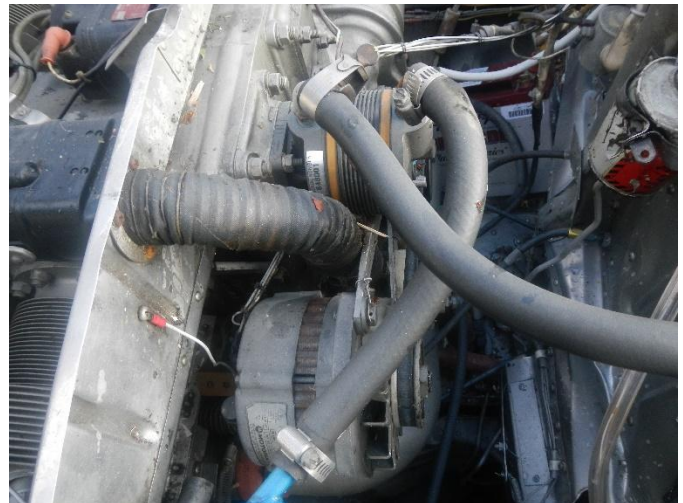
The belt-driven alternator remained attached to the backside of the engine and the drive belt was in place. Rotation of the crankshaft resulted in a rotation of the drive pulley and belt. No pre-accident anomalies were noted.

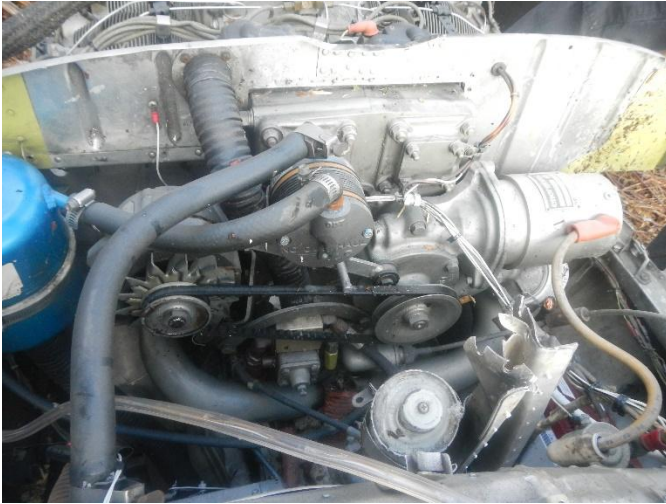
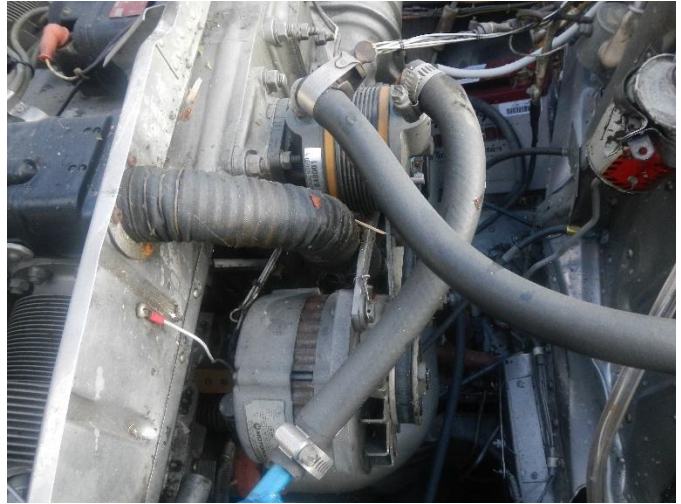
The vacuum pump remained secured on the backside of the engine with no pre-accident anomalies noted. Rotation of the propeller resulted in rotation of the vacuum pump drive coupling.

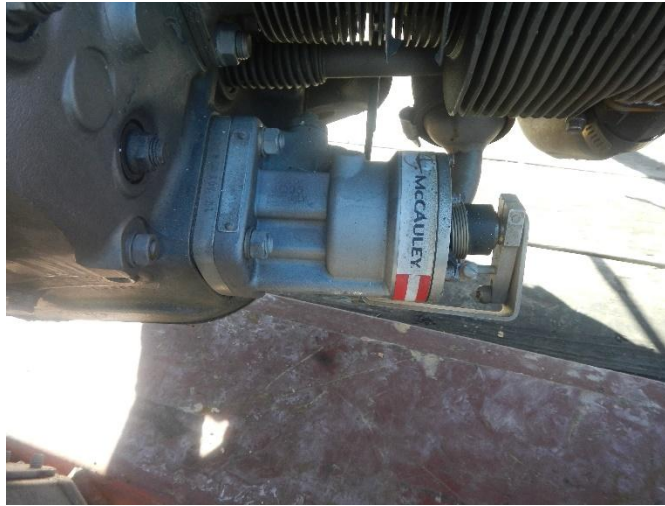
The propeller governor remained secured to the front left side of the engine. There were no pre-accident external anomalies noted. The propeller control cable remained attached to the control lever.

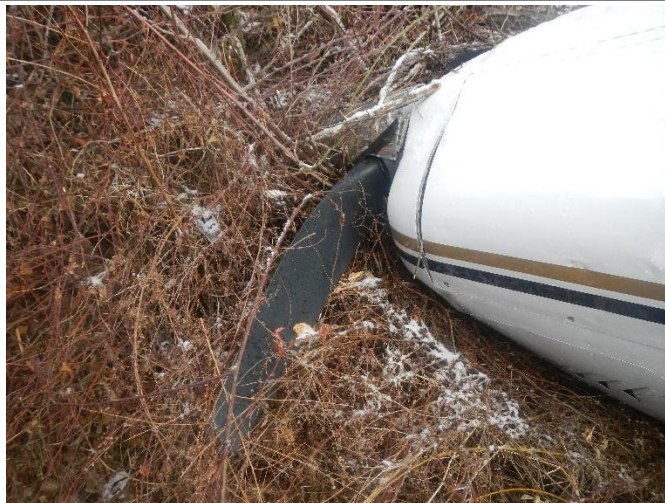
The two-bladed McCauley propeller remained attached to the engine. The spinner remained in place and displayed a dent on one side. Both blades remained attached to the propeller hub. One blade was bent aft about mid-span and the other was bent aft slightly.
