## **NATIONAL TRANSPORTATION SAFETY BOARD**

### **AIRFRAME AND ENGINE EXAMINATION SUMMARY**

**ANC18FA036**

| Aircraft: | Piper PA-28-180 N7061W |

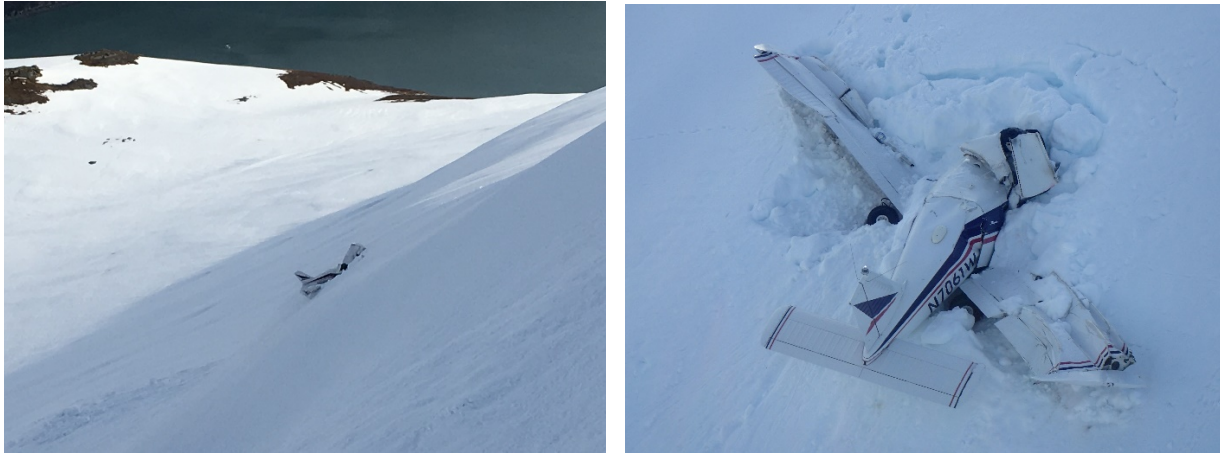
The NTSB participated in a flyover of the accident site. However, due to hazardous terrain and snow conditions, an on-site examination was not conducted. The Alaska Mountain Rescue Group, on behalf of the Alaska State Troopers, retrieved the pilot and took photographs of the wreckage. A review of photographs taken of the wreckage revealed that the accident site was on the side of a mountain on the south side of portage pass on an incline of about 40 °in deep snow. The airplane came to rest in a slightly nose up, level attitude heading 110° with the nose displaced upward and right and the wings each rotated about 30° to the right around the vertical axis with significant leading-edge crush damage. All airplane major components were attached and present in the confined area. (figure 1)

*Figure 1. N7061W at the accident site.*

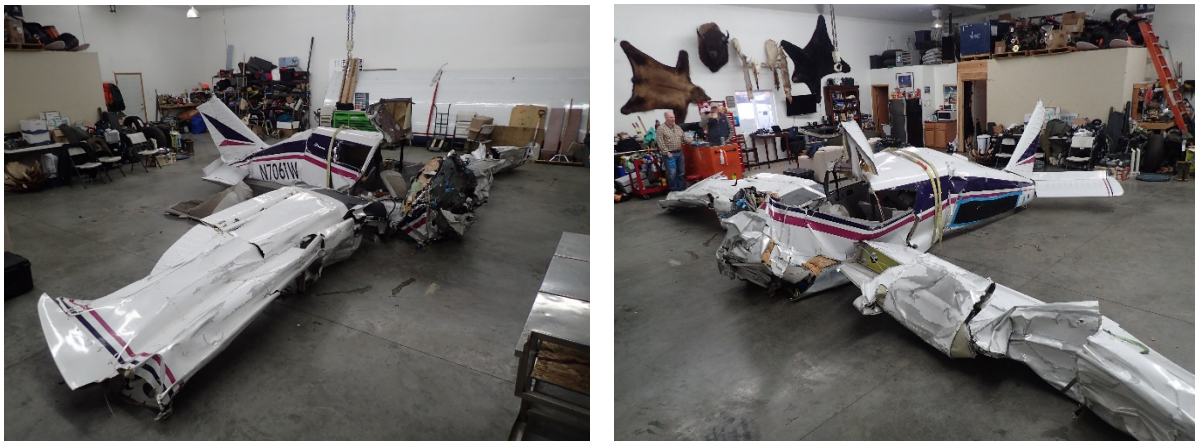
*Figure 2. N7061W wreckage during detailed airframe exam.*

The overall fuselage exhibited extensive damage to the forward section and circumferential buckling at FS 138 aft of the baggage compartment. The top of the cabin was ripped up and aft from the front windshield support post and pillar fractures back to the top of the door frame. The front windshield was fragmented into multiple pieces, some of which were in the cockpit and cabin. The left front sidewall was buckled inward into the left pilot station and separated from the floor board. The cockpit floor was bucked upward with

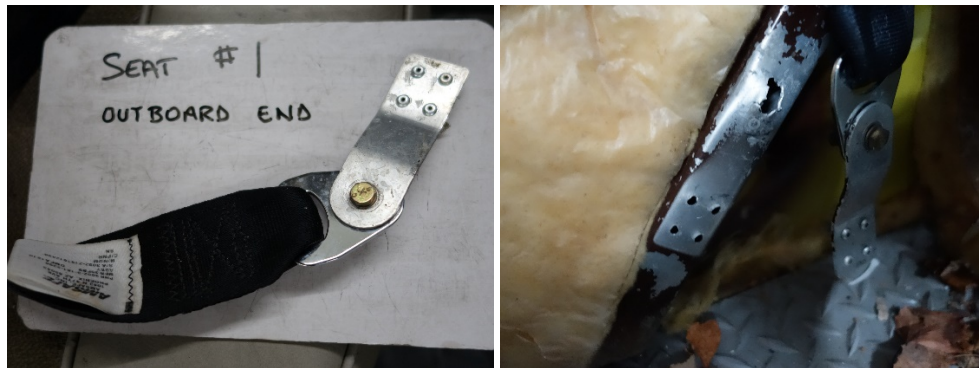
The restraint system was a traditional AmSafe three point design with inertial reel shoulder harnesses. The front left pilot seat outboard lap belt was pulled out of the left fuselage mounting structure by the rivets on the lap belt connector. See figure 3. The rivets were “pull type” fasteners that did not comply with the solid rivets (MS20470) required by the manufacturer. The right side of the pilot lap belt was attached and intact. The shoulder harness was still attached to the upper fuselage structure and the inertial reel worked properly. The shoulder harness connecting hardware on the lap belt and the shoulder harness exhibited no deformation or surface marks to indicate stress during impact. (On-scene photographic evidence shows the lap belt was buckled, however the left mount separated from the airframe structure and no shoulder harness was connected to the lap belt.)

*Figure 3. Pilot's outboard lap belt mount and attachment structure.*

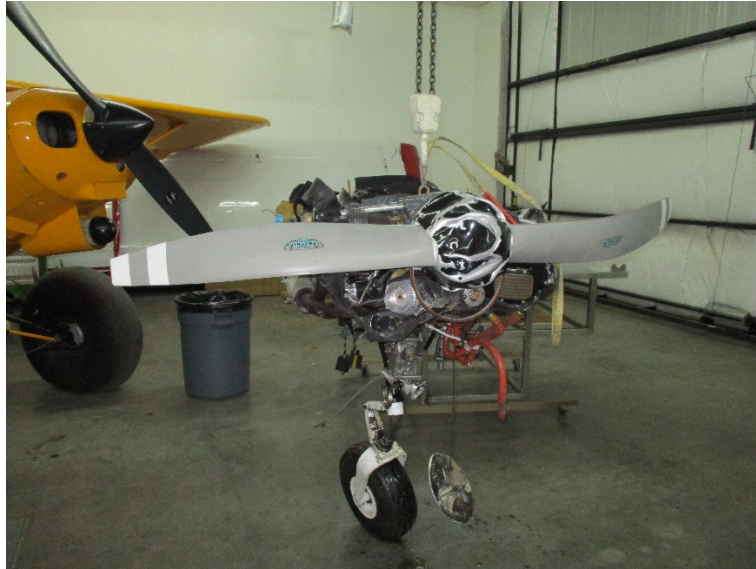
*Figure 4. Engine and propeller.*

The propeller remained attached to the engine. The propeller indicated mild aft bending and minimal torsional twist, indicative of impact with engine power into deep snow-covered terrain.

No evidence of pre-impact mechanical anomalies or malfunction was observed with the engine.
