## MEMORANDUM

**NTSB Accident Number: ANC18FA036 N7061W PA-28**  
**Subject: Investigative Weather Information**

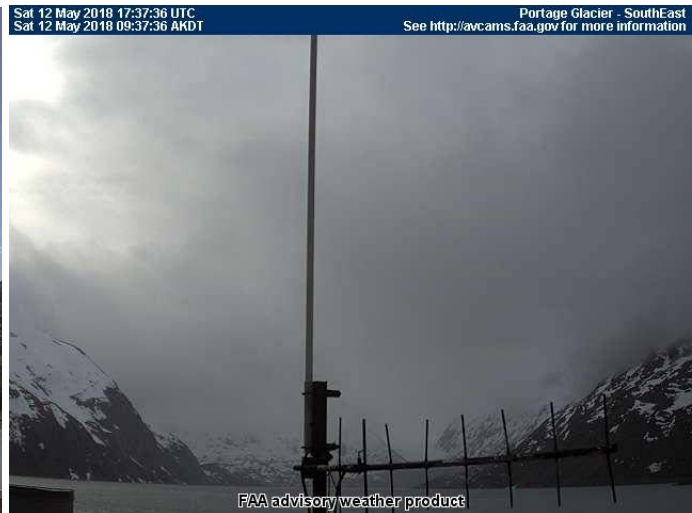
Portage Glacier Camera views are depicted on the Anchorage VFR Sectional in figure 1. The Southeast (SE) views and visibility on a clear day are depicted in figure 2 and the actual camera image from the time surrounding the accident (0937 local) is depicted in figure 3. The visibility is about 2 statute miles (sm) and the mountains are obscured.

Figure 3. Same view at 0937 on May 12, 2018.

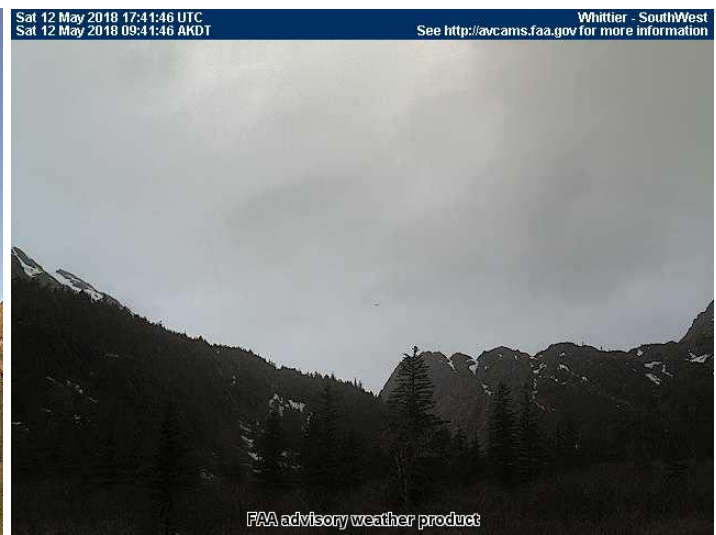
Whittier camera views are depicted in figure 4 and the southwest view on a clear day is depicted in figure 5. The actual southwest camera image at 0941 on May 12 is depicted in figure 6. It indicates that there was a broken to overcast ceiling slightly above 800 ft mean sea level (msl) and the visibility was between 1 and 5 sm. The Whittier northeast view is depicted in figures 7 and 8. Figure 8 indicates that the lowest cloud layer to the north was below 3,100 ft msl and visibility was between 7.5 and 10 sm.

Figure 6. Same view at 0941 on the accident day.

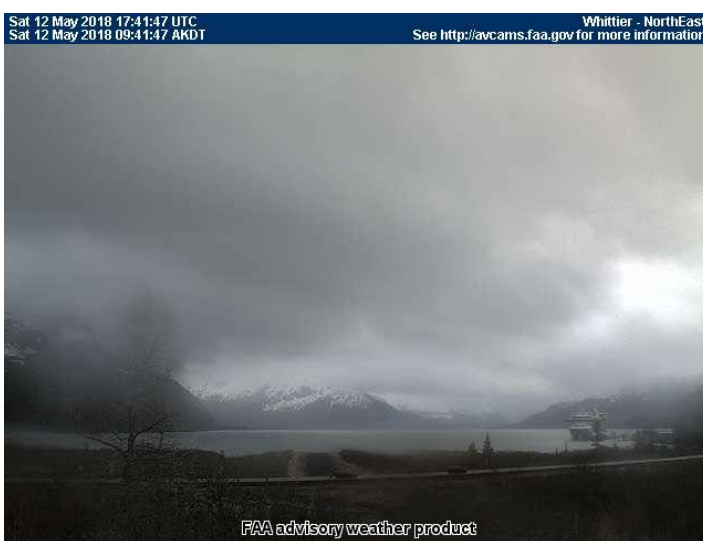
Figure 8. The same view at 0942 on the accident day.

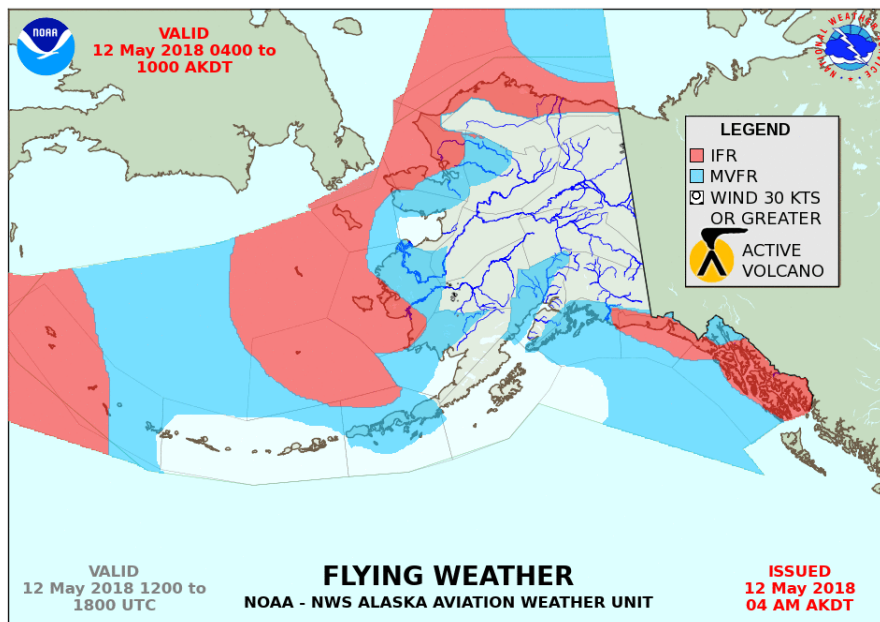
Figures 9, 10 and 11 were forecast products that were available to the pilot before the flight and were valid at the time of the accident. Figure 9 indicates that conditions in the area east of Whittier were expected to be marginal visual flight rules (MVFR-ceiling between 1,000 and 3,000 ft and/or visibility between 3 to 5 sm.) Figures 10 and 11 indicate that turbulence and icing were not forecasted for the area.

Figure 9. Flying weather graphic.

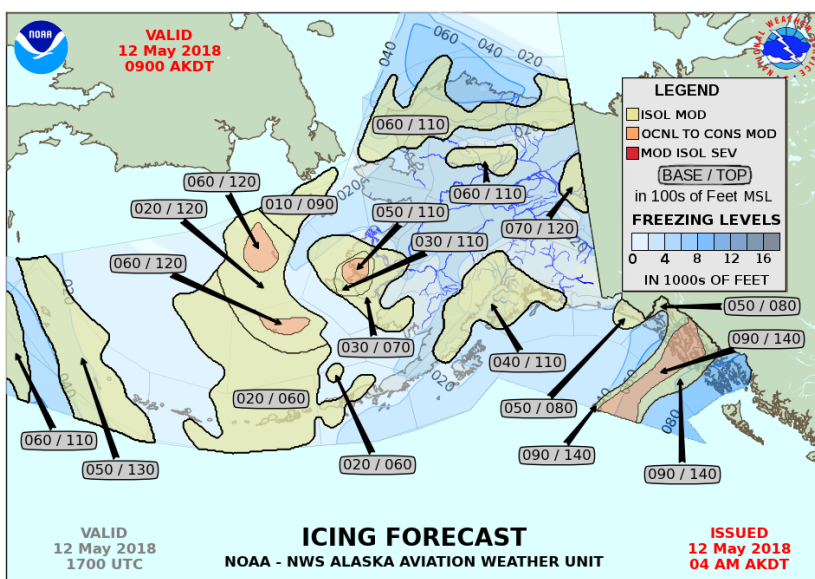
Figure 10. Icing forecast graphic.

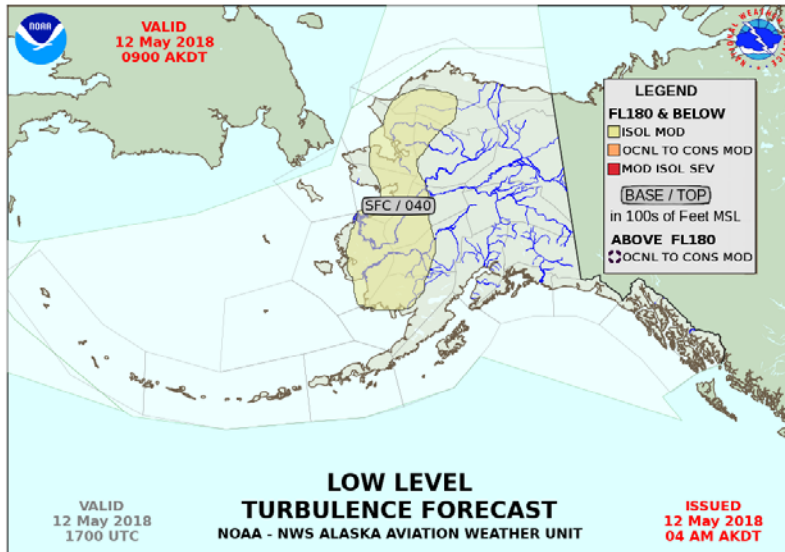
Figure 11. Turbulence forecast.
