## **NATIONAL TRANSPORTATION SAFETY BOARD**

### **Airframe and Engine Examination Summary**

NTSB Number: ANC18FA044

Aircraft: PA-18 N1203A

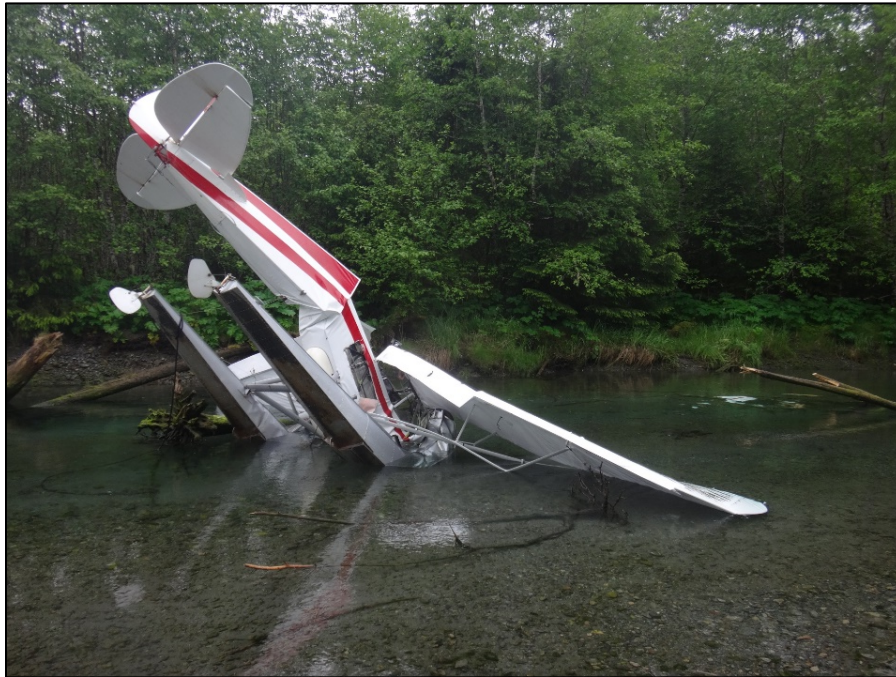
*Figure 1. N1203A at the accident scene.*

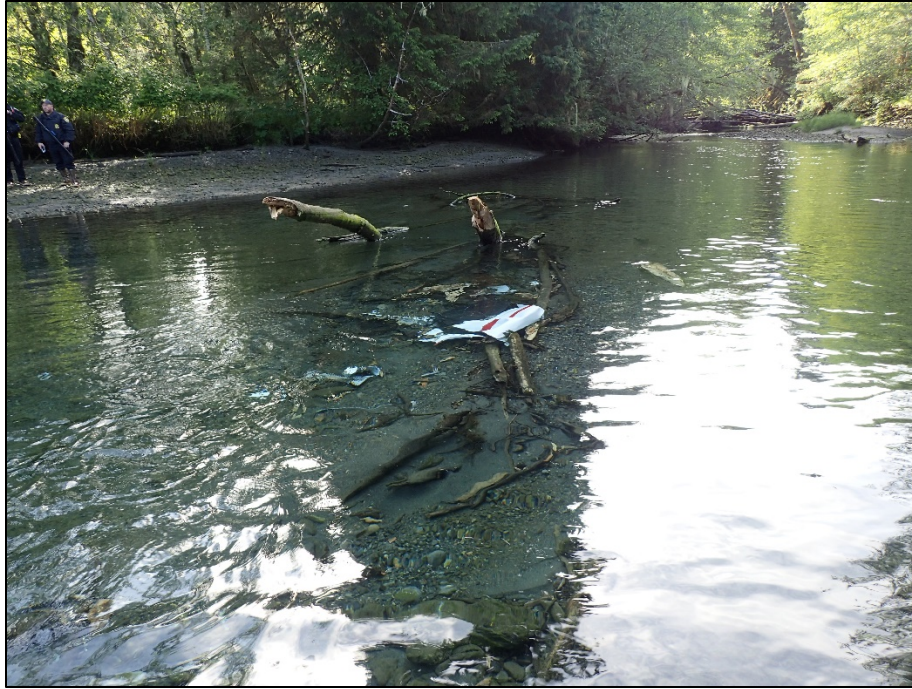
The airplane came to rest nose down in a finger of the Katlian River which was about 30 ft wide at the time of the examination and surrounded by large trees and thick brush. The airplane was heading upstream about 110 ° and resting 70° nose down on the crushed forward sections of the floats and the propeller. The wings were rotated forward with forward tips resting on the riverbed. The empennage was displaced and twisted right. See figure 1. A depression of about 6 x 6 ft in the river bottom was present about 20 ft upriver of the wreckage and contained small airplane debris, the engine cowlings, and an iPhone. This depression appeared to be the first area of impact. Two waterlogged dead tree trunks lay in the river next to the depression and indicated fresh breaks and propeller cuts. The dead tree trunks had a large growth of moss and appeared like the other deadfall trees that the current deposited throughout the river. There was no evidence of tree strikes in the surrounding live trees. See figure 2.

*Figure 2. Initial impact site with dead fall tree strikes evident.*

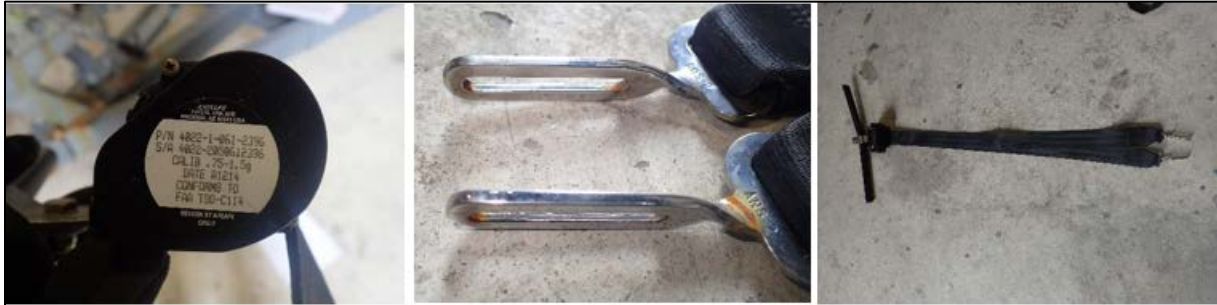
The airplane was equipped with four point restraint system in the front and rear seats. (AmSafe P/N 4022-1-061-2396, TSO c114 compliant) The front seat lap belt straps were securely attached to the floor

structure. The buckle was unfastened and tested properly when examined. The front seat shoulder harness inertia reel and straps were attached to the overhead structural tube that was separated from fuselage and deformed at mid-span. The reel and webbing were undamaged and functioned properly when extended and pulled. The shoulder straps' metal connectors had no evidence of forced mechanical release. (deformation or scratches) The front seat was in the full forward position. See the figures 3.

*Figure 3. Front seat restraint system.*

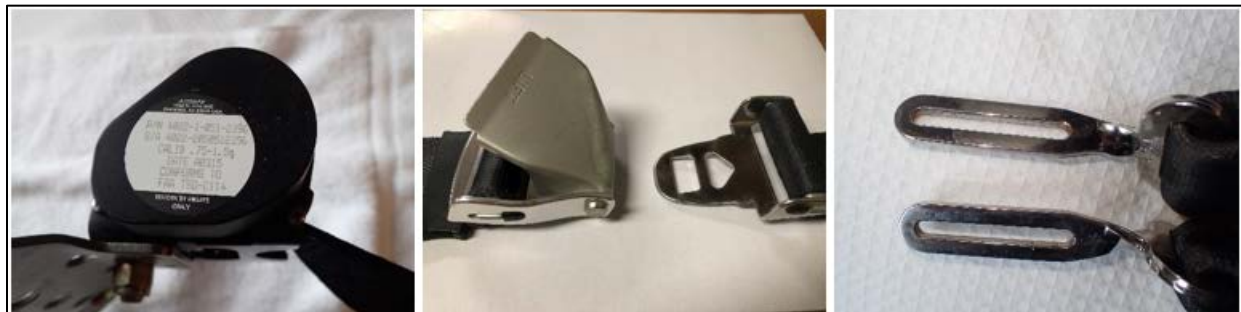
The rear seat was intact with the lapbelt secured to the floor structure and the buckle disconnected. The buckle latch exhibited deformation in the outward direction. The latch could not be rotated fully due to the metal deformation. The shoulder harness connectors had no evidence of deformation or scrapes. See the figures 4.

*Figure 4. Rear seat restraint system with buckle deformation evident.*

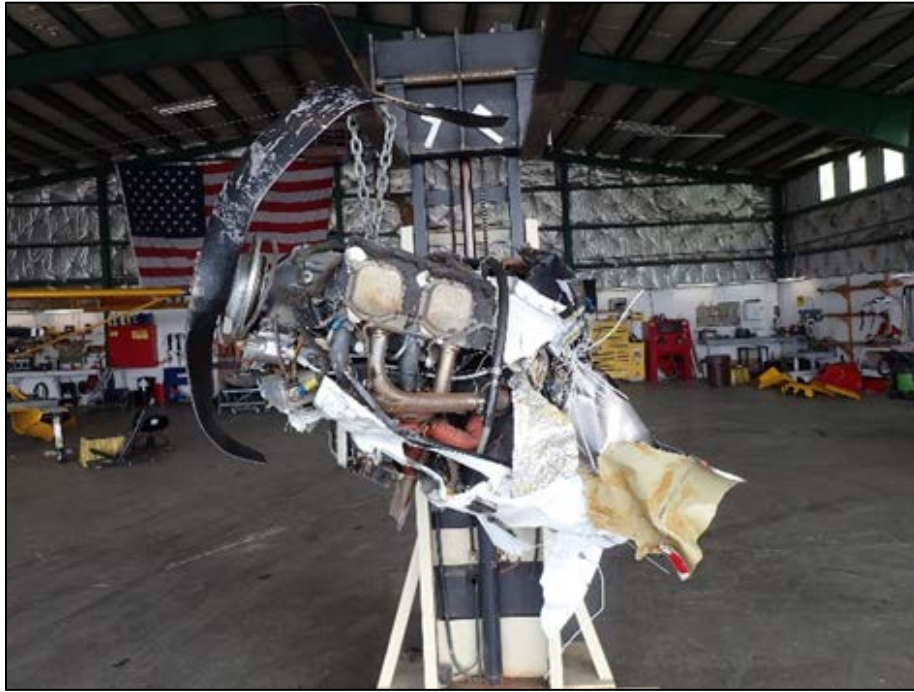
On June 25, 2018 , a detailed examination of the engine was performed at Harris Air, Sitka, Alaska, by the NTSB IIC with maintenance support. The engine was removed from the airframe and suspended by a hoist for the examination. See figure 5.

*Figure 5. Lycoming O-320 engine during examination.*

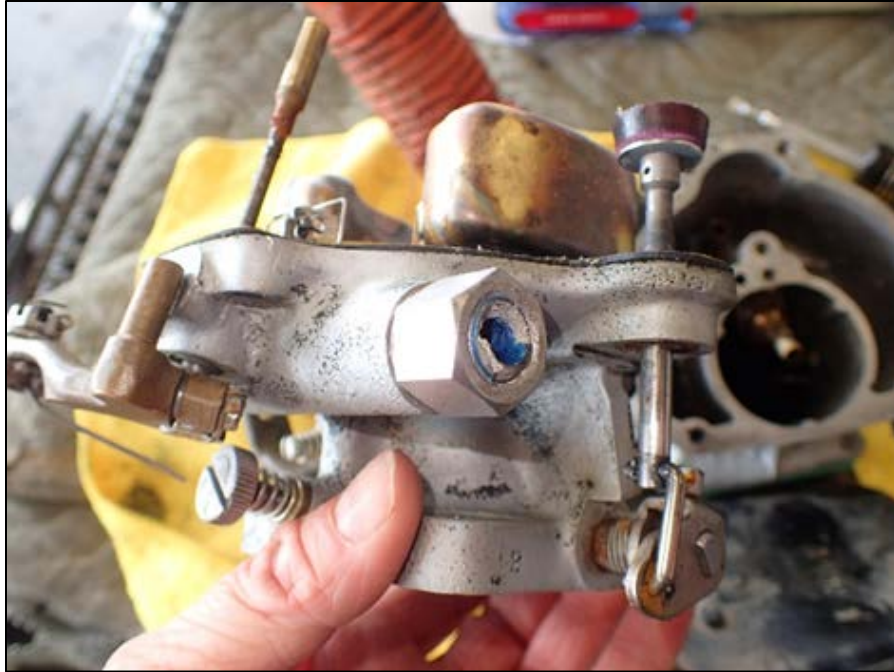
The engine case was intact. The spark plugs were removed and indicated normal wear with mild corrosion. Spark could *not* be produced at the ignition leads. The magnetos were secure, and after removal, spark was evident at each terminal post when manually rotated. Thumb compressions tested good in the appropriate order when the engine was rotated by hand. All cylinders were inspected with a flashlight. No anomalies were noted with the cylinder barrels or pistons. The rocker box covers were removed, and rocker arms were noted to move appropriately when the engine was manually rotated. The carburetor was intact with the fuel inlet line broken at the nut with overload fractures evident. The fuel inlet filter had white salt like debris present. The carburetor bowl had seawater present. The float assembly and needle operated normally. The accelerator pump was functional. See figure 6.

*Figure 6. Carburetor indicating fractured inlet fuel line.*

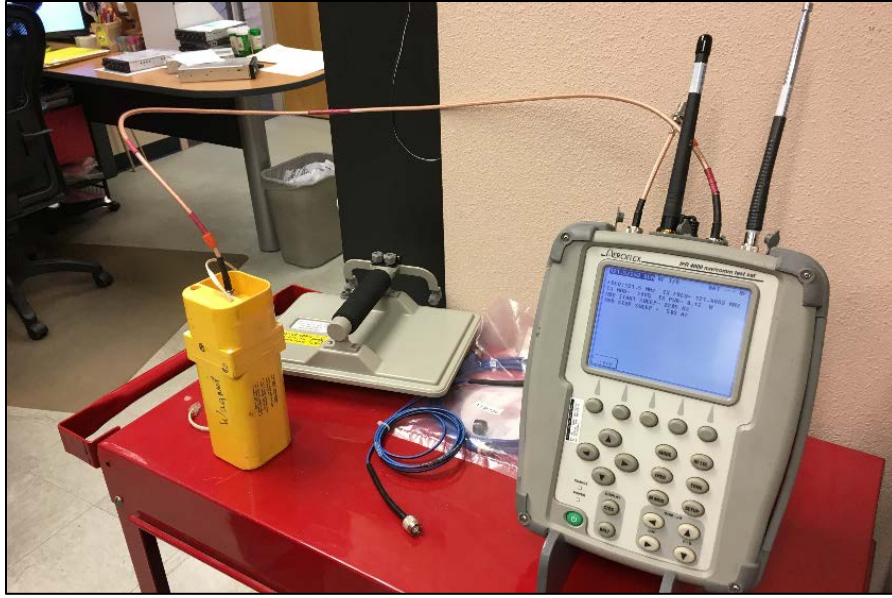
The Ack Technologies Model E0-1 ELT was attached to the mount and antennae at the accident scene. The switch was in the armed position. The Alaska Rescue Coordination Center duty person stated that no ELT was received, and the helicopter that found the airplane did not hear a transmission on 121.5 MHz. The ELT was removed from the wreckage and a functionality test was completed at Northern Lights Avionics in Anchorage. The unit tested successfully on an IFR 4000 Nav/Com Test set for transmission on 121.5 MHz, but failed 3 out of 6 mechanical activation tests, indicating a likely failure of the G switch. See figure 7.

*Figure 7. The ELT connected to test set during function testing.*
