## **NATIONAL TRANSPORTATION SAFETY BOARD**

### **Meteorology Factual Report**

ANC18FA053

Location: Hydaburg, Alaska  
Date: July 10, 2018  
Time: 0835 Alaska daylight time (1635 UTC<sup>1</sup>)  
Airplane: De Havilland DHC3 Turbine Otter; N3952B

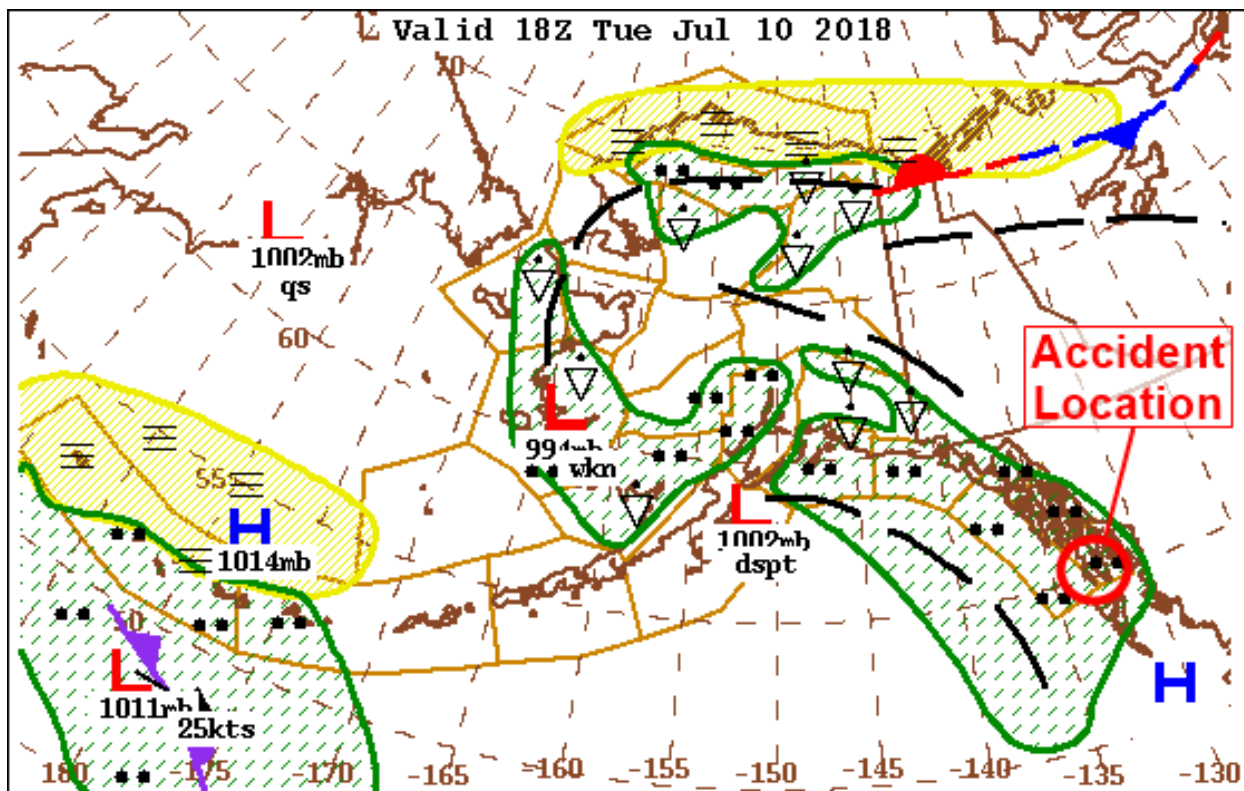
A surface chart issued by the Alaska Aviation Weather Unit (AAWU) and valid for 1000 AKDT is presented in figure 1. The chart identified a high-pressure center south of the accident location. A northwest/southeast-oriented trough was depicted to the west of the Alaska Panhandle over the Gulf of Alaska. Light continuous rain was identified over almost all southeast Alaska.

Figure 1 - AAWU surface chart for 1000 AKDT.

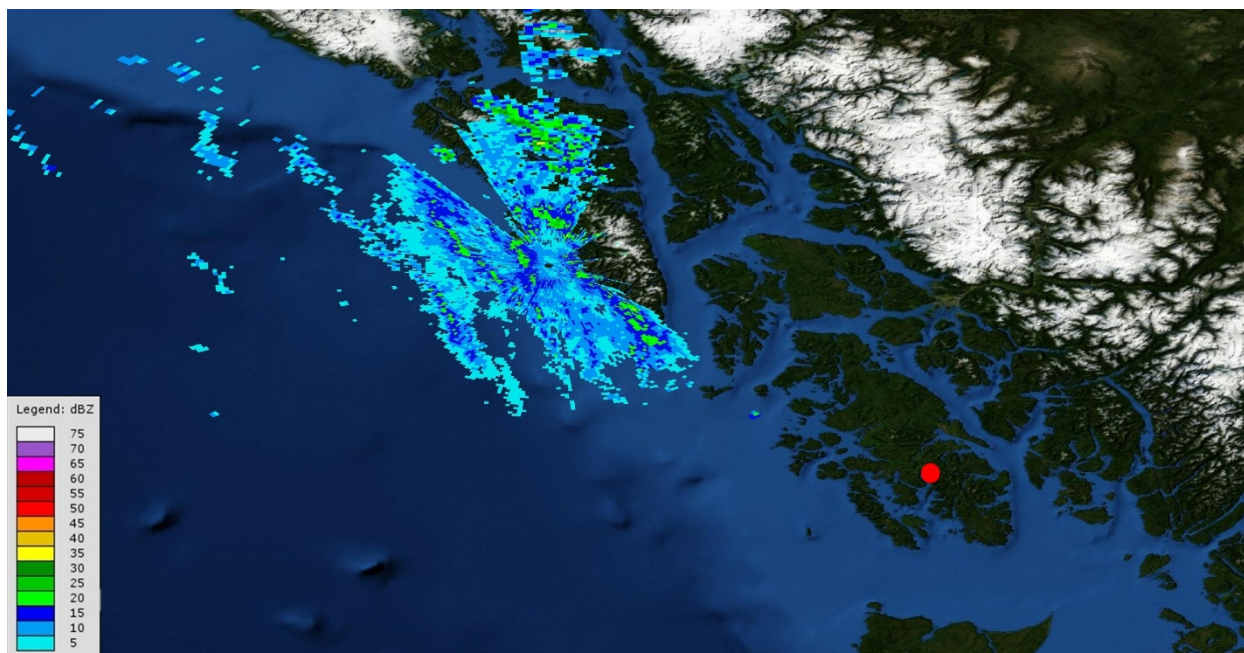
WSR-88D Level-III long range (248 mile) base reflectivity weather radar imagery from Biorka Island, Alaska (PACG), is presented in figure 2. PACG was located approximately 140 miles northwest of the accident site at an elevation of about 240 feet. Assuming standard refraction and considering the 0.95° beam width for the WSR-88D radar beam, the PACG 0.5° tilt would have “seen” altitudes above the accident location of between about 13,600 and 27,700 feet above msl. There was no reflectivity depicted in the accident area.

**Figure 2** – PACG 0.5° Level-III long range (248 mile) base reflectivity product from 0833 AKDT. Accident site denoted by red circle.

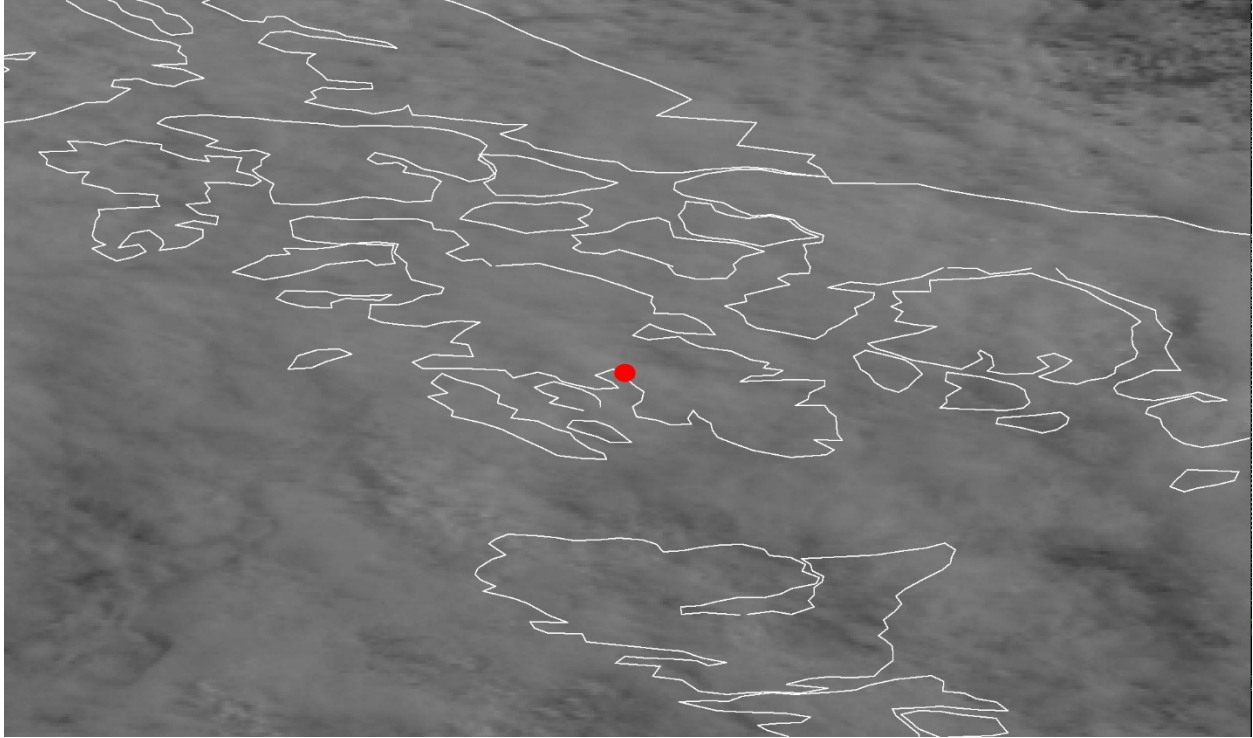
**Figure 4** – GOES-15 visible imagery from 0830 AKDT. Accident location denoted by red dot. This image has not been corrected for any parallax error.

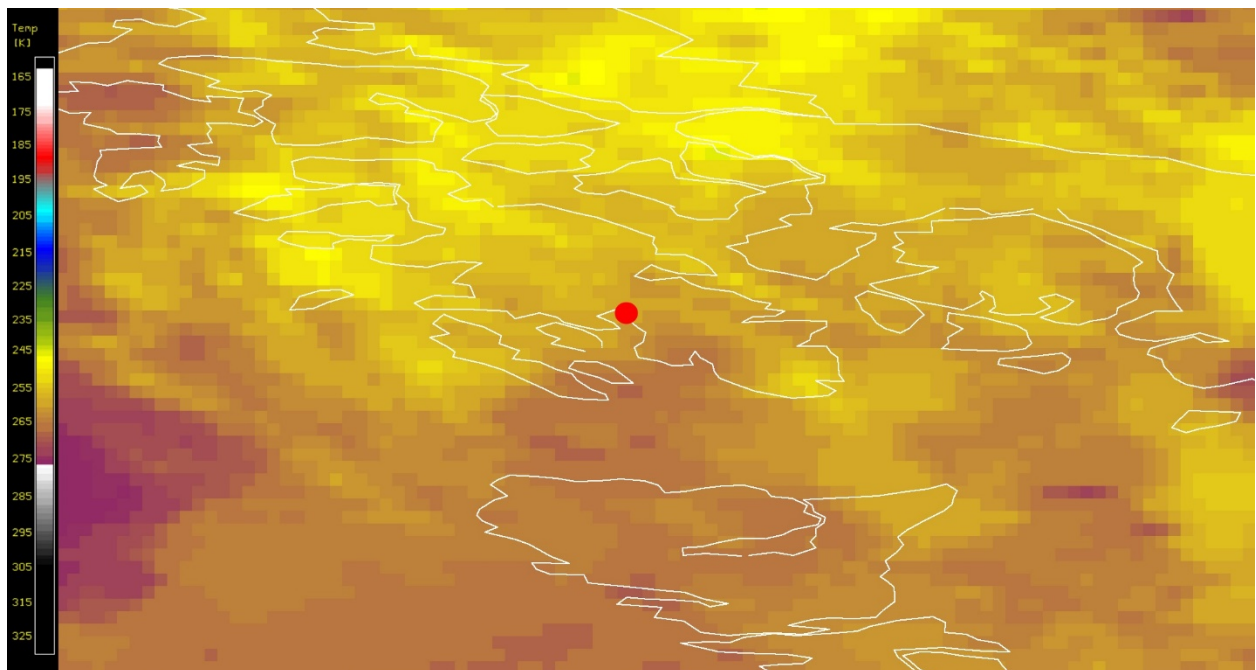
**Figure 5** – GOES-15 infrared imagery (brightness temperature in degrees Kelvin) from 0830 AKDT. Accident location denoted by red dot. This image has not been corrected for any parallax error.

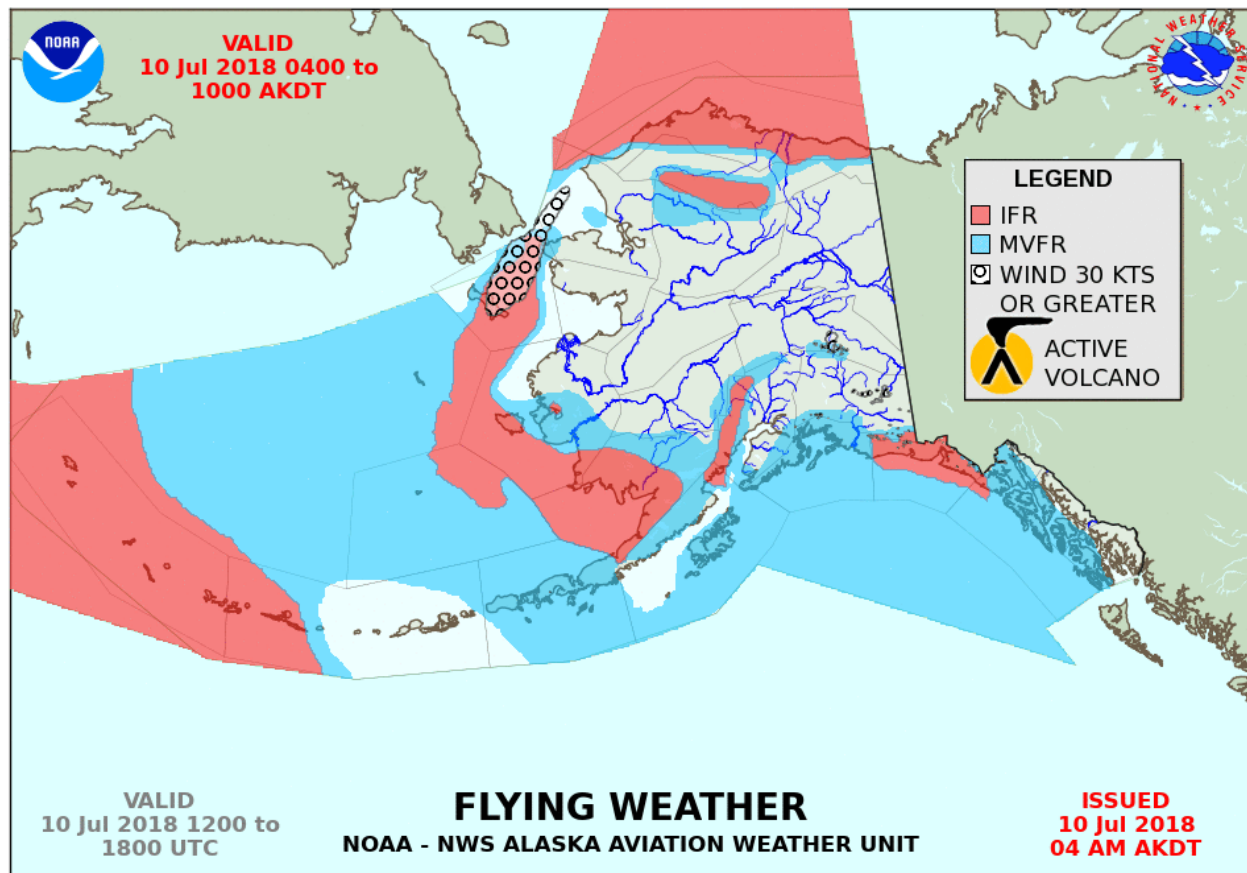
Aviation-related graphic products issued by the AAWU applicable to the accident time are presented in figures 6-8. The graphics forecasted MVFR<sup>6</sup> conditions over the accident site.

**Figure 6** – Flying Weather graphic issued at 0400 AKDT and valid between 0400 and 1000 AKDT.

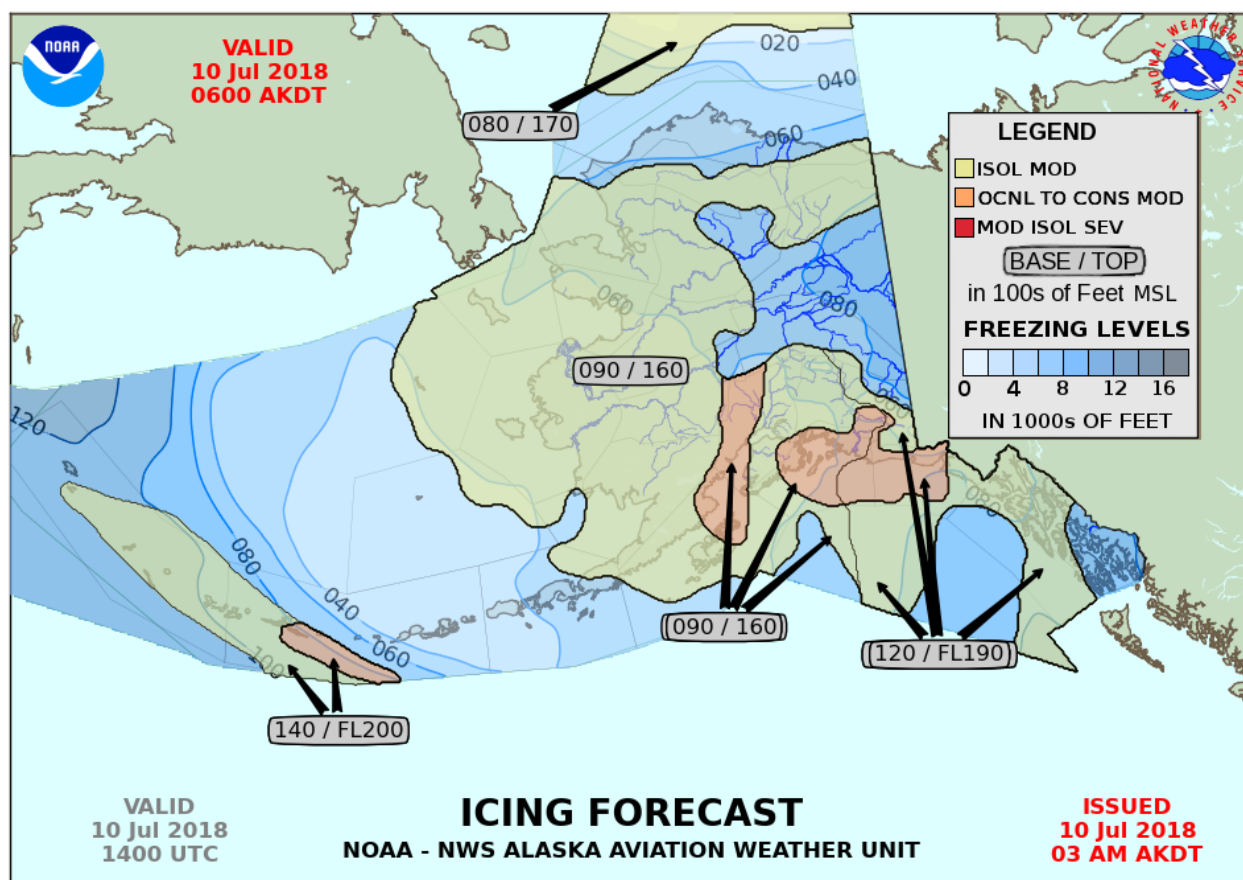
**Figure 7** – Icing Forecast graphic issued at 0300 AKDT and valid for 0600 AKDT.

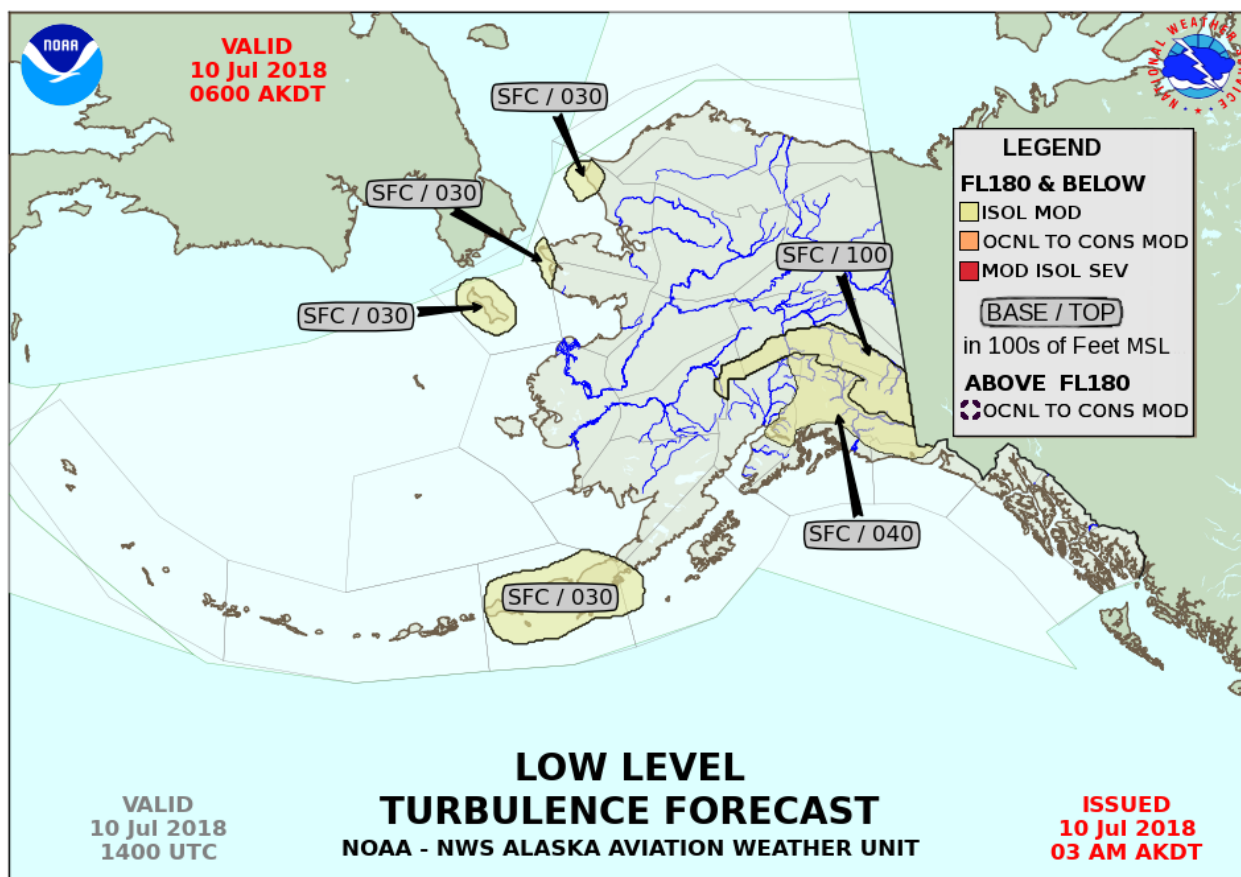
**Figure 8** – Low Level Turbulence Forecast graphic issued at 0300 AKDT and valid for 0600 AKDT.

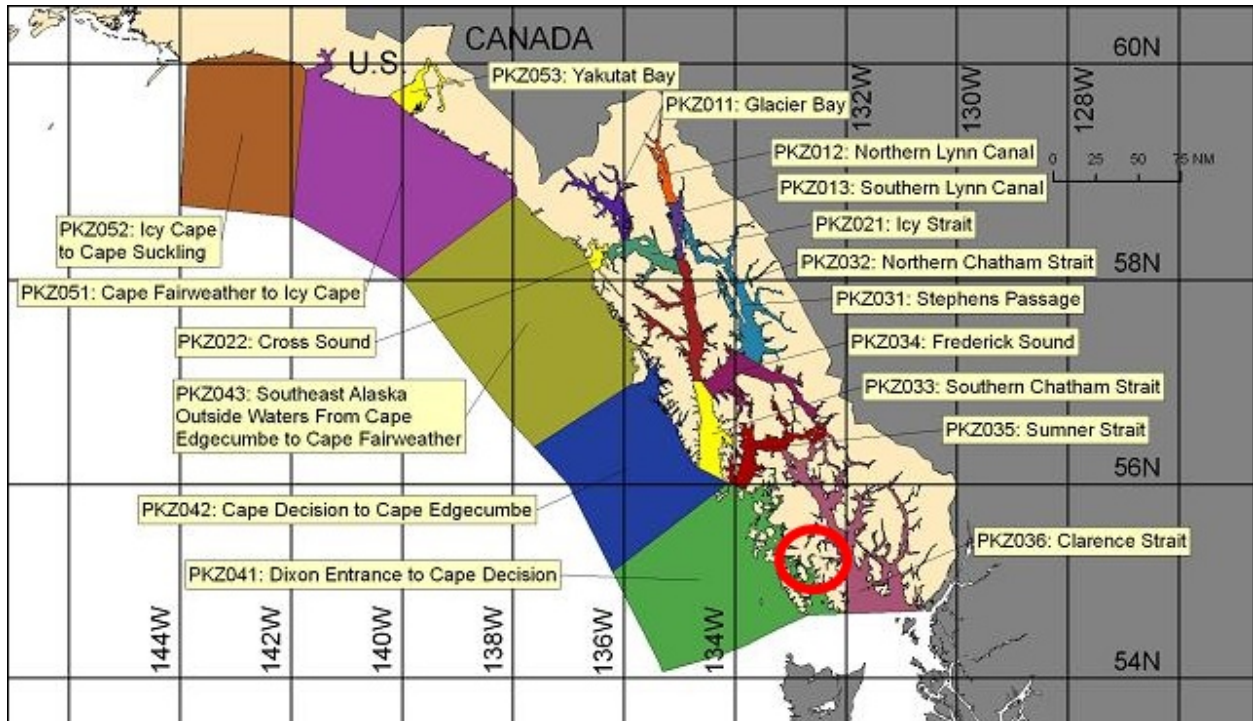
**Figure 9** – Map of NWS marine forecast zones for southeast Alaska. Accident location denoted by red circle.
