**NATIONAL TRANSPORTATION SAFETY BOARD**

## **Video Study**

**NTSB Case Number:  
ANC18FA055**

Location: Willow, Alaska  
Date: July 18, 2018  
Time: 1900 Alaska Daylight Time  
Aircraft: De Havilland DHC-2 (Beaver)

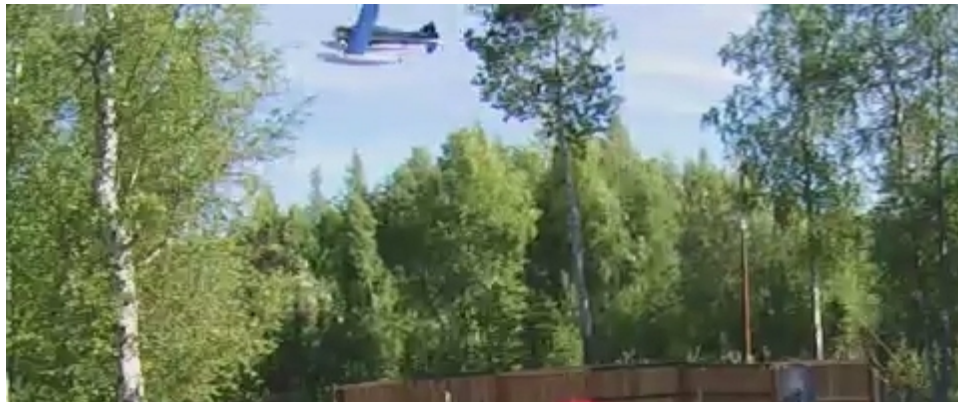
**Figure 1. Segment from a Video Frame that Shows the Airplane**

Figure 1 shows a 480x200 pixel segment from a video frame that shows the accident airplane. That video frame was recorded at time 112.5 seconds. When the airplane was visible in the video, it was approximately in front of the camera and was moving approximately parallel to the image plane of the camera. This simplified the speed estimation because the known total length of the DHC-2 floatplane, 32.75 feet, could be used for estimating its flown distance between video frames. Since the time between video frames was known because the frame times were known, speed could be estimated by dividing a flown distance by the time it took to fly that distance. The speed was estimated between several pairs of video frames and the estimated speed was  $56 \pm 3$  knots.

The known length of the DHC-2 was also used for estimating its altitude. When it appeared first in the video, its altitude was about 115 feet above the crash location. It impacted the ground 3.5 seconds later. During these 3.5 seconds, the airplane had a large and increasing left-wing-down bank angle. This bank angle, visible in Figure 1, indicates that the airplane was in a left turn when it was recorded by the camera. It is estimated that the bank angle was about  $25^\circ$  at time 112.5 seconds, corresponding to Figure 1, and was increasing rapidly. At time 114.1 seconds, the bank angle was close to  $90^\circ$ .

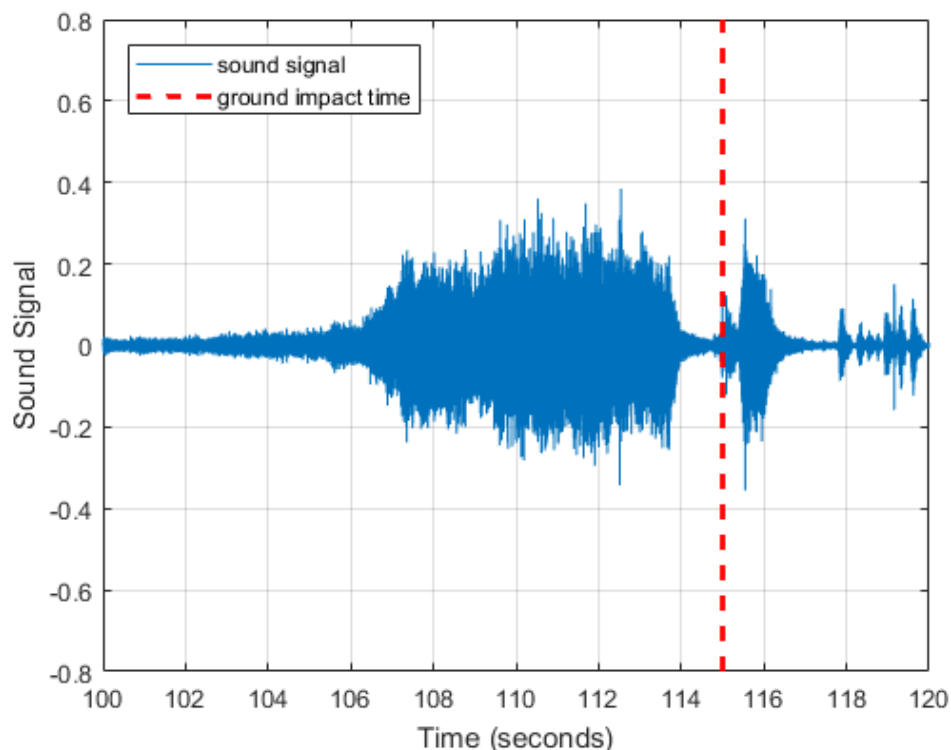
**Figure 2. Sound Signal Recorded by the Camera Microphone**

The video included an audio channel that was sampled at 16 kHz. It was used for estimating the engine speed via spectral analysis of the sound. Figure 2 shows the sound intensity signal during a 20 second period. The dotted red line indicates the time of ground impact, at 115.0 seconds. Based on the figure, it was assumed that the airplane was closest to the camera between time 110 seconds and time 112 seconds, when the sound intensity was highest.

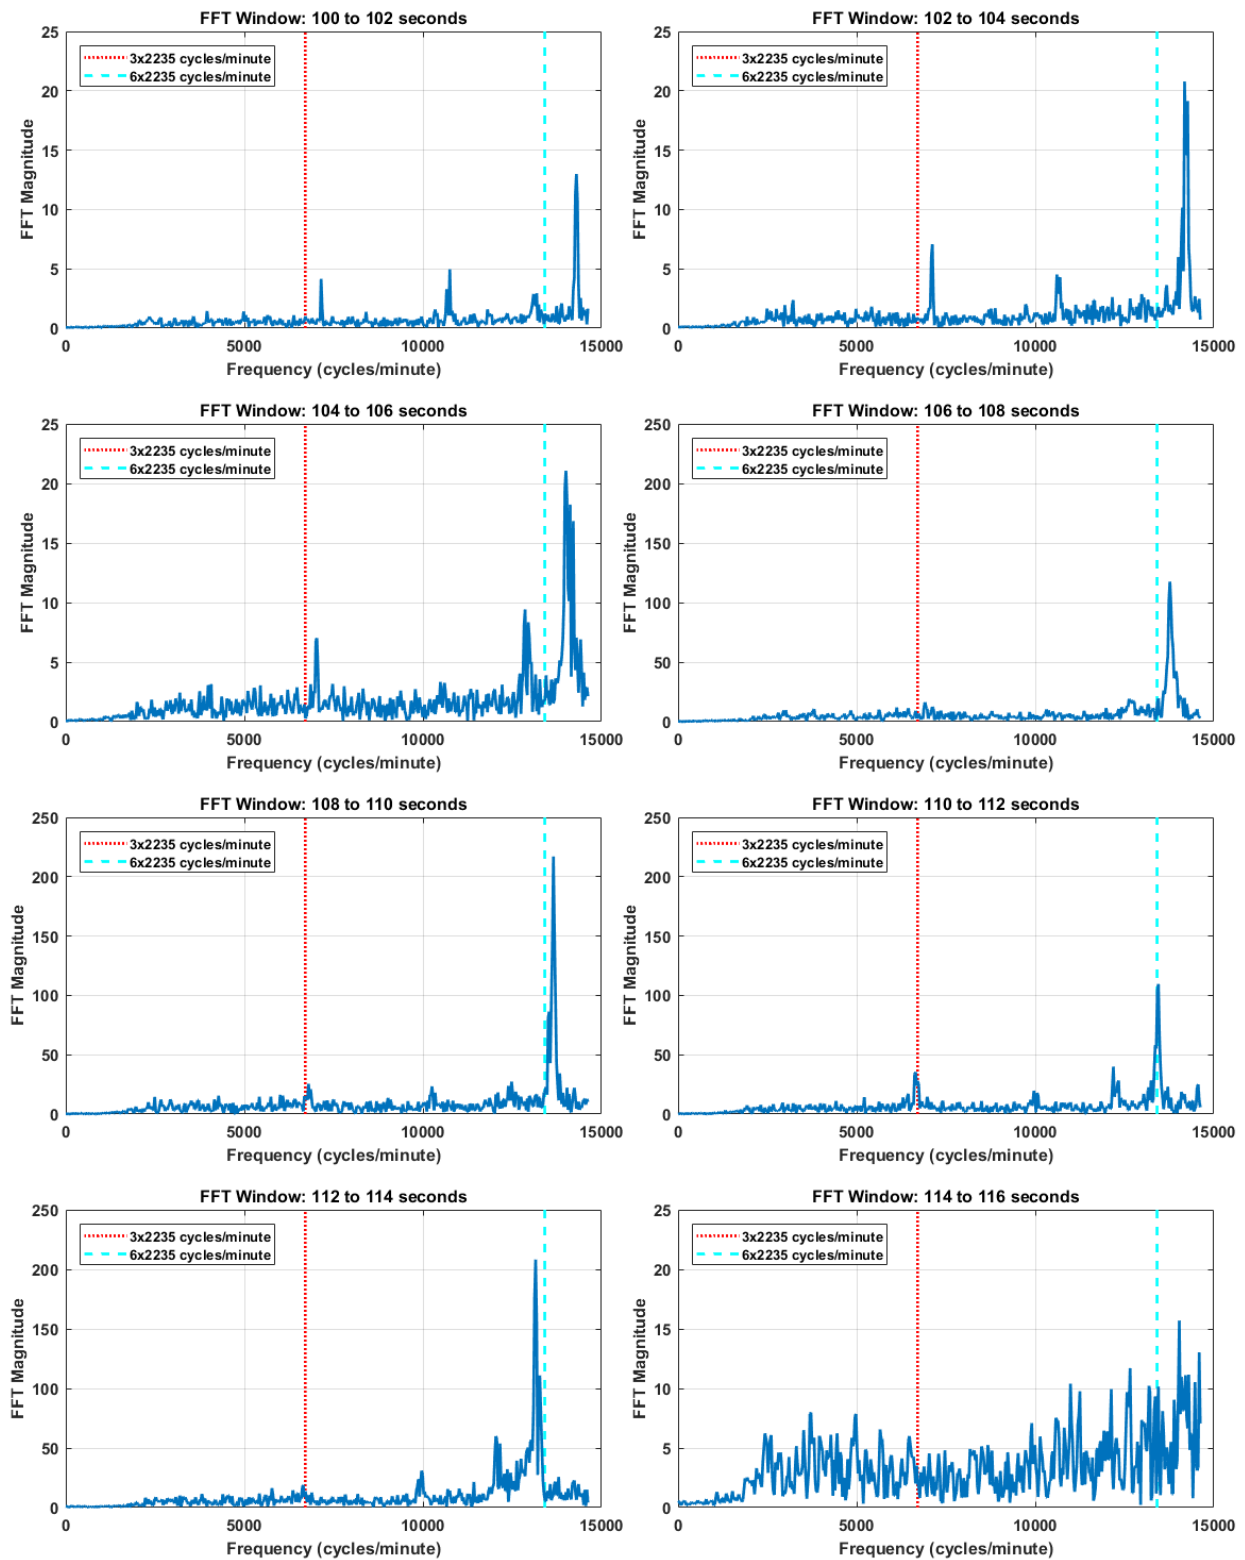
Figure 3. Airplane Propeller Sound Spectrum Plots

The spectrum was computed with a 32,768-point FFT (Fast Fourier Transform) algorithm. Figure 3 shows eight spectra, each computed over a two-seconds long signal segment. Since there was no FFT averaging or segment overlap, the eight segments cover  $8 \times 2 = 16$  seconds of signal, from video time 100 seconds to video time 116 seconds.

There are two vertical lines superimposed on each spectrum plot in Figure 3. The dotted red line is at frequency  $3 \times 2235 = 6705$  cycles/minute. The broken cyan line is at  $6 \times 2235 = 13,410$  cycles/minute. These two lines are at the frequencies of the first and the second harmonic peak in the spectrum plot corresponding to the time interval between 110 seconds and 112 seconds, where the Doppler shift is expected to be close to zero because the airplane was closest to the camera microphone. Therefore, the engine rotational speed is estimated to be 2235 RPM.

Figure 3 shows that before time 110 seconds, the spectral peaks are at frequencies higher than 6705 cycles/minute and 13,410 cycles/minute due to the Doppler effect. Past time 112 seconds, spectral peaks are at frequencies lower than 6705 cycles/minute and 13,410 cycles/minute. The wide frequency content of the spectrum between time 114 seconds and 116 seconds is due to the sound generated by the ground impact at time 115.0 seconds.
