## **NATIONAL TRANSPORTATION SAFETY BOARD**

### **AIRFRAME AND ENGINE EXAMINATION SUMMARY**

**ANC18FA055**

| Aircraft: | DHC-2, N9878R |

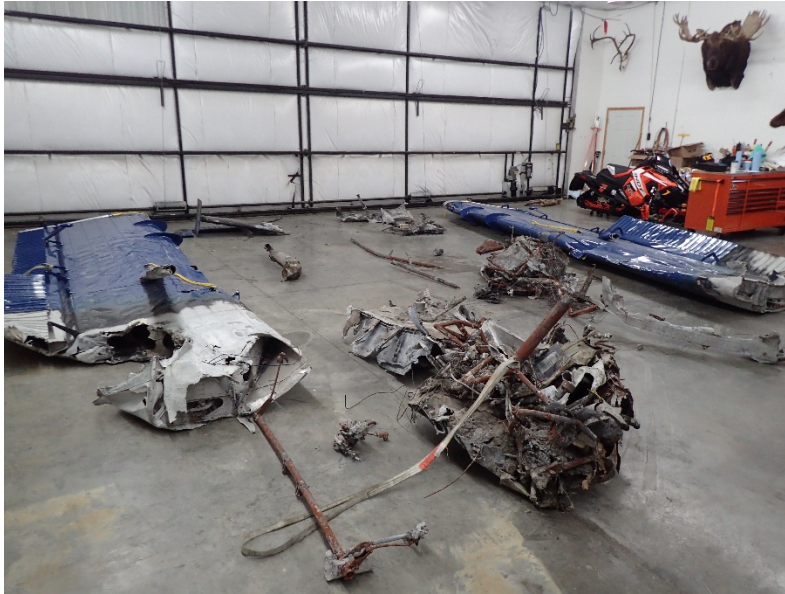
*Figure 1. N9878R airframe wreckage at examination hangar.*

The wreckage consisted primarily of the wings, forward fuselage frame, floor structure and engine with propeller attached. The wreckage exhibited either soot, charring, oxidized metal, or melted aluminum. There was hardened masonry mortar intermixed with airframe and engine components. The right wing was mostly intact with some fore to aft buckling on the outboard leading edge and the flap and aileron were attached. The left wing had significant leading edge buckling near the outer edge. The left flap and aileron were attached, but the flap control rod was disconnected at the C clamp. The left aileron inboard edge had impact damage that matched the adjacent flap edge damage with the flaps extended about 30°, which indicated the flaps were likely at or near the takeoff position at the time of impact.

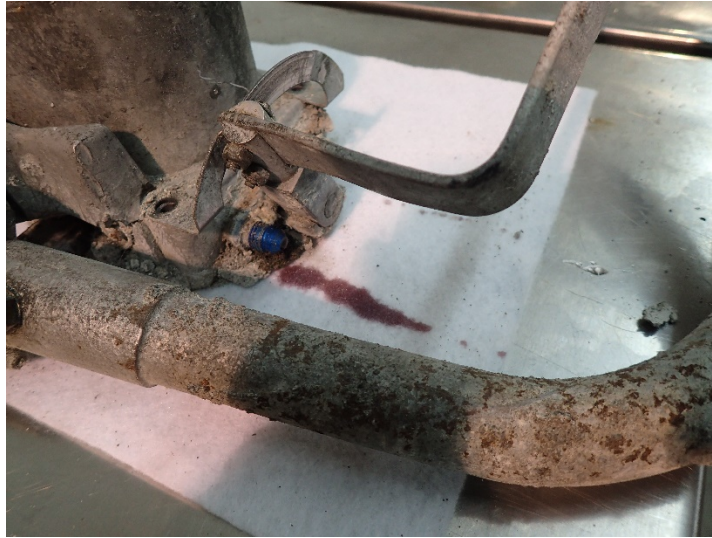
The hydraulic reservoir, flap hand pump and flap selector assembly was located on the airframe floor covered in debris. The flap selector lever was in the DOWN position (flaps extension mode) and the hydraulic hand pump lever was down. During a detailed examination, the assembly was cleaned and removed from the airframe. Dark purple hydraulic fluid was present at the disconnected lines. The reservoir contained about ¼ inch of fluid. The flap selector lever was manually moved from detent to detent and exhibited smooth operation throughout. The flap selector lever was placed in the DOWN position and the pump handle was moved from stop to stop which resulted in positive hydraulic fluid flow out the down port. The flap selector lever was placed in the UP position and hydraulic fluid flowed out the up port when the pump handle was moved. See figure 2.

*Figure 2. Hydraulic flap pump exhibiting positive flow.*

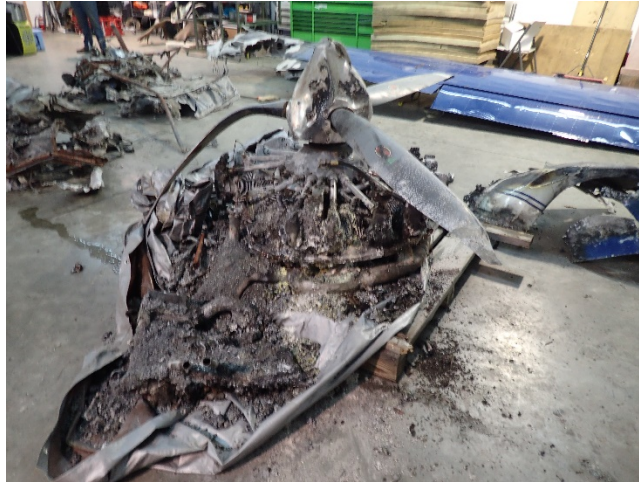
The engine rear accessory section was melted, and accessory gears were liberated from the assembly. The propeller was attached to the crank shaft and the forward propeller hub was intact with soot and orange oxidation present. All 9 cylinders were present, however when debris (mud, dirt, and mortar) was cleaned away from the No 4 and 5 cylinders, the no. 4 cylinder head detached. No. 5 control tube ends and valves were significantly burned and buried under hardened mortar and burned debris. The valve covers for cylinder numbers 3 through 7 displayed thermal damage and black, white, and yellow deposits. All of the interconnecting oil lines were burned or missing with charred deposits present. The oil sump was intact. The air intake and exhaust tubes exhibited impact deformation and oxidation, with most significant crushing aft of cylinders 4 -8. All control rods were intact and straight. Spark plugs were removed from each cylinder except for No. 4 which was not located and presumed to be in the hardened mortar mix that was removed from the cylinder. All spark plugs exhibited dark orange oxidation deposits and no. 5 exhibited white crystalline granules and no. 7 exhibited extensive oxidation and some white crystallization. All spark plug wear appeared normal. The carburetor exhibited extensive thermal damage with the throttle valve separated and melted. The mixture control rod was attached, and the throttle arm was attached to the throttle valve which was detached and burned. The air intake was charred and destroyed. See figure 3.

*Figure 3. Pratt and Whitney R-985 engine and propeller exhibiting mechanical and thermal damage.*

The engine crankshaft could not be rotated due to extensive damage and melted mortar debris, therefore valvetrain and crankcase continuity was not established.

The propeller was attached, and each blade exhibited thermal discoloration or deformation. One blade was bent aft with some torsional twist, and the other two blades were straight with impact and thermal deformation at the outer ends.
