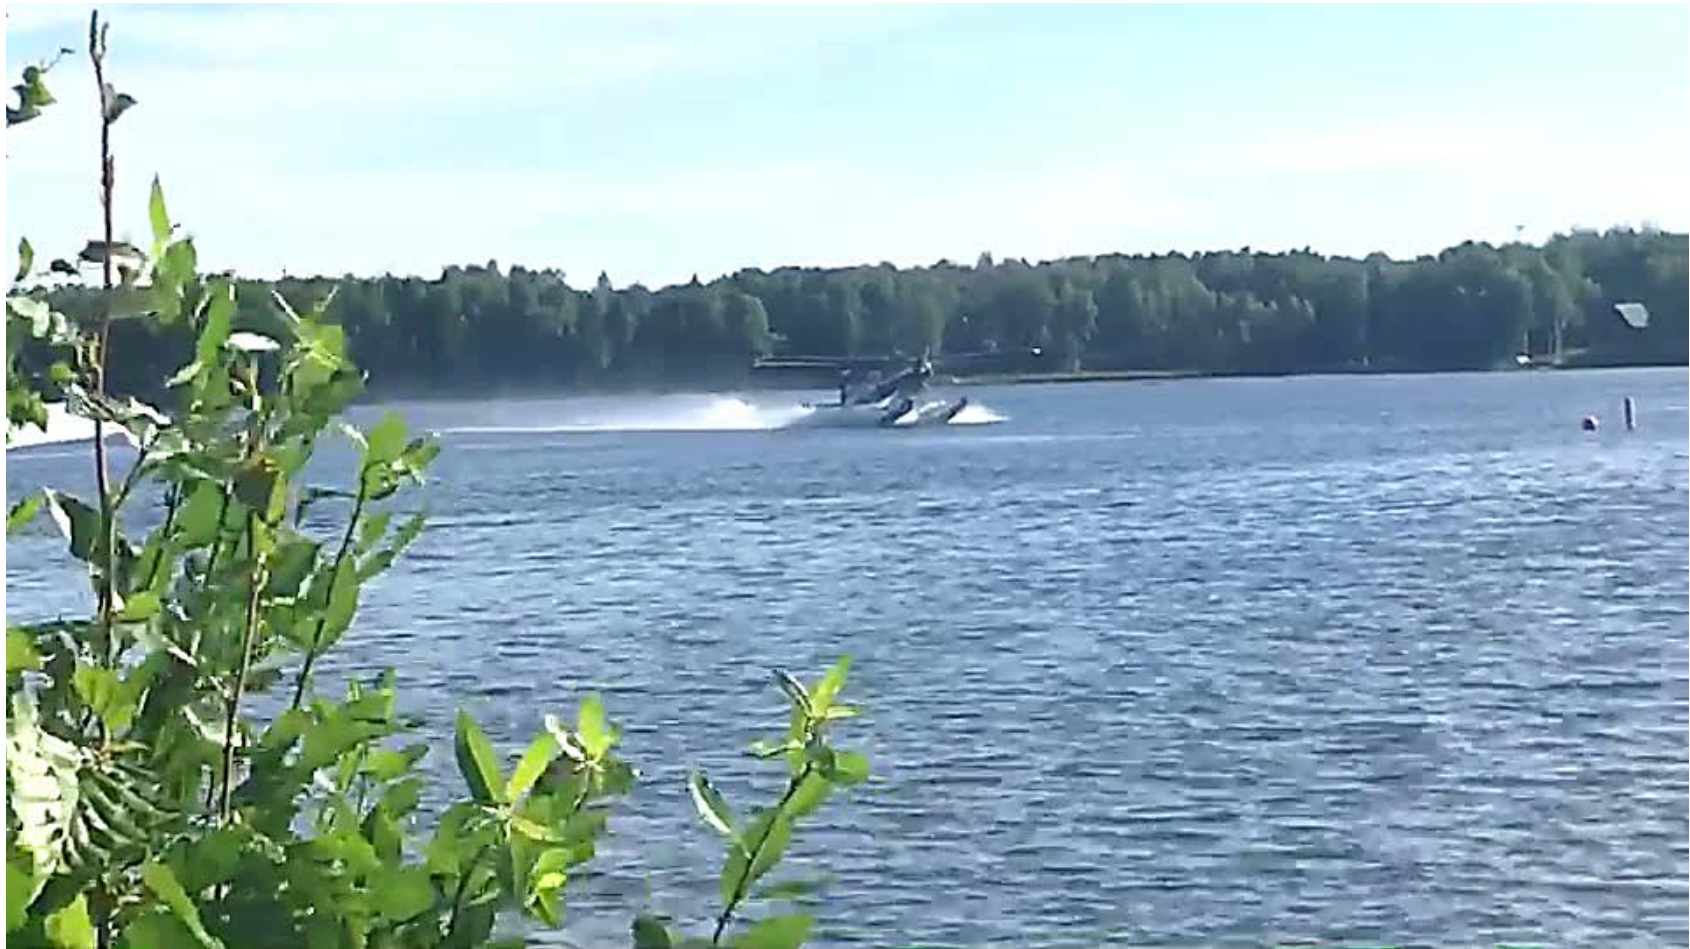
**Photo 1 – Video clip of N9878R taxiing back after aborted takeoff. (Courtesy of Phil Stanger)**

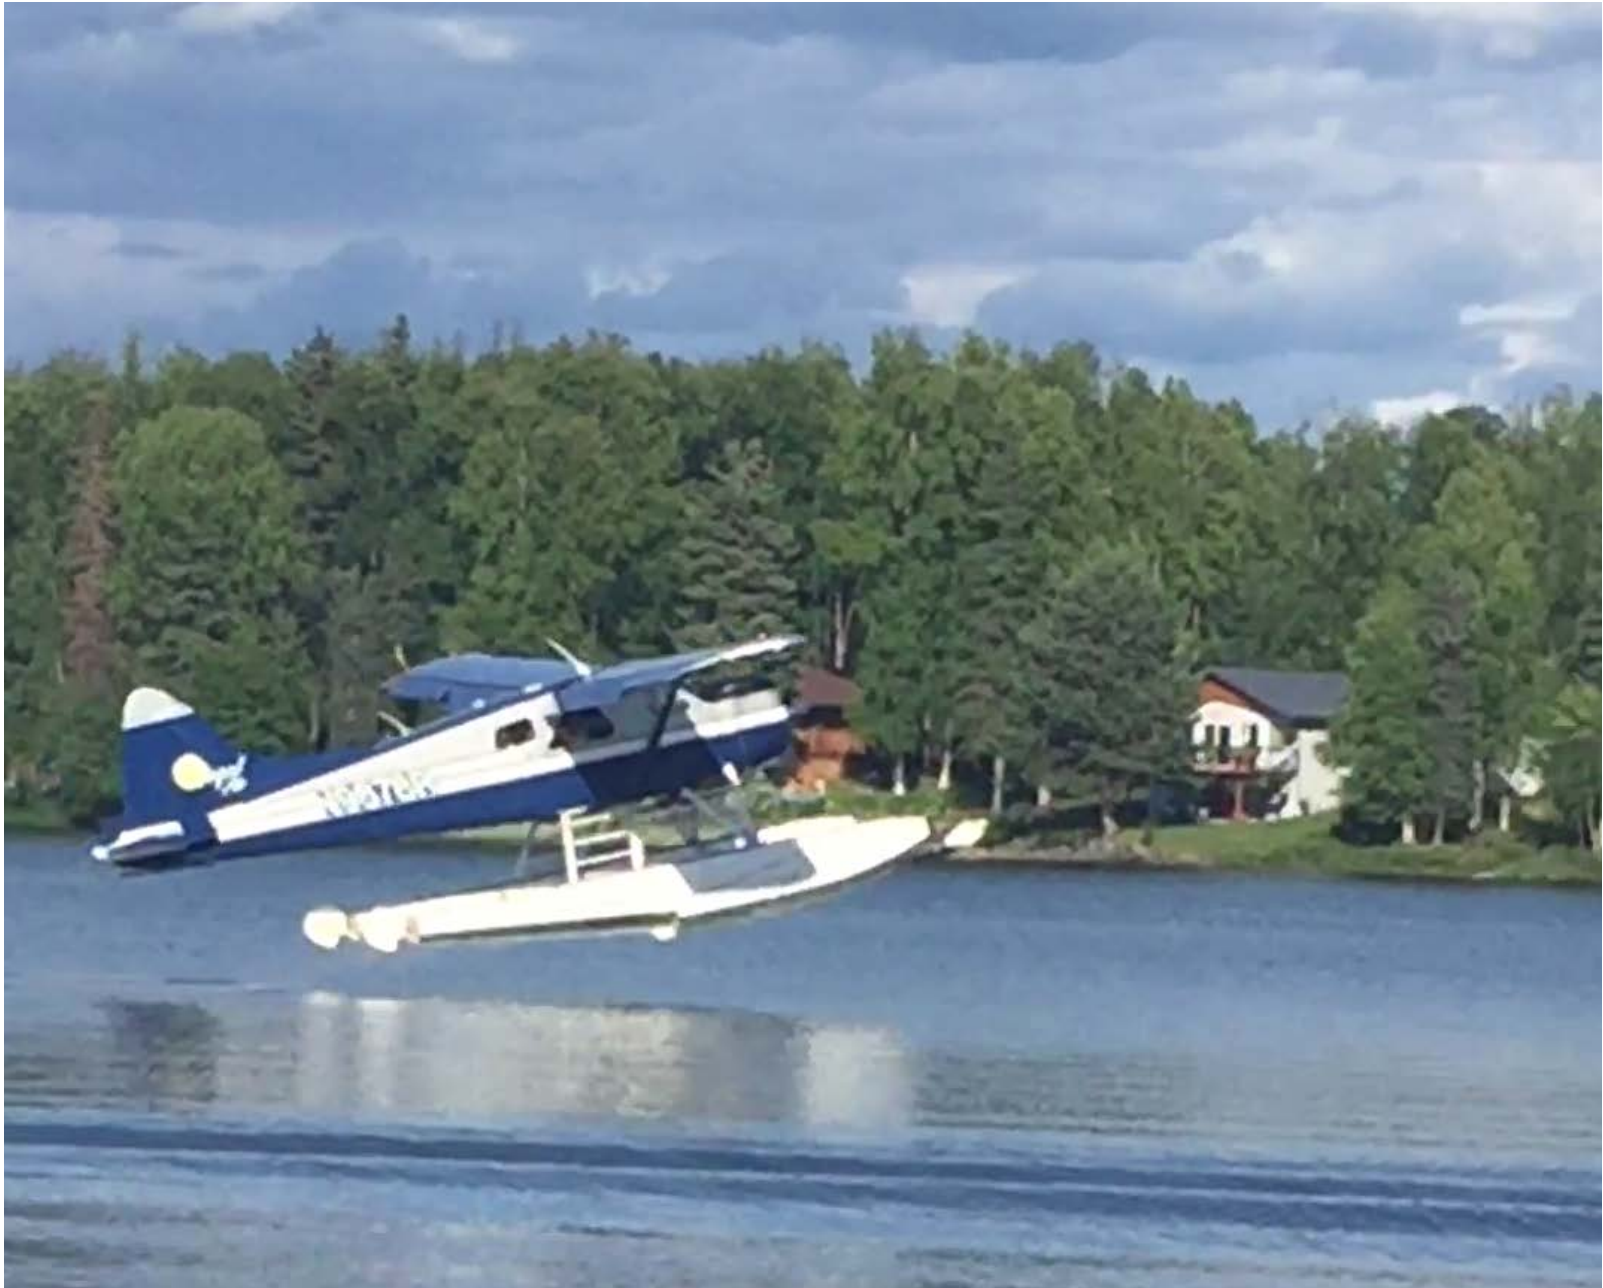
**Photo 2 - Video clip of the airplane after takeoff. (Courtesy of Marty Spinde)**

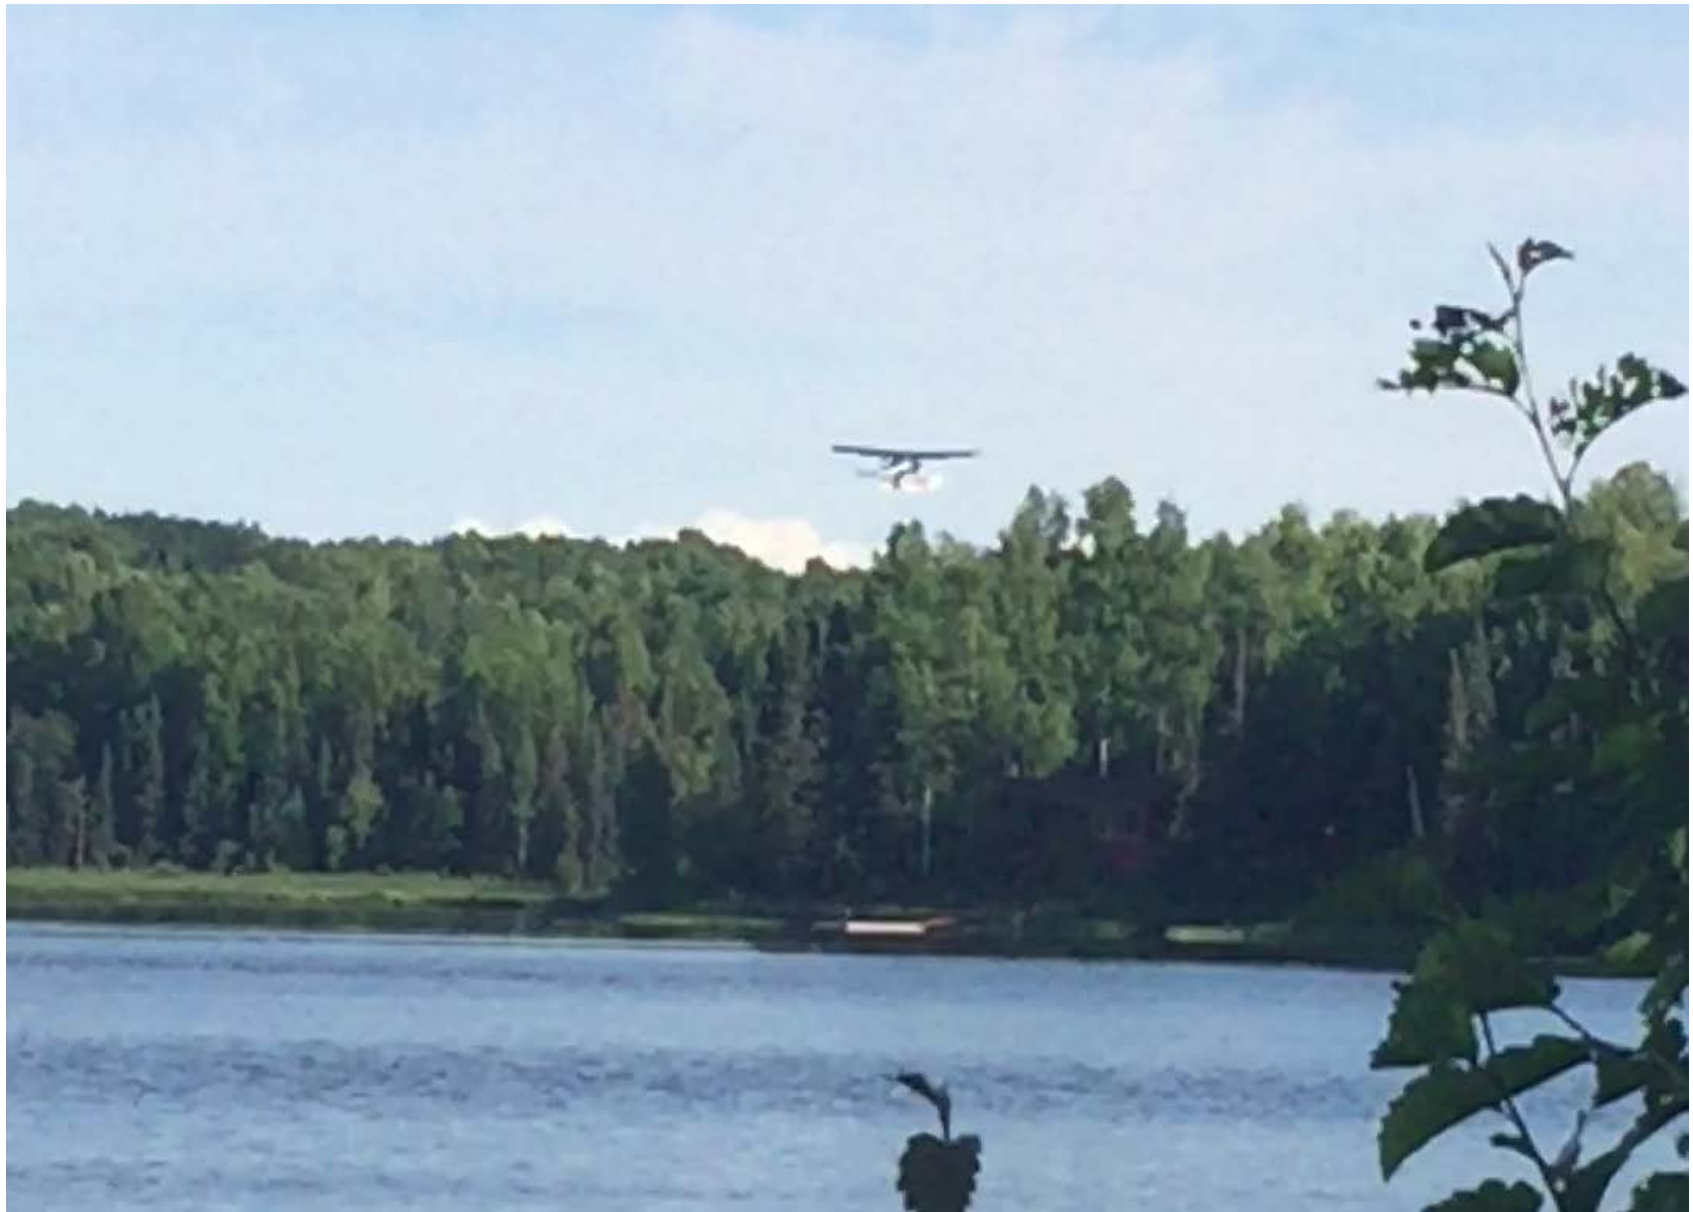
**Photo 3 - Video clip of the airplane climbing to the south. (Courtesy of Marty Spinde)**

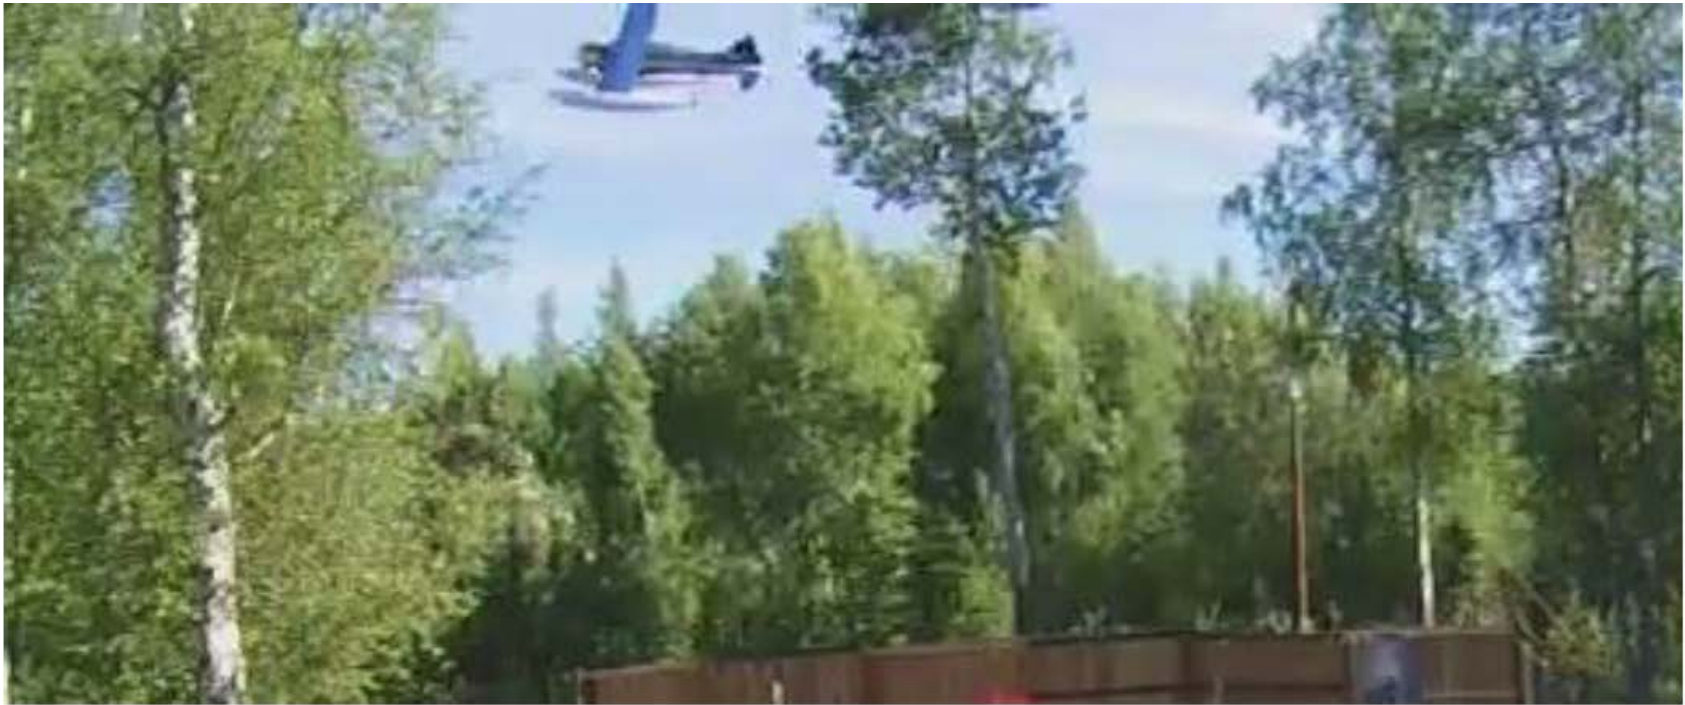
**Photo 4 - Video clip from south facing security camera seconds before impact. (Courtesy of Marianne Shoppmeyer)**

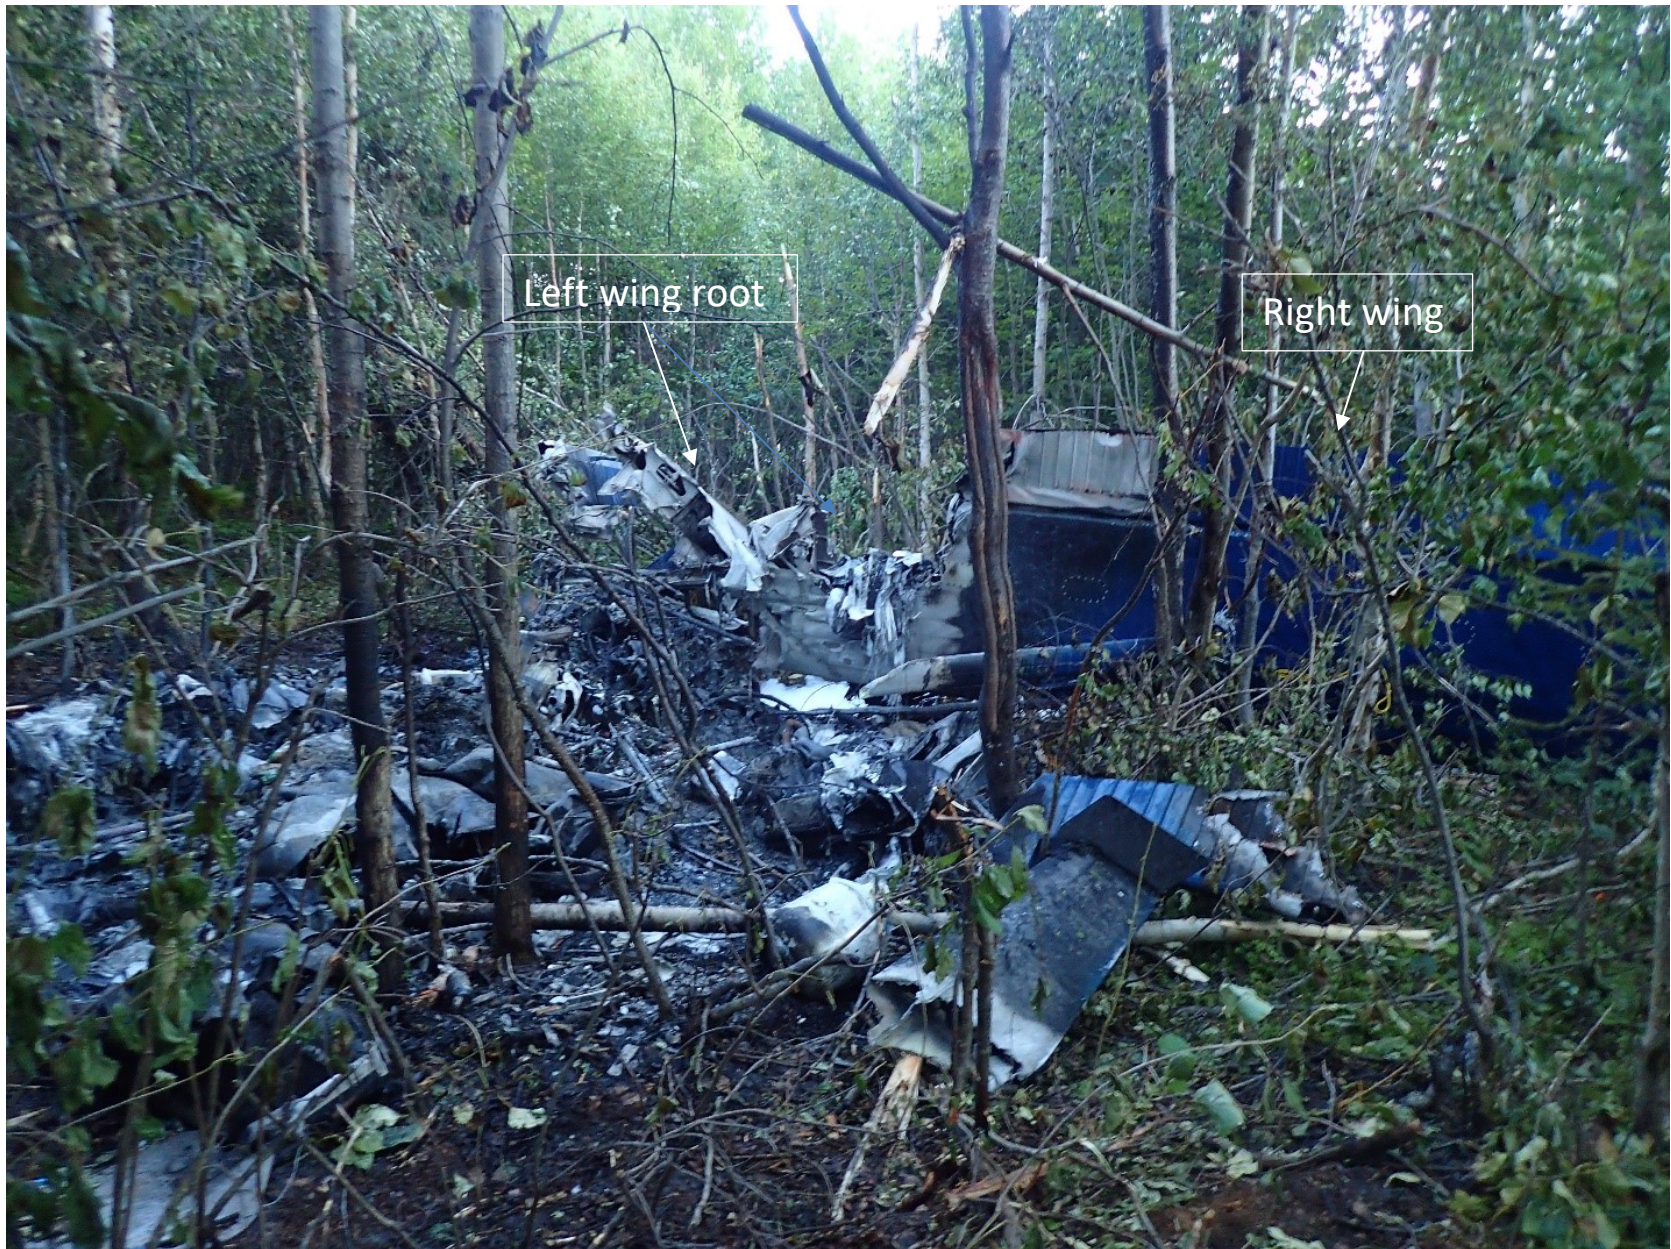
**Photo 5 - Westerly view of wreckage.**

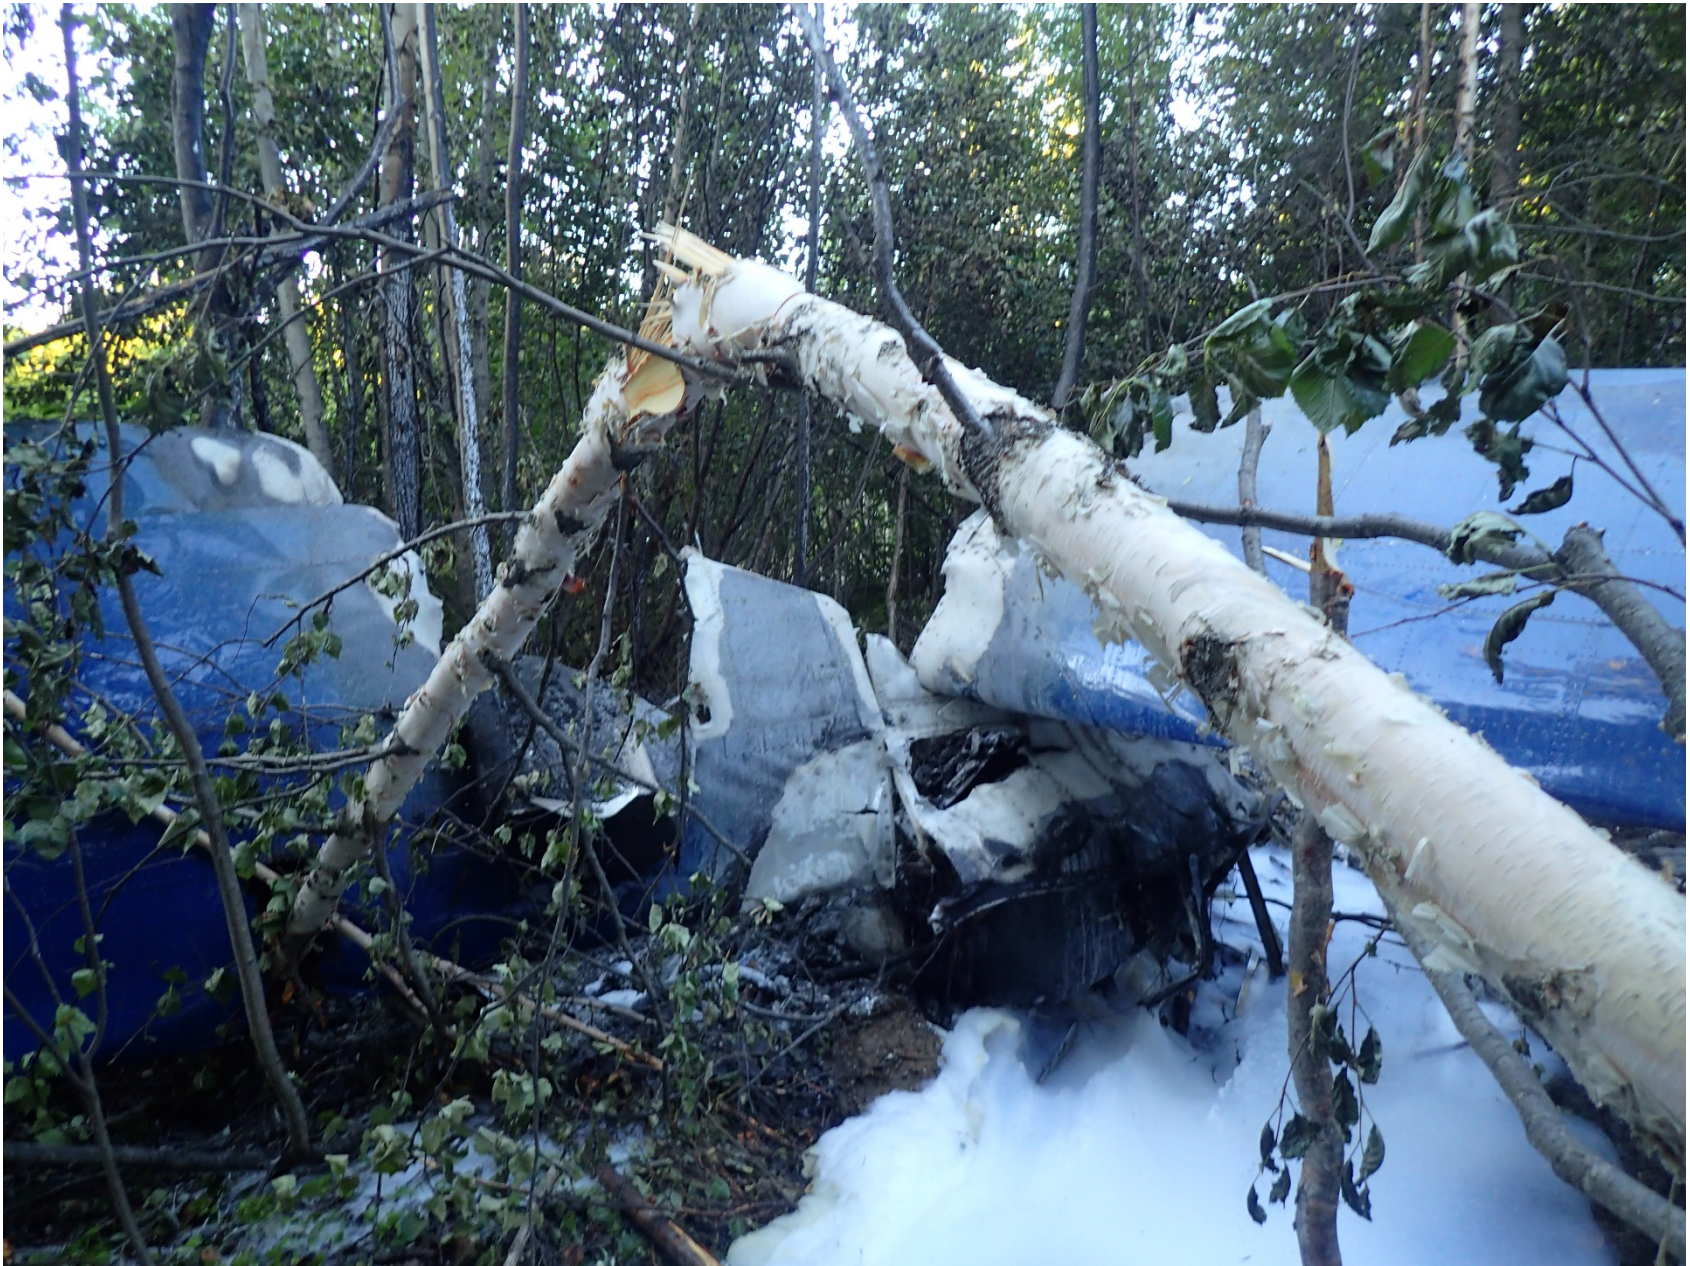
**Photo 6 - Easterly view of wreckage.**

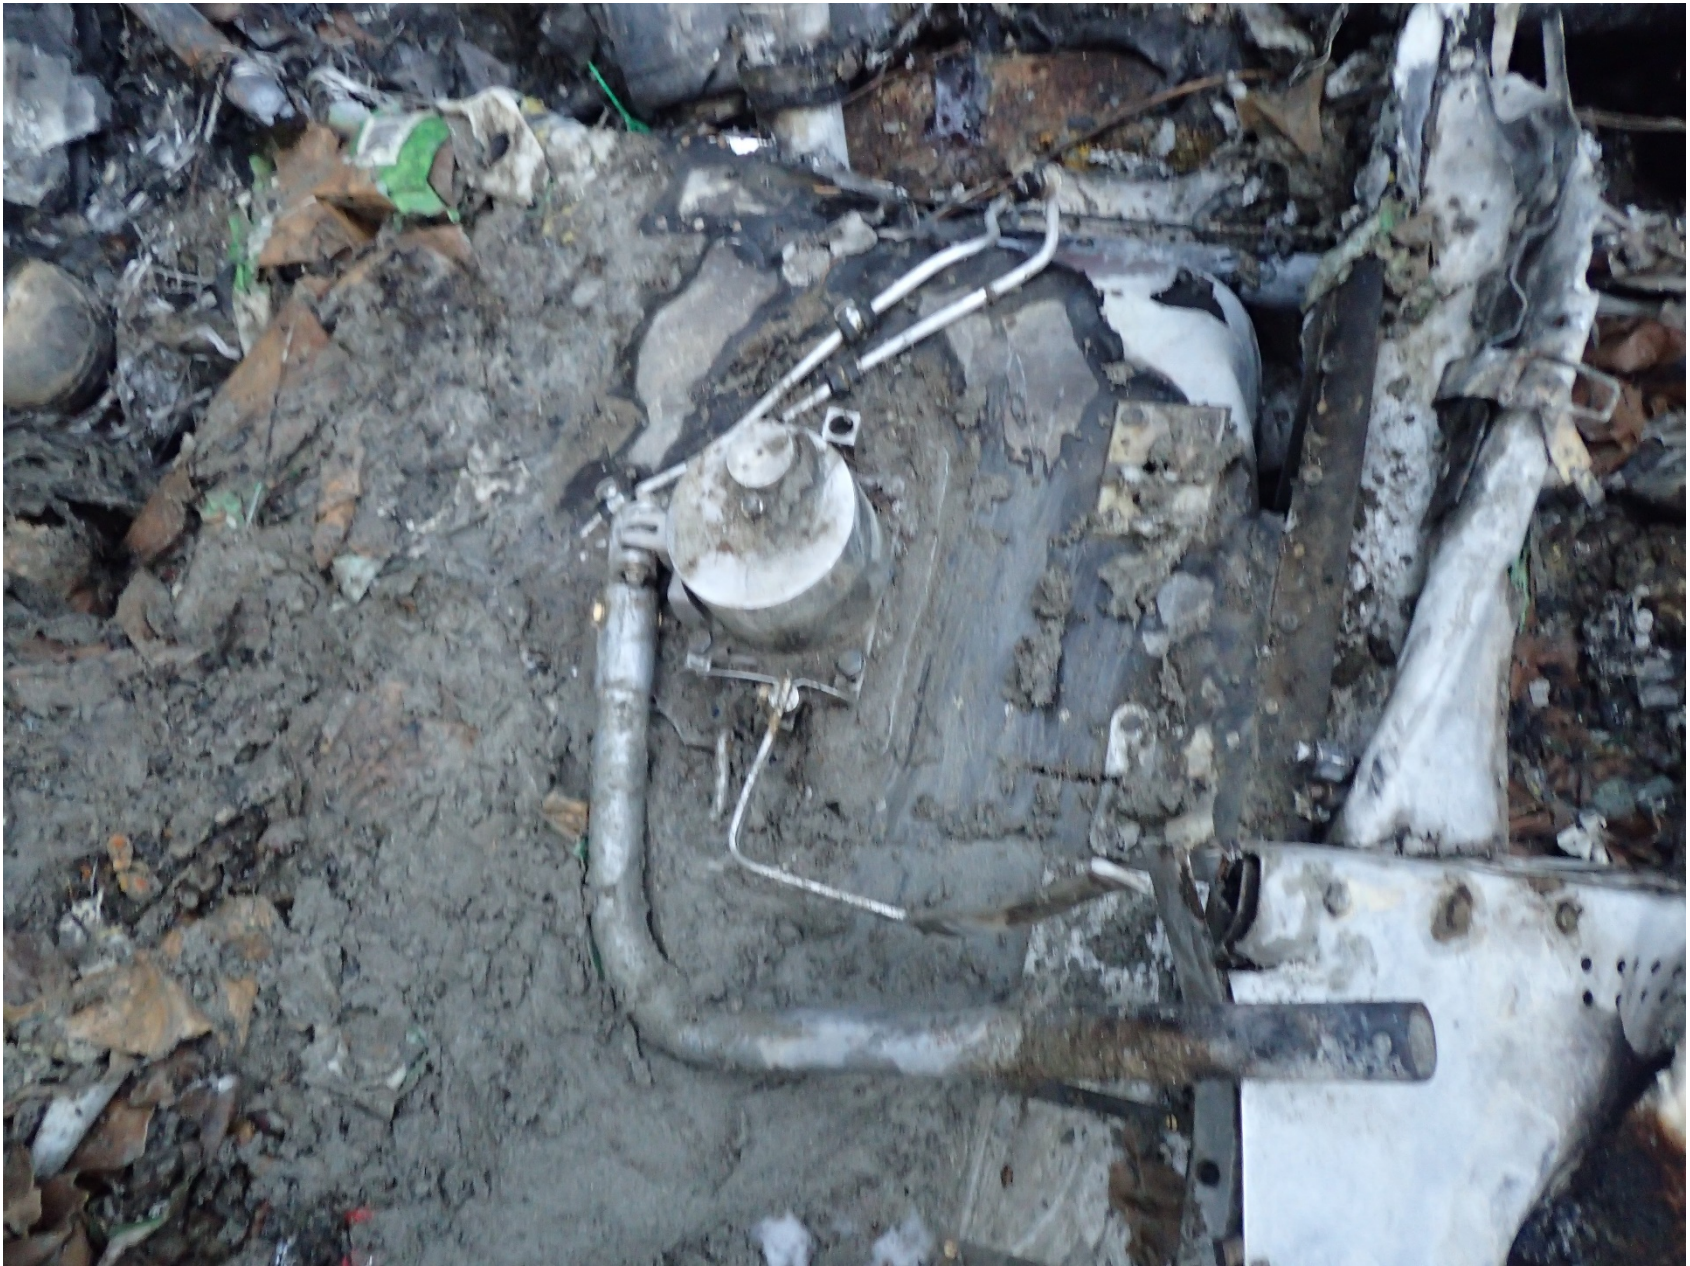
**Photo 8 - Hydraulic reservoir and flap pump and flap selector indicating down positions.**

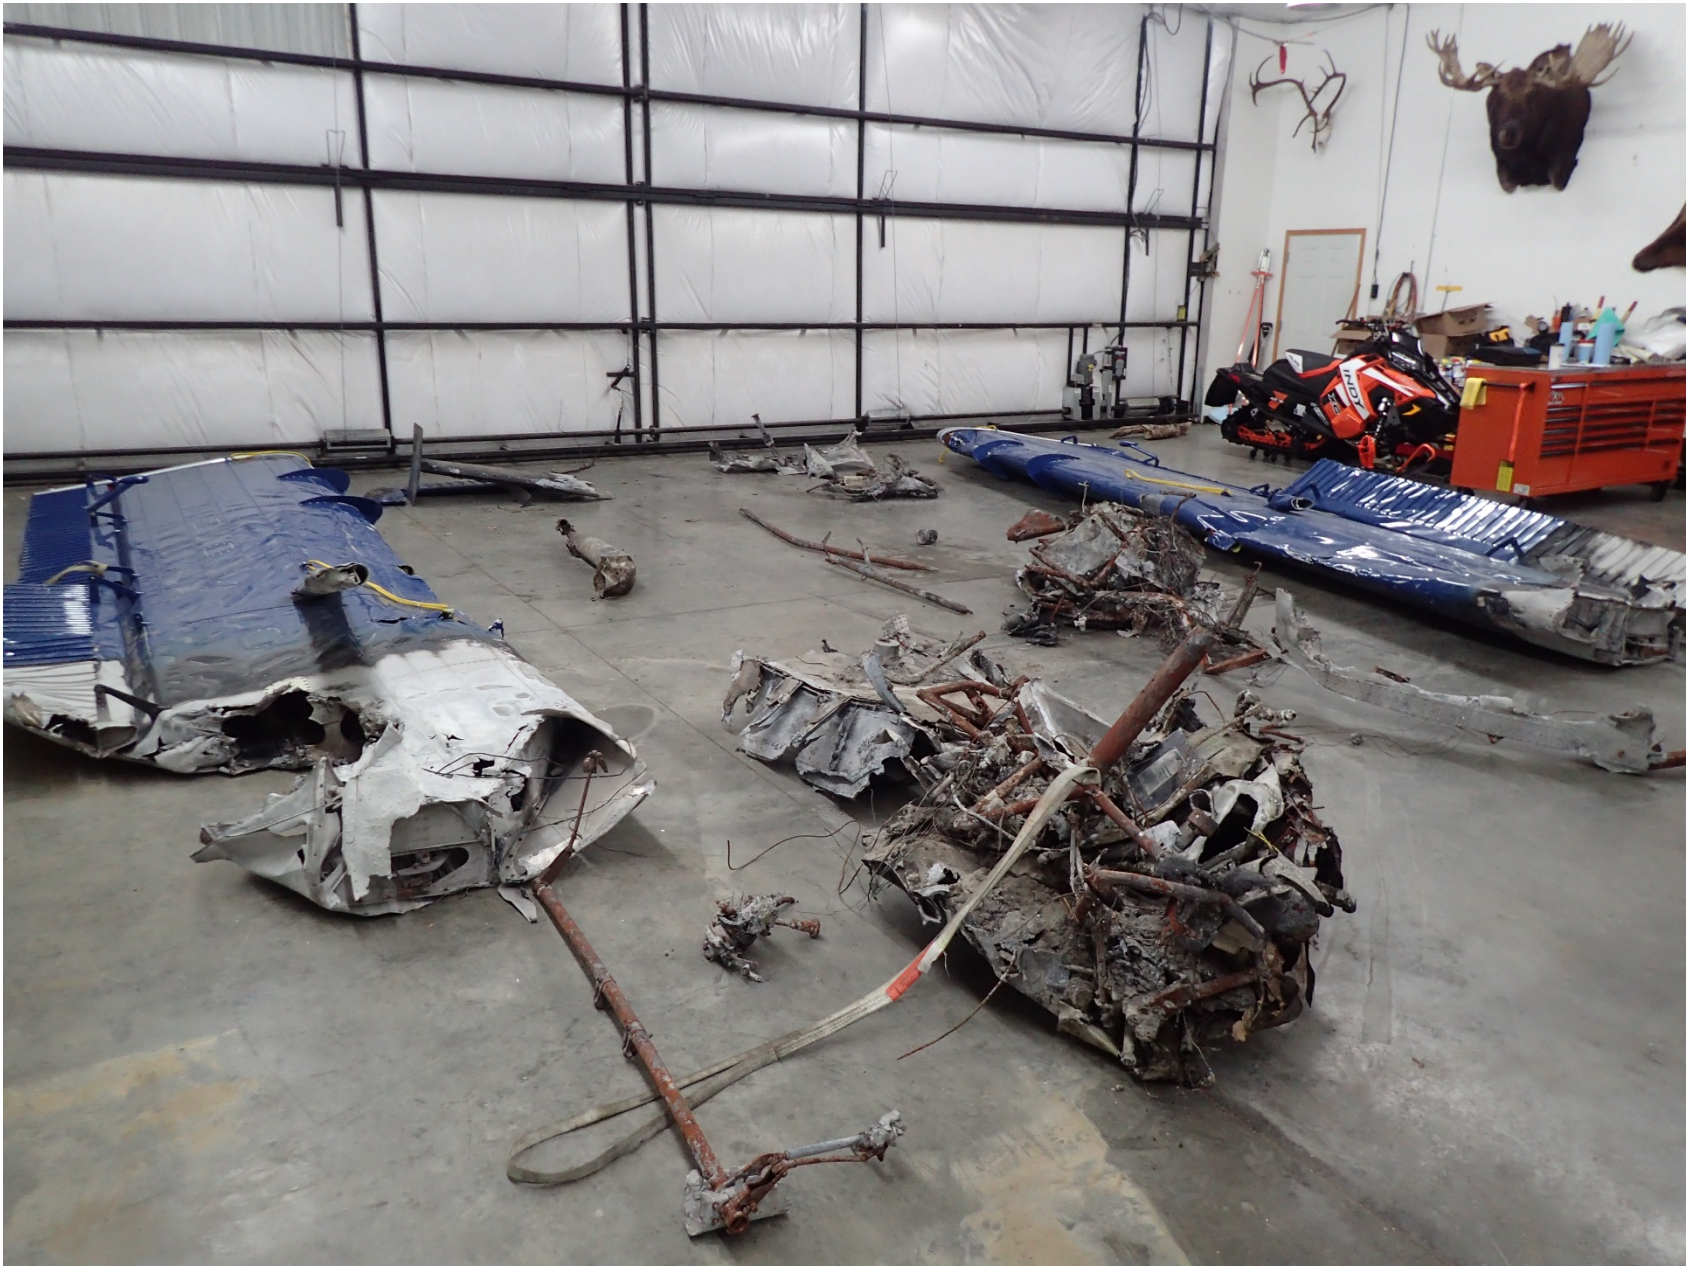
**Photo 9 - Wreckage at hangar during examination.**

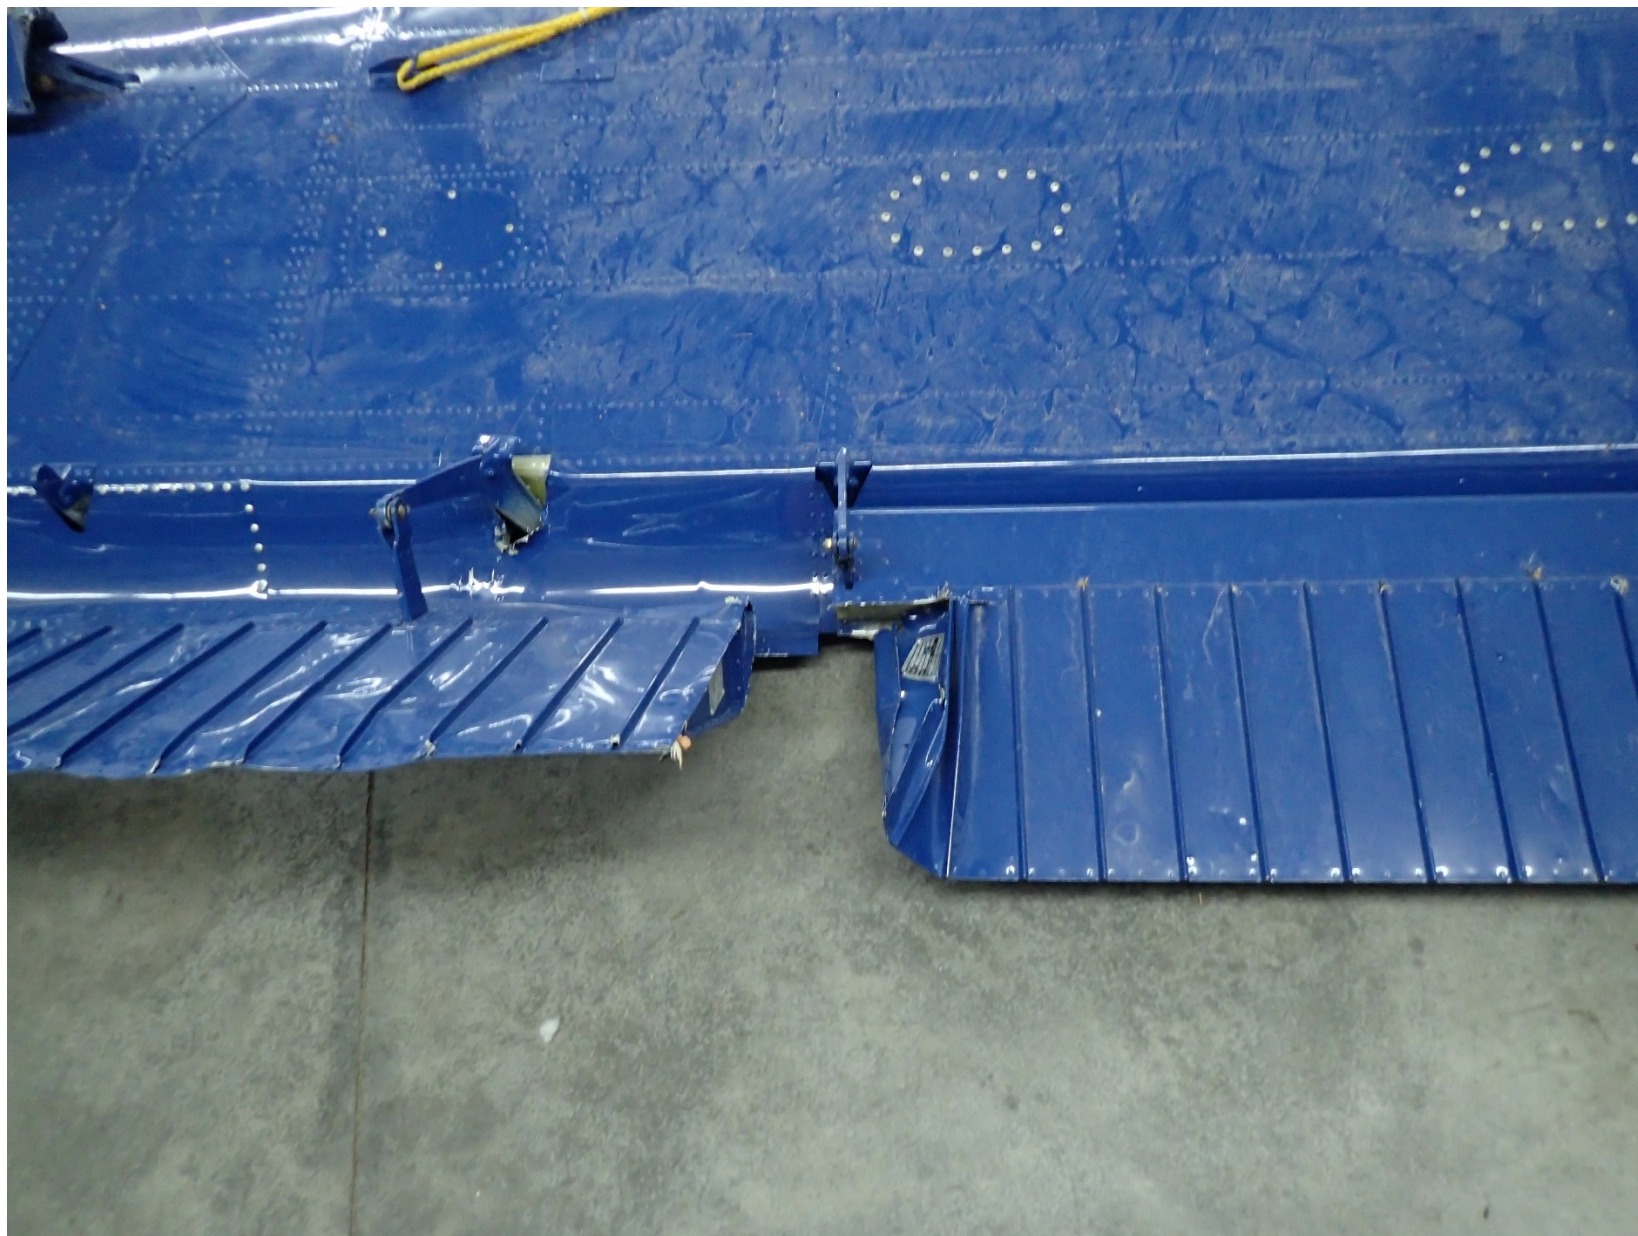
**Photo 10 - Left flap and aileron indicating impact deformation.**
