# Continental Motors

## ENGINE RUN REPORT

| ENGINE MODEL | TSIO-550-K1B |
| AIRCRAFT MAKE & MODEL | Cirrus SR22T |

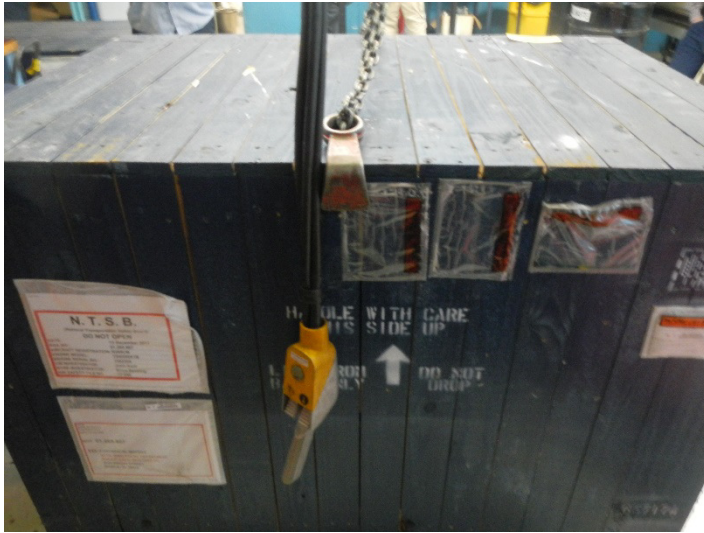
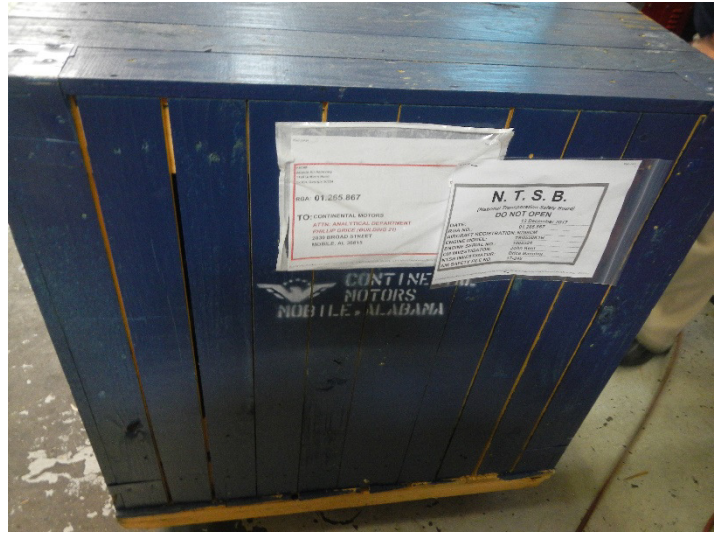
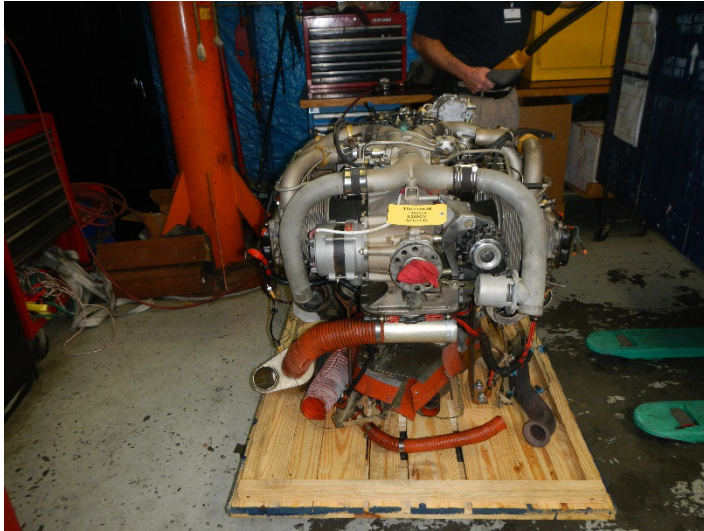
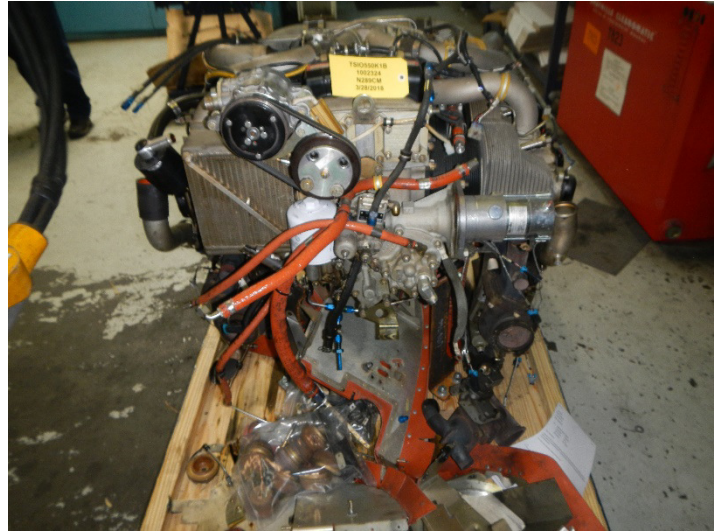
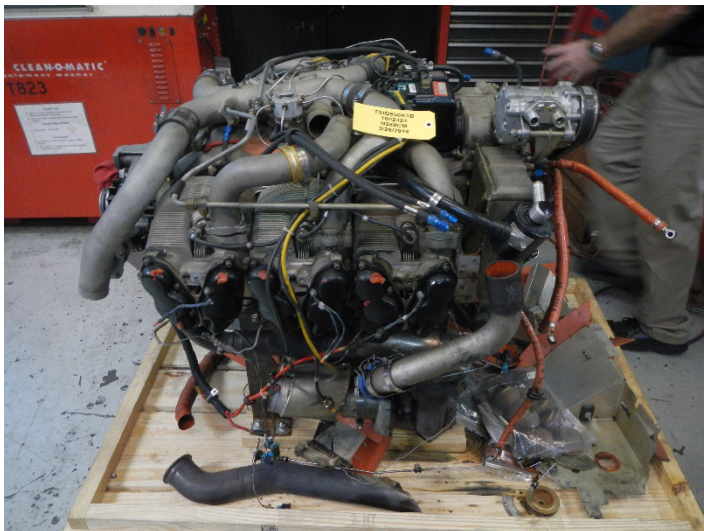
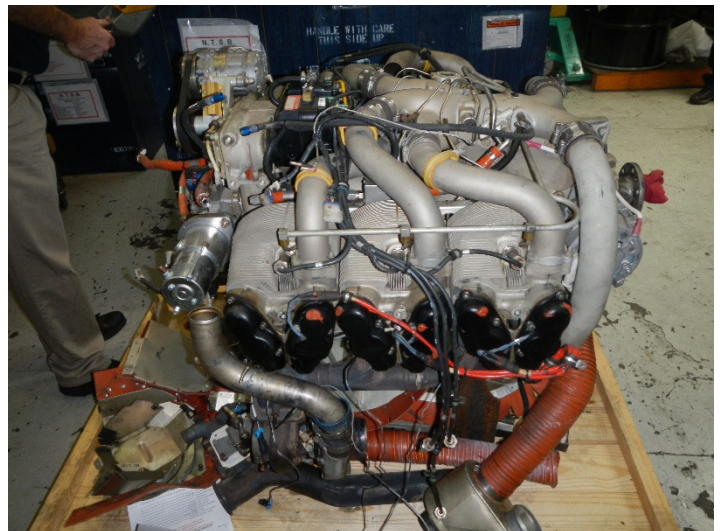
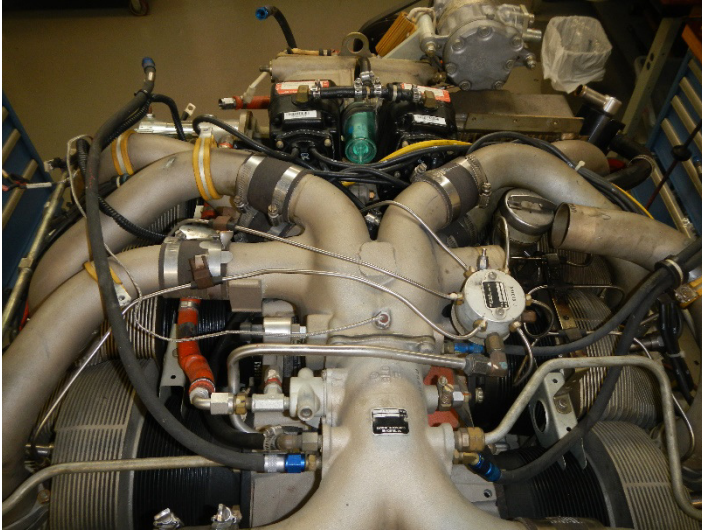
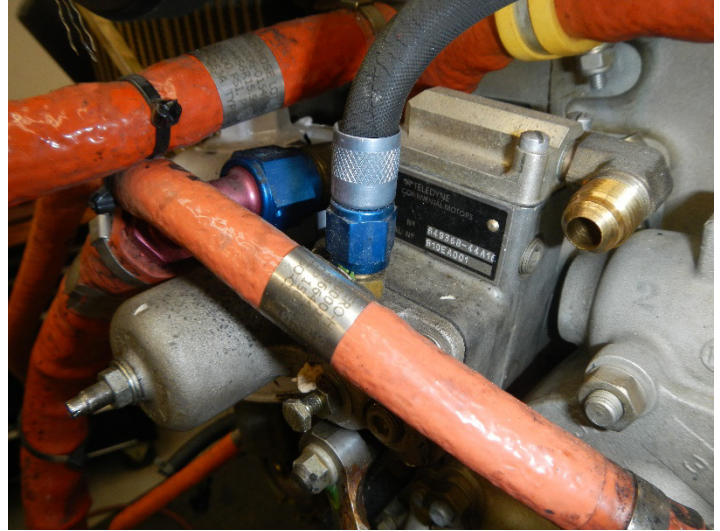
The engine was mounted in the crate with the cooling baffle and intercoolers removed. A number of intake tubes were displaced and the waste gate was located within the crate with the tailpipes. The bottom ignition leads were not attached to the bottom sparkplugs. The slope controller was not located in the crate and was shipped to the factory separately.

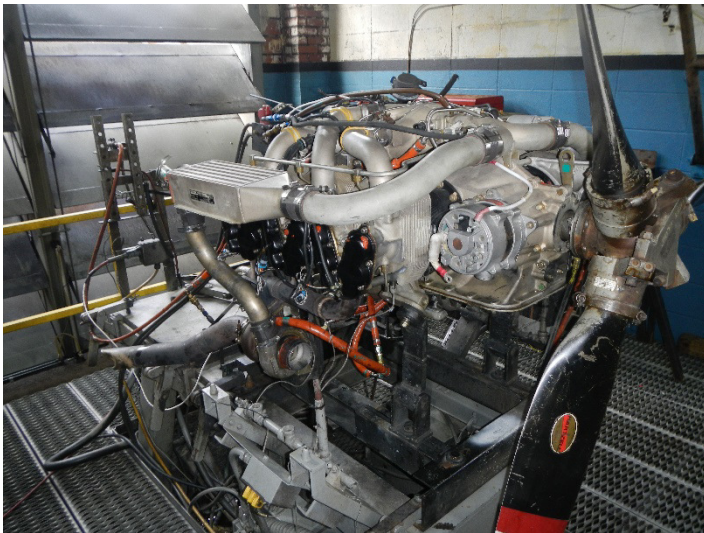
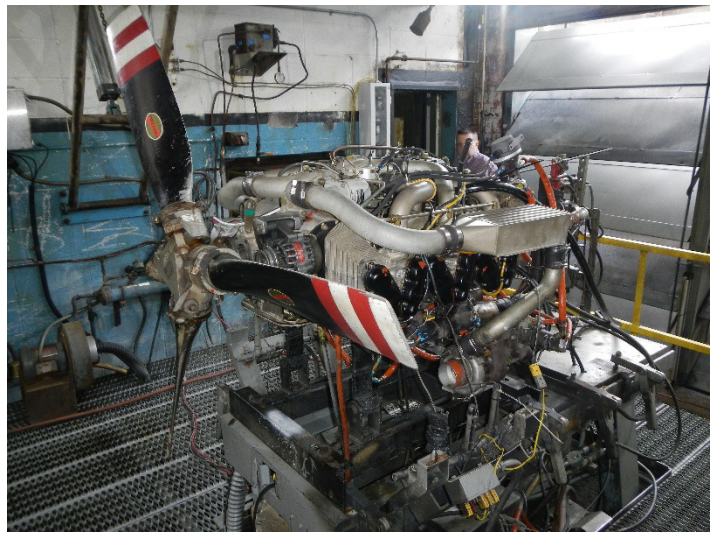
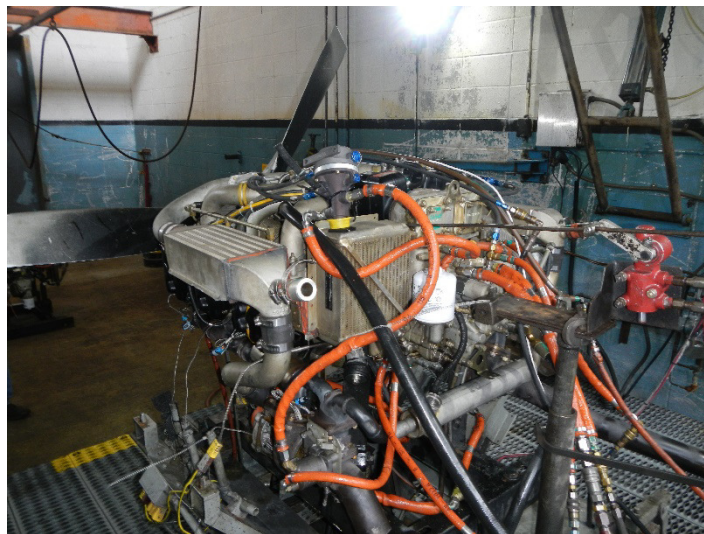
Priming fuel was applied to the engine and a leak was observed from the engine-driven fuel pump. It should be noted that the leak was not observed during the initial test run on the airplane. The pump was removed from the engine and, without adjusting any settings, the low pressure relief valve diaphragm and mixture shaft O-ring were removed and replaced. The diaphragm exhibited a crack on the spring side, but it did not appear to penetrate through. The pump was reassembled and placed on a test stand. When priming fuel was applied, the pump continued to leak. A decision was made by the NTSB IIC to utilize the pump as-is on the engine during the tests.

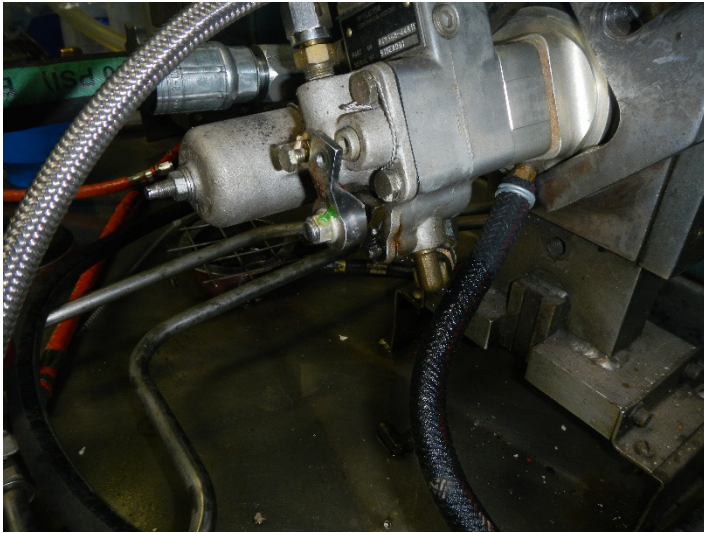
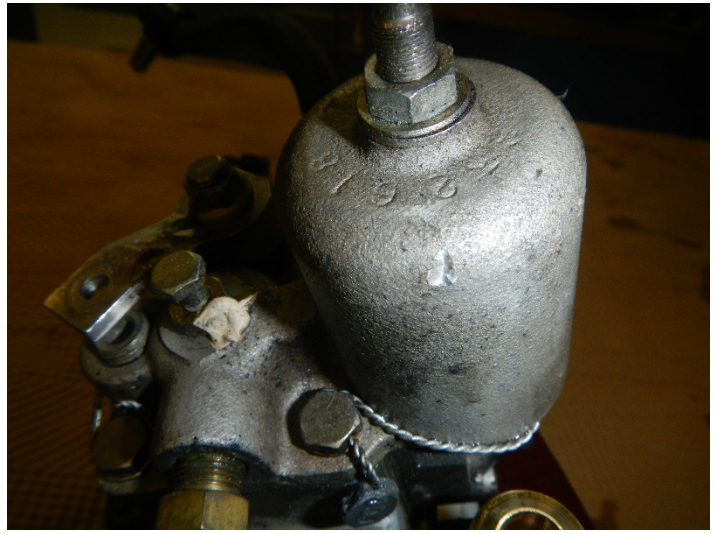
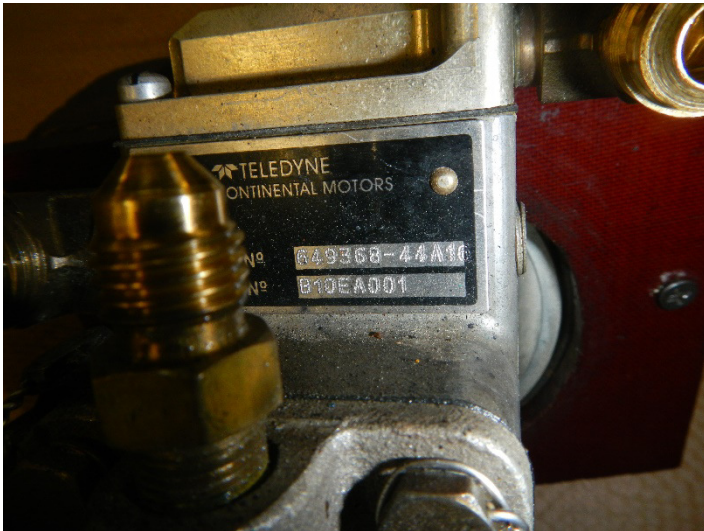
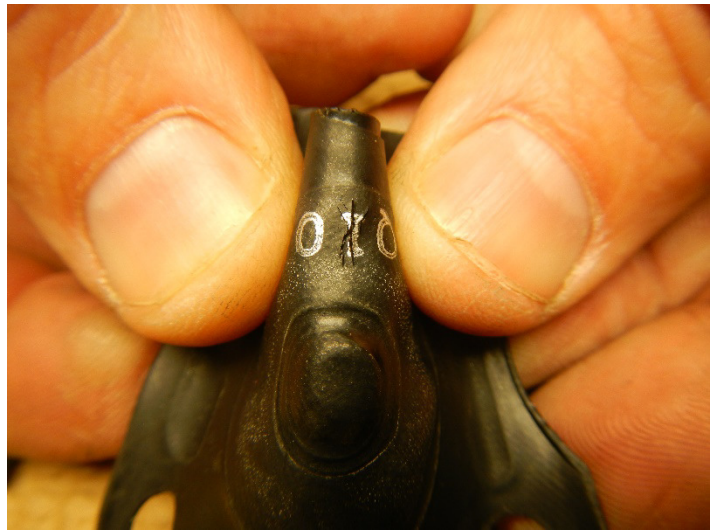
Due to the recorded engine parameters and pilot statement, the NTSB IIC elected to run the engine to record the parameters as-is. The engine experienced a normal start on the first attempt without hesitation or stumbling in observed RPM. As the throttle was advanced it was noted that the fuel flow exceeded the Continental Motors' full-throttle high-side limit once the MP surpassed 36". Continued movement of the throttle resulted in a MP of around 39" before the engine began experiencing fuel flows that were too excessive to support combustion. The slope controller was then adjusted to bring the MP down to that specified by Cirrus (36.5") and the engine test run continued with high fuel flows. The engine throttle was rapidly advanced after adjustment from idle to full throttle five times where it performed normally without any hesitation, stumbling or interruption in power.

Overall, it was determined that both the slope controller and the fuel pump were adjusted in excess of that specified by the manufacturers'. Otherwise, no pre-accident anomalies were noted with the remaining engine components.
