# NATIONAL TRANSPORTATION SAFETY BOARD

## MATERIALS LABORATORY FACTUAL REPORT

Report No. 19-004

Place : Lynchburg, Virginia  
Date : January 1, 2018  
Vehicle : Costruzioni Aero Tecnam P2006T, N594MA  
NTSB No. : ANC18LA018  
Investigator : Michael Hodges, AS-ANC

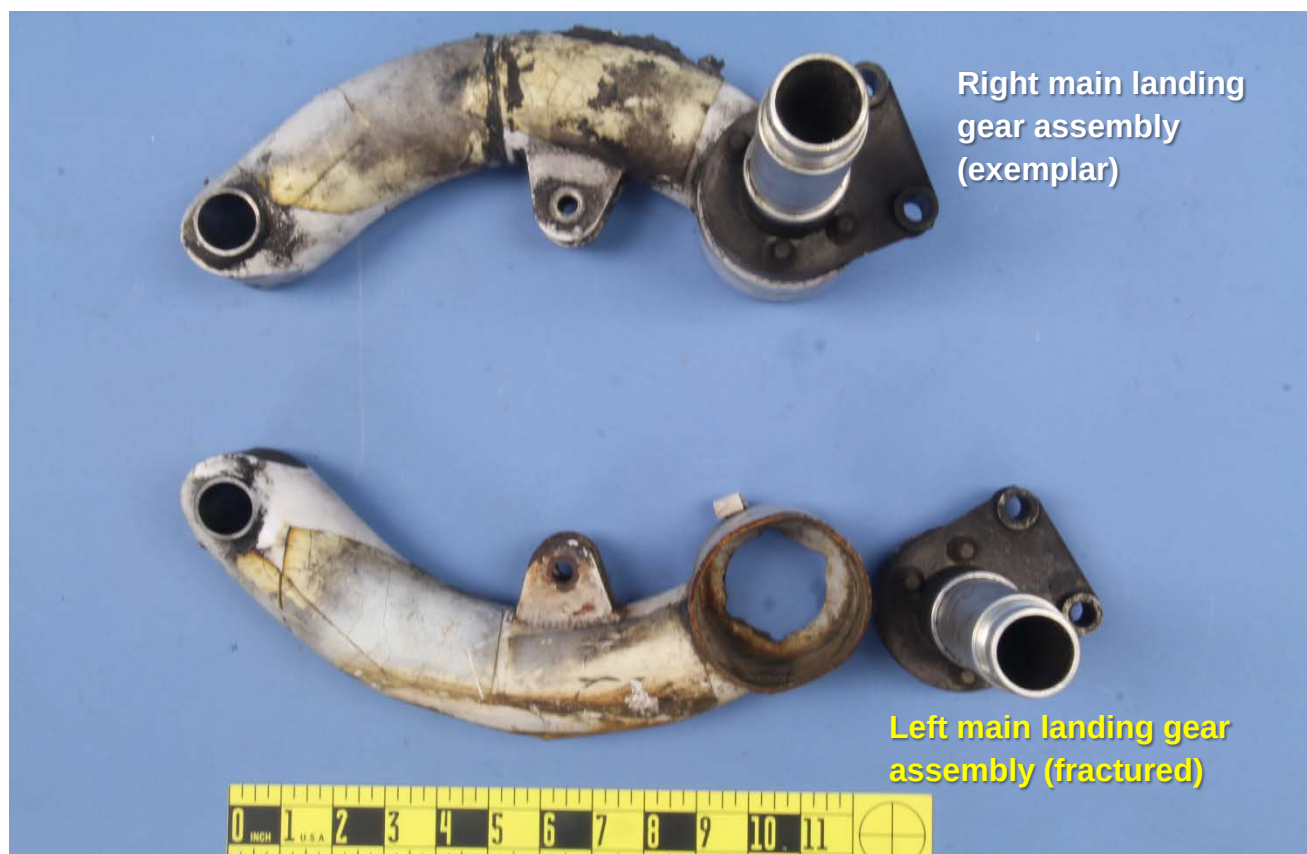
Figure 1 shows the landing gear assembly components, as received. The left main landing gear assembly had fractured along the interior circumferential weld on the attachment flange of the trailing arm. This flange is where the wheel hub axle and bushing plate affix. The right main landing gear assembly was intact and used as an exemplar reference. Figure 2 shows a side view, highlighting the location of the fracture.

Figure 1 – The landing gear assembly components, as received.

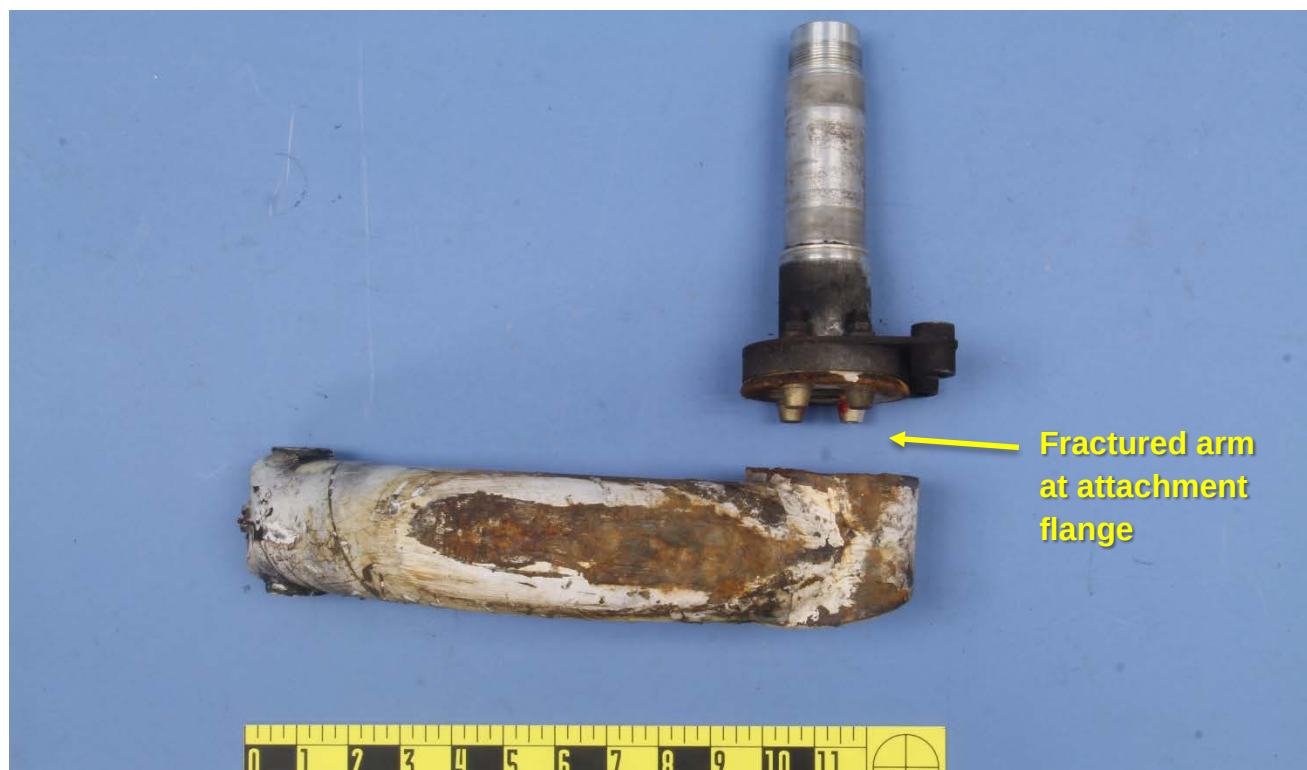
Figure 2 – The halves of the left assembly, positioned such that the fracture surfaces mate.

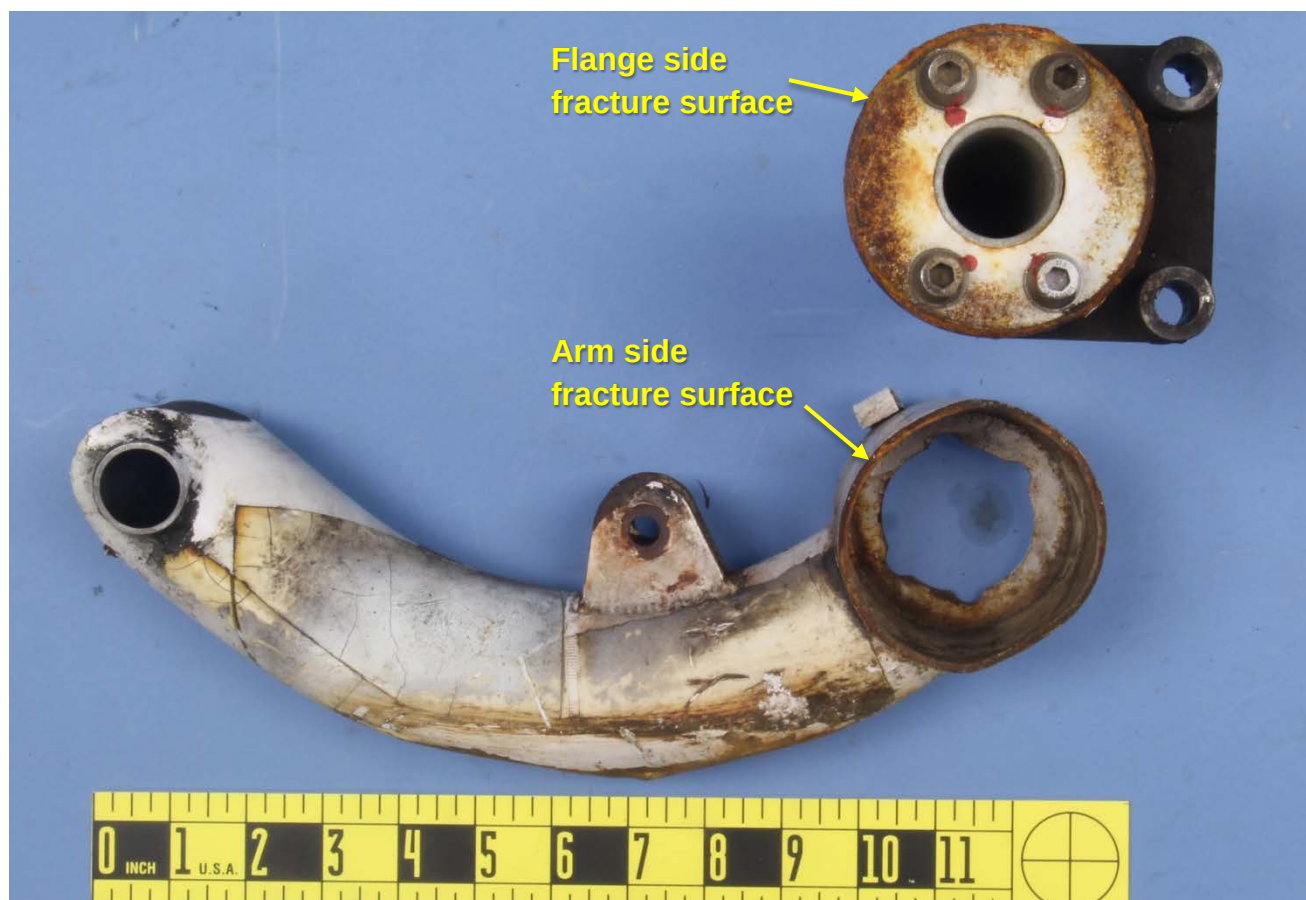
Figure 3 shows the mating fracture surfaces of the fractured circumferential weld on the strut, positioned to face the reader at the same time. The inside fracture was located along the weld on the attachment flange. The flange had been affixed to the axle via four attachment bolts. The mating outside fracture was located on the circumferential weld on the trailing arm tube. Figure 4 shows a closer view of the mating fracture surfaces. All of the fracture surfaces exhibited rust, consistent with post-fracture oxidation from exposure to moist air and water.

Figure 3 – The halves of the left assembly, with the fracture surfaces facing the reader.

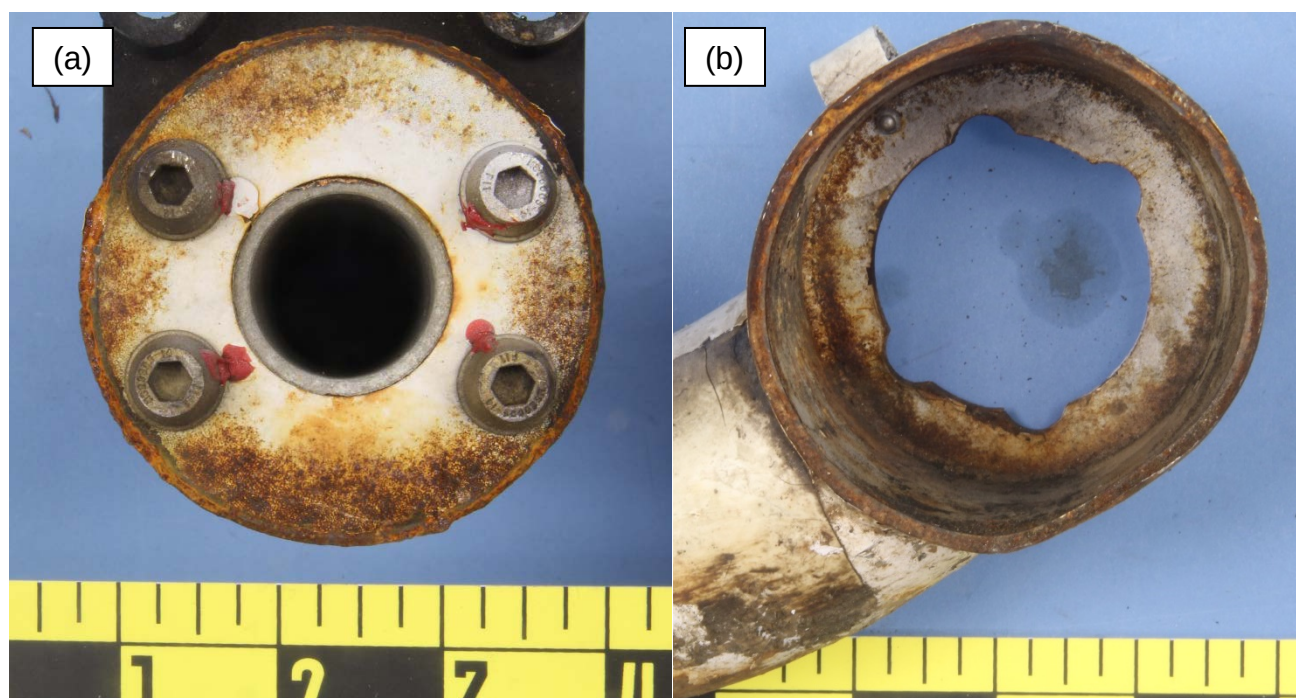
Figure 4 – The fracture surfaces from (a) the attachment flange side and (b) the arm side.

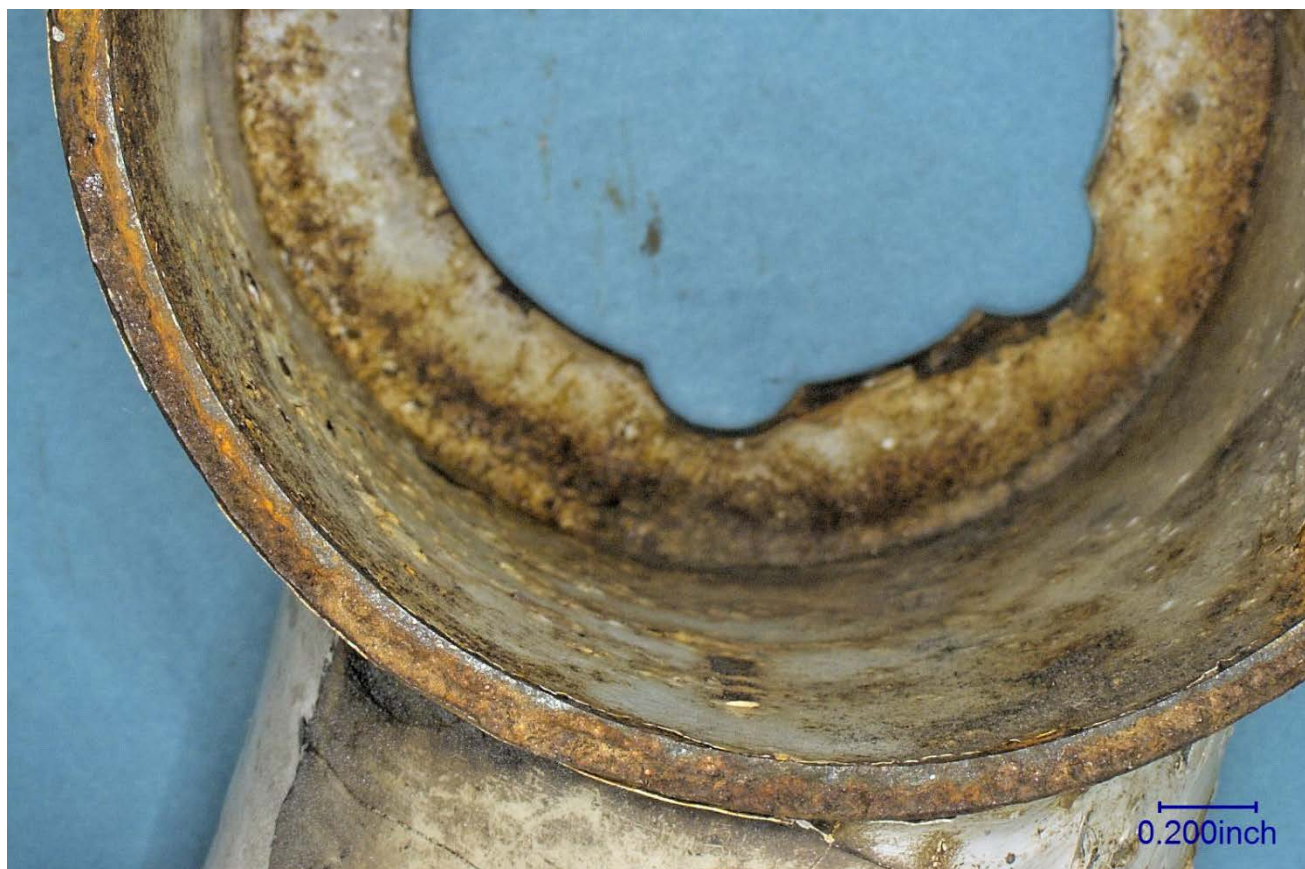
Figure 5 and Figure 6 show the fracture surface. The inner regions of the arm side fracture surface were shinier and flatter, consistent with an area absent weld filler material. Conversely, the outer areas exhibited a slanted morphology and rougher surface texture, consistent with a fracture through the weld filler. Figure 7 and Figure 8 show a portion of the arm side fracture surface before and after cleaning with acetone in an ultrasonic bath, respectively. Figure 7 shows elongated parallel marks on the inner surface of the tube. These marks were inconsistent with crack arrest marks, but rather they were consistent with machine or lapping marks made on the surface prior to welding. This flatter, shinier area was consistent with unwelded sections of the tube face.

Figure 5 – Closer view of the fracture surface from the arm side.

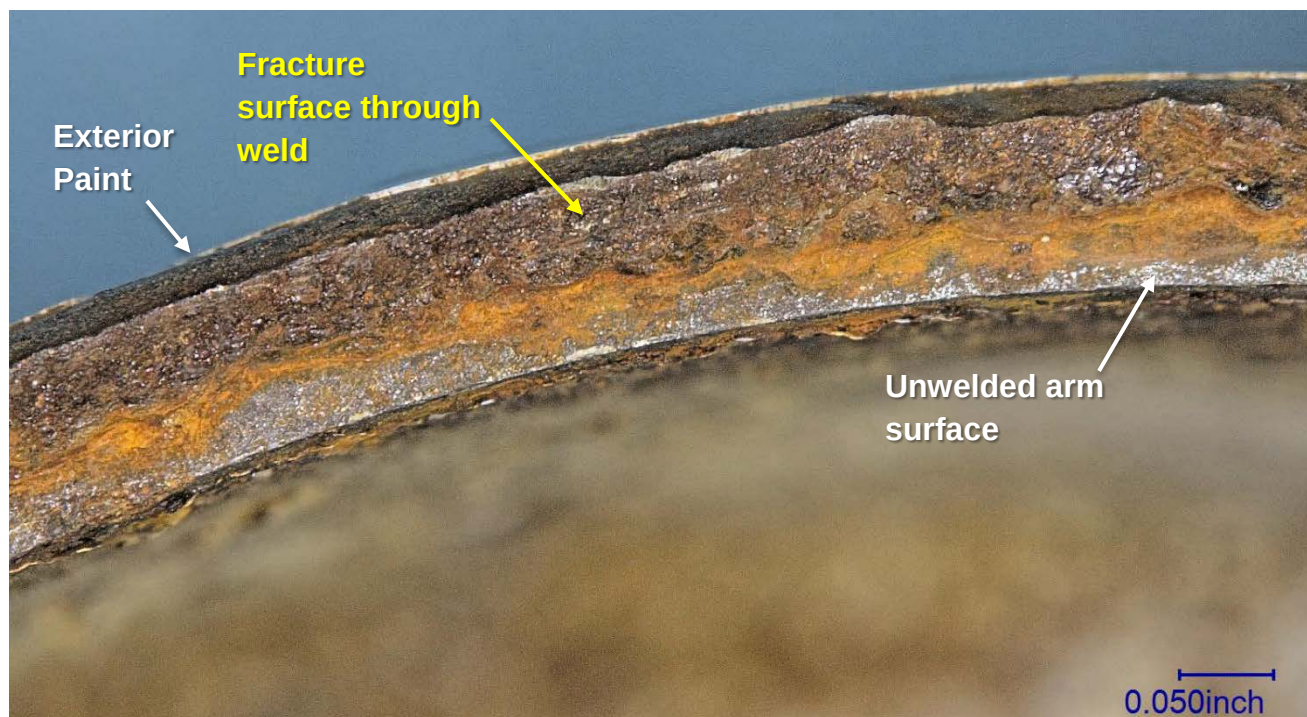
Figure 6 – View of a portion of the arm side fracture surface, showing fractured weld and unwelded surfaces.

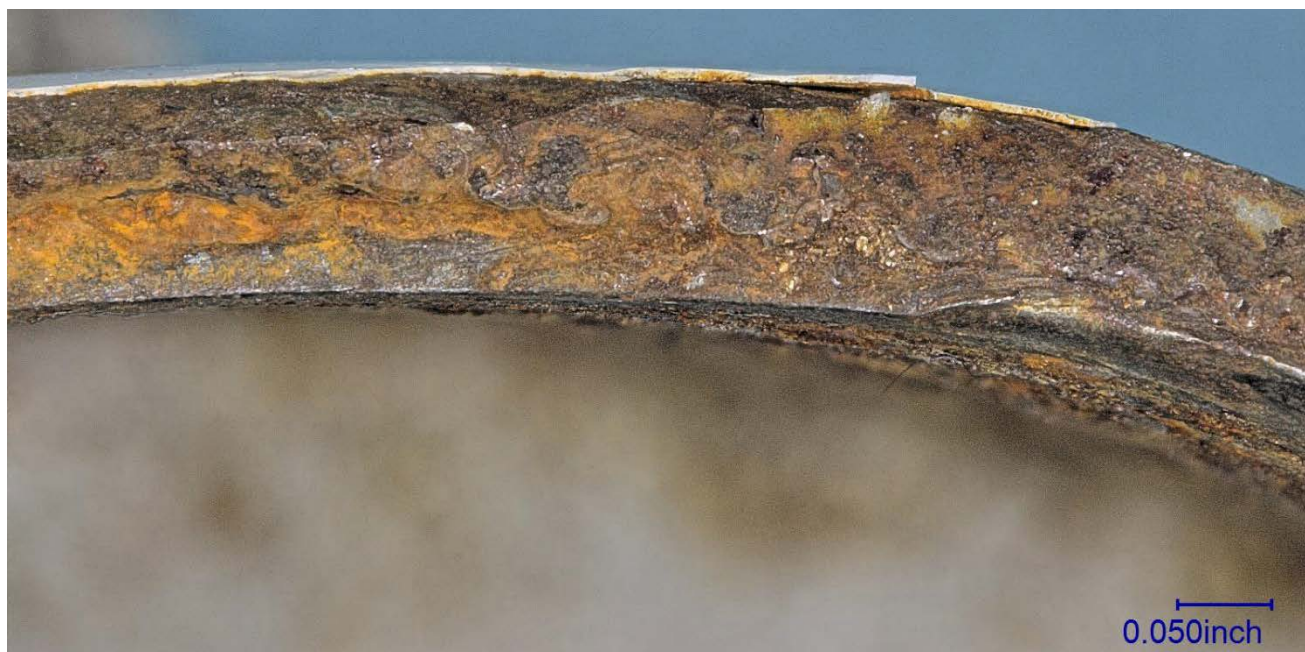
Figure 7 – A portion of the arm side fracture surface, prior to cleaning with acetone.

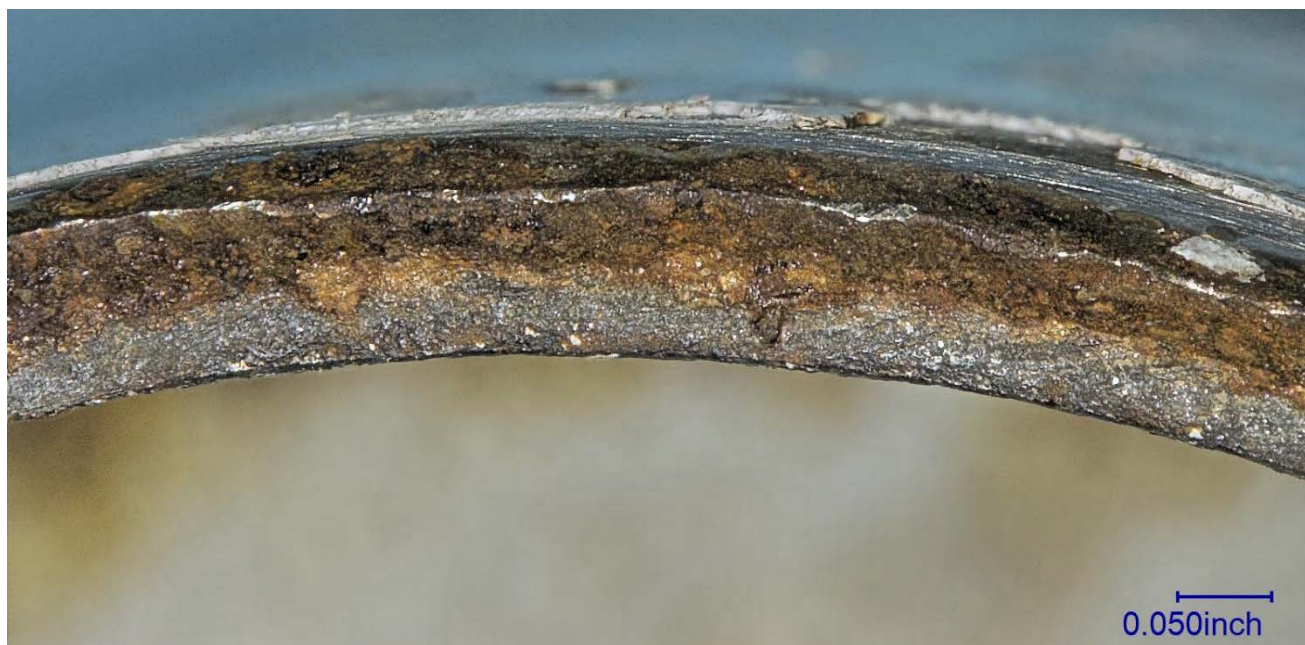
Figure 8 – A portion of the arm side fracture surface, after cleaning with acetone.

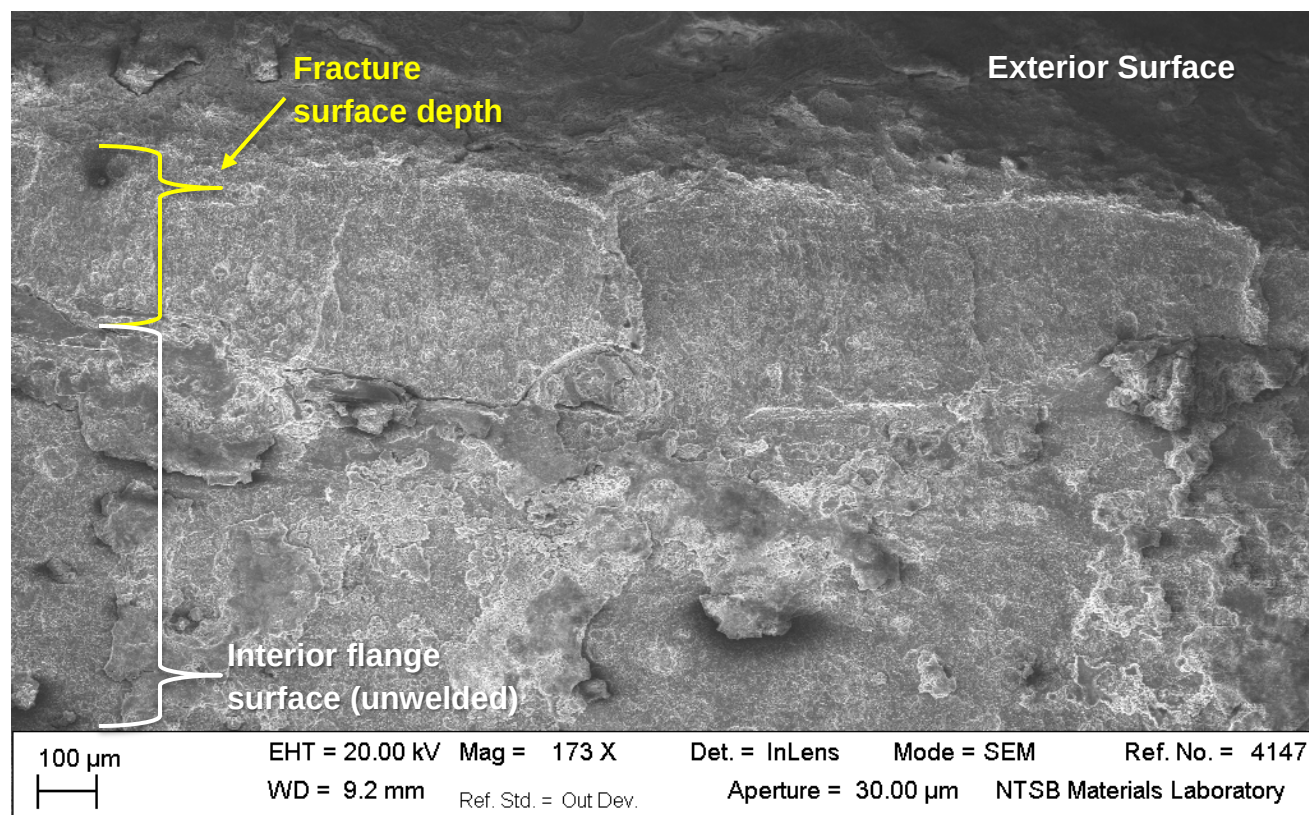
The flange side fracture surface was cleaned successively using acetone and then a solution with Alconox and water.<sup>1</sup> This fracture surface was examined using a scanning electron microscope (SEM). The majority of the fracture surface had been covered in rust-colored oxidation. When the cleaning process removed this product, the underlying fracture features had been obliterated, leaving pits and selected underlying microstructural features. While many of the microstructural features were damaged, some areas were relatively undamaged, such as illustrated in Figure 9.

Figure 9 is oriented such that the exterior of the flange faces upward (absent paint removed during cleaning). As shown in this figure, most of the area shown had not been welded. All of the area in the figure exhibited damage from the surface corrosion, consistent with exposure to the environment. The lower half of Figure 9 shows an area that had not been welded and thus had not fractured.

Figure 9 – Secondary electron (SE) micrograph of a section of the cleaned flange-side fracture surface.

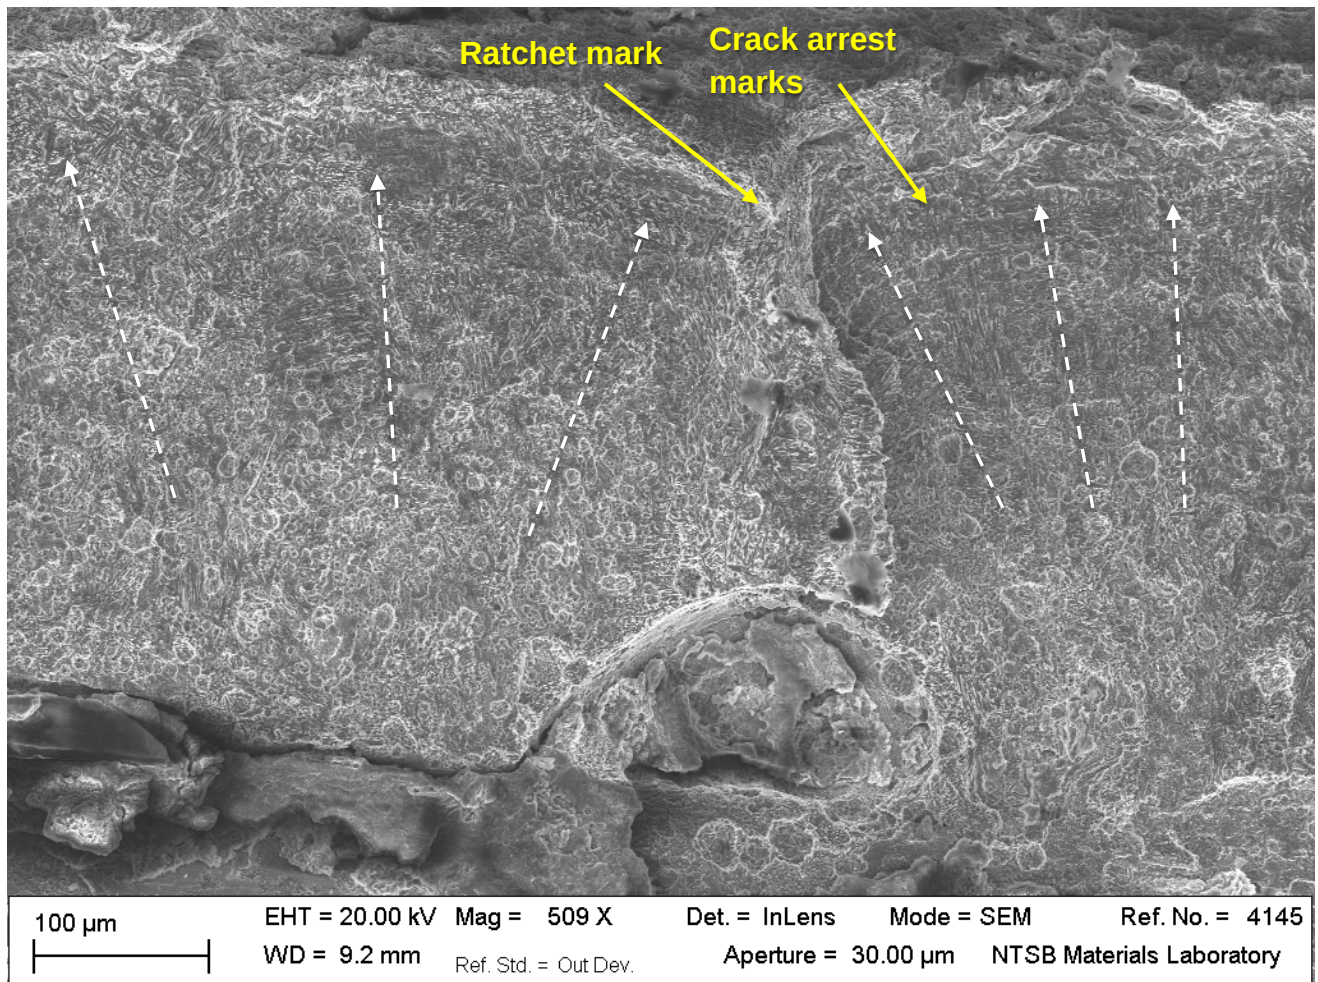
The upper area exhibited fracture features consistent with progressive cracking. As labeled in Figure 10, both crack arrest marks and ratchet marks were present—these were consistent with progressive crack growth and multiple crack coalescence, respectively. Figure 11 and Figure 12 shows a closer view of some of the crack arrest marks. As illustrated in these figures, fatigue striations consistent with fatigue crack propagation were present.

The crack initiation sites of these fatigue cracks were examined using a SEM. Due to the amount of oxidation, no information could be found that was consistent with material defects at the initiation sites. There were, however, pores present in the weld, as shown in the lower middle of Figure 10. In addition, other smaller voids or pores were found throughout the fracture surface, consistent with them having been present since the welding process.

Figure 10 – SE micrograph of the fracture surface section in Figure 9, showing crack arrest marks and a central ratchet mark. The dashed white arrows show the general crack growth directions from interior to exterior.

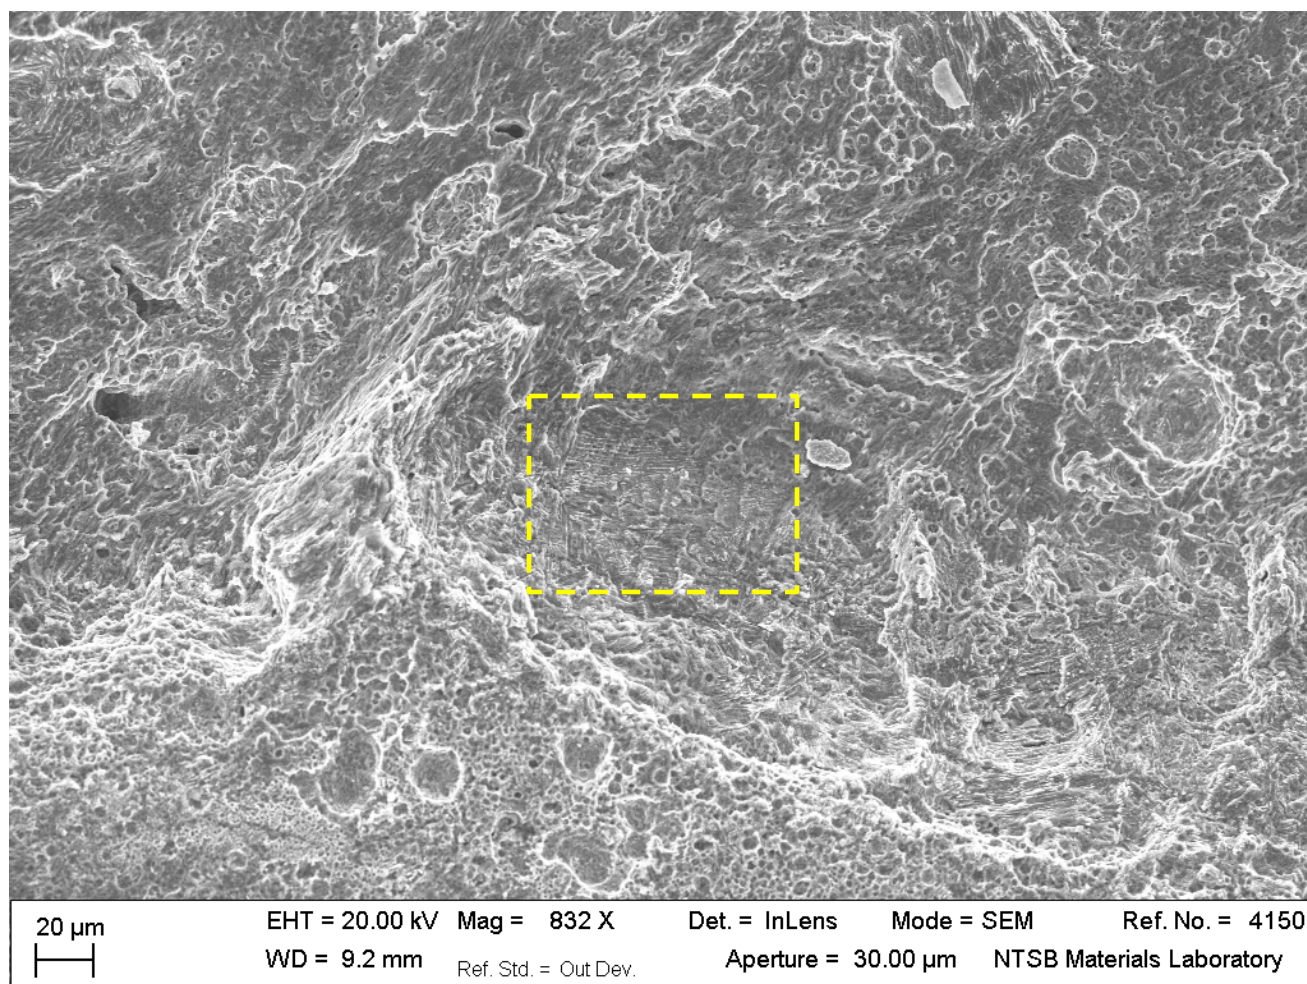
Figure 11 – SE micrograph of an area with clear crack arrest marks, showing fatigue striations, highlighted in Figure 12 (yellow-dashed box).

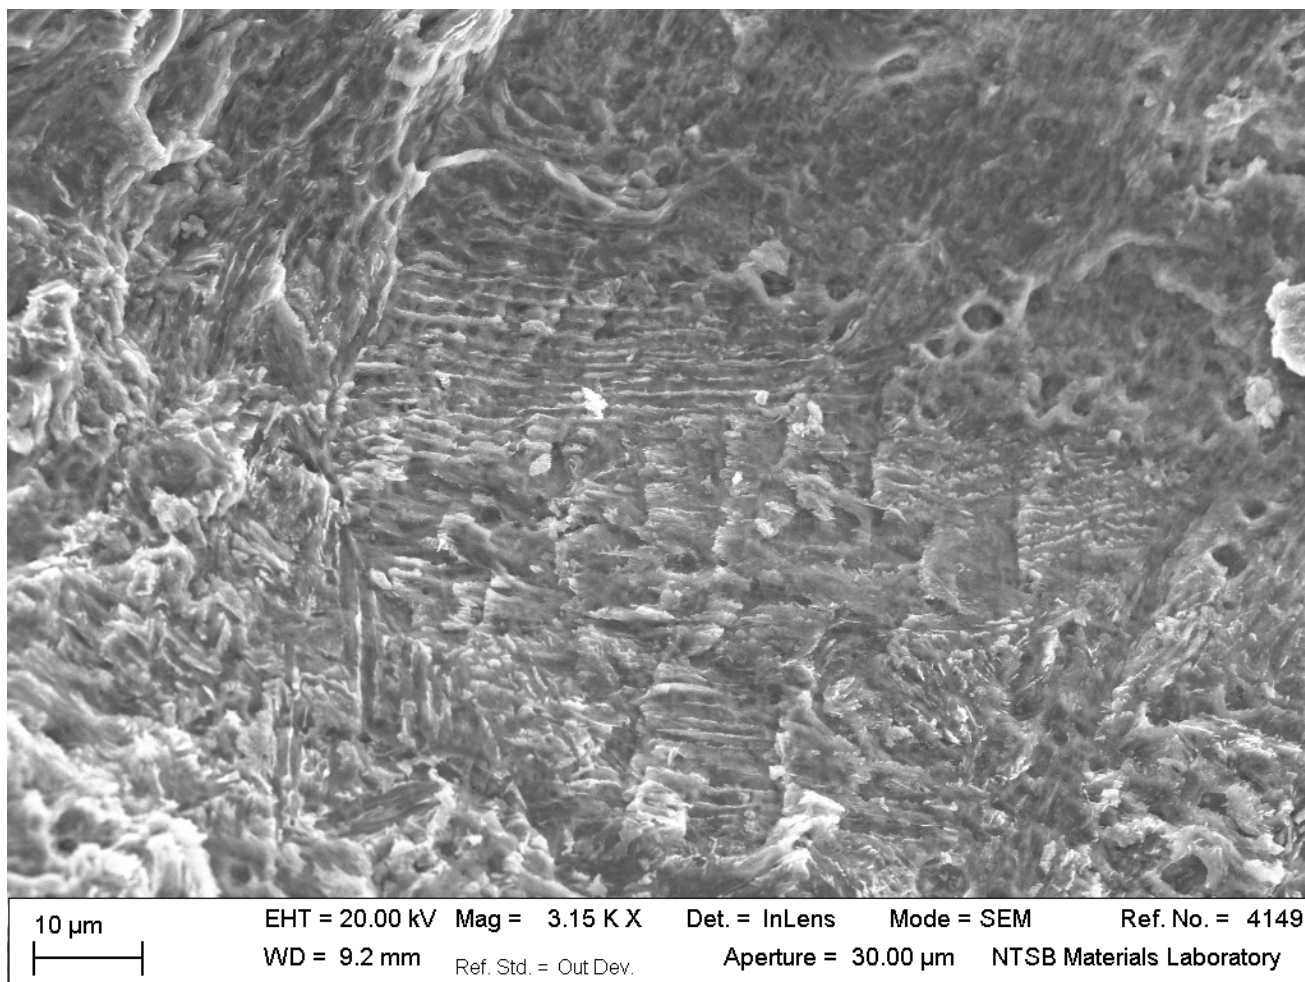
Figure 12 – SE micrograph showing the fatigue striations (after cleaning) in Figure 11.

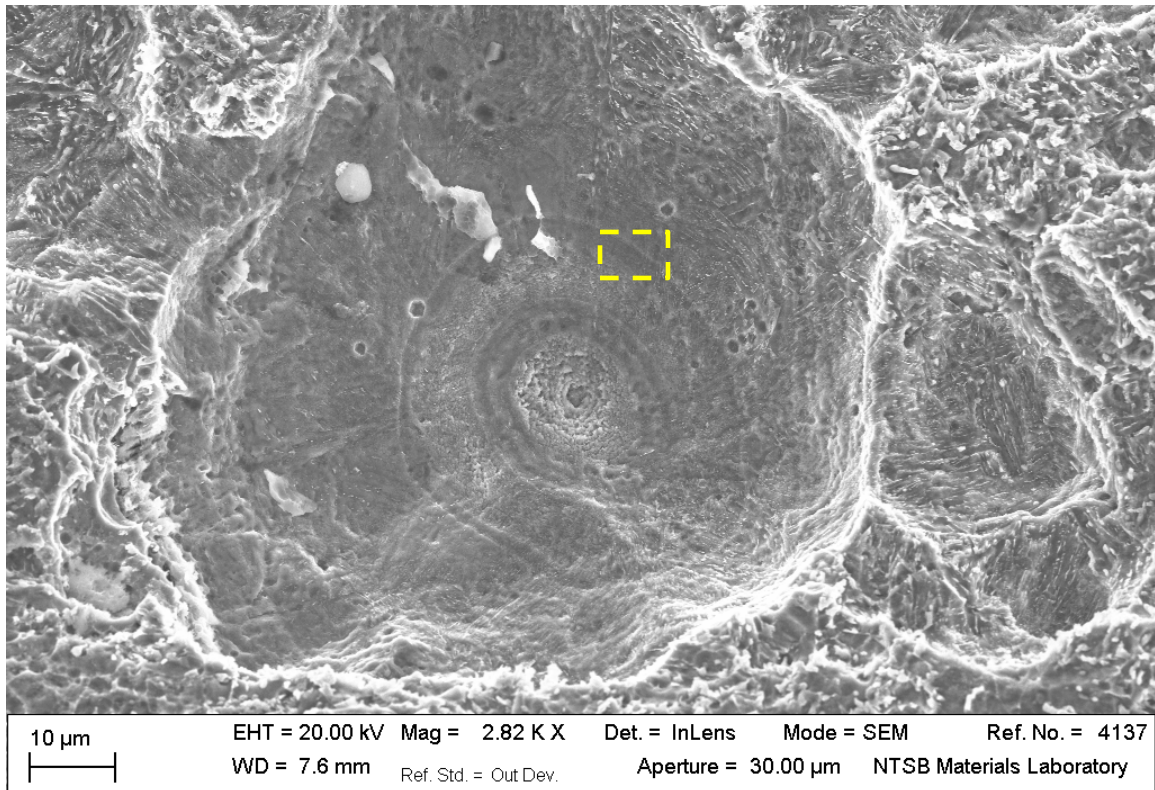
Figure 13 shows an area with concentric, circular crack arrest marks emanating from small pore. These features were found to be fatigue striations (see Figure 14). These features were consistent with a fatigue crack that initiated at a small (approximately 10  $\mu\text{m}$  in diameter) pore in the weld filler material.

Figure 13 – SE micrograph showing an area of fatigue striations propagating radially outward from a central void; the boxed area is shown in Figure 14.

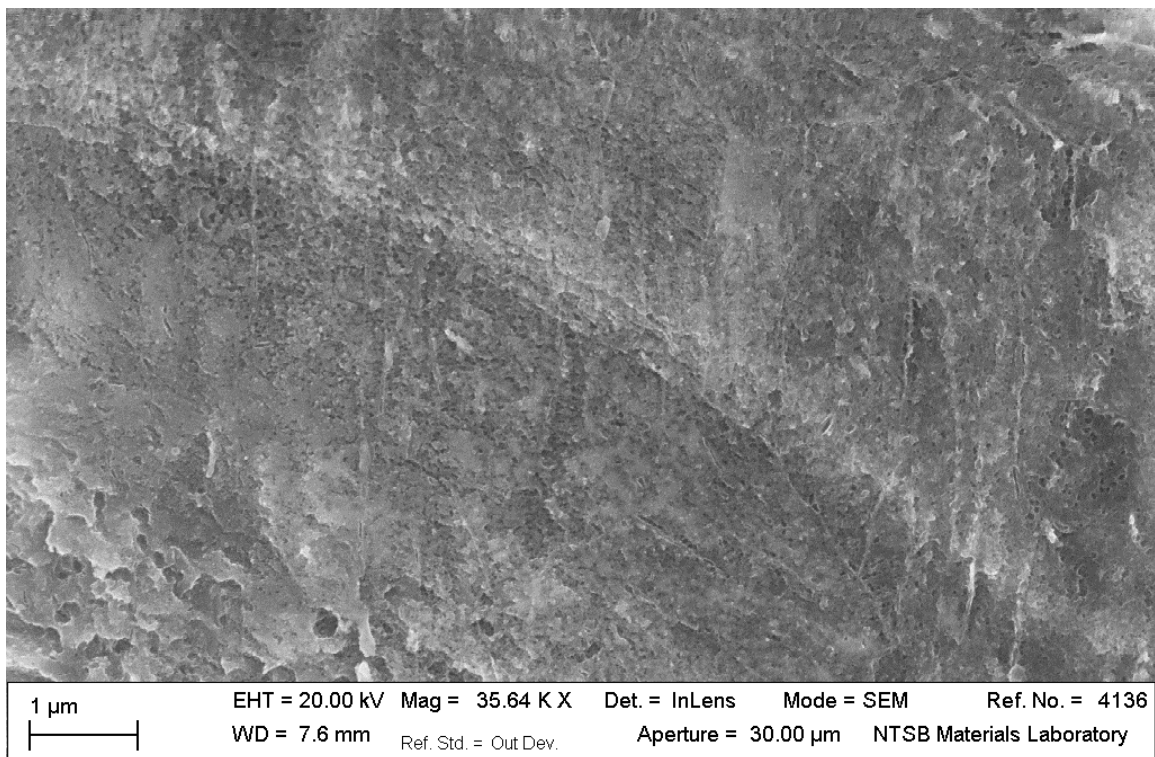
Figure 14 – SE micrograph showing a closer view of the fatigue striations in Figure 13.

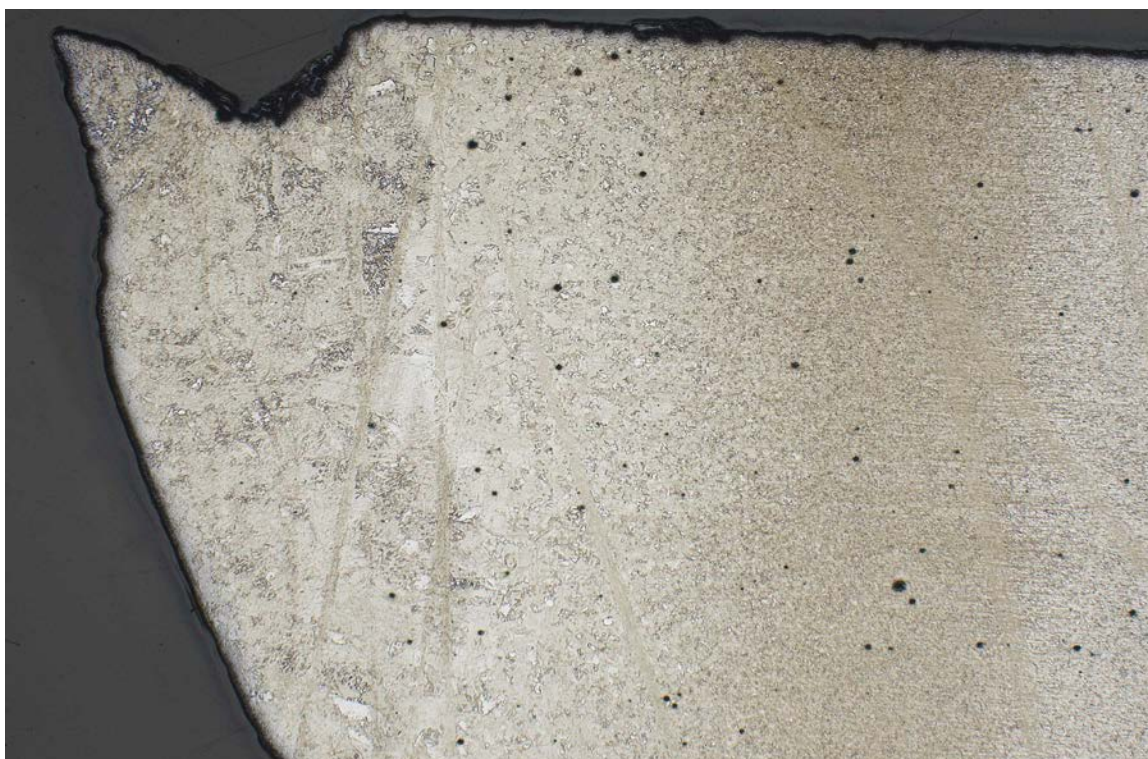
Part of the flange was sectioned through the fracture surface. This section was vacuum mounted using slow-curing epoxy, polished, and etched with 2% Nital solution.<sup>4</sup> Figure 15 shows this cross section through the fractured weld. Figure 16 shows corrosion on the fracture surface through the weld. The corrosion appears to be consistent with pitting that occurred after fracture. No branching or subsurface cracks were present in this cross section.

Figure 15 – Bright-field (BF) micrograph of a cross section through the fracture surface on the flange side weld (upper left) (~25X, etched 2% Nital).

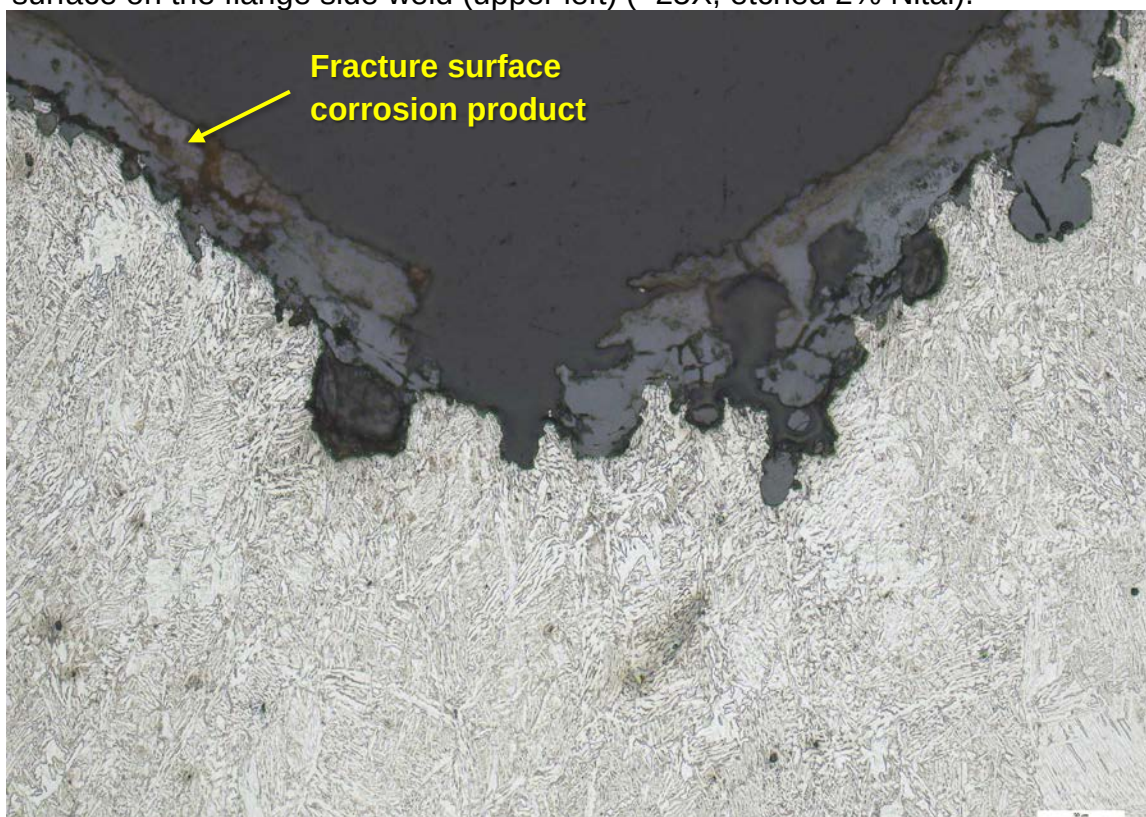
Figure 16 – BF micrograph showing the corrosion product on the fracture weld surface of the arm flange (~100X, etched 2% Nital).

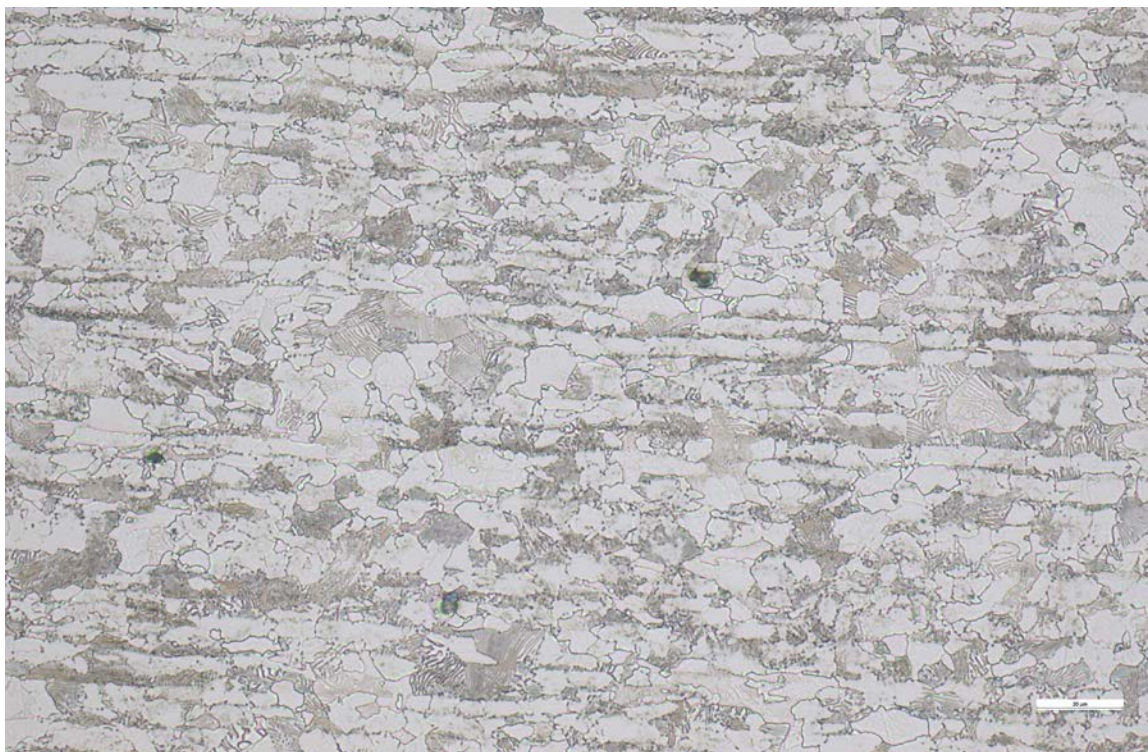
Figure 17 shows a typical area of the strut attachment flange microstructure. This microstructure shows horizontal grain flow lines and small, elongated grains, typical of a rolled component. The microstructural constituents were a mix of pearlite (darker colored) and ferrite (lighter color). This microstructure was consistent with the composition and mechanical properties measured above. Figure 18 shows a typical area of the weld filler material microstructure. This microstructure exhibited more martensite, typical of faster cooling in alloy steels.

Figure 17 – BF micrograph showing a typical area of the arm flange microstructure (~200X, etched 2% Nital).

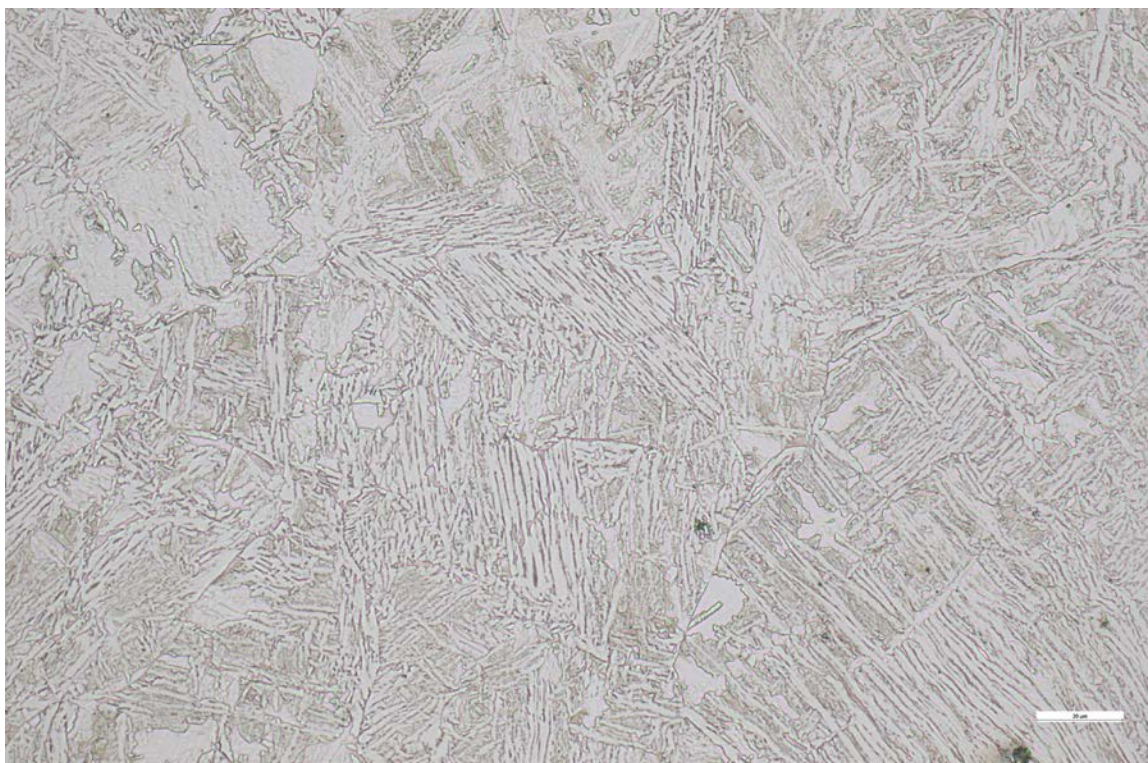
Figure 18 – BF micrograph showing a typical area of the weld filler microstructure (~500X, etched 2% Nital).
