**Photo 1 –N3607Y Cessna 210. (Source: Federal Aviation Administration)**

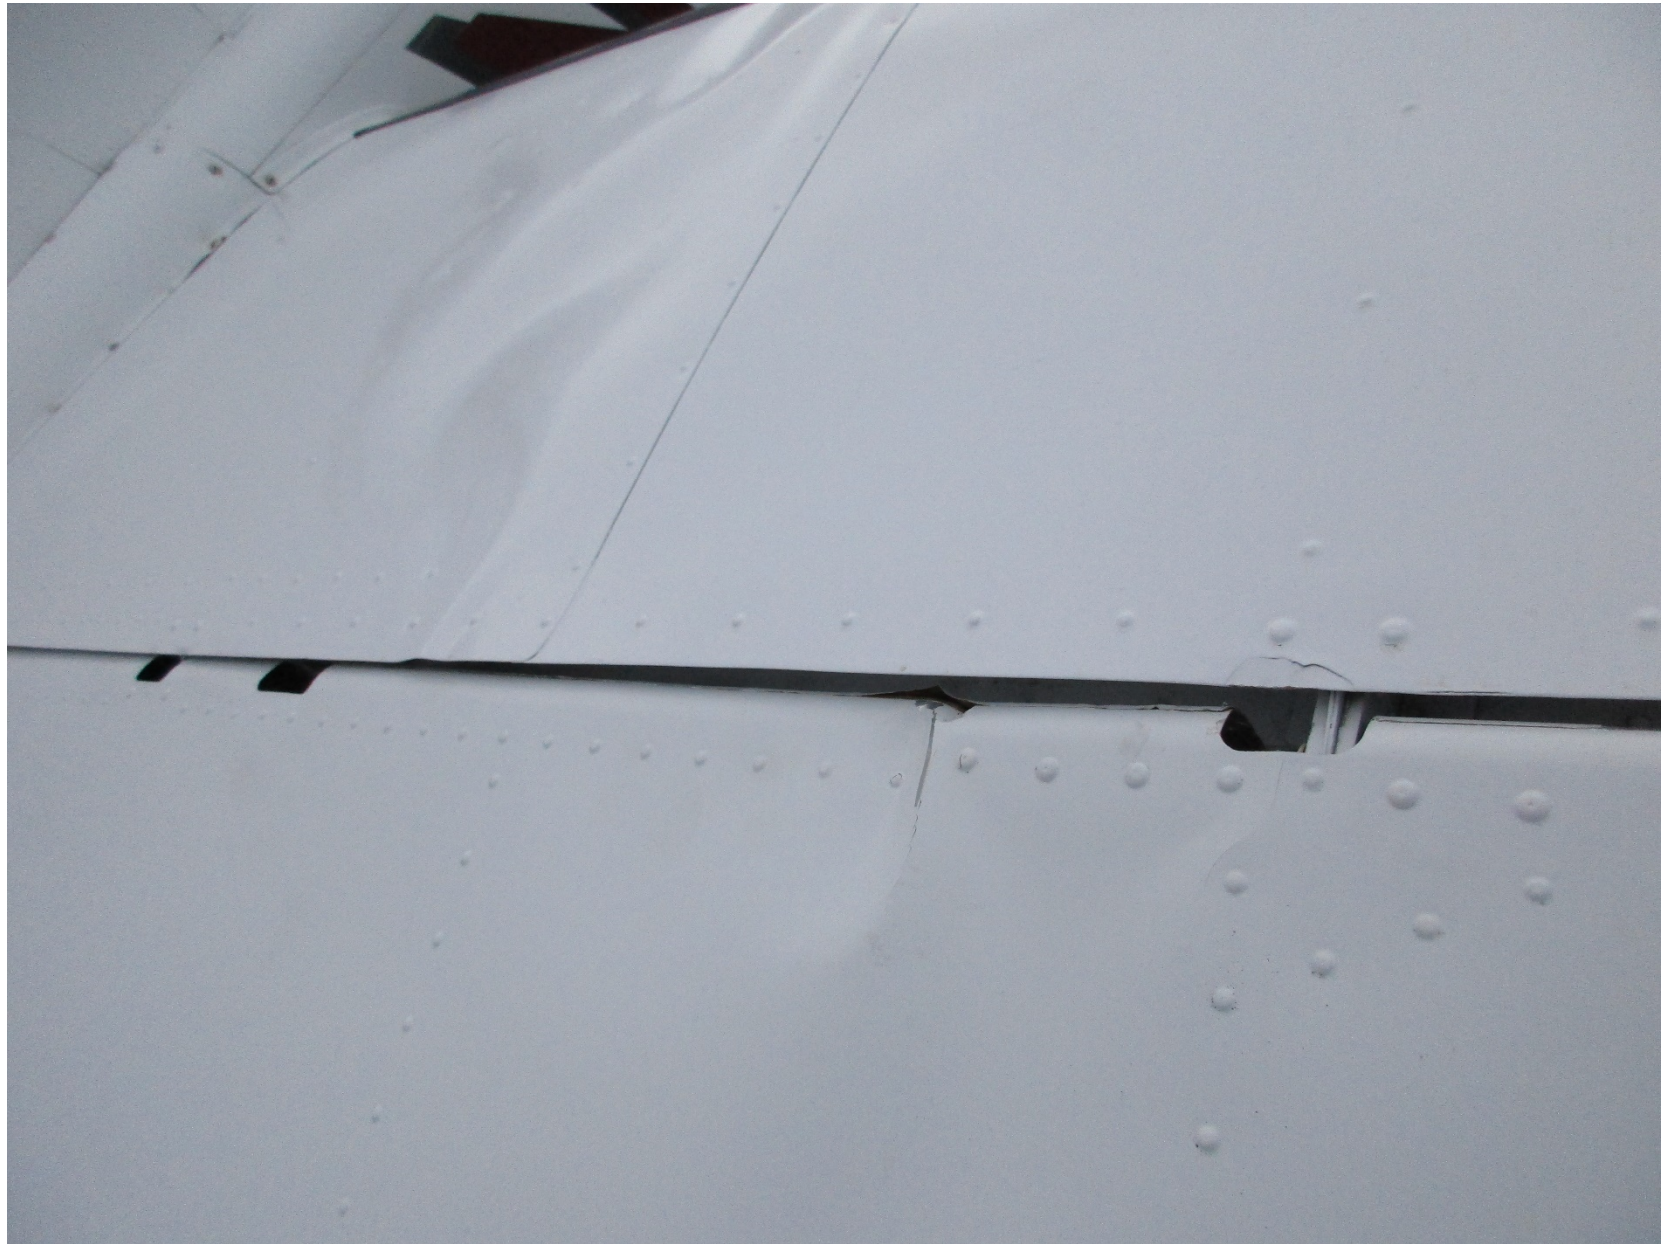
**Photo 2 - Right wing and aileron substantial damage. (Source: Federal Aviation Administration)**

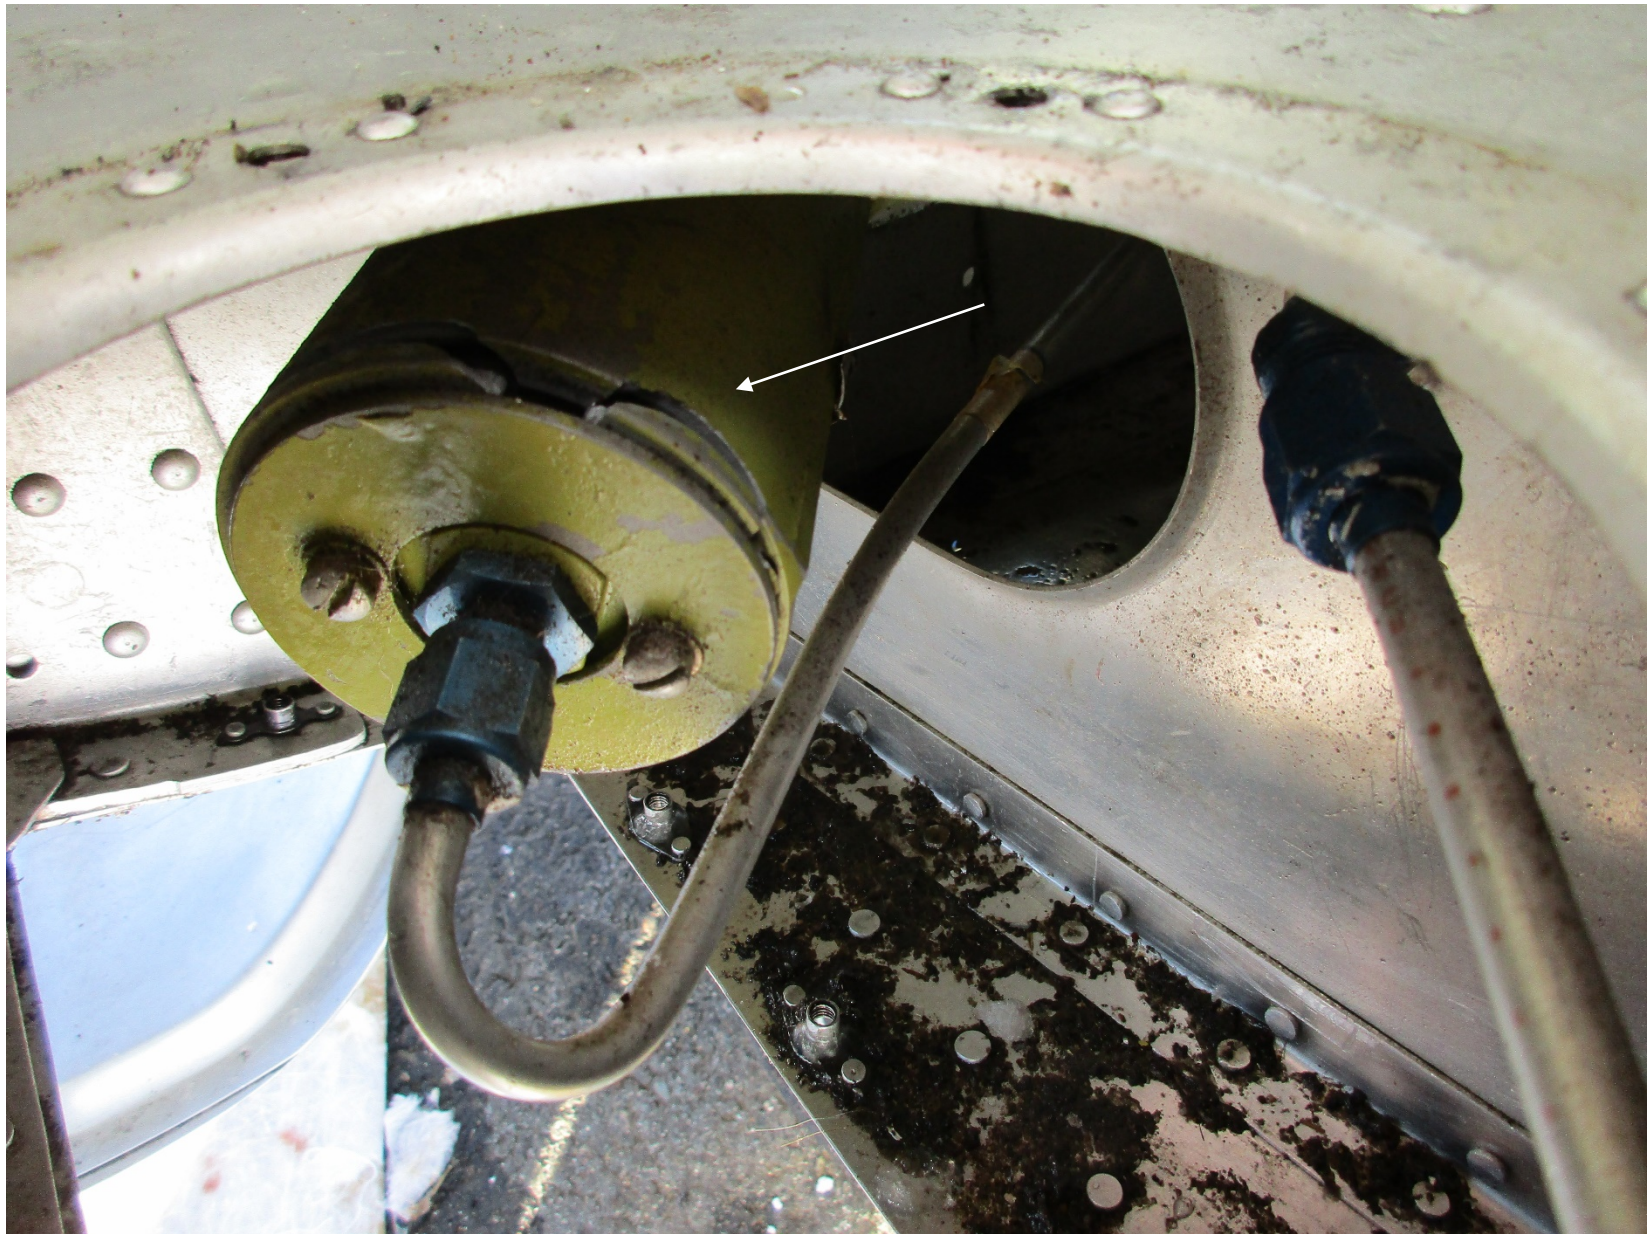
**Photo 3 - Landing gear actuator exhibiting fractures. (Source: Federal Aviation Administration)**

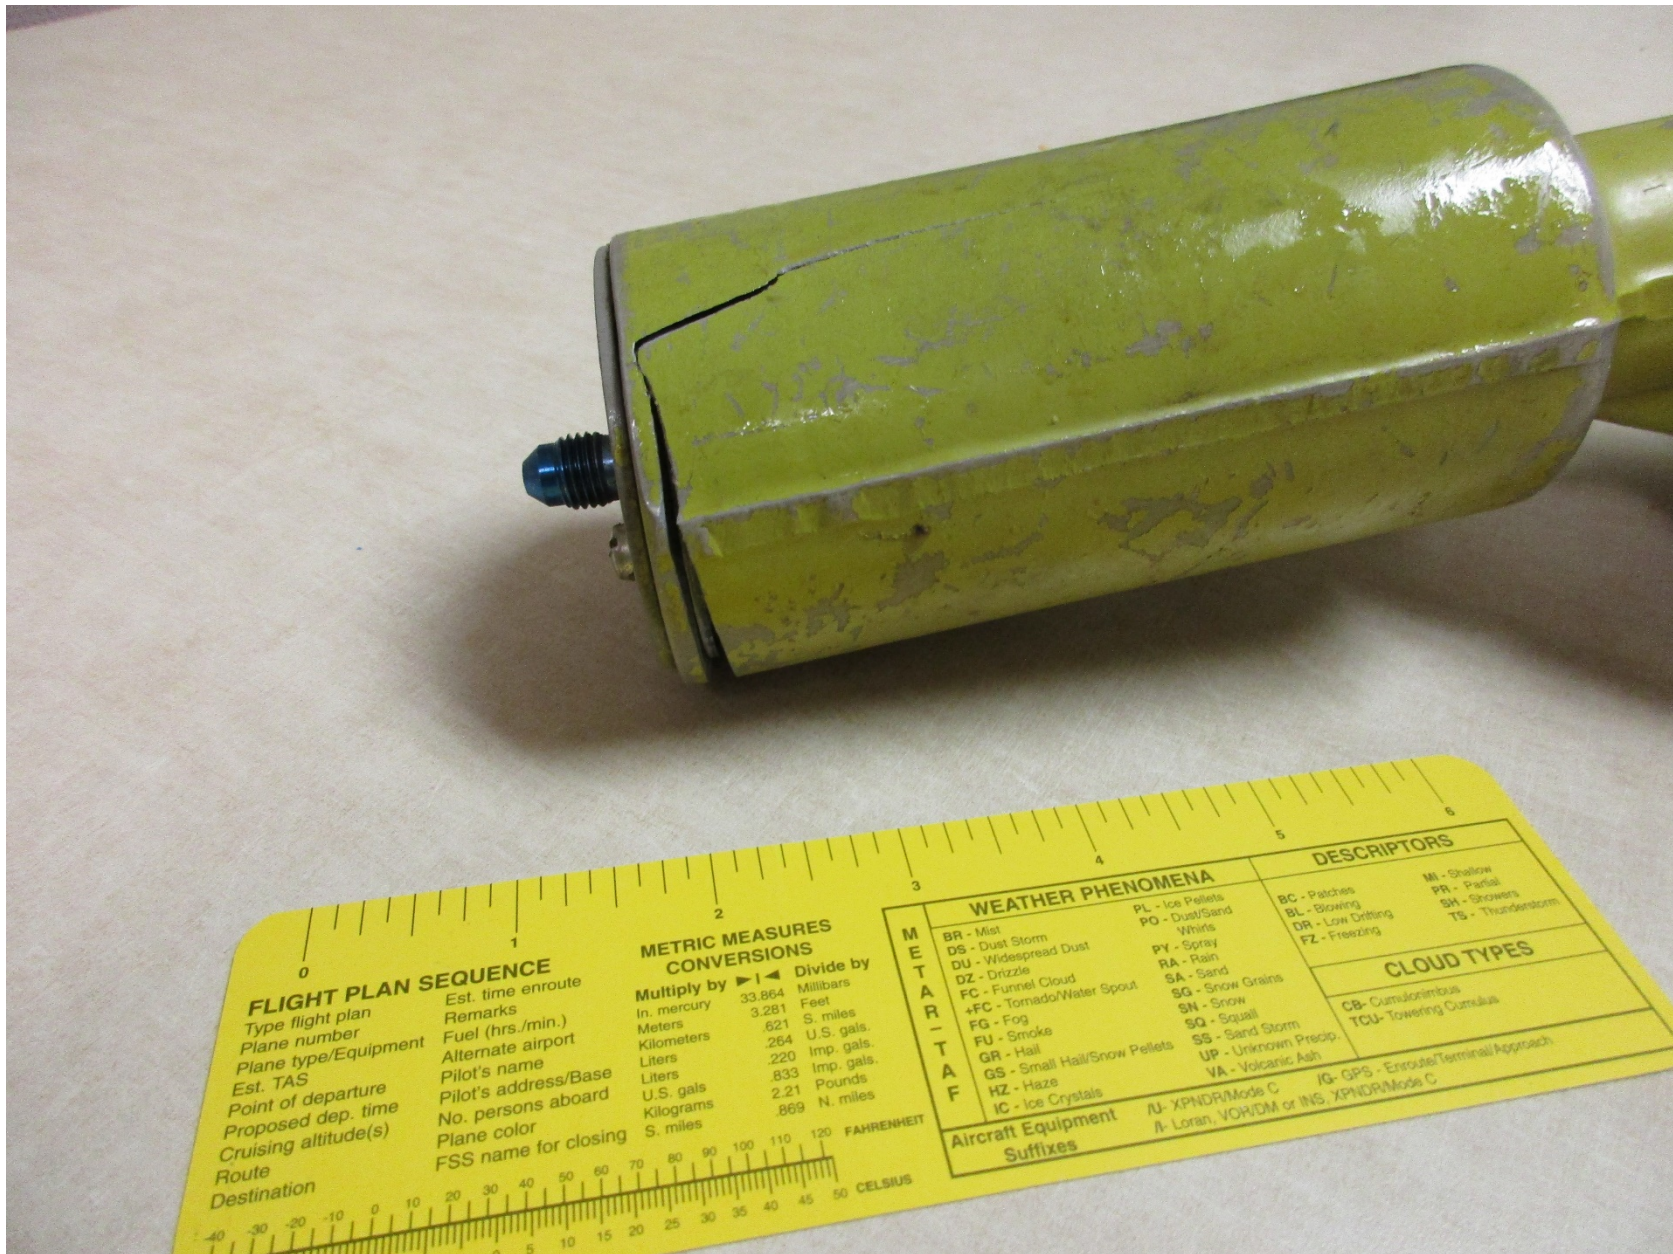
Photo 4 - Landing gear actuator exhibiting circumferential fracture.
