# NATIONAL TRANSPORTATION SAFETY BOARD

## MATERIALS LABORATORY FACTUAL REPORT

Report No. 18-052

Place : Juneau, Alaska  
Date : January 14, 2018  
Vehicle : Cessna 210C, N3607Y  
NTSB No. : ANC18LA019  
Investigator : Noreen Price, AS-ANC

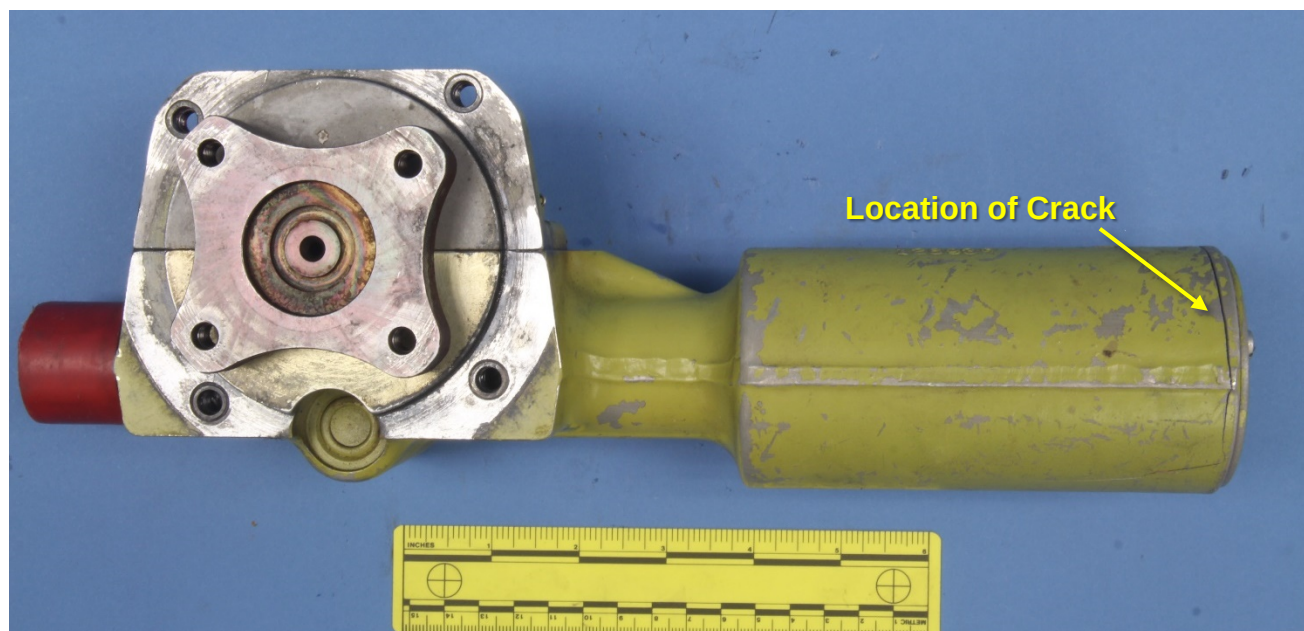
The cracked hydraulic actuator is illustrated in Figure 1, as received. The part was cracked about the barrel section adjacent the endcap with a circumferential and a longitudinal component, as shown in Figure 2 and Figure 3, respectively. The stencil markings on the barrel stated:

Figure 1 – The cracked hydraulic actuator, as received.

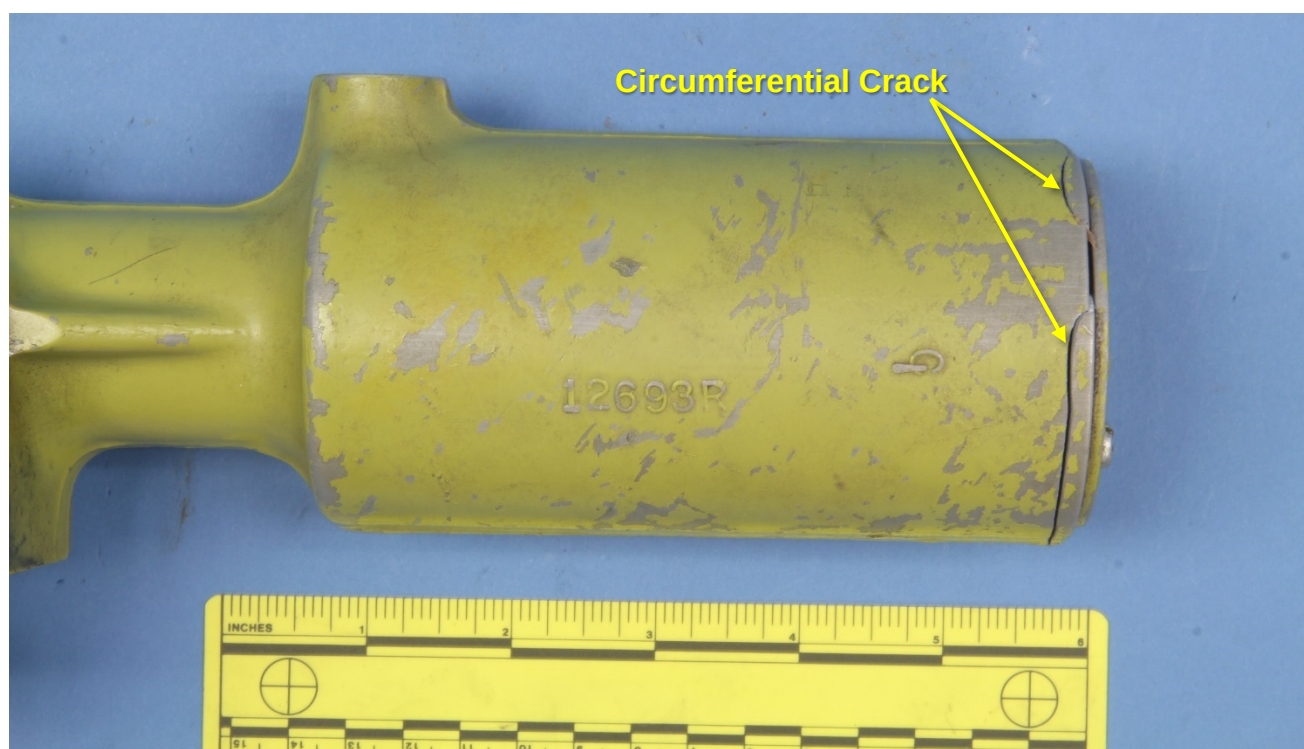
Figure 2 – The cracked portion of the actuator, showing the circumferential and longitudinal cracks.

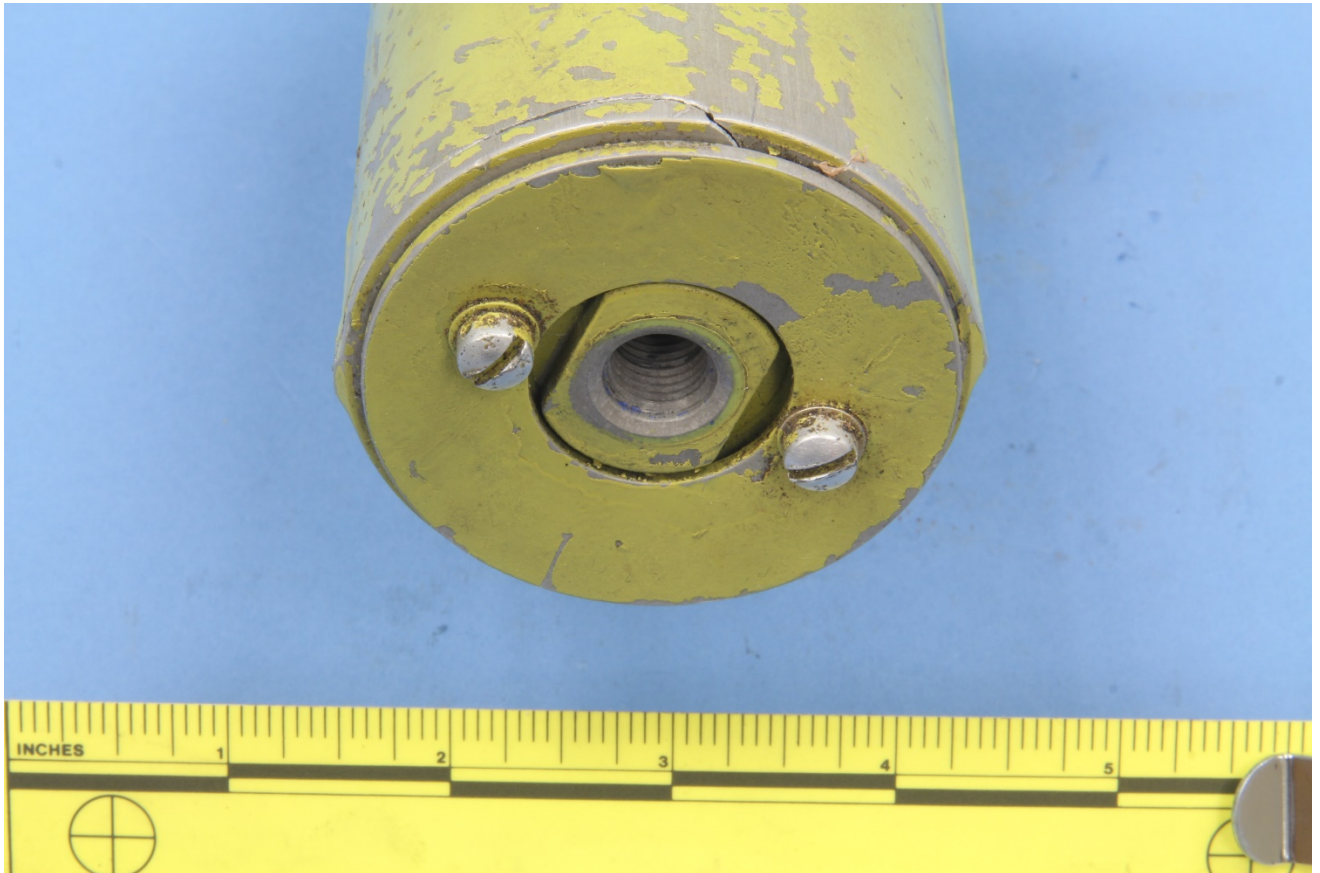
Figure 3 – The end of the hydraulic actuator, showing the circumferential portion of the crack.

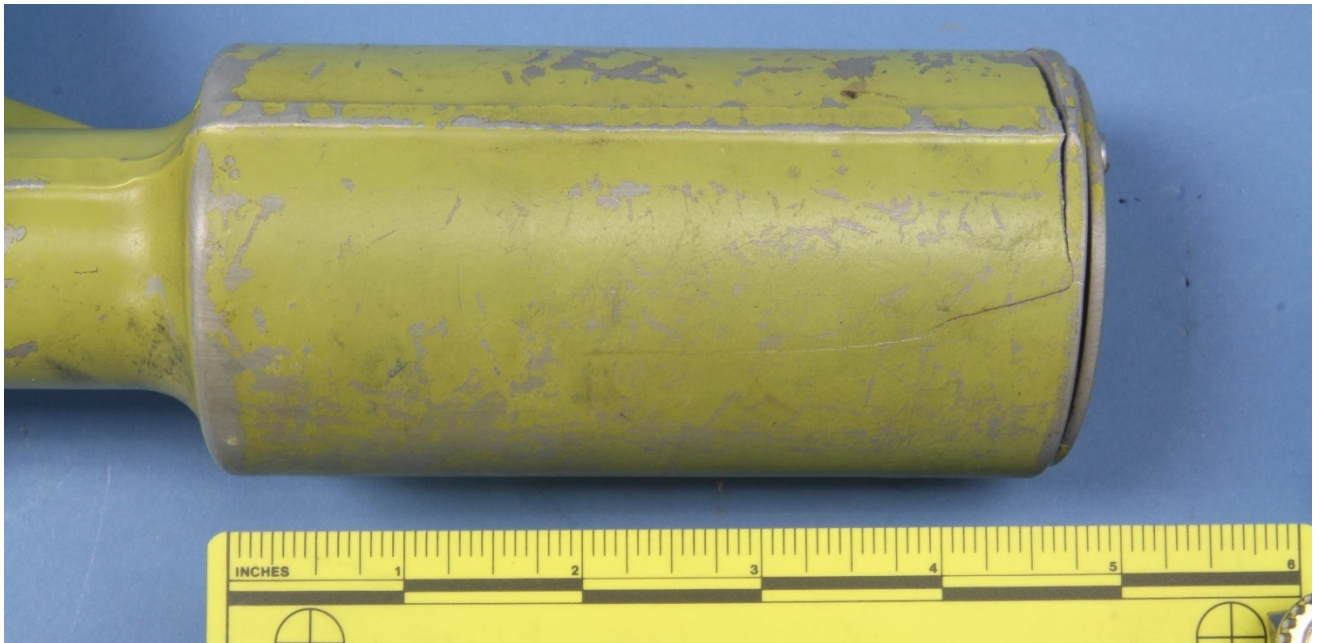
Figure 4 – The longitudinal crack on the actuator housing.

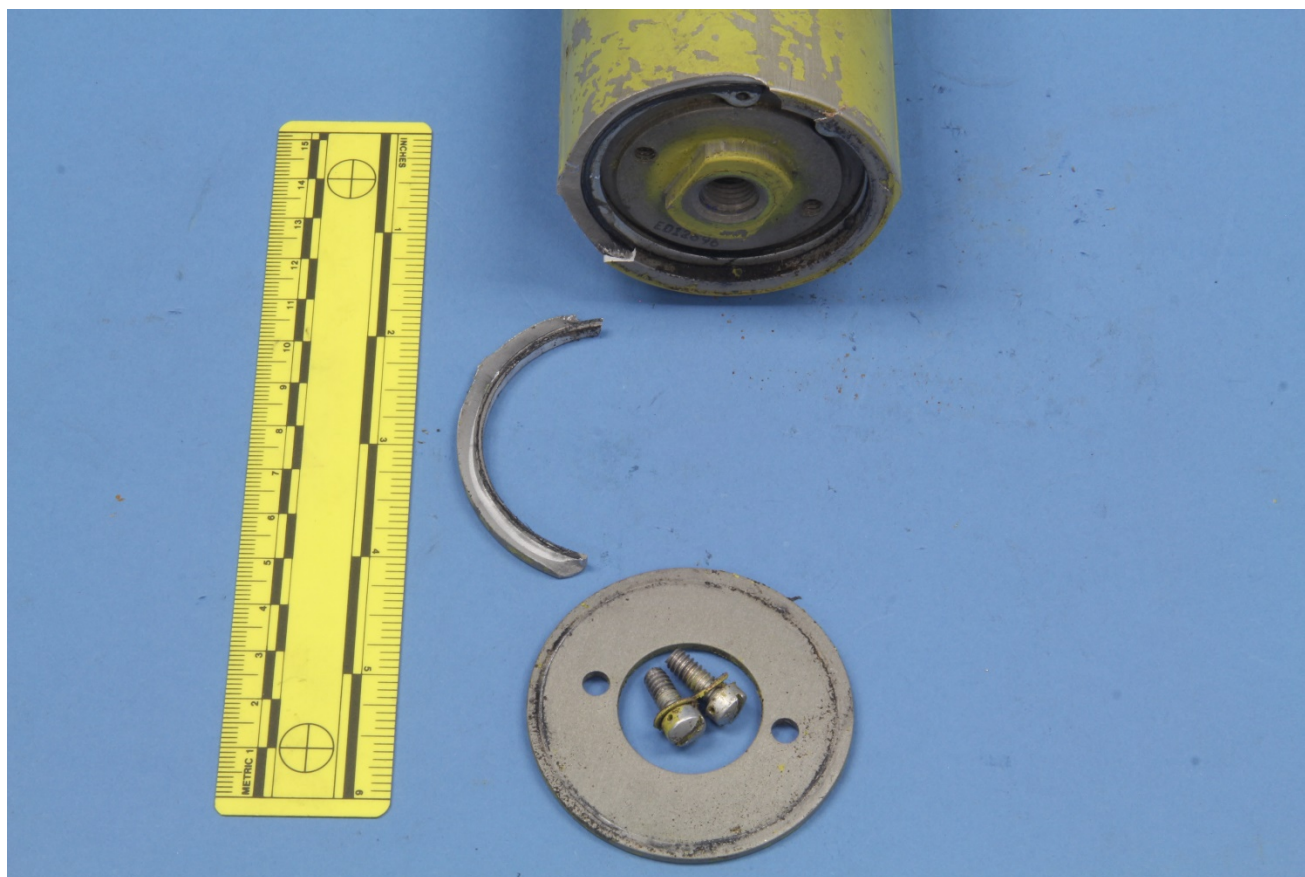
Figure 5 – The cracked end of the actuator pictured in Figure 3, after removal of the screws and the end cap.

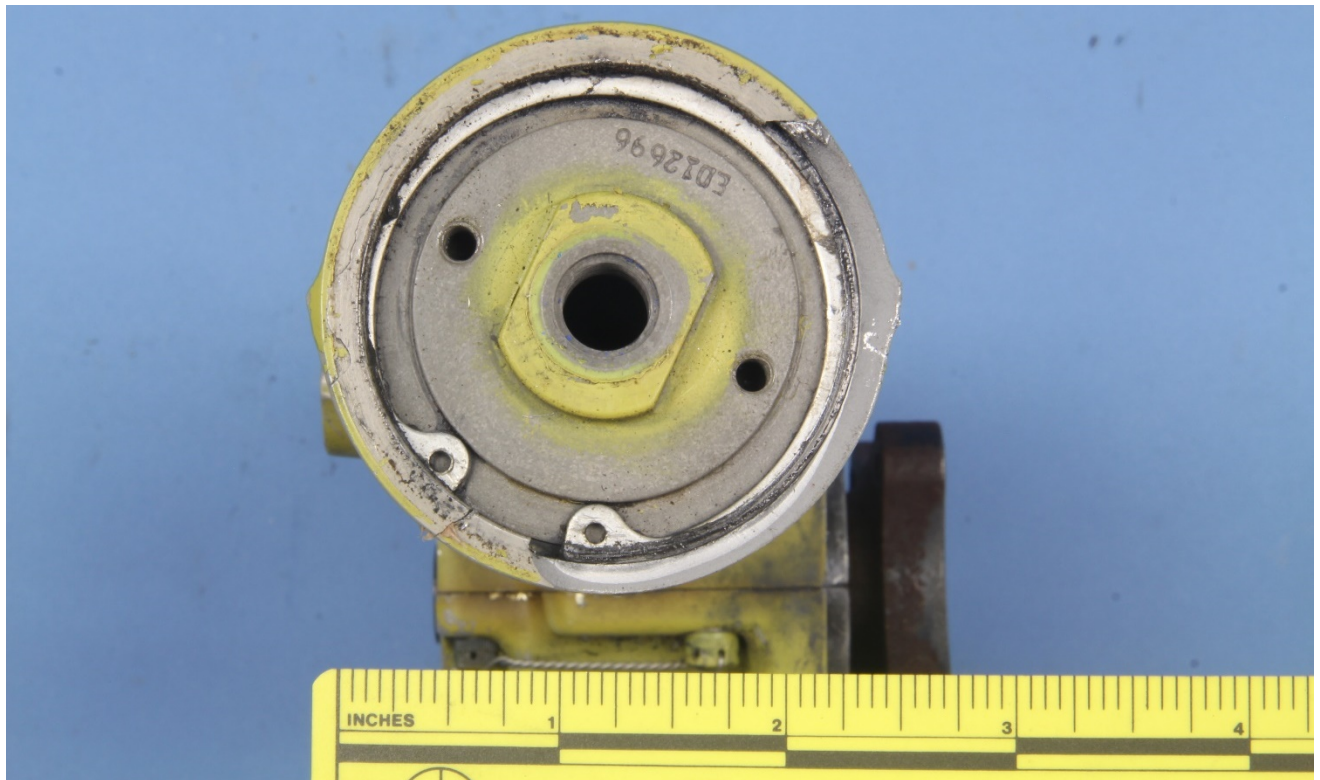
Figure 6 – The fractured end of the actuator, after disassembly. The retaining ring was still in place in the groove.

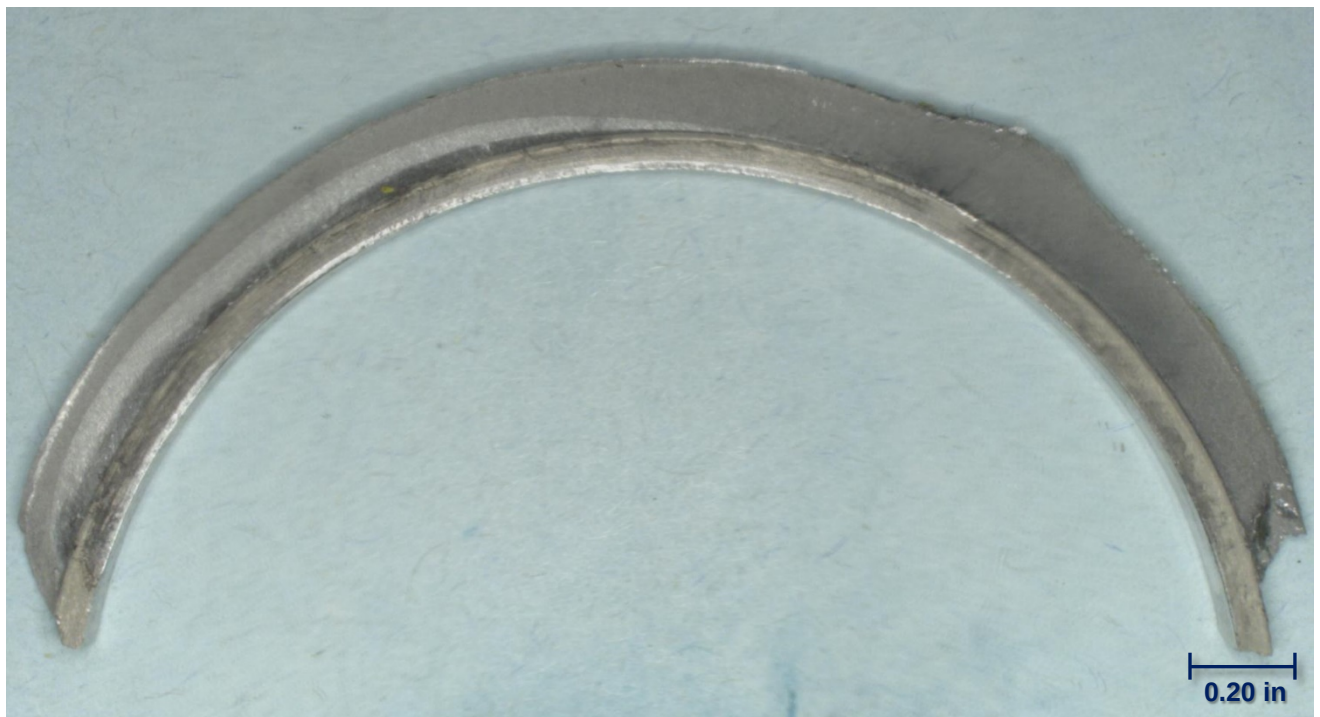
This fracture surface exhibited one thumbnail-shaped crack. The thumbnail portions of this fracture surface exhibited crack arrest marks, consistent with progressive cracking, later determined to be fatigue. The fatigue cracks originated from the retaining ring groove, progressing through half of the actuator barrel thickness at the largest portion (see Figure 8). The thumbnail crack initiated at a corner in the retainer clip groove. Figure 9 shows the mating fracture surface on the actuator barrel, illustrating the location of the retainer clip groove, and the location of the corners.

Figure 7 – Montage of magnified images of the crack face of the circumferential crack, showing indications of progressive cracking.

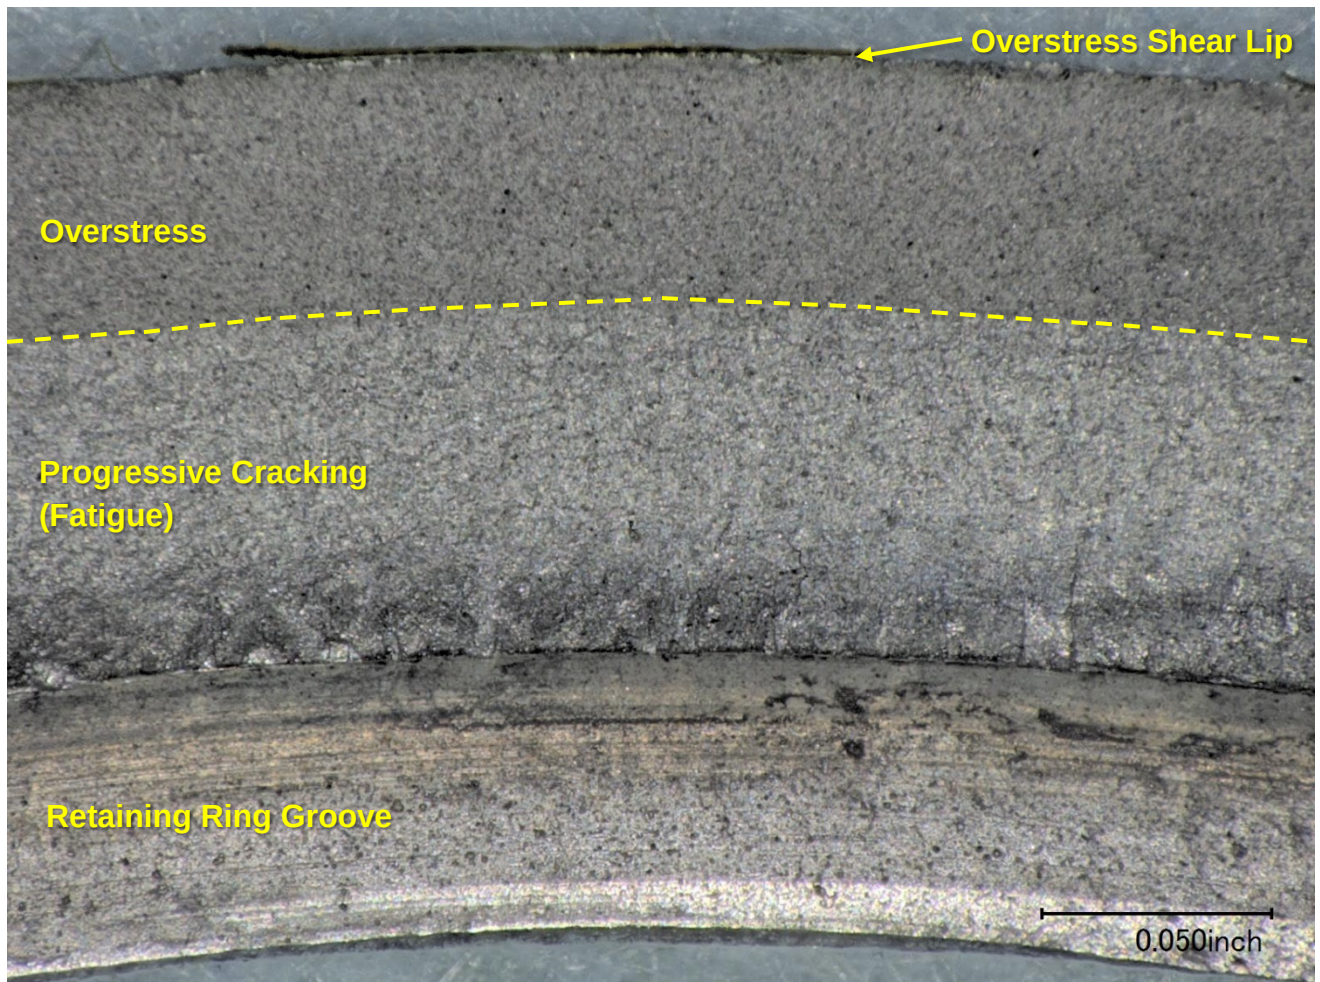
Figure 8 – The progressive crack in Figure 6, tilted to showing the retaining ring groove.

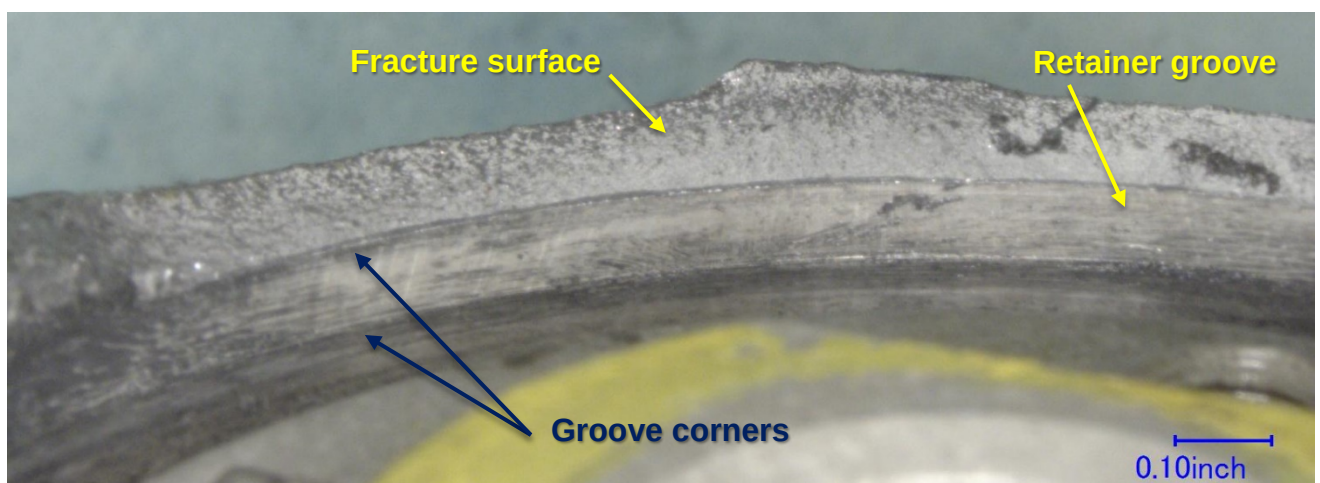
Figure 9 – The mating fracture surface on the actuator barrel, showing the location of the thumbnail crack in relation to the retainer groove (retainer clip removed).

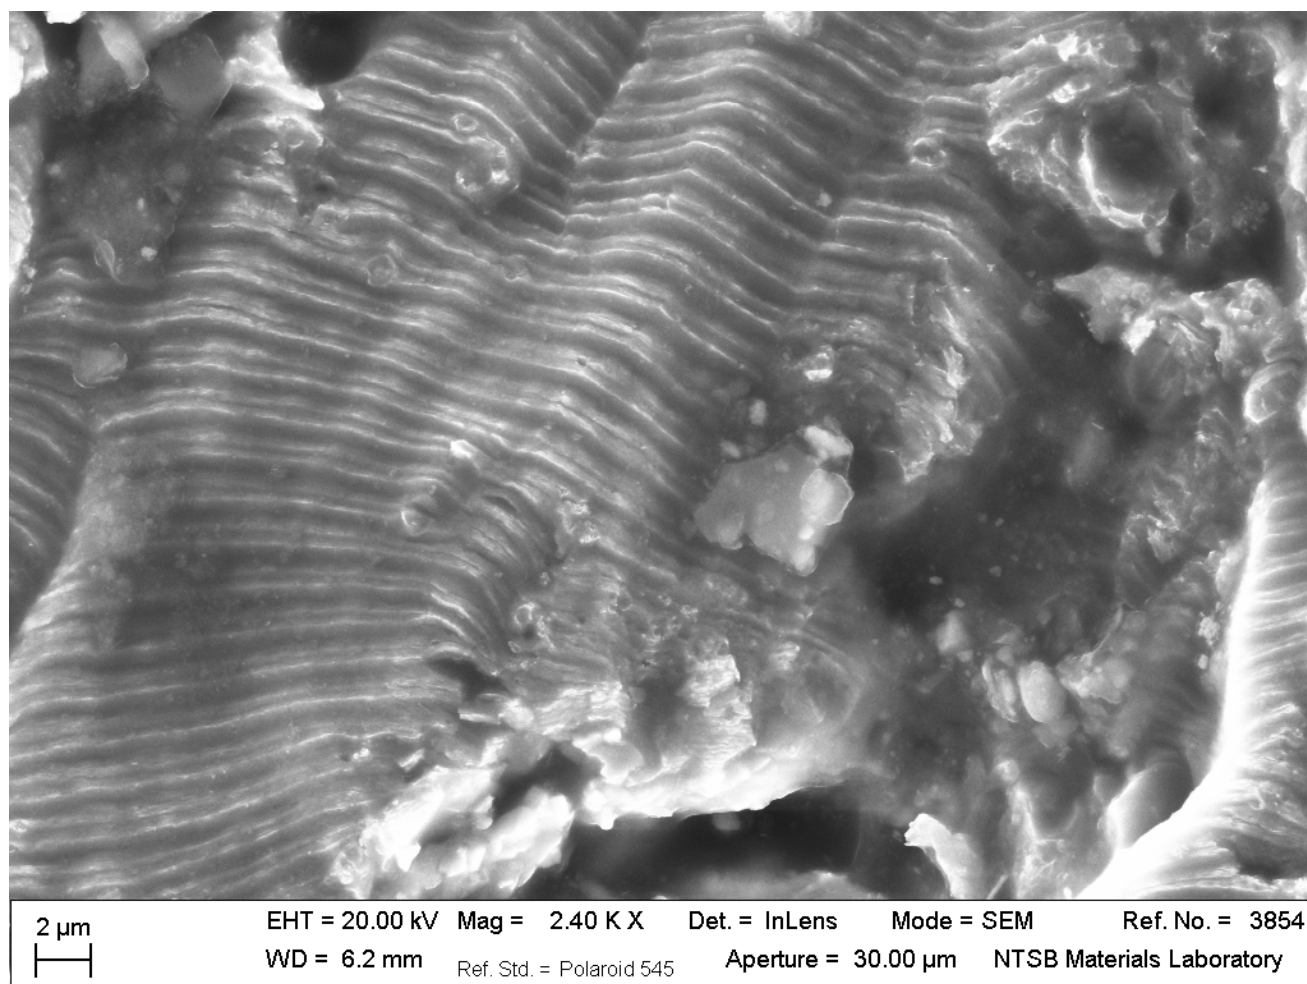
The actuator fracture surface was examined using a scanning electron microscope (SEM). Figure 10 shows a typical area of the thumbnail region, displaying striations consistent with fatigue crack propagation. Portions of the fracture surface outside of the fatigue crack revealed dimple rupture, consistent with subsequent overstress fracture (Figure 11).

Figure 10 – Secondary electron (SE) micrograph showing fatigue striations in the progressive cracking portion of the fracture surface.

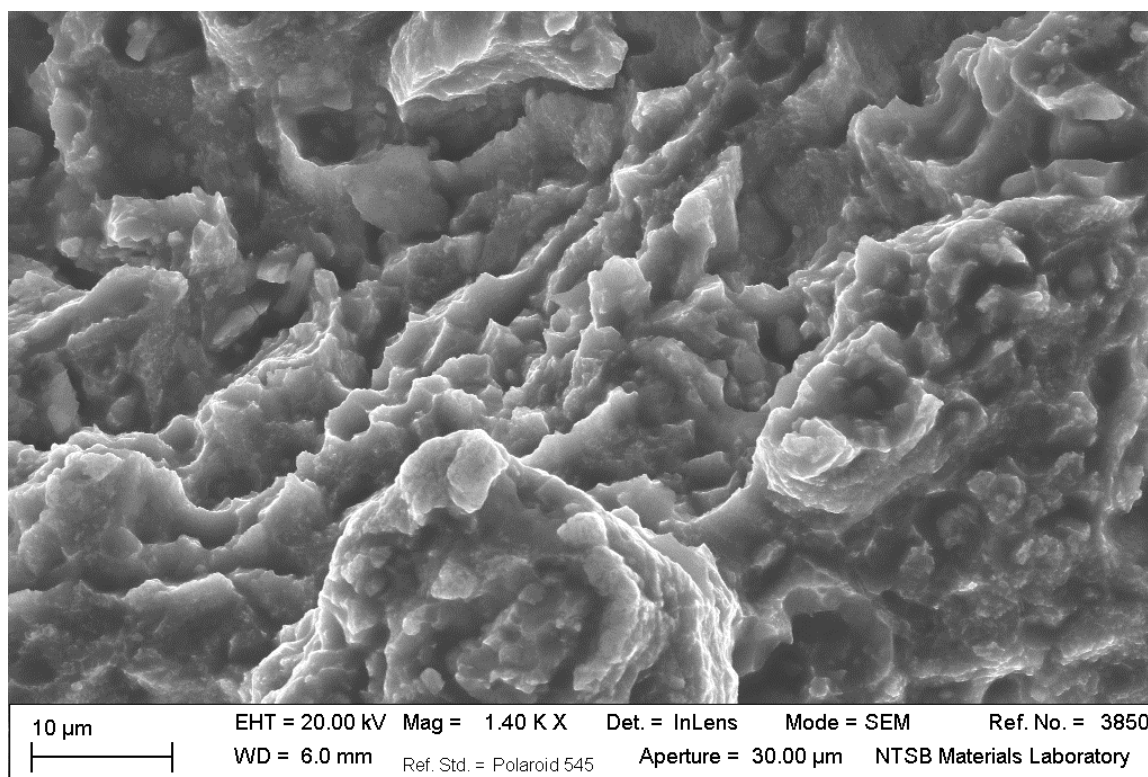
Figure 11 – SE micrograph showing dimple rupture, indicative of overstress, in the fracture surface regions outside the fatigue region.

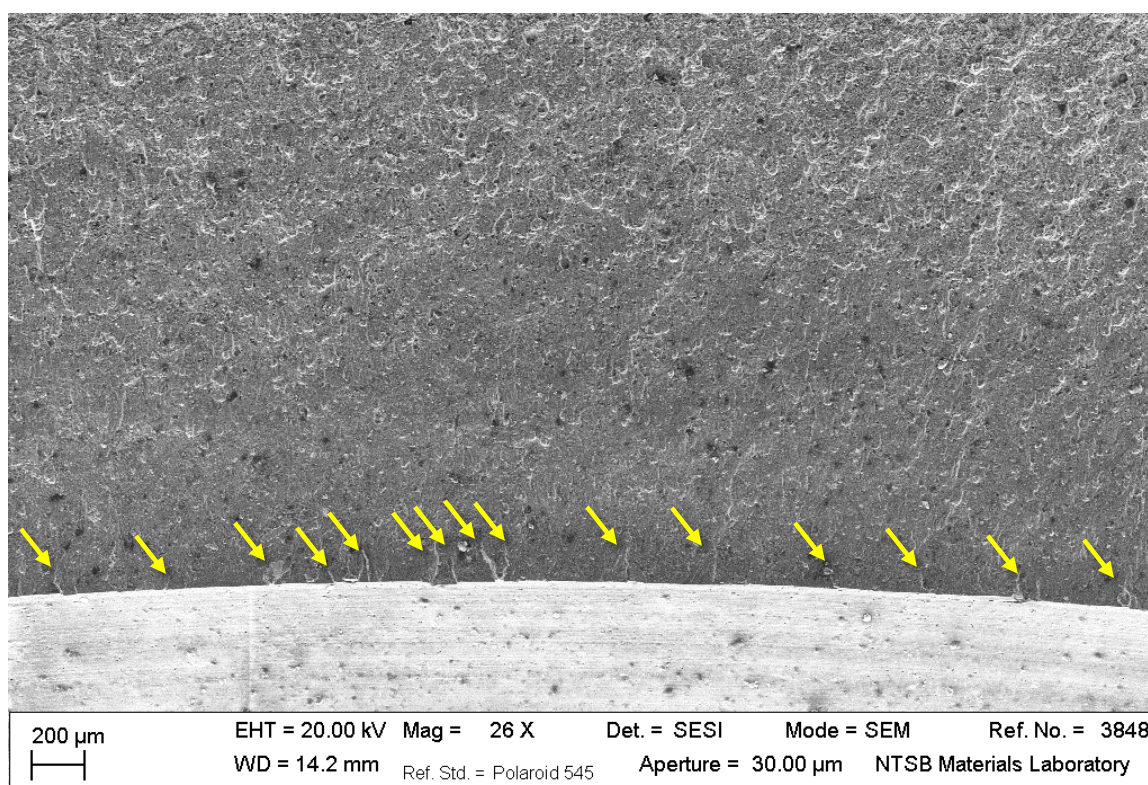
The thumbnail-shaped fatigue cracks exhibited ratchet marks, consistent with multiple fatigue crack initiation (see Figure 12). Examination of these initiation sites revealed small pit-like features. Examination of the surface of the retaining ring groove revealed multiple corrosion pits, as exemplified in Figure 13.

Figure 12 – SE micrograph of the thumbnail crack, showing ratchet marks (arrows).

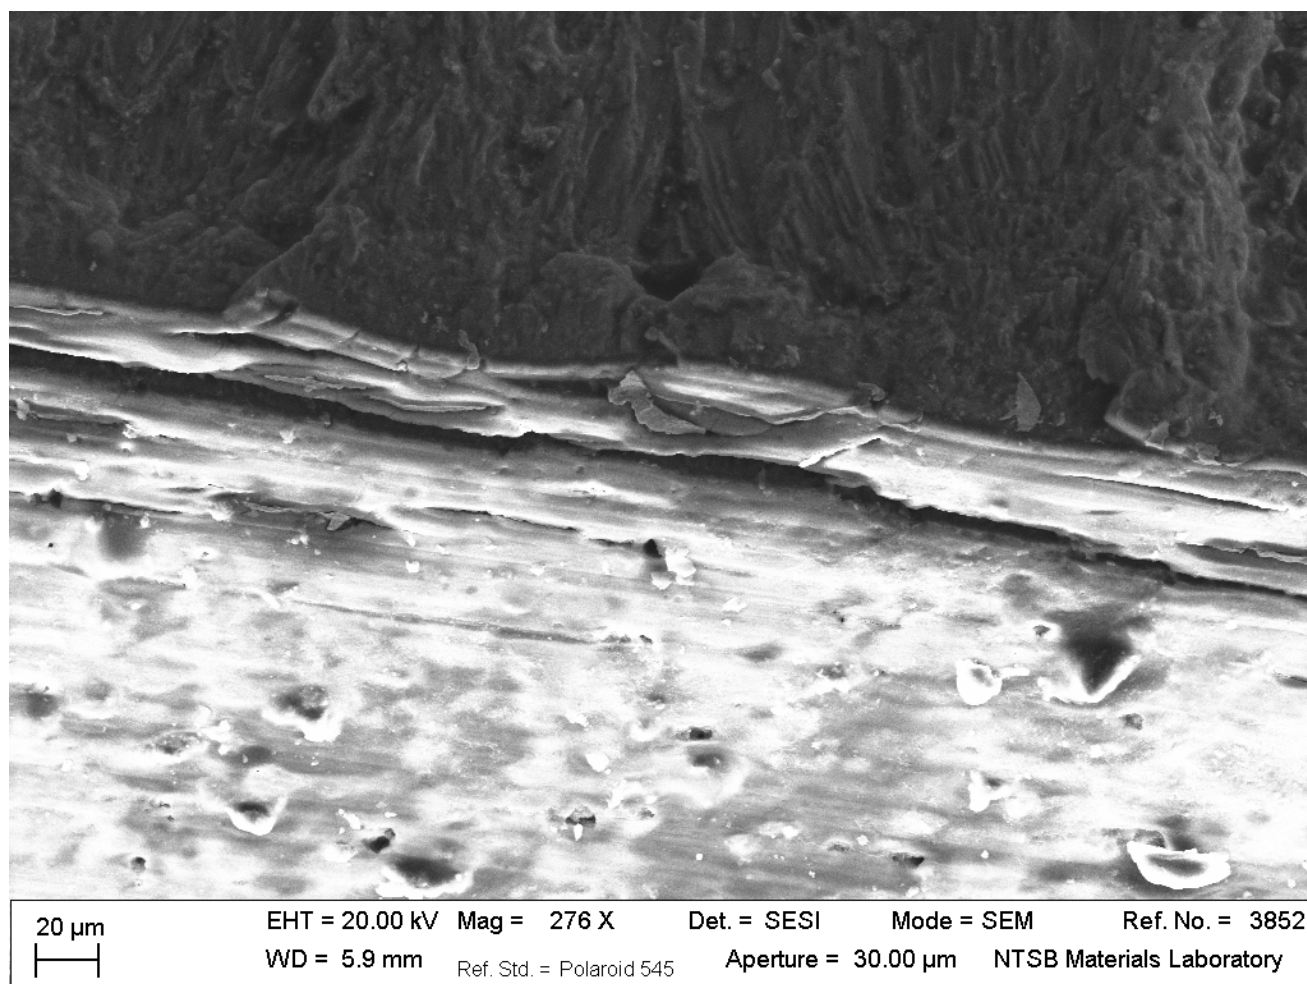
Figure 13 – Backscattered electron (BE) micrograph showing pits on the actuator retaining ring groove.

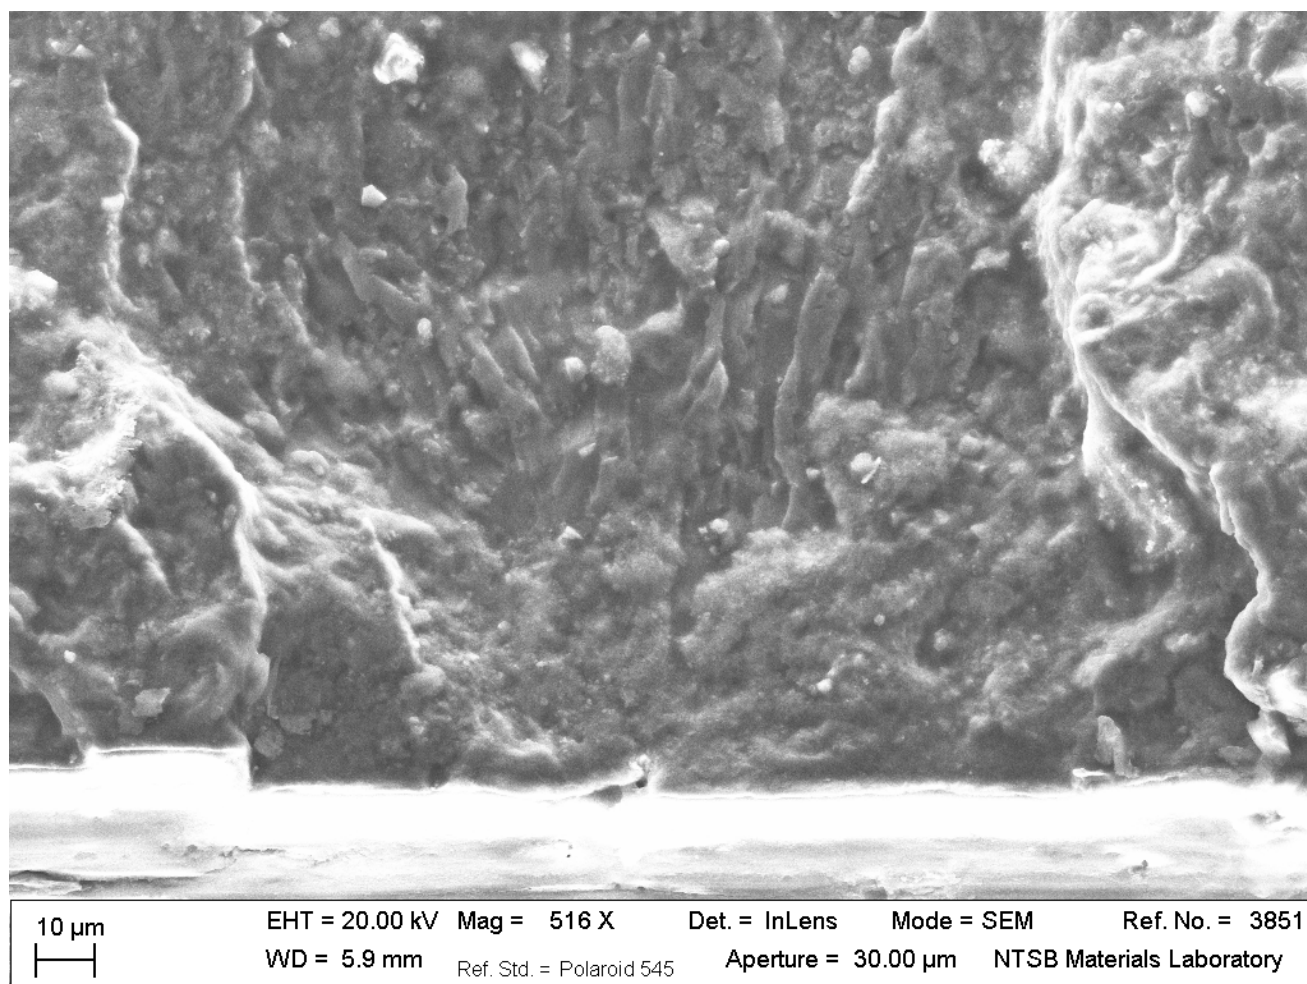
Figure 14 – SE micrograph of one of the fatigue crack initiation sites on the cylinder groove.

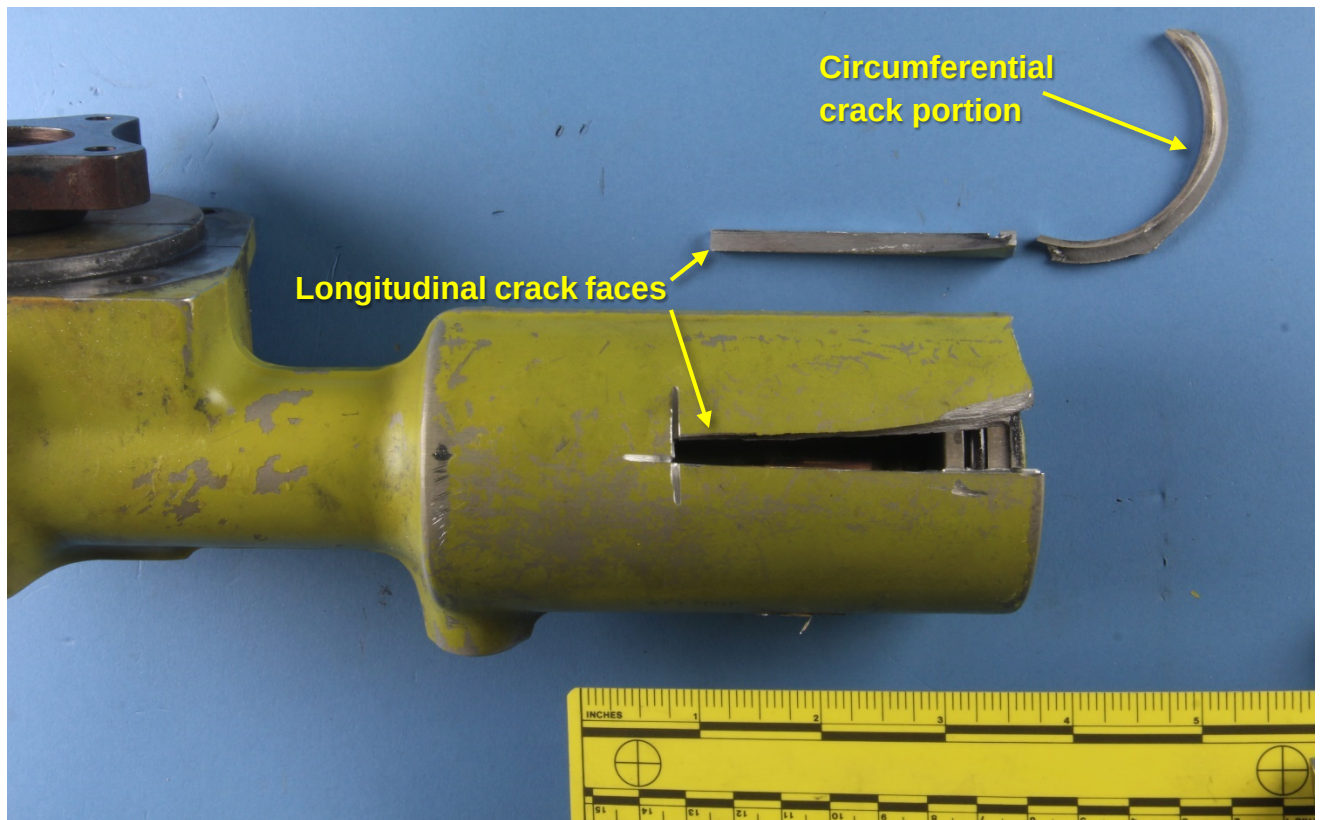
Figure 15 – The cracked portion of the actuator housing, after sectioning to expose the longitudinal portion of the crack.

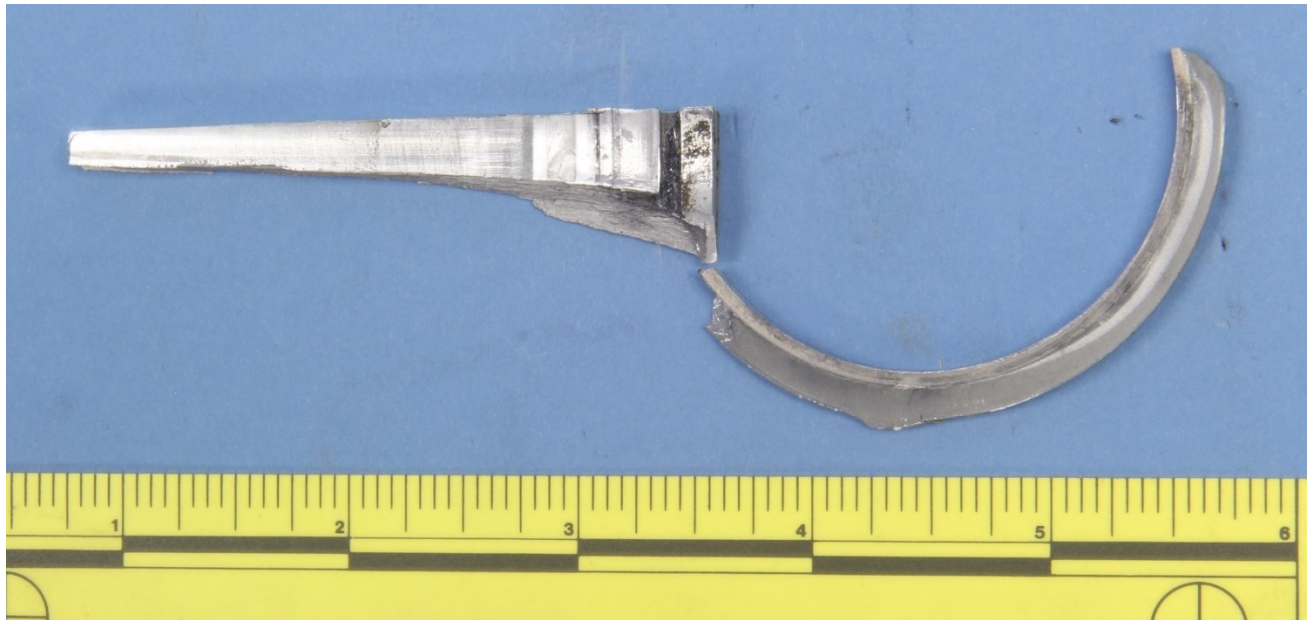
Figure 16 – The fracture surfaces of the circumferential fatigue and overstress fracture and the longitudinal fracture, after disassembly, sectioning, and cleaning.

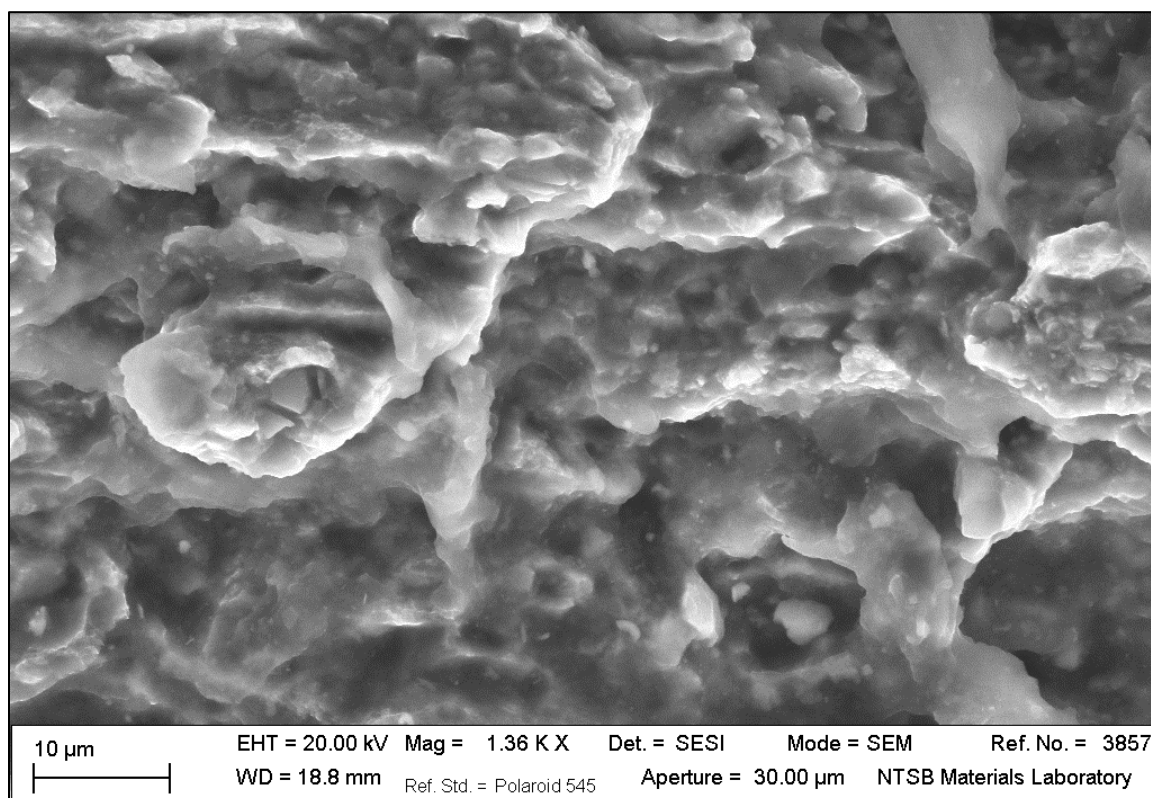
The actuator barrel was sectioned in order to expose the longitudinal crack. The sectioned housing and mating fracture faces are shown in Figure 14. The longitudinal crack face is illustrated in Figure 15. As revealed from examination of this crack face using a SEM, the fracture features exhibited dimple rupture, consistent with tensile overstress fracture.

Figure 17 – SE micrograph of the fracture surface of the longitudinal crack, revealing dimple rupture consistent with overstress.

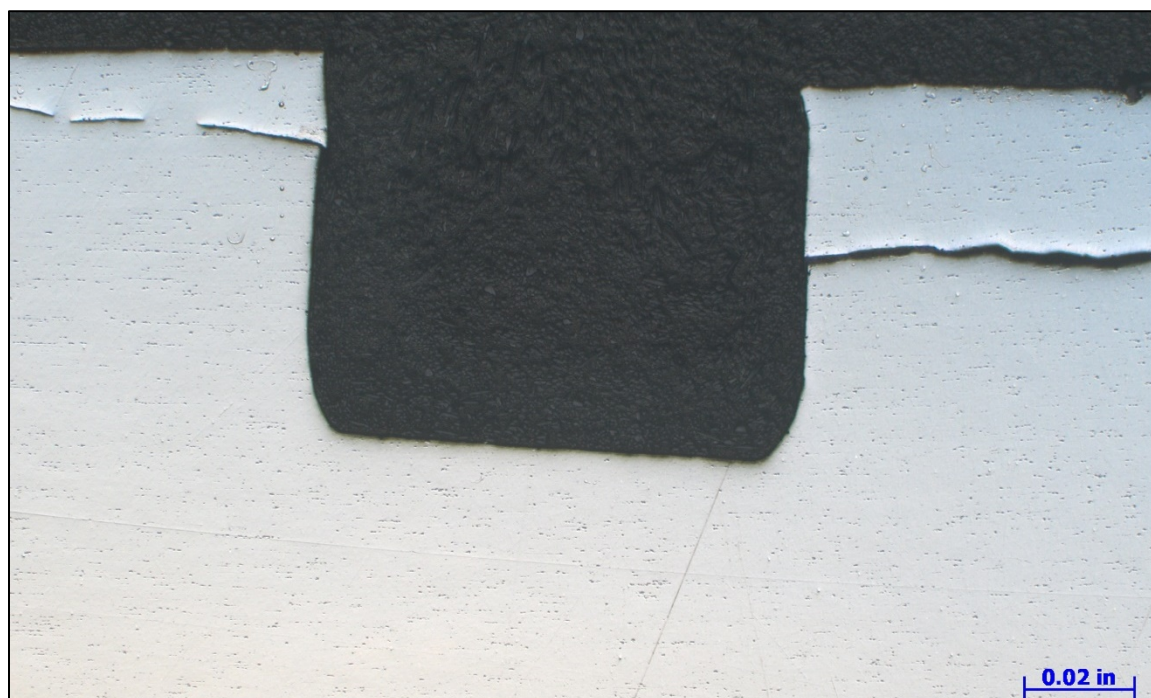
Figure 18 – Bright-field (BF) optical metallograph cross-section of the actuator retaining ring showing a horizontal crack through the groove (~25X, as polished).

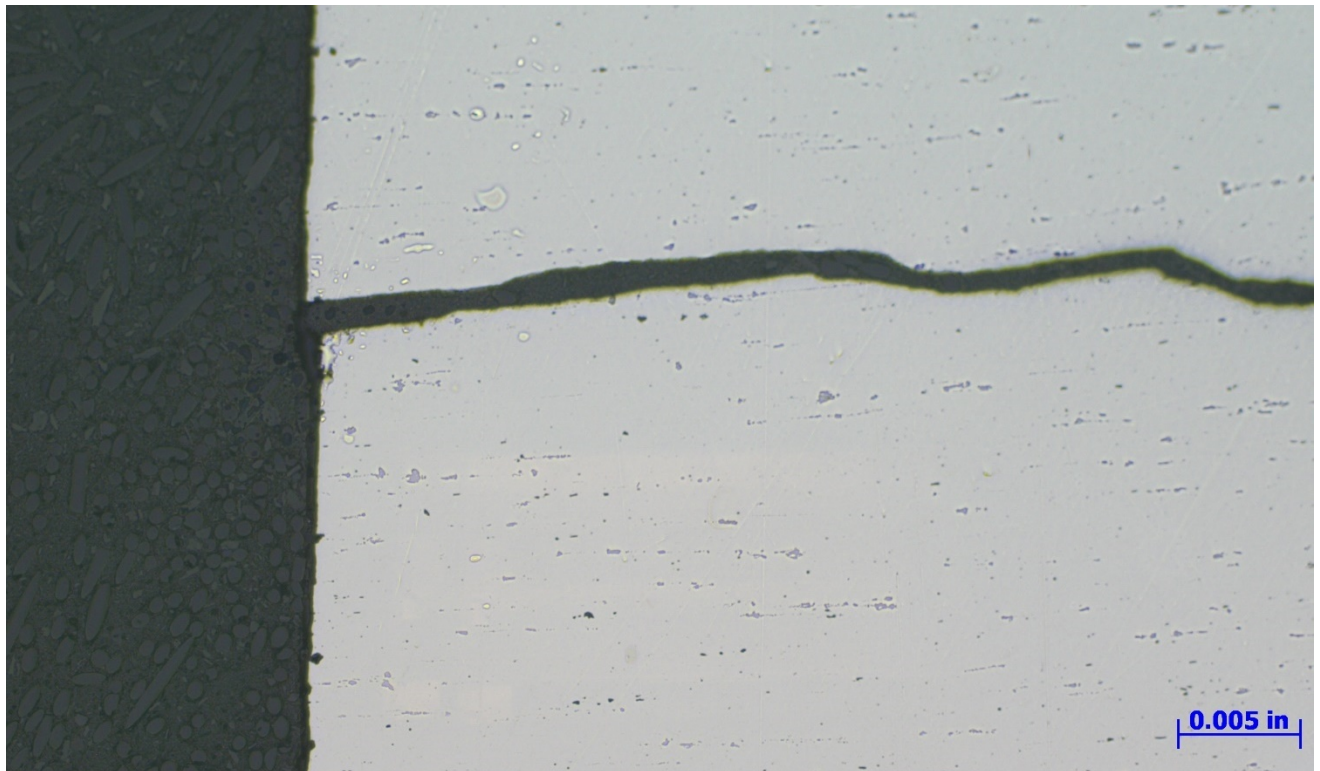
Figure 19 – BF optical metallograph showing a closer view of the right crack from Figure 16 (~100X, as polished).

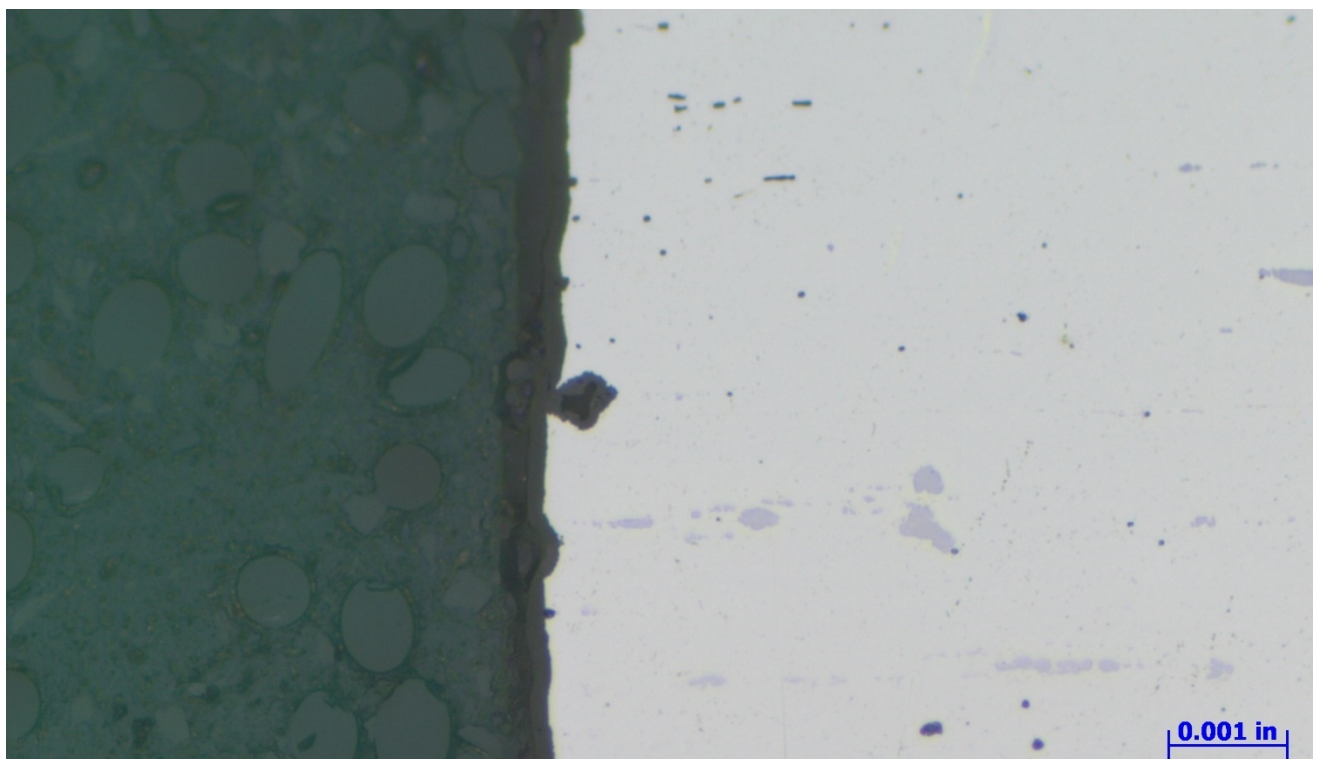
Figure 20 – BF optical metallograph of the actuator retaining ring surface, showing a small surface pit (~500X, as polished).
