# NATIONAL TRANSPORTATION SAFETY BOARD

## MATERIALS LABORATORY FACTUAL REPORT

Report No. 18-021

Place : Pacific Ocean near Japan  
Date : January 26, 2018  
Vehicle : Airbus Helicopters (Aérospatiale) SA330J  
NTSB No. : ANC18LA020  
Investigator : Shaun Williams, AS-ANC

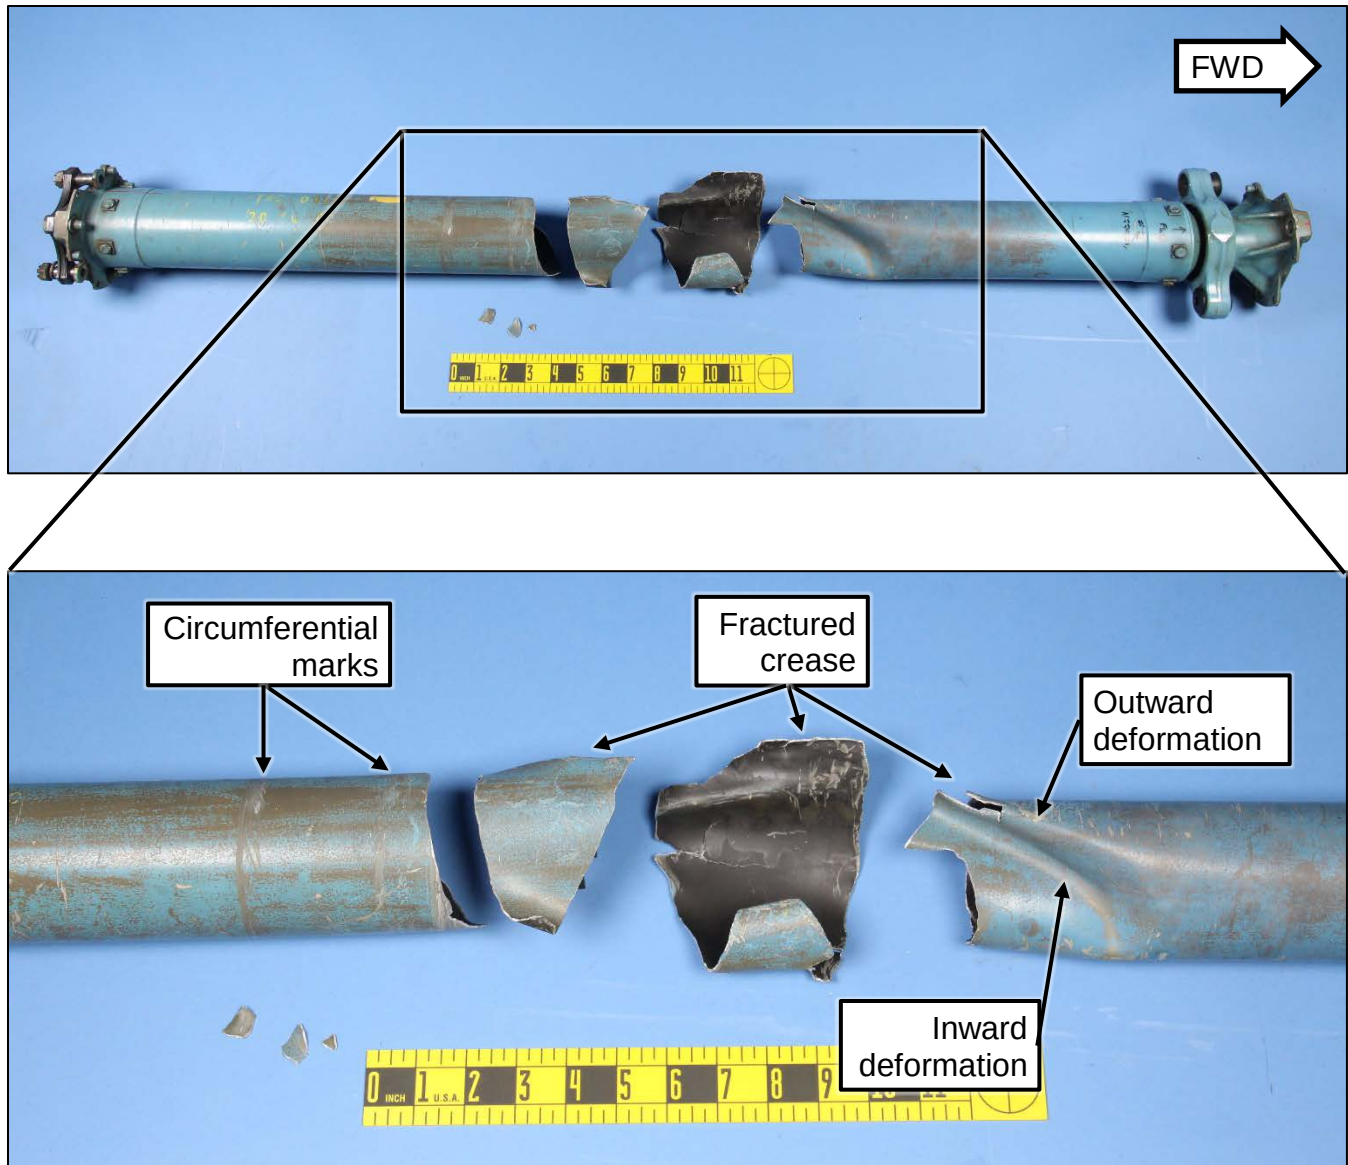
Overall views of the fractured tail rotor drive shaft pieces are shown in figures 1 and 2. The drive shaft was fractured near the middle of the shaft, and two larger pieces had fracture features that were mated to the adjacent end pieces as shown in figures 1 and 2. Several smaller drive shaft pieces were also submitted, but the mating location for those pieces was not determined conclusively.

As indicated in figures 1 and 2, the shaft had buckling deformation in the area of the fracture and adjacent areas on the forward and aft pieces consistent with an overstress torsion load. The buckling was oriented at an angle relative to the shaft axis, and the angle was consistent the forward end rotating clockwise<sup>1</sup> relative to the aft end. Inward and outward deformation and a fracture at an outward crease were continuous across the fractured pieces, consistent with buckling deformation occurring before the fracture.

Sliding contact marks extending around much of the circumference were observed on the aft shaft piece at locations indicated in figures 1 and 2. However, the marks did not coincide with a fracture location. The fractured pieces between the two end pieces were deformed and curled outward consistent with a change in the relative axis of rotation between the forward and aft pieces as the fractures progressed.

Figure 1. Overall view of the tail rotor drive shaft (upper image) with a closer view of the fractured pieces from the middle portion (lower image). Mating fracture faces of the larger pieces are displayed close to each other and are aligned approximately circumferentially.

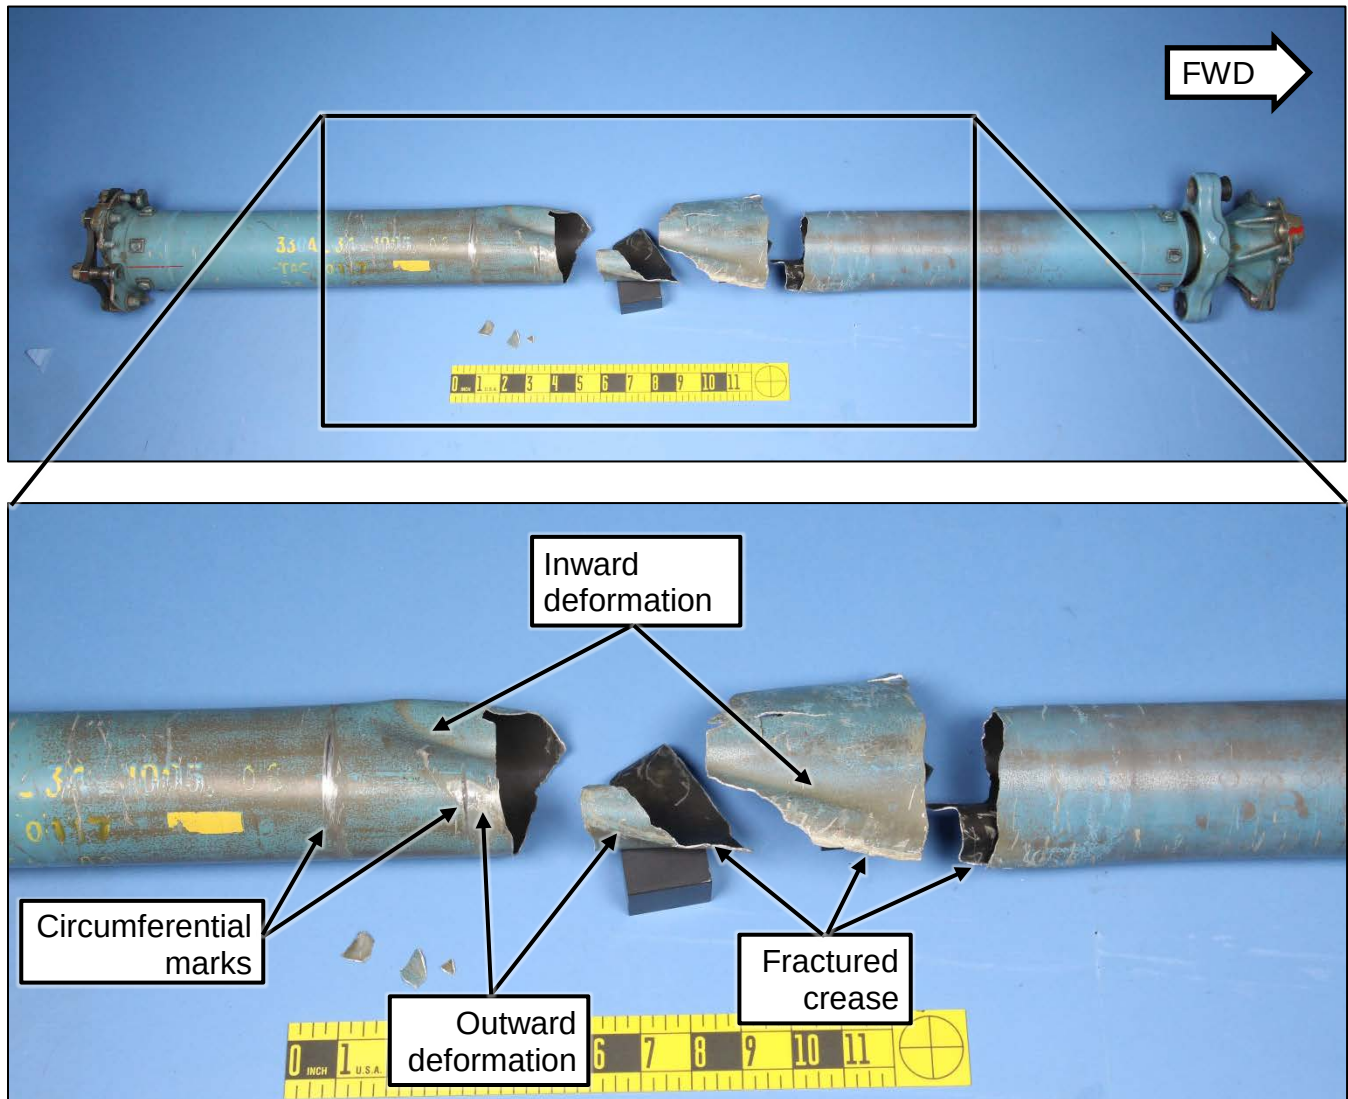
Figure 2. Overall view of the tail rotor drive shaft (upper image) rotated 180 degrees relative to the previous figure with a closer view of the fractured pieces from the middle portion (lower image). Mating fracture faces of the larger pieces are displayed close to each other and are aligned approximately circumferentially.
