# NATIONAL TRANSPORTATION SAFETY BOARD

## MATERIALS LABORATORY FACTUAL REPORT

Report No. 18-106

Place : Anchorage, Alaska  
Date : March 25, 2018  
Vehicle : Champion 7GC, N4844E  
NTSB No. : ANC18LA030  
Investigator : Mike Hodges, AS-ANC

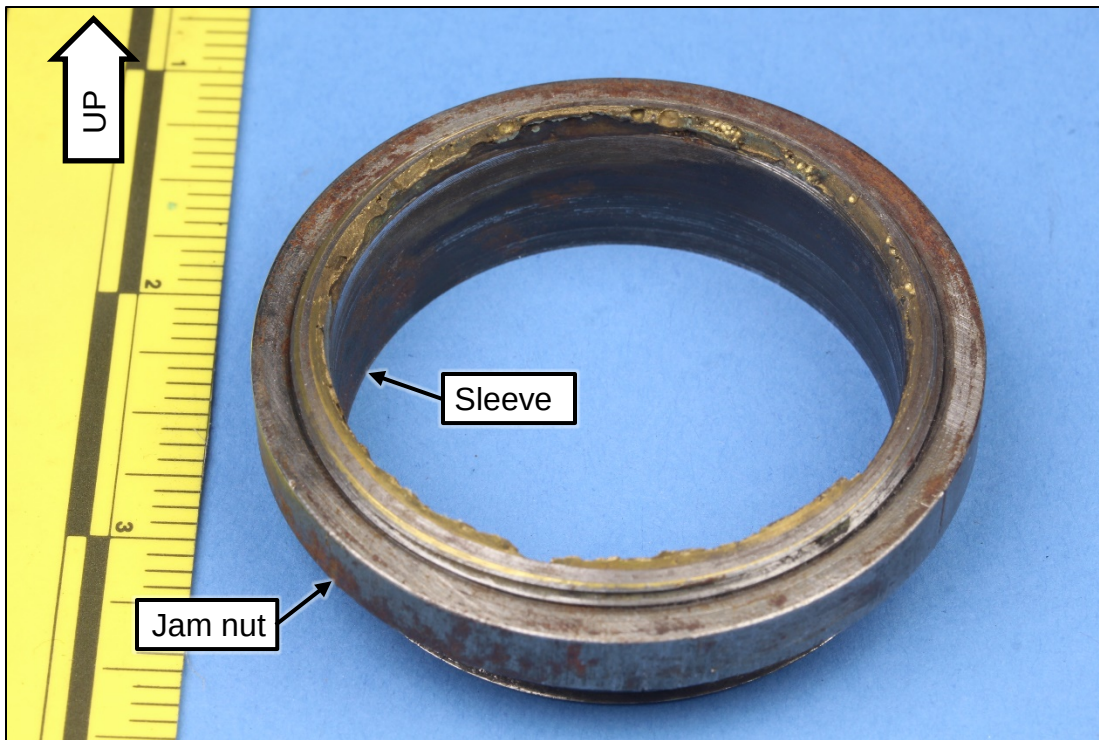
An overall view of the submitted sleeve and jam nut are shown in figure 1. The sleeve had reportedly fractured from the lower end of the right main landing gear during the accident landing sequence. In describing the landing, pilot reported that upon landing on a dry asphalt runway, the airplane touched down and ground looped<sup>1</sup> to the left.

As shown in figure 1, the sleeve had fractured from the lower end of the oleo strut tube. The jam nut was in place on the sleeve, and the external threads on the sleeve

Figure 1. Overall view of the submitted threaded sleeve with attached jam nut.

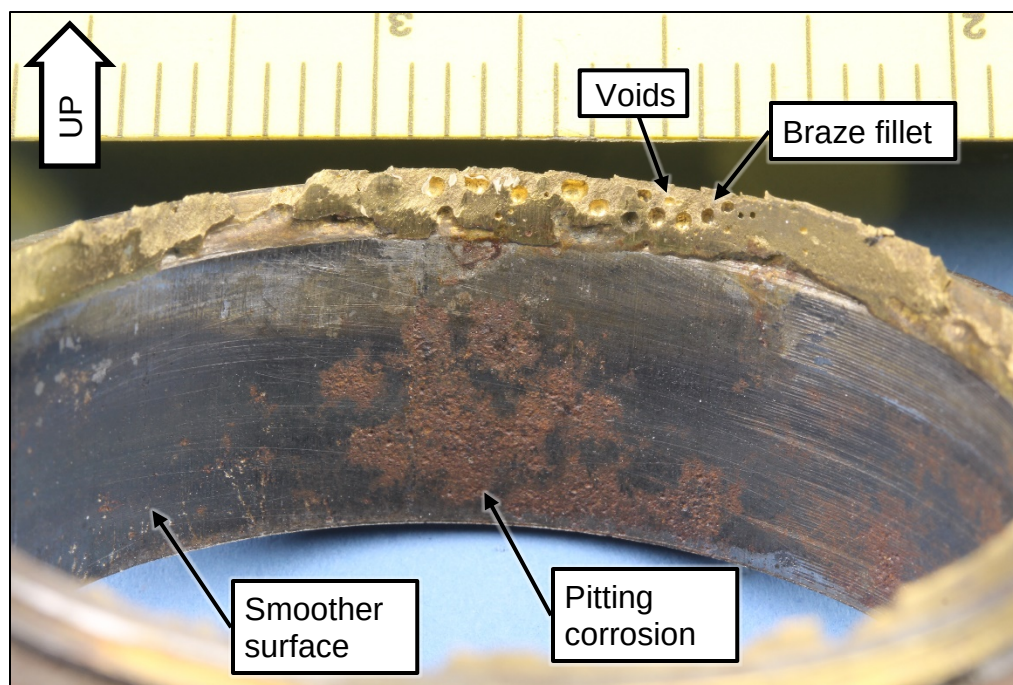
The braze material had a light yellow color in contrast to the silver and dark gray color of the sleeve surfaces. Fracture of the braze material occurred through the fillet through the middle of the fillet as shown in figure 4, near the upper side of the fillet as shown in figure 5, and close to the chamfer surface as shown in figure 6. Large voids were present at the interior surface of the fillet in some areas, and the largest void is shown in figure 5. The fracture also intersected smaller spherical voids in the fillet such as those indicated in figure 4. Fracture features were generally uniform in color with no evidence of post-fracture rubbing or long-term oxidation. Secondary crack openings and deformation to the fillet material was consistent with ductile overstress fracture with the sleeve moving downward relative to the oleo strut tube.

Figure 4. Interior face of the sleeve in a smoother area with pitting corrosion.

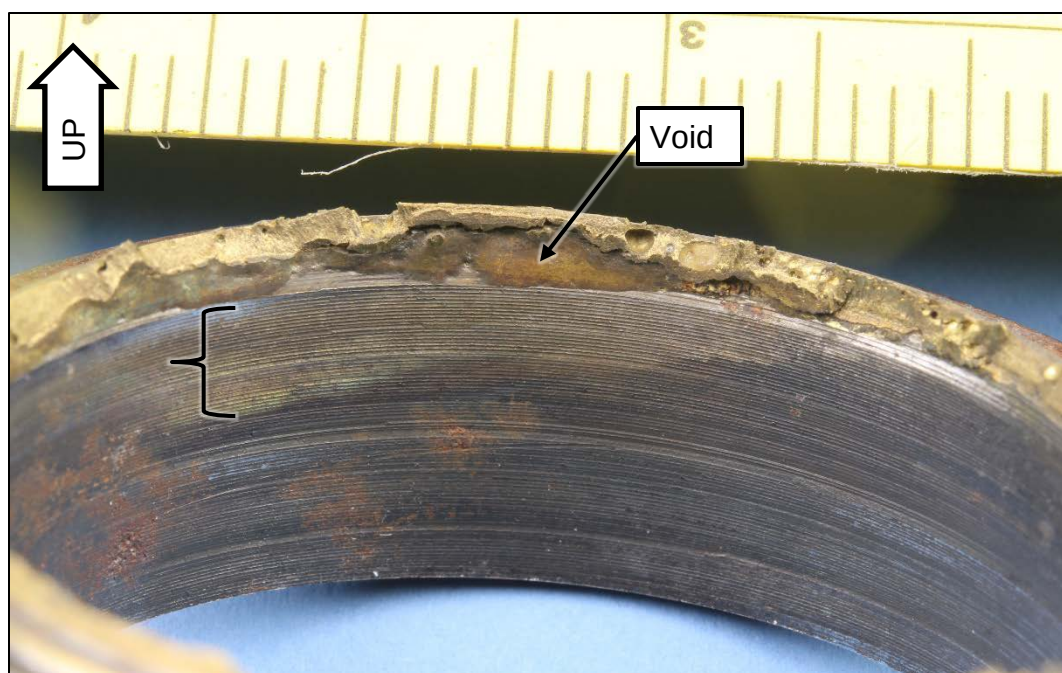
Most of the interior surface of the sleeve had a dark gray color with areas of oxidation as noted above. However, adjacent to the void shown in figure 5, the upper end of the sleeve had a yellow color consistent with a thin coating of braze material. A bracket in figure 5 indicates the extent of the thin braze coating extending up to 0.2 inch below the chamfer. The circumferential machining marks remained visible on the interior surface in the coated area, and none of the machining grooves on the interior surface of the sleeve were filled with braze material. According to the engineering drawing for the oleo strut tube assembly provided by a representative of American Champion Aircraft Corporation, the sleeve-to-tube joint should have a continuous braze fillet around the circumference of the tube. A note in the engineering drawing pertaining to the sleeve-to-tube joint stated the braze must penetrate and be evident on the opposite side of the sleeve and be continuous around the circumference.

Figure 5. Interior face of the sleeve showing a void across most of the fillet radius. An unlabeled bracket indicates a gold-colored surface appearance adjacent to the braze fillet.

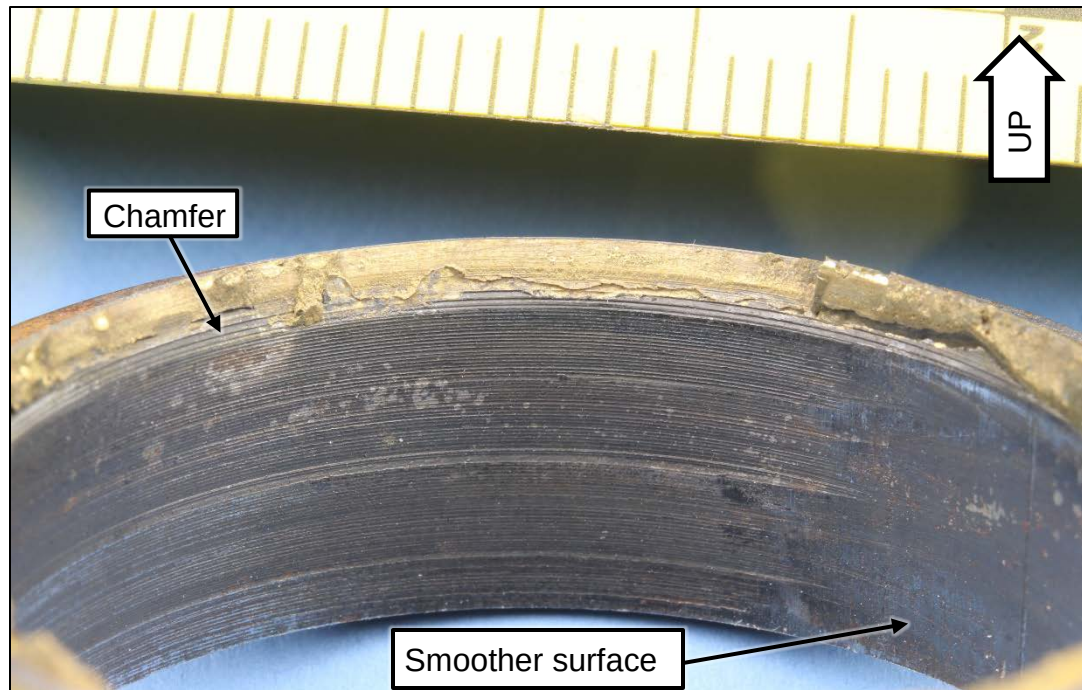
The fracture occurred through the braze fillet at the upper side of the sleeve. Views of the fracture surface and sleeve interior surface are shown in figures 4 through 6. The interior surface of the sleeve had relatively prominent circumferential machining marks that extended around most of the circumference. However, a relatively smooth area where the circumferential machining marks were absent was observed as indicated in figure 4. Pits with orange-colored oxidation was observed in the smooth area and an adjacent area with circumferential machining marks as indicated in figure 4. The orange oxidation and pits extended around approximately 1/3 of the circumference. A chamfer between the inner diameter and the upper end of the sleeve was mostly covered by the braze fillet but was partially visible in areas such as the area noted in figure 6.

Figure 6. Interior face of the sleeve showing the chamfer surface at the upper side of the sleeve that was not covered by braze metal.
