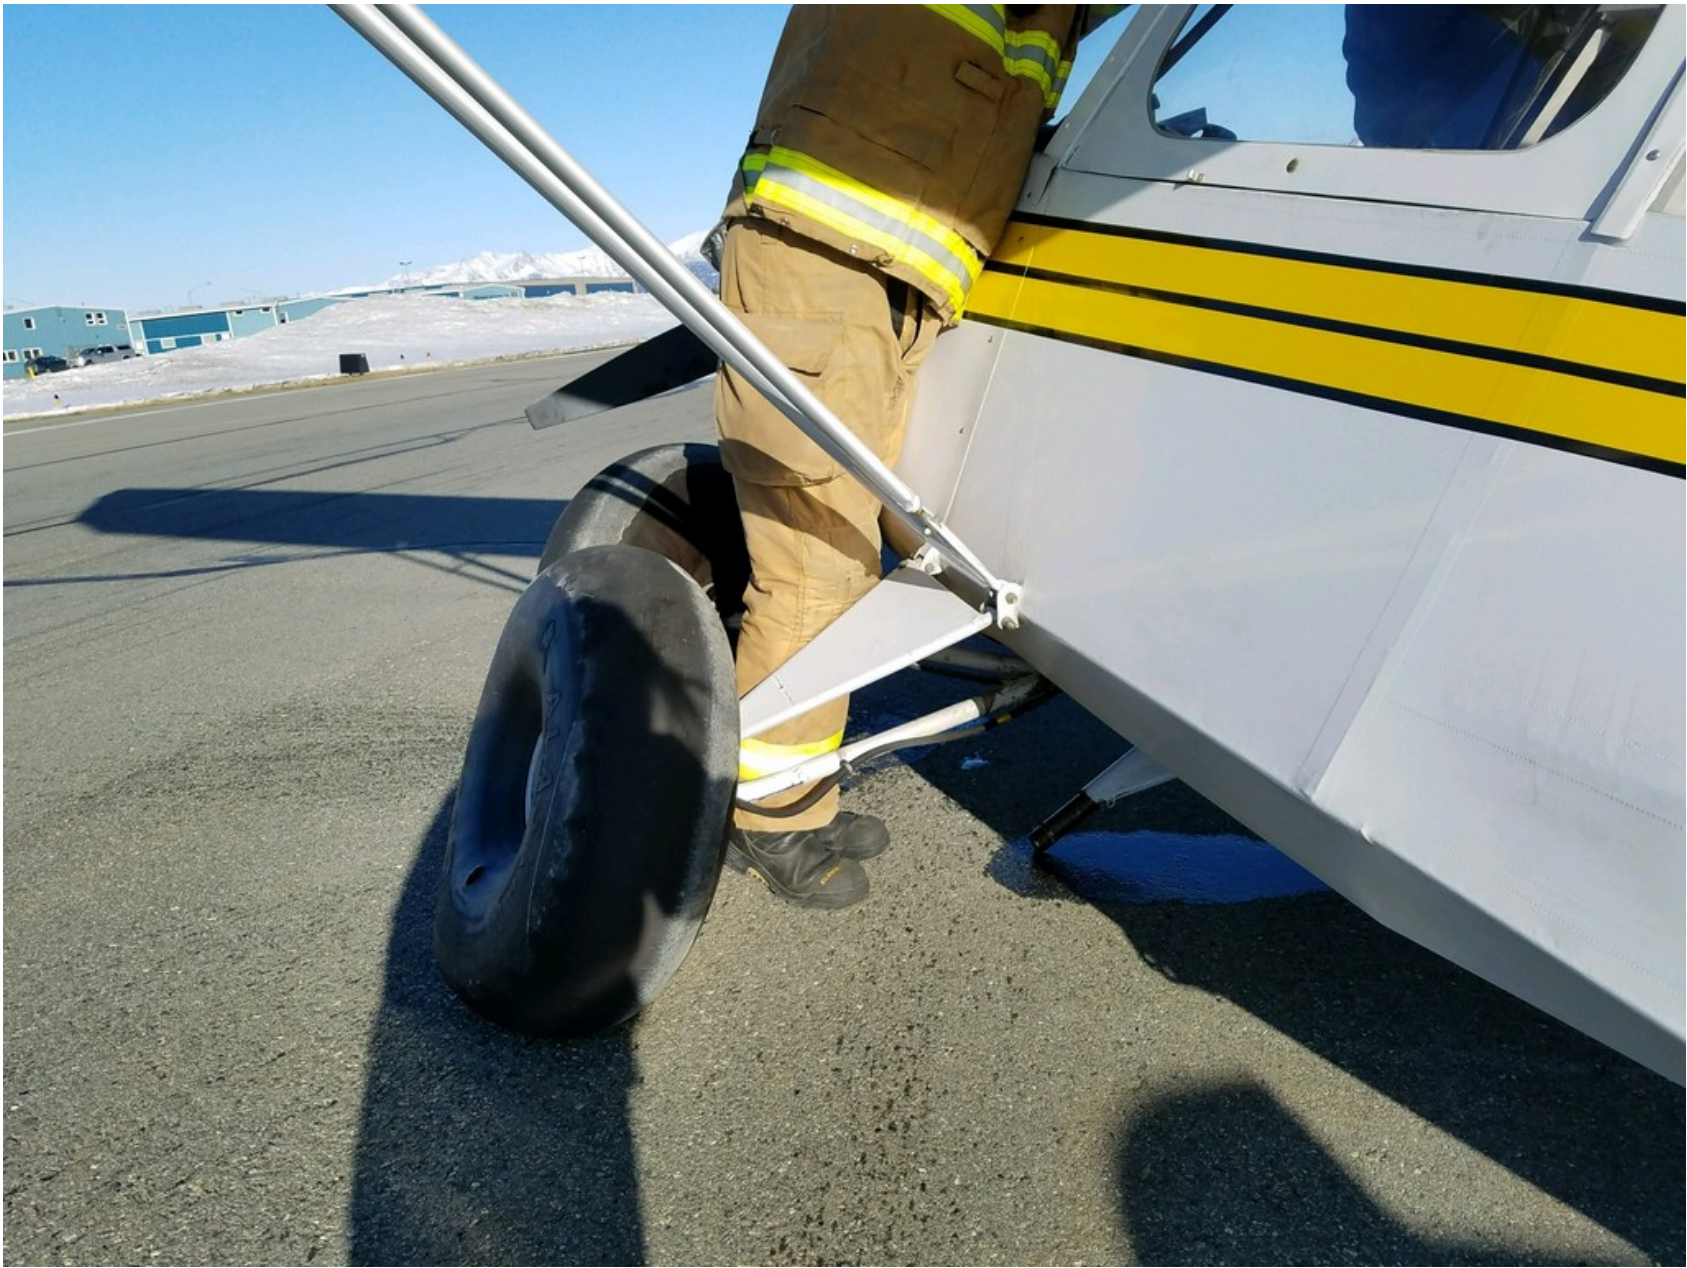
**Photo 1 – View of the intact left main landing gear and the separated right main landing gear (courtesy of the pilot).**

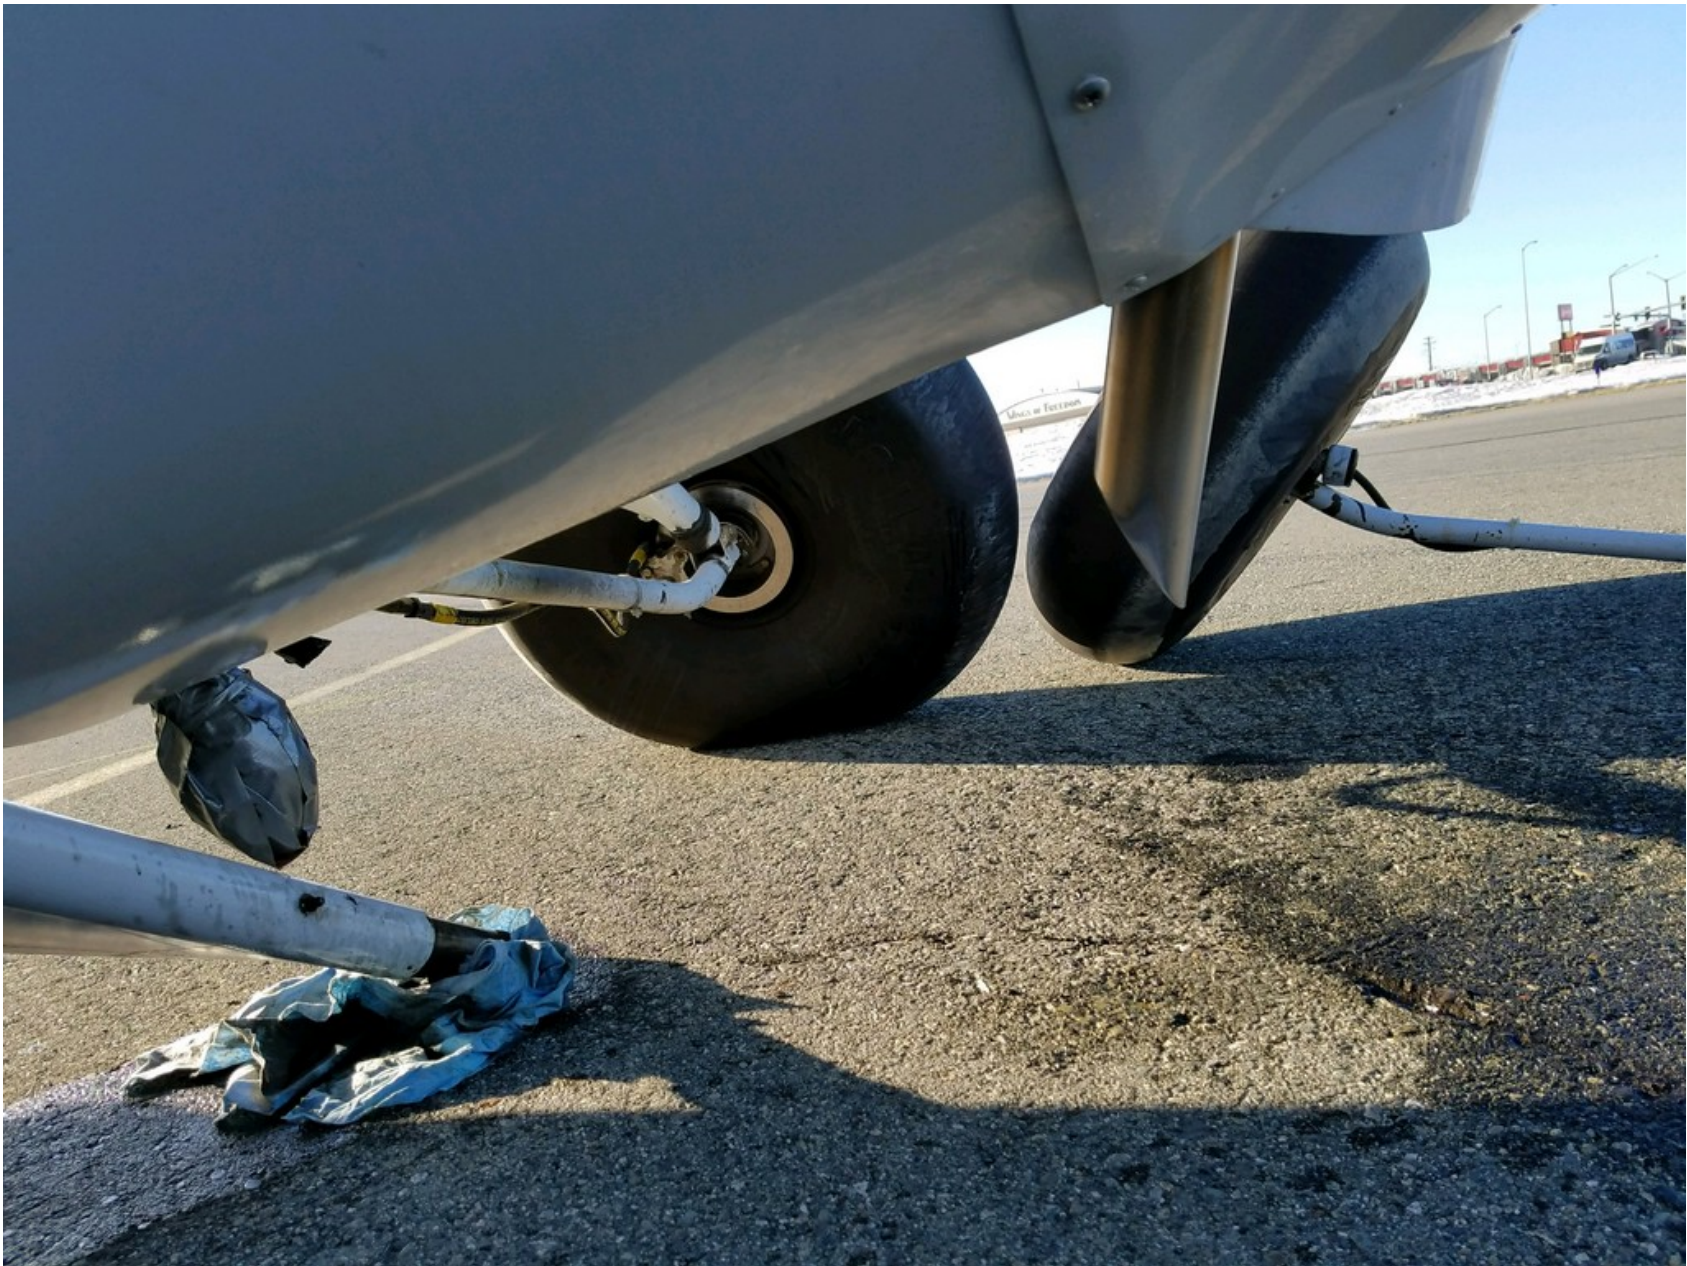
**Photo 2 – View of the intact left main landing gear and the separated right main landing gear (courtesy of the pilot).**

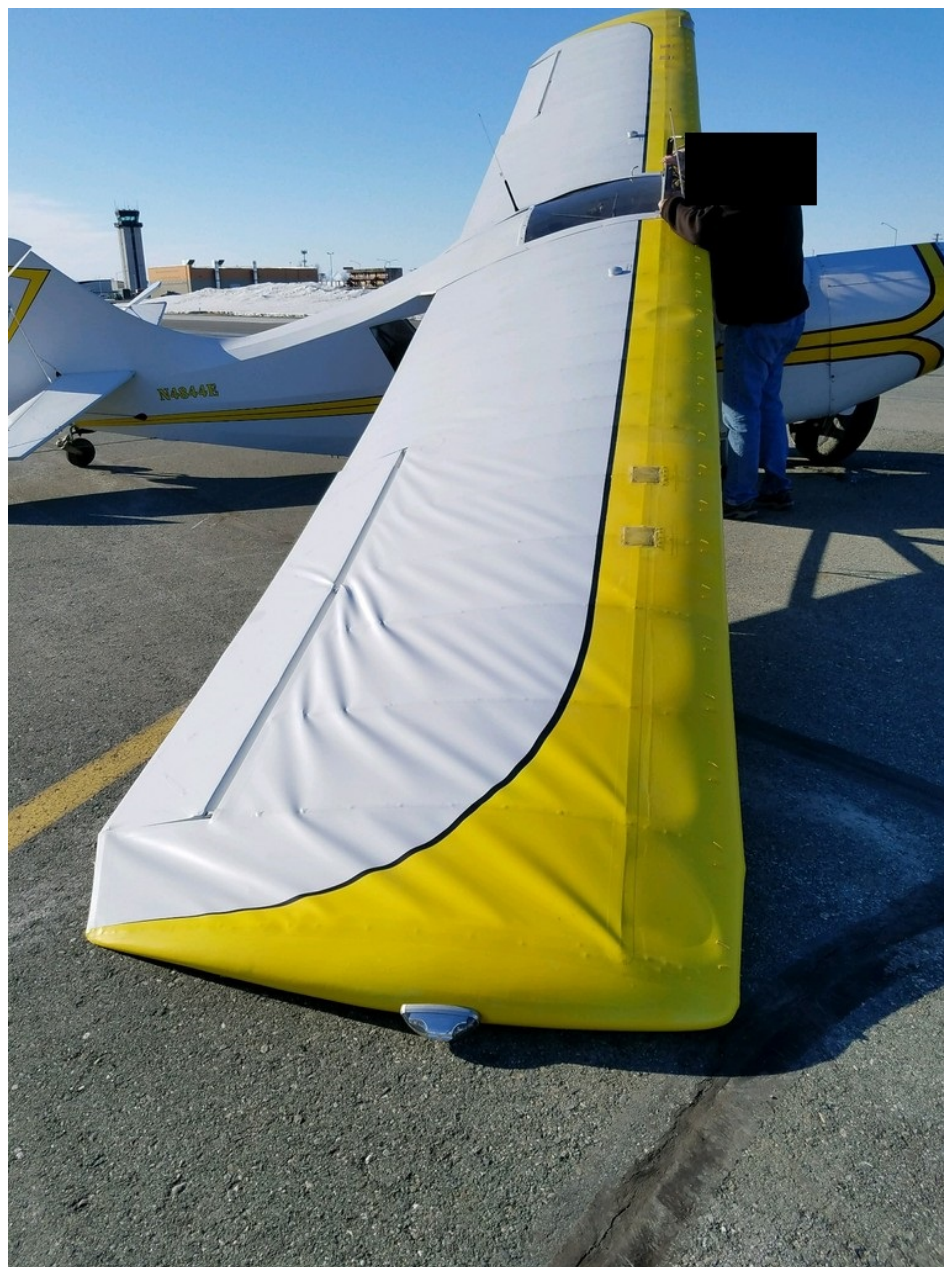
**Photo 3 – View of the substantial damage to the right wing and the right aileron (courtesy of the pilot).**

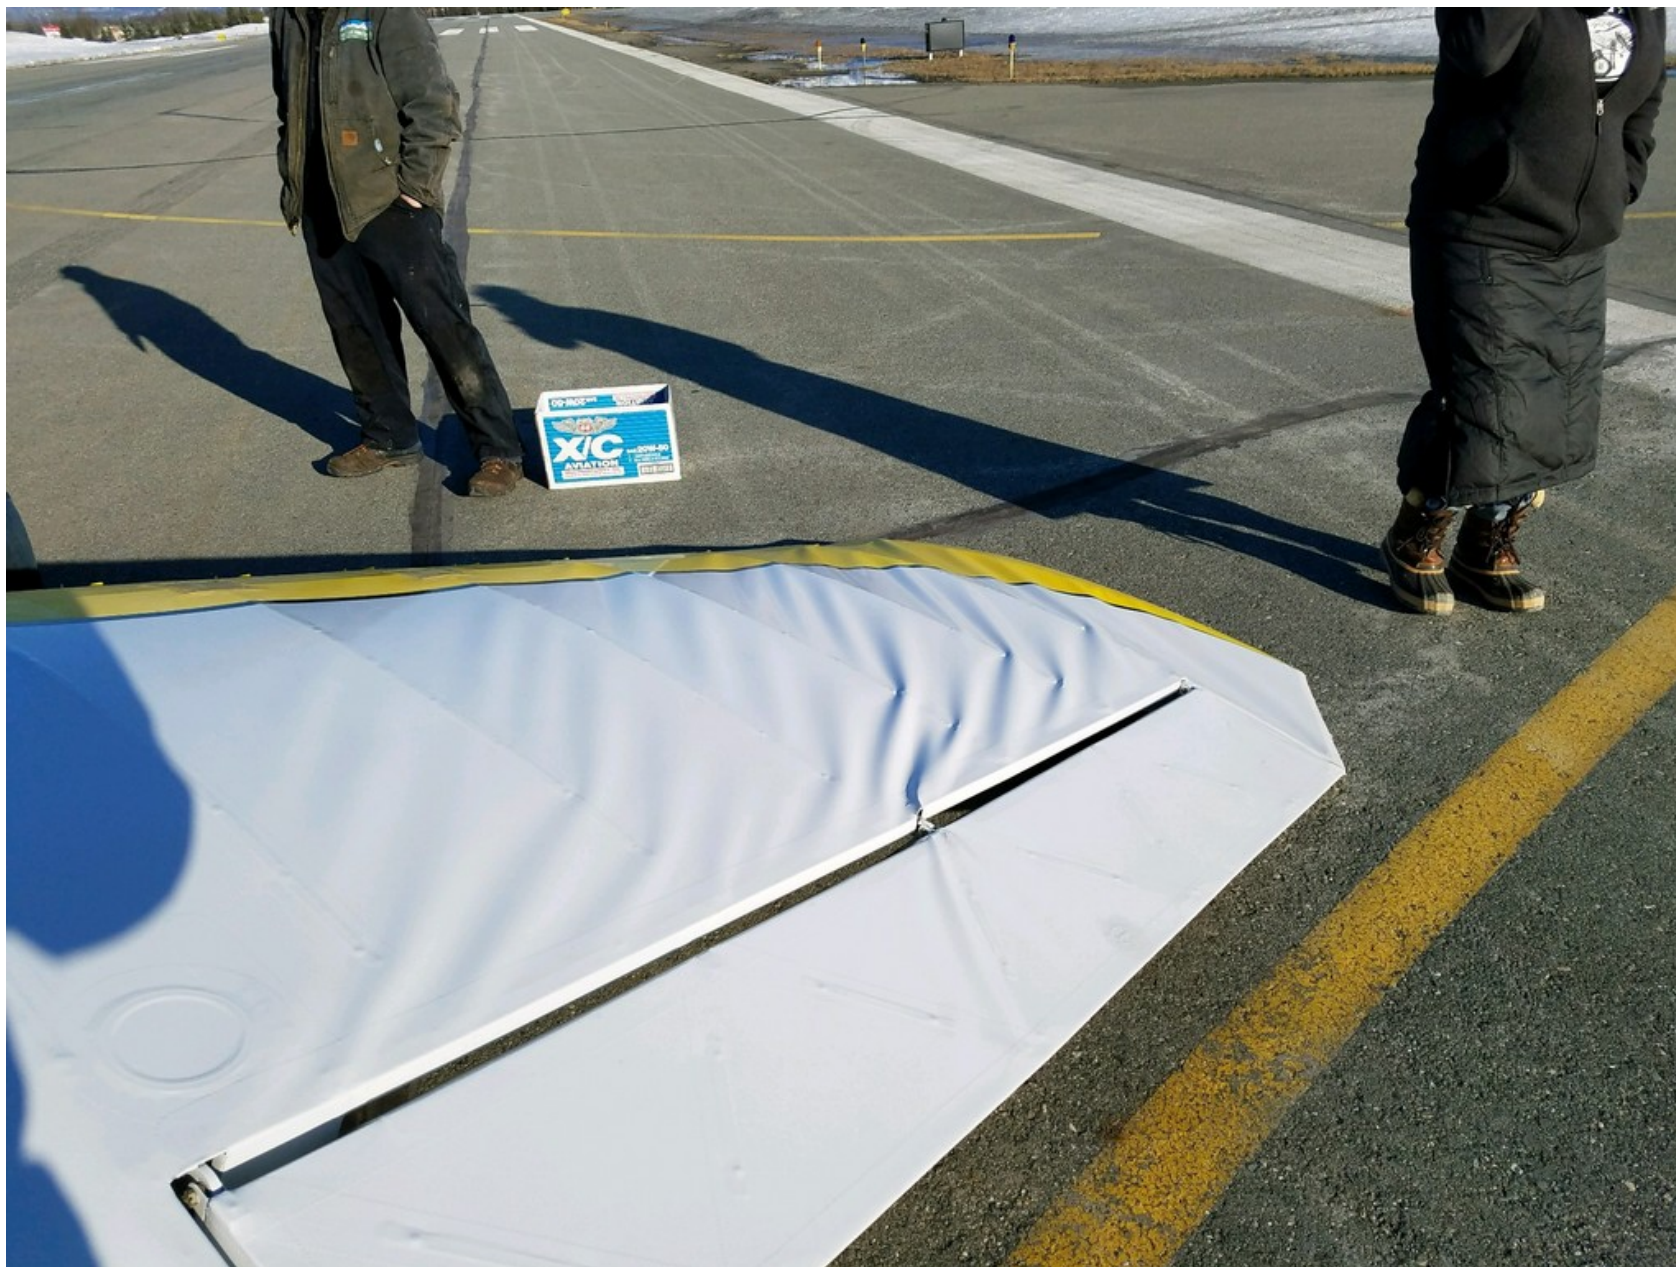
**Photo 4 – View of the substantial damage to the right wing and to the right aileron (courtesy of the pilot).**
