**PNATIONAL TRANSPORTATION SAFETY BOARD**

**Airworthiness Group Chairman's Factual Report**

**A. ACCIDENT                      ANC18LA031**

Location:                      Atqasuk, Alaska  
Date:                              April 11, 2018  
Time:                              0818 Local Time  
Aircraft:                      Ravn Connect Flight 3370, a Textron Aviation 208B, N814GV

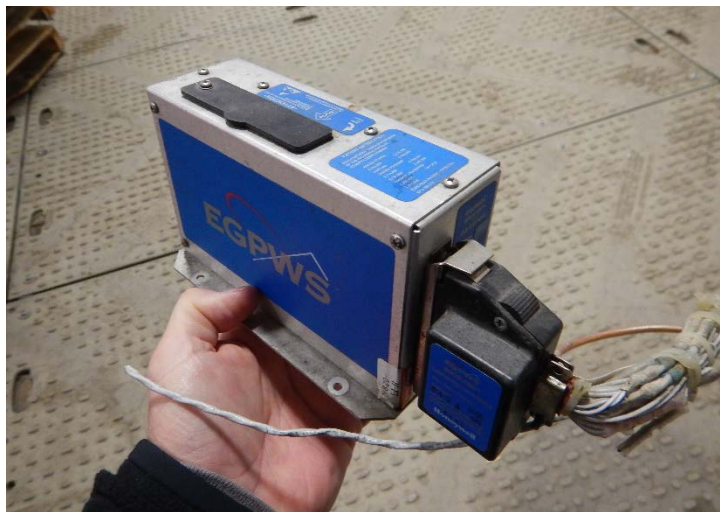
Figure 2 - The airplane's TAWS Unit, as removed.

For the examination, the dust cover (outer) case was removed and the internal components examined to ensure that the download would be successful. The terrain data base cover was also removed; the terrain data base data card and ports appeared to be intact.

The Processor Circuit Card Assembly (PCCA) board was removed and appeared to be intact. A few white deposits were noted on the board and cleaned with isopropyl alcohol prior to testing. The PCCA board was then installed onto a surrogate KGP 560 unit for download. All connector pins to the interface unit appeared to be intact.

The download of data from the last operational use was successful. There were no current faults related to the operation of the EGPWS computer. Flight Leg 15890 was established as the last flight leg that was recorded. The recorded information indicated that “terrain inhibit” was not selected on flight leg 15890.

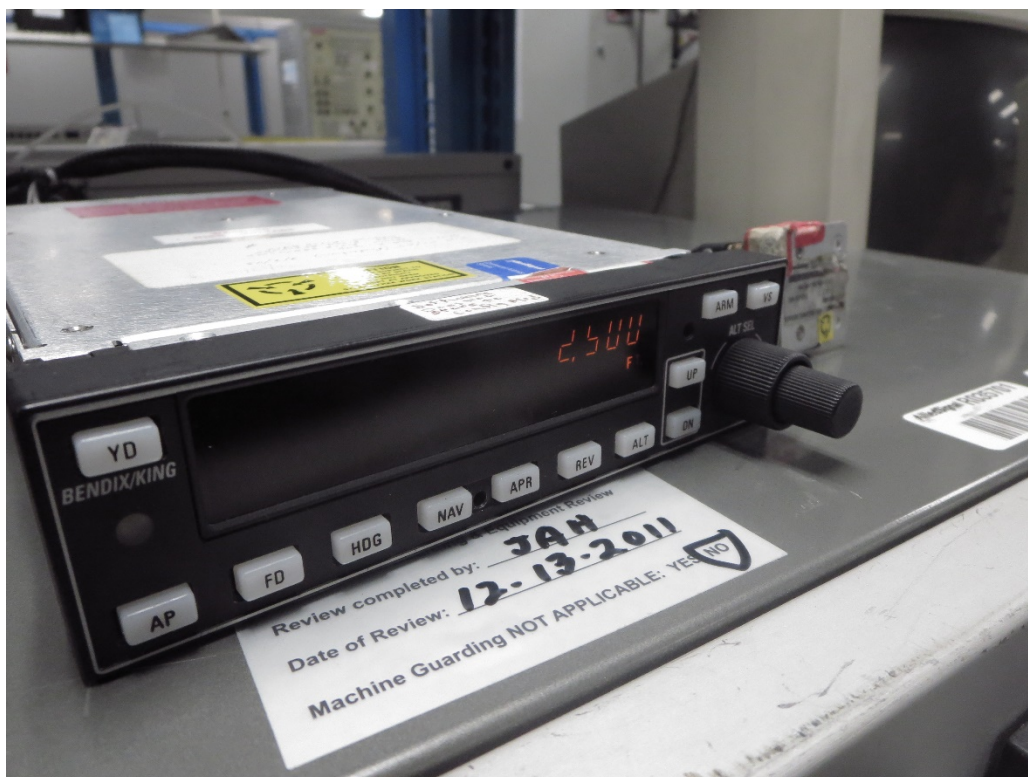
Figure 3 – KC 225 Autopilot Computer with 2,500 altitude value displayed after power was applied.

No visual physical damage to the unit was noted; however, the unit had areas of sticky substance on the exterior (Note: the airplane was carrying cases of Dr. Pepper soft drink)

The KC225 and the KCM 100 Configuration Module were connected to the Honeywell KC225 Test Bench for download and system level examination. The test bench includes test unit autopilot computer, servos, and configuration module. When power was first applied, the KC 225 indicated 2,500 feet. According to Honeywell, the Configuration Module will hold in memory the last programmed altitude selected. See Figure 3.

The KC 225 was connected to the Honeywell KC225 Test Bench and the Final Acceptance/Return to Service test procedure was conducted on the unit. The unit passed all tests with no faults found. The resultant KC 225 Final Test Data Sheets were included in Attachment 2.

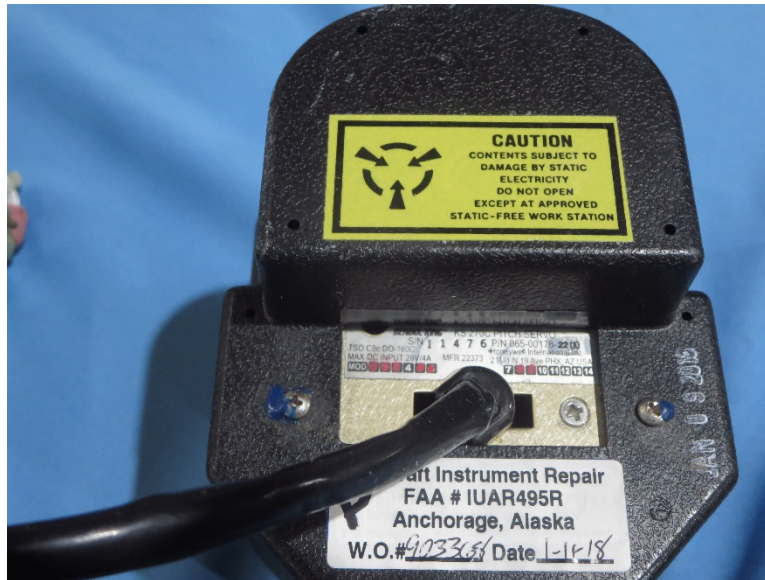
Figure 4 - Pitch Servo, as Received.

No visible damage was noted to the servo. See Figure 4.

The KS 270C Pitch Servo Actuator was attached to the Honeywell Servo Actuator Test Bench and the Final Acceptance/Return to Service test accomplished on the unit. No faults were found.

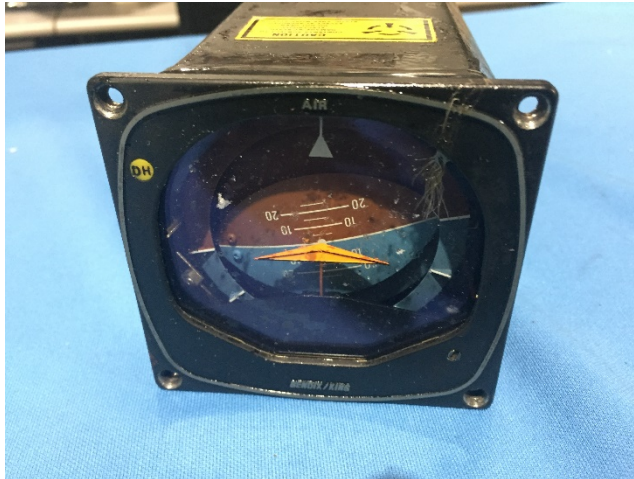
Figure 5 - The KI 256 Front View, as Received.

No visual physical damage was noted to the unit, but when the unit was rotated, a rattling noise was heard. See Figure 5.

The dust cover was removed and one of the “fast erect vanes” was found dislodged and loose. The vane was re-installed.

The KI 256 was connected to the Honeywell KI 256 Test Bench and the final acceptance/return to service test was conducted. The unit functioned correctly, but the alignment nulls were slightly out of tolerance.

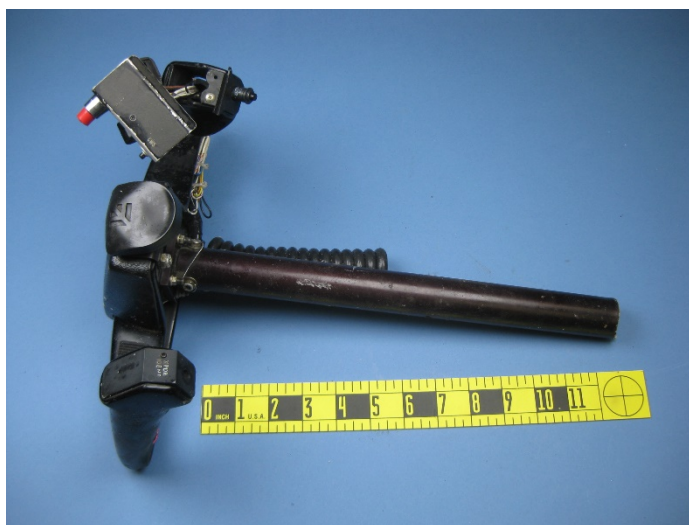
Figure 6 - Control Wheel and Column

- The column and control wheel wiring were cut for removal from the airplane. See Figure 6.

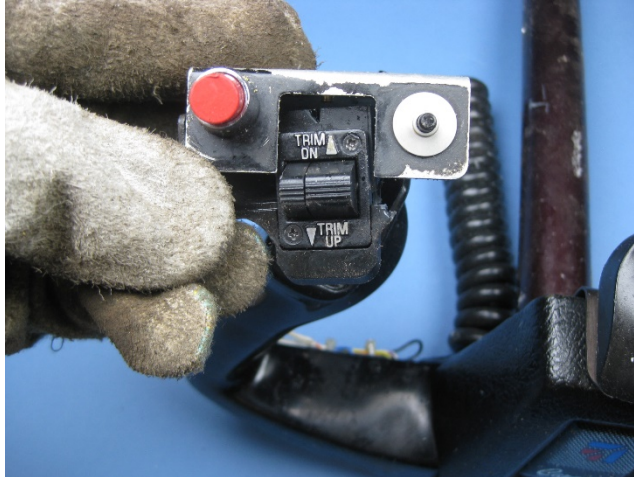
Figure 7 - Control Wheel Trim Switch

- The trim switch fixture was dislodged from the control wheel. See Figure 7.

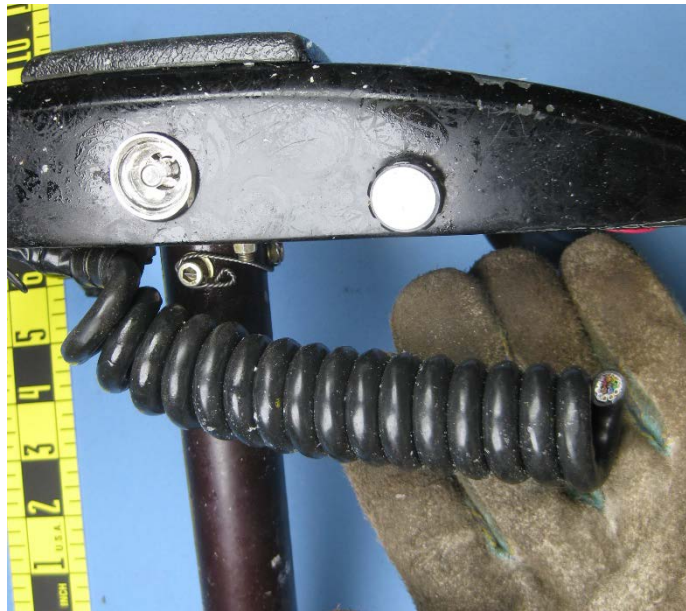
Figure 8 - Segment of External Control Wheel Wire

- The segment of external coiled wire was visually examined. No cuts, kinks, or deformations were noted on the segment. See Figure 8.
