**From:** Fox Matthew  
**Sent:** Thursday, July 19, 2018 1:34 PM  
**To:** Williams Shaun  
**Subject:** ANC18LA048 - Fairbanks, Alaska - Brake line examination  
**Attachments:** IMG\_1545.JPG; IMG\_1546.JPG; IMG\_1549.JPG; IMG\_1553.JPG

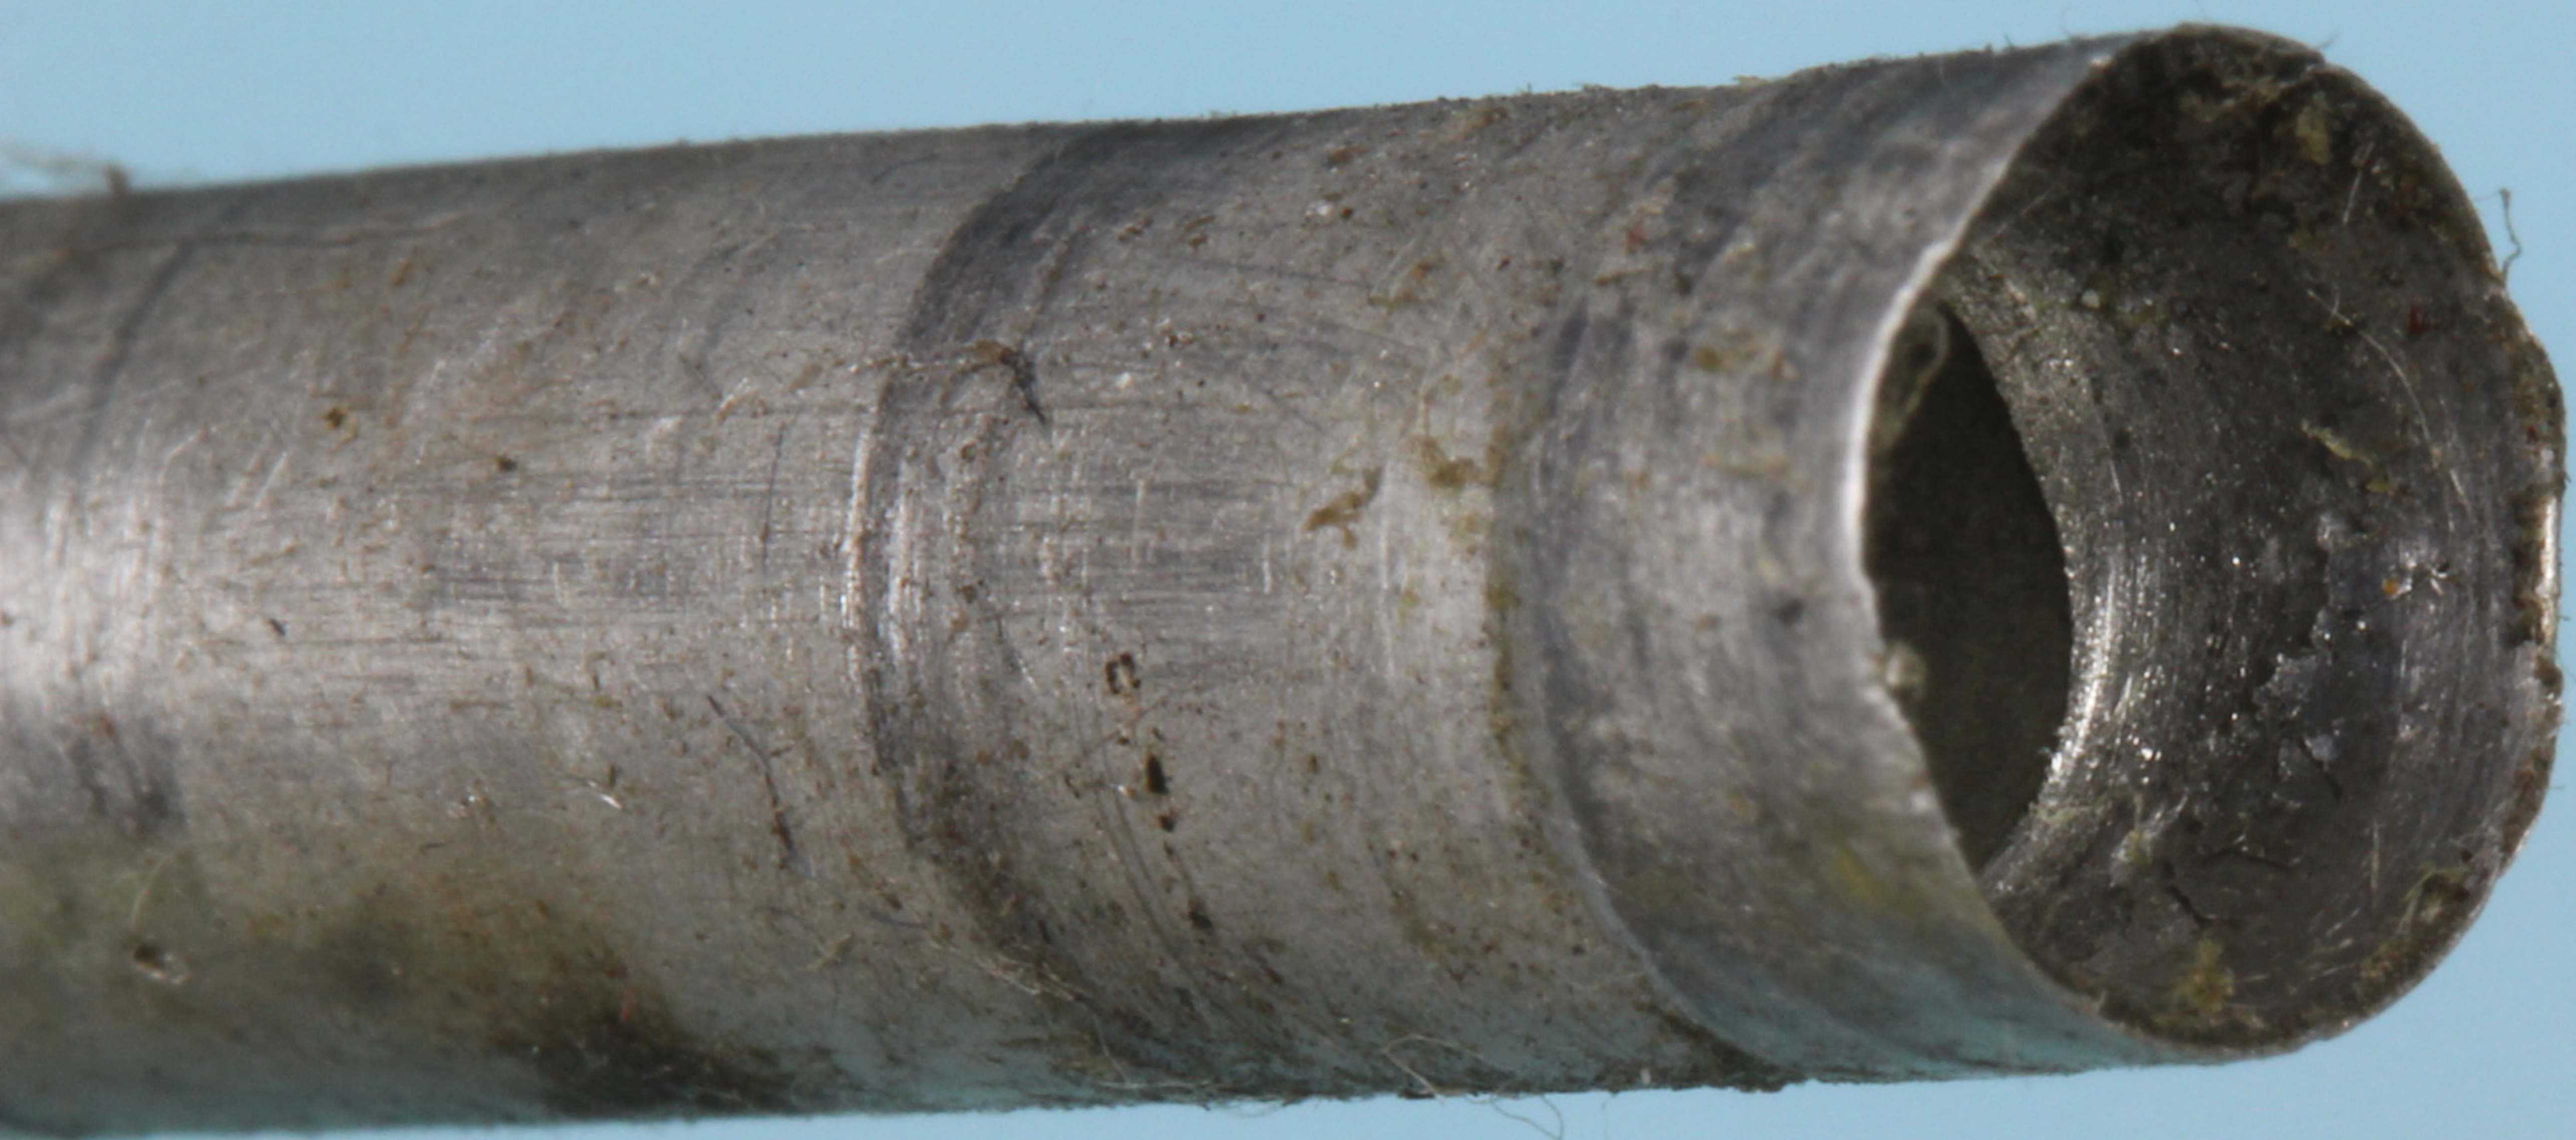
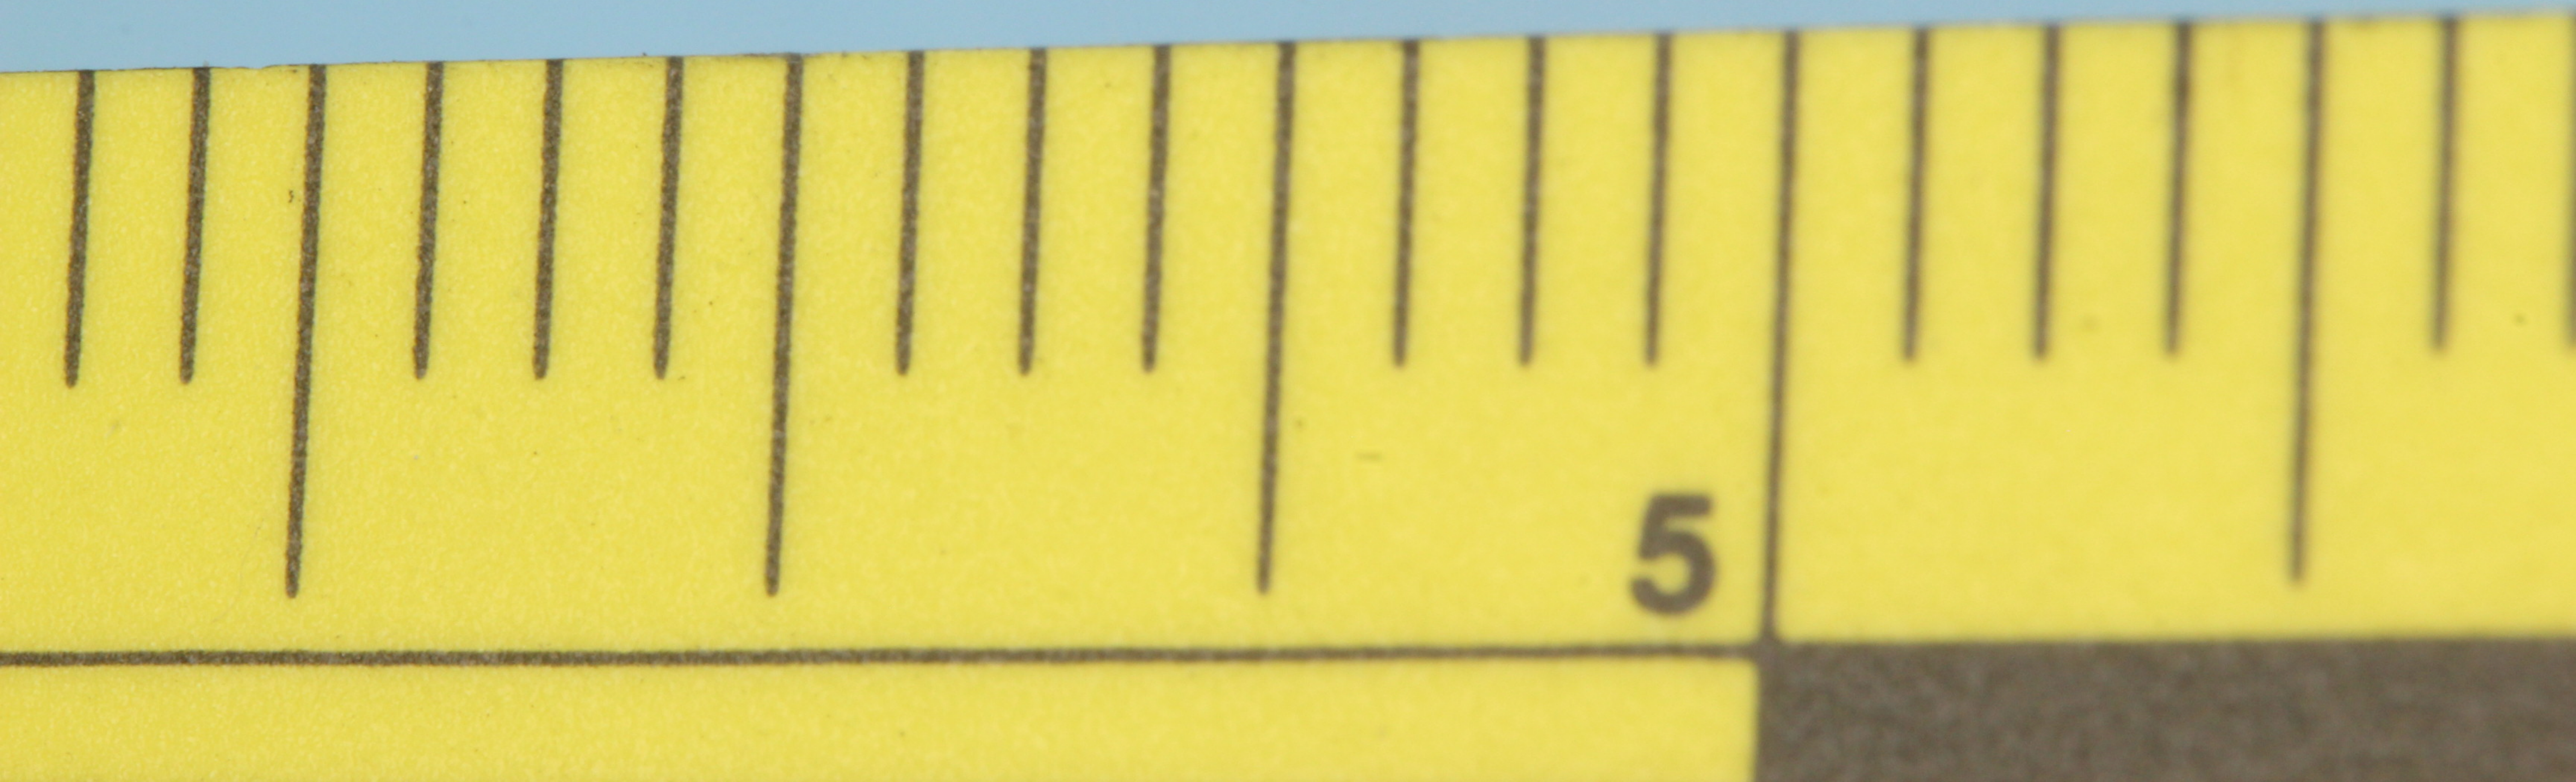
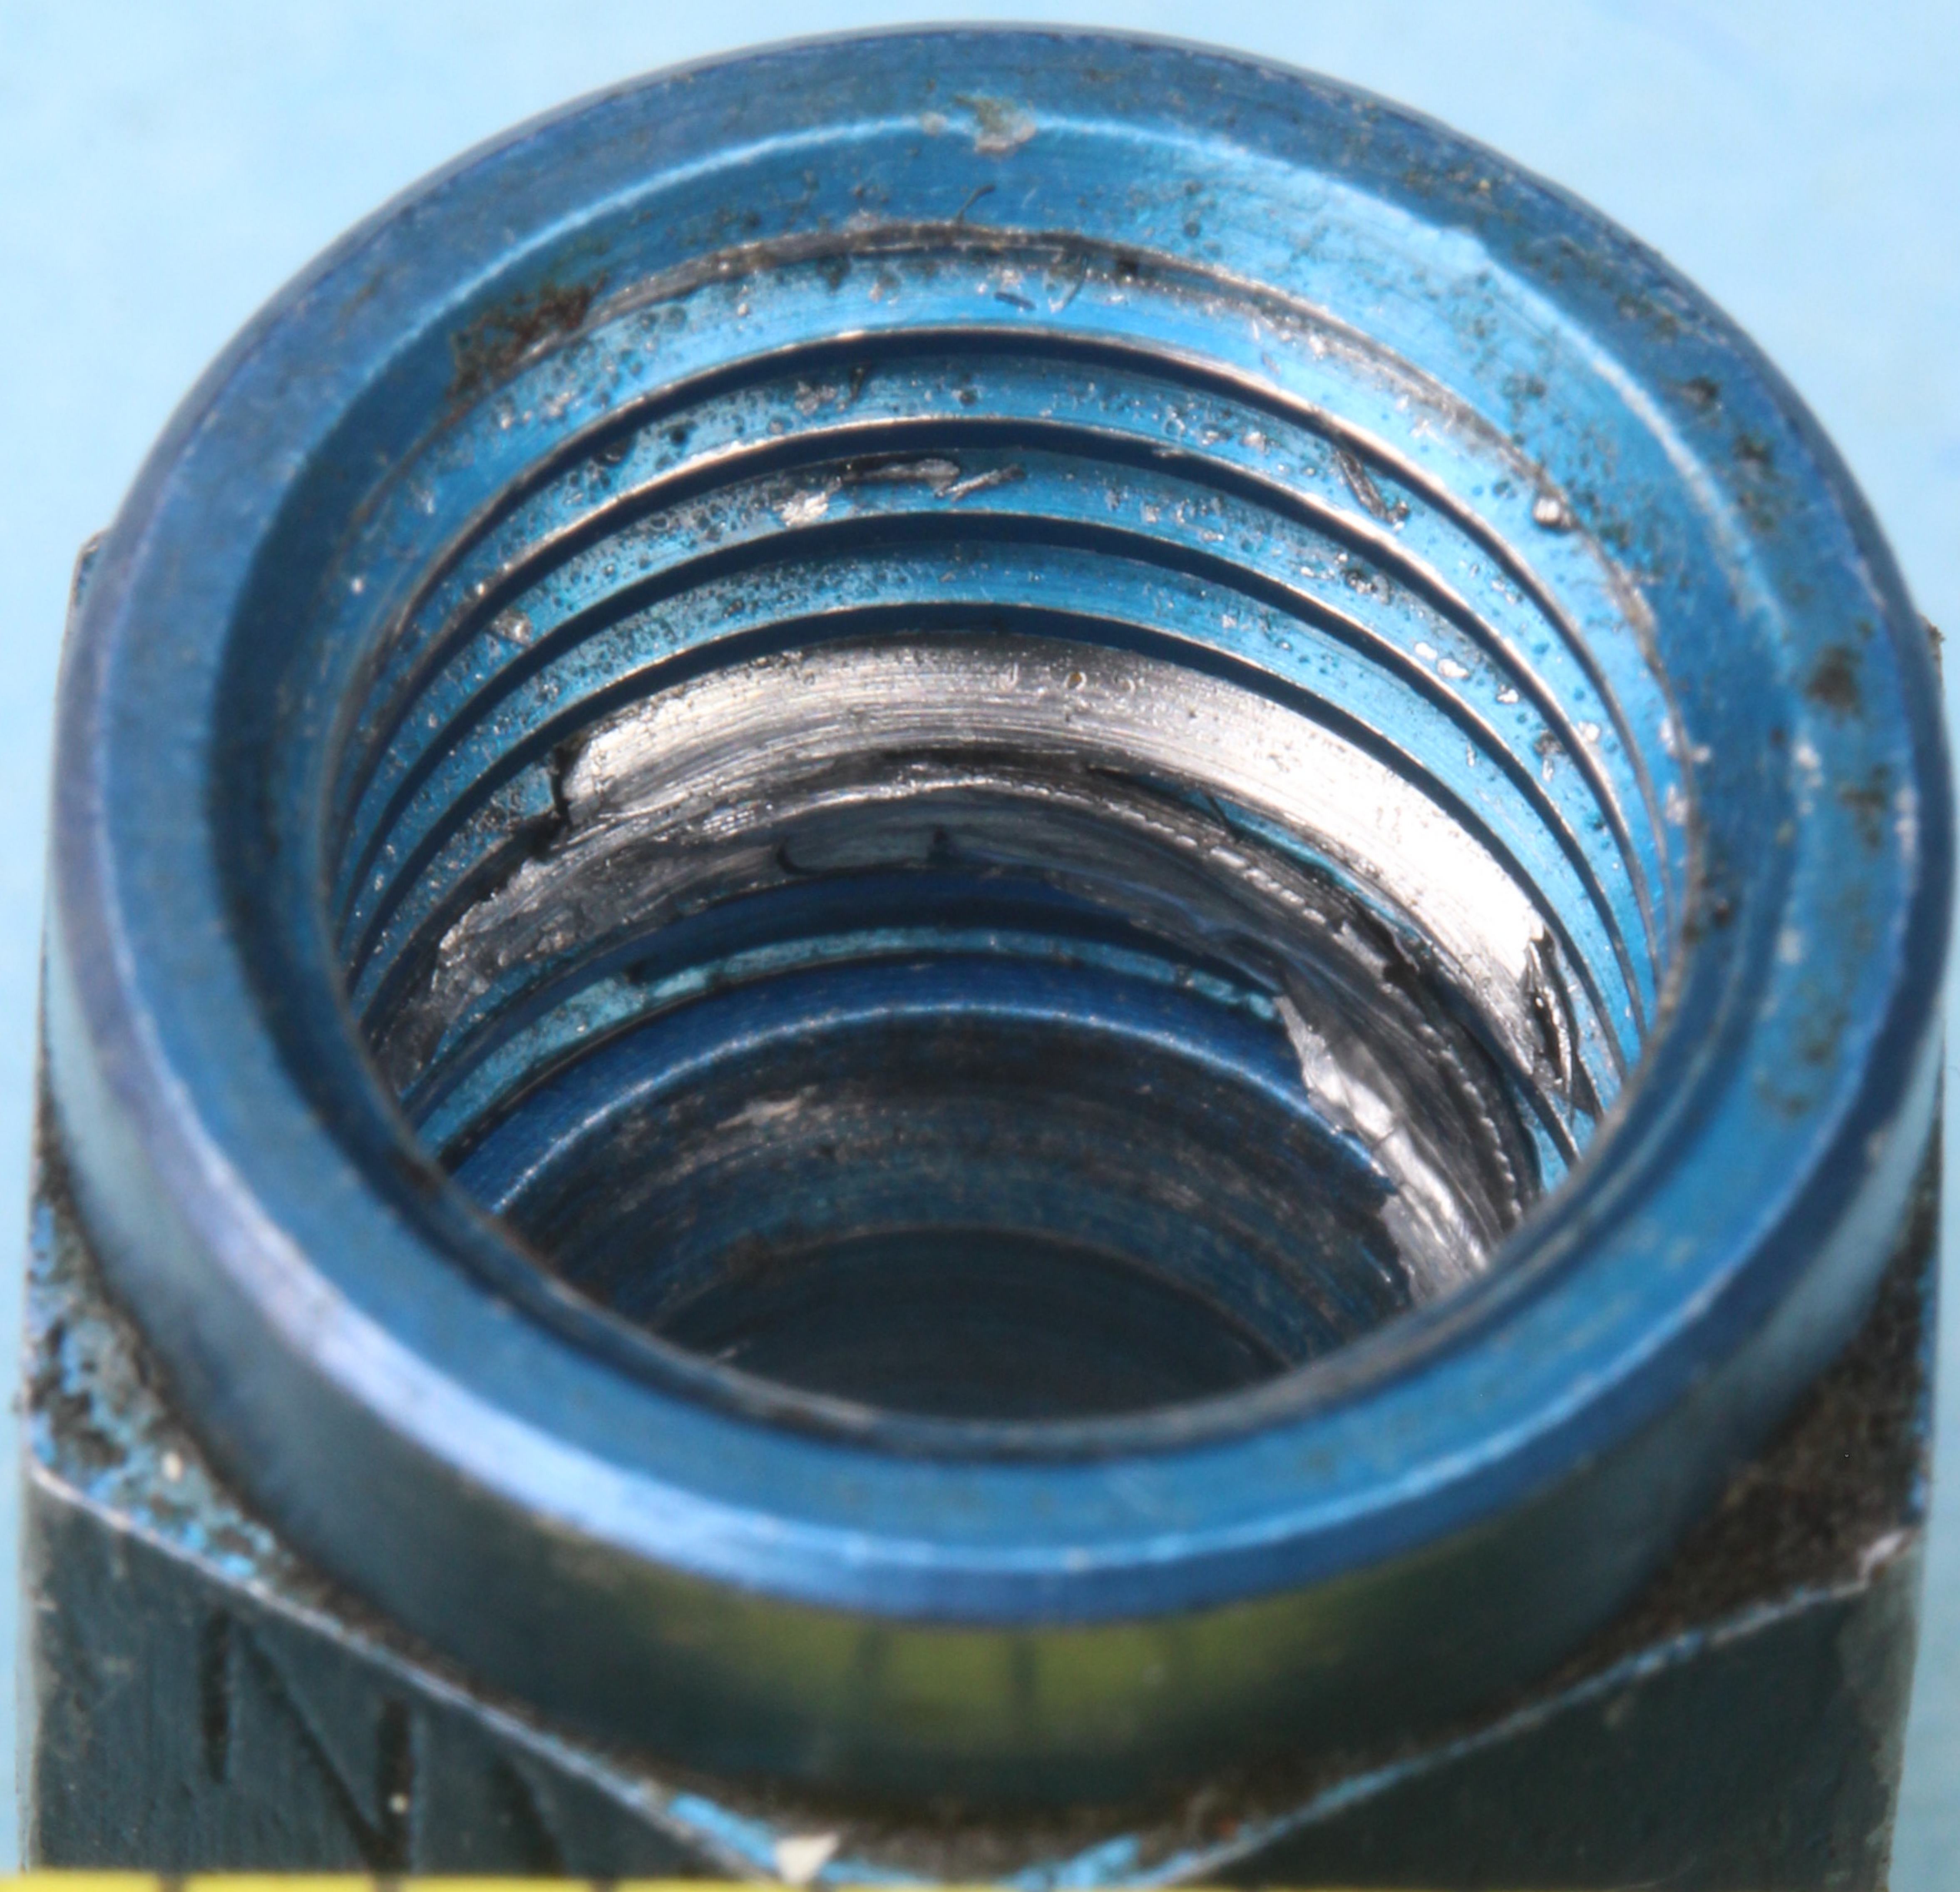
The submitted brake line tube and fitting hardware from the subject investigation were examined at the NTSB Materials Laboratory (see attached photos). At the failed end, the outer diameter of the tube approximately matched the nominal outer diameter of the ¼-inch diameter aluminum tube. The interior surface of the failed end had circumferential marks up to 0.136 inch from the end consistent with formation of a flared end with a flaring tool. The sleeve was trapped within the nut from the failed end, and deposits of gray metal appearing consistent with deformed brake tube material was observed deposited on internal threads of the nut up to 3 threads from the end of the sleeve.

An intact flare with a nut and sleeve was present at the opposite end of the tube. When assembled with the sleeve in place on the intact flared end, the end of the tube was approximately flush with the end of the sleeve. The length of the flared end measured along the interior surface was 0.109 inch.

According to Federal Aviation Administration Advisory Circular AC 43-13-1B, *Acceptable Methods, Techniques, and Practices – Aircraft Inspection and Repair*, a double flare is used on soft aluminum tubing having a 3/8-inch outside diameter or less. No evidence of folded walls consistent with a double flare was noted at either end of the submitted brake line tube.
