## **NATIONAL TRANSPORTATION SAFETY BOARD**

### **On Scene and Examination Summary**

August 28, 2018  
Anchorage, Alaska

NTSB Number: ANC18LA051  
Location: Lake Hood Airport  
Date: June 29, 2018  
Aircraft: N7675D Piper PA-18-150, 1957, S/N 18-5897  
Engine: Lycoming O-320-B2B, S/N L-32397-27A

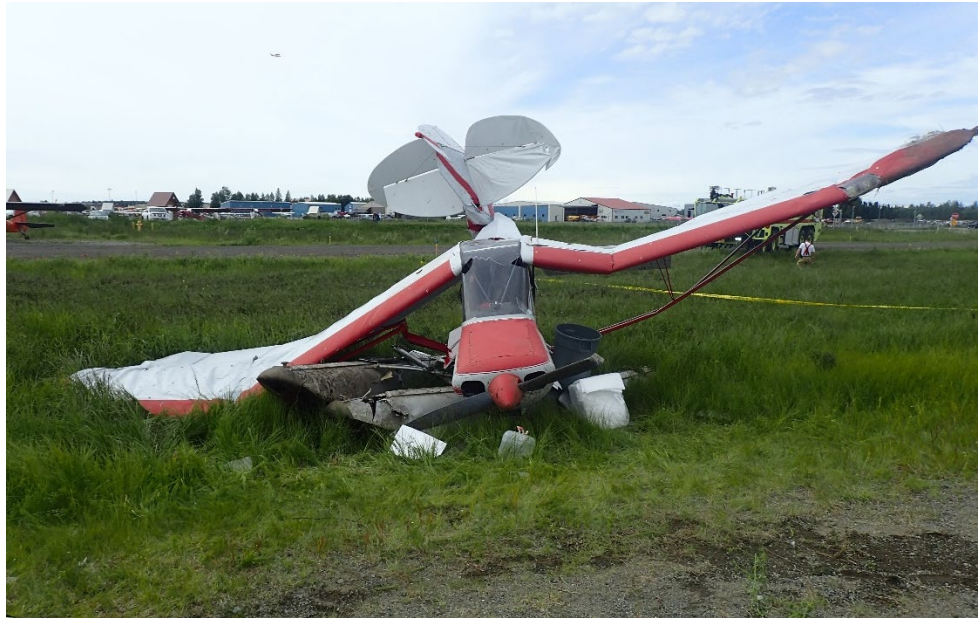
runway 14 while he "pumped" the throttle and had the passenger check that the fuel selector valve was in the "ON" position. The airplane impacted the grass area between runway 14 and taxiway hotel north of H3. See figure 1.

*Figure 1. PA-18 wreckage at the accident scene.*

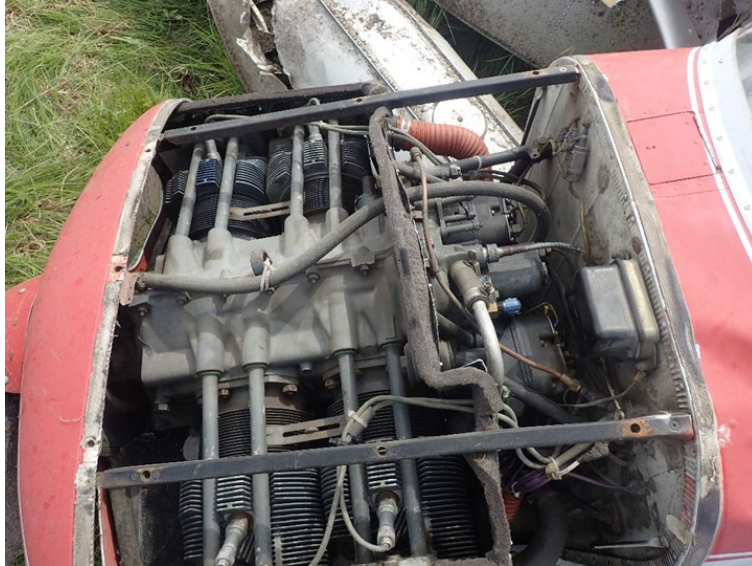
Ground scars in the grass and dirt were present along a 100 ft line that crossed the taxiway and a grass area where the airplane came to rest. The airplane came to rest on a heading of about 070° and sustained substantial damage to the fuselage and wings. The airplane was leaning on the right wing. A substantial quantity of fuel was leaking from the left wing root. Impact damage and deformation was evident in the empennage, fuselage, left and right wings. The floats were displaced to the right and rotated about 60 °right of the final heading and exhibited impact damage. The float struts were fractured and deformed. The empennage frame was deformed upward 90° and the wings were bent downward at the roots and upward at the outboard sections. The engine was intact and attached to the airframe. See figure 2.

*Figure 2. Lycoming O-320 engine at the accident scene with the cowling removed.*

The propeller assembly remained connected to the engine crankshaft. One propeller blade had a rearward curl and slight S bend at the outer 8 inches. It also exhibited leading edge impact damage and scrapes in various directions. The other blade was straight with extensive trailing edge impact damage and dirt and grass dried to the cambered face, indicative of no rotation during impact and damage from dragging during the accident sequence.

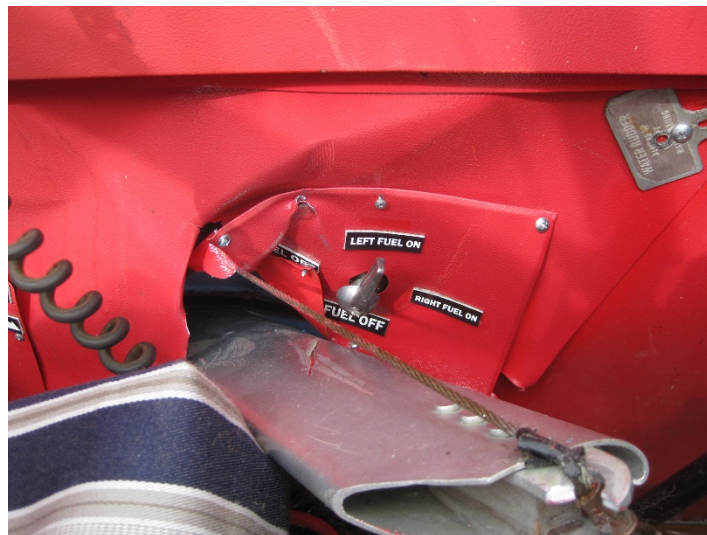
The following observations were made in the front cockpit: elevator trim center, throttle 1/3 forward, fuel selector in the Left Fuel On position, master electric switch on, ignition switch off, flap handle up (extended), mixture full out, carb heat full in, tachometer 504.6 hours. See figure 3.

*Figure 3. Front cockpit fuel selector in Left Fuel On position and float strut intrusion into the cockpit.*

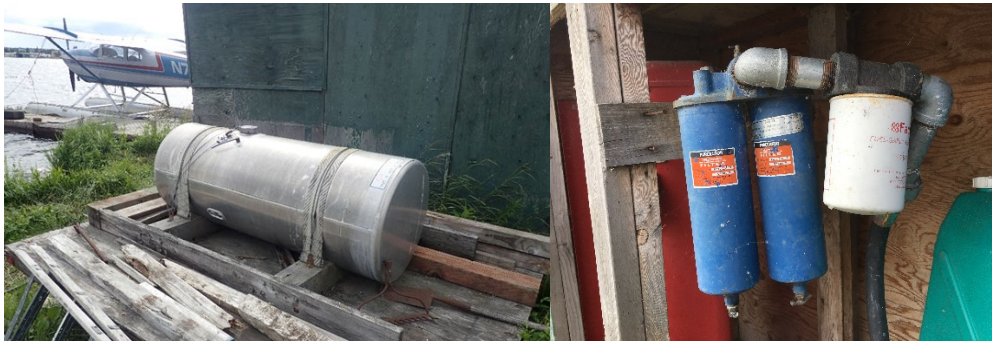
Fuel sample taken from the fuel strainer had characteristics consistent with avgas and indicated negative for water when tested with Sar-Gel paste. A few pieces of small dirt like debris was present. The pilot's private fuel tank system was inspected. The 379 liter tank was opened. No visible presence of water was evident when illuminated with flashlight. The hoses and nozzle were intact; however, the attached nozzle was laying in dirt and grass and had minor debris present on the end. A fuel sample was taken from the nozzle and the fuel had characteristics consistent with avgas. The sample was tested with Sar-Gel paste which resulted in negative presence of water. The system was equipped with one Facet spin on monitor filter with no expiration date visible and two Purolator Micronic filters. It could not be determined when the filter elements were replaced last. See figure 4.

Figure 4. Owner's fuel supply system.

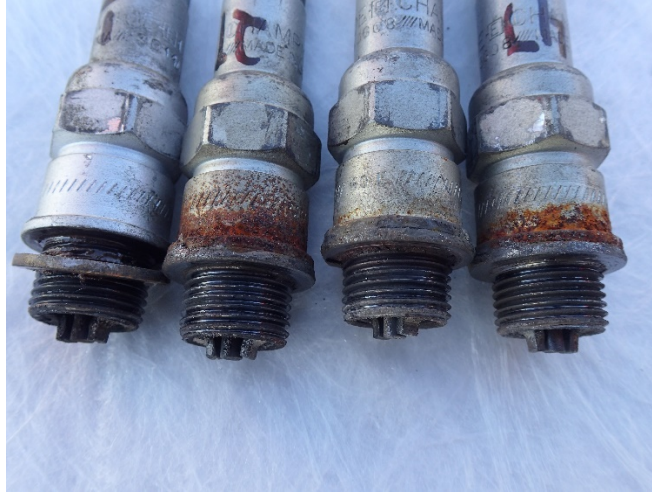
The ignition harness was intact. Excessive electrical insulating compound was present on the leads. The upper spark plugs (*Champion REM40E*) were removed and examined. Anti-seize compound and corrosion was observed on the spark plug threads, gasket and neck. All indicated dark coloring, with carbon fouling present on 2T, and no gasket present on 4T. The bottom sparkplugs were removed and examined. They each exhibited similar dark appearance as the top sparkplugs, with less corrosion present. Some corrosion may have been due to environmental exposure before the examination. See figure 3.

*Figure 2. Top sparkplugs.*

Spark could not be produced at the leads when the propeller was rotated. The magnetos were each removed and bench tested with no anomalies noted.

The corrosion on the top spark plugs and the failure of spark production at the leads may have been caused by water exposure during the two months after the accident with the engine cowling off. All fuel samples and fuel filters indicated clear with no water present. Other than the lack of fuel from the fuel strainer to the engine and the carburetor carburetor itself, there were no anomalies noted that would preclude normal operation of the engine.

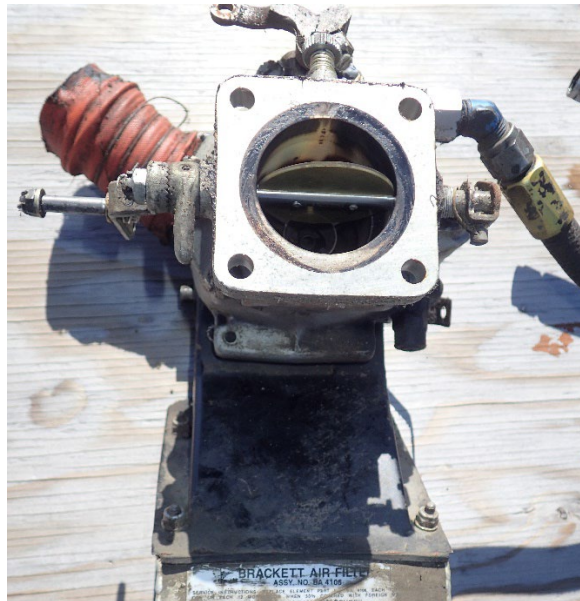
The carburetor had throttle, mixture and carb heat attachments in tact and functional. The carburetor was removed and examined. The throttle valve had minor black thermal damage, indicative of a past carburetor fire. There was no fuel present in the carburetor. The finger fuel filter clear of debris. No anomalies noted. See figure 4.

*Figure 3. Carburetor.*
